Article

# Mechanical Behavior of Brick Masonry in an Acidic Atmospheric Environment

Shansuo Zheng, Lihua Niu \*, Pei Pei and Jinqi Dong

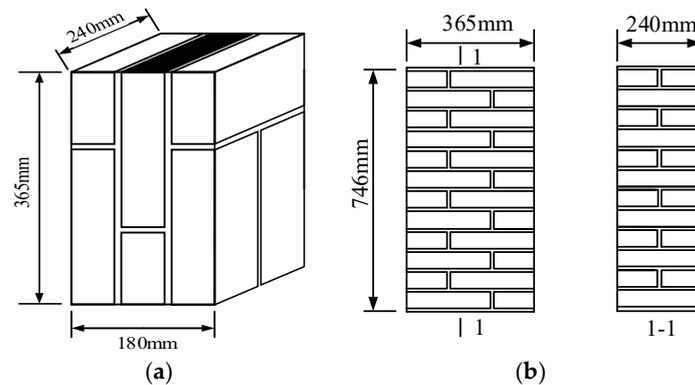
**Figure 1.** Layout of specimens used for (a) masonry direct shear and (b) masonry compression.

In order to quantify the evolution of the mechanical properties, three measurements were made: the compressive strength of the mortar, the shear behavior, and the compression behavior of the masonry. The specimen geometric sizes and the number of specimens used for each test and testing condition are summarized in Table 5 and Figure 1. Three different types of mortar prisms, that is, a cement mortar prism (CEM), a cement-lime mortar prism (CEM-LIM), and a cement-fly ash mortar prism (CEM-FLY), were prepared in order to obtain a variety of physical properties, which allows different acid rain resistances. Seven groups of mortar prisms were prepared for each type of mortar and brick, corresponding to different acid corrosion cycles (0 cycle, 50 cycles, 100 cycles, 150 cycles, 200 cycles, 250 cycles, and 300 cycles). In order to assess the shear bond strength between mortar and brick under acid rain corrosion and to reveal the deterioration regularity of the shear-bond strength caused by acid rain corrosion damage, 28 shear specimens with different acid corrosion cycles were tested under axial compression. The specimens were divided into four groups, which were called KJMA, KJMB, KJMC, and KJMD (KJM stand for the shear masonry in Chinese) corresponding to 0, 100, 200, and 300 designed acid corrosion cycles, respectively. Seven specimens were tested for each group, according to the minimum required by GB/T50129-2011 [27]. In order to obtain the basic mechanical properties of the masonry material under acid rain corrosion, 32 brick masonry compressive specimens with different acid corrosion cycles were designed. The specimens were divided into four groups, which were called KYMA, KYMB, KYMC, and KYMD (KYM stand for the compressive masonry in Chinese), corresponding to 0, 40, 80, and 120 designed acid corrosion cycles, respectively. Eight specimens were tested for each group, according to the minimum required by GB/T50129-2011 [27]. For each type of specimen, the mortar compressive strength rating was M10 and a uniform mortar thickness of 10 mm was adopted for the joint mortar.

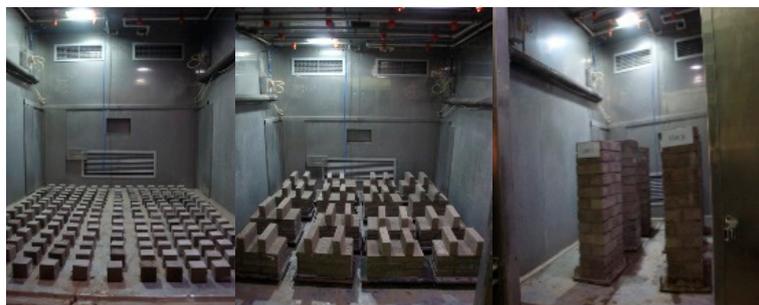
**Figure 2.** Specimens in laboratory exposure chambers.

In order to simulate an acidic atmospheric environment, it was decided to simulate acid rain by using sulfuric acid and nitric acid. The reason can be explained as follows. Various sulfurous pollutants and nitrous pollutants can be oxidized and converted to sulfuric acid and nitric acid with higher acidity. Sulfuric acid and nitric acid are still relevant in many zones, particularly in developing countries such as China [28]. To better simulate the strong acid rain and shorten the test period, much research was reported on with regard to accelerating the concrete corrosion in an acid rain environment, where the pH value decreases and the concentration of acid radical ions increases [29]. Therefore, an acid solution of pH = 3.5 was prepared, in which the major constituents were H<sub>2</sub>SO<sub>4</sub> and HNO<sub>3</sub> with a proportion of 9:1. The specimens were cured for 28 days in a natural environment, and they were placed into the environment chamber to reach the desired levels of corrosion damage. Specimens in the laboratory exposure chambers are shown in Figure 2. The acid rain corrosion rule is shown in Figure 3.

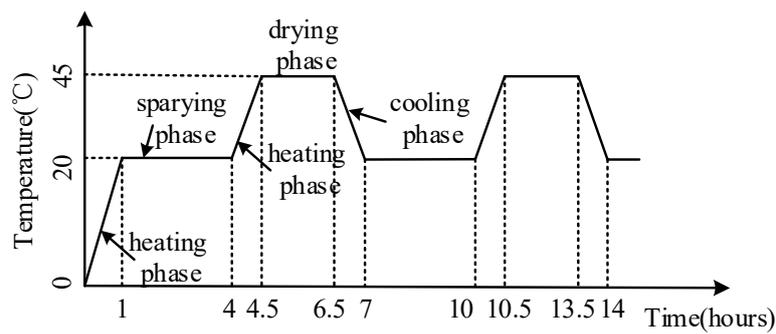
Figure 3. Corrosion cycle system schematic diagram.

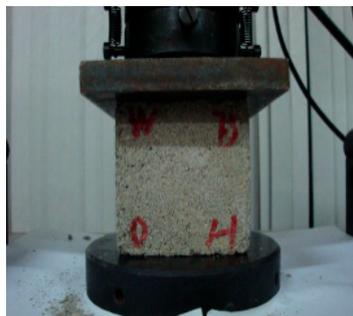
Figure 4 shows the compression test of mortar prisms. According to the Chinese standards JGJ/T 70-2009 [30], the appearance damage and geometry size of the mortar prism were recorded before the mortar prism was subjected to the compression test. Then, the mortar prisms were placed on the lower press plate of a universal axial testing machine. To ensure a uniform force of the mortar prisms, the center of the mortar prisms was aligned with the center of the upper and lower press plates of the universal axial testing machine and the surface of mortar prisms was placed parallel to the contact surface of the upper and lower pressure plates. The loading procedure was load controlled monotonically at a loading rate of 1.5 kN/s.

Figure 4. Compression test of mortar prism.

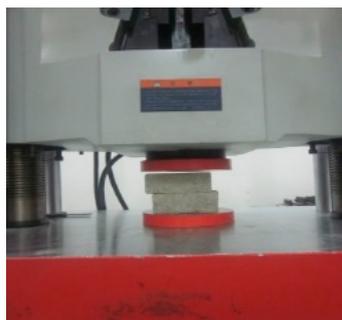
Figure 5 shows the compression test of the brick. The compressive strengths of bricks subjected to different acid rain corrosion cycles were determined according to Chinese standards [27]. The length and the width of two bonded surfaces of brick and geometry size of the brick were recorded. Then the compression experiment was conducted. The loading speed was controlled to 4 kN/s so that the brick was evenly loaded.

Figure 5. Compression test of brick.

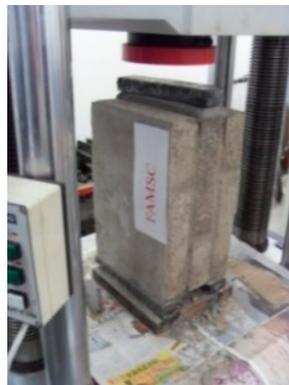
Figure 6 shows the shear test loading of the specimen. The direct shear test was conducted on the WAW-1000 universal axial testing machine of the structural engineering and seismic laboratory of the Xi'an University of Architecture and Technology. The shear test was performed in accordance with the Chinese standards GB/T 50129-2011 [27], which can be stated as follows. (1) The size of the sheared surface was measured and the measuring accuracy was 1 mm. (2) The masonry shear specimen was placed on the bar-shaped pressure plate of the testing machine and the centerline of the specimen coincided with the axis of the upper and lower plate of the test machine. To ensure that the upper and lower press plates was in close contact with the masonry shear specimen, a 10-mm thick hard rubber was placed between the specimen and the bar-shaped pressure plate. (3) A direct shear test was carried out by a uniform and continuous load. The load speed was controlled by breaking the specimen within 1 to 3 minutes. When the sheared surface was damaged, the specimen was considered destroyed.

**Figure 6.** The test loading of the shear specimen.

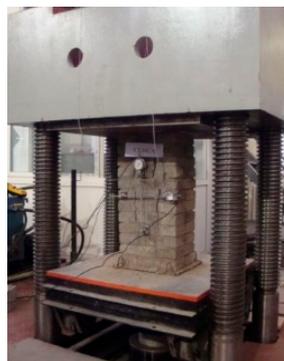
Figure 7 shows the test loading device of the masonry compressive specimen. Prior to the test, strain gages were attached to the compressive specimen vertically and horizontally. The gauge length of the horizontally attached strain gage was 265 mm, and the gauge length of the vertically attached strain gage was 325 mm. In order to check the sensitivity of the instrument and the firmness of the installation, a 5% estimated failure load was first applied to the compressive specimen. Then 5% to 20% of the estimated failure load was applied to the specimen and the pre-load was repeated (three to five times) in order to adjust the axial deformation of the wide sides of the compressive specimen. The consecutive loading method was adopted and 10% of the estimated failure load was applied per load step. In addition, the uniform acceleration was completed within 1 to 1.5 minutes. The compressive specimen declared damage when the load reached the ultimate load.

**Figure 7.** The test loading of the compressive specimen.

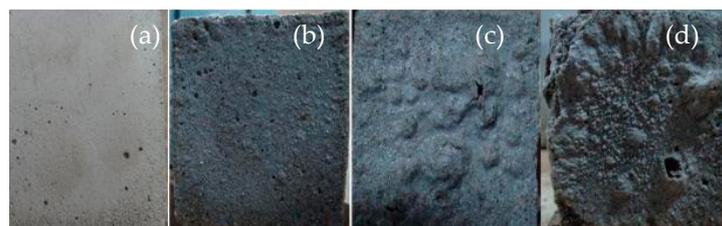
Figure 8 shows the apparent morphology of a mortar prism after acid rain corrosion. Figure 8a shows an uncorroded mortar prism as a comparative test. In the initial stage of acid rain corrosion, the color of the mortar prism surface changed from gray to dark. The crystal and sanding phenomena appeared on the mortar prism surface, as shown in Figure 8b. In the middle stage of acid rain corrosion, the peeling appearance of the mortar prism surface and the color of the mortar prism became lighter, as shown in Figure 8c. At the end stage of the acid rain corrosion, the crumbling and blistering appearance of the mortar prism surface became more and more serious, and the appearance of flaking and disintegration could be observed in some places, as shown in Figure 8d.

**Figure 8.** Apparent morphology of the mortar prism under different corrosion cycles. (a) 0, (b) 100 cycles, (c) 200 cycles, and (d) 300 cycles.

The interpretation of the above observations may be summarized as follows. During the initial stage of acid rain corrosion, the white crystal on the mortar prism surface was caused by the chemical reaction of  $\text{Ca}(\text{OH})_2$ ,  $\text{SO}_4^{2-}$  and  $\text{H}_2\text{O}$ . At the later stage of the acid rain corrosion,  $\text{H}^+$  and  $\text{Ca}(\text{OH})_2$  on the surface of the mortar prisms reacted to form  $\text{Ca}^{2+}$ , which caused the alkalinity of the mortar to drastically decrease. The internal hydration calcium silicate and the calcium aluminate hydration lost their stability and accelerated their hydrolysis, destroying the gel structure of the mortar, which led to the mortar occurring in the layer-by-layer corrosion damage from the outside to the inside [18].

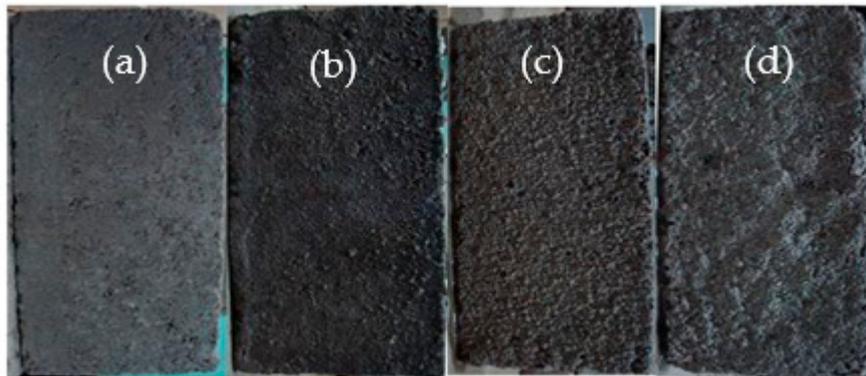
Figure 9 shows the apparent morphology of brick subjected to different acid rain corrosion cycles, which could be divided into three stages. Figure 9a shows uncorroded brick as a comparative test. In the initial stage of the acid rain corrosion, the surface color of bricks became deeper and darker, as shown in Figure 9b. In the middle stage of the acid rain corrosion, powdery substances formed on the surface of the brick, as shown in Figure 9c. At the end stage of the acid rain corrosion, the surface of brick appeared to be “skinning” and the phenomenon of “open mouth” in the corners was clear, as shown in Figure 9d.

**Figure 9.** Apparent morphology of brick under different corrosion cycles. (a) 0, (b) 100 cycles, (c) 200 cycles, and (d) 300 cycles.

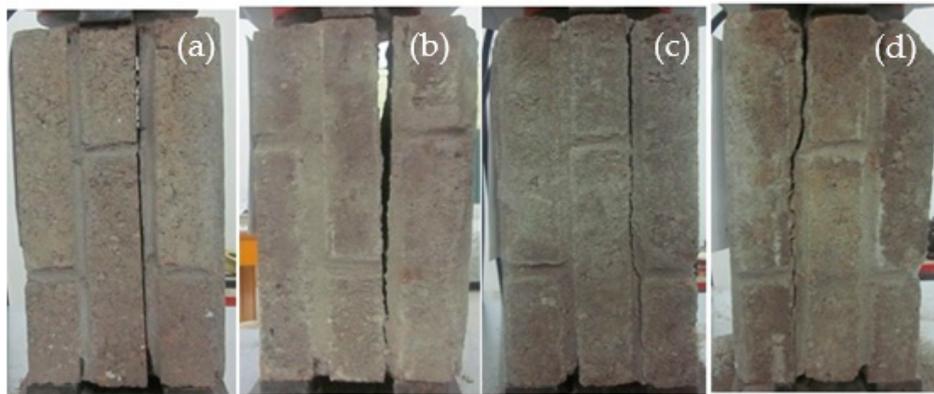
Figure 10 illustrates the final damage state of the shear specimens subjected to 0 (KJMA), 100 (KJMB), 200 (KJMC), and 300 (KJMD) acid rain corrosion cycles. The failure processes of the specimens were essentially the same, and all the shear specimens showed brittle failures with monotonic vertical loading. At the initial stage of loading, the overall shear resistances of the masonry shear specimens were not affected by acid rain corrosion. When the vertical load reached the ultimate shear load, the specimens underwent sudden brittle failure along the sheared surface without any symptoms.

**Figure 10.** Failure pattern of shear specimen under different corrosion cycles. (a) KJMA. (b) KJMB. (c) KJMC. (d) KJMD.

By comparing the final damage states of the shear specimens with different amounts of acid rain corrosion, it can be observed that the shear failure surface was no longer flat and it became more irregular as the number of acid corrosion cycles increased. The reason for this can be explained as follows. As the number of acid corrosion cycles increased, the compressive strength of the mortar decreased and the gelled material in the outer cement-based material was lost. Then, the sulfate crystals formed an intumescent substance and micro-cracks appeared on the brick–mortar interface under the expansion pressure. When the vertical load reached the ultimate shear load, a stress concentrate phenomenon occurred at the brick-mortar interface and the micro-cracks further propagated. Hence, irregular splitting damage formed in the brick-mortar interface under the action of the external force.

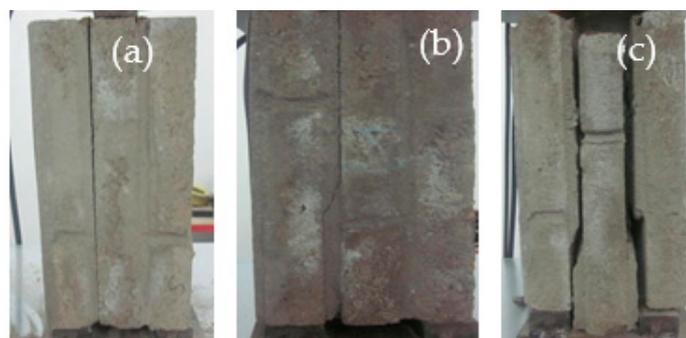
Figure 11 illustrates the main failure patterns of the shear specimens in the direct shear test. The failure pattern of the shear specimen was manifested as a single shear or a double shear. Referring to the single–shear modes, the failure occurred with the separation of the mortar from the brick due to the weakness of the brick–mortar interface. When the double–shear failure occurred, the crack first appeared on the bond interface with lower shear strength. With the load increasing, the first crack developed to a certain degree, the other shear interface appeared to crack one after another, and the time interval between the two cracks was short. In particular, due to the close compressive strength of the masonry mortar and brick, the mortar at the adhesive interface of some shear specimens was destroyed in the bed joint along a  $45^\circ$  angle under the action of the main tensile stress.

**Figure 11.** Failure pattern observed in shear test. (a) Single shear ( $0^\circ$  angle). (b) Single shear ( $45^\circ$  angle). (c) Double shear.

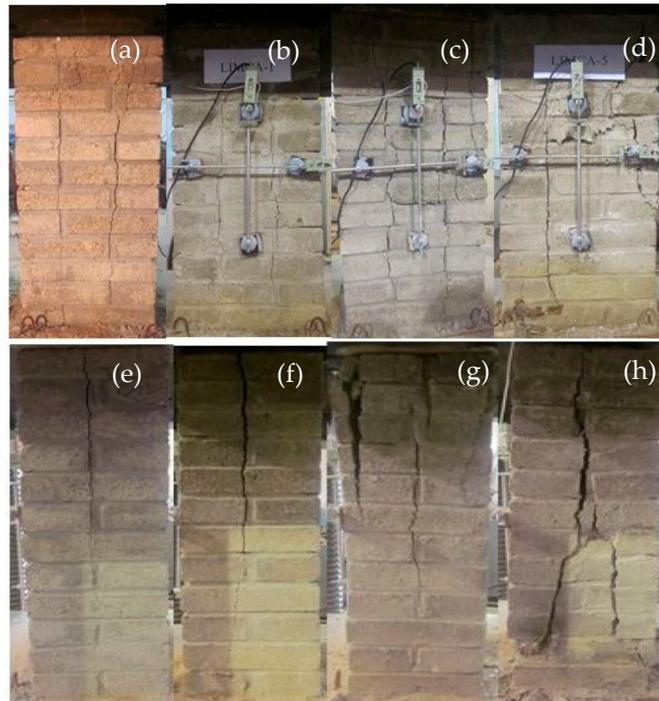
Figure 12 illustrates the final damage state of the compression specimens subjected to 0 (KYMA), 100 (KYMB), 200 (KYMC), and 300 (KYMD) acid rain corrosion cycles. The failure processes of the specimens were essentially the same and all specimens experienced initial cracking, crack development, and failure stages. In the initial cracking stages, the stress increased uniformly with the growth of the strain and these factors were approximately linearly related, which indicates that the specimens were in the elastic stage. When the vertical load reached 50% to 70% of the ultimate load, the first batch of vertical cracks was observed in the specimen. In the crack development stages, the initial crack gradually extended downward along the longitudinal direction with the increase of the vertical load. When the load reached 80% to 90% of the ultimate load, the primary crack developed into a main vertical crack and there were several vertical micro-cracks parallel to the main vertical crack [35]. In the failure stages, the width of the main vertical crack gradually increased with the further increase of

the vertical load, some bricks were crushed, and the lateral strain of the specimen increased rapidly. When the load reached the ultimate load, the specimens were divided into several small prisms by the penetrating crack and failure was ultimately pronounced.

**Figure 12.** Failure pattern of compression specimen under a different corrosion cycle. (a) Wide side of KYMA. (b) Wide side of KYMB. (c) Wide side of KYMC. (d) Wide side of KYMD. (e) Narrow side of KYMA. (f) Narrow side of KYMB. (g) Narrow side of KYMC. (h) Narrow side of KYMD.

The differences in the failure process of the specimens subjected to 0 (KYMA), 100 (KYMB), 200 (KYMC), and 300 (KYMD) acid rain corrosion cycles can be summarized as follows: (1) Compared with the group KYMA and KYMB specimens, the number of vertical cracks in groups KYMC and KYMD were significantly larger in quantity, the distribution of vertical cracks in groups KYMC and KYMD was more dispersed, the average cumulative crack widths in groups KYMC and KYMD was wider, and the main vertical crack lengths on the narrow side surfaces in groups KYMC and KYMD was longer (the maximum length of the main vertical cracks of group KYMD was 693 mm whereas the maximum length of the main vertical cracks of group KYMA was 424 mm). This phenomenon showed that the specimens were damaged because acid rain corrosion and micro-cracks were more likely to take place when the specimens were subjected to a vertical load. (2) The surface spalling phenomenon occurred on the edges of the surfaces in groups KYMC and KYMD and the damage degree of the compression specimens increased with the number of acid rain corrosion cycles. This phenomenon was ascribed to the vertical micro-cracks caused by acid rain corrosion. The vertical micro-cracks developed and penetrated as the vertical load increased. Then one layer of the edge for the compression specimen was easily “cut away.” (3) Two vertical cracks appeared at the bottom 1/4 of the height in group KYMD (Figure 12) and partial crushing occurred at the feet of the specimen (Figure 13). The reason for this phenomenon was that the simulated corrosion solution slowly flowed down along the specimen and stacked at the bottom. Hence, the acid corrosion degree at the bottom of the specimen was the most serious, which resulted in a weak part at the bottom of the specimen. (4) As the number of acid rain corrosion cycles increased, the initial crack load of the compression specimen gradually decreased. This means that the time for the occurrence of the initial crack gradually advanced.

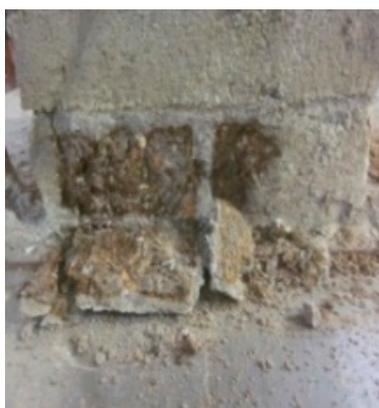
**Figure 13.** The feet of the corrosion specimen.

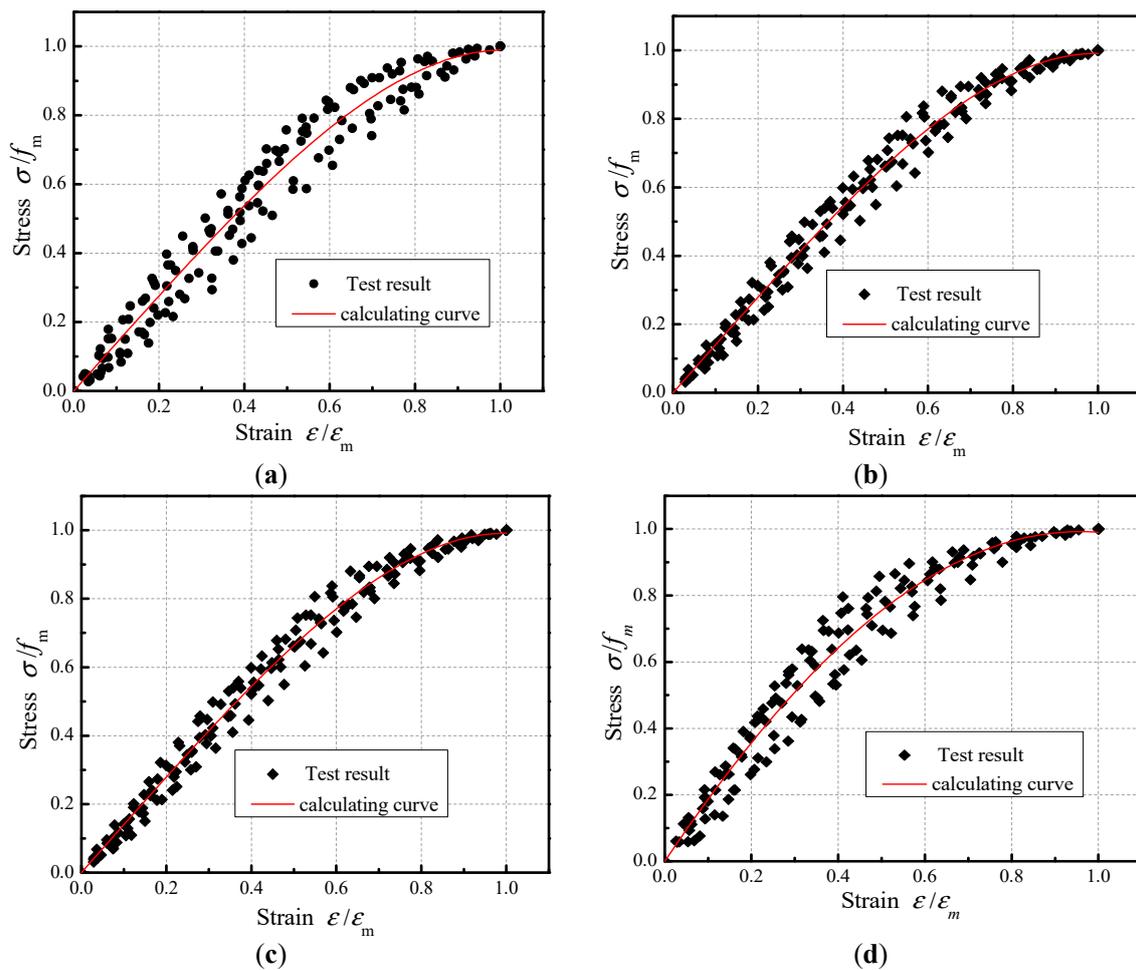
According to the literature [36], an effective model on evaluating the stress–strain behavior of compression specimen subjected to different acid rain corrosion cycles was given, as illustrated in Equation (6). The different acid rain corrosion cycles were normalized and the fitting stress–strain curves were shown in Figure 14.

**Figure 14.** Fitting curves of stress-strain under different acid rain corrosion cycles. (a) 0 cycle, (b) 100 cycles, (c) 200 cycles, and (d) 300 cycles.

Table 9 summarizes the parameters of the regression stress-strain curves for the compression specimens subjected to different acid corrosion cycles. As can be seen from Table 9, the average correlation coefficient  $R^2 = 0.97$  of the stress—strain curve under different acid rain corrosion cycles was relatively high, which confirmed the good quality and repeatability of the results.

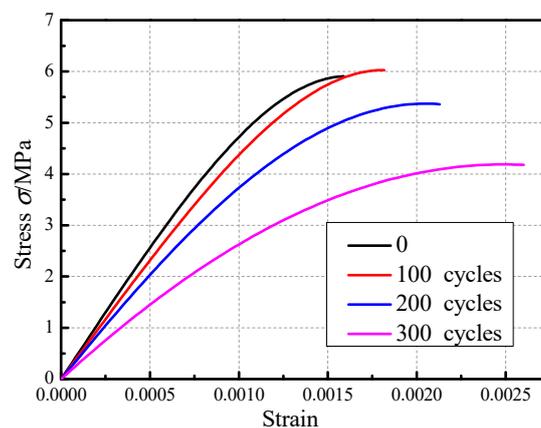
Figure 15 illustrates the compression stress versus the longitudinal strain for a compression specimen under different acid corrosion cycles. The observations made based on Figure 15 is as follows. (1) The tendency of these curves was essentially the same. Compared to the uncorroded specimen, the compressive specimens that were subjected to 100 acid rain corrosion cycles exhibited slightly increased in term of the peak stress, which was ascribed to chemical adsorption. With the

number of acid rain corrosion cycles continuously increasing, the peak stress gradually decreased and the decreased degree was high. (2) The strain corresponding to the peak stress gradually increased with the increasing number of acid corrosion cycles. (3) The slope of the stress-strain curve for the compression specimen gradually decreased with the increasing number of acid corrosion cycles, which indicated that the elastic modulus of the compression specimen gradually decreased and the ability of the specimen to resist deformation gradually lowered. The above phenomena indicate that acid rain corrosion caused a significant decrease in the masonry mechanical properties.

**Figure 15.** Stress–strain curve of the masonry prism subjected to different corrosion cycles.

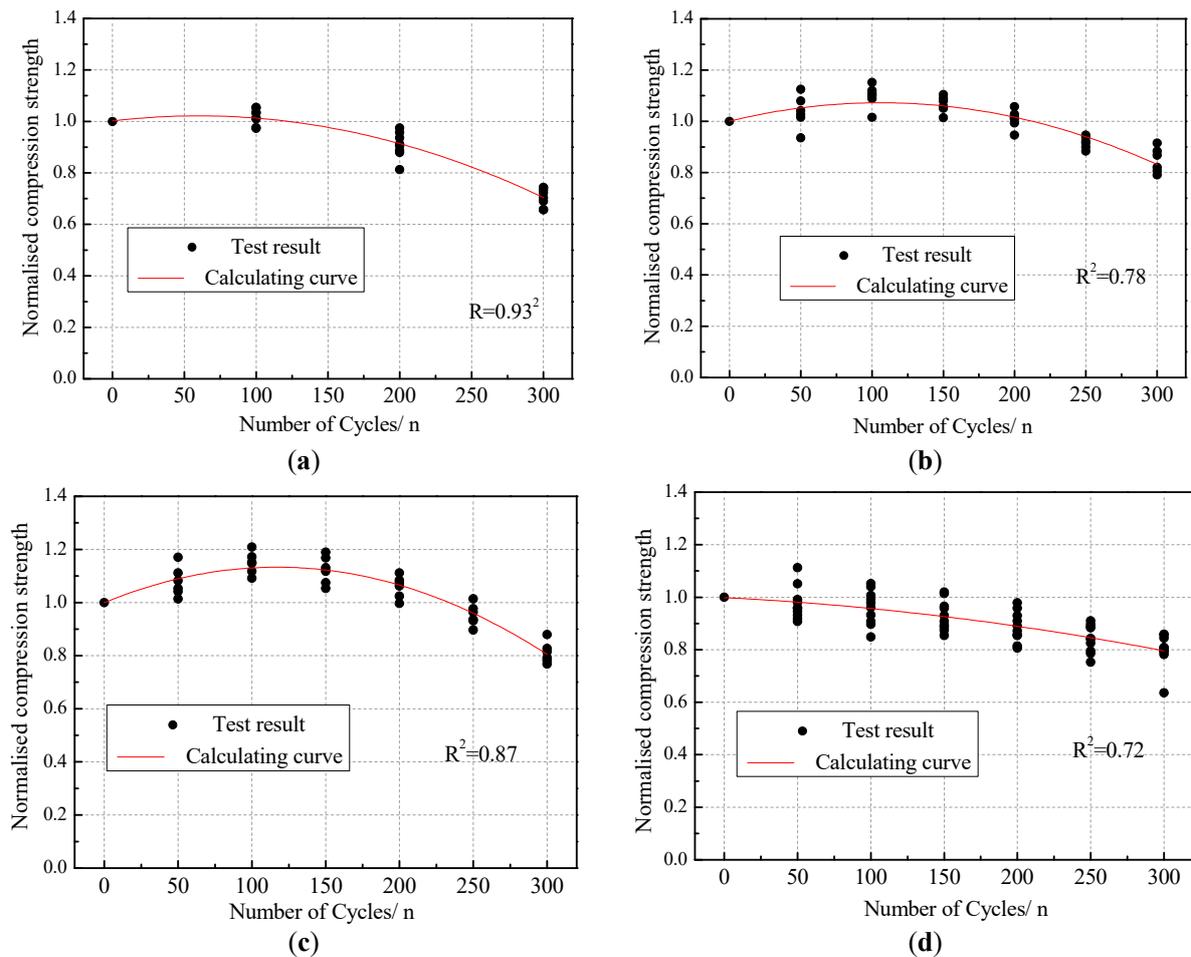
This section provides an overview of the proposed models that were established to describe the test results of the mechanical properties for brick masonry subjected to different acid rain corrosion cycles. Through the comparison and statistical analysis of test data, it can be seen that the compressive strength of the cement mortar prism, cement-lime mortar prism, cement-fly ash mortar prism, brick unit, and acid rain corrosion cycle approximated a quadratic function relationship. The variations of the normalized compressive strength compared to their initial values are plotted in Figure 16. The analytical expressions of the compressive strength attenuation model for mortars and brick units are given in Equations (7) to (10).

**Figure 16.** The compressive strength attenuation model of mortars and brick. (a) Cement-lime mortar prism. (b) Cement mortar prism. (c) Cement-fly ash mortar prism. (d) Brick unit.

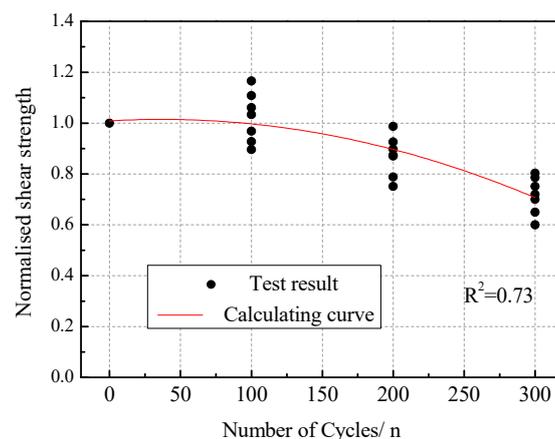
Through the comparison and statistical analysis of test data, it can be seen that the shear strength and compressive strength of masonry gradually decreased with the increasing number of acid rain corrosion cycles. The variations of the normalized shear strength and compressive strength compared to their initial values are plotted in Figures 17 and 18. The evolution appeared to be quadratic with the number of acid rain corrosion cycles. Therefore, the shear strength attenuation model (Equation (11))

Figure 17. Shear strength attenuation model.

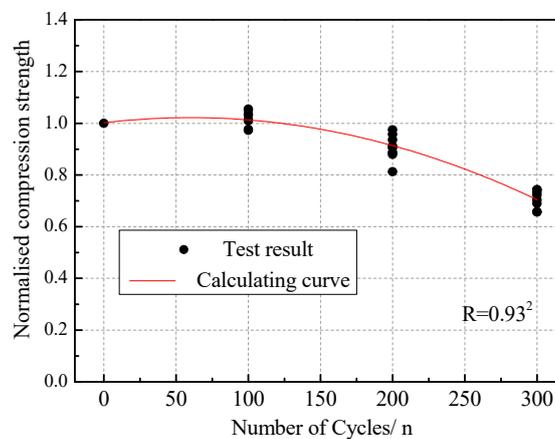
and compressive strength attenuation model (Equation (12)) of brick masonry considering the effect of acid rain corrosion cycles were proposed.

Figure 18. Compressive strength attenuation model.

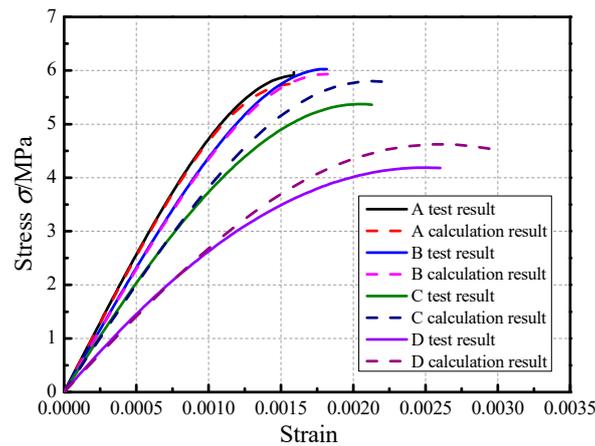
(6) Figure 19 illustrates the comparison between the deduced damage constitutive model and the experimental data of brick masonry under different acid rain corrosion cycles. As Figure 19 shows, it was indicated that the uniaxial compression damage constitutive model of brick masonry could objectively reflect the variation of the uniaxial compression performance of brick masonry under different acid rain corrosion cycles.

**Figure 19.** Comparison between proposed analytical models and experimental data for the specimens.
