Research and TLS (LiDAR) Construction Diagnostics of Clay Brick Masonry Arched Stairs

Abstract: The study presents the terrestrial laser scanning (TLS) diagnostic of the clay brick masonry arched staircase in a historic building. Based on the measurements of the existing arched stair flights, 1:1 scale experimental models with and without stair treads were made. Strength tests of the models were carried out for different concentrated force locations in relation to the supporting structure. Force, deflections and reaction in the upper support of the run were measured during the tests. The influence of the masonry steps on the curved vault on the load capacity and stiffness of the run structure was analyzed. The conducted experimental investigations showed that the key element responsible for the actual load-bearing capacity and stiffness of this type of stair flights were the treads above the masonry arch.

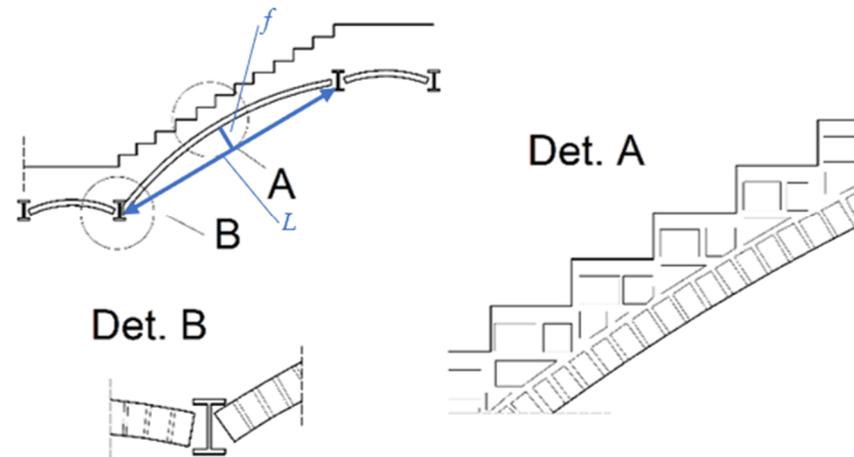
Figure 1. Masonry stairs with segmental vault and arched staircase slab, based on [1].

In the authors' countries, in historical buildings from the 19th century, masonry arch stairs were commonly used to connect floors [1]. The arches were shaped between steel beams as a load-bearing span for the staircase landings and flights. At that time, the technology of reinforced concrete was not yet known, so steel and masonry construction was the most popular, especially in residential buildings. The construction of staircases was mostly in the form of segmental or cross vaults. The structure of the flights was made as a stair arch with the thickness of half a brick (12 cm) and elevation $f = 1/12-1/14 L$ [1] (Figures 1 and 2).

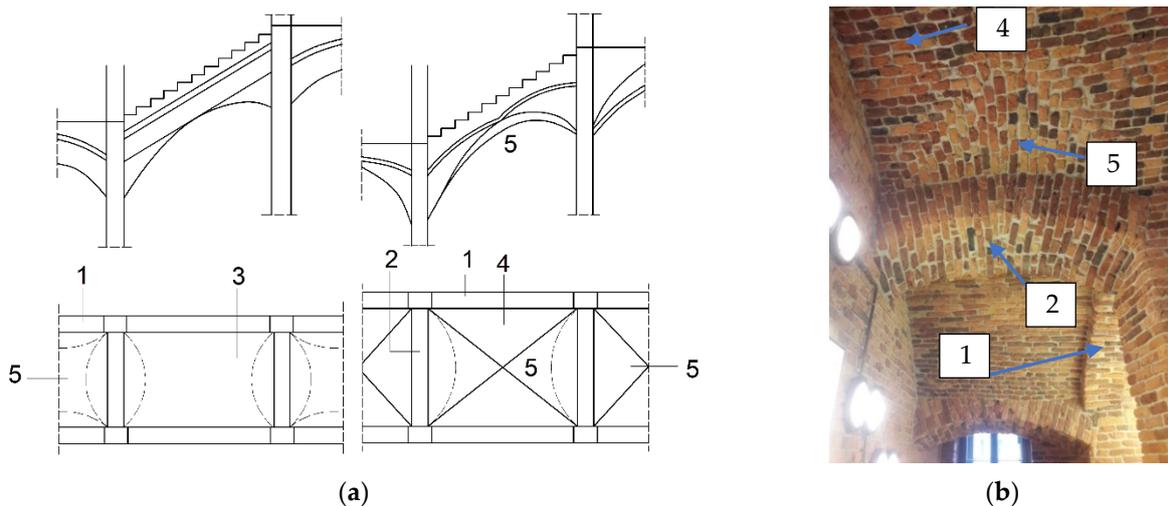
Figure 2. Brick stairs with column supports based on [1]. Scheme (a) and partial photo (b): 1—arched masonry stair sides; 2—arched masonry bolt; 3—barrel staircase with support on sides; 4—groin vault in stair flight; 5—groin or barrel vaults in stair landing.

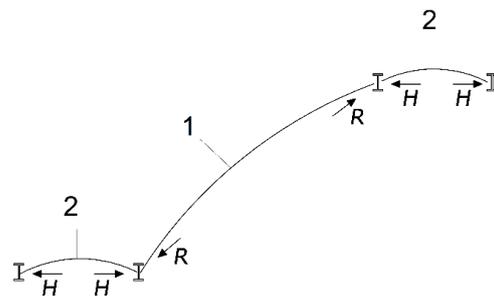
Figure 3. Calculation scheme of masonry stairs with segmental vault and arched staircase slab: 1—arched staircase slab; 2—landings.

Information on calculation methods or principles of construction is often difficult to find. This type of construction was created mainly on the basis of experience with brick vaults. The steel beams supporting the vaults were calculated by the methods available at that time [1]. The operation of landing vaults is similar to balcony or roof vaults. On the other hand, staircase slabs are at an angle depending on their length and height. The distribution of stresses and internal forces is different from other staircase structures. A calculation scheme of an example of an arched masonry stairs with vaulted landings supported on steel beams is shown in Figure 3.

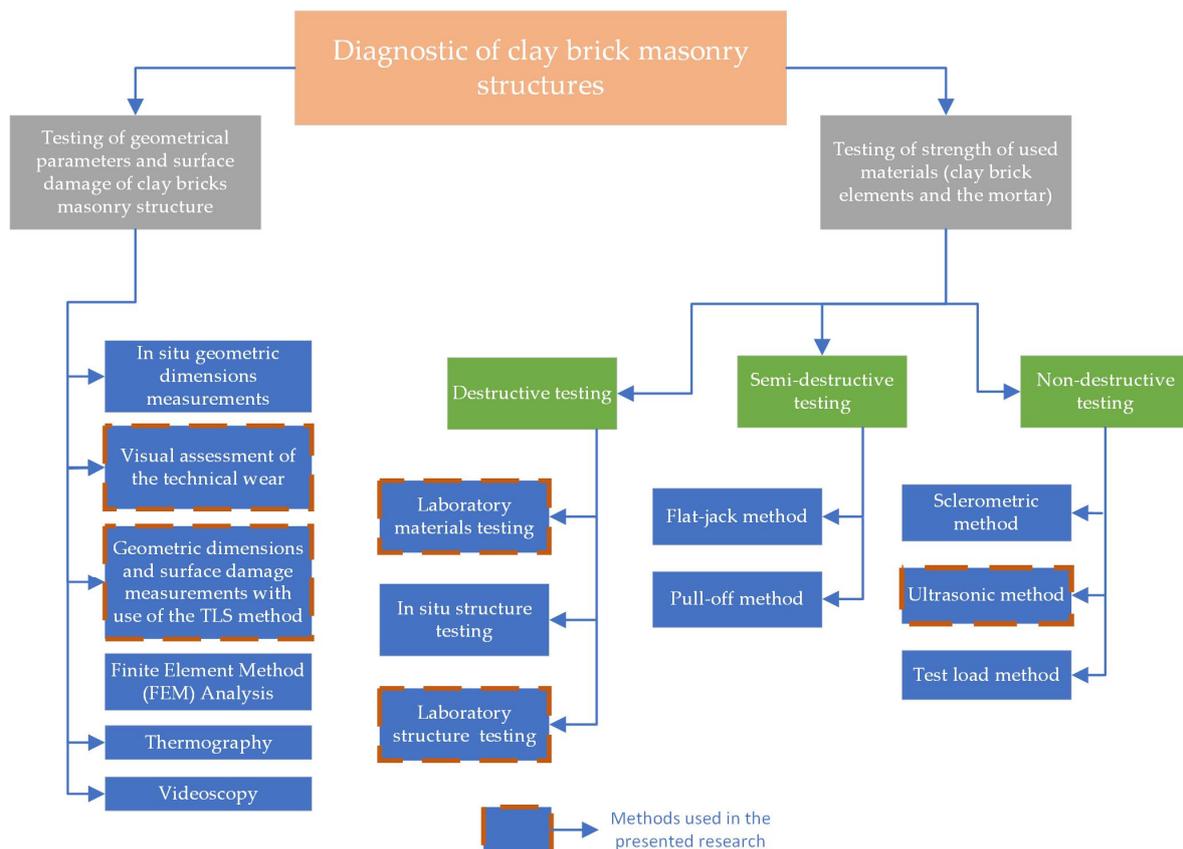
Figure 4. Flowchart for clay brick masonry structure diagnostics.

One of the most prevalent issues in this type of stairs is the necessity of diagnostics of their technical condition in order to confirm their durability and functional use. The chosen methods used in the diagnostics of masonry structures in the authors’ countries are shown in Figure 4.

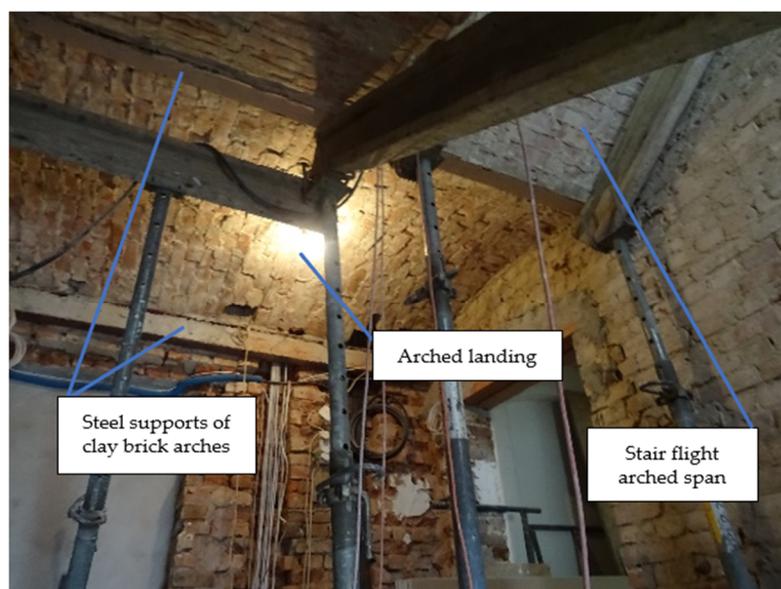
Figure 5. View of the researched masonry staircase.

The building had four residential floors and an attic. The ceilings on the upper floors were made of wooden beams, while, on the first floor, they were made as arched segmental vaults on steel beams. The floors were 3.2 m high. The staircase was 2.5 m wide and 5.3 m long. The length of the landings was 1.6–1.7 m and the length of the flights was 2.6 m, with a width of 1.2 m. The analyzed stair flights were at an angle of 38°. The stairs were made of steel and masonry, with arched spans between the landings. The rise of the stair arch had a value of $f = 1/19 L$. Figure 5 shows the general view of the arched stair structure under consideration.

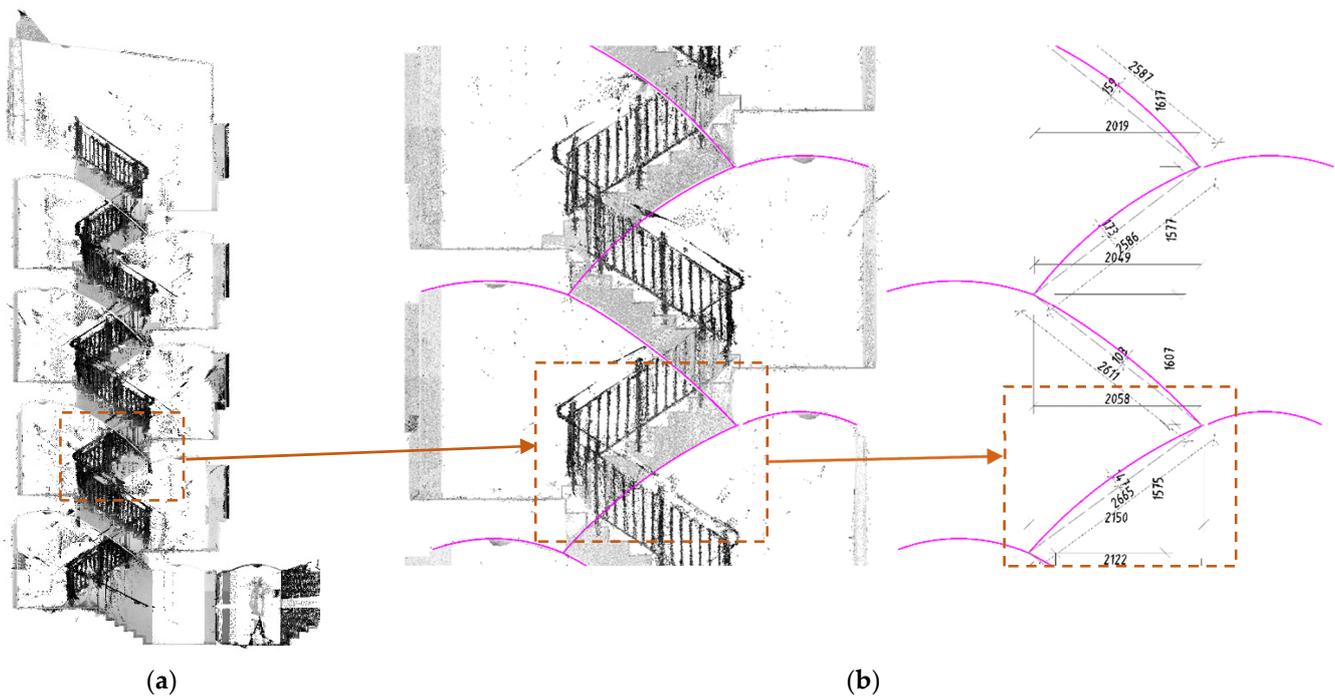
Figure 6. TLS data acquired from existing building: section view of building (a) and geometry measurements for analysis (b). The dashed line marks the stair flight which was subjected to further laboratory testing.

The TLS measurements allowed us to determine the exact geometry of the stair flight. Figure 6 shows a general view of the obtained TLS measurement map along with a picture of the geometry of the curved staircase of the building.

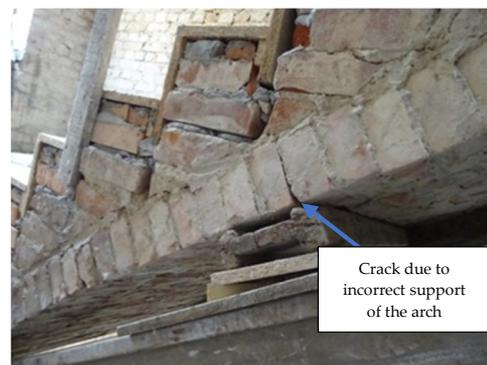
Figure 7. Section of the staircase with visible crack of the arch caused by improper renovation and deterioration of masonry joints.

Alongside TLS measurements, a visual evaluation of the mortar joints in the stair flights as well as of the treads was performed. Numerous damages and cracks were found. The most important was a crack in the joint on the masonry arch presented in Figure 7.

Incorrectly made support changed the distribution of internal forces in the masonry arch, which was the reason for the whole structural diagnosis. Support should have been put in place for the entire surface of the arch in the form of a centering with an appropriate shape to match the actual geometry of each stair flight arch. Figure 8 shows the output of TLS diagnostics for the run fault of the stair flight.

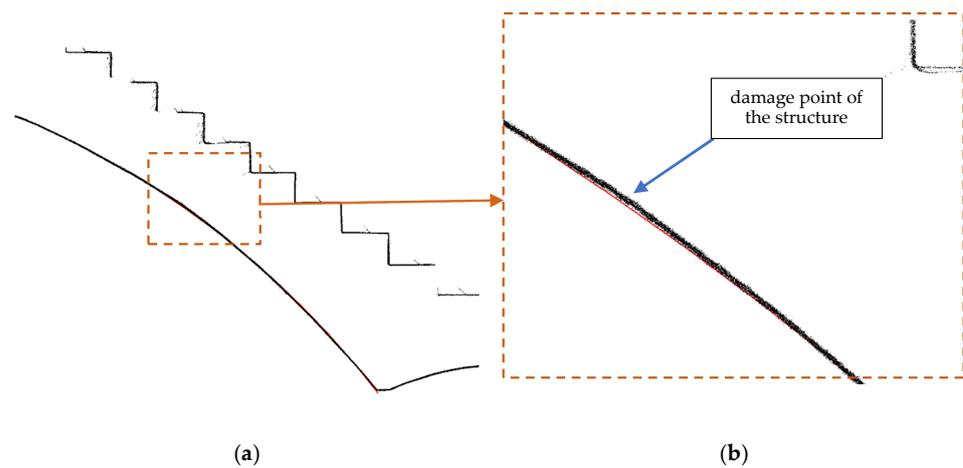
Figure 8. TLS data output for the point damage of the stair flight: section view of the stair flight (a) and point of damage (b).

The weakest points of the analyzed masonry arch structure were the joints between bricks and mortar. On the basis of the research work carried out, it was decided to reinforce the whole structure of flights and landings with a steel structure fixed from the bottom.

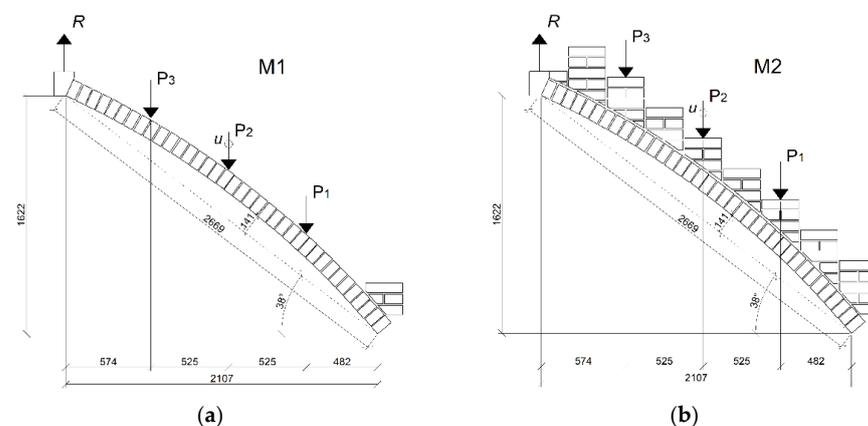
Figure 9. Laboratory models of stair flights (dimensions in mm): model M1—without treads (a); model M2—with treads (b). P_1 – P_3 —force application points; R —force from the arch registered with a force gauge; u —vertical displacement in the middle of the arch span.

Laboratory tests were conducted on two models of the stair flights—without stair treads (M1) and with stair treads (M2). The models were made in a 1:1 scale based on the measurements of the analyzed construction, with a width of a single 25 cm brick (Figure 9).

The stair flight construction was supported on a self-made test bench frame. During the masonry works, a wooden structure with expanded polystyrene was used as a centering for the arch. The support was removed while the arch structure was drying, so that the structure could be pressed down naturally. Due to indoor conditions, the bricks were soaked in water before construction, then wetted with water daily during the mortar curing processes. In order to take measurements, a force gauge was placed in the upper corner of the flight to transfer the vertical force.

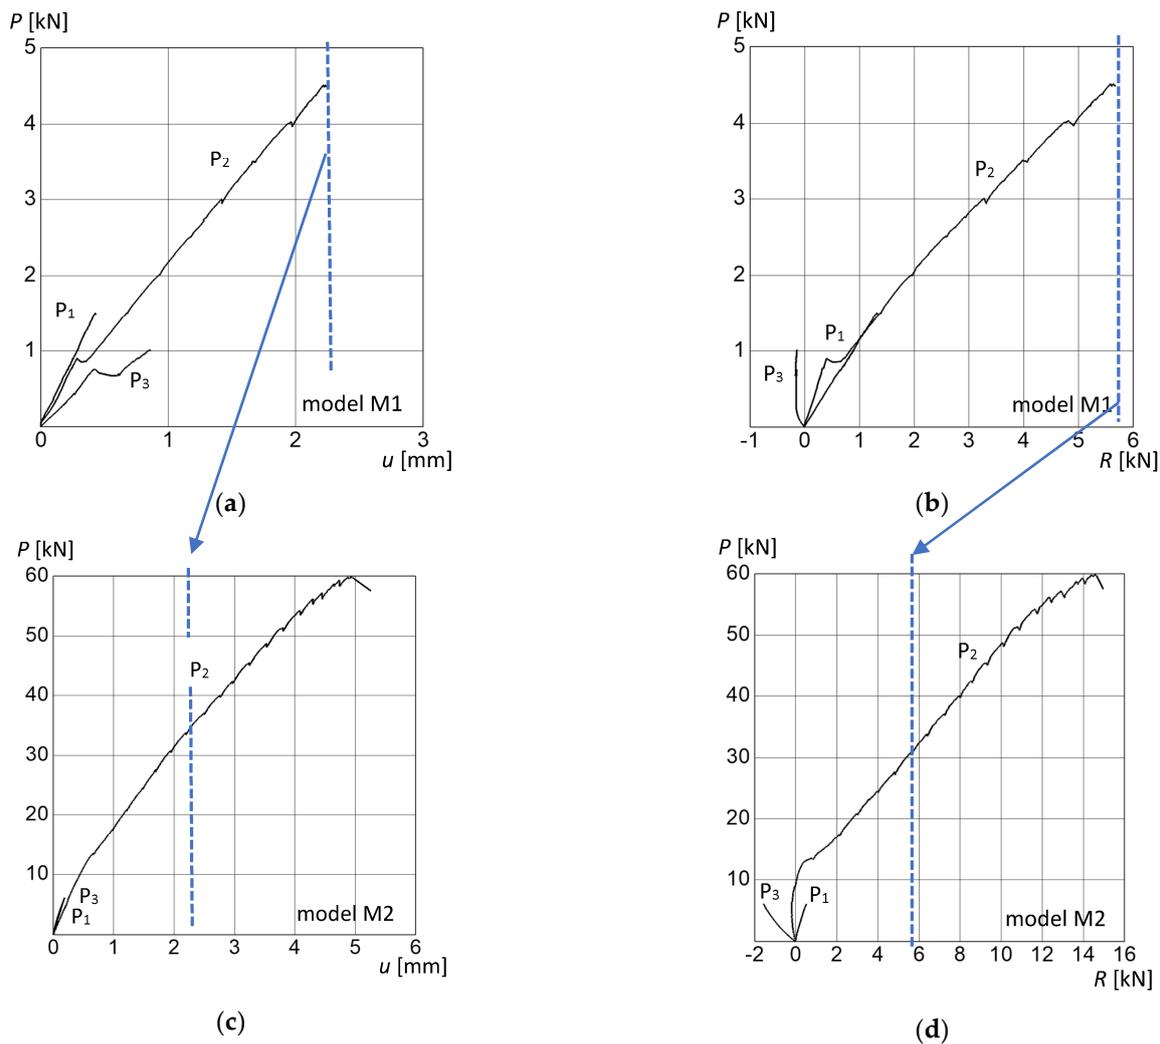
Figure 10. Experimental results of masonry staircases: relation P - u (vertical displacement in the middle of an arch in point P_2) for model M1 (a); force P -reaction R for model M1 (b); force P -displacement u (vertical displacement in the middle of an arch in point P_2) for model M2 (c); force P -reaction R for model M2 (d).

The model with masonry treads (M2) was loaded at the same locations as model M1 by applying concentrated forces on the masonry treads. At points P_1 and P_3 , a structural load of $P_1 = P_3 = 6$ kN was applied. At the middle point, P_2 , the value of the load was increased until failure due to cracking, which occurred at a force of $P = 59.8$ kN. The results of the measurements of the displacement and support reactions of the researched models are presented in Figure 10.

For model M1 (without treads), the deflection measured vertically in the load range up to 0.9 kN developed similarly for points P_1 and P_2 . The deflection curve for P_3 was significantly different from that for P_1 and P_2 . Comparing the curves for a load level $P = 1$ kN, it was found that the smallest deflection of the structure was recorded for the load at point P_1 (48.2 cm from the lower support), for which a vertical deflection of the structure $u = 0.3$ mm was measured. At point P_2 (100.7 cm from the lower support), the vertical deflection $u = 0.4$ mm was obtained. At point P_3 (153.2 cm from the lower support and 57.4 cm from the upper support), the highest vertical deflection of the structure $u = 0.8$ mm was achieved. At point P_2 , the deflection was 1.3 times higher in relation to point P_1 , while, at point P_3 , it was 2.7 times higher than at P_1 . That is, the lower the location of force along the staircase was, the lower the influence on the deformation of the structure.

Changing the location of the force had also a significant effect on the recorded reaction R in the upper part of the staircase. For model M1, in the case of force applied to the middle and lower parts of the staircase (P_1 and P_2), the reaction was positive, which means that it was directed vertically downwards and balanced the horizontal forces in the arch. However, for the force at point P_3 , the situation was completely different. Due to the different geometry of the arch compared to typical vaults, the reaction had the opposite direction. The arch in this place did not generate compressive force on the upper support, but, rather, a tension. Comparing the values of the reaction R between different force points at the force level $P = 1$ kN, it should be noted that the reaction for points P_1 and P_2 was similar and was about $R = 0.8$ kN. For point P_3 , the reaction was $R = -0.1$ kN, which was eight times lower. The reactions for points P_1 and P_2 had different values until the inflection point on the P_2 curve, at force $P = 0.9$ kN.

Different results were obtained for model M2 (with treads). The differences in deflection u were less visible between P_1 and P_3 . For the load level $P = 5$ kN at points P_1 and P_3 , the deflection had a value of $u = 0.2$ mm. In the investigated load range, the addition of stair treads increased the stiffness of the structure regardless of force location.

For model M2, the reaction forces in the support differed from each other. Negative values for the support were registered again for point P_3 but also partially for point P_2 . The reaction in the case of the force at the center (P_2) operated in a tension range, up to $P = 9$ kN, after which it started to work in compression. At the force level $P = 5$ kN, the reaction at point P_1 was $R = 0.4$ kN; at point P_2 , it was $R = -0.2$ kN; and, at point P_3 , it was $R = -1.4$ kN. The spreading force for the force $P = 5$ kN was recorded only for the force at point P_1 . In the case of force at points P_2 and P_3 , tension was observed. The value of the reaction for P_3 was seven times higher than for P_2 .

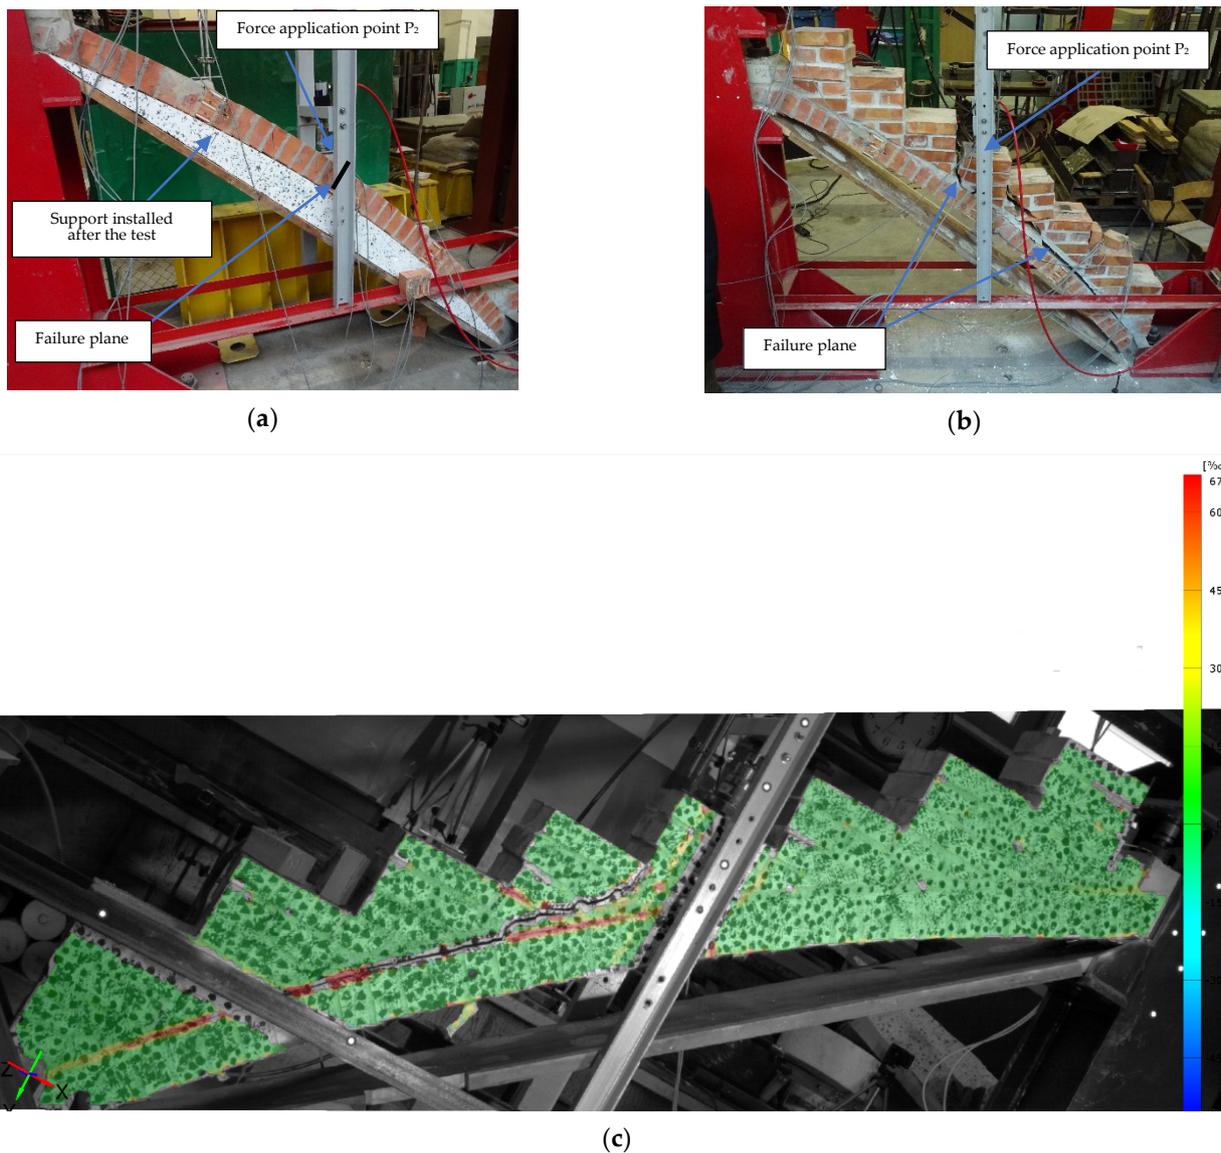
Figure 11. Registered failure mode of tested models of stair arches: model M1 (a), model M2 (b) and measurements from ARAMIS of deformation during failure of model M2 (c).

By including the treads in the stair flight curve analysis, the load capacity was considerably higher than previously assumed. The load-bearing capacity for the model with treads was 13.3 times higher than in the model without treads. The deflection for the same load level $P = 4$ kN at point P_2 for model M1 was $u = 1.9$ mm and, for model M2, $u = 0.2$ mm. The deflection value of model M2 was 9.5 times smaller than the deflection of model M1. The steps masoned above the staircase significantly increased the load-bearing capacity of the structure, as well as its stiffness. Figure 11 shows the failure mode of the tested models of stair arches and the results of the measurement of the deformations for M2 made with the ARAMIS system at the moment of destruction.

The model of structural failure changed, which, in the case of model M2, occurred as a result of cracking along the arch, at the interface of the arch with the brick treads. First of all, the masonry above the arch detached from the rest of the structure (masoned brick treads). This proved the significant importance of the stair treads above the arch in its load-bearing capacity. Once the crack formed between the arch and the treads, the rest of the structure exhibited rapid failure.

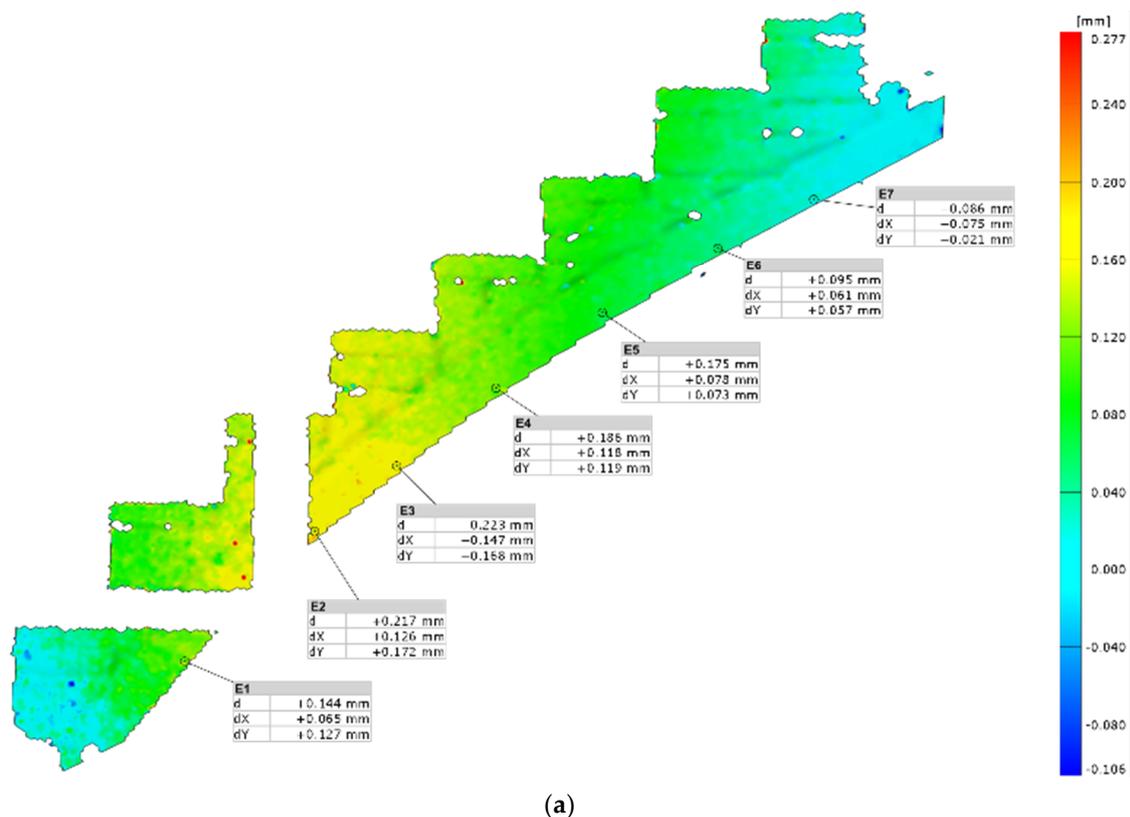
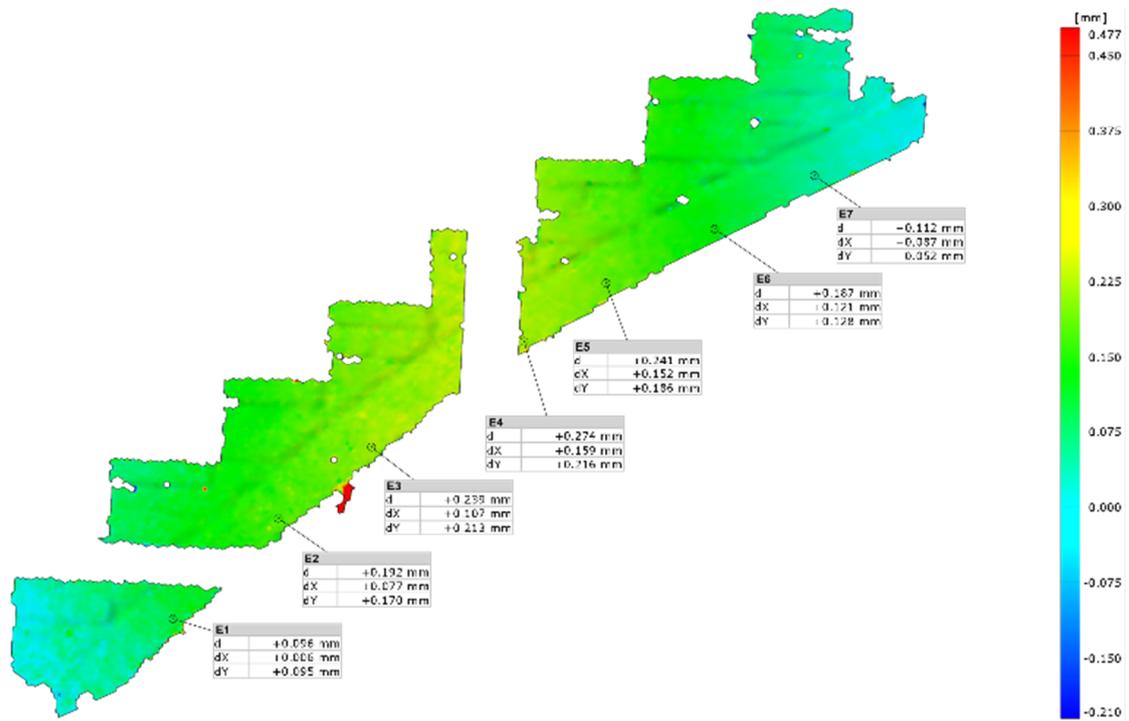
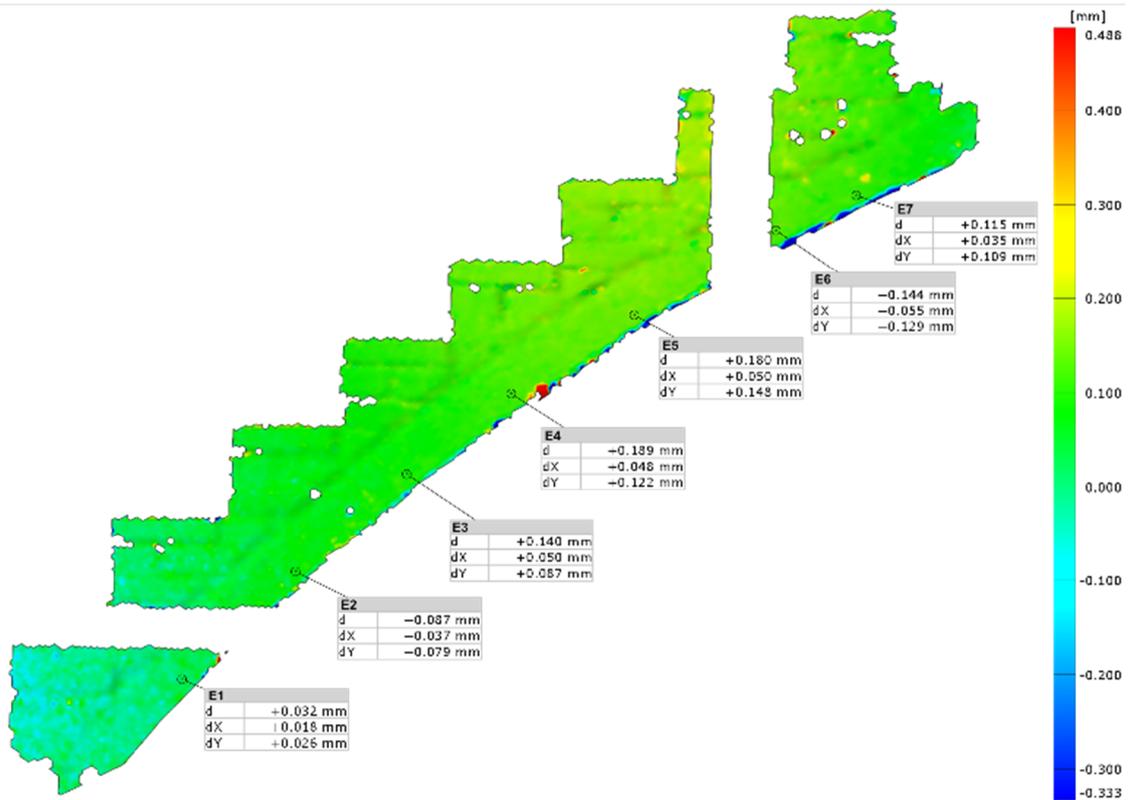
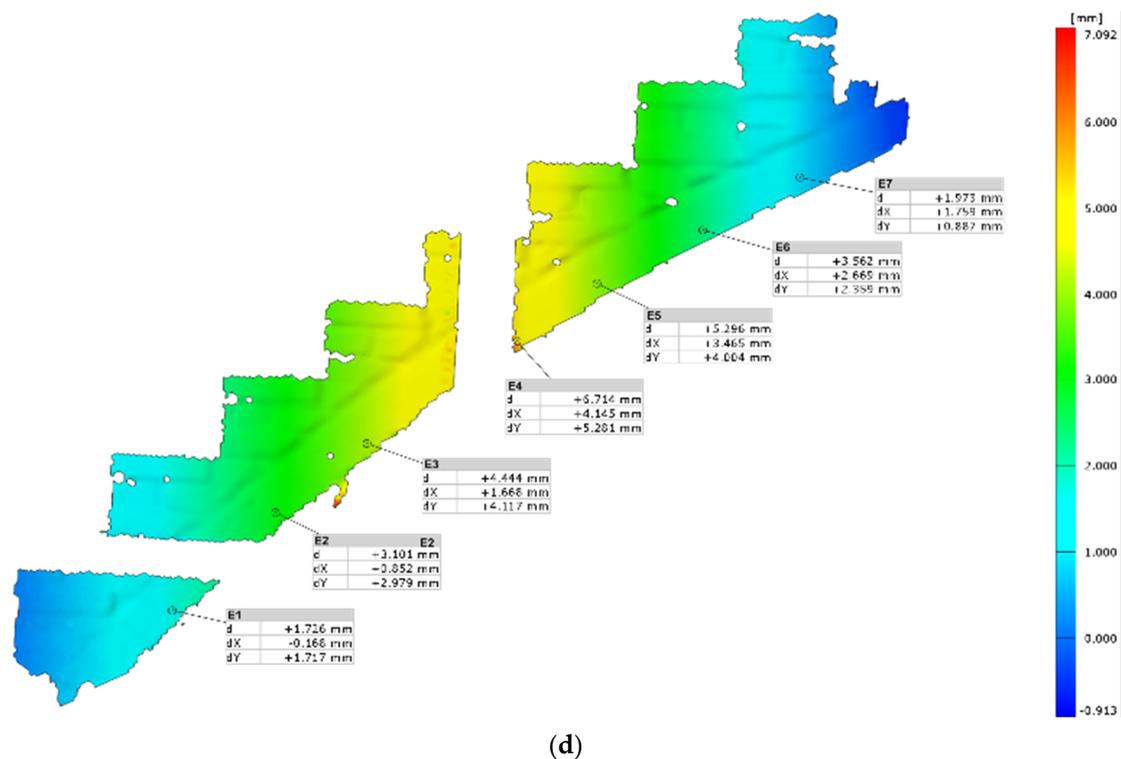
Figure 12. Results of experimental test of masonry staircases—displacement measured by ARAMIS: load $P = 6$ kN at point P_1 (bottom) (a), load $P = 6$ kN at point P_2 (middle) (b), load $P = 6$ kN at point P_3 (top) (c) and load at failure $P = 59.8$ kN in point P_2 (d). d—resultant displacement; dX—horizontal displacement; dY—vertical displacement.

The results measured using the ARAMIS system allowed us to analyze the displacement with higher precision. For the reference load level $P = 6$ kN, there were visible differences in the operation of the structure depending on the load application point. Analyzing the displacement maps (Figure 12), it is visible that there were local deformations.

Those were caused by the movement of the bricks toward each other due to the changes in the joints.

For model M2, regardless of the load application point, the values of arch displacement were of the same sign. This is different from a typical operation of a masonry arch. The biggest displacement of the staircase was achieved when the force was applied at point P₂. The results for points P₁ (value for E4, virtual point, in the middle, $d = 0.186$ mm) and P₃ (also value for E4, virtual point, in the middle, $d = 0.189$ mm) were similar. The values of deflections at the points directly under the applied forces differed for P₁ (virtual point E2, $d = 0.217$ mm) and P₃ (virtual point E6, $d = 0.144$ mm), even though the total deflection at point E2 was similar. For the load level $P = 6$ kN, the highest resultant deflection for point P₂ was $d = 0.274$ mm. This is a value that can be hardly seen with a naked eye. The failure of the structure was also at a small resultant displacement of $d = 6.714$ mm. These results confirm a significant influence of masonry treads on the rigidity of the whole structure. The treads are responsible for increased stiffness of a lean masonry arch. Due to the low values of the displacement of treads, the diagnostic of the structure should be performed with precise measurement equipment, such as 3D scanners (TLS).
