# Seismic Tests of Full Scale Reinforced Concrete T Joints with Light External Continuous Composite Rope Strengthening—Joint Deterioration and Failure Assessment

**Abstract:** Beam–column connections (joints) are one of the most critical elements which govern the overall seismic behavior of reinforced concrete (RC) structures. Especially in buildings designed according to previous generation codes, joints are often encountered with insufficient transverse reinforcement detailing, or even with no stirrups, leading to brittle failure. Therefore, externally bonded composite materials may be applied, due to the ease of application, low specific weight and corrosion-free properties. The present work assesses the seismic performance of insufficiently reinforced large-scale T beam–column connections with large and heavily reinforced beams. The joints receive externally bonded NSM X-shaped composite ropes with improved versatile continuous detailing. The columns are subjected to low normalized axial load, while the free end of the beam is subjected to transverse displacement reversals. Different failure criteria are investigated, based on the beam free-end transverse load, as well as on t

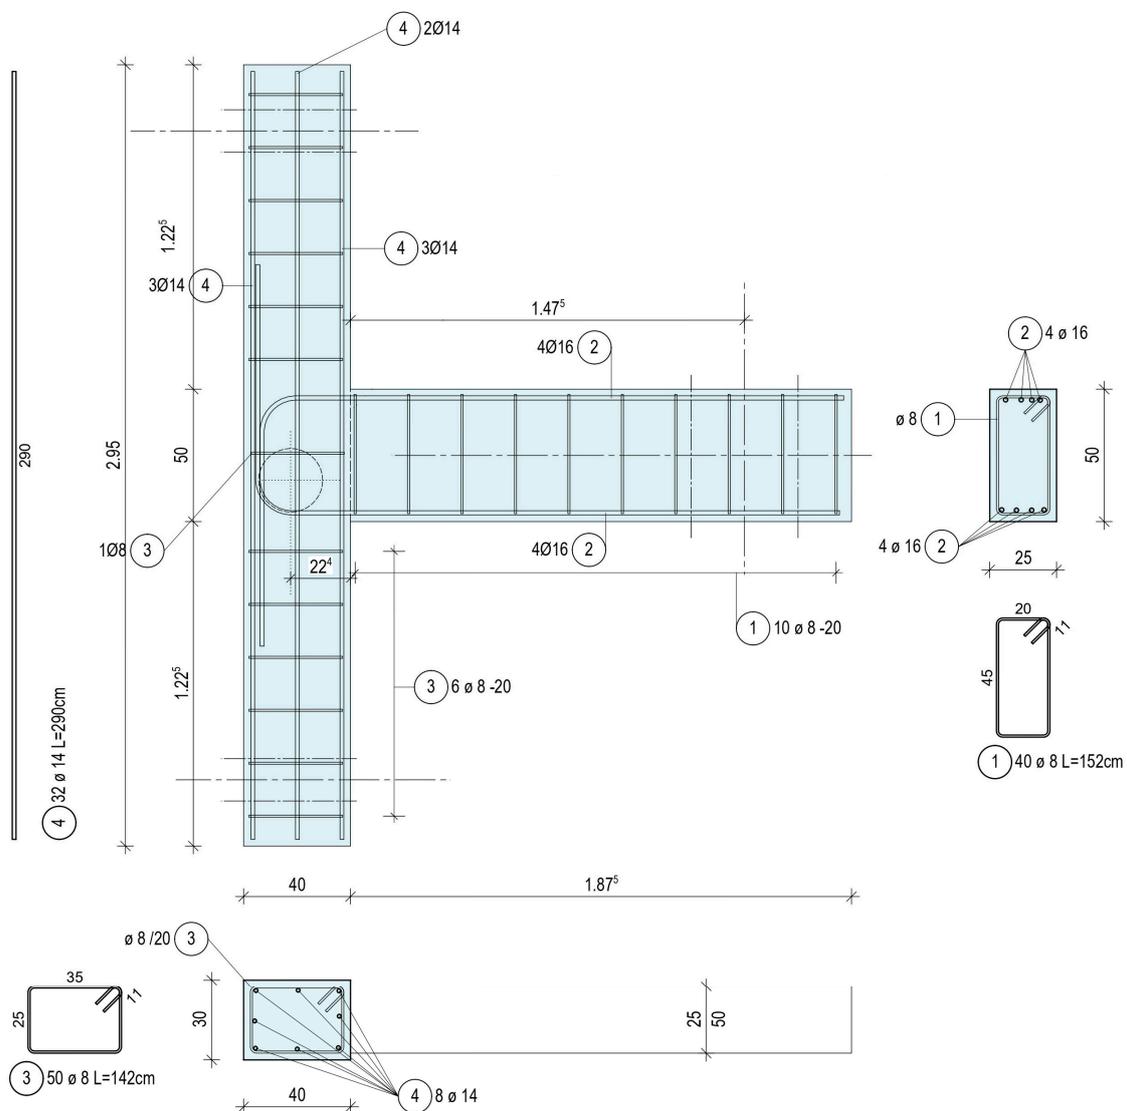
**Figure 1.** Geometry and steel reinforcement of specimen CON1 (dimensions in m).

The tests investigate the performance of two-dimensional T beam–column connection subsystems consisting of half-length upper and bottom columns connected with half-length beams and their shared joint region. The total length of the two half-columns is 2.95 m

(including 0.5 m of vertical joint size) and represents typical floor height. The clear half span of the beam is 1.875 m, while of the column is 1.225 m. The cross-section of the column has dimensions 300 mm × 400 mm and the beam 250 mm × 500 mm, respectively. These cross-section dimensions form a large joint volume element at the connection of the three ‘beam’ elements with dimensions 400 mm × 500 mm × 250 mm. Further, the columns have eight bars of 14 mm diameter (reinforcement with number (4) in Figure 1) and an 8 mm diameter closed stirrup (reinforcement with number (3) in Figure 1). The beam has eight longitudinal bars of 16 mm diameter (reinforcement with number (2) in Figure 1), symmetrically placed four at the bottom and four at the top of the section, and  $\Phi 8$  closed stirrup (reinforcement with number (1) in Figure 1). T beam–column CON0 has no stirrup in the joint region, while CON1 has one stirrup. The exact detailing of the reinforcements, the anchorage detailing of the  $\Phi 16$  bars in the joint region, as well as the position of the pinned supports for the columns and of the pinned actuator at the free end of the beam, are presented in Figure 1.

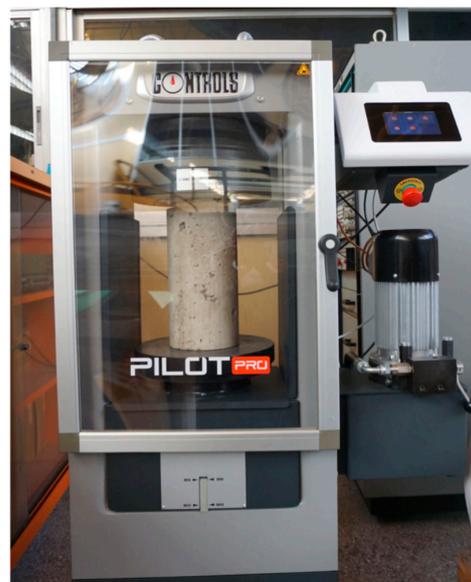
cylinder	max load (kN)	strength (Mpa)
1	450.83	25.512
2	404.57	22.894
3	332.32	18.805
average	395.91	<b>22.4</b>

**Figure 2.** Compression tests on concrete cylinders and results.

Ready mixed concrete was used to cast all four reinforced concrete specimens with the same batch without any construction joints. The concrete compressive strength was  $f_c' = 22.4$  MPa, based on the mean value of three standard cylinders with diameter of 150 mm and height 300 mm, tested at 28 days. The compression machine and gathered results are presented in Figure 2. The steel used for the construction of the cages of the internal longitudinal bars and stirrups was of quality B500C, suitable for seismic-resistant structures. The tensile stress at yielding of the steel was equal to 550 MPa and the tensile strength (at ultimate) was 650 MPa.

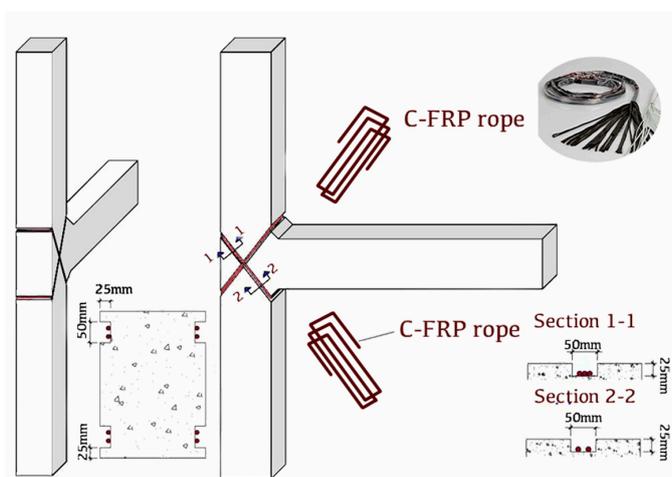
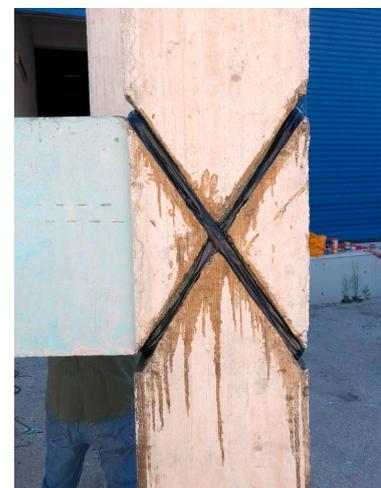
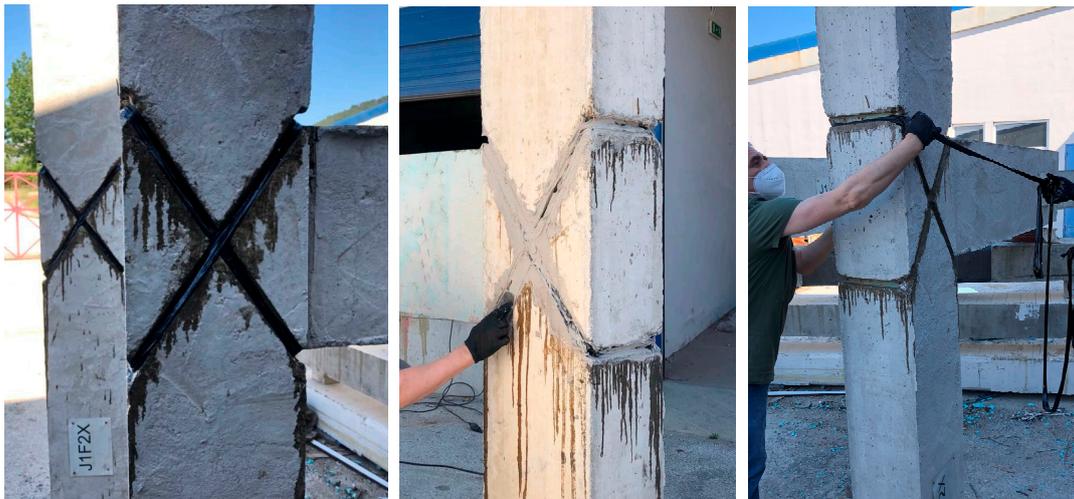
**Figure 3.** Strengthened specimens CON0F2X, CON1F2X; C-FRP ropes are applied in an X-shape form on the joint body.

The flexible composite rope is applied inside grooves with a depth of 25 mm and a width of 50 mm. While the grooves decrease the shear strength of the joint, their application is necessary, as the X shape of the rope tends to move when it comes to tension. The notches that are on the width of the beams, at least, are necessary, so that the rope does not leave its initial position. Therefore, it was decided to provide adequate grooving all around the perimeter of the region under retrofit. An adequate concrete cover has to be provided, as the internal steel reinforcement has to be protected against direct damage or galvanic corrosion from contact with carbon fibers. The grooves follow the diagonals of the joint at both faces (see also [45]). The grooves terminate in horizontal segments outside the height of the joint, inside the reinforced concrete columns sections, as depicted in Figure 3. The grooves are of great importance as they prevent the rope from slipping over the back surface of the column. They are well rounded at the eight corners of the grooves in the columns to maximize the force exerted by the ropes against the two diagonal concrete sections and to avoid excessive stress concentration that may cause damage. The dust is then cleaned with compressed air. The second step is the application of a two-component epoxy resin in the notches as an adhesive substance between the ropes and the concrete. Instead of cutting the rope in two different layers (see [35,37,38,46,47]), here the continuous flexible rope is cut for the total length of the two layers and for the self-anchorage length and is resin-impregnated. The anchorage of the rope started at the point where the two diagonals intersect and was anchored after two laps and at the corresponding intersection point of the opposite face of the joint. The improved detailing ensures higher versatility in the application of the strengthening and the need for lower dimensions of the grooves in case of higher number of layers. The composite rope is placed inside the diagonal grooves by hand while stretching it against the concrete member. Finally, the grooves are fully filled with the epoxy resin paste (Figure 3). Thorough filling of the notches with high strength epoxy paste ensures the rehabilitation of the extracted concrete cover of the notches.

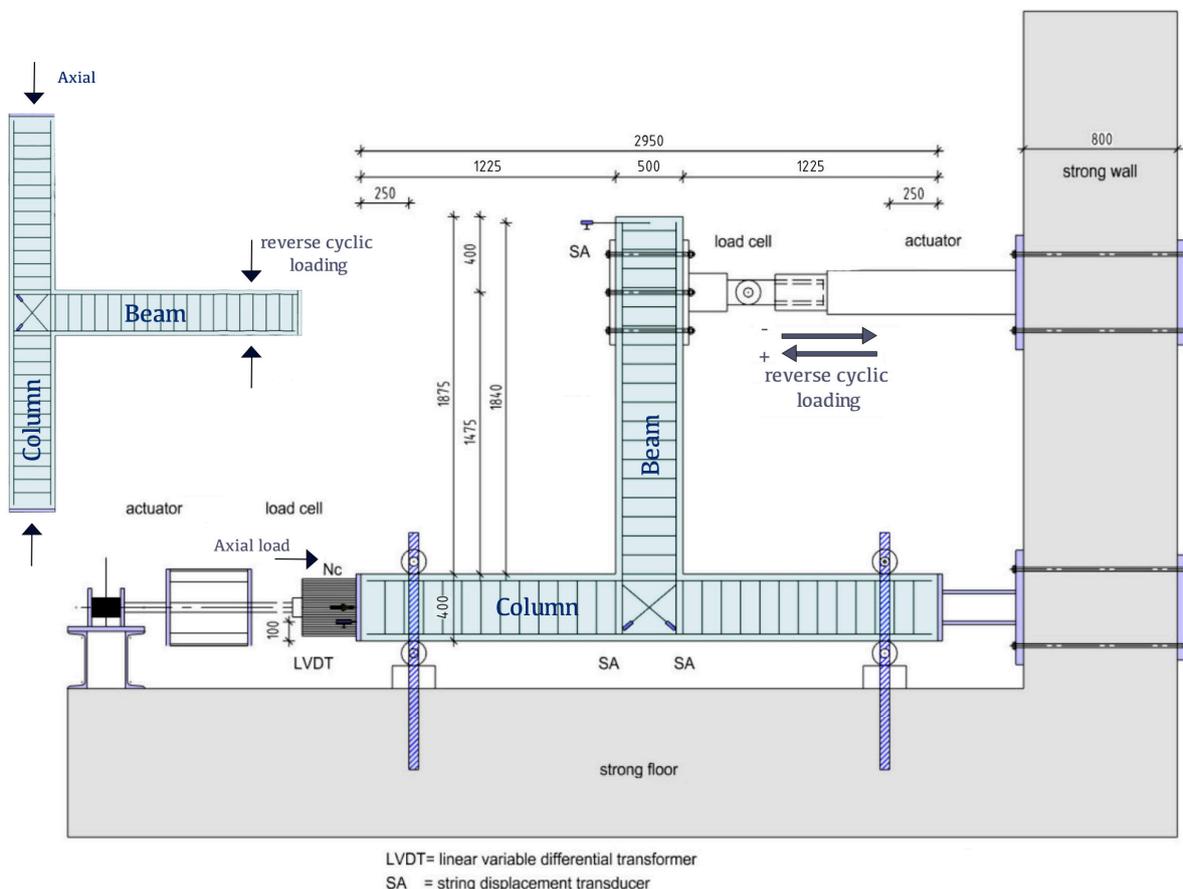
**Figure 4.** Test setup and instrumentation.

The test setup is presented in Figure 4. The T specimen is rotated by 90° so that the columns are in the horizontal direction whereas the beam is in the vertical direction. The end supports of the columns are hinged to allow rotation and simulate the inflection points of the columns in the middle of the floors in a real seismic-resistant framed structure. Both columns are subjected to constant low-magnitude concentric axial compressive load equal to  $N_c = 0.05 A_{cfc} = 134 \text{ kN}$  throughout the testing procedure.

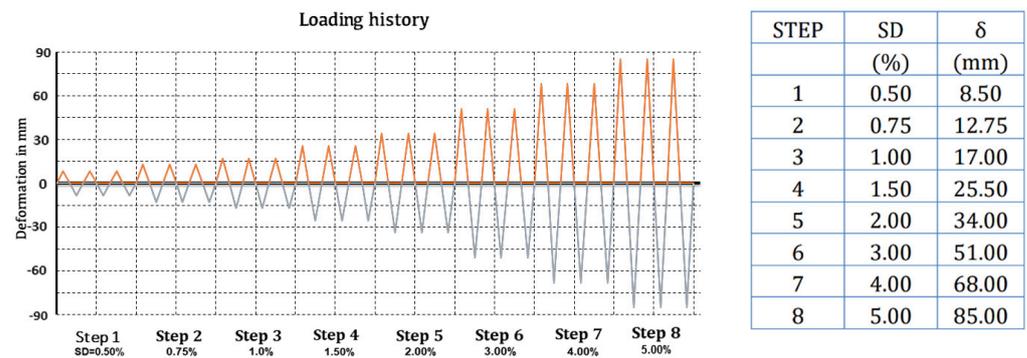
Figure 5. Loading sequence, drift ratios and corresponding displacements.

All beams are subjected to fully symmetric transverse cyclic deformation near their free end, at a length of 1.475 m, by a swivel connector with the actuator (depicted in the horizontal direction in Figure 4). The T specimens were subjected to eight successive steps of increasing displacement with corresponding drift ratios equal to 0.50% (8.5 mm), 0.75% (12.75 mm), 1.0% (17 mm), 1.5% (25.5 mm), 2% (34.0 mm), 3% (51 mm), 4% (68 mm) and 5% (85 mm), respectively. Each loading step included three full displacement cycles, as shown in Figure 5, to assess the deterioration of the shear capacity of the joint and the low-cycle fatigue of steel. The imposed load was measured by a load cell, while the displacements of the column, the beam, and the joint area were measured by a linear variable differential transducer. The recorded results involve transverse beam load ( $P$ ) and beam end displacement ( $\delta$ ) as well as diagonal deformations ( $\gamma$ ) of the joint throughout testing for constant column axial load ( $N$ ).

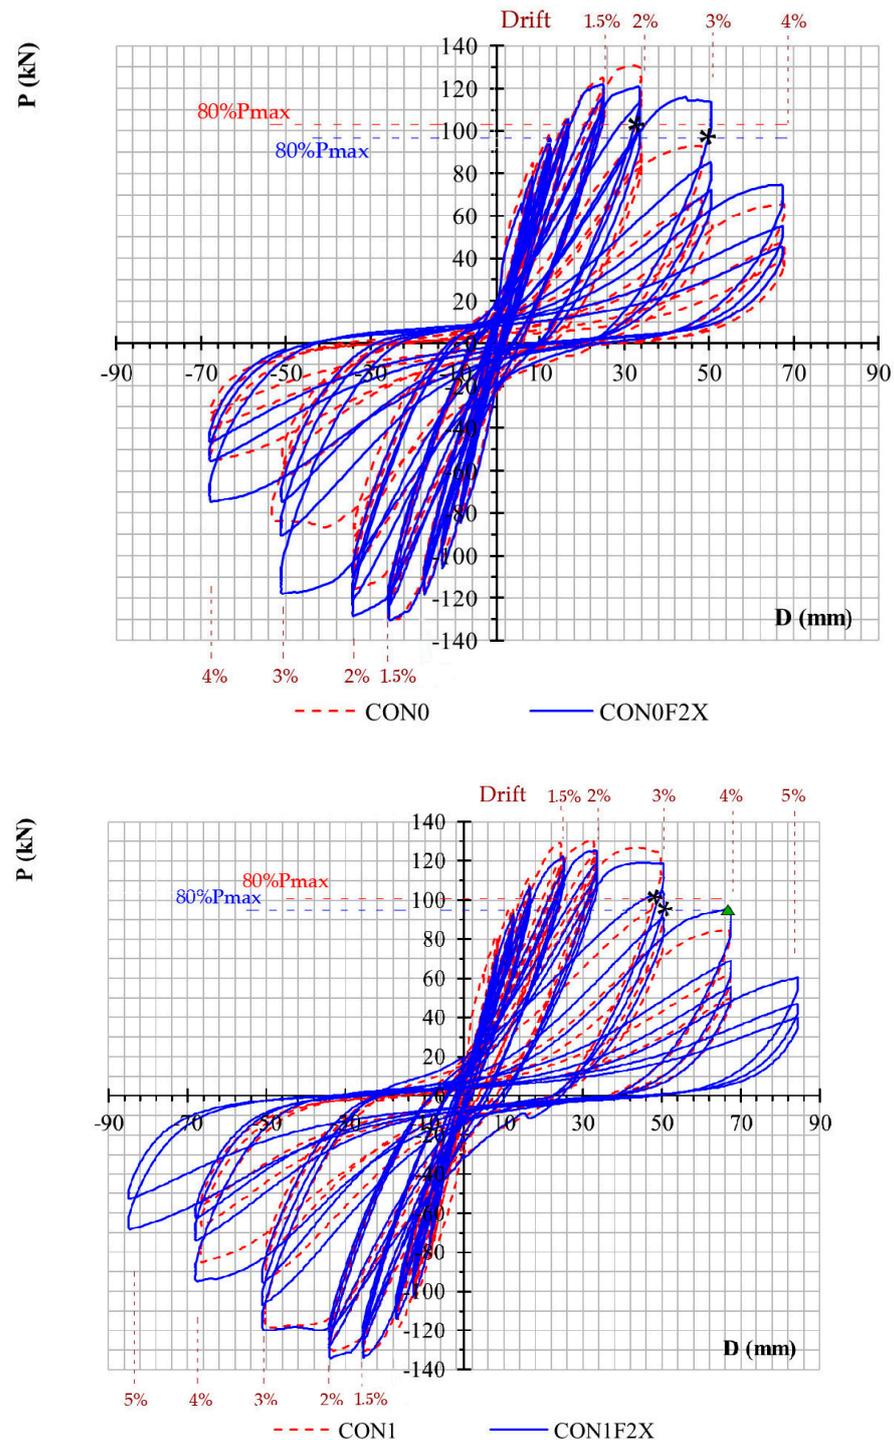
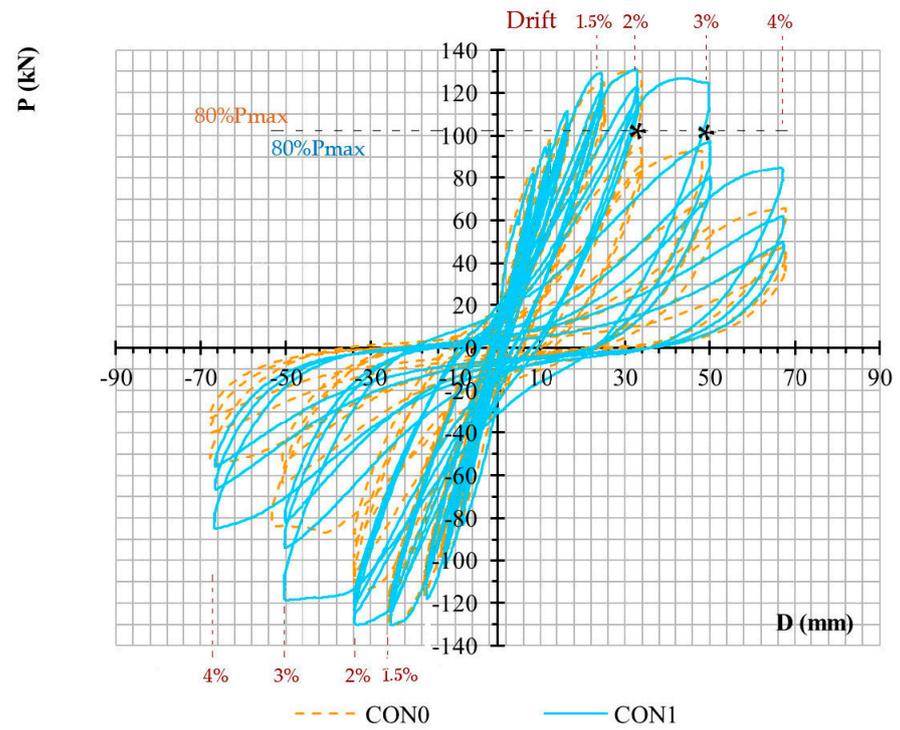
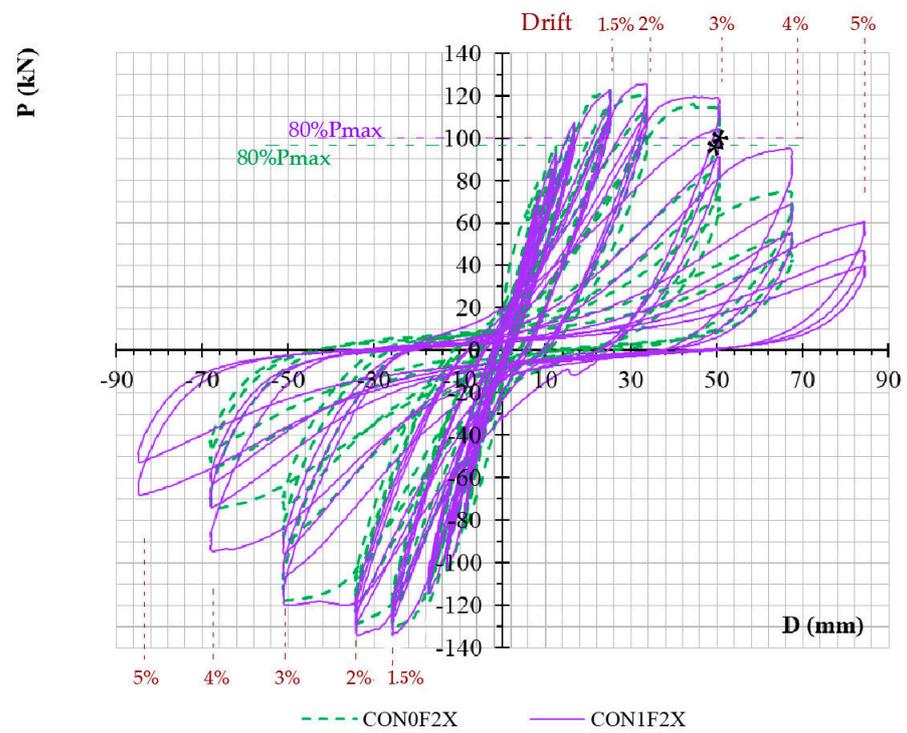
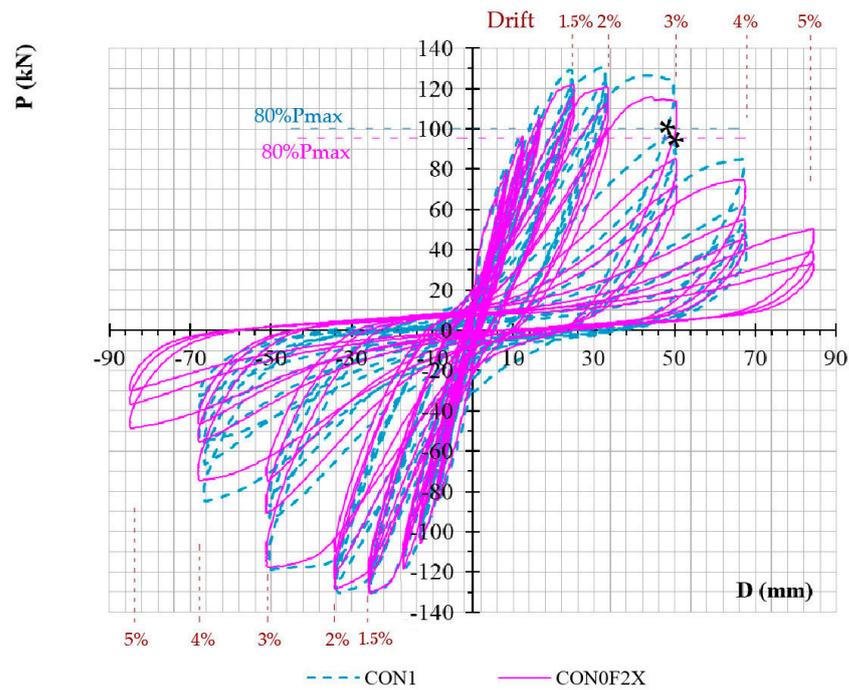
Figure 6. Comparative presentation of the hysteretic responses of the specimens.

The  $P$ - $\delta$  hysteretic curves for the four specimens are presented in Figure 6. It can be concluded that in terms of load carrying capacity, all joints with or without a steel stirrup in the joint region and with or without CFRP rope strengthening, develop the full load that corresponds to the yielding of the tensile steel reinforcement of the beam for both push and pull directions in a symmetric way. This is observed at 1% drift for the unstrengthened specimens and at 1.5% for the strengthened ones. As per the loading cycle, joints CON1F2X or CON0F2X externally strengthened with CFRP ropes exhibited an improved hysteretic response in comparison to the unstrengthened counterpart specimens CON1 and CON0. This is particularly pronounced in the high loading drifts of 3% and 4% or the loading cycles of the 6th and 7th loading steps (Figure 6). Similarly, joints CON1 or CON1F2X with the addition of a steel stirrup in the joint region revealed a better hysteretic response than the corresponding joints CON0 and CON0F2X without a joint steel stirrup. What is more interesting is that the comparison of  $P$ - $\delta$  behavior between CON1 and CON0F2X suggest that the two specimens present a rather equivalent mechanical response. Structural failure of the member may be defined at the drift level in which the post-peak transverse load of the beam reduces to 80% of the peak one, i.e.,  $0.8 P_{\max}$  (see [39,41,48]). Therefore, Figure 6 suggests that specimen CON0 fails at a bearing load of 104.5 kN during the 2nd reversal at step 5 which corresponds to 2% drift. Specimen CON1 fails at 106.4 kN load during the 2nd reversal of the 6th step corresponding to 3% drift. Similarly, specimen CON0F2X fails at 105 kN during the 2nd cycle at 3% drift. Finally, CON1F2X fails at 107.4 kN during the 3rd cycle of step 6 at 3% drift. However, the bearing load of the 1st cycle at 4% drift is at  $0.76 P_{\max}$  which is reasonably close to  $0.8 P_{\max}$  limit for CON1F2X. The above results, for all the specimens, are similar and symmetrical for both push and pull directions.

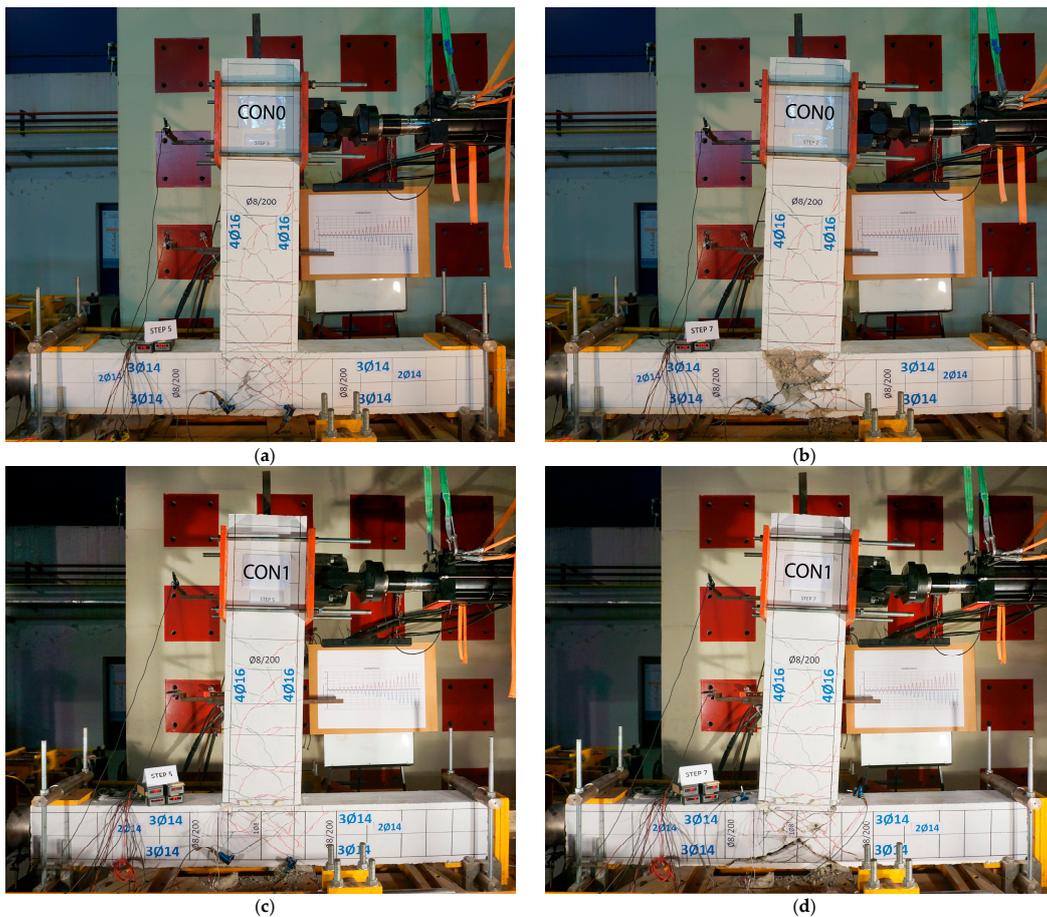
Figure 7. Damage states of unstrengthened specimens. (a) Specimen CON0. Damage state at the 5th step (drift 2%). (b) Specimen CON0. Damage state at the 7th step (drift 4%). (c) Specimen CON1. Damage state at the 5th step (drift 2%). (d) Specimen CON1. Damage state at the 7th step (drift 4%).

As a result of the design target, the severe damage in specimen CON0 is expected to be located mainly at the joint body after yielding of the tensile steel of the bars of the beam. Actually, from the first cycles of loading, the cracks were concentrated at the region of the joint, and the subsequent loading cycles resulted in a gradual increase in the width of the

cracks across the joint region. Finally, the concrete of this region was partially fragmented. The damage state of the specimen CON0 at the 5th step of the loading (drift 2%) is presented in Figure 7a. It is observed that X-shaped cracks have been formed in the joint body and have increased as the steps progressed. The failure of the joint is presented in Figure 7b, where the damage state of the specimen at the end of the loading procedure (at the 7th step—drift 4%) is shown. The damage state of the specimen CON1 at the 5th step of the loading (drift 2%) is presented in Figure 7c. Similarly, CON1 reveals lower damage accumulation inside the joint region than CON0 at similar drift levels up to final failure.

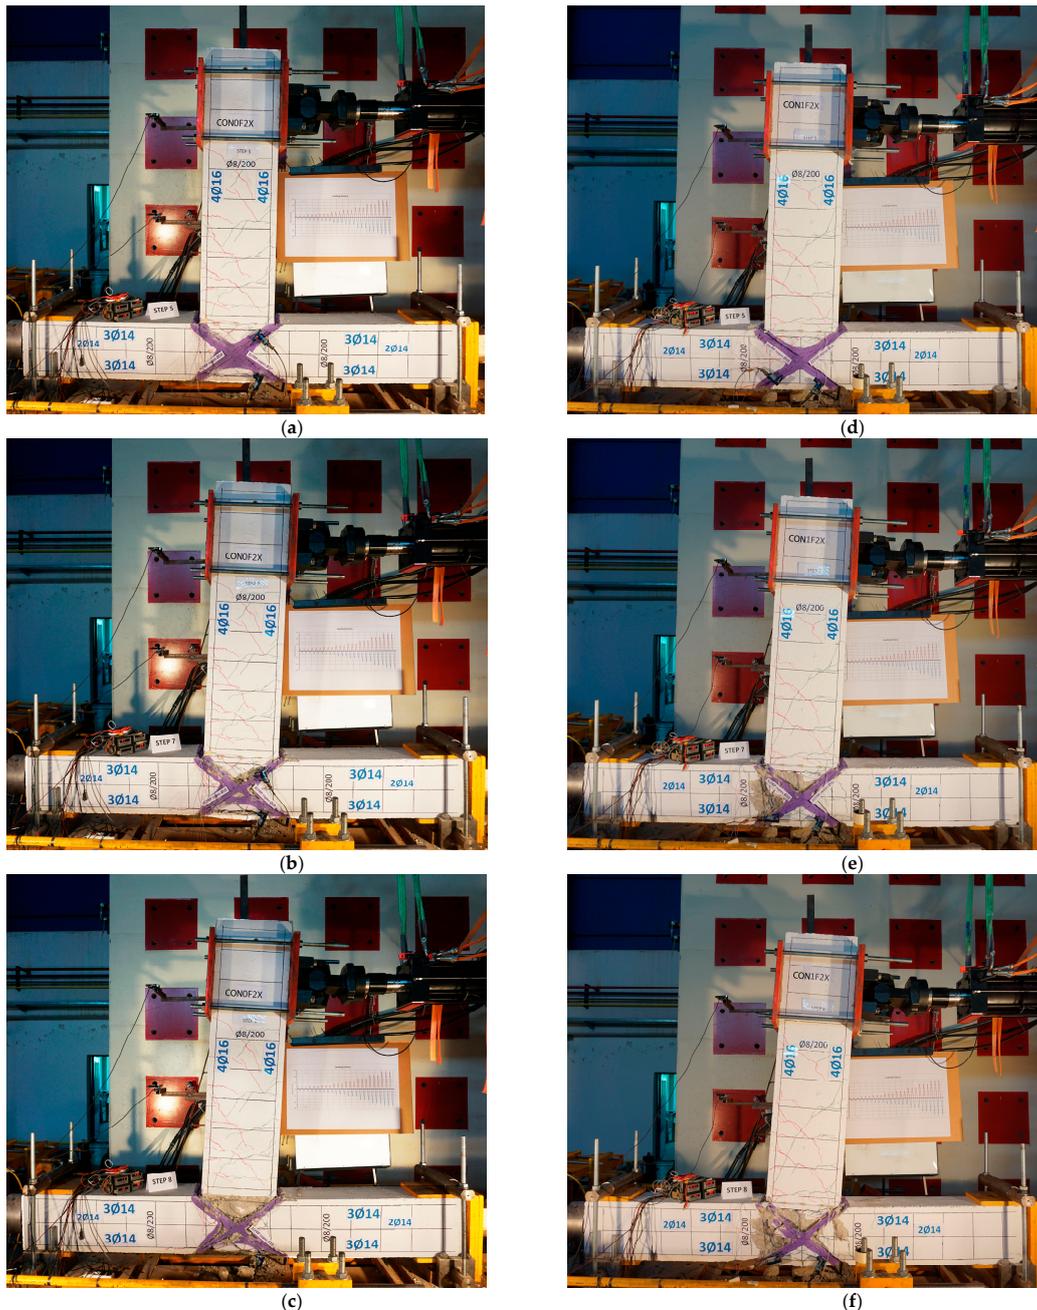
**Figure 8.** Damage states of strengthened specimens. (a) Specimen CON0F2X. Damage state at the 5th step (drift 2%). (b) Specimen CON0F2X. Damage state at the 7th step (drift 4%). (c) Specimen CON0F2X. Damage state at the 8th step (drift 5%). (d) Specimen CON1F2X. Damage state at the 5th step (drift 2%). (e) Specimen CON1F2X. Damage state at the 7th step (drift 4%). (f) Specimen CON1F2X. Damage state at the 8th step (drift 5%).

Specimen CON0F2X has been strengthened at the joint body with X-shaped CFRP ropes. In this case, hairline cracks were observed during the first loading cycles both in the joint region and at the end of the beam. In subsequent loading cycles, severe damage was accumulated in the joint region. However, the cracks were smaller, and not as wide as those in the reference specimen CON0. Figure 8a shows the damage state of the specimen CON0F2X at the 5th step of the loading (drift 2%). The damage is further accumulated inside the joint region at the 7th step—drift 4% (Figure 8b). The case is similar for CON1F2X, revealing slightly lower damage accumulation. In both cases, the X-shaped CFRP ropes hold the fragmented joint concrete core together.

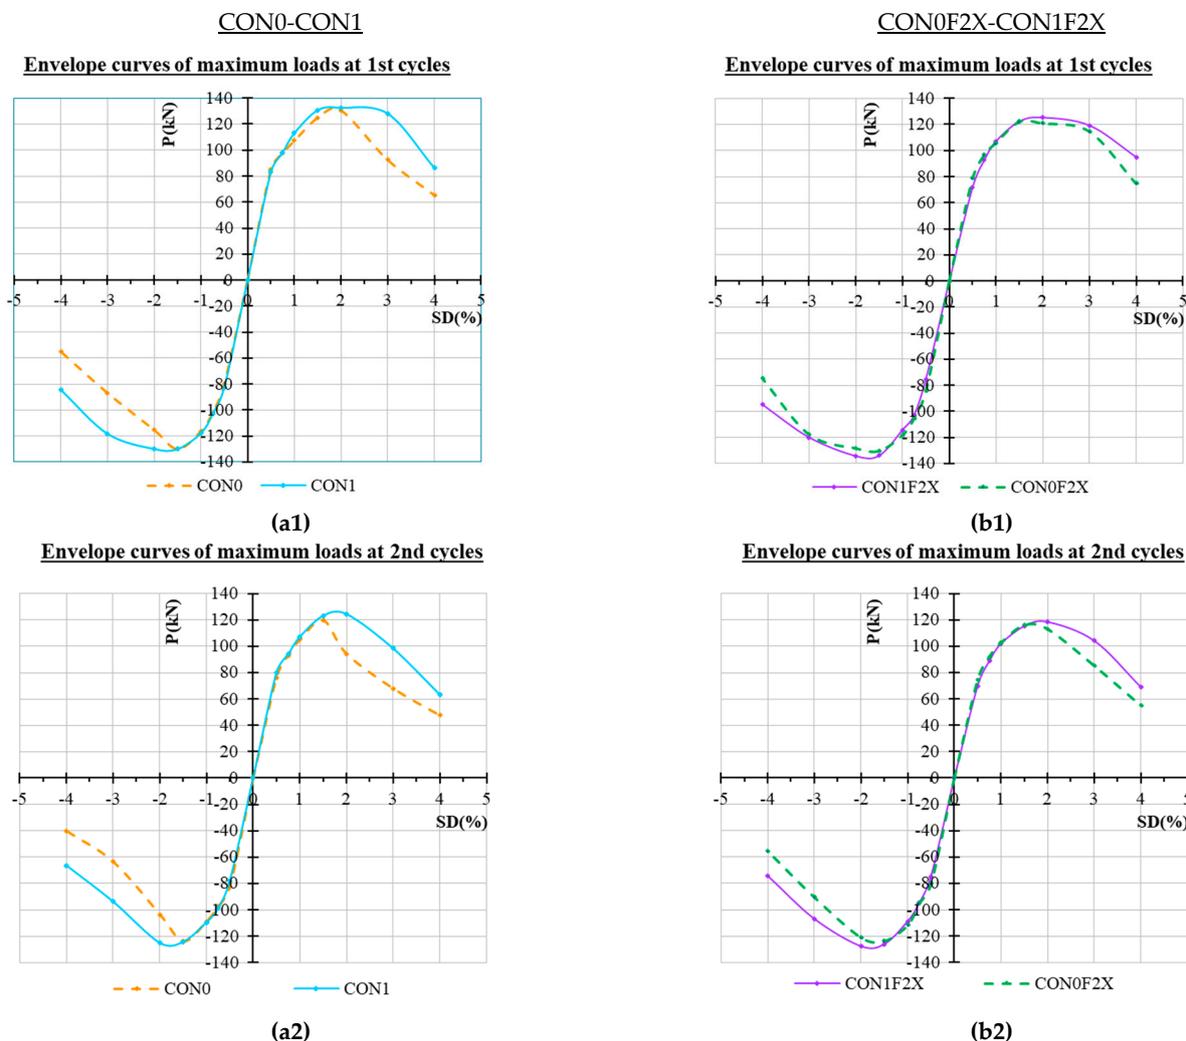
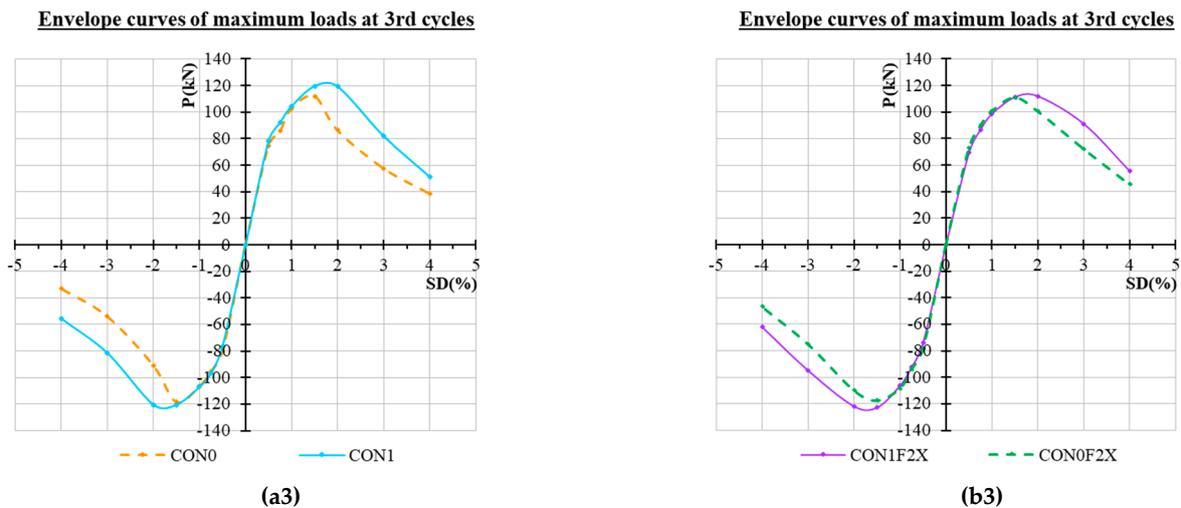
**Figure 9.** Comparative presentation of the envelope curves of the hysteretic responses of the specimens. (a1–a3) Maximum loads of 1st, 2nd and 3rd cycles of unstrengthened specimens. (b1–b3) Maximum loads of 1st, 2nd and 3rd cycles of strengthened specimens.

Comparative presentations of the envelope curves of the unstrengthened specimens (CON0 and CON1) and the strengthened specimens (CON0F2X and CON1F2X) with and without stirrups inside the joint are included in Figure 9 for the first cycle (Figure 9a), the second cycle (Figure 9b) and the third cycle (Figure 9c) of each loading step. From these comparisons, it is observed that the CFRP strengthening has increased the load carrying capacity and the ductility of the strengthened joint compared to the unstrengthened one in the high drifts of 3% and 4%. The comparative curves of specimens CON1-CON0F2X show the envelope curves almost coincide.

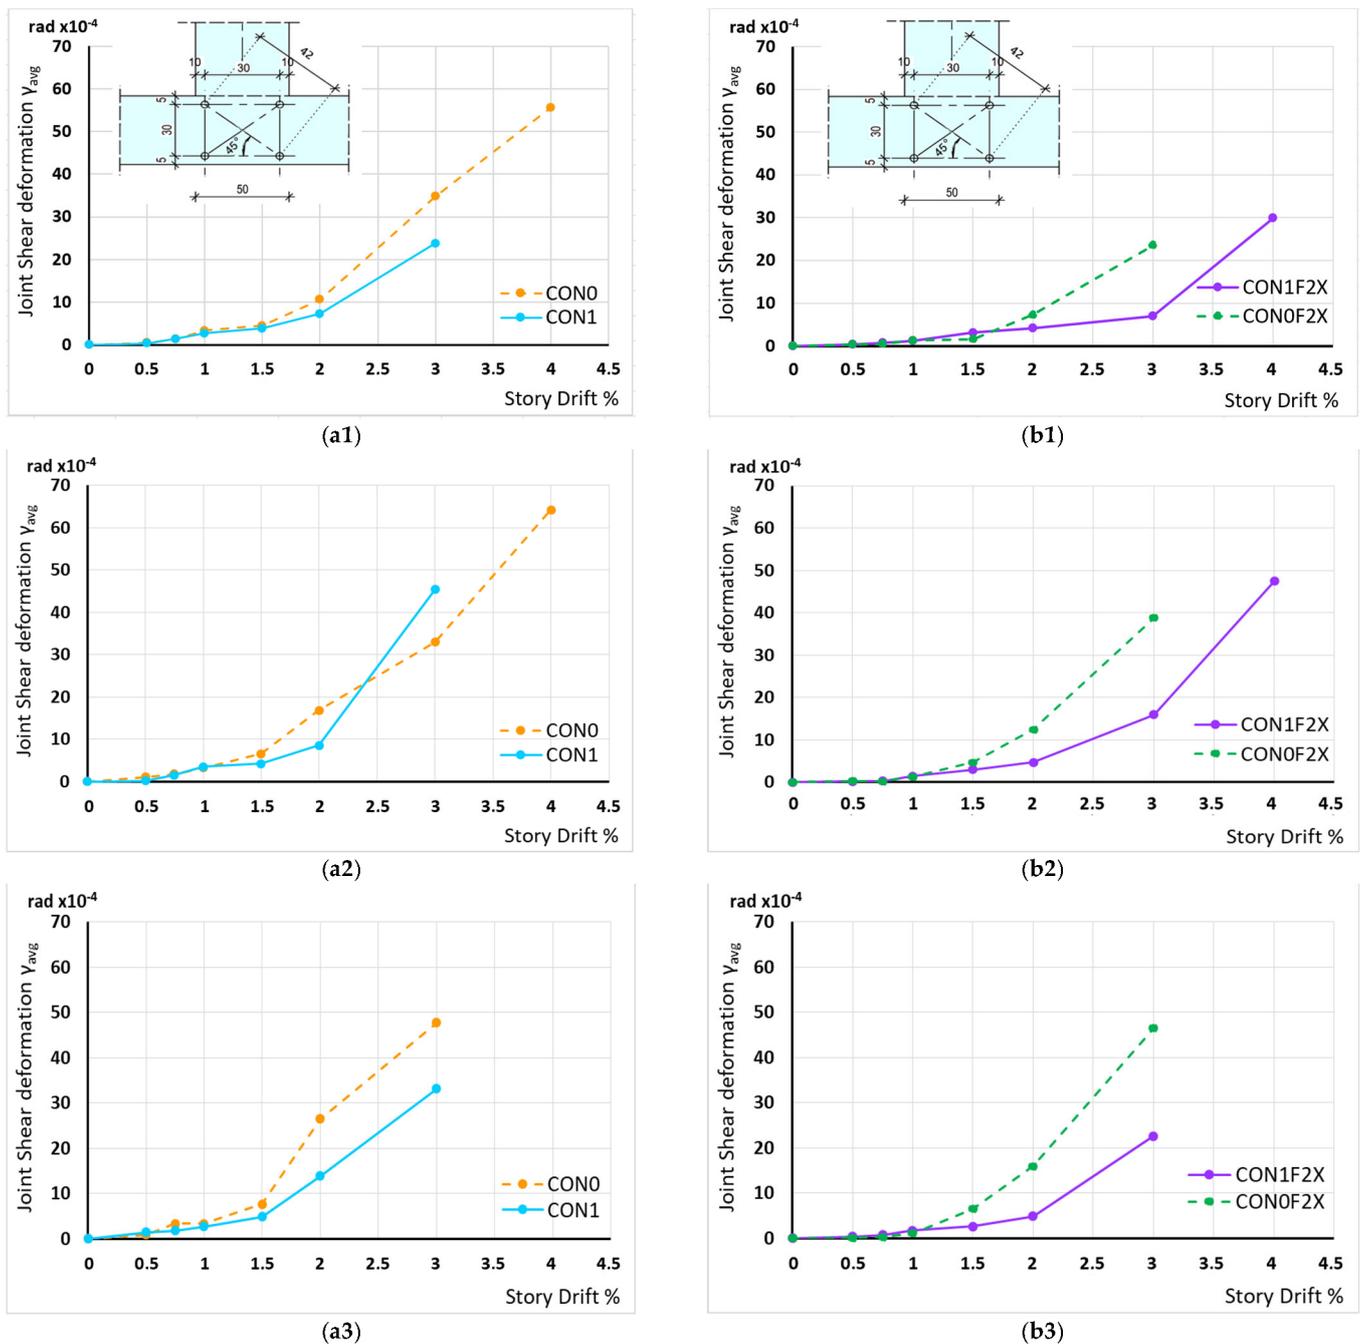
**Figure 10.** Shear deformation of CON0-CON1 (a) and CON0F2X-CON1F2X (b) at (a1,b1) 1st cycle, (a2,b2) 2nd cycle, (a3,b3) 3rd cycle. Shear deformations of the specimens' joint body as obtained by the diagonally mounted string displacement transducers (LVDTs).

Comparative presentation of maximum absolute values of the joint shear deformations in CON0 deviate from the elastic range during 2% lateral drift and during the 2nd cycle. In CON1 the disintegration of the joint initiates during 2% lateral drift and during the 3rd cycle. Specimen CON0F2X deviates from elastic response during 2% lateral drift during the 3rd cycle. Finally, CON1F2X maintains the elastic response up to the 1st cycle at 3% drift. Significant disintegration of the joint region for CON1F2X occurs at 4% drift, 1st cycle, for  $\gamma_{avg} 30 \times 10^{-4}$  rad. The drift level for similar shear deformations for CON0F2X occurs at 3% drift, 2nd cycle, for CON1 at 3% drift, 2nd cycle, and for CON0 at 2% drift, 3rd cycle. From the figures it is apparent that as the imposed displacement increases, the observed joint shear deformations of specimen CON1F2X are substantially reduced compared to the corresponding ones of the unstrengthened specimen CON1. The low deformations observed for the strengthened specimen CON1F2X are apparently attributed to the shear strengthening imposed by the X-shaped CFRP ropes externally applied on the joint body. From these observations it can be concluded that the strengthening technique improves the joints in terms of shear bearing capacity. The limit drifts for elastic joint cyclic behavior are clearly assessed. No cyclic loading effect is evidenced for CON1F2X up to 3% drift, for CON0F2X up to 2% drift, for CON1 up to 2% drift and for CON0 up to 2% drift. Specimens CON1 and CON0F2X reveal an almost identical variation of shear deformations with the beam drift for the 1st, 2nd or 3rd cycles.
