Article

Microstructure and Mechanical Properties of Ti-6Al-4V Welds Produced with Different Processes

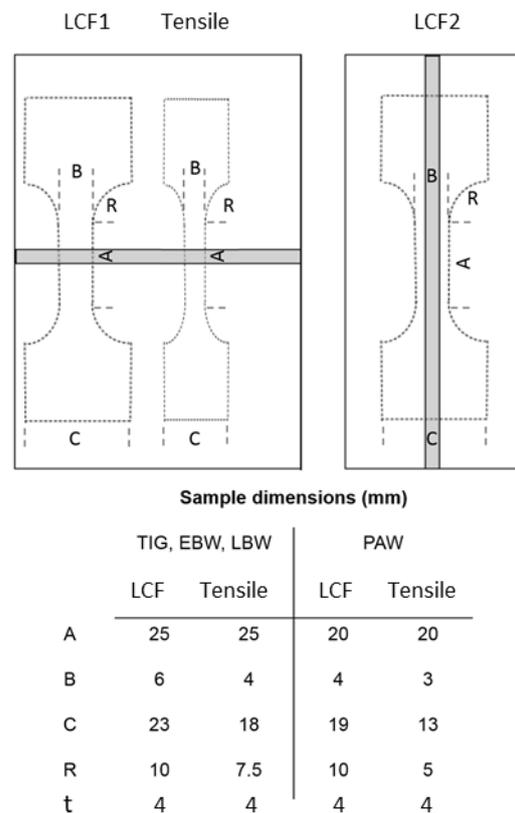
Figure 1. Schematic drawings and dimensions of the samples used for mechanical testing. Tensile and LCF type 1 specimens were perpendicular to the weld zone, and the LCF type 2 specimen was parallel to the weld zone.

The external weld geometry was machined off from the mechanical test specimens. This was conducted in order to minimize the influence of the weld geometry in order to be able to study specifically the effect of microstructure and weld defects on the mechanical properties. The strain-controlled tensile testing for the base material and for the welds was performed according to ASTM E8 [21] at room temperature, and according to ASTM E21 [22] at 250 °C. The tensile testing was performed in transverse direction to the weld. Load controlled fatigue testing was performed according to ASTM E466 [23] at room temperature, and at 250 °C in air atmosphere, with stress ratio $R = 0$. In addition, a number of LBW samples were not polished after welding in order to investigate the influence of external weld geometry on fatigue properties. These samples were tested at 200 °C. Fatigue test samples were prepared in both transverse and longitudinal directions to the weld. The number of cycles to fracture and the total stress range were recorded during each test, and plotted in a diagram to show the low cycle fatigue strength. The dimensions and schematic drawings of the samples used for mechanical testing are shown in Figure 1.

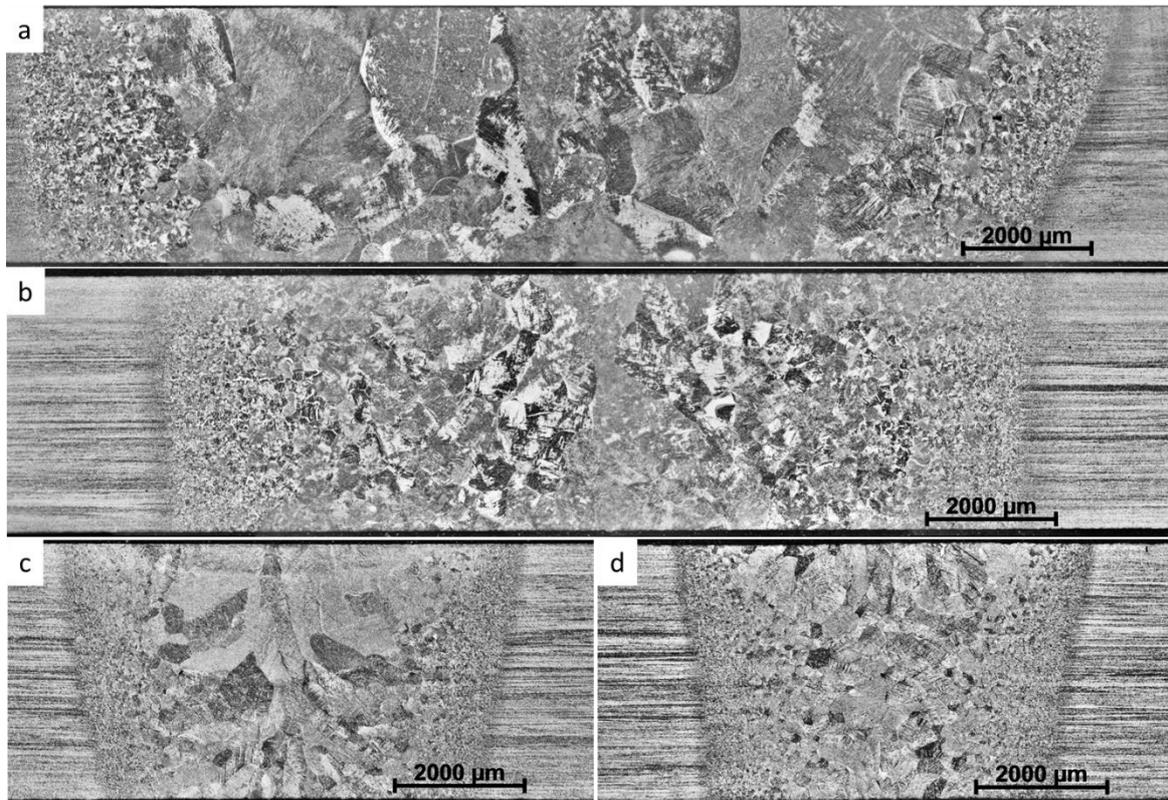
Figure 2. Optical micrographs showing the weld cross sections for (a) TIG, (b) PAW, (c) EBW, and (d) LBW welds in 4 mm thick Ti-64 sheet material.

Optical micrographs of the studied post weld heat-treated welds are shown in Figure 2. The heat-affected zones (HAZs) are characterized by prior- β grains that gradually become coarser towards the fusion zones. In general, the width of the welds was slightly wider at the top than at the bottom. The dimensions of all examined welds and the average

hardness of fusion zones are summarized and shown in Table 2. The TIG weld was widest and contained the largest prior- β grains. The fusion zone (FZ) and prior- β grain size was smaller in PAWs than in TIG welds. Welds produced by EBW and LBW were considerably narrower. LBW had the smallest weld zone and smallest prior- β grain size. Also, the prior- β grains in LBW were more equiaxed as compared to the other welds where prior- β grains are elongated.

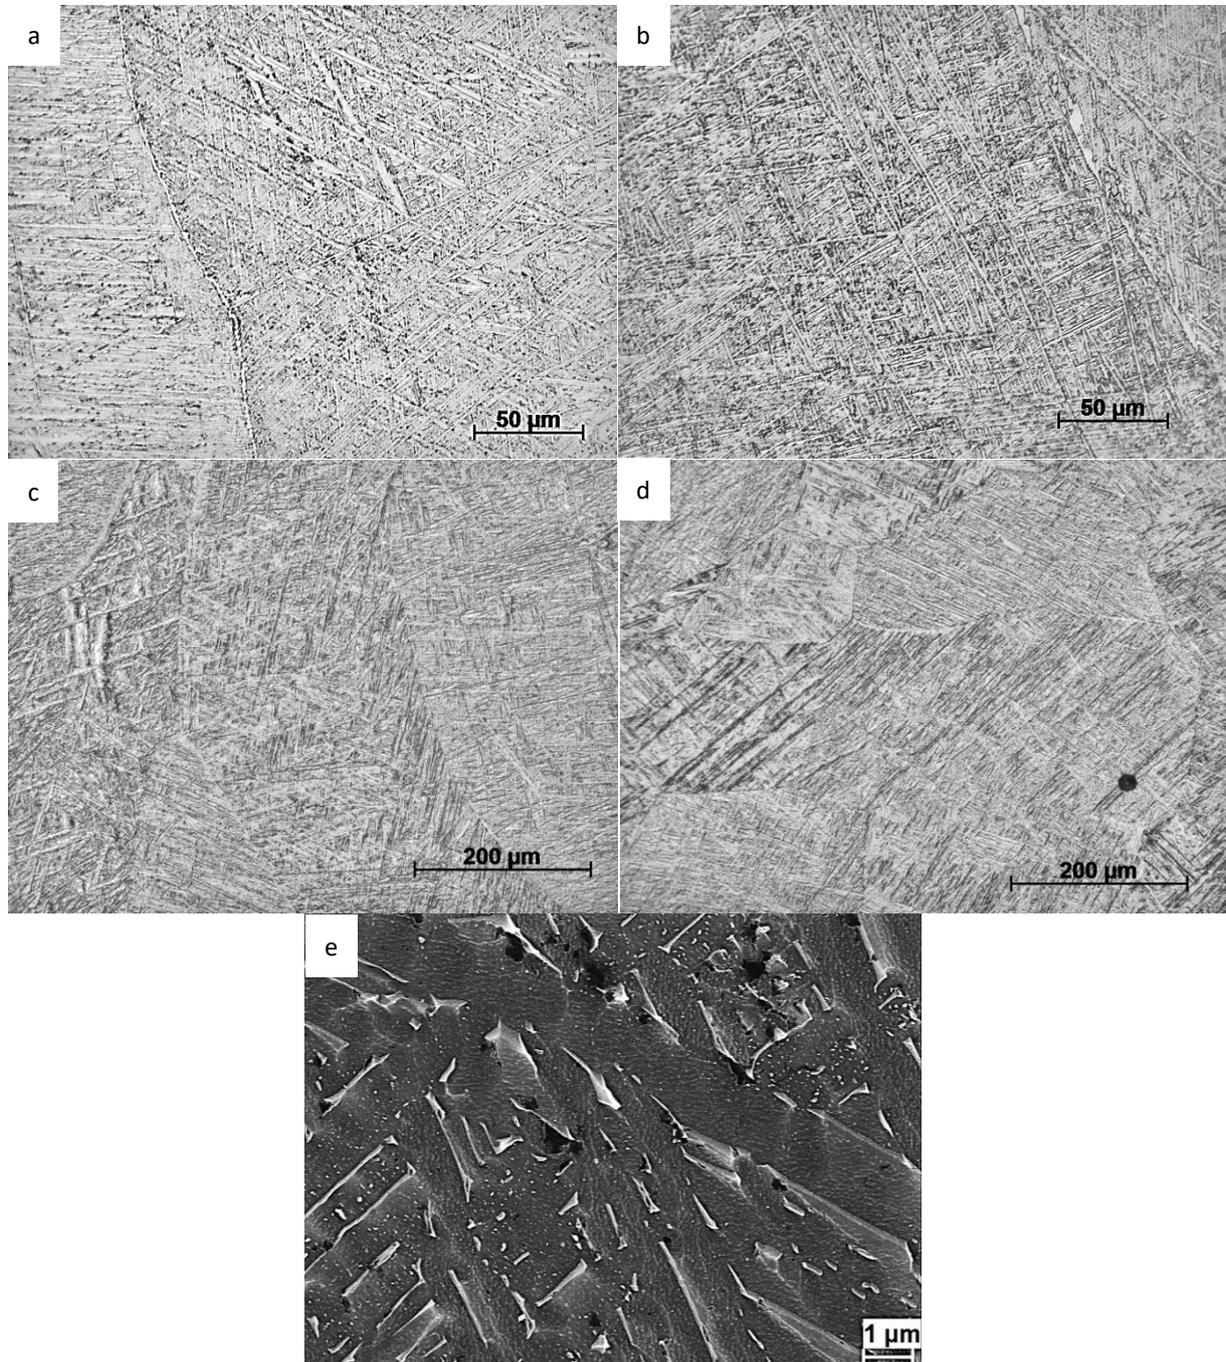
Figure 3. Optical micrographs of (a) TIG, (b) PAW, (c) EBW, and (d) LBW welds, and (e) SEM micrograph of PAW weld. The different magnifications can be noticed.

Figure 3 shows typical microstructures inside prior- β grains in the fusion zones of each type of weld after post weld heat treatment. The microstructure of all the welds consisted of fine α laths separated by thin layers of β phase, as shown in Figure 3e in the PAW weld. Inside prior- β grains in TIG and PAW, the microstructure consisted of both colony and basketweave types of microstructures. In the TIG welds, the fraction of colony structure was higher than in the other welds. This is because of the higher heat input and slower cooling rate in TIG welds as compared with the other welding processes, which promotes the transformation into a colony type of structure [4]. In EBW and LBW the α laths were more acicular and they formed a very fine basketweave type of microstructure. In EBW and LBW, grain boundary- α was observed in a few prior- β grain boundaries. In TIG and PAW, the grain boundary- α was more continuous and thicker. The average α lath

spacing in EBW and LBW were estimated to be $0.9 \pm 0.1 \mu\text{m}$, and in TIG and PAW the corresponding α lath spacing were estimated to be $1.2 \pm 0.1 \mu\text{m}$. These values were based on 10 optical micrographs investigated for each weld. In addition, porosity was noticeable in the LBW micrographs.

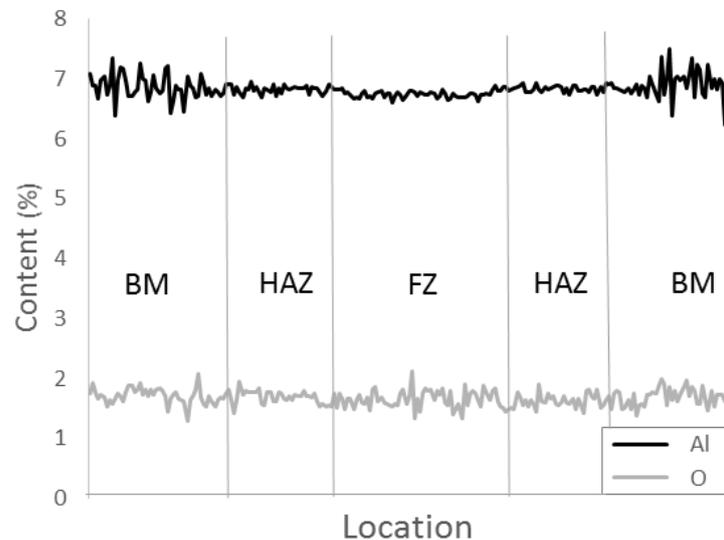
Figure 4. EPMA line scan across a TIG weld showing the distribution of aluminium and oxygen across the weld, i.e., in the base material, the heat affected zone, and the fusion zone.

In Figure 4, a qualitative electron probe micro analysis (EPMA) line scan across a TIG weld is shown. The absolute values are not correct; however, the relative variation between base material and the weld zone are correct. The oxygen content in the base material was 0.12 wt.%. The EPMA results revealed no difference in oxygen content between the base material and weld zones. A small drop in aluminium was observed in the fusion zone.

Aluminium has a lower boiling point than titanium and vanadium, which is why it can vaporize more easily during the welding process. An EPMA line scan across an EBW showed similar behaviour.

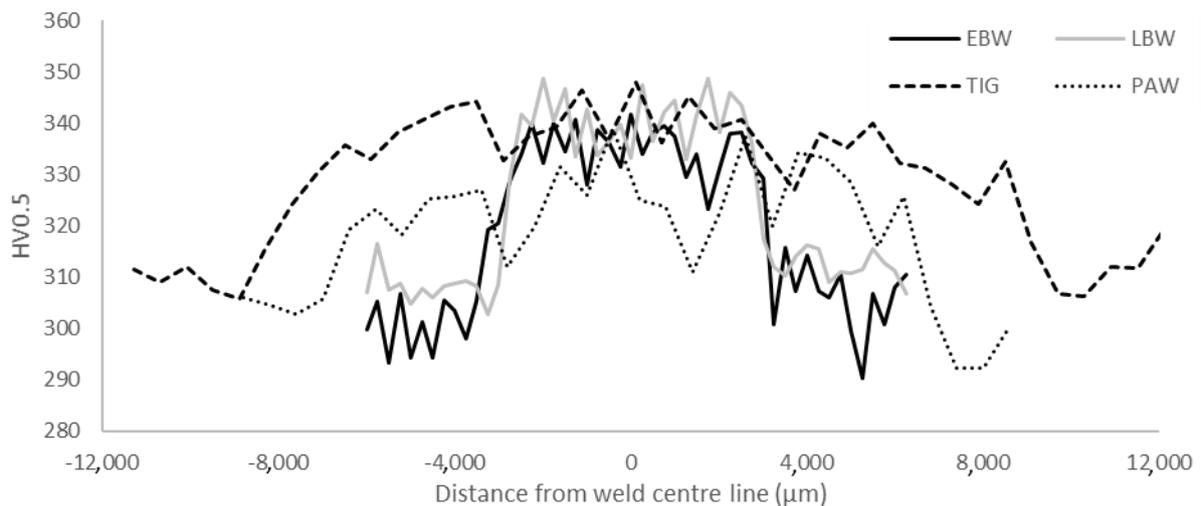
Figure 5. Microhardness profiles across welds produced by EBW, LBW, TIG and PAW after post weld heat treatment.

Microhardness profiles across the different weld cross-sections are summarized in Figure 5. In general, all four types of welds showed a similar trend. The hardness was found to be lowest in the base material and increasing through the HAZ, with the maximum hardness located in the fusion zone. The average hardnesses of the weld fusion zones are shown in Table 2.

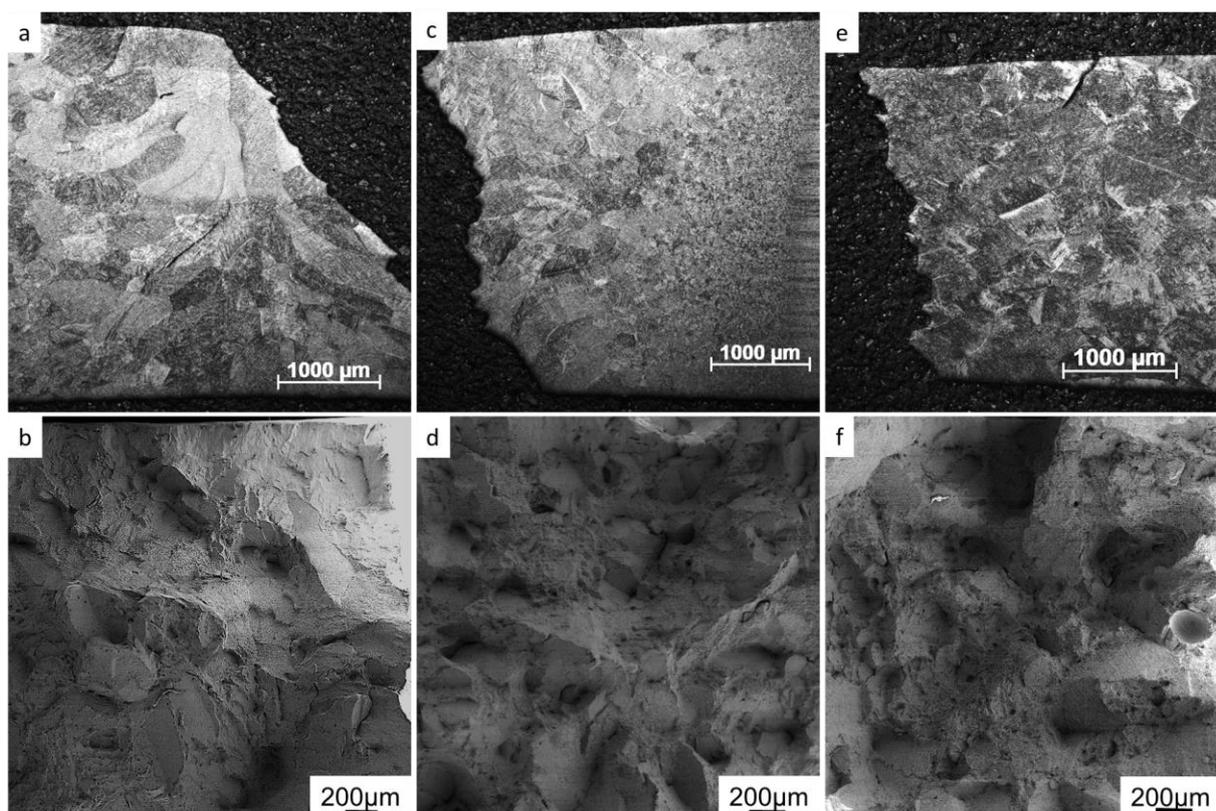
**Figure 6.** Room-temperature tensile tested weld samples. Etched side views and fracture surfaces of (a,b) EBW, (c,d) LBW, and (e,f) PAW.

In all welded tensile test specimens, the fracture was located in the weld zones. In Figure 6, etched side views and the fracture surfaces of tensile test welds tested at room temperature are shown. In all welds, the fracture was found to be a combination of transgranular and intergranular fracture. Moreover, cracks were also observed along prior- β grain boundaries, and through prior- β grains outside the main fracture. Areas of intergranular fracture appear as flat areas in fractographs in Figure 6b,d,f. The shape and size of these areas correspond to the prior- β grains in the microstructure. Dimples were found in all areas indicating fracture through coalesced micro voids.

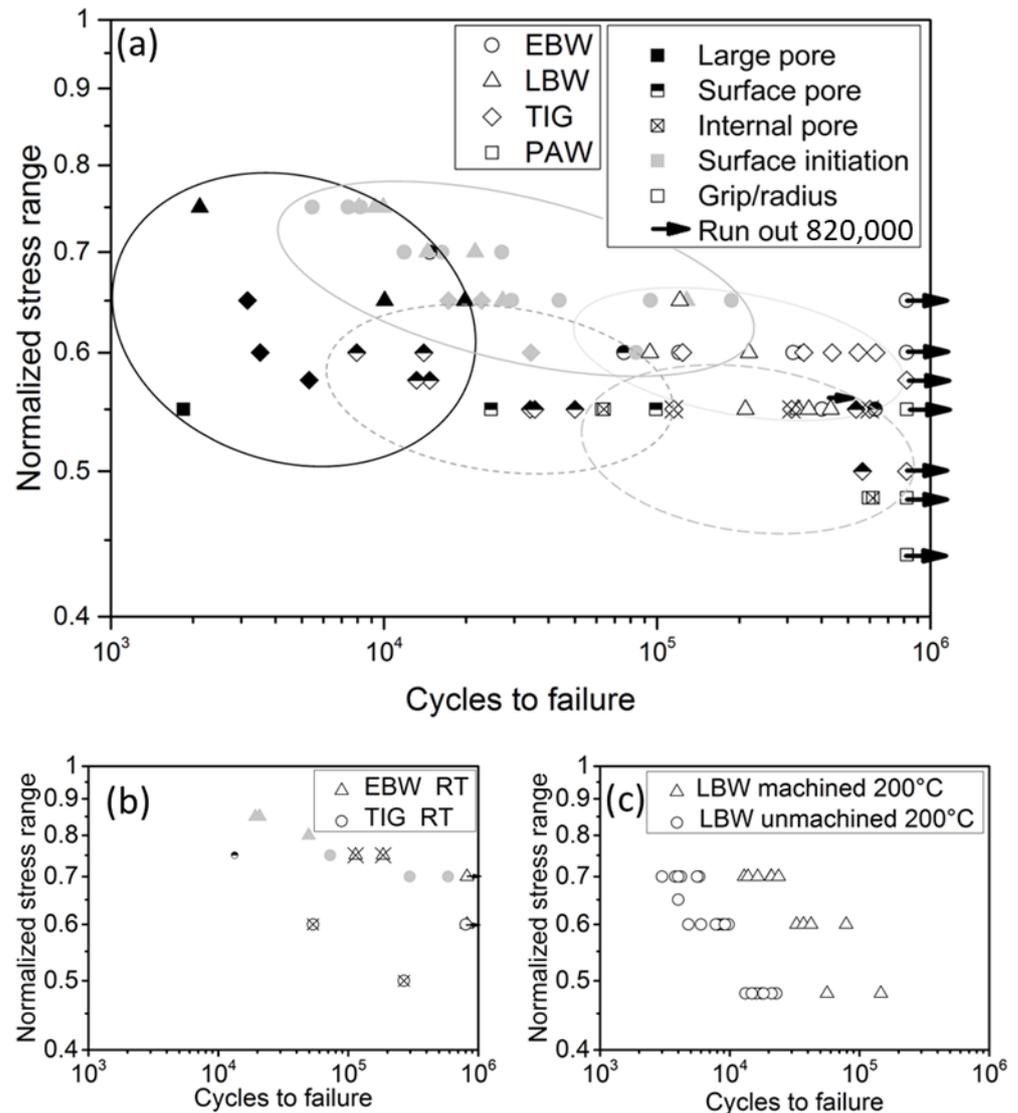
Figure 7. LCF results (a) for welds produced by TIG, PAW, EBW, and LBW at 250 °C; (b) EBW and TIG at room temperature; and (c) the effect of weld geometry in LBW. In (a,b), the shape of the symbol indicates the welding process, and the fill of the symbol indicates the type of initiation.

Results from low cycle fatigue testing at room temperature, and at 250 °C, are shown in Figure 7. The stress range values have been normalized with regard to the highest stress

range applied during testing. Crack initiation sites have been categorized as *surface pores*, *internal pores*, *large pores (>400 μm)*, and *surface initiation*. Each type is indicated by a unique symbol. Grip/radius samples failed outside the cage section of the test specimen, which is typically considered an invalid test. Here the specimens were included because they performed better than average. The testing direction was not found to have significant influence, and the results from the specimen types 1 and 2 (Figure 1) have been combined in Figure 7.

At 250 °C, welds produced by EBW and LBW were found to have superior LCF performance in comparison to the welds produced by TIG and PAW. EBW seems to have the best LCF performance and the smallest scatter of data. Most of the LBW samples have a similar fatigue life as the EBW samples, but the scatter of the data for the LBW samples is higher. The main reason for this was the significantly lower fatigue life in a few of the LBW samples, caused by large pores. The fatigue strength of welds produced by PAW and TIG was found to be similar to each other. However, because of the limited number of tested samples, these results should be interpreted as indicative rather than as conclusive.

In the LCF tests performed at room temperature (Figure 7b), the EBW and TIG welds had higher fatigue strength than at elevated temperature. The welds produced by EBW performed better and had considerably smaller scatter than the TIG welds.

As shown in Figure 7a, the majority of the samples tested at high stress ranges had a crack initiation at the surface of the sample (Figure 9d), which shows that cracks initiate easily at the specimen surface at high stress ranges. Most EBW and LBW specimens had a crack initiation with a facet at the surface of the sample. Facets in titanium alloys under cyclic loading can occur along basal planes, creating flat faceted features on fracture surface at a low-stress intensity range. Thousands of cycles can contribute to the formation of a facet [28]. Surface initiations with facets were observed in specimens tested at the highest stress ranges, and surface initiations were not found to occur at normalized stress ranges below 0.6. The specimens with crack initiation at a facet had the highest fatigue lives. At a high stress range, only large pores (>400 μm) were found to initiate cracks. Large pores were also found to be the most detrimental defect type for fatigue life. At 250 °C, small and internal pores were found to initiate cracks only at lower stress ranges where surface facet initiations did not occur. However, at room temperature, internal pores were found to initiate cracks in TIG and EBW samples at relatively high stress ranges (Figure 7b). At elevated temperatures, surface cracks become dominant more easily than internal cracks. Sarrazin-Bauduox et al. [29] showed that in Ti-64, the crack growth rate is higher in air than in a vacuum. The effect is more pronounced at elevated temperatures and for small cracks. Cracks initiated by internal defects grow in a quasi-vacuum. This is one reason why internal cracks grow slower than surface cracks and why surface cracks can become dominant more easily. At room temperature, the difference in crack growth rate is smaller and cracks initiated by internal pores have a bigger chance to become dominant, which may explain why LCF life seemed to be more sensitive to internal pores at room temperature than at elevated temperature. Åkerfeldt et al. [30] also suggested that increased ductility at elevated temperature might make LCF performance less sensitive to porosity.

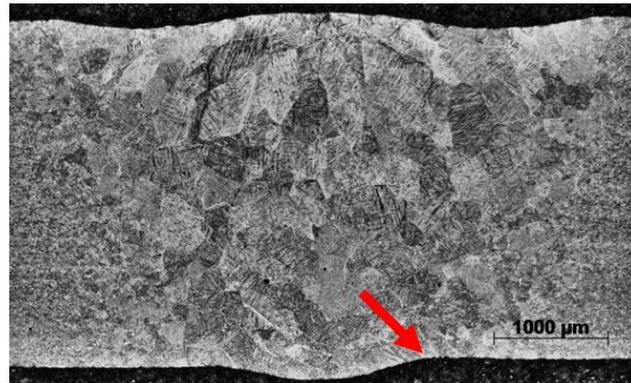
Figure 8. Optical micrograph of LBW showing the weld geometry. Typical crack initiation site at the weld toe on the root side indicated.

The LCF testing of polished and unpolished LBW specimens showed that the external weld geometry has a significant effect on the fatigue strength. The weld geometry of unpolished LBW is shown in Figure 8. Weld face underfill was found to be 80–100 μm , and root undercut 30–50 μm . As shown in Figure 7c, the machined samples had 5–10 times longer fatigue life compared with the samples with the external weld geometry retained. In the unpolished specimens, cracks always initiated at the weld toe on the root side and never at internal defects.

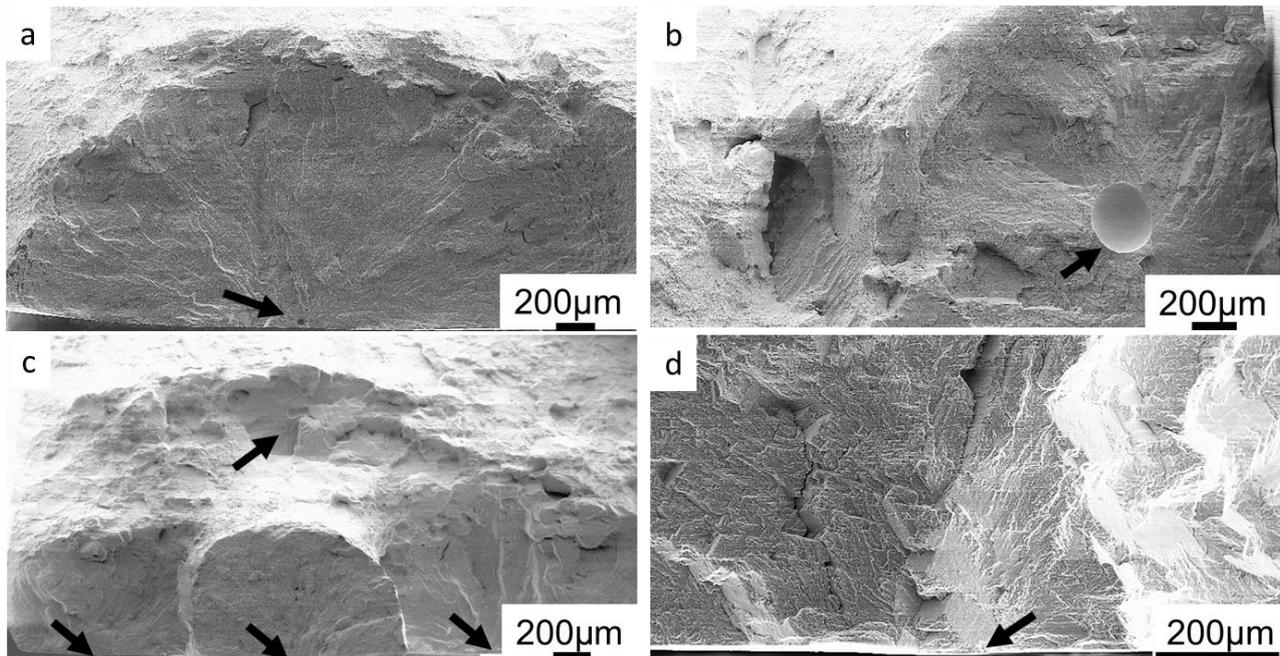
Figure 9. Fatigue fracture surfaces showing different types of crack initiation sites: (a) a small pore close to surface (EBW); (b) a large internal pore (TIG); (c) initiations at surface and at a cluster of pores (LBW); and (d) a surface initiation site with a facet (EBW).

Fractographic investigation of LCF samples with lower fatigue life mainly revealed two characteristics: (i) fatigue crack initiation at a large pore in the center of the sample, or (ii) fatigue crack initiation at a pore located close to the surface of the specimen. Fatigue specimens with long fatigue life typically had crack initiation at the surface of the sample. Fracture surfaces showing typical crack initiation sites and crack propagation areas around them are shown in Figure 9. Arrows indicate the crack initiation sites.

Under cyclic loading, there were a number of microcracks initiating, but only some of the microcracks kept growing and eventually caused failure. Numerous cracks were observed in individual specimens produced by LBW (Figure 9c) and TIG (Figure 11). It is often assumed that under high stress, as around a stress raiser such as a pore, cracks initiate almost immediately [27]. In the present work however, somewhat different findings were made. In the TIG specimen shown in Figure 11, three pores of similar size and location were found, but only one of the pores induced macrocracks that led to the final fracture. Pore 2 was found to initiate a microcrack and pore 3 had not initiated a detectable crack. This shows that crack initiation at small pores is difficult to predict, and may indicate that the time for a pore to initiate a crack is not negligible. Tammas-Williams et al. [19] found that surface defects are more harmful than a conventional fracture mechanics approach [18] would predict. The combination of defect size, location, aspect ratio, and proximity to other pores and the surface, provided a more accurate prediction of the most harmful pores.

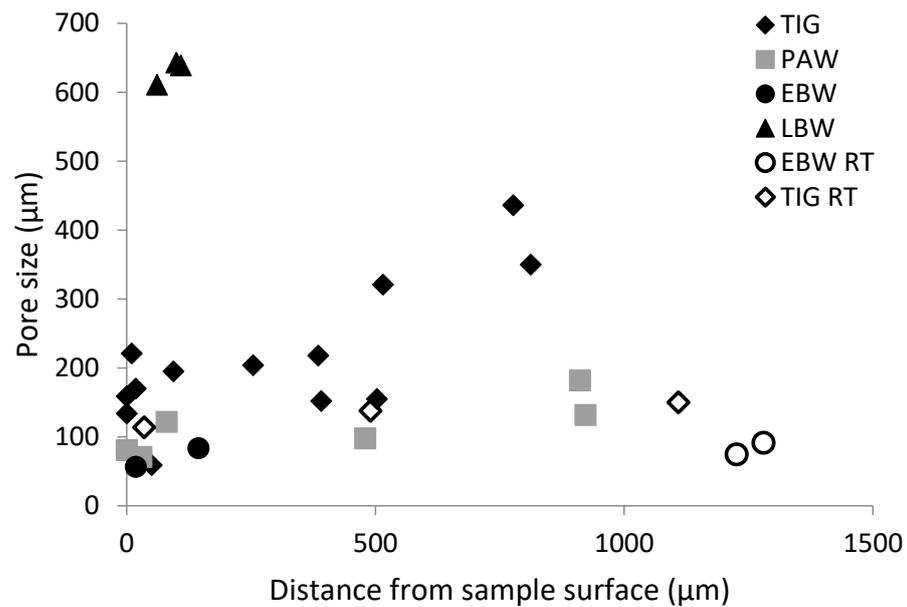
Figure 10. The sizes and location of pores initiating fatigue cracks.

In Figure 10, the size of pores which initiated a crack, as well as their distance to the sample surface, are shown. Approximately half of the pores that initiated cracks had a larger diameter than its respective distance to the surface.

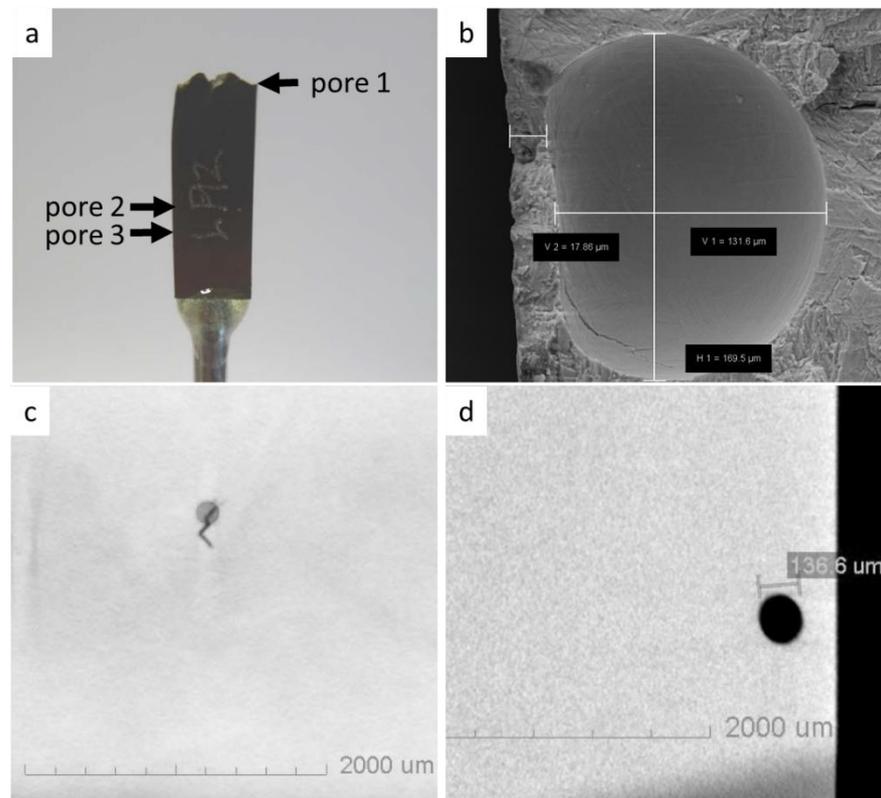
Figure 11. TIG welded LCF specimen investigated with XRM: (a) overview of the fractured LCF specimen; (b) SEM fractograph of pore 1, which initiated the fatigue crack that led to failure of the TIG welded LCF specimen; (c) XRM virtual slice of the surface-breaking pore 2, with a diameter of 136 μm , which initiated a 300–400 μm long microcrack; and (d) XRM virtual slice of pore 3 which did not initiate a crack.

X-ray microscopy scans were performed on 2 TIG and LBW LCF specimens (LCF Type 2). All the specimens were tested at a normalized stress range of 0.55. The results of the XRM scan of a TIG specimen that failed after 13,166 cycles are shown in Figure 11. Figure 11b shows a pore on the fracture surface, which initiated the crack leading to failure in the TIG welded sample. Figure 11c,d shows two 2D virtual slices from the XRM 3D scans of the same specimen. Pore 1, which caused the failure of the sample, was 169 µm in diameter. In the XRM scan in Figure 11c, a surface-breaking pore, pore 2, with a diameter of 136 µm was found, which initiated a crack of approximately 300–400 µm in length. A third pore, pore 3, with a diameter of 148 µm, was found located right below the fracture surface (Figure 11d). Pore 3 did not initiate a crack. The other TIG welded LCF specimen was discontinued after 820,000 cycles since no failure occurred. The XRM scan of this specimen revealed 2 pores with diameters of about 20 µm. No cracks were detected in this specimen.

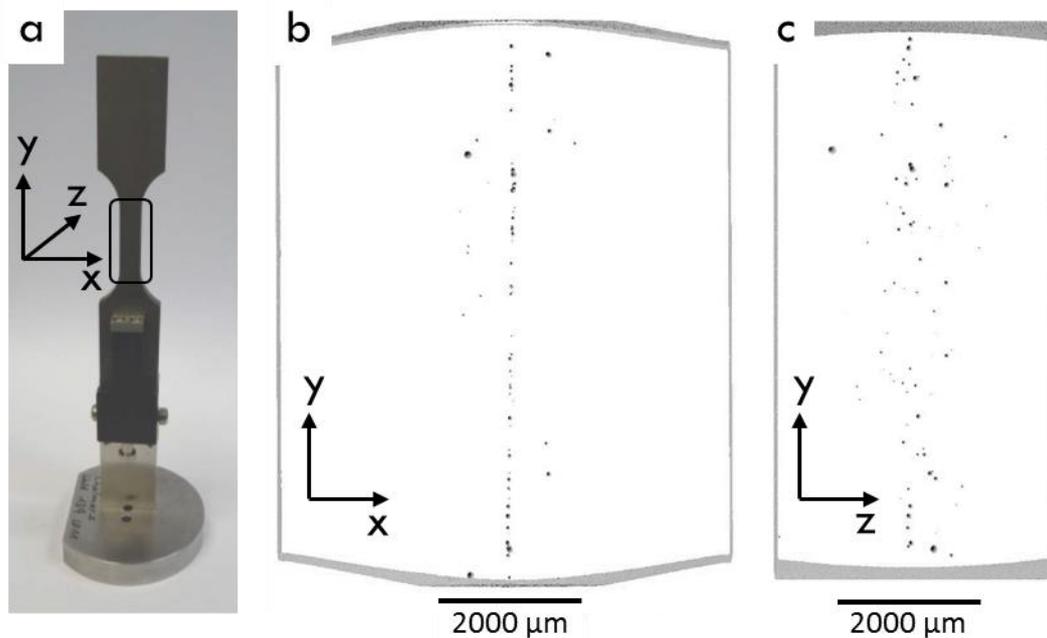
Figure 12. XRM 3D volume rendering showing distribution of porosity in a fatigue tested, but not fractured, LCF specimen produced by LBW: (a) overview of the LCF specimen, (b) view from top of the weld, x-y-plane, and (c) view from the side of the weld, y-z-plane.

In Figure 12, a 3D reconstruction from an XRM investigation of the LBW LCF specimens shown. The test was discontinued after 432,000 cycles with no failure. The XRM investigation showed that the LBW specimen contained continuous porosity along the centerline of the weld. In the z-direction of the sheet, the pores seemed to be more scattered but they were still mostly located close to the center of the weld. No porosity was observed close to the surface of the weld. The pore size along the centerline was normally less than 100 µm in diameter and the pores were mostly scattered. The largest pore detected in this sample was 113 µm in diameter. It was interesting to note that this number of pores and their distribution across the weld did not have any significant effect on the fatigue strength under the applied load conditions.
