## Construction of an Environmentally Sustainable Development on a Modified Coastal Sand Mined and Landfill Site – Part 1. Planning and Implementation

**Abstract:** The Magenta Shores development fronts 2.3 km of Tuggerah Beach on a formerly sand mined and landfill site in an urban growth area on the central coast of New South Wales. To increase the natural defences against storm waves and mass sand movements, the incipient foredune was retained and the parallel beach ridge landform was re-established by mimicking natural processes. Analysis of waste and resources led to a coordinated large-scale onsite re-use, recycling and waste management program that reduced landfill, transportation and natural resource requirements. Bitou bush removed from the Coastal Protection Zone was incorporated into golf course soils to improve grass growth. Leachate in the groundwater from the former landfill was diverted away from Tuggerah Lake and re-used in golf course irrigation. Upgrade of the local sewer treatment plant and installation of a public dual pipeline servicing Magenta and the adjoining township satisfied irrigation demands and provided non-potable water for the existing and expanding

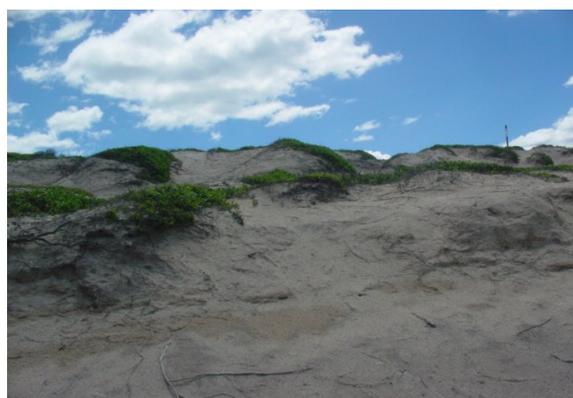
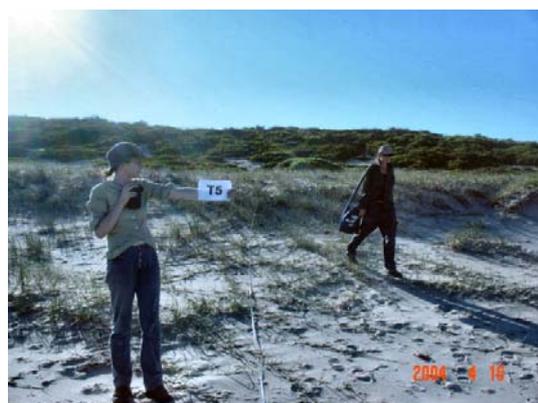
**Figure 4.** Difference in north and south related to vegetation composition in 2004.

Mined sand dominated by bitou bush (south)

Northern dune colonised by native vegetation

In 2004, thirty years post mining, the native vegetation was restricted to a narrow band of *Spinifex sericeus* (Spinifex) on the incipient foredune. This is consistent with Spinifex seed being deposited by springtides [16]. In the south, Bitou Bush dominated the foredunes (landward of the incipient foredune), resulting in a highly erodible steep landform. Towards the north, there was a greater native component, a more even gradient and a wider incipient foredune (Figure 4).

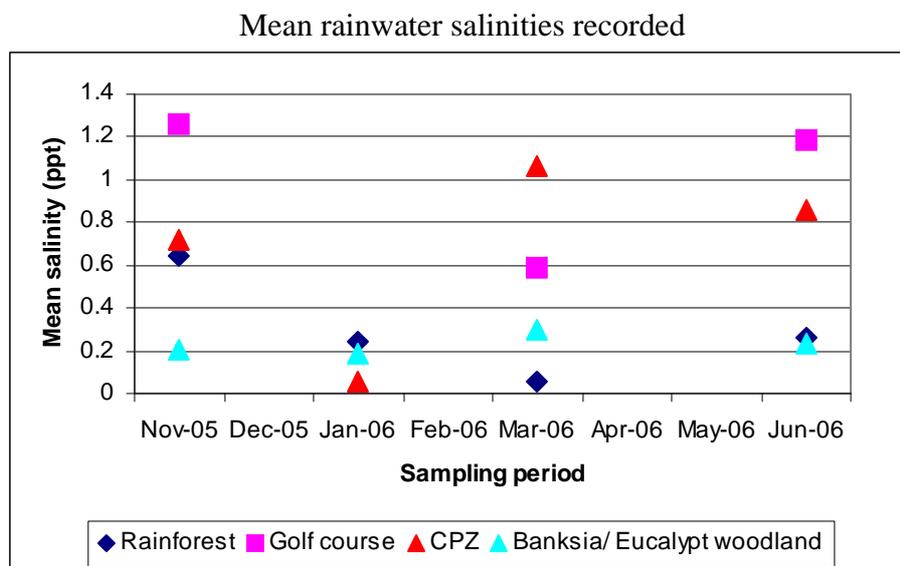
**Figure 5.** Rainfall during the sampling period and mean salinity of rainwater at monitoring locations.

Nov 2005	Dec 2005	Jan 2006	Feb 2006	Mar 2006	April 2006	May 2006	Jun 2006
Rainfall (mm)	77.2	49.4	72.4	35.0	69.6	45.8	109.8	224.6

The extent of rainfall had little impact on the rainwater salinity recorded (Figure 5). The highest salinity readings were recorded in the open areas of the CPZ and golf course, with rainwater salinity equivalent to about 3% of seawater salinity. Lower readings were recorded in the banksia woodland/eucalypt forest and littoral rainforest which are protected by the re-constructed landform (Figure 5).
