Article

Materials Challenges in Reconstruction of Historical Projects: A Case Study of the Old Riwaq Project

Basem Al Khatib, Yap Soon Poh and Ahmed El-Shafie *

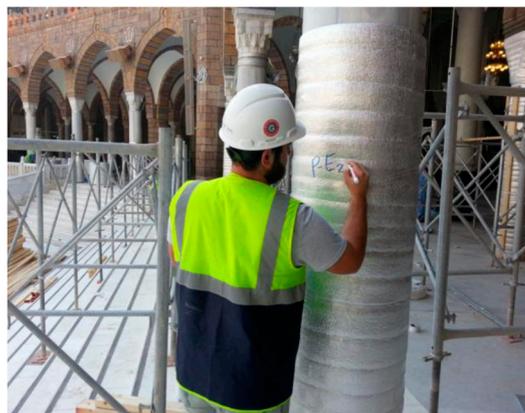
Figure 5. Numbering the column body.

The second challenge in this stage was the numbering of the historical elements, dismantling works, protecting, packaging and transportation them in special wooden boxes to the workshop areas. In fact, this is considered a very important step in order to maintain the sustainability and the style of the historical elements. Figures 4–8 show some of these works related to the historical columns which were divided into three parts for safety and sustainability purposes: the capital, the body and the base. These parts were numbered, dismantled, protected, and packaged.

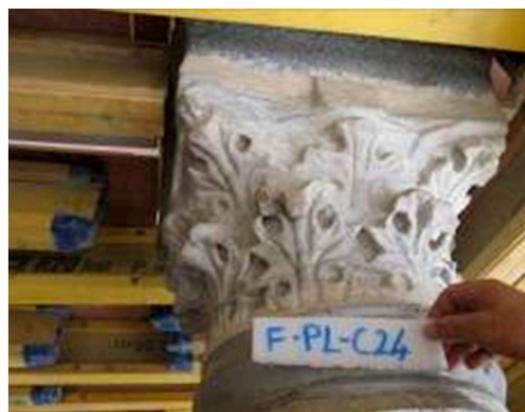
Figure 6. Numbering the column capital.

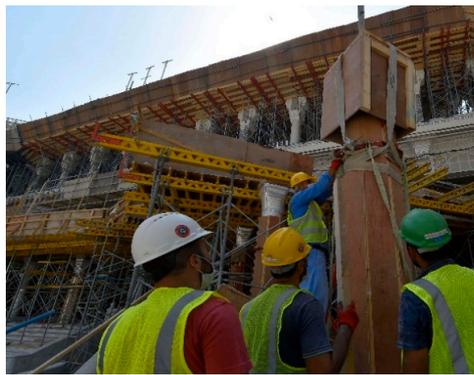
Figure 7. Protecting and packing the column.

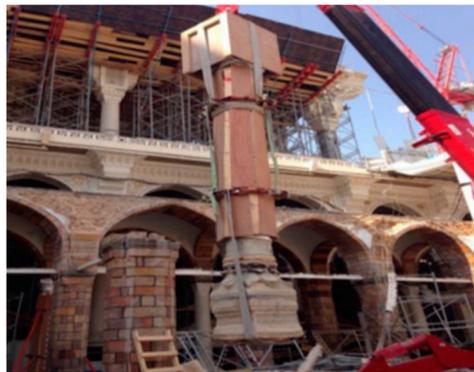
Figure 8. Column dismantling.

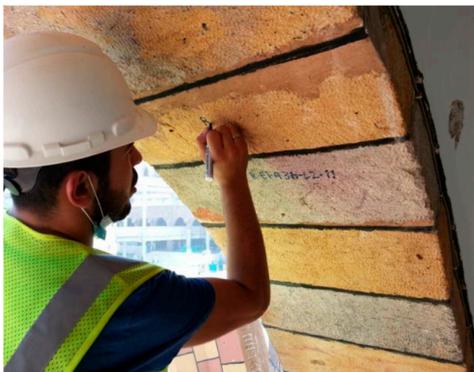
Figure 9. Numbering the historical stones.

Figures 9–12 show the numbering works for the historical stones, the dismantling works for the domes, the facade stones, and the dismantling works for the arches. All the historical stones were protected, packed and transported to the workshop areas. The experts mentioned that the previous works required special and manual dismantling tools. In spite of the availability of the skilled laborers, however these works required a long period that negatively affected the project duration.

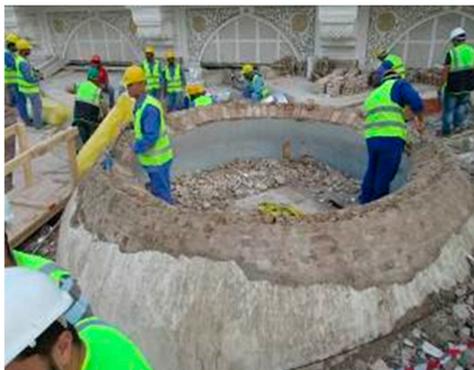
Figure 10. Domes dismantling.

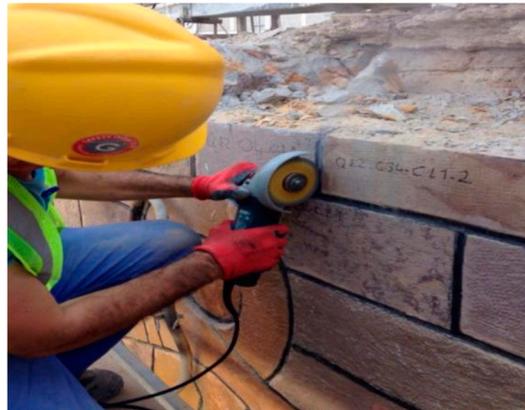
Figure 11. Facade stones dismantling.

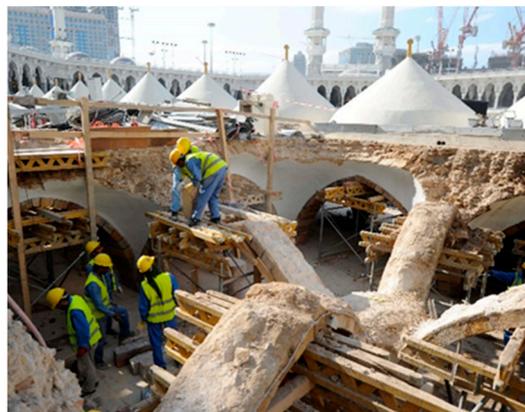
Figure 12. Arches stones dismantling.

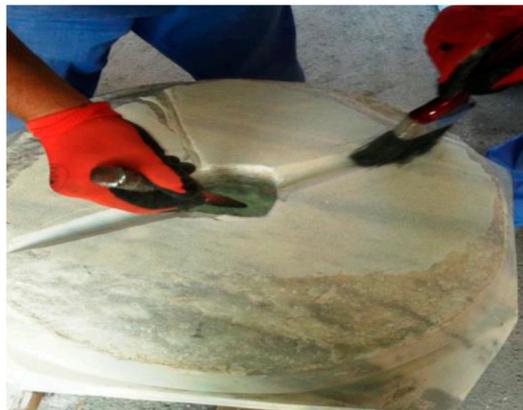
Figure 17. Surface cleaning of a column base.

The experts mentioned that the selected items were treated through a series of activities according to the item condition. The first activity was the cleaning works which divided into two steps. The step one was the surface cleaning by using soft brushes and small spatulas, while the step two was the deep cleaning by using the chemical materials in order to remove the grease and oil stains, as well as cleaning the joints and spaces as shown in Figures 17 and 18.

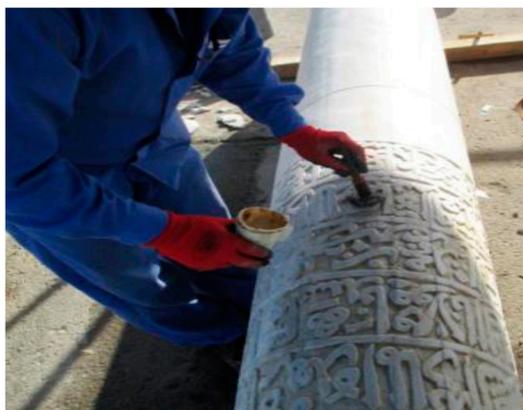
Figure 18. Deep cleaning of a column body.

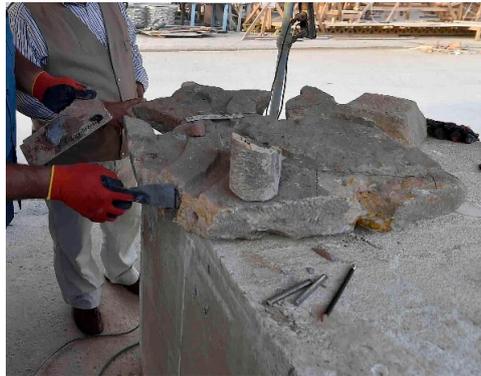
Figure 19. Chemical substances applied.

The final step in this stage was the restoration work, which depends on the amount of damage for each item. In fact, the restoration works were divided into two main types. The first type is related to surface damages and cracks. This type was restored by using special chemical substances that were mixed with a powder similar to the nature of the architectural item. The results were a mortar similar to the historical item with high sustainability used to restore the surface damages and the cracks. However, the second type of the restoration is related to the joining of two pieces or more of the historical item together by using chemical substances in addition to special steel anchors if necessary. Actually, sometimes the joining pieces could be from the same historical item, as shown in Figures 19–22.

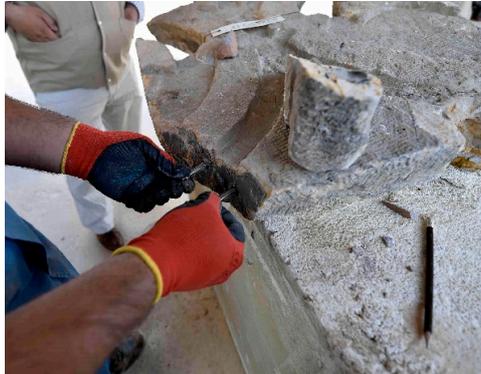
Figure 20. Steel anchors utilized.

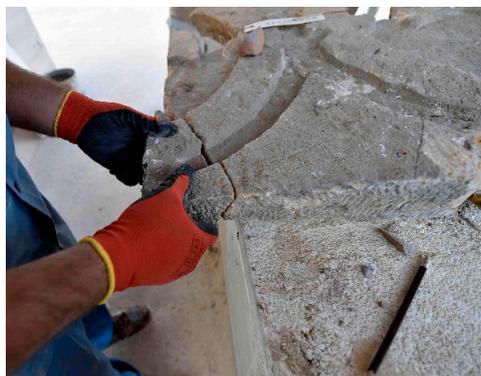
Figure 21. Stone pieces joined.

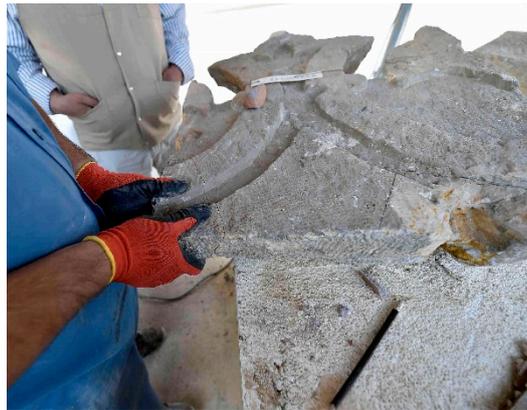
Figure 22. Stone shape after restoration.

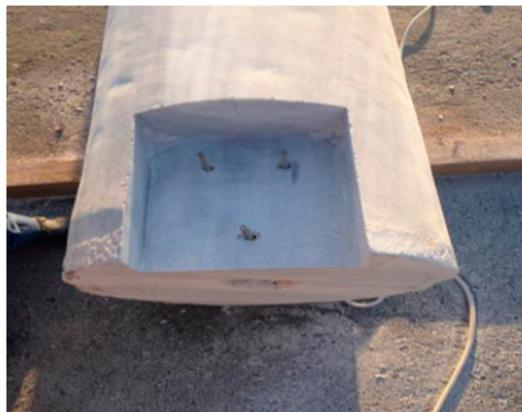
Figure 23. Chemical substances and anchors applied.

However, sometimes a new piece could be joined which possessed the same nature of the historical item, as shown in Figures 23 and 24.

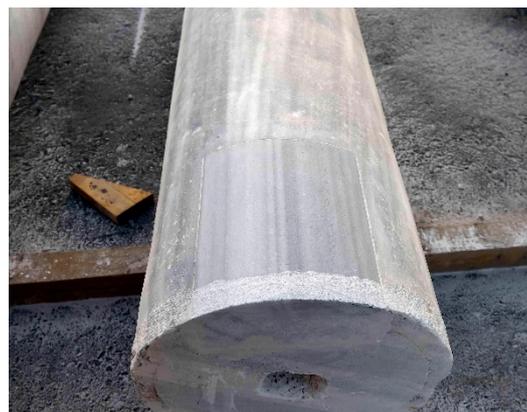
Figure 24. Marble column after restoration.

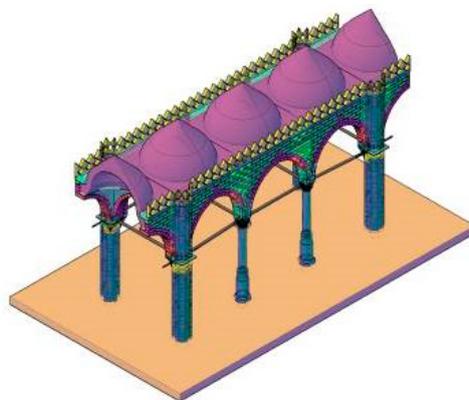
Figure 25. 3D module for the new design.

The new design approval from all the related parties before proceeding with the reconstruction works at site was subject to the building of a mockup showing all the details related to the structure, mechanical, plumbing and electrical design. In fact, the execution of the mockup was the final outcome of all the above-mentioned stages and challenges, as mentioned by the experts in the project, as it was the penultimate step preceding the reconstruction of the Old Riwaq at the project site. In addition, during the interviews many purposes for the mockup were mentioned such as: testing the best and fastest methods for the reconstruction works, especially the formwork systems and the required equipment; testing the design constructability and conflicts; showing the shape of the restoration elements after the installation works and the final integration form of the project; testing the sustainability and the safety requirement for the new reconstruction building; and to obtain approvals from the consultant and other entities in order to start the actual reconstruction works at site. Figures 25 and 26 show the three-dimensional module for the new design and the new historical building mockup.

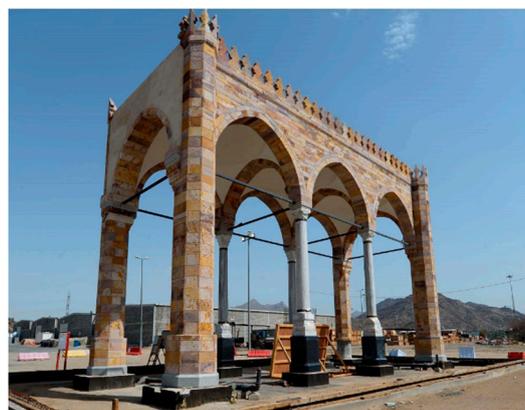
Figure 26. New historical building mockup.
