Article

Cob Construction in Italy: Some Lessons from the Past

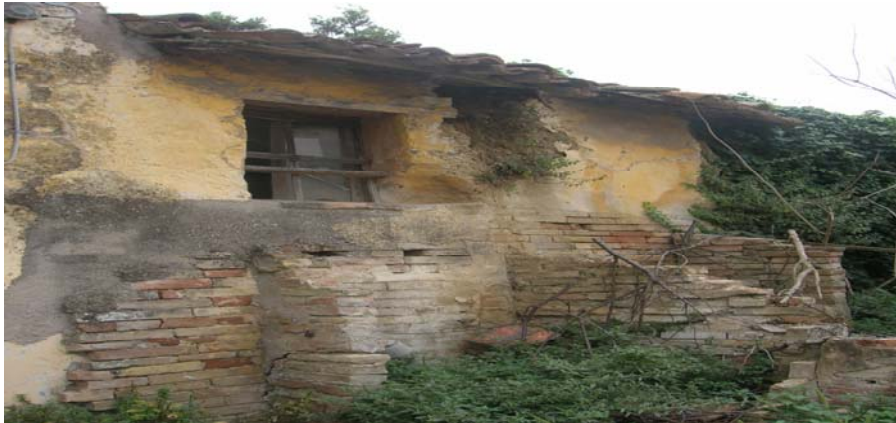
Figure 1. An example of a neglected raw-earth cob building in Macerata (Italy). The erosion by weathering due to the lack of the roof protection can be seen.

In any case, almost all the houses have been abandoned by their owners and have been particularly subjected to weathering since there are often no protective elements such as guttering left (Figure 1). There are many reasons why these houses were abandoned, but most commonly this is because the idea of poverty and marginalization has always been associated with this type of housing in this geographical area.

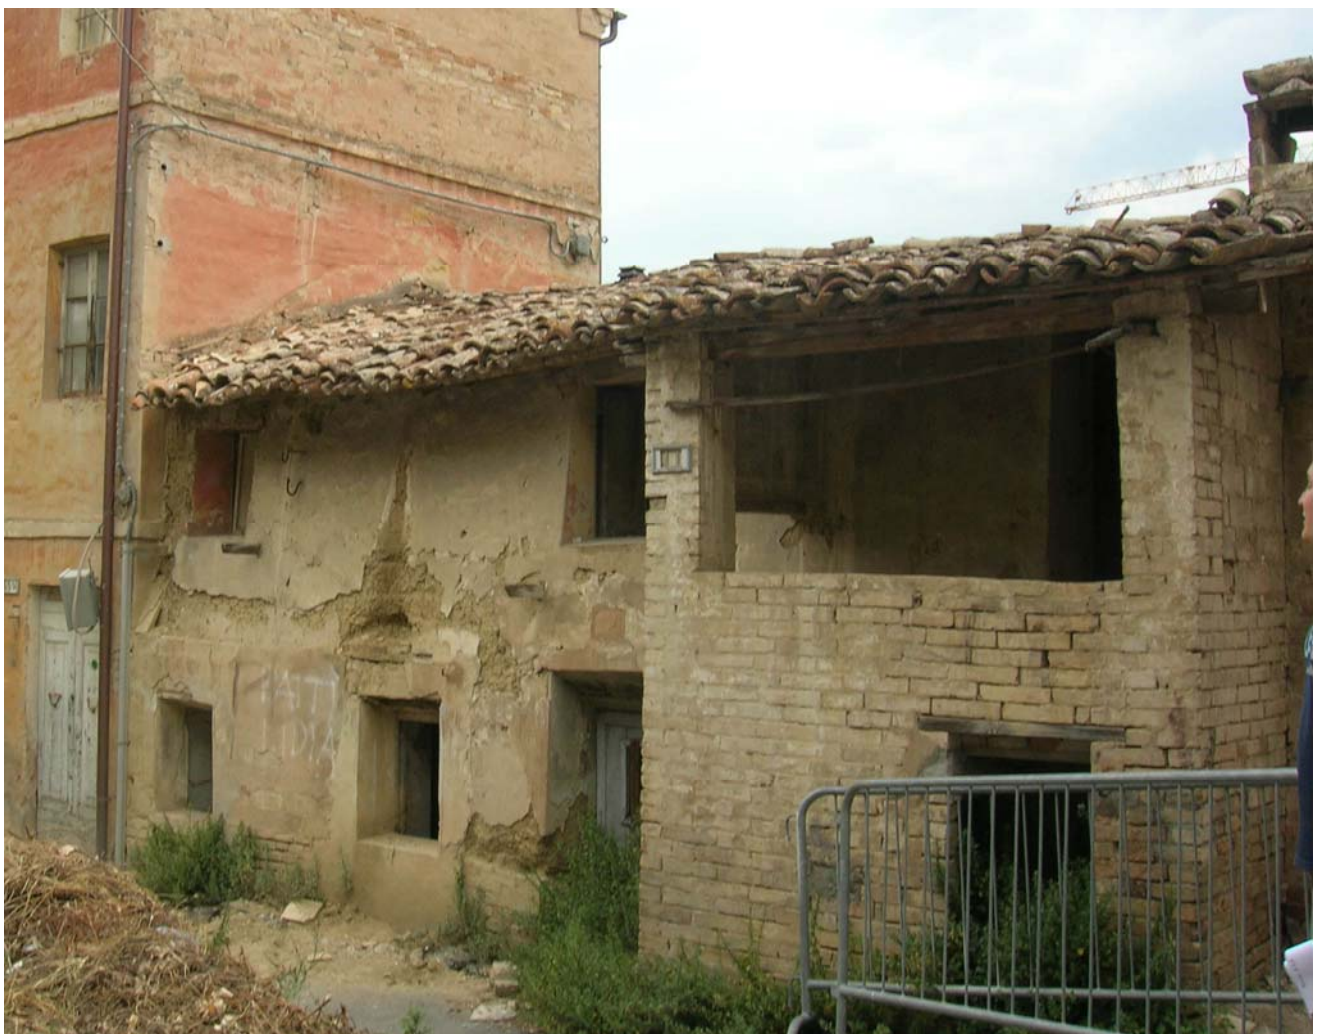
Figure 2. Typical raw-earth cob architecture at “Villa Ficana” in Macerata (Italy). An external masonry staircase is often present to connect the two levels of the house. A masonry support is also visible low on the left.

The common typology of these houses is two floors with a generally external masonry stair (Figure 2). The floor system is composed of a series of timber beams and joists covered with a layer of tile elements. The roof, covered by tile elements, is sloped, usually with the presence of a primary and secondary timber beams. The eaves have a length up to 0.40–0.50 m to protect the walls from rain.

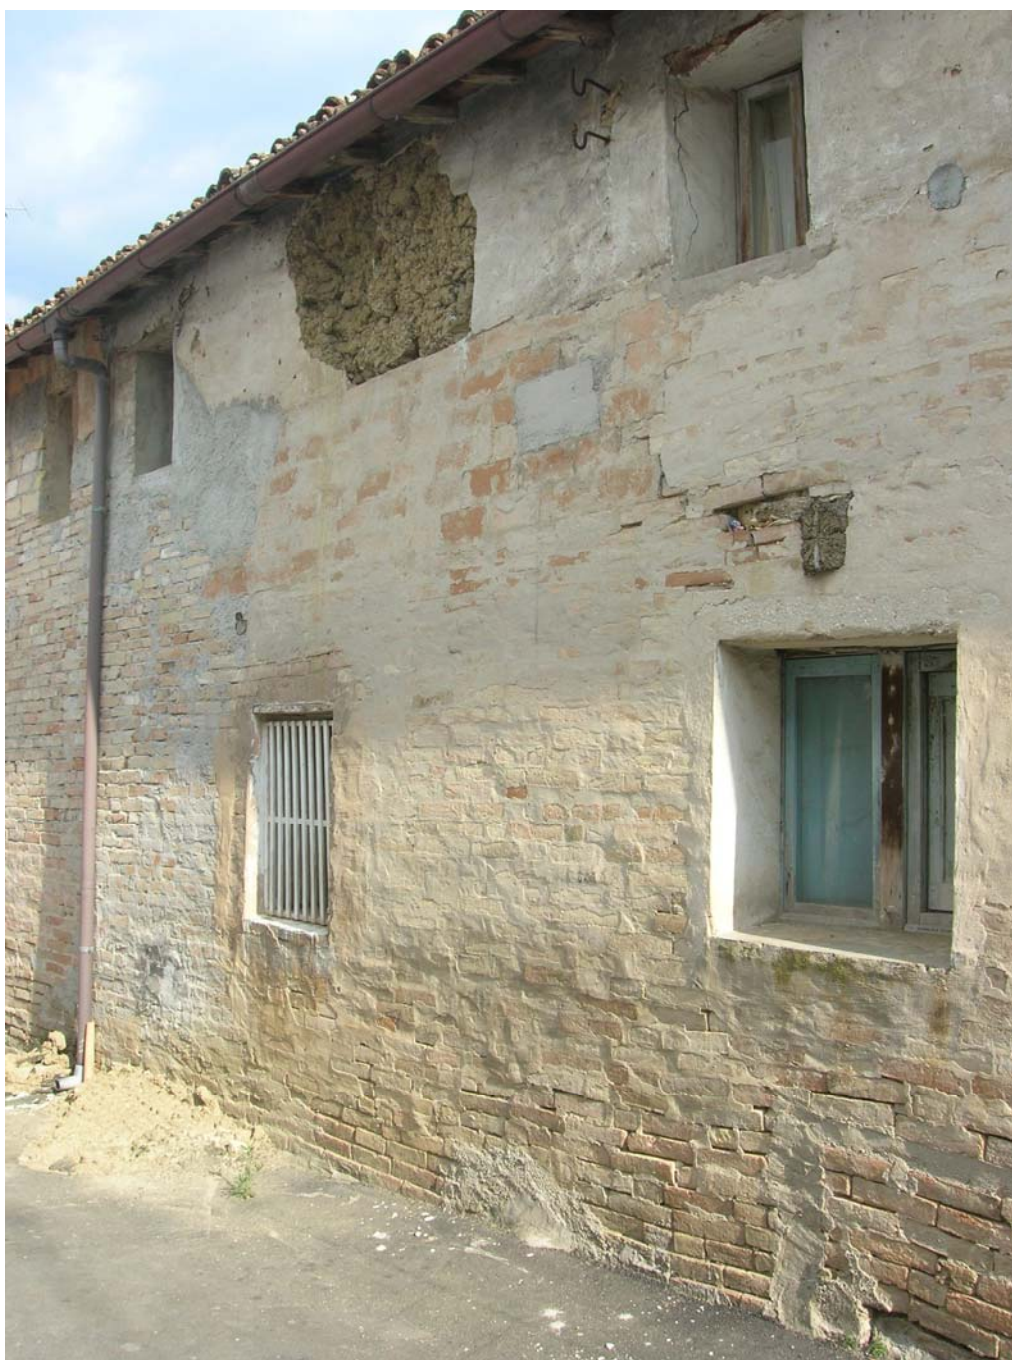
Figure 3. Raw-earth cob walls are often safeguarded by a thick earthen plaster or by a layer of fired bricks.

The thickness of the earthen walls is about 1–1.10 m on the ground floor and from 0.60 to 1.10 m on the first floor, and the windows are small in order to reduce heat dispersion and water infiltration. In some houses there are also walls made by fired bricks. Several earthen walls were built above a masonry base which has a height of about 0.40–0.50 m. This allowed the wall to resist excessive vulnerability with respect to ground surface erosion and water absorption. Earthen wall external surfaces are sometimes safeguarded by a 0.05–0.10 m earthen plaster or a common vertical brick layer (Figure 3).

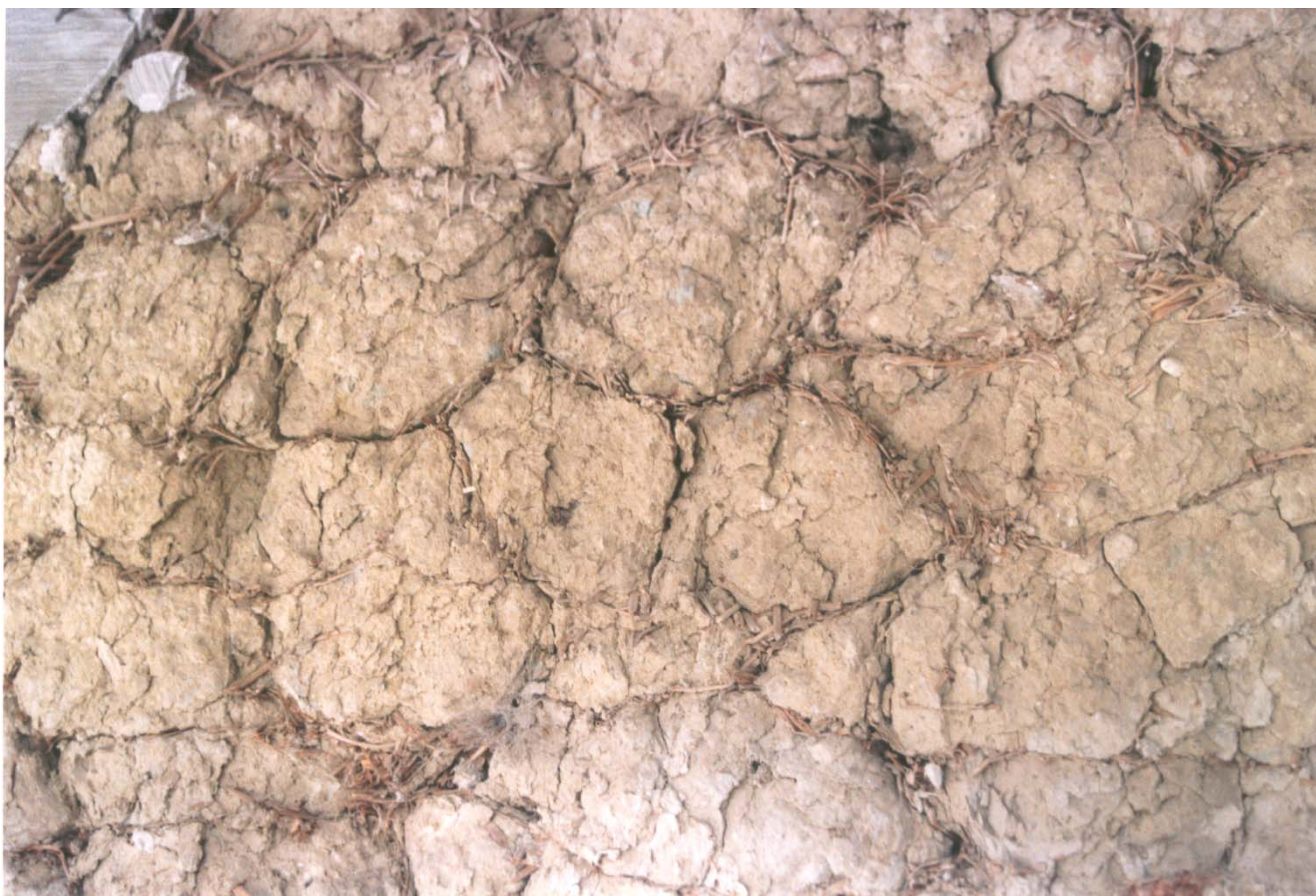
Figure 4. An external wall reveals the presence of cob bricks covered by straw.

Processing the acquired data during accurate surveys and subsequently by laboratory analysis carried out on these earth buildings, it was possible to identify—as first results—the technique used to construct the earthen walls. The technique is similar to the one commonly called “bauge” in France or “cob” in the United Kingdom. Large cylinder-shaped “bricks” (cob bricks) can be in fact easily recognized (Figure 4). They are more or less compressed due to the construction of the wall which bears its own weight. Each base element, or cob brick, is called “massone” in jargon by local inhabitants.

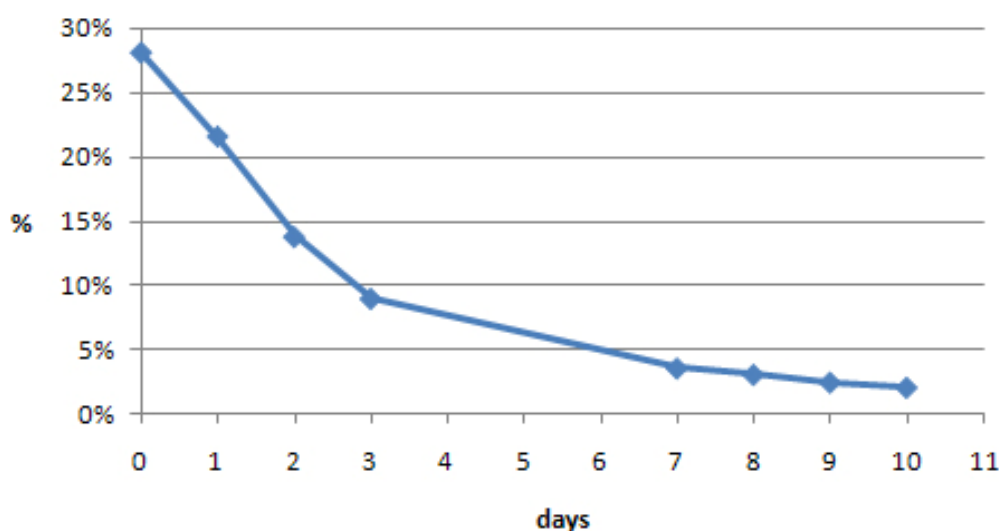
Figure 5. Typical drying curve for a cob brick at a temperature (T) = 30 °C and maximum relative humidity (RH) \approx 30%. % water content is shown over time.

An average water content of about 28% was found for each cob brick at the end. This is in total agreement with other previous studies [1]. Figure 5 reports a typical drying curve for a cob brick at a constant temperature (T) of 30 °C and a maximum relative humidity (RH) of 30%. It is worth noting that after about a day, each cob brick reached, on average, a water content lower than its plastic limit, and after about a week its water content was similar to those found on the earthen walls *in situ*. No samples cracked during the drying process.

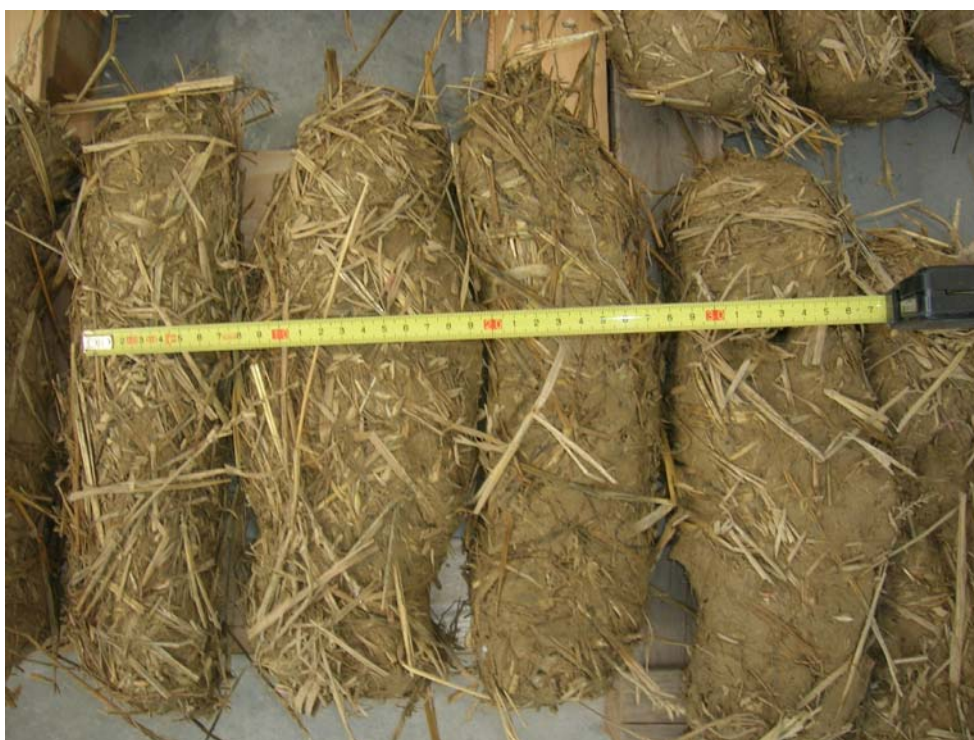
Figure 6. Some cob bricks made by yellow soil.

In this way, about 210 cob bricks were manufactured (Figure 6) and seven earthen walls were made.

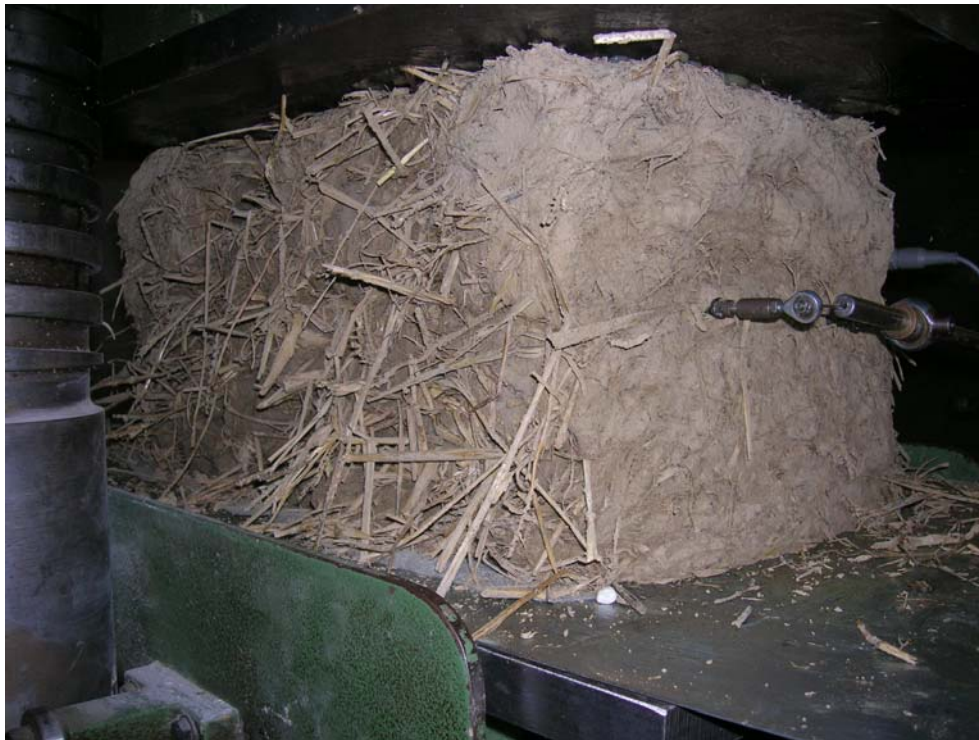
Figure 7. A raw-earth cob sample tested by uniaxial compression.

Compression tests were set to allow uniform distribution of stresses on specimens. For this purpose, each specimen was inserted between a lower and an upper steel plate sprinkled by fat in order to reduce friction. All the samples were tested along the direction they generally withstood loads. The apparatus used for the compression tests was a first class “Metrocom MI 300” with a 1% error and with an end scale of 3,000 kN. It had two transducers: one for pressure and one for vertical displacement.

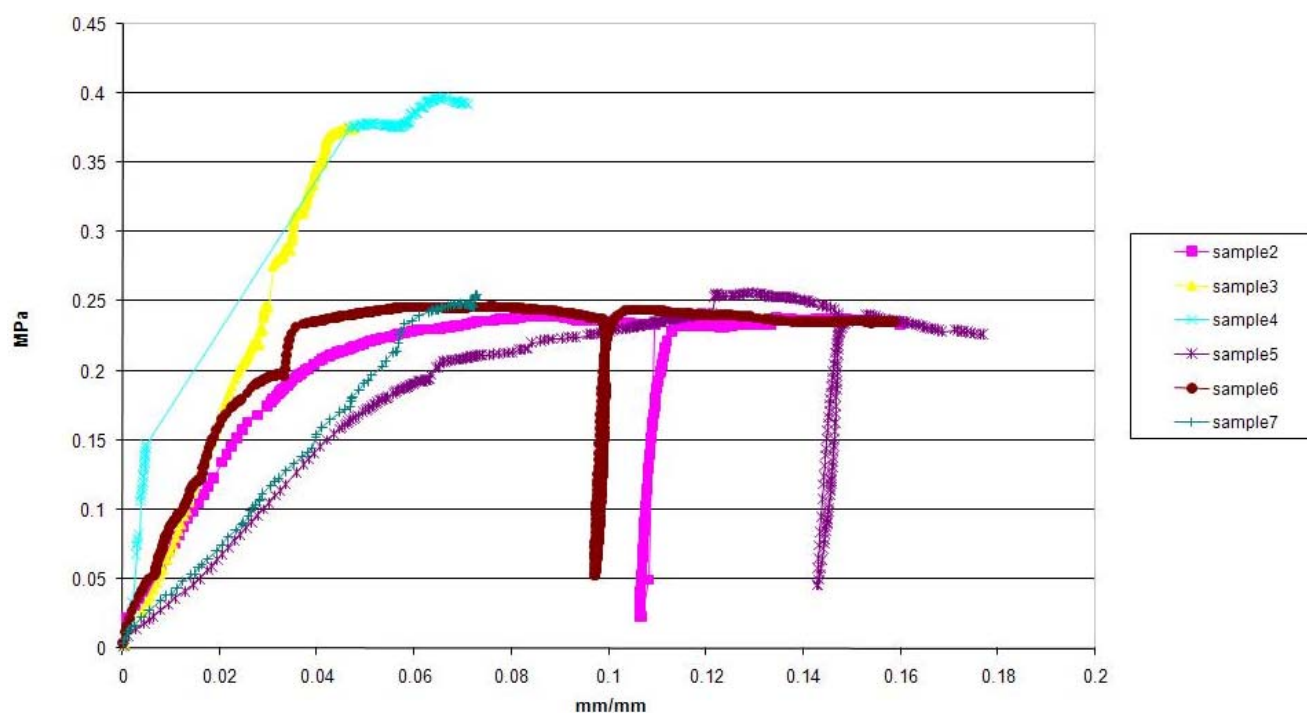
Figure 8. Compressive stress-strain relationship for all the tested samples. Samples 2, 5 and 6 were also unloaded after they had reached their σ_{\max} .

Stress-strain diagrams for the tested specimens are reported in Figure 8. The maximum compression stress (σ_{\max}) and its related strain ($\epsilon_{\sigma_{\max}}$), and the internal (ω_{int}) and external water content (ω_{ext}) for each tested wall are reported in Table 3. The internal water content was still high after one and a half months, while the external water content was a bit greater than that found on the original earthen walls. This is quite reasonable. In fact, as the cob bricks were still moist when used for making an earthen wall, the whole fresh earthen wall took time to dry, depending on the weather conditions and on the free evaporative area for each cob brick, which was reduced to the only external one. In this way, in order to reuse this building technique once again, it is important to assess the *initial* compressive strength, which will be surely lower than that after drying [4].

Looking at Figure 8, from the loaded and unloaded specimens it emerges that there is no significant differences in terms of when they reach their “plastic” plateau before and after the unload cycle. Moreover, when unloaded and then reloaded, all the three samples seem to show a rigid-plastic behavior. This confirms the old rule of art about the importance of forcefully pre-compressing each cob brick added on, layer after layer, when an earthen wall is built, so as to reduce deformations.

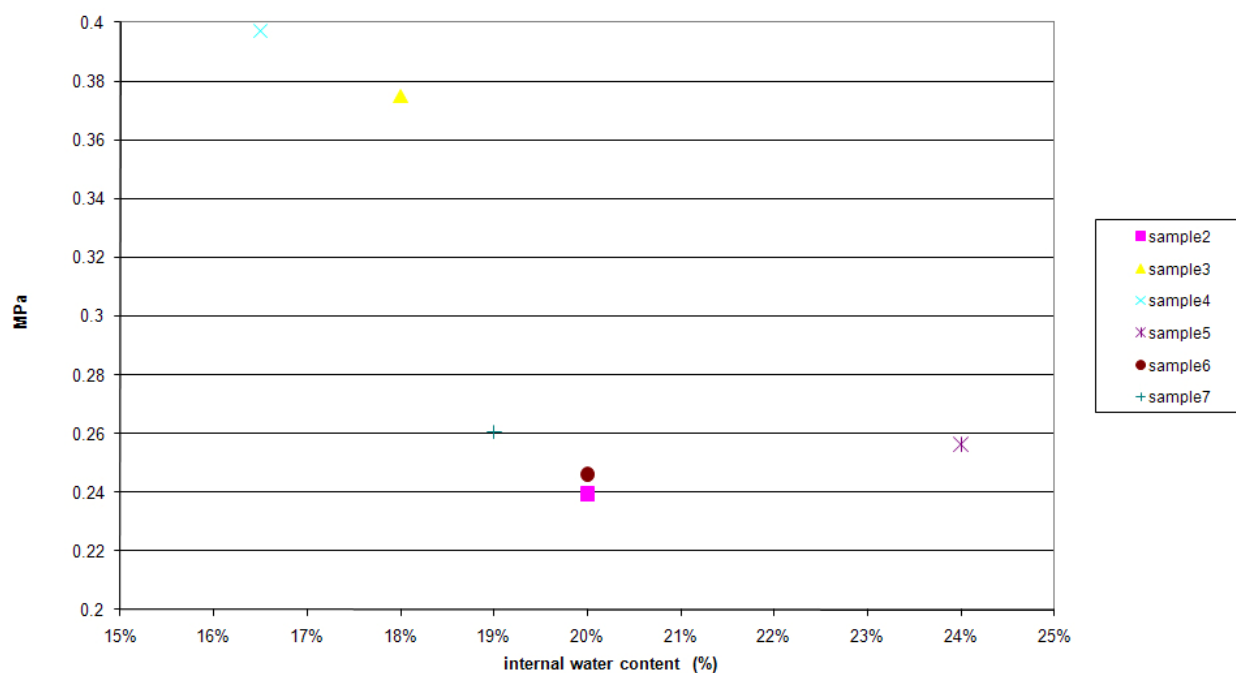
Figure 9. The dependence of the compressive strength on internal water content for each tested wall.

From Table 3, the *initial* compressive strength from all samples is 0.30 MPa. It is immediately possible to note that two walls show a higher maximum compression stress than the others. This can surely be explained by looking at Figure 9, where ω_{int} is related to σ_{\max} . An $\omega_{\text{int}} \approx 19\%$ seems to be a low limit below which compression strength rapidly increases. Thus, if we take apart wall 3 and 4, the *initial* compressive strength is 0.25 MPa. Instead, for wall 3 and 4 the *initial* compressive strength is 0.39 MPa, which is more than 50% the previous *initial* compressive strength. All these values are clearly much lower than those expected for common unstabilized raw-earth constructions (about 2 MPa), even if there are not so many and such detailed data for raw-earth cob constructions [24].

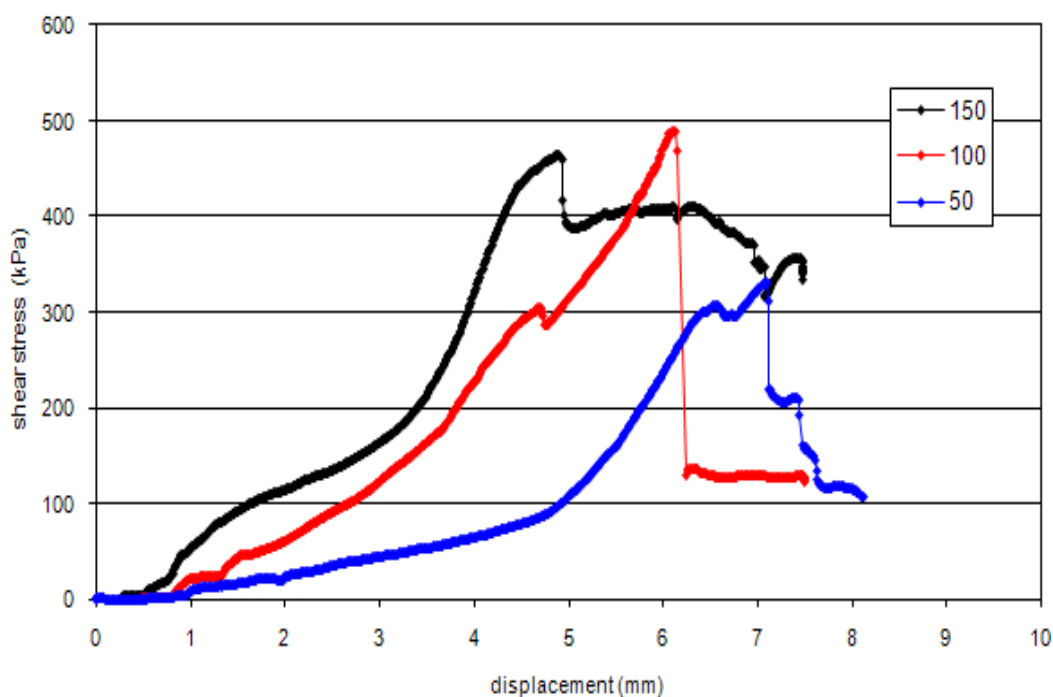
Figure 10. Shear stress-displacement relationship for DD-samples for a constant vertical compression of 50, 100 and 150 kPa.

Figures 10 and 11 show the relationships between applied shear stress and its related displacements for DD-samples and WD-samples at different constant compression stresses.

For DD-samples, the contact adjustment phase corresponded to the start of loading (≈ 1 mm). This lag probably depended on the non-perfect contact of the soil specimens with the internal metal faces of the Casagrande box due to its shrinkage by seasoning. Anyway, after this phase, the shear strength reached sharp peaks that seemed to be not influenced too much by friction (that is, cohesion played the most important role), reaching high values between 0.3–0.5 MPa; values that are similar to those found for common unstabilized raw-earth constructions (about 0.5 MPa) even if not explicitly for cob constructions [24].

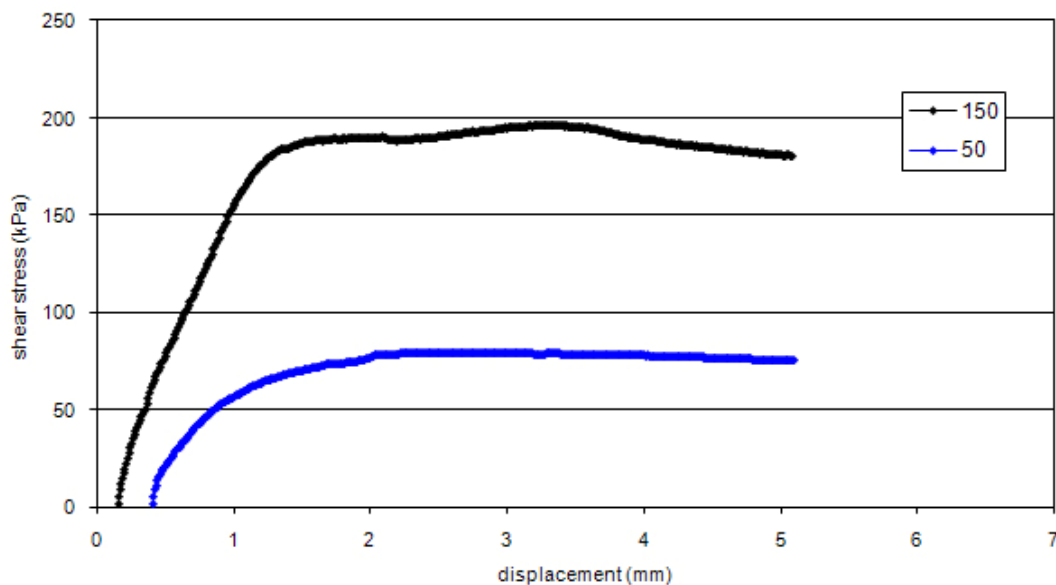
Figure 11. Shear stress-displacement relationship for WD-samples for a constant vertical compression of 50 and 150 kPa.

WD-specimens instead showed a smoother and lower shear strength, as expected, which was, however, high (0.07–0.20 MPa) if we consider that a half-specimen is wet. In this way, it can be reasonable to suppose that these values could be increased when straw is present and above all when the moistened cob bricks will start to dry.

In this case, friction played the most important role, thus the *initial* shear strength seemed to be roughly proportional to the applied vertical compression stress, with a friction coefficient $\mu > 1$. This closely corresponds to the *initial* shear strength that could be activated along a discontinuity between a dried existing earthen cob wall and the newly added moistened cob bricks, e.g., when a crack is repaired or an existing part of a cob earthen wall is super-elevated. In this last case, for example, if we consider a compression vertical stress of 0.05 MPa, which corresponds to about a single-storey earthen wall height of 2.5 m, along this discontinuity the *initial* shear strength will be about 0.07 MPa, thus a sliding collapse due to, for example, an earthquake, is avoided before it rocks as a monolithic wall [20].
