Article

Nondestructive Evaluation of Historic Hakka Rammed Earth Structures

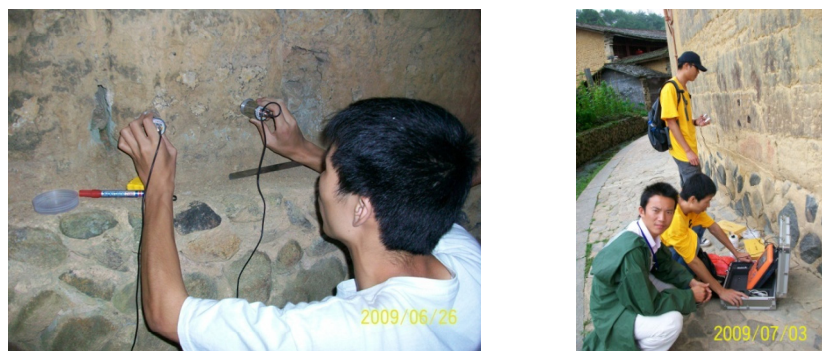
Figure 5. Ultrasonic testing heads and device.

The model NM-4B ultrasonic device that was used in the study was developed and manufactured by Beijing Zhongkelujian Instrument & Equipment Co., Ltd. This portable device can dynamically in real-time display the wave with automatic scaling of frequency and amplitude at high sensitivity. This device is designed to detect the strength or cracking depth of concrete or its uniformity or defects.

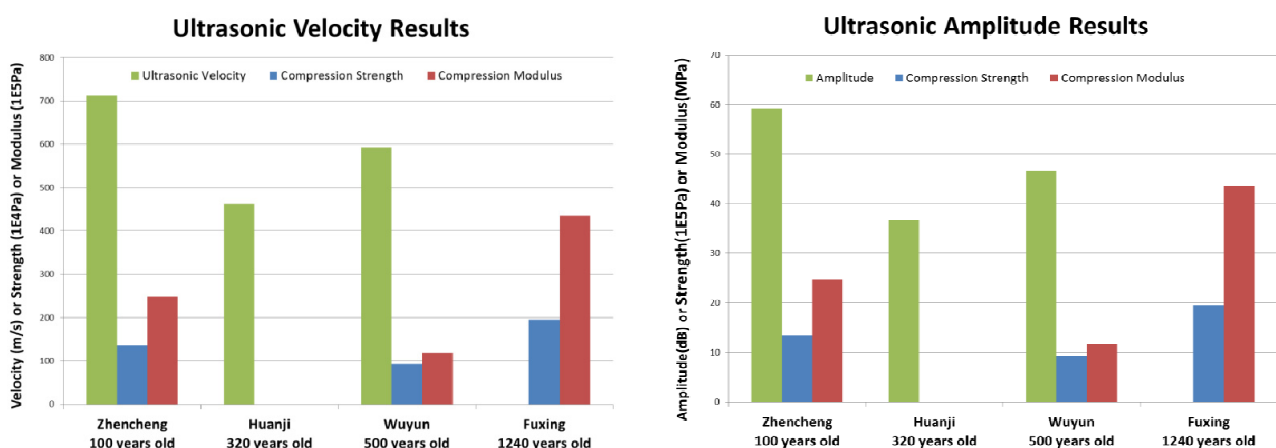
Figure 6. Ultrasonic testing results.

were conducted on the wet walls caused by rainy weather. Figure 6 shows both the ultrasonic velocity and amplitude results for the buildings tested. Note that each data point represents an average of 25 to 30 measurements. Both charts show a consistent trend. As can be seen in Figure 6, apparently, there is no direct correlation between the ages of the Tulou structures and the velocity/amplitude (the strength of the rammed earth walls) of the ultrasonic wave. Other than the age, there are many more parameters in the wall system varying from one building to another, including different earth constituents, with or without wall ribs and varying construction quality.

Even though there are limited ultrasonic data, a useful discussion can be made with reference to the compression properties of the rammed earth wall samples that were generated in the laboratory [8]. The compression strength and modulus data available for the buildings studied are also listed in Figure 6. Ultrasonic testing indicates that the Zhencheng earth wall is stronger than that of Wuyun. This observation agrees with the compression testing results. The ultrasonic result also shows that the Wuyun earth wall is stronger than that of Huanji. Unfortunately, the Huanji Tulou earth sample was too brittle and the researchers were not able to prepare any specimens of a regular shape. Thus, the Huanji Tulou earth sample would have the lowest strength among the buildings studied. The Fuxing Tulou earth sample has the highest compression strength and modulus, even though it was built 1,200 years ago. This is because its earth wall was made of a mix known as “sahetu” that contains a significant amount of lime [7]. Therefore, the limited ultrasonic testing results do appear to agree with the mechanical properties of the earth wall samples.

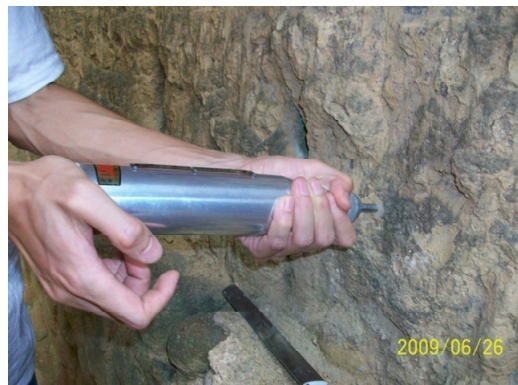
Figure 7. Rebound hammer being used to test the rammed earth wall.

As per ASTM C805, a rebound hammer works as follows: a steel hammer impacts, with a predetermined amount of energy, a steel plunger in contact with the surface of concrete, and the distance that the hammer rebounds is measured. This is shown in Figure 7 for the rammed earth wall instead of concrete. Note that the rebound hammer is not designated for a rammed earth wall, but it might offer a method to quantitatively evaluate the strength of Tulou earth walls. During the field study, two types of rebound hammer models, HT-75 and HT-20, were used, and both were manufactured by Tianjin Building Instrument & Testing Machine Company. The model HT-75 applies an impact energy of 0.075 kgf.m and is designated for red brick applications, while the model HT-20 applies an impact energy of 0.020kgf.m for mortar applications. Figure 8 shows the results of the rebound hammer tests using both HT-75 and HT-20. Each data point represents an average of 32 to 64 rebound hammer measurement readings. Again, all the measurements on the Fuxing building were conducted on wet walls because of rainy weather during the field study, and so the values were not representative.

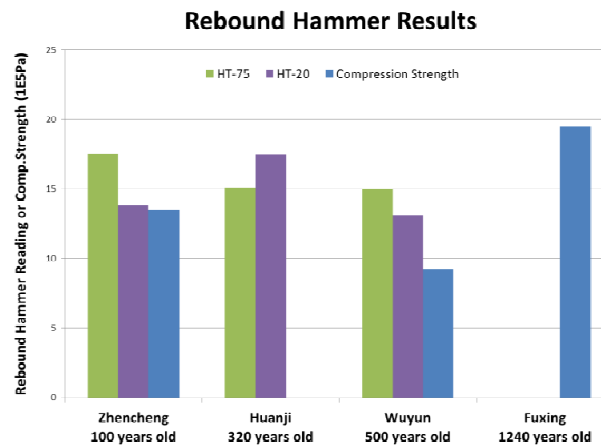
Figure 8. Rebound hammer results.

Similar to the ultrasonic data, the discussion on the rebound number can be drawn with reference to the strength data of the rammed earth wall samples reported in the paper by Liang *et al* [8]. As shown in Figure 8, apparently, the HT-75 brick rebound hammer readings correlated to the compression strength data of the earth walls better than the HT-20 mortar rebound hammer readings. It is interesting to note that the Wuyun and Huanji earth walls have had similar HT-75 hammer readings, and the HT-20 mortar rebound hammer average reading of the Huanji building earth wall was much higher than those of the Zhencheng and Wuyun buildings.

In this study, an ultrasonic device and rebound hammer were used with the intention of preliminarily comparing the strengths of the rammed earth walls of the different Tulou buildings tested. However, a calibration chart of the ultrasonic device/rebound hammer for the rammed earth wall should be developed in order to derive the earth wall strength values from such tests. Currently, a comparison of NDE data with experimentally determined strength data of the rammed earth walls would provide some trends for further use of such NDE techniques. The results indicate that ultrasonic testing appears to reflect the strength of the earth wall better than the rebound hammer. The nature of

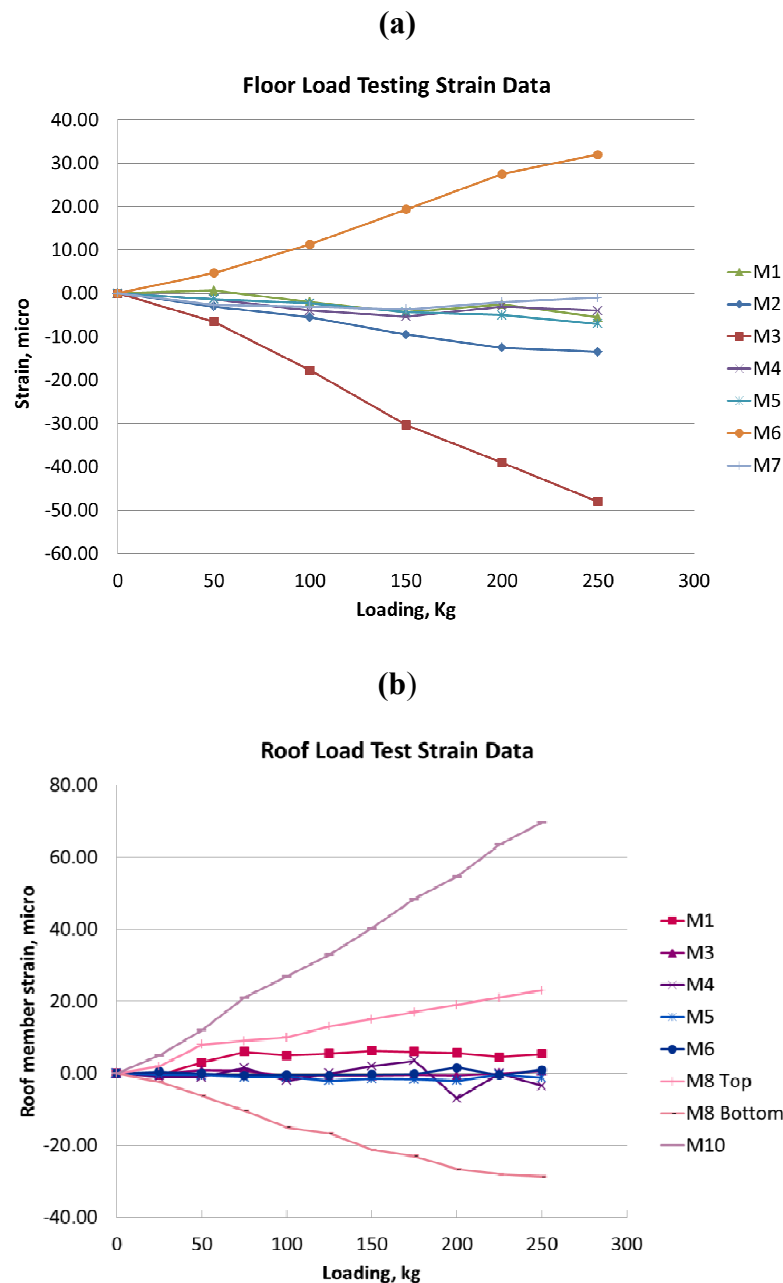
Figure 11. Strain data from load testing, (a) floor system member strain data and (b) roof truss member strain data.

The strain data generated from the floor testing are graphically shown in Figure 11a, in terms of the strain gage locations and corresponding structural members, as defined in Figure 10. The strain was recorded as a function of loadings for each member. Each strain value at a given loading was an average of three measurements from three separate runs. The load applying member M6 (gage #4) behaved as expected and gave a strain of 32 microstrains (parts per million) under maximal loading of 250 kg. All other members had small strain values, except the vertical member M3 (gage #5) that had unusually much higher values and gave a strain of 48 microstrains under 250 kg.

The strain data generated from the roof truss structure testing are graphically shown in Figure 11b, as per the strain gage locations and corresponding structural members defined in Figure 12. Similarly, the strain value was recorded as a function of loadings for each member mounted with a strain gage. Each strain value at a given loading was an average of three measurements from three separate runs, except that Member M4 (gage #8) had only two sets of data to average, while the third set of data were mostly positive, resulting in an uncertain trend for Member M4. Such uncertain trend may be attributed to potential disturbance during testing or imperfect connection of wires to the strain gage. Note that the strain gages used were all 50 mm long gages to maximize the ability of detecting any small strains. All other members, except M4, behaved as expected. The load applying member M10 (gage #4) resulted

in 70 microstrains under a maximal loading of 250 kg. For M8, the bottom side was subjected to compression (negative strain), and the strain values were closely matching those of the top tension side.
