## Article

# Assessing Ecotourism Potential of Traditional Wooden Architecture in Rural Areas: The Case of Papart Valley

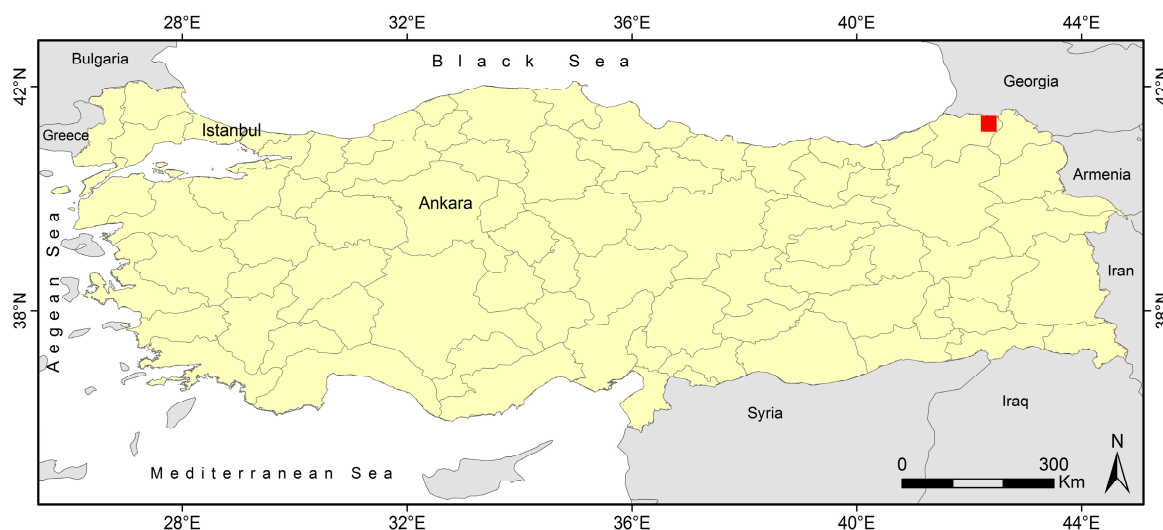
**Figure 1.** The study area, Papart Valley.

Papart Valley, dealt with in this study, is located in the Şavşat district of Artvin, in the northeast corner of Turkey which borders Georgia. Giving the valley its name, Papart Creek originates in Büyükmera Mountain on the Georgia border and flows northwest from the southeast from Hasta to the Sarıçayır Mountains. In the southern shadow of Mount Büyükmera is Camili region, which was declared to be a biosphere reserve in 2005 by The United Nations Education, Scientific, and Cultural Organization (UNESCO). The eastern slope of Mount Büyükmera, which faces Papart Valley, is covered in Papart Forests, which were declared as a seed stand area by the Ministry of Forestry and Water Affairs. Neighbourhoods and villages located in Papart Valley cluster along the Papart Stream. On the ridges of the surrounding mountains are hamlets and uplands managed by the villagers. The north slope of the Sarıçay Mountains lies in Georgia (Figure 1).

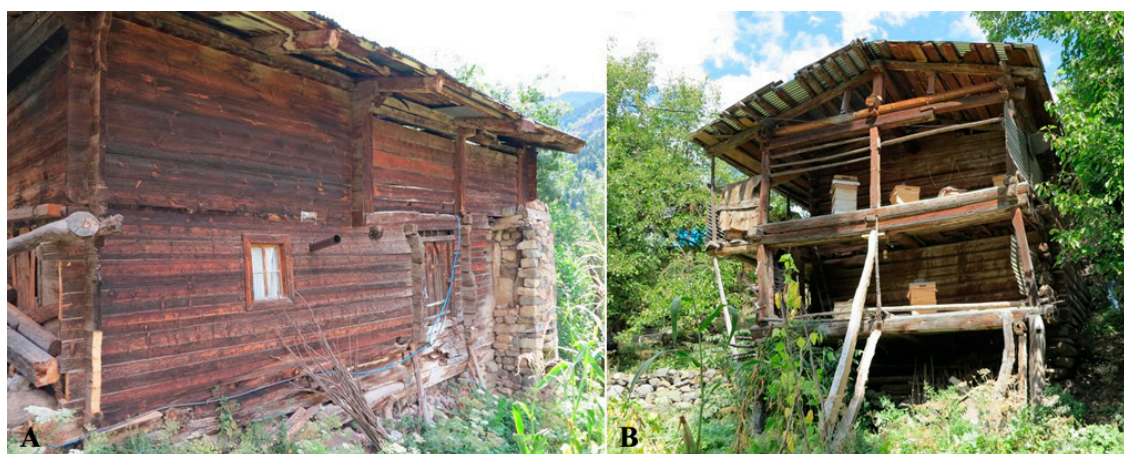
**Figure 2.** The traditional wooden house (A) and the hayloft (B), which were selected for damage investigation and dendrochronological dating.

To evaluate the material damage of the selected house and hayloft in the region (Figure 2), a visual (macroscopic) inspection method was used. This involves making simple interventions using a hammer and a pointed opener to inspect for damage to the wood surface and interior. Rotten parts caused by fungal activity, and possible sources for moisture (i.e., roof, floor, and plumbing condition) were investigated. Flight holes, tunnels resulted from wear, and sawdust-like frass were sought in order to determine the presenece of pest damage. Finally, whether the identified pest activity was presently occurring was determined. In addition to those macroscopic evaluations; microscopic examinations for destruction were carried out using the samples taken for dendrochronological analysis.

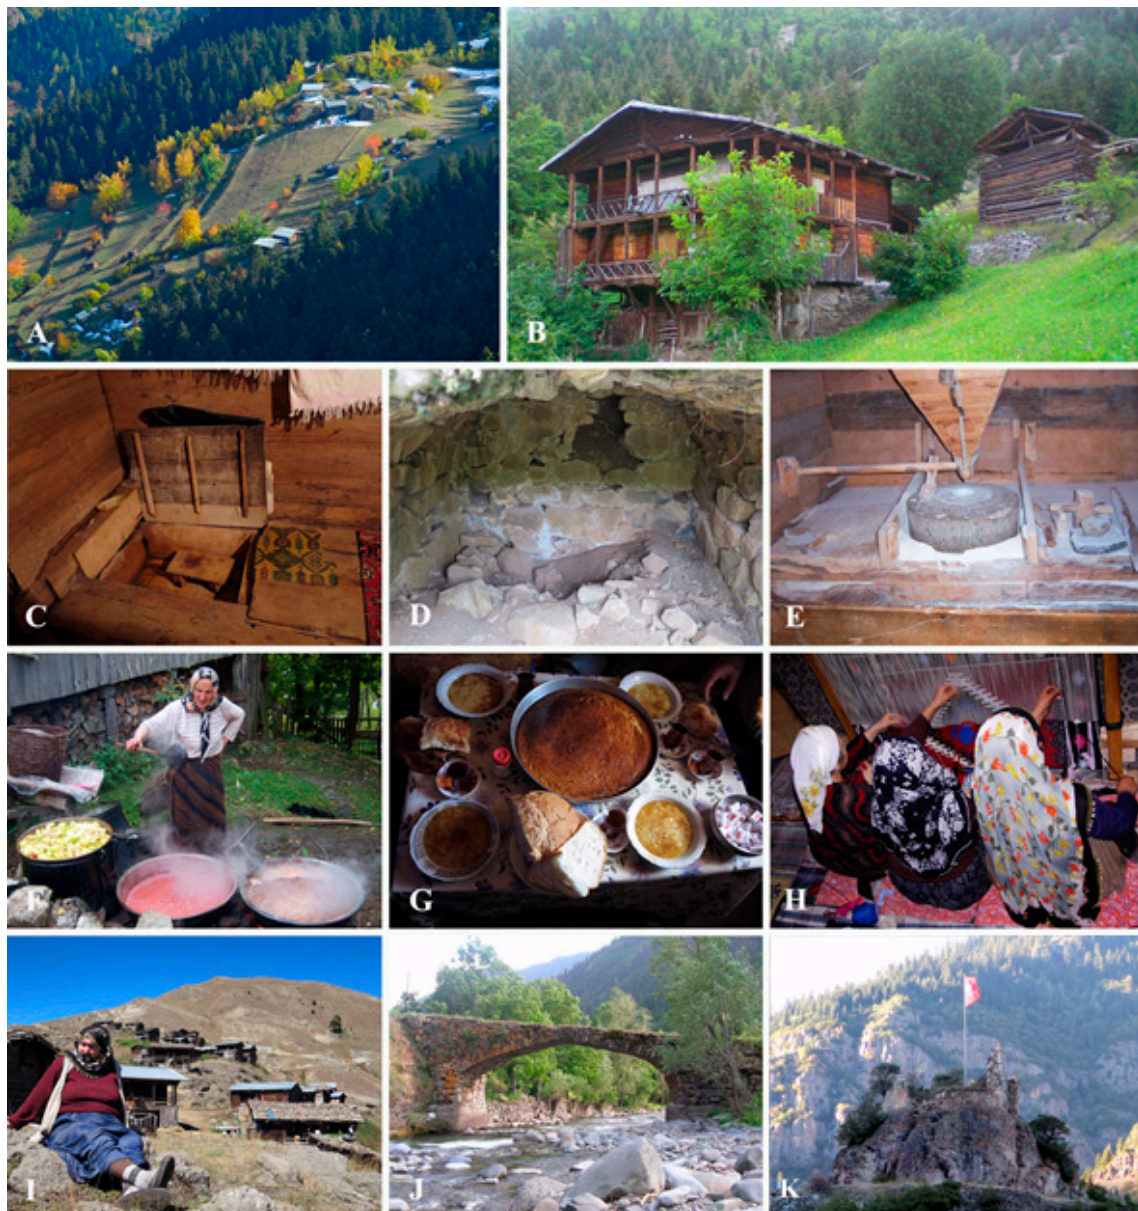
**Figure 3.** The samples of natural and cultural resource values of Papart Valley. General view (A); A traditional wooden house (B); A wooden bath hidden in the floor (C); Daran (D); A wooden mill (E); Local foods (F,G); Handicrafts (H); Plateau homes and transhumance (I); Taş bridge (J); Parih Castle (K).

Resource Values	Explanations
Flora	Principal tree species in the forest are fir (80%) and spruce (15%) (Figure 3A). Additionally, beech, hornbeam, birch, aspen, wild cherry and cranberry partly are present. Wild strawberry, blackberry, arbutus, bearberry, raspberry, thyme, blueberries and a few rhododendrons are seen.
Fauna	The region is important in terms of its population of Wild Goat ( <i>Capra aegagrus</i> ), Hook-Horned Mountain Goat ( <i>Rupicapra rupicapra</i> ), Brown Bear ( <i>Ursus arctus</i> ), Caspian Snowcock ( <i>Tetraogallus caspius</i> ), and Grouse ( <i>Tetrao mlkosiewicz</i> ). In addition, there are lynxes ( <i>Lynx lynx</i> ). Streams here host a notable brown trout population [40].
Panoramic points	Views of settlements and wild terrain can be enjoyed from the points such as Vela Hill, Autket Ridge of Erikli Plateau, Hasta Ridge (above the Satave Festival Site); Sakart Straight, and Kayabaşı Position.

Resource Values	Explanations
Traditional wooden structures	In the region there are lots of wooden structures built with traditional construction techniques, such as houses (Figure 3B,C), haylofts, mills (Figure 3E), plateau homes (Figure 3I) and winter homes. Traditional homes are located adjacent to gardens of medium and large size. Residential gardens are areas where daily activities are performed.
Historical structures	Among the well-preserved ruins in the region are Parih Castle (Figure 3K), Taş Bridge (Figure 3J), and Balıklı Mosque. Again, there are old commercial buildings in the village squares, named “Camikapı”. Taş Bridge and Karaca Bridge are among the ones that survived until today. In the region, there are man-made stone caves, called “Daran” (Figure 3D).
Handicrafts	Activities such as weaving (Figure 3H), carpentry, wood craftsmanship (Figure 3C), etc., continue to be practiced.

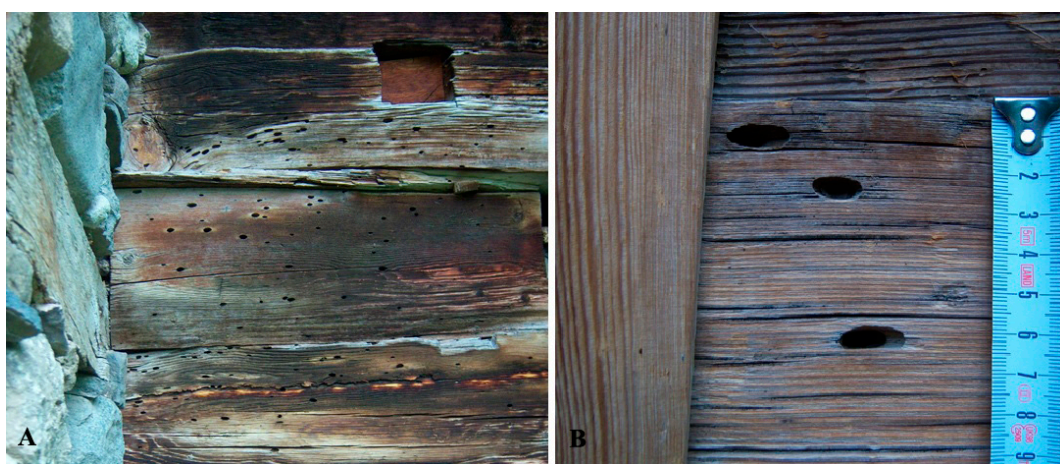
**Figure 4.** The flight holes which are formed by old-house borer (*Hylotrupes bajulus*). General view (A) and closer photo of flight holes (B).

It was determined that the most significant destruction to the wooden house and hayloft examined was caused by old-house borer (*Hylotrupes bajulus*) and that insect activity was not effective. In the fir and spruce, wooden building elements that were inspected showed oval flight holes of  $5 \times 9$  mm in diameter, and frass powders falling out (Figure 4). It was observed that the tunnels under the solid wood layer are tightly stuffed with a powdery substance. It was determined that almost all of the tunnels were connected with one another to damage the whole sapwood, and that their cross-sections were ovals of 6–10 mm. It was determined that frass powders were cream-coloured, coarse-textured, and also that the pellets were 1 mm long, cylinder-shaped and in granular structure (Figure 5). Also, in the wooden house, brown rot was identified (Figure 6), and the areas destroyed by insects and fungi were identified (Table 5).

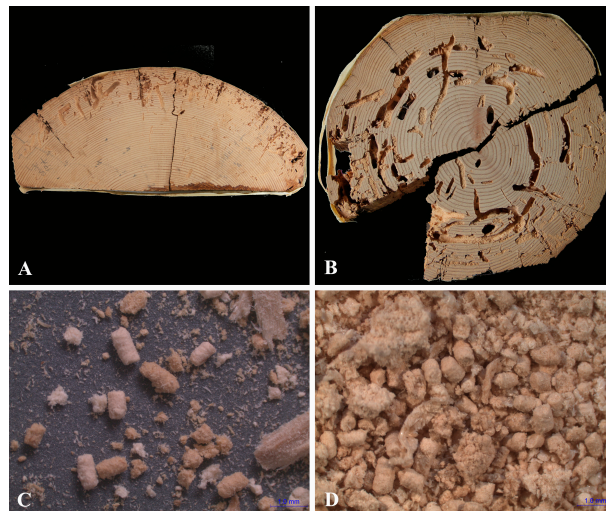
**Figure 5.** The tunnels which are formed by old-house borer (*Hylotrupes bajulus*) observed in wooden samples from the house (A) and the hayloft (B); and images of their pellets and frass under stereomicroscope ((C,D), respectively).

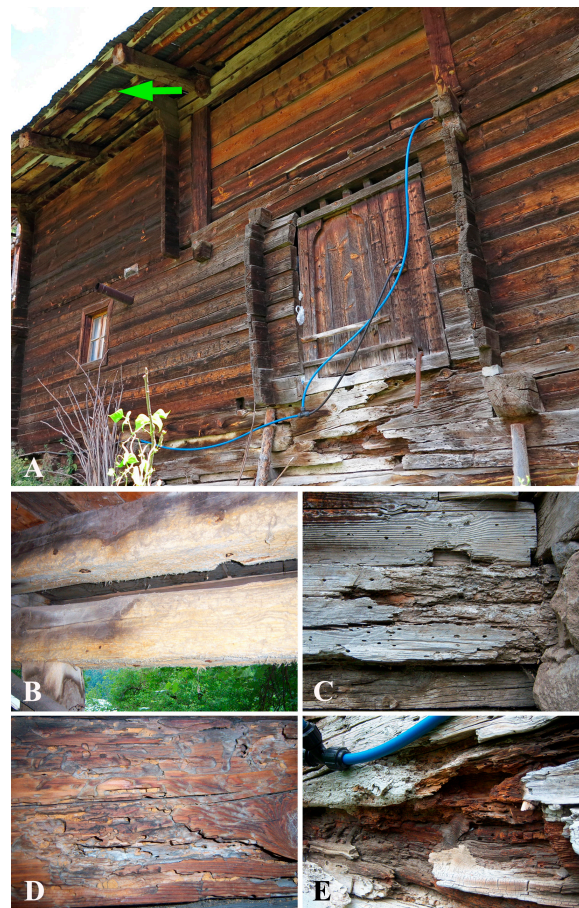
**Figure 6.** The wooden house damaged by old-house borer (*Hylotrupes bajulus*) and brown rot fungi. The arrow shows damaged rafter by fungi (A); Decayed wood elements in contact with water leaking (B); The wooden elements and insects in contact with the stone chimney damaged by both fungi (C); The tunnels formed by insects on the wooden wall inside the building (D); Bonding timbers near the foundation damaged by both fungi and insects (E).

Destruction Type	Areas Where the Damage Was Seen
Fungal damage	1. Rafters, areas adjacent to eaves exposed to precipitation before the repair of the roof (Figure 6A).
	2. The outer part of the wood elements in contact with the stone chimney (Figure 6C).
	3. Moisture soak-up from precipitation and soil contact due to structural failures; bonding timbers near the foundation (Figure 6E).
	4. Wood elements in contact with water leaking from the drains depending on the plumbing subsequently added to the structure (Figure 6B).
Insect damage	5. Bonding timbers near the foundation (Figure 6E).
	6. In most of the load-bearing walls, upper surface of the timber elements (usually limited to sapwood with robust texture).
	7. Few wooden walls inside the building (tunnels caused by insects) (Figure 6D).

When examining the points in which fungus destruction is found, it is seen that the most important reason for the occurrence of such damage is the moisture increase in these areas. In order to be able to keep moisture level below 20%, the isolation of moisture introduced through soil contact and improper plumbing; repairs of roof, chimneys and the others must be carried out.

Insect damage in the bearing walls is generally seen to be limited to the sapwood. It is seen that the robust texture is at a sufficient level, and the load-bearing elements fulfil their function. Although no alterations or repairs are required in these areas, acrylic resins can be used to prevent dust problems caused by insects' galleries which appear on wooden surfaces; that is one of the most important problems for the users, especially inside the building [47]. However, consolidation and replacement are required in order to correct the damage seen on wood elements where the damage is at its advanced level.
