Article

Impact on Water Quality of Nandoni Water Reservoir Downstream of Municipal Sewage Plants in Vhembe District, South Africa

Keywords: pollution; water quality; municipal sewage plants; principal component analysis

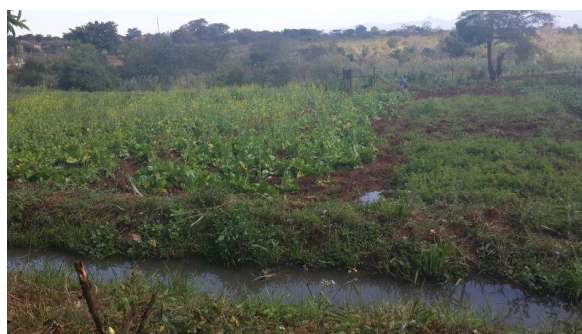
Figure 4. Subsistence agricultural activities practiced at Mvudi upstream.
