Article

The impact of Lighting on Vandalism in Hot Climates: The Case of the Abu Shagara Vandalised Corridor in Sharjah, United Arab Emirates

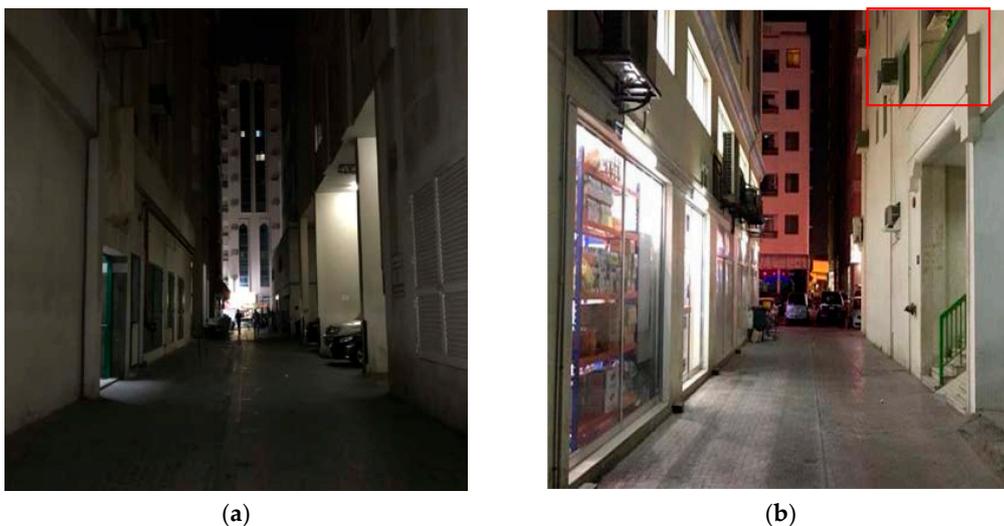
Figure 2. (a) Vandalised corridor A showing neighbouring buildings with only windows overlooking the corridor, and (b) non-vandalised corridor B with one neighbouring building (labelled in red) having balconies overlooking the corridor.

The vandalised corridor A (Figure 2a) was compared to the non-vandalised corridor B (Figure 2b); in addition, IESVE simulations were run in order to identify solutions to prevent acts of vandalism in corridor A. In these examples, lighting would prevent vandalism, as suggested by the absence of lighting in corridor A, as can be seen in Figure 2. In this case, a lit-up space was not a comfortable space to perform the act of vandalism.

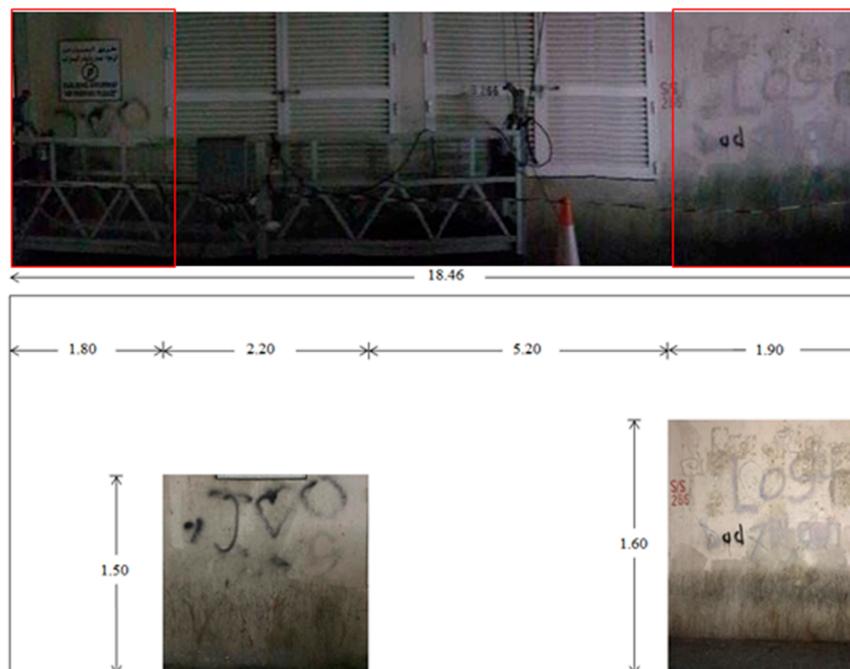
Figure 3. Image illustrating the width and height in meters of the vandalised wall in corridor A.

Illuminance measurements evaluate the illumination of a specific location resulting from the light hitting it, by performing lux measurements [16]. In this study, illuminance measurements were performed by measuring the lux levels in a designated area and by subsequently verifying the results of the IESVE software. The measurements of the lighting differences between the two corridors were our main focus. Further measurements for the vandalised areas in the examined corridor were also performed in this study. At the same time, the illuminance measurements were used to calculate the lux levels in the corridors in order to compare the differences in lux levels. Corridor A was vandalised in two wall areas (Figure 3). The points labelled in the corridor represent the maximum distance for a visitor to vandalise a wall and be seen by a passing visitor (Figure 4). The shaded area is the area vandalised in the corridor. Corridor A consists of two vandalised areas, one area of 2.85 m² and the other of 3.3 m². Therefore, the total area vandalised in the corridor is of 6.15 m². The lux level of each vandalised area was measured in the middle using the illuminance measurements. Four reading trials were conducted for each area, and the average lux level of points A and B were approximated to 2.95 and 3.18 lux, respectively.
