Article

Unpiloted Aerial System (UAS)-Supported Biogeomorphic Analysis of Restored Sierra Nevada Montane Meadows

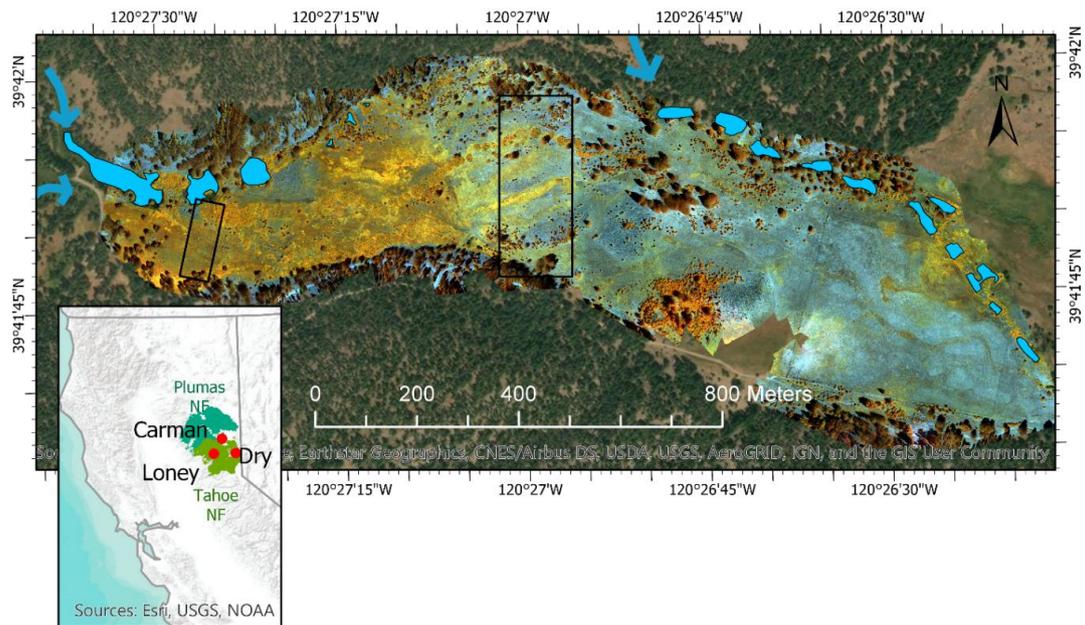
Figure 1. Meadow study sites. Knuthson Meadow, the largest studied on the Carman system, with July and August 2017 UAS-collected multispectral imagery from this project. False color image displays near infrared (NIR) (820–860 nm) as red, red-edge (712–722 nm) as green, and red (663–673 nm) as blue. Ponds from pond-and-plug restoration follow the pre-restoration incised channel along the northern edge of the meadow. Major surface streamflow inputs are indicated with arrows. Flow is toward the east to southeast, with the westernmost pond overflowing into small channels to the south. Locations of cross-section Figure 8 (left) and Figures 9 and 10 (right) are shown as rectangles. The inset map locates the three Tahoe National Forest meadow systems that were the focus of this study: Carman (including upper Carman Valley and Knuthson), Dry, and Loney, as well as the adjacent Plumas National Forest where numerous pond-and-plug projects have been built by the Plumas Corporation (accessed 2018).

The Carman Creek system of meadows, including Knuthson Meadow (Figure 1), near the northern boundary of Tahoe National Forest in the Feather River watershed, has been the subject of multiple phases of pond-and-plug restoration [49]. Upstream of Knuthson Meadow, especially on West Carman Creek, are several other projects ranging from check dams to pond-and-plug installations. Carman Valley on this west fork exhibits several discontinuous gullies deemed insufficiently degraded to warrant attention more effective than check dams, the more traditional method focused on addressing head cuts. Knuthson Meadow provides a clear example of a shift in surface drainage away from the formerly incised creek, now occupied by a series of ponds and plugs, into numerous shallow channels along the more southerly parts of the meadow, with most of the flow incorporated into the meadow aquifer. Note that these Knuthson channels are substantially smaller than the pre-restoration channel which had grown to several meters in width. The upstream unrestored Carman Valley channels are currently wider despite having a much smaller watershed (see Table 1); here, the more traditional check dams are proving to be ineffective at addressing headcuts, and therefore channels are deeper and wider. Other meadow systems that are the focus of this study include the following: (1) another pond-and-plug restoration project, Dry Creek meadow in the Truckee River drainage; (2) Loney Meadow in the Yuba River watershed, which is being restored using a limited (no excavation) pond-and-plug method [50]; and (3) the perennial Dixie Creek, part of the Red Clover Valley system, being restored using beaver dam analogues [33].

Somewhat unclear at this stage is whether these shrubs preferably propagate along these sites or if their root systems or shading enhance scouring as has been documented elsewhere [27,64], whereas Stokes and Cunningham [65] noted that, in Australia, (invasive) willows spread more rapidly in streams of greater sinuosity where bare soil exposures were more common, at least at their sites. Certainly, a more incised stream with greater stream power can also more readily distribute willow stems for vegetative reproduction; willows are well known for vegetative propagation along stream courses, a property that makes them a favorite for stream riparian restoration. Sedge growth can also be affected by shading and moisture uptake by willow shrubs that create an environment conducive to root mat disturbance. Positive feedback could be contributing, with willows (once established and possibly increasing scour) creating conditions for further propagation; we could be seeing this in a string of willows at 39°41'55" N and 120°27'00" W (see Figure 1), which also exhibits evidence of scour.

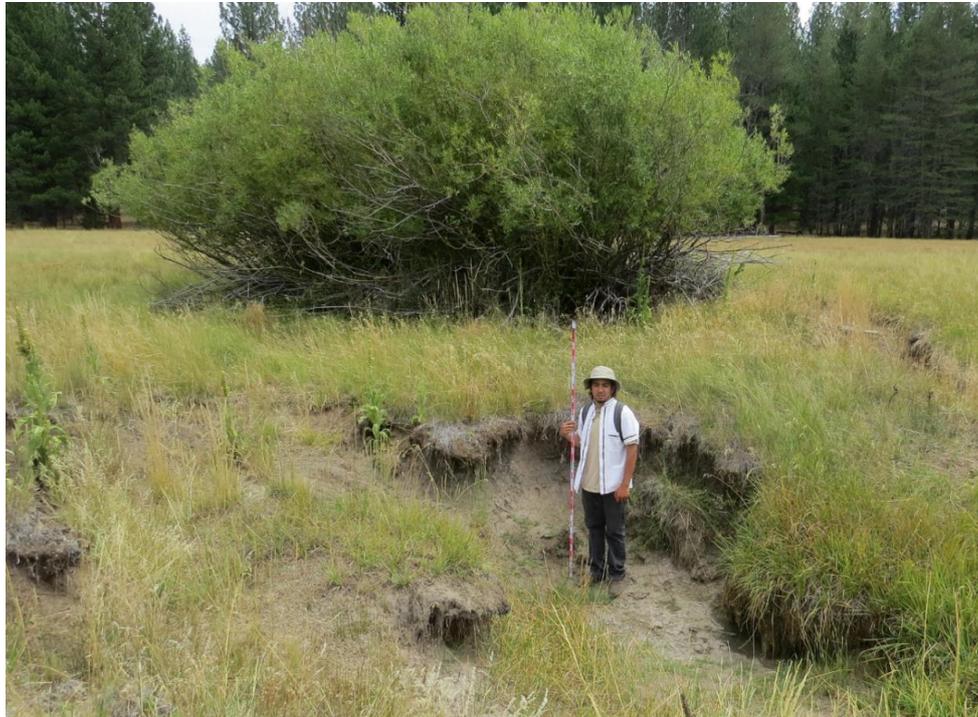
Figure 2. A discontinuous gully in West Fork Carman. Note *Salix lemmonii* (willow), commonly growing adjacent to scour features. Photograph is by Heather Milton, used with permission.

Willows (*Salix* species) were noted adjacent to many discontinuous gullies in both the Carman system (upper Carman Valley and Knuthson Meadow) and Loney Meadow, and willows were also associated with relatively sharp bends in the channel, producing high local sinuosity (see Figures 6, 7 and 13), as was supported by a linear model (see Figure 15). In unrestored meadows, i.e., Carman Valley and Loney Meadow, willows can grow along channels in inset floodplains (see Figures 2, 4 and 13).

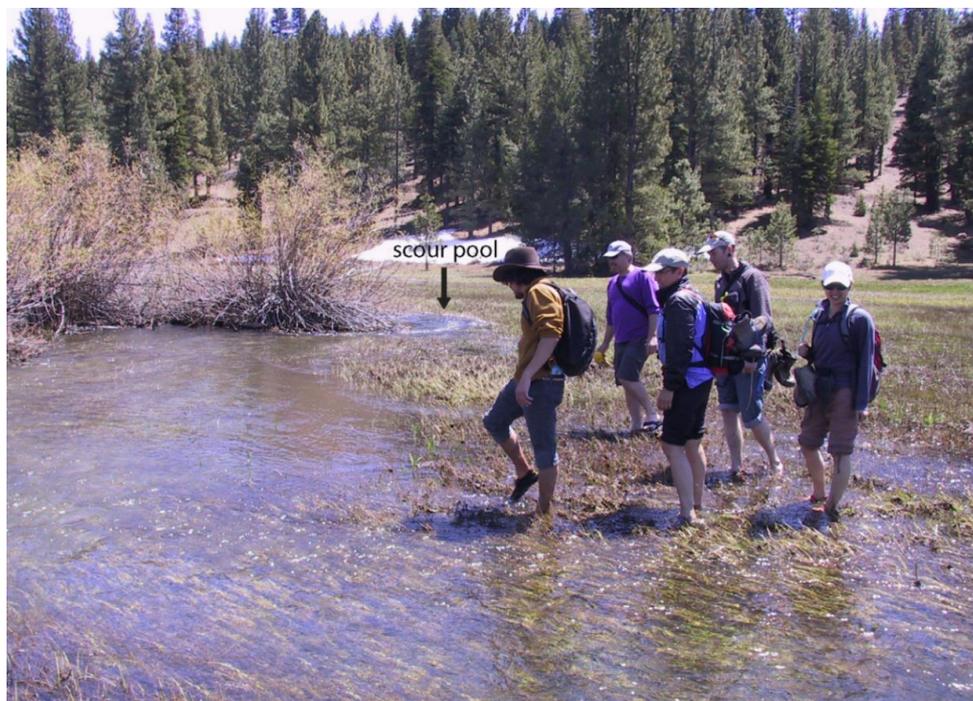
Figure 3. Spring snowmelt in the upper Knuthson meadow, visited during spring snowmelt on 1 May 2011, illustrating a system not unlike a pool-riffle system, with wider shallow sheet flows over the high-friction vegetated sections and concentrated flow through scoured pools, often developed adjacent to willow copses. A scoured pool is visible just to the right of willow copse at left center.

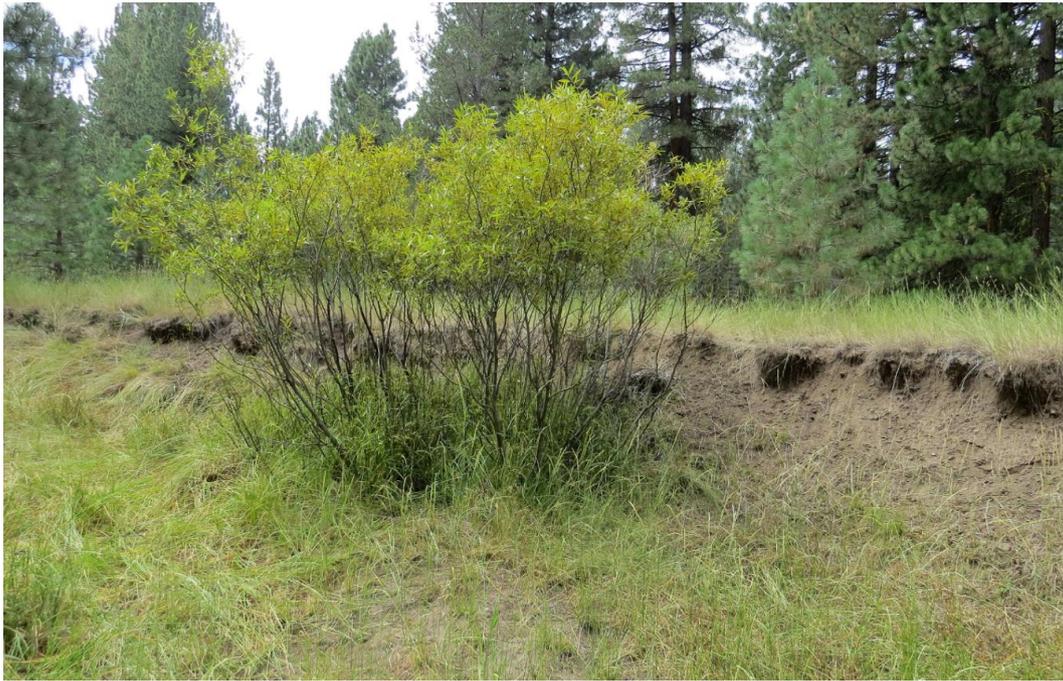
Figure 4. Terrace scarp exposing pre-incision (assumed) *Carex*-dominated root mat at West Fork Carman, upstream of Knuthson Meadow. Photograph is by Heather Milton, used with permission.

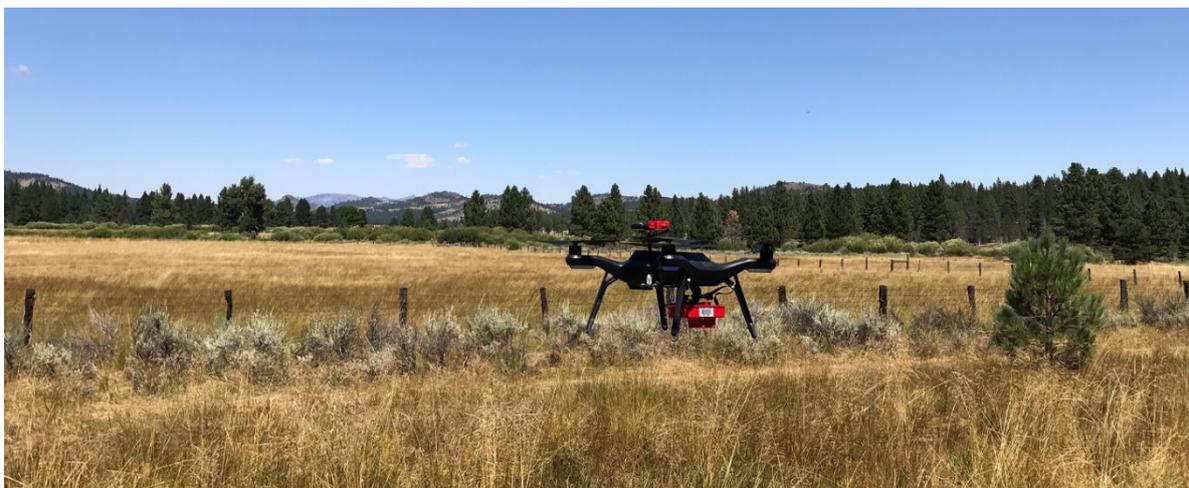
Figure 5. MicaSense RedEdge 5-band camera mounted on a 3DR Solo quadcopter, at lower Knuthson Meadow. This small drone (26 cm width) is capable of carrying a small camera such as a GoPro, or the 150 g MicaSense unit as shown here. Photograph is by Quentin Clark, used with permission.

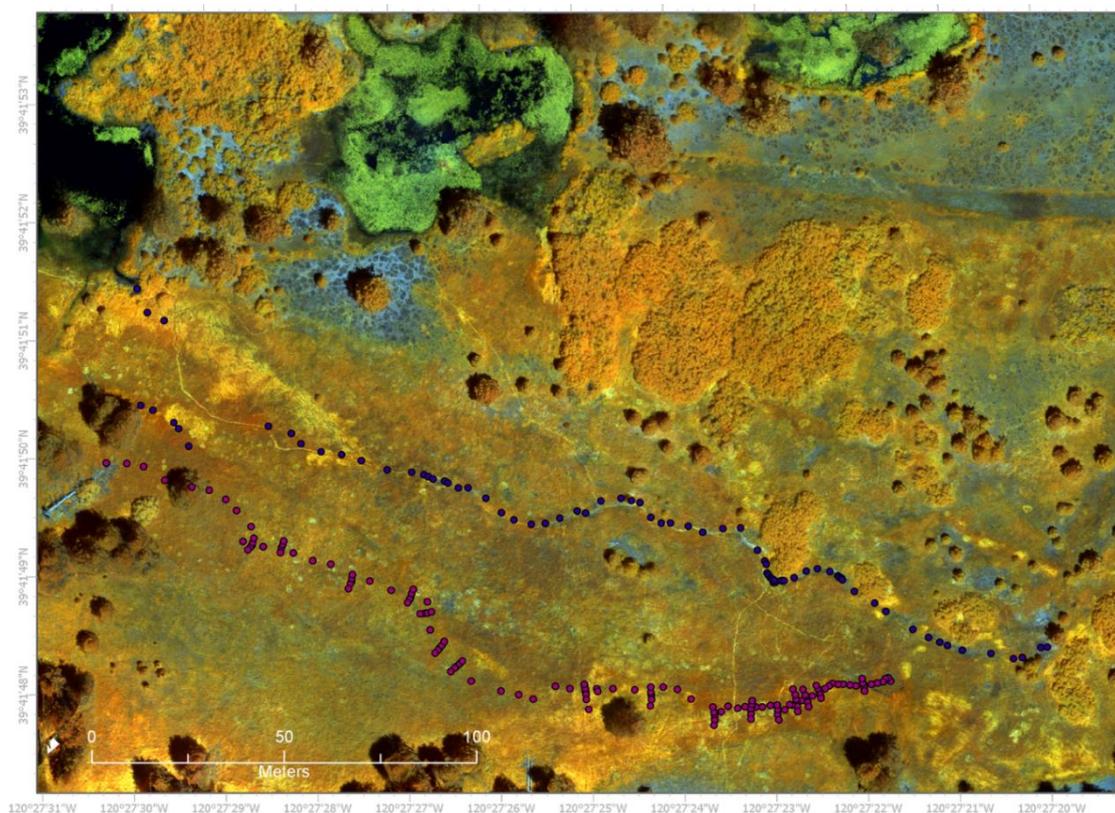
Figure 6. Upper Knuthson Meadow. Channel survey points surveyed by Slocombe and Davis (2014).

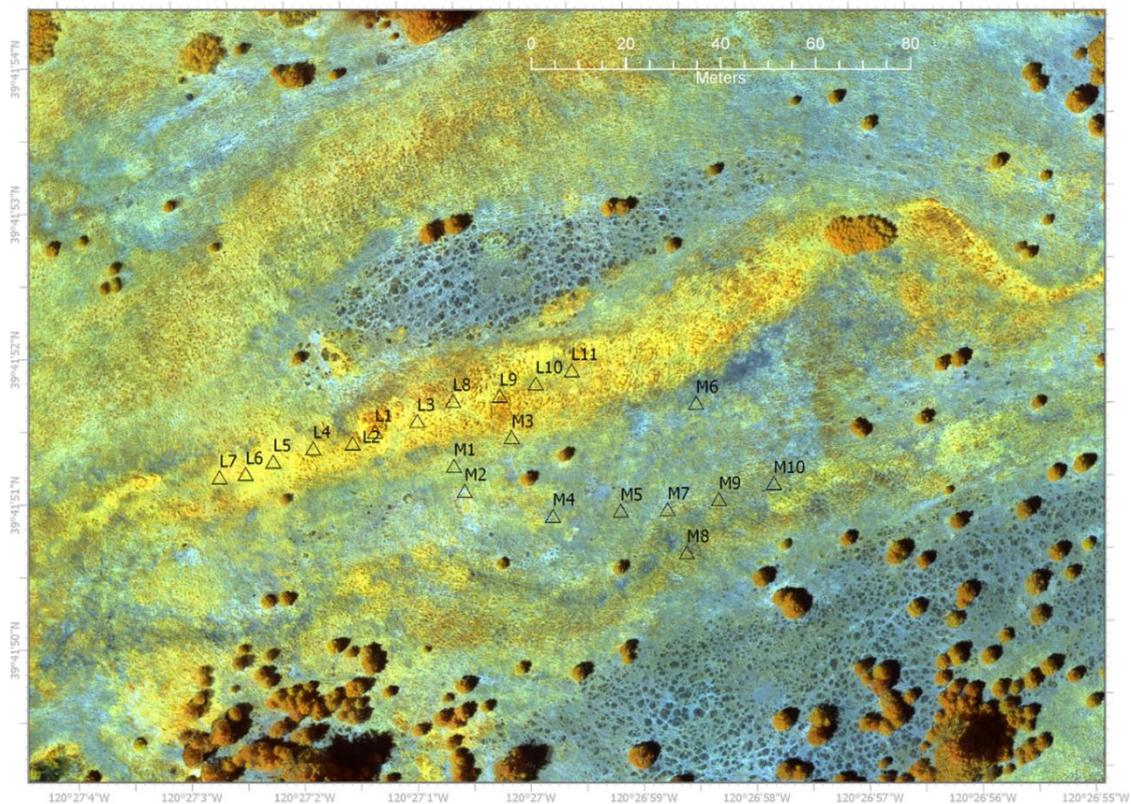
Figure 7. Central Knuthson Meadow. Site of an eddy covariance micrometeorological study by Maher (2016). The 21-vegetation quadrat and soil sample locations used in that study are shown as point symbols, with 11 “L” sites located in lower areas dominated by *Carex* and 10 “M” sites on slightly elevated (+ ~0.5 m) sites with more diverse facultative wetland and upland herbaceous species.

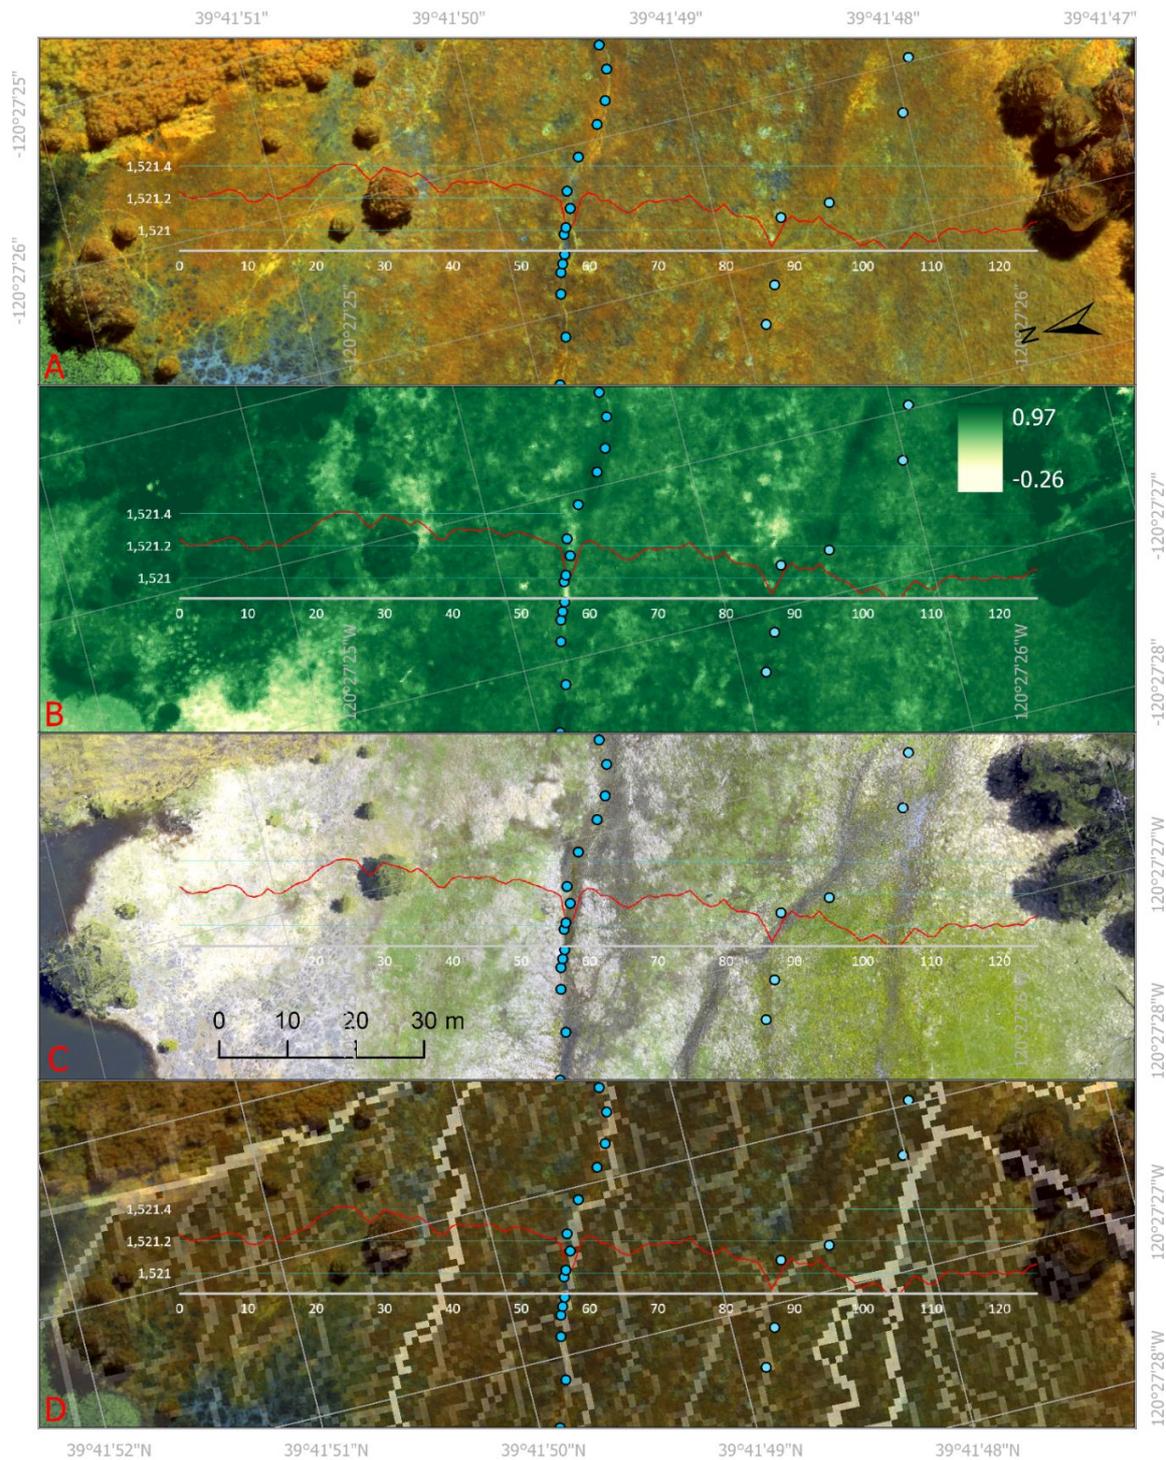
Figure 8. Upper Knuthson cross-section. Displayed as (A) false color, (R = NIR, G = red-edge, B = red); (B) normalized difference vegetation index (NDVI); (C) 21 April 2013 drone color image (GoPro Hero 3) mosaic; and (D) natural logarithm of flow accumulation over false color. The cross-section was derived along the white line with distances in meters from Tahoe National Forest LiDAR. The head-most pond of the pond-and-plug restoration is partially visible with the bright green color of aquatic vegetation at the letter A, while a small area of sagebrush is immediately to the south.

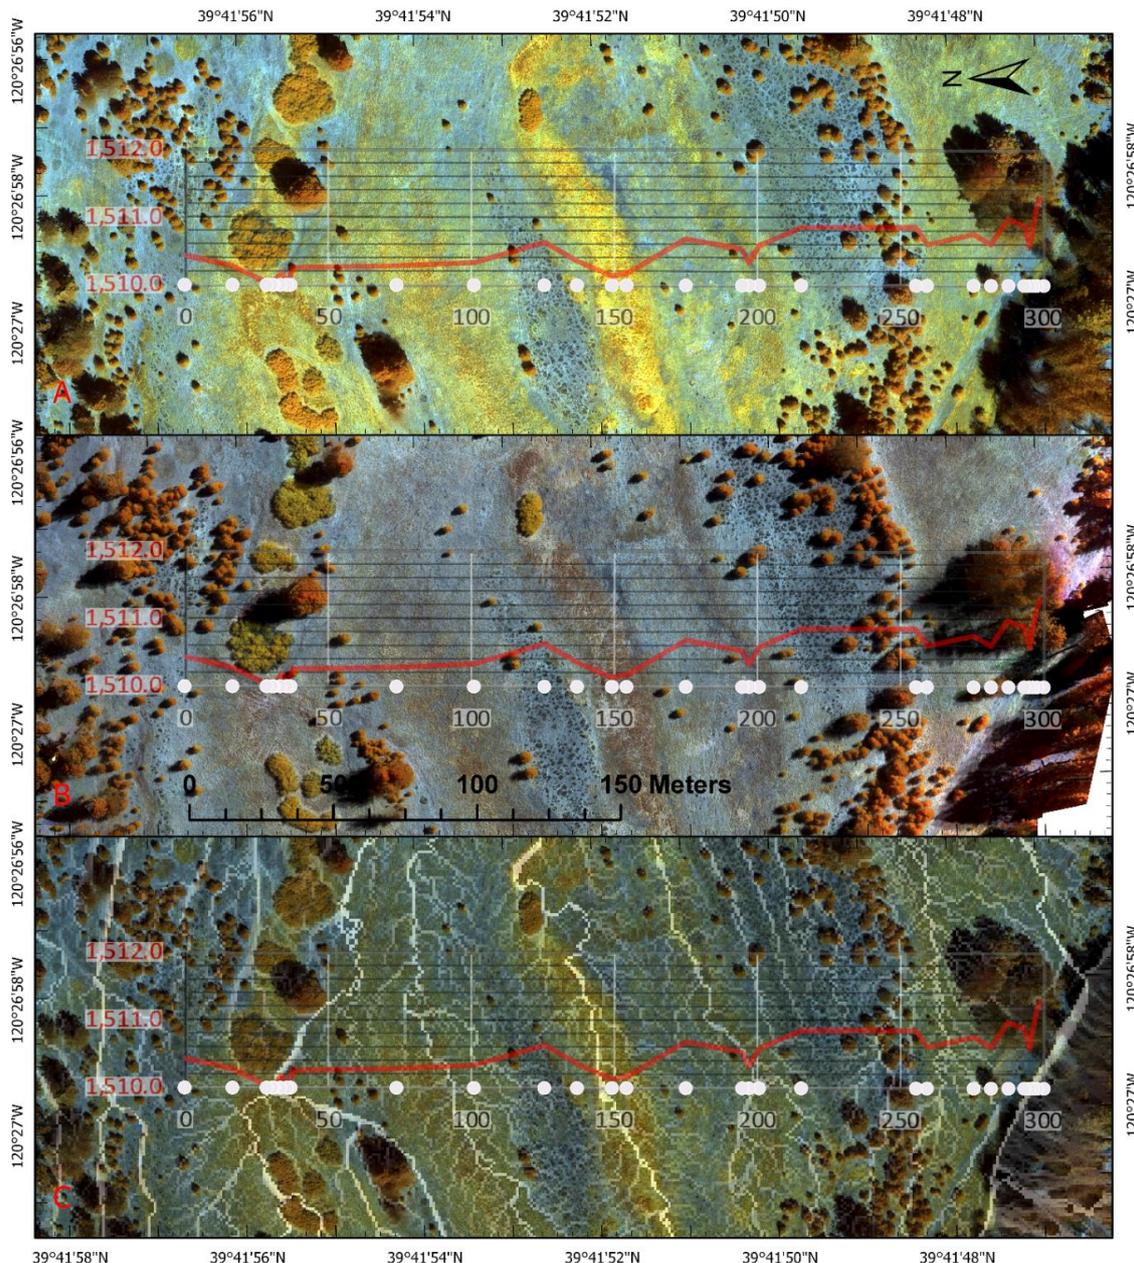
Figure 9. Central Knuthson Meadow cross-section. Laser-level surveyed cross-section superimposed on UAS images from growing and senescent seasons. (A) Growing season July 2017 false color (NIR/red-edge/red as RGB); (B) Senescent season September 2018; and (C) Natural logarithm of flow accumulation over growing season image. False color image displays NIR (820–860 nm) as red, red-edge (712–722 nm) as green, and red (663–673 nm) as blue. Cross-section units are meters horizontally and vertically.

UAS imagery collected on 23 September 2018, not surprisingly, exhibits highly senescent (and grazed) meadow vegetation (Figure 9B). The NDVI and Cl_{re} indices from both phenological periods provide a view of the likely effect of topographically related soil moisture variations in influencing tendencies ranging from xeric *Artemisia* to hydrophilic *Carex*-dominated sites (Figure 10). During the senescent phenological phase, NDVI and Cl_{re} are greatly reduced, with high values only in trees, although drainage lines such as the *Carex*-dominated area at cross-section distance 150 m has a higher NDVI than more elevated mixed graminoid or sagebrush-dominated areas. Leaving out the trees, there is a clear pattern seen in Figure 11 of higher NDVI and Cl_{re} values in lower-lying areas

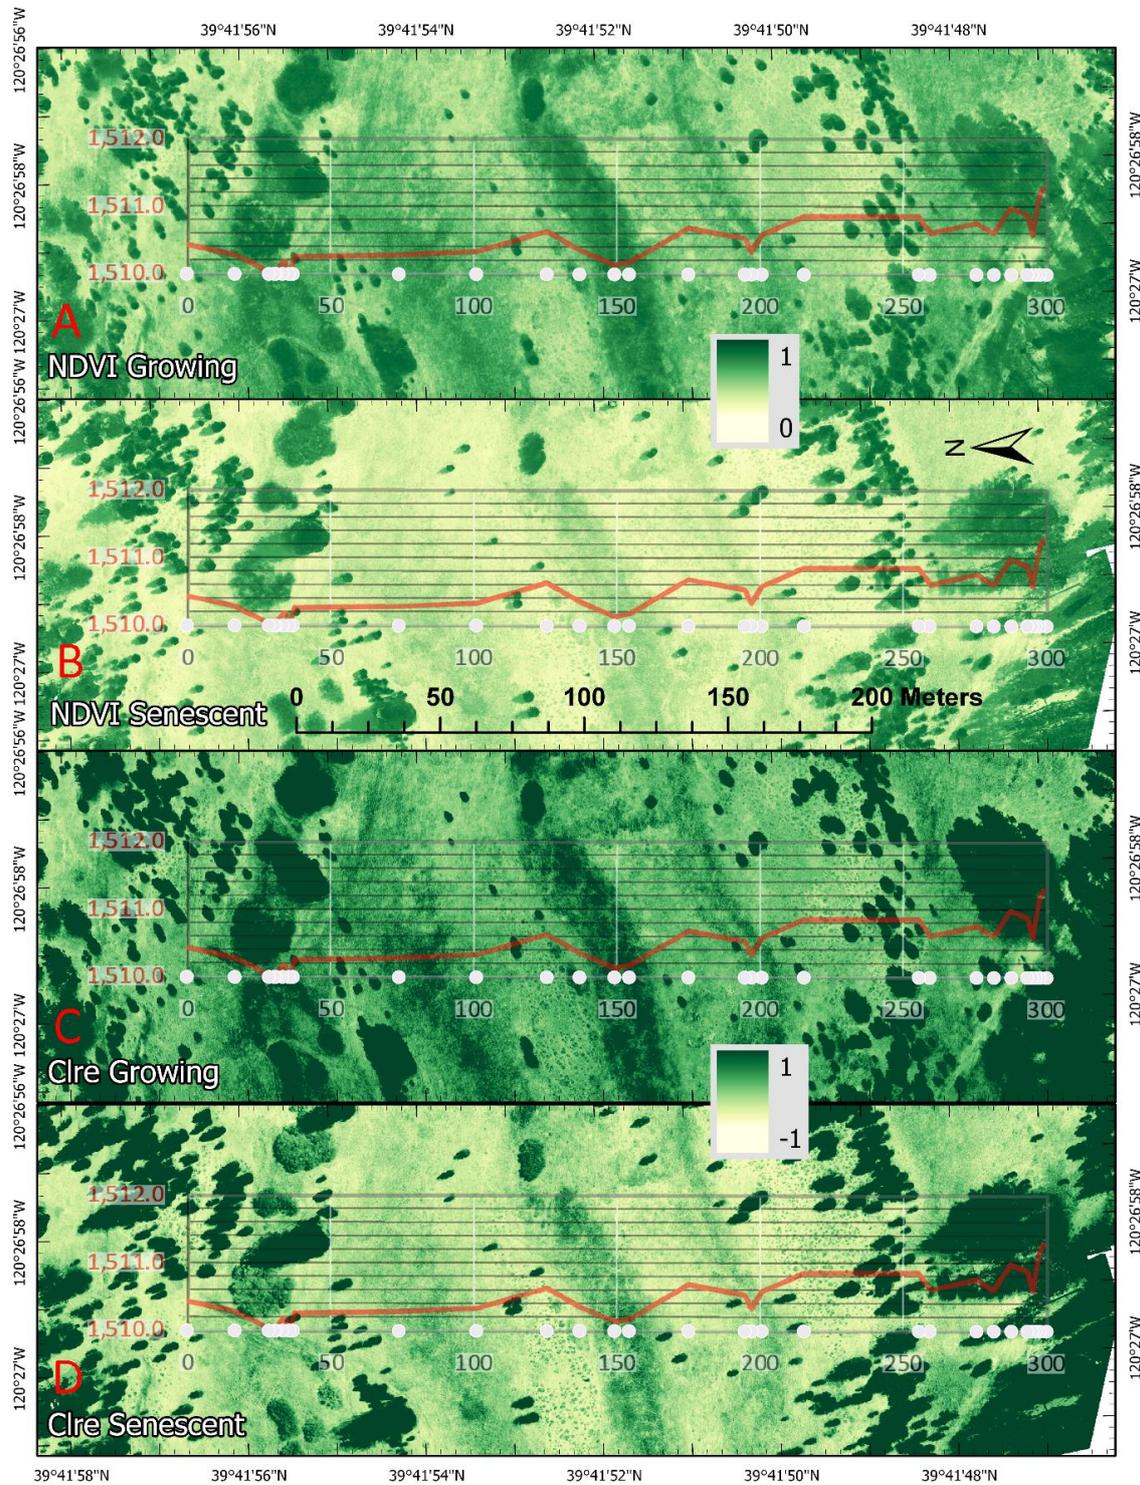
Figure 10. NDVI and Cl_{re} indices of central Knuthson Meadow cross-section. Same cross-section as previous figure. (A) July 2017 NDVI; (B) Sep 2017 NDVI; (C) July 2017 Cl_{re} ; and (D) Sep 2018 Cl_{re} . Legend corresponds to all maps.

Table 2. Linear model results of the NDVI and red-edge chlorophyll index (Cl_{re}) predicted by elevation at vegetation samples along the north-south leveling transect in Figure 10. Tree (willow and pine) samples are excluded.

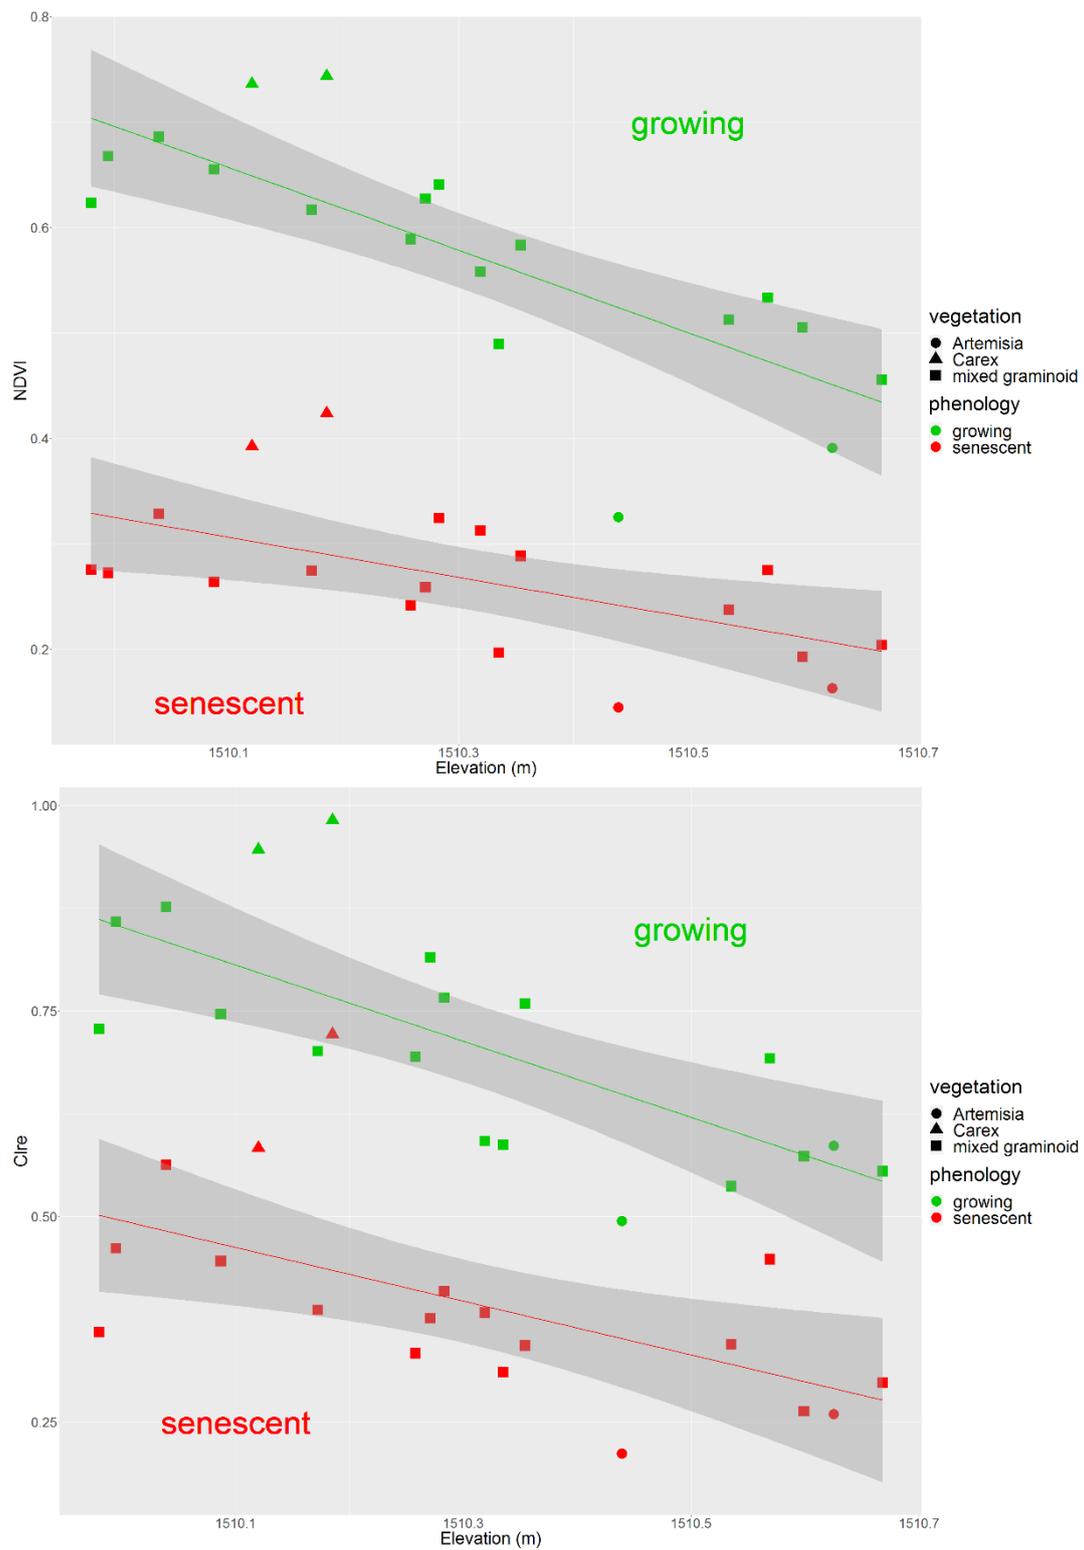
Figure 11. NDVI and Cl_{re} during growing and senescent seasons, plotted at elevations of non-tree points along the 23 September 2018 laser-level cross-section. Low-lying areas in closer contact to groundwater sources are indicated by lower elevations.

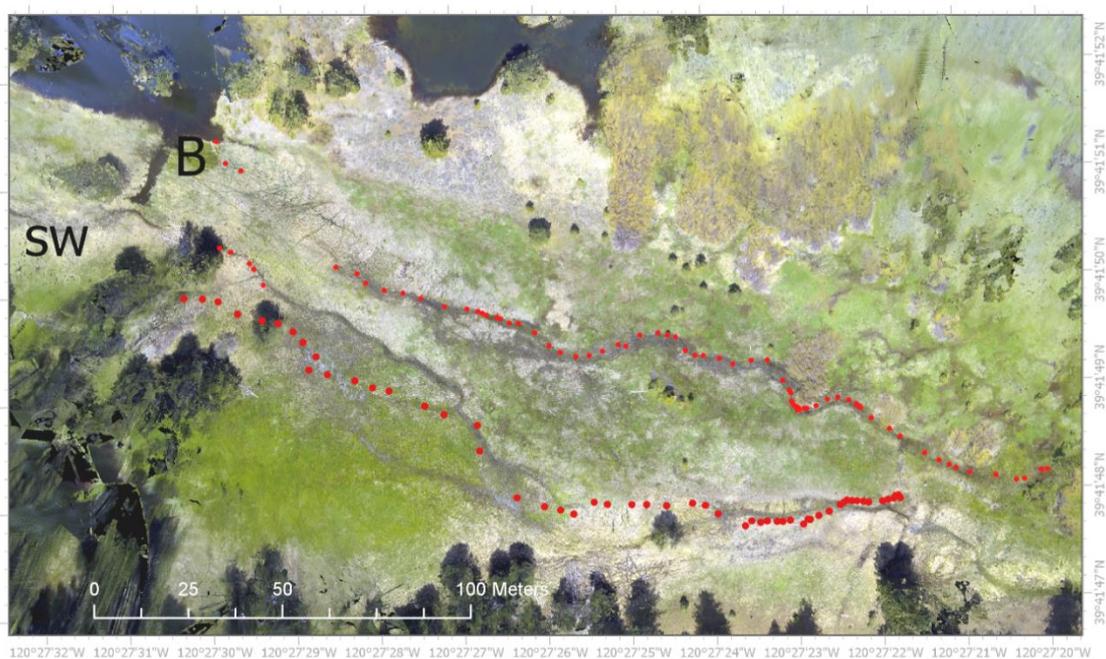
Figure 12. West end of Knuthson meadow from a 21 April 2013 color image mosaic. At this time, surface flows can be seen in ephemeral channels. The largest inflow into the meadow is into the pond above (B) in the image, with a basin area of 30 km²; at (B), beavers have frequently built dams to increase the height of the pond. Flow from the southwest (SW) is from a much smaller basin of 3 km², yet this contributes more evident surface flows. Channel surveys from 2012 are shown. Imagery was captured using a 3DR Arducopter-mounted GoPro Hero-3 camera and processed with Pix4D. Distorted results in the forest surrounding the meadow is to be expected given limited image coverage and should be ignored as the focus is on the meadow.

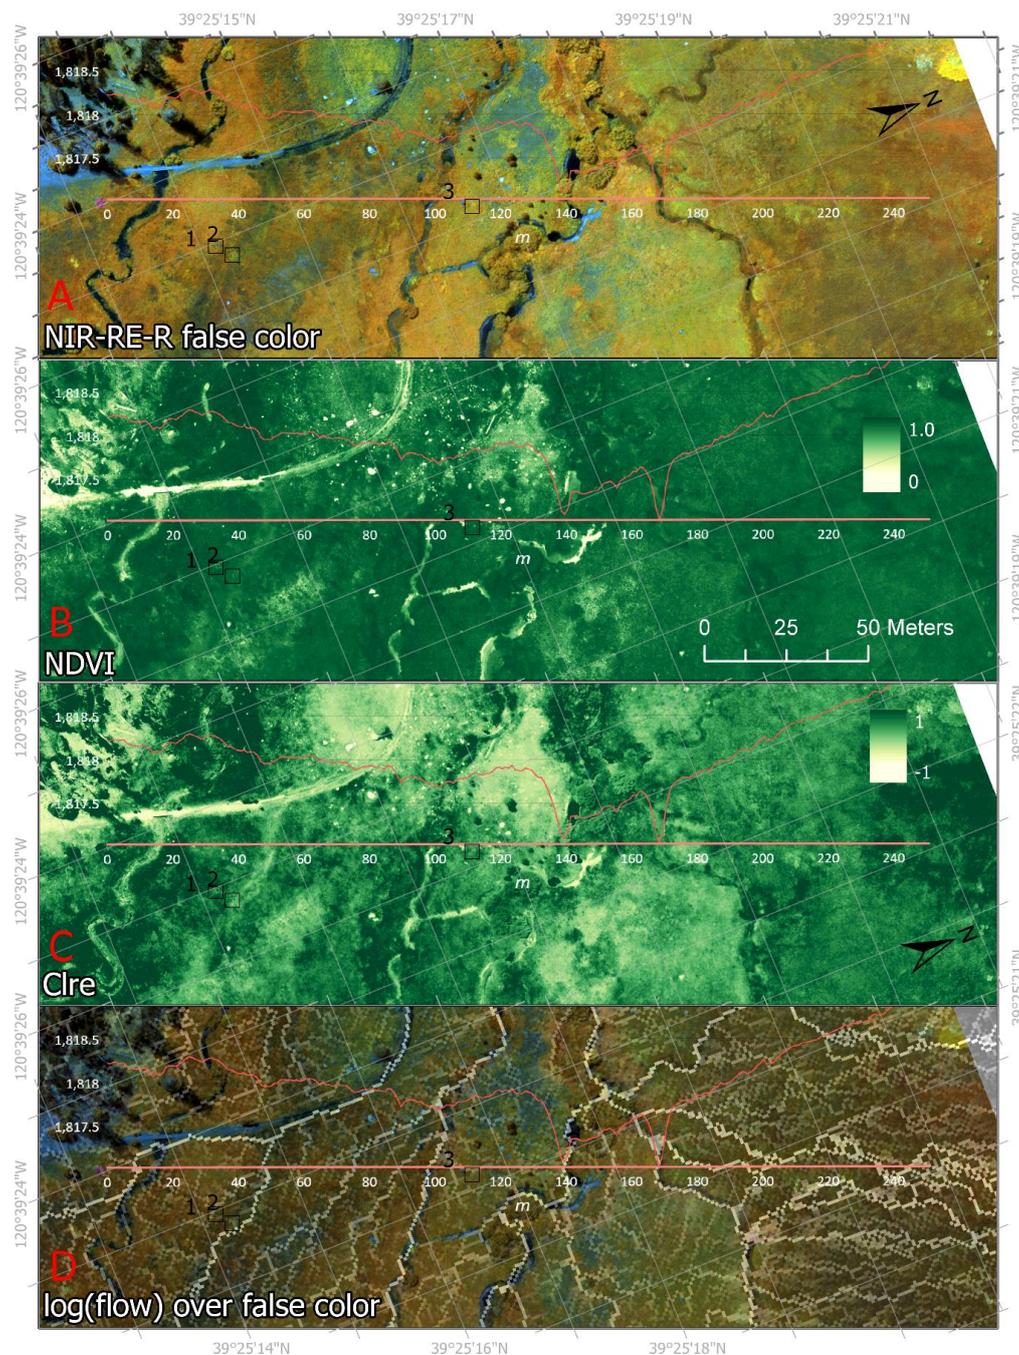
Figure 13. Loney Meadow cross-section. Four panels of the same areas display (A) NIR/red-edge (RE)/red (R) false color, (B) NDVI, (C) Cl_{re} , and (D) natural logarithm of flow accumulation over false color. The cross-section was derived along the orange line. Note the main trail and bridge crossing the meadow in the northwest corner of the image.

Loney Meadow also illustrates a complex set of channels. In the cross-section (Figure 13) of the meadow relatively near its western (downstream) end, several areas of focused flow can be seen in the log(flow) view. The deepest channels are not necessarily the wettest predicted by flow accumulation, nor are they observed in the field or in imagery to have the greatest flows. This likely resulted, in part, from the effect of 20th century ditching along the south side of the meadow; however, groundwater flow interactions are likely, as seen in the patterns of vegetation and NDVI and Cl_{re} that do not closely match the LiDAR-derived flow accumulation results. Salix copses are evident in the deepest channels and are associated with the greatest local sinuosity.

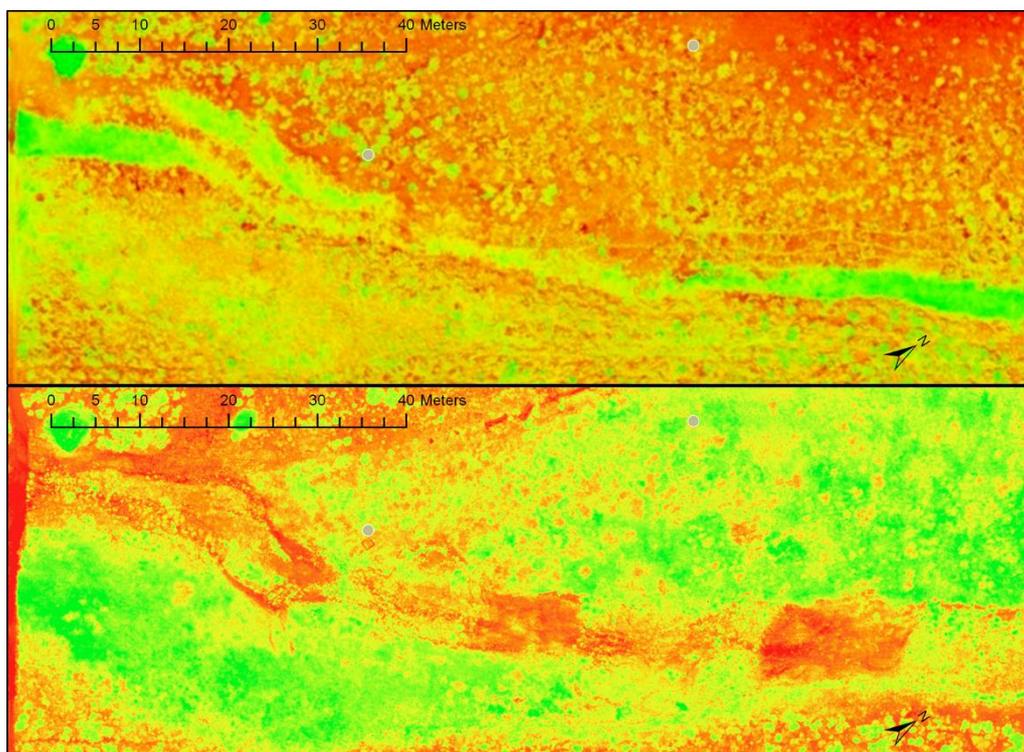
Figure 14. NDVI of part of Dry Creek Meadow. Collected 26 July 2013 (top) and 23 July 2017 (bottom), with bright green representing high NDVI values. In 2013, hydrophilic plants producing high NDVI values are only found along an inset channel floodplain. This channel was the focus of pond-and-plug restoration, which raised the water table sufficiently to create much more extensive hydrophilic growth indicated by high NDVI values in the 2017 map. The 2013 map is modified from Christian [55].

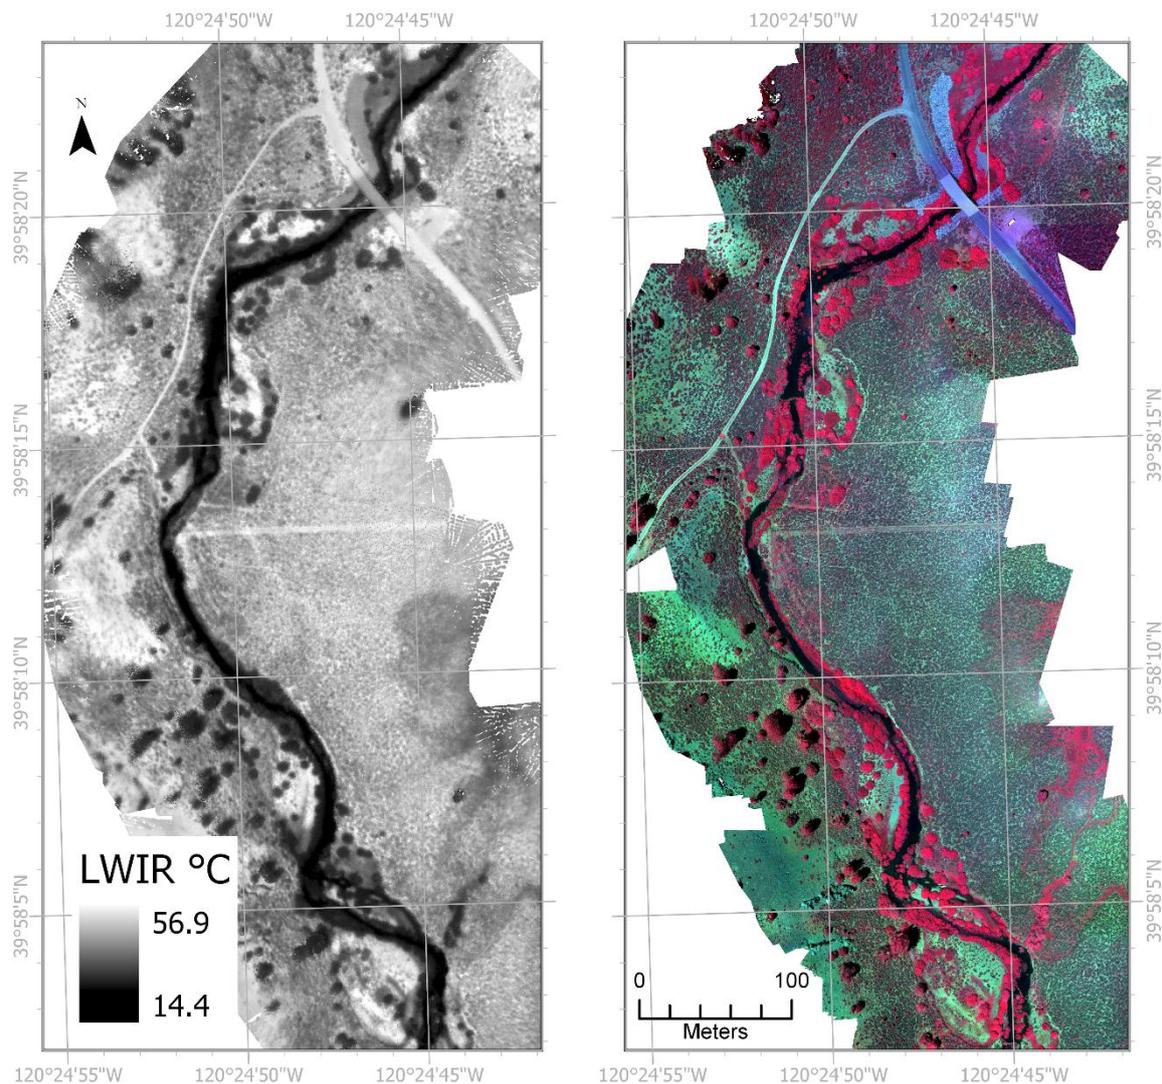
Figure 16. Longwave IR (left) and NIR-R-G false color (right) images of Dixie Creek in Red Clover Valley, flown using the MicaSense Altum camera mounted on a DJI Matrice 100 drone on 30 June 2019.
