# Impact of Hurricane Harvey on the Upper Texas Coast: Using Airborne Lidar Data Sets with UAV-Derived Topographic Data to Monitor Change and Track Recovery

Sara S. Rojas, Shuhab D. Khan \* and Aydin Shahtakhtinskiy

Department of Earth and Atmospheric Sciences, University of Houston, Houston, TX 77204, USA

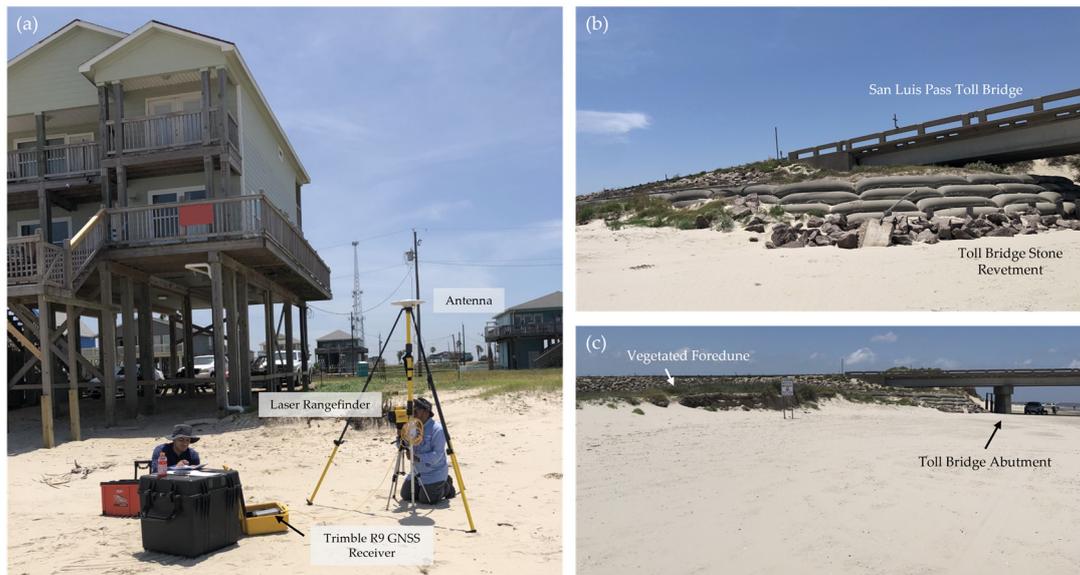
**Figure 2.** Survey set-up for Follett’s Site 1 in May of 2022. (a) GPS base station setup with a rangefinder used to collect distances between the base station and the ground control points; (b) San Luis Toll bridge with sandbags and partial stone revetment; (c) Vegetated dune field within the survey site in relation to the toll bridge.

Follett’s Site 1 (Figures 1c and 2) is located southeast of the San Luis Pass Toll Bridge, where foredunes intersect with a residential property. Site 1 is on the southeastern side of the toll bridge, where the daily flow of water provides sediment aiding shoreline advance but also carves sediment away, contributing to shoreline retreat. This site is affected by property development and is a direct comparison to the unaltered and protected beach northwest of the toll bridge.

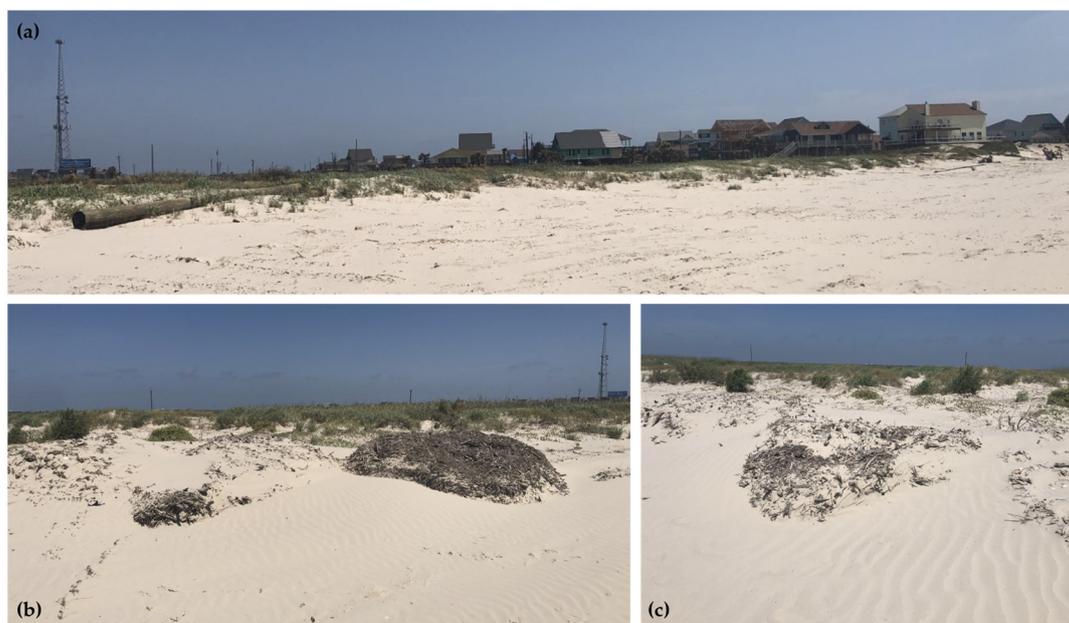
**Figure 3.** Follett’s Site 2 in May of 2022. (a) The UAV survey site with a flat backbeach followed by vegetated dune fields with no wood or mulch; (b) piles of wood chips at the westward end of the UAV survey; (c) example of a more eroded mulch pile compared to (b).

The “Treasure Island MUD Shoreline Protection” [29] project altered Follett’s Site 2 (Figures 1c and 3) between November 2017 and August 2019 via the construction of a stone revetment (a stone or slab wall built to protect a shoreline from scarp, strong wave action, or storm surges) connecting the pre-existing revetment near the southeastern extent of Gulf Beach Drive to the CR257 bridge abutment (Figure 2c). The western end of the UAV survey for Site 2 contained piles of wood chips or mulch (Figure 3b). Similar features are present at Follett’s Site 3, where there was a confirmed dune restoration project (Figures 1c and 4a).

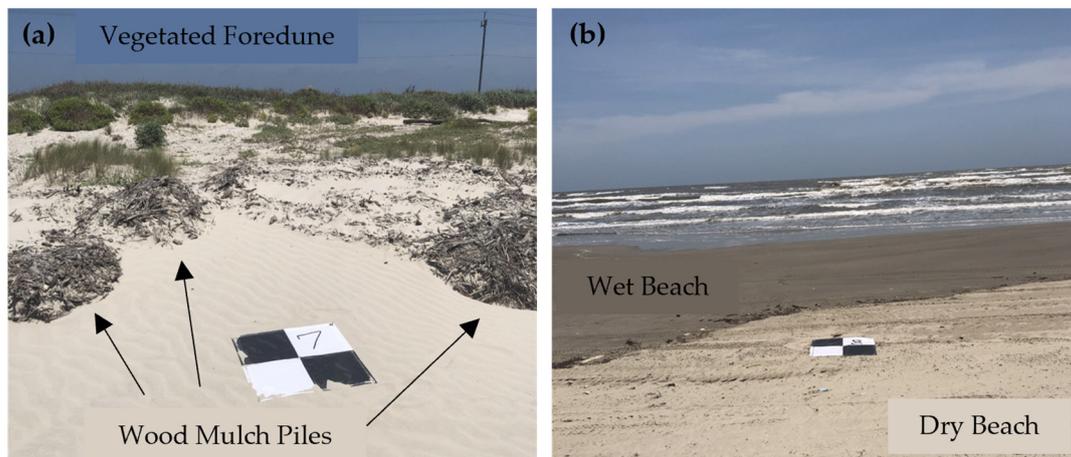
**Figure 4.** Follett's Site 3 in May of 2022. (a) Ground control point 7 between wood chip piles in the foreground with a vegetated dune field in the background. The county road CR257 is visually blocked but sits immediately behind the vegetated foredunes; (b) Ground control point 8 near the water line.

The “CR 257 Dune Restoration” project zone seen in Figure 1c contains Follett's Site 3 (Figure 4). The project began in October 2011 and restored approximately 5 miles of dune systems protecting wetland complexes and preserving the island's main road, County Road 257 [30].

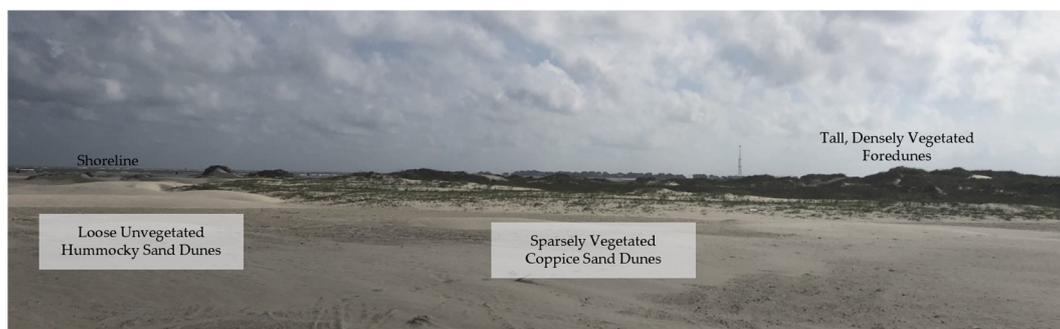
**Figure 5.** Galveston Site in May of 2022.

The western end of Galveston Island has advanced since the mid-1990s [5,9]. The area possesses a different morphology than Follett's sites described in this study. Shorelines typically extend further outward toward the Gulf of Mexico with a broader backbeach extent, more expansive, lightly vegetated coppice dune clusters, and taller and laterally longer foredunes compared to the Follett's Island sites (Figure 5). Within the foredune systems, loose unvegetated channels of sand (interdunal troughs), commonly altered by tourists driving through with all-terrain vehicles, run between foredune ridges.

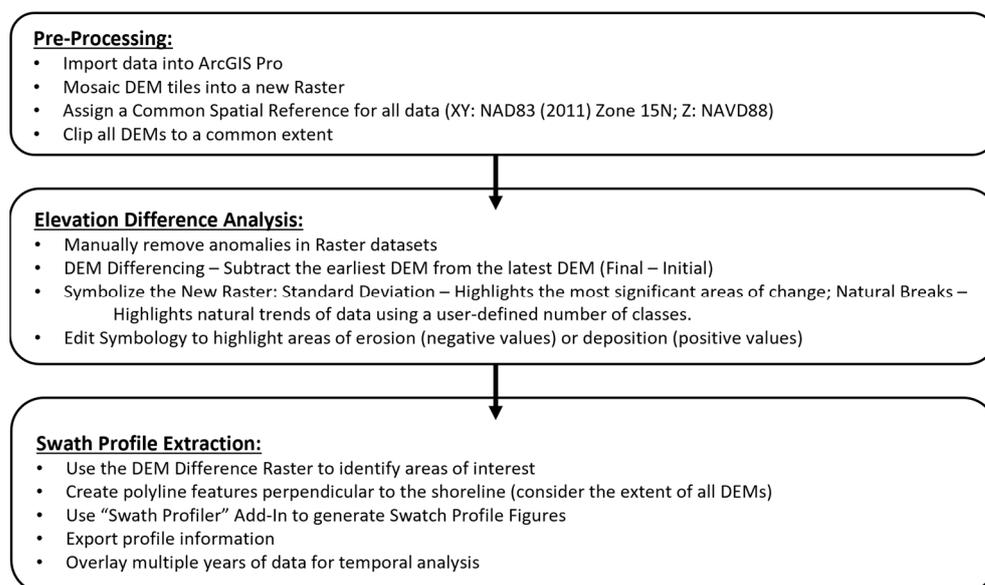
**Figure 6.** Workflow diagram summarizing the key steps taken to process data for the change analysis.

raster from the newer raster using the “Raster Calculator” tool. Figure 6 contains a general workflow for data processing in this study.

Bare ground elevation data sets (2016, 2018, and 2018/2019) (Table 1) were downloaded for the local bare ground change analysis from NOAA Data Access Viewer using the current geoid model, Geoid 18, and pre-processed following the steps listed in Figure 6.

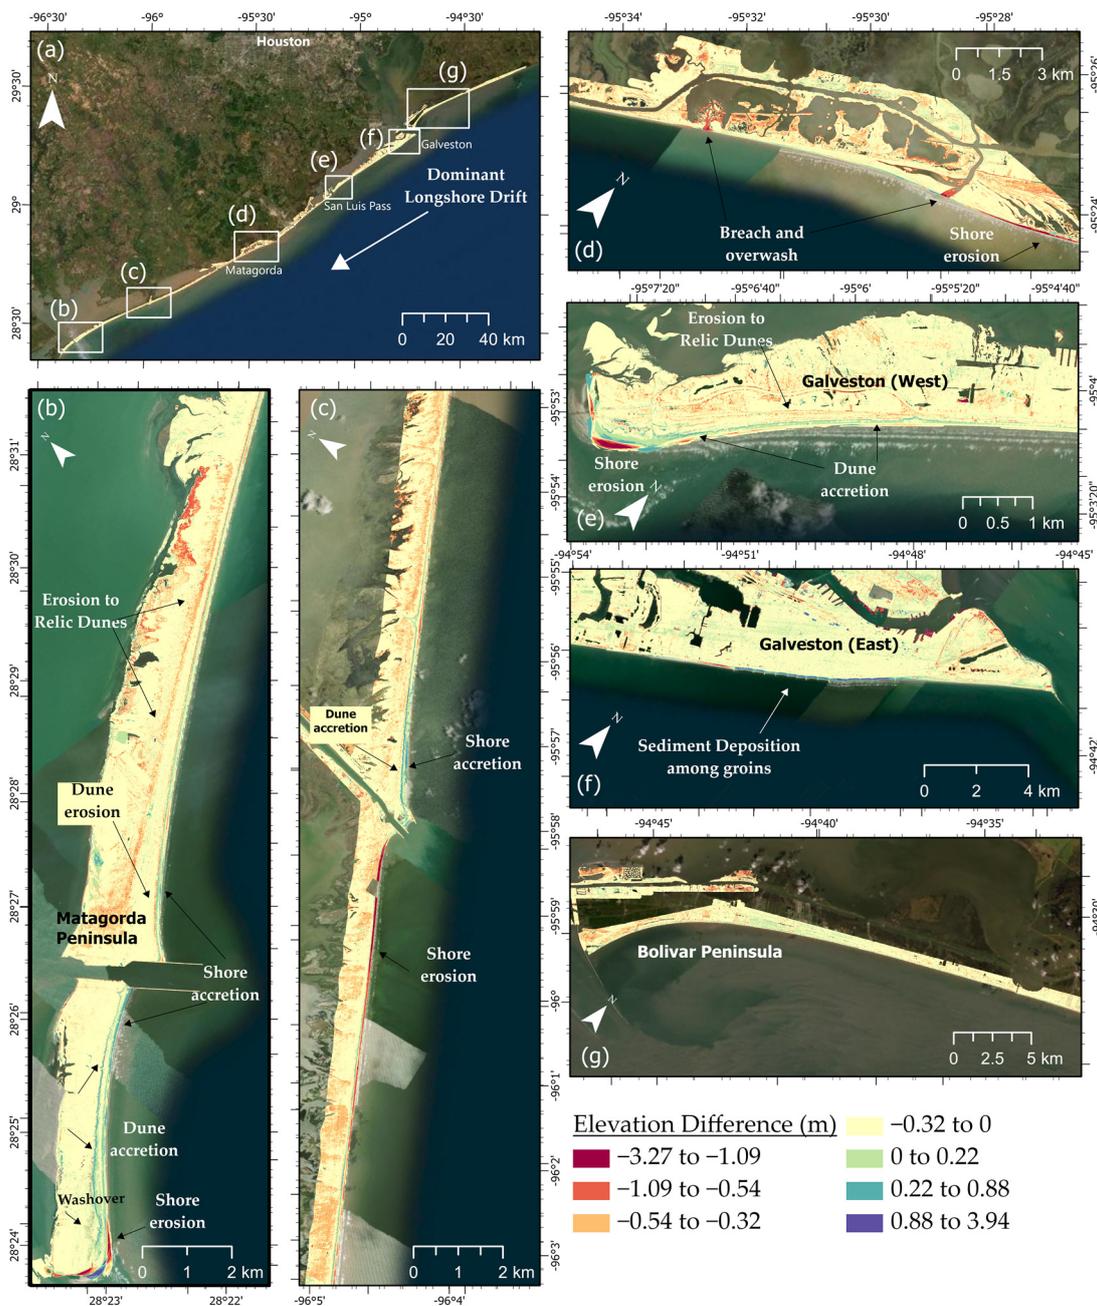
**Figure 7.** Digital elevation model difference map representing changes between 2016 and 2018. Erosion is represented by yellow, orange, and red. Sediment accretion is represented by green, turquoise, and purple. (a) For the full extent of regional data, refer to Figure 1b for the regional study extent in reference to the state of Texas; (b) Western end of Matagorda Peninsula; (c) Changes around Jetty Park and Matagorda Beach; (d) Overwash fans between Sargent and Freeport; (e) West end of Galveston Island; (f) East end of Galveston Island with seawall, jetty, and groins; (g) Bolivar Peninsula.

About 65 to 70 km northeast of Harvey’s landfall, scarped shorelines, breached dunes, and a visible overwash (Figure 7b) were observed on the southwestern end of the Matagorda Peninsula (southwest of the Matagorda Ship Channel). Fore-dune complexes, approximately 425 m inland, experienced vertical erosion of around ~1 m with some instances of ~2 m (Figure 7b). Between 2016 and 2018, the remainder of the peninsula experienced shoreline advance, berm build-up along the post-storm shoreline, aggregation of the backbeach, and accretion of sediment along the windward fore-dune slope. The larger section of Matagorda Peninsula to the northeast of the ship channel exhibited mainly berm build-up and deposition along the beach with around 0.5–1 m of vertical erosion along the primary fore-dune ridges.

About 106 km northeast of Harvey’s landfall, a 3 to 4 km stretch southwest of the Matagorda Channel displayed significant scarping of the shoreline, with a ~2 to 3 m decrease in elevation along the shoreline (Figure 7c). Shore accretion occurred on the channel’s opposing side. About 160 km northeast of Harvey’s landfall, two large overwash fans (left—about 420 m across along the shoreline; right—about 400 m across along the shoreline) occurred between Sargent and Freeport; both flattened the beach-dune areas by

about 0.5 to 1 m and connected the Gulf of Mexico to Cedar Lakes and surrounding water bodies (Figure 7d).

Between 2016 and 2018, the groins along Seawall Boulevard in Galveston trapped around 0.5 to 1m of sediment, with a maximum of ~1.5 m increase within the first pair of groins (Figure 7f). Figure 7f,g shows subsections of the Bolivar Peninsula and Galveston Island (approximately 260 km northeast of landfall) with sediment deposition along the windward foredune boundary and backbeach, relic foredune erosion, and some instances of berm buildup.

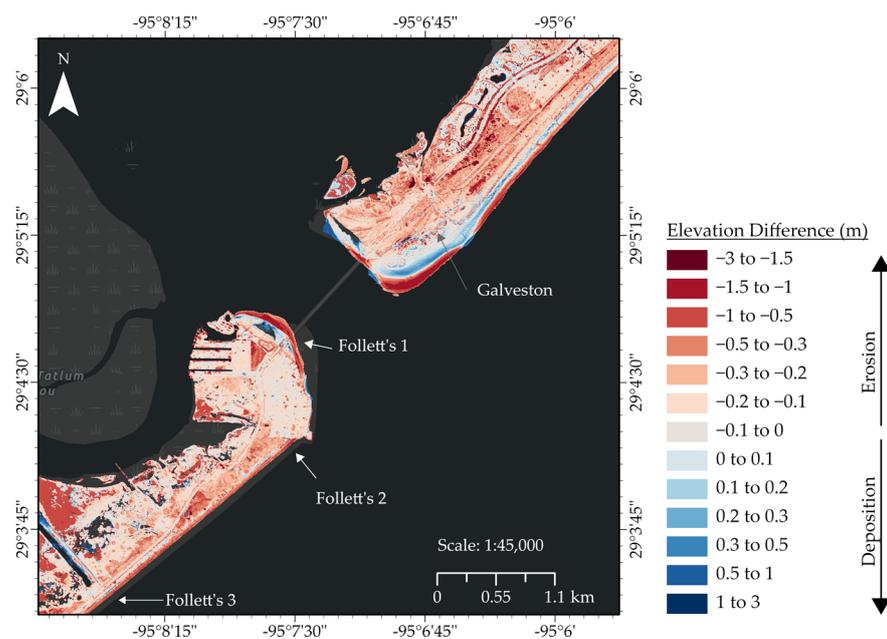
**Figure 8.** Elevation difference map for the full extent of the 2016 and 2017 San Luis Pass. Post-Harvey 2017 data were collected between 31 August and 29 October.

The instantaneous changes to Galveston and Follett's Islands due to Harvey can be seen in Figure 8. Follett's Island experienced shoreline retreat, with scarped shorelines and back beaches. All of Follett's sites were eroded back to the pre-Harvey coppice dunes boundaries, while coppice dunes decreased in height. Washouts can be seen between evenly spaced dunes along the linear section of Follett's Island. Washover fans are also visible, with erosion along the throat and sediment deposition behind the foredune features. Overwash fans were not observed along Galveston Island; however, the shoreline and berms were scarped, and berm buildup was seen along the post-Harvey shoreline. Sediment accumulation occurred between interdunal troughs and along the coppice dune boundaries, widening previous dune extents (Figure 8).

The western end of Galveston Island experienced scarped shorelines, but the flat beach and coppice dunes were unaffected by storm waves (Figures 8 and 12c). Berm buildup near the post-storm shoreline is shown in Figure 8, with an increase in up to 0.5 m in elevation. Various levels of vertical erosion can be seen along coppice dune heights, with sediment depositional values of up to 0.4 m around coppice dune boundaries. Some instances of seaward advance were present among coppice dunes due to rear-slope erosion and sediment accumulation on the seaward boundary, as seen in Figure 12c. There were various degrees of erosion along foredune ridges with sediment deposition between ridges in the interdunal troughs. The Galveston Site shown in Figure 12 displayed more segmented foredune complexes than laterally longer and linearly connected foredune ridges seen in Figure 8. As seen in Figure 12, rear-slope erosion occurred along the foredunes; however, other laterally longer and taller foredunes exhibited rear-slope accretion after Harvey (Figure 8).

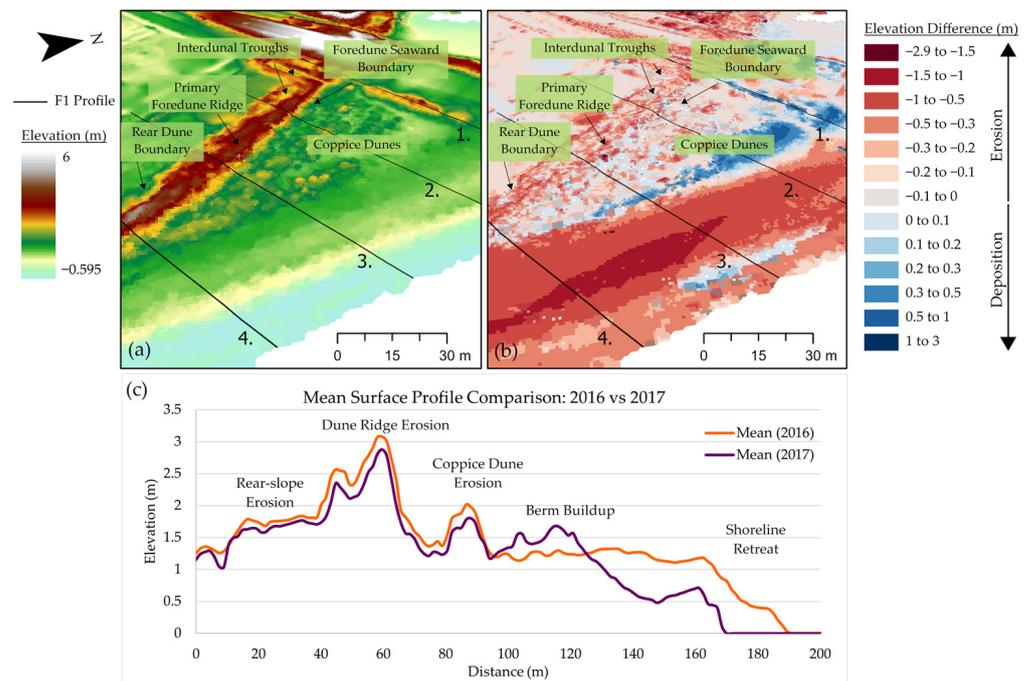
**Figure 9.** Change analysis for Follett’s Site 1. (a) A 3D model of 2016 USACE’s edited topobathy lidar-derived DEM with 4 shore perpendicular transects used to compare pre- and post- storm beach profiles within Follett’s Site 1; (b) DEM difference map created using USACE’s 2016 and BEG’s 2017 surface elevation data draped over the 2016 elevation model to show changes to the site after Harvey; (c) The 2016 and 2017 mean profiles for transect 2 overlaid for comparison.

Erosion to Follett's Site 1 foredune rear-slope and ridge height varied with values up to 0.5 m seen in Figure 9b. The pre-storm shoreline, berm, and backbeach in Figure 9a have scraped away between data sets, visualized by a concave profile in Figure 9c. Vegetated hummocky coppice dunes were eroded vertically, and up to 0.7 m of sediment was deposited along the post-storm berm.

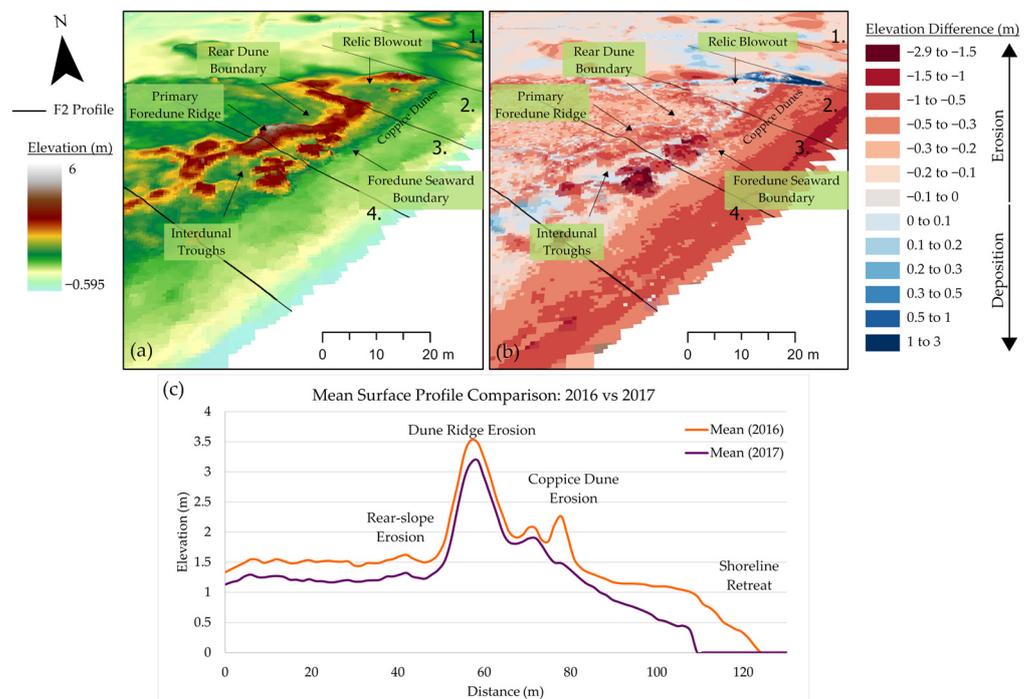
**Figure 10.** 3D models of Follett’s Site 2. (a) A 3D model of 2016 USACE’s edited topobathy lidar-derived DEM with 4 labeled shore perpendicular transects used to compare pre- and post- storm beach profiles within Follett’s Site 2; (b) DEM Difference Map was created using USACE’s 2016 and BEG’s 2017 surface elevation data draped over the 2016 elevation model to show changes to the site after Harvey; (c) The 2016 and 2017 mean profiles for transect 4 overlaid for comparison.

Scarped shorelines and backbeach areas were observed along Follett's Site 2 (Figure 10b) and in the subtle post-storm concave beach profile in Figure 10c.

Pre-Harvey foredunes within Site 2 were ~3 m tall, with a few instances of ~4 m tall (Figure 10a). In some cases, the coppice dunes decreased in elevation from 0.5–1.5 m, while taller primary foredune ridges further inland were eroded by up to 0.5 m. A ~1.5 m elevation increase is observed within a relic blowout linear shore-perpendicular dune at the east end of the survey.

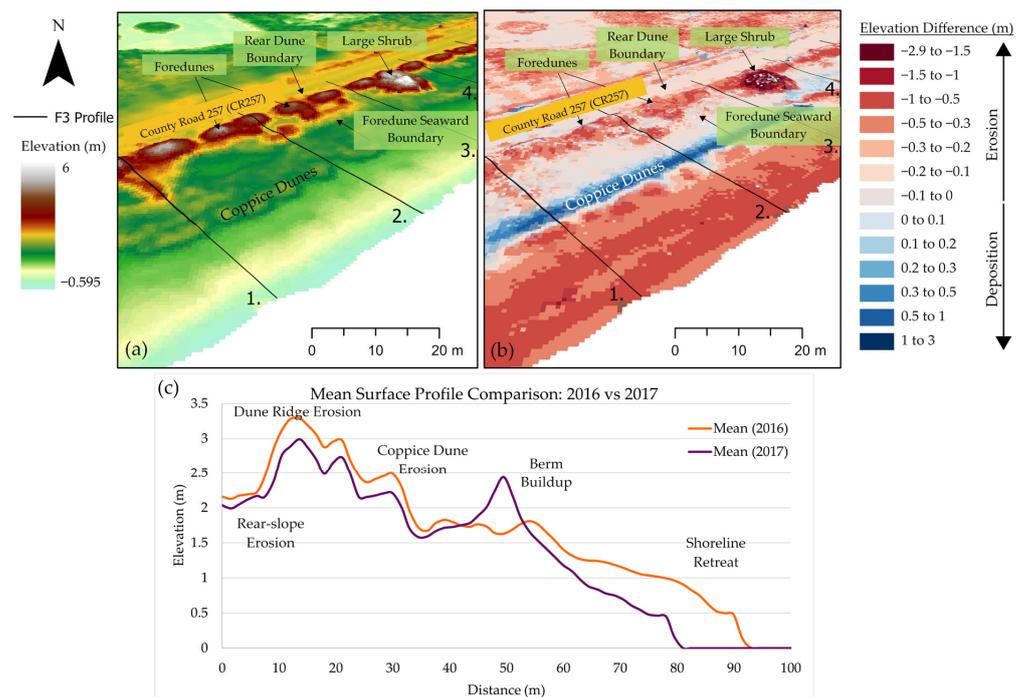
**Figure 11.** 3D models of Follett's Site 3. (a) A 3D model of 2016 USACE's edited topobathy lidar-derived DEM with 4 shore perpendicular transects used to compare pre- and post-storm beach profiles within Follett's Site 3; (b) DEM Difference Map was created using USACE's 2016 and BEG's 2017 surface elevation data draped over the 2016 elevation model to show changes to the site after Harvey; (c) The 2016 and 2017 mean profiles for transect 2 overlaid for comparison.

Follett's Site 3 experienced a scarped shoreline and berm zone, resulting in shoreline retreat with backbeach erosion up to the coppice dune boundary. Berm buildup along the post-storm shoreline of up to 0.8 m coincided with coppice dune boundaries (Figure 11b,c). Pre-Harvey foredunes of 3.5–4 m tall pre-Harvey (Figure 11a) were eroded up to 0.49 m after Harvey. As an example of changes to Site 3, Figure 11c shows erosion along the dune ridges, front and rear foredune toes, and along the berm and shoreline (Figure 11c).

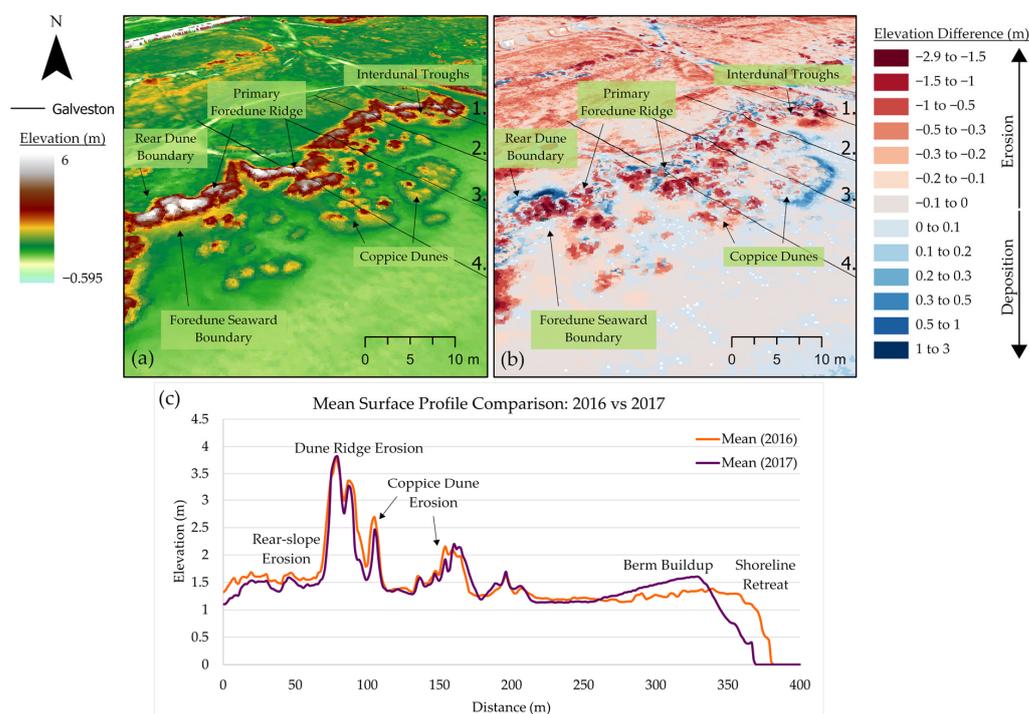
**Figure 12.** 3D models of Galveston Site. (a) A 3D model of 2016 USACE's edited topobathy lidar-derived DEM with 4 shore perpendicular transects used to compare pre- and post-storm beach profiles within the Galveston Site; (b) DEM Difference Map was created using USACE's 2016 and BEG's 2017 surface elevation data draped over the 2016 elevation model to show changes to the site after Harvey. (c) The 2016 and 2017 mean profiles for transect 3 overlaid for comparison.

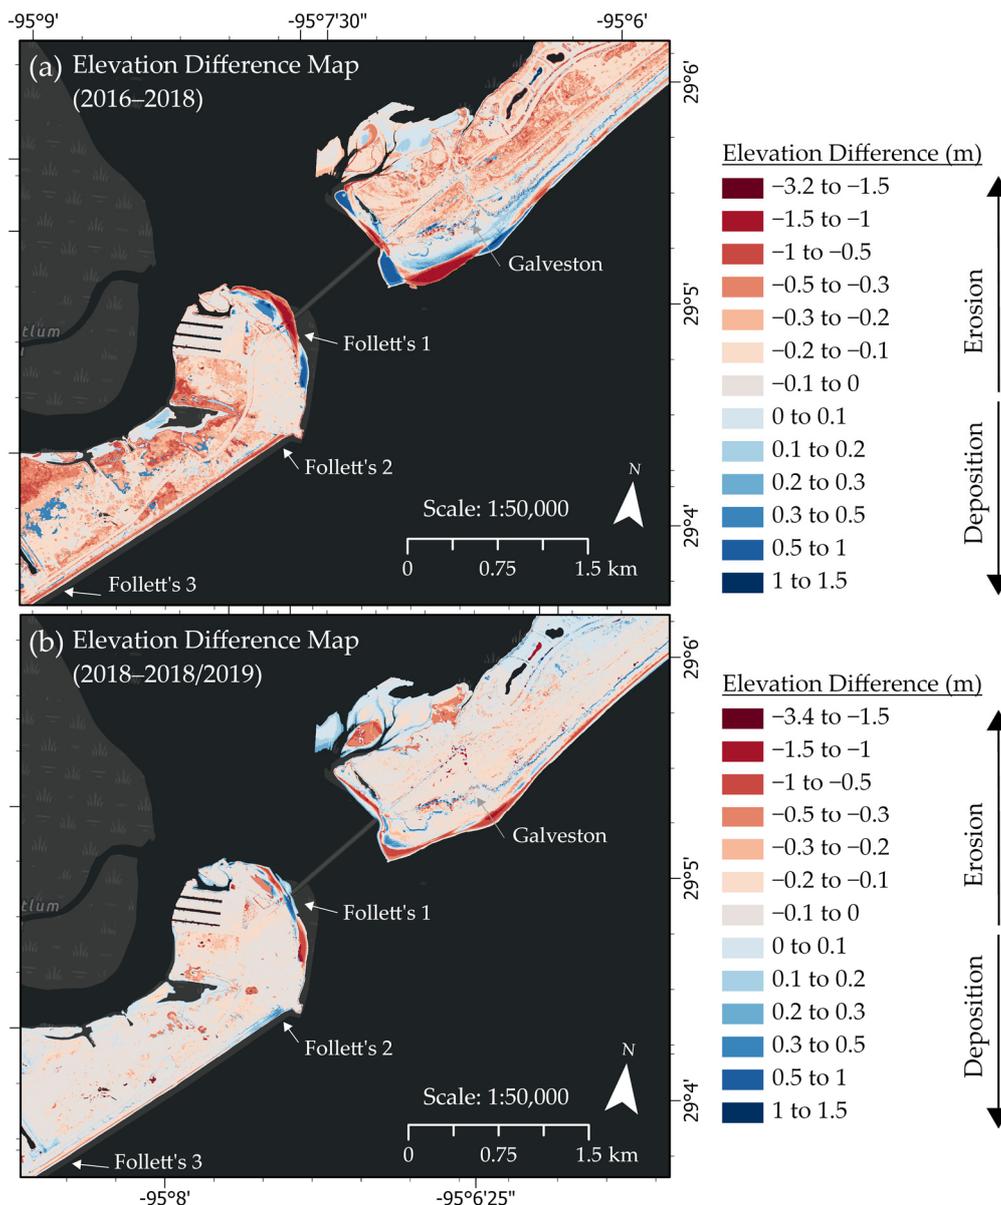
**Figure 13.** Comparison of elevation difference maps. (a) A difference map generated by comparing 2016 and 2018 bare ground data sets; (b) A difference map was generated by comparing 2018 and 2018/2019 data (Table 1).

Shoreline and backbeach erosion were observed along Follett's Site 1 in Figure 13a, with berm buildup of up to 0.6 m occurring between October 2016 and March 2018. Values of up to 0.3 m of erosion occurred among the fore-dune ridge within Site 1. Shoreline advance occurred along the stone revetment backing residential areas south of Follett's Site 1 (Figure 13a). Shoreline retreat due to scarped shorelines and coppice dunes were observed along Follett's Site 2. Additionally, ~0.4 m of sediment deposition along the fore-dunes was observed around Follett's Site 2 in Figure 13a. The berm buildup displayed values of up to ~0.6 m along the coppice dune boundary in Follett's Site 3 (Figure 13a). The throats of washover fans between Follett's Site 2 and 3 were not as prominent in March of 2018 (Figure 13a) as in October 2017 (Figure 8), but deposition was still observed landward of the fore-dune boundary (Figure 13a). Shoreline retreat was observed along the southwestern toe of Galveston Island, with areas of shoreline advance on both sides of the erosional feature seen in Figure 13a. Berm buildup of up to ~0.4 m was observed by March 2018. Deposition around seaward coppice dune boundaries was up to ~0.4 m, while laterally longer fore-dunes experienced up to 1 m of rear-slope accretion.

Between March 2018 and March 2019, Follett's Site 1 experienced backbeach aggradation and shoreline advance. The stone revetment south of Site 1 experienced significant erosion, shown in Figure 13b. Increases in elevation among the shoreline and backbeach of Follett's Site 2 are represented as a large light blue zone in Figure 13b. Increases of up to 0.5 m were observed among the fore-dune complexes of Site 2 (Figure 13b).

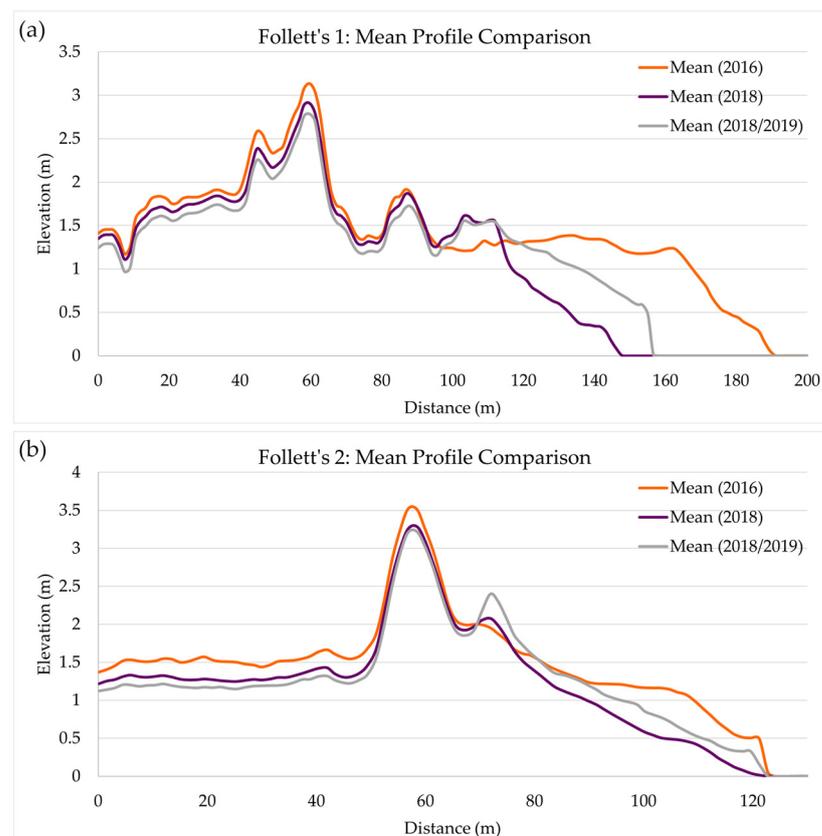
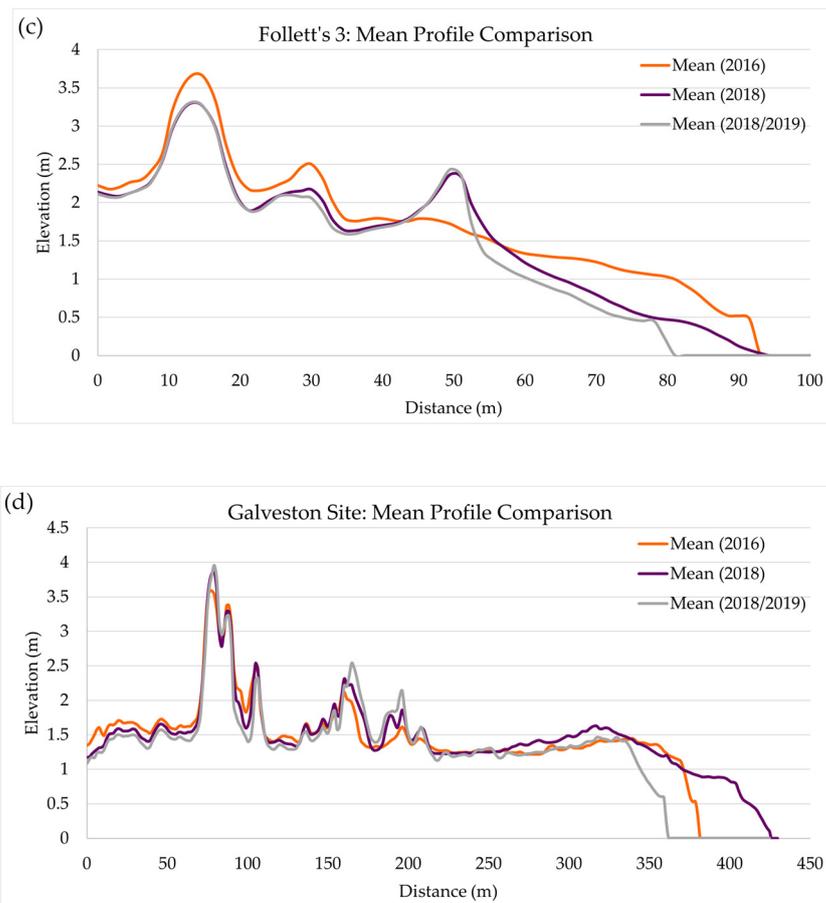
Figure 14. Cont.

**Figure 14.** Multiyear profile analyses to examine temporal variation from 2016 to 2019. (a) Follett's Site 1 Profile 2; (b) Follett's 2 Profile 4; (c) Follett's Site 3 Profile 2; (d) Galveston Site Profile 3.

Follett's mean profiles extracted from DEMs are presented as an example of morphology over time (2016 to 2019) within select sites within this study (Figure 14). Follett's sites in Figure 14a,c have smoother mean profiles compared to the jagged Galveston site mean profile (Figure 14d). Follett's Site 1 in Figure 14a shows vertical erosion along the foredune and coppice dune ridges, along with rear-slope erosion along the foredune landward

boundary. Between October 2016 and March 2018, the shoreline was scarped, as shown in a concave profile in Figure 14a; however, berm buildup along the post-storm shoreline was higher than pre-storm conditions (Figure 14a). Backbeach aggradation continued elongating the backbeach extend through March 2019, but elevations remained below pre-storm conditions (Figure 14a).

Between October 2016 and March 2019, Follett's Site 2 experienced vertical erosion along the foredune ridge, rear and seaward foredune boundaries. Scarped shorelines and backbeach are shown in Figure 14b, while coppice dunes around 2 m increased in height between 2018 and 2019.

Erosion along foredune ridges and coppice dune ridges occurred along Follett's 3 between October 2016 and March 2018 (Figure 14c). The shoreline was scarped away by storm waves, and berm buildup occurred along the post-storm shoreline. Between March 2018 and March 2019, the foredune and new seaward most coppice dune features appear relatively stable based on Figure 14c. The backbeach and shoreline within Follett's Site 3 continue to erode into March 2019 (Figure 14c).

Lastly, Figure 14d shows localized shoreline advances between October 2016 and March 2018. The Galveston mean profile shows vertical aggradation along foredune ridges, coppice dune ridges, and along the backbeach by March 2018 (Figure 14d). As of March 2019, the shoreline retreated further than the 2016 position, and backbeach elevations resemble pre-storm 2016 levels (Figure 14d). By March 2019, foredune ridges and some coppice dune heights were higher than pre-storm 2016 heights, while erosion continued to occur along the rear foredune boundary between 2016 and 2019 (Figure 14d).

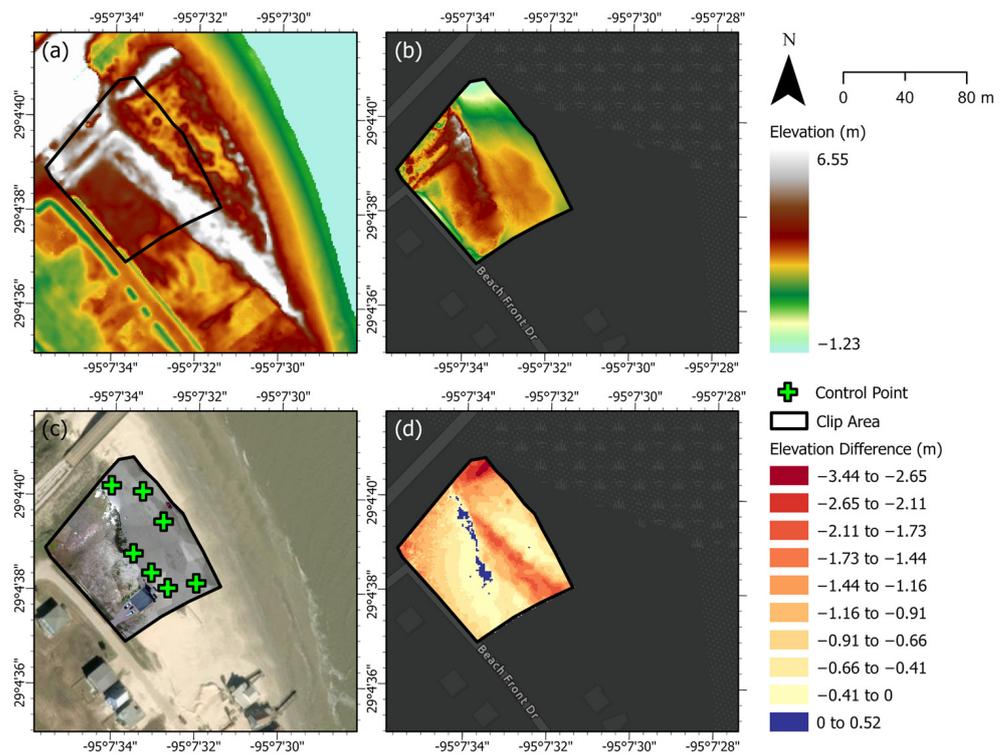
**Figure 15.** Follett’s Site 1 comparison of 2022 UAV data and 2018/2019 data. Spatial Reference: NAD 1983 UTM Zone 15n. (a) 2018/2019 NOAA’s Post Hurricane Harvey elevation model with survey clipping boundary; (b) May 2022 digital elevation model; (c) May 2022 orthophoto with a World Imagery Maxar base map; (d) Elevation difference map with erosion represented as yellow through red, and deposition represented by blue.

As of May 2022, the ~3 m tall foredune ridges within Follett's Site 1 (Figure 15a,d) were shortened by 1–2 m. Additionally, the dune segment decreased from ~150 m across to ~60 m before intersecting with the property, and the foredune width decreased from ~20 m to ~10–15 m (Figure 15a,b). The foredune eroded from the seaward side and shifted backward, pushing sediment behind the ridge (Figure 15d).

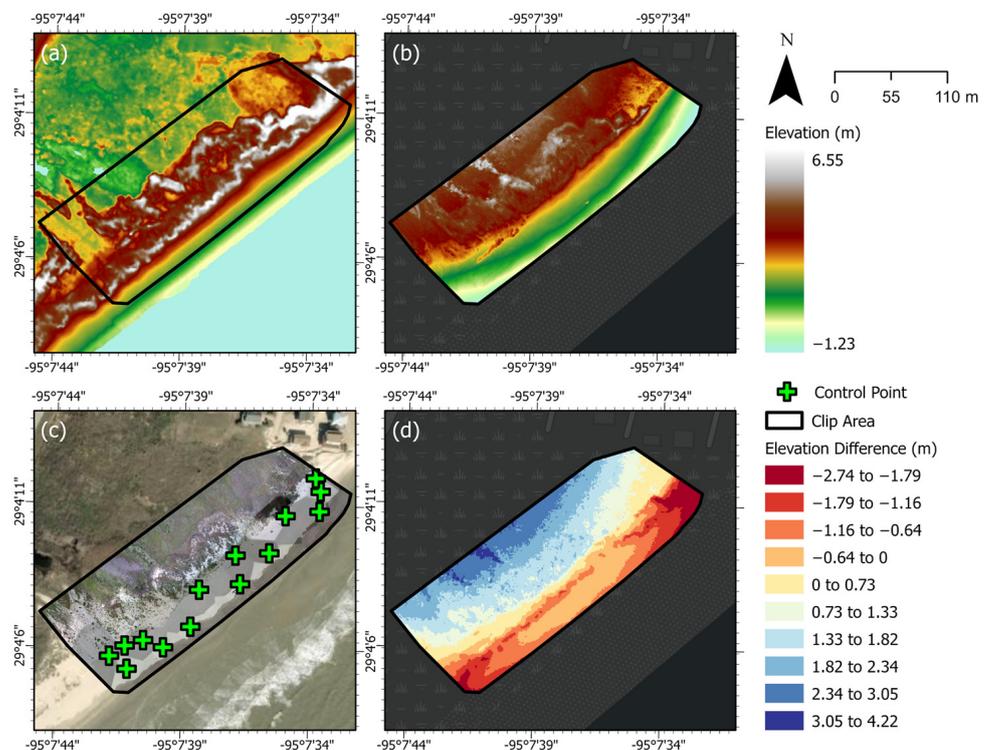
**Figure 16.** Follett’s Site 2 comparison of 2022 UAV data and 2018/2019 data. Spatial Reference: NAD 1983 UTM Zone 15n. (a) 2018/2019 NOAA’s Post Hurricane Harvey elevation model with survey clipping

boundary; (b) May 2022 digital elevation model; (c) May 2022 orthophoto with a World Imagery Maxar base map; (d) Elevation difference map with erosion represented as orange through red, and deposition represented by yellow to blue.

May 2022 UAV surveys of Follett's Site 2 no longer show the shore-parallel linear primary foredune ridge seen in Figure 16a and further erosion of the foredune boundary inland by up to 0.63 m. UAV DEMs also show increases in elevation, or sediment accumulation, occurring behind the post-storm foredune boundary filling interdunal troughs higher than 2019 levels (Figure 16b,d).

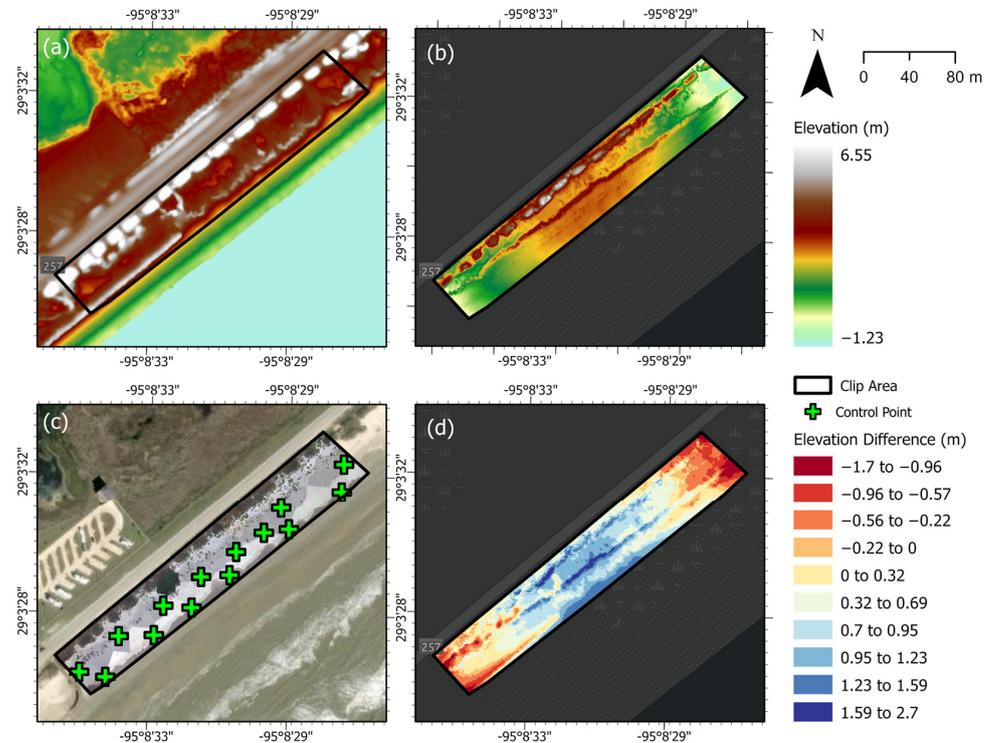
**Figure 17.** Follett's Site 3 comparison of 2022 UAV data and 2018/2019 data. Spatial Reference: NAD 1983 UTM Zone 15n. (a) 2018/2019 NOAA's Post Hurricane Harvey elevation model with survey clipping boundary; (b) May 2022 digital elevation model; (c) May 2022 orthophoto with a World Imagery Maxar base map; (d) The elevation difference map with erosion represented as orange through red, and deposition represented by yellow to blue.

As of March 2019, the main foredune features along Site 3 were ~10 m wide (Figure 17a), while 2022 foredunes are about 8 m wide. Additionally, there were instances of increasing foredune heights seen in blue (Figure 17d). The May 2022 UAV elevation data (Figure 17b) included the wet/dry shoreline boundary along the southeastern polygon boundary. In comparison to the 2019 shoreline seen in Figure 17a, shoreline retreat was observed between March 2019 and 2022, where the shoreline was cut back to the seaward most coppice dunes. The initial berm build-up along the coppice dune boundary that appeared after Harvey has been eroded by 2022 (Figure 17d). Additionally, the seaward most coppice dunes seen in Figure 17a have been eroded or moved further inland, as there was a new coppice dune ridge formed in the 2022 imagery (Figure 17b) not previously seen in the 2019 imagery; seen as accretion (blue) in Figure 17d.

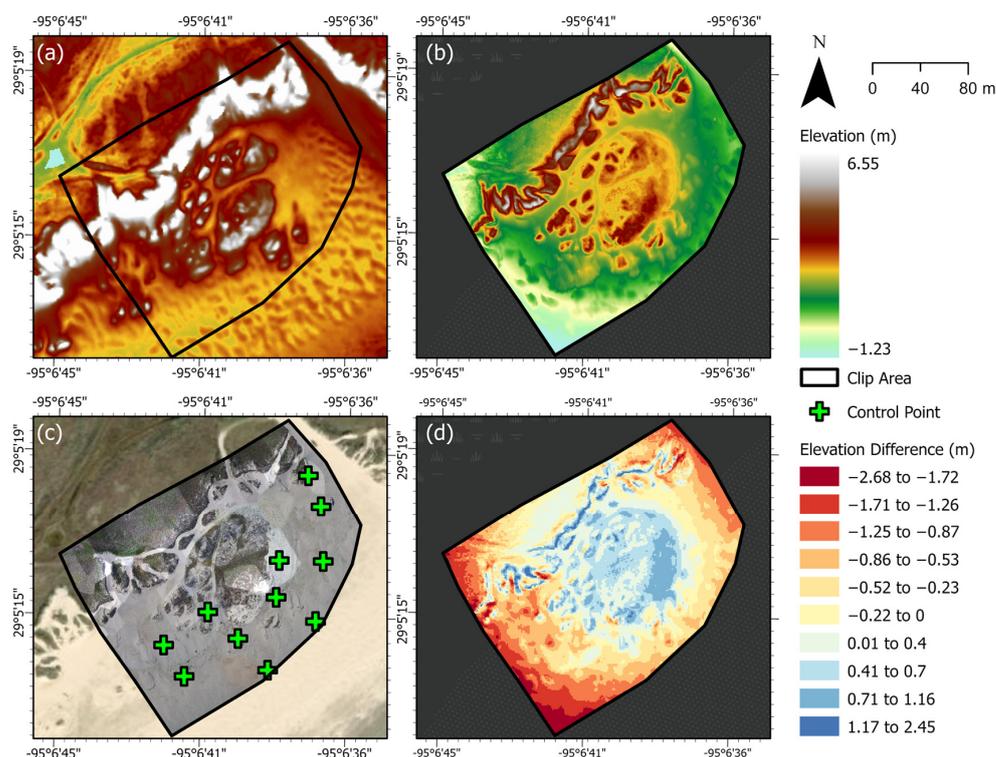
**Figure 18.** Galveston Site comparison of 2022 UAV data and 2018/2019 data. Spatial Reference: NAD 1983 UTM Zone 15n. (a) 2018/2019 NOAA's Post Hurricane Harvey elevation model with survey clipping boundary; (b) May 2022 digital elevation model; (c) May 2022 orthophoto with a World Imagery Maxar base map; (d) The elevation difference map with erosion represented as light green through red, and deposition represented by shades of blue.

The primary foredunes at the Galveston Site run parallel to the shore and have longer segments than Follett's sites, around 3 to 5 m tall in 2019, with shore-perpendicular widths of 20 to 30 m (Figure 18a). The 2022 UAV surveys (Figure 18b) show the foredune shore-perpendicular widths to be around 5 to 10 m, as sediment was eroded along the rear foredune slope. The dunes within this survey appear to have migrated slightly toward the shore at levels of around 2 m of sediment accumulated along the seaward foredune slope while the landward boundary eroded (Figure 18d). Various levels of deposition occurred around the lightly vegetated coppice dunes seen in Figure 18d, where sediment was trapped around the base of the dune boundaries widening the coverage area and increasing the heights.
