## Long-Term Bending Creep Behavior of Thin-Walled CFRP Tendon Pretensioned Spun Concrete Poles

**Abstract:** This paper discusses the long-term behavior of a series of highly-loaded, spun concrete pole specimens prestressed with carbon fiber-reinforced polymer (CFRP) tendons, which were subjected to outdoor four-point bending creep tests since 1996 in the frame of collaboration with the Swiss precast concrete producer, SACAC (Società Anonima Cementi Armati Centrifugati). The 2 m span cylindrical beams studied are models for lighting poles produced for the last 10 years and sold on the European market. Five thin-walled pole specimens were investigated (diameter: 100 mm; wall-thickness: 25–27 mm). All specimens were produced in a pretensioning and spinning technique and were prestressed by pultruded CFRP tendons. Initially, two reference pole specimens were tested in quasi-static four-point bending to determine the short-term failure moment and to model the short-term flexural behavior. Then, three pole specimens were loaded to different bending creep moments: while the lowest loaded specimen was initially uncracked, the second specimen was loaded with 50% of the short-term bending

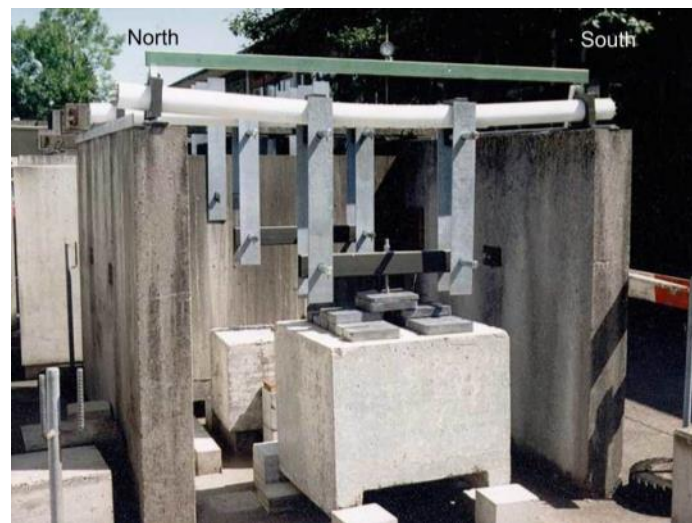
**Figure 2.** Outdoor bending creep test of the highest loaded pole specimen (pole No. 14).

In the outdoor bending creep experiments, concrete blocks of known mass were hung in the two third-points of the pole specimens. Lead plates fixed thereon allowed the precise adjustment of the selected load level, taking into account the mass of the steel loading devices (Figure 2). Pole No. 12

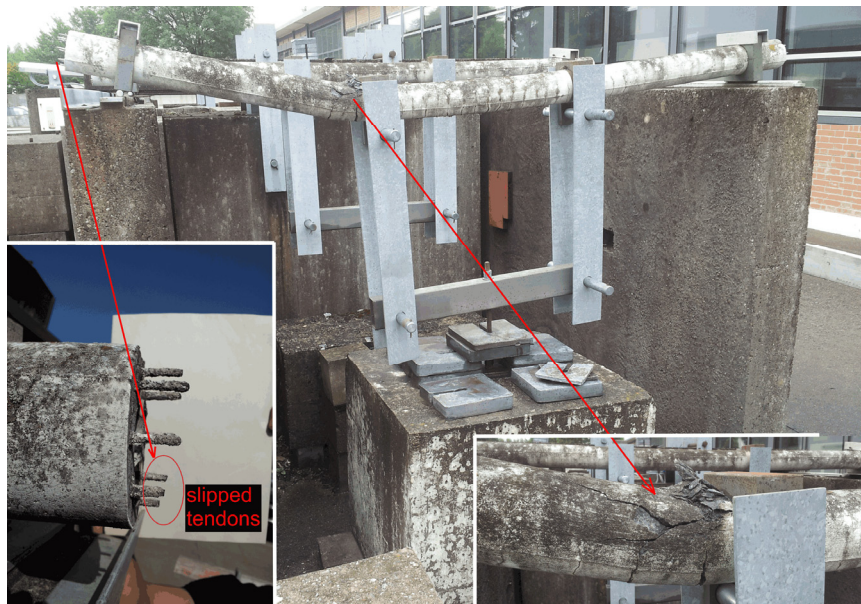
**Figure 6.** Failure of pole No. 14 due to slippage of the lowest CFRP tendon in the tensile zone at the north end of the pole, which led to local crushing of the high strength spun concrete.

increased to 16.28‰ (2942 MPa). This increased tendon stress was calculated from the measured values of  $\Delta\epsilon_{c,max}$  at the top edge and  $\Delta\epsilon_{t,max}$  at the lower edge of the pole and shows the stress redistribution over the section due to bending creep and crack growth. It is hypothesized that this increased bottom tendon strain and the coating's bond creep led to the CFRP anchorage failure by debonding of the  $Al_2O_3$  sand coating from the CFRP tendon surface after 16.5 years.
