Experimental Study on the Fracturing Behaviors and Mechanical Properties of Cracks under Coupled Hydro-Mechanical Effects in Rock-like Specimens

Keywords: Coupled hydro-mechanical effect; triaxial compression loading test; microscopic observation; tensile and shear properties

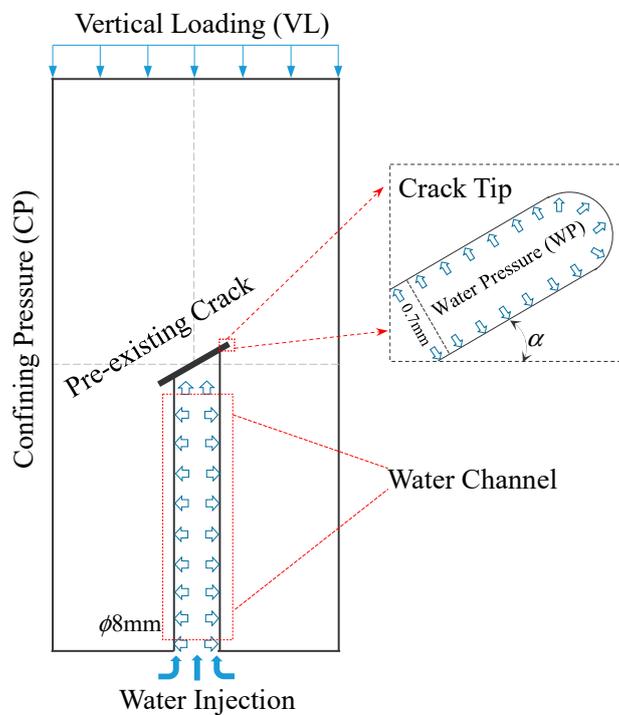
**Figure 1.** Loading conditions used in the hydraulic fracturing tests.

The cylinder gypsum specimens (Table 1) used in the fracturing tests were $\phi 50 \text{ mm} \times 100 \text{ mm}$, and the crack length and aperture were 14 mm and 0.7 mm, respectively. The specimens are comprised a mixture of gypsum, water, and retarder in the ratio by weight of 1:0.35:0.005. To generate single pre-existing crack, a piece of mica sheet ($60 \times 14 \times 0.7 \text{ mm}^3$) is placed into slots in the mold template and remained in the specimen during curing. To create different crack inclination angles, the orientations of the mica sheet are predetermined and can be adjusted with the slots. As shown in Figure 1, in order to fill the pre-existing cracks with water pressure, a hydraulic channel with a diameter of 8mm was drilled in advance. This hydraulic channel was in the middle of the specimen along the vertical direction from the bottom to the pre-cracks. The inclination angle of pre-existing crack (α) varied from 15° to 75° in 15° increments. In the present study, '30° specimen' denotes the specimen for which α is 30° .

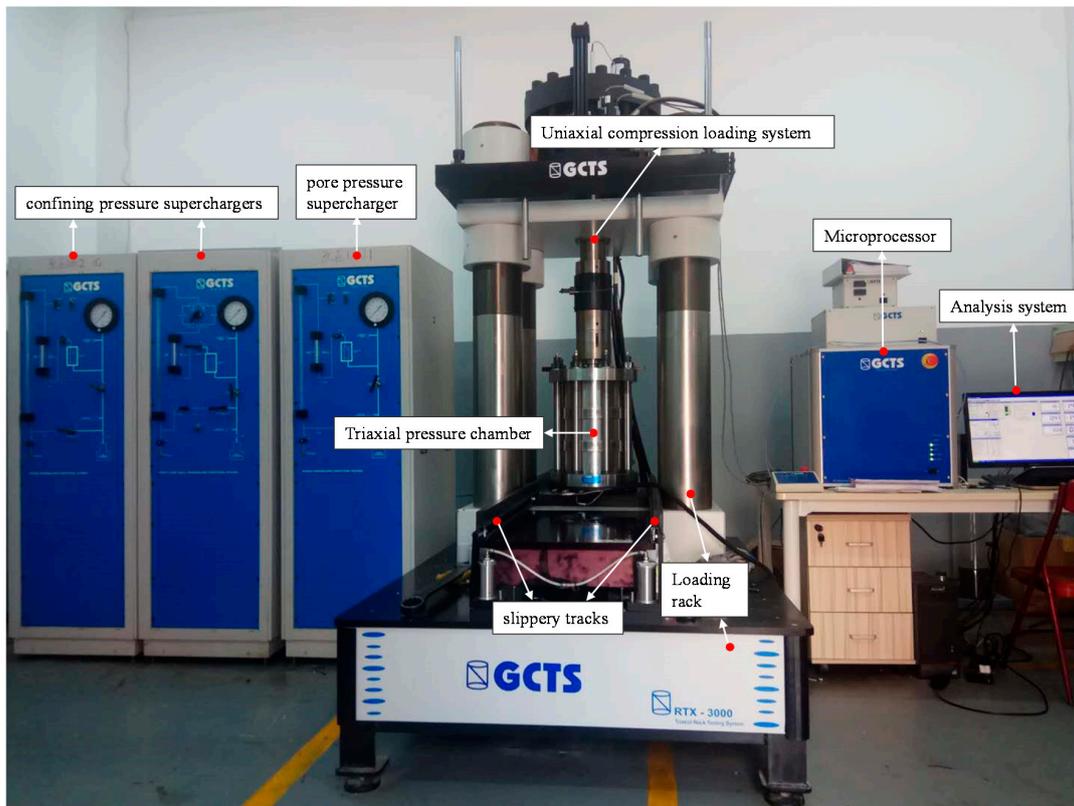
Figure 2. GCTS RTX-3000 triaxial rock testing system.

The macroscopic experiments in this study were conducted using a GCTS RTX-3000 triaxial rock testing system (Figure 2), which is housed in Tongji University, China. This testing system consists of a uniaxial compression loading system, a loading rack with slippery tracks, a triaxial pressure chamber, two confining pressure superchargers, a pore pressure supercharger, a microprocessor, and an analysis system. The uniaxial compression and confining pressure are applied using a piston mounted inside the confining vessel and the confining hydraulic oil, respectively. The fracturing fluid can be injected inside the specimens simultaneously inside the pressure chamber.

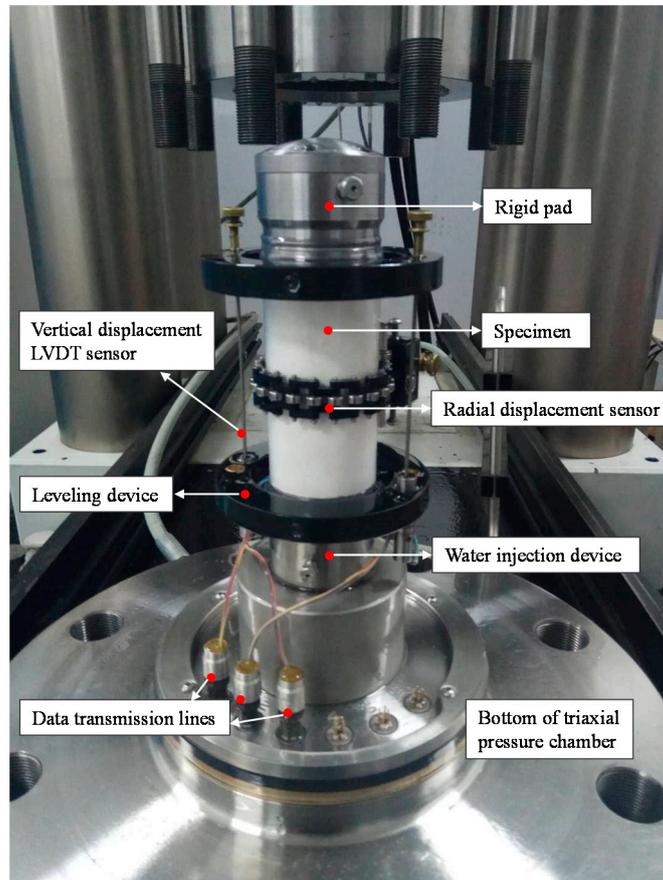
Figure 3. Photograph of experimental devices installed.

Figure 3 shows the specimen with the experimental devices installed. The measurement accuracy of the vertical displacement LVDT sensors and the radial displacement sensor are 0.001 mm. The procedure to perform the hydro-mechanical fracturing experiment is divided into five steps. First, adjust the pressure cushion to reach the boundary of the specimen, and ensure the reading of displacement sensors are 0. Second, apply the confining pressure to the target level at a rate of 0.1 MPa/s. Third, inject the fracturing water at a constant rate of 0.2 mL/s into the specimen through the water channel, the constant injection will last 5 min after the water pressure reaches the target level. Fourth, apply the vertical loading to the specimen using displacement control at a rate of 0.1 mm/min until the specimen failure. Finally, export the test data, which are recorded at a rate of 10 Hz, and unload the water pressure, the confining pressure, and the axial pressure alternately. In this study, the confining pressure was 6 MPa, and two hydraulic pressure values (0 MPa and 5 MPa) were applied to the specimens with the same inclination angles.

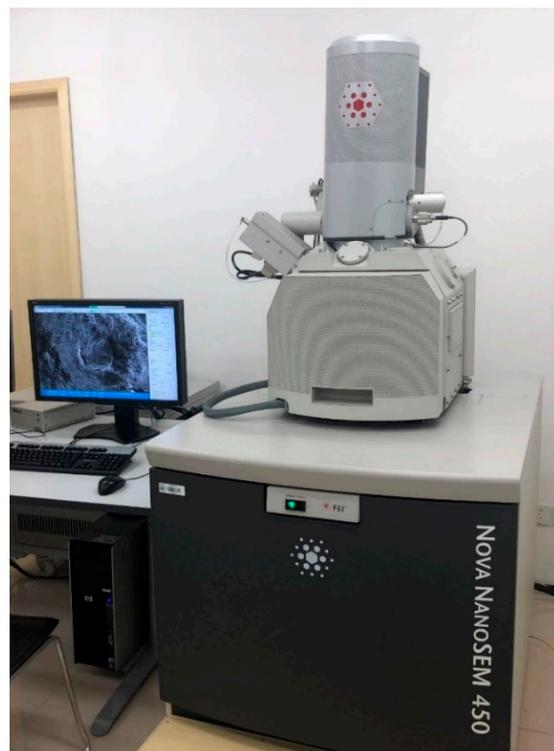
Figure 4. SEM system-Nova NanoSEM 450.

In order to investigate the mechanical properties of hydro-mechanical coupled cracks on a micro-scale, a scanning electron microscope (SEM) test was then carried out. The SEM system, Nova NanoSEM 450, in Tongji University was used for this study (Figure 4). The failure specimens were trimmed down to appropriate sizes (10 mm wide \times 5 mm thick \times 8 mm high), and a gold coating was applied to the fracture surfaces of the specimens before being placed in the SEM. In order to improve the clarity and accuracy of the scanning images, the SEM system was operated under the accelerating voltage of 10 KV. Thus, the measuring error caused by electronic reflection was reduced to 1.2 nm.

As reported in the Section 3.1, the crack type of HCC cannot be confirmed on a macro scale. Therefore, this section deals with the microscopic aspects of the study. Specifically, the scanning electron microscope (SEM), Nova NanoSEM 450, which is housed in Tongji University since 2016, was adopted for this research.

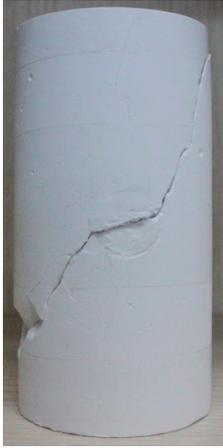
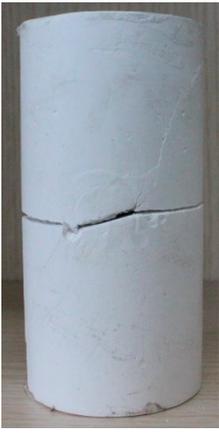
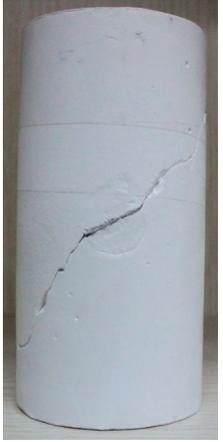
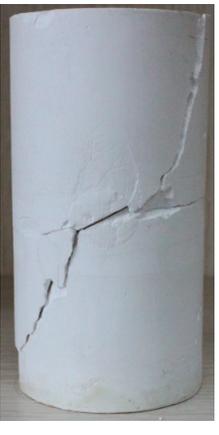
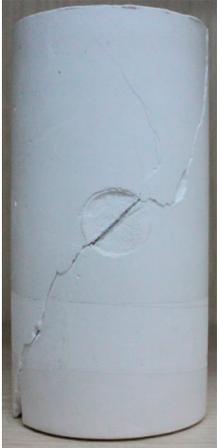
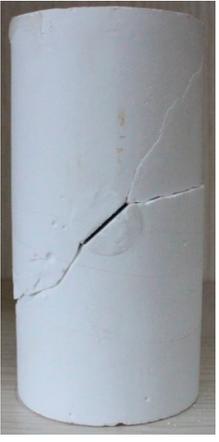
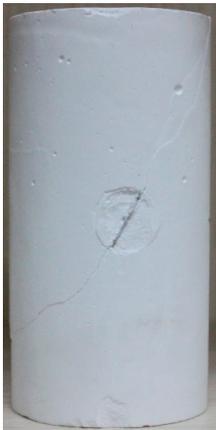
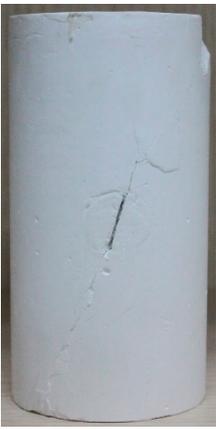
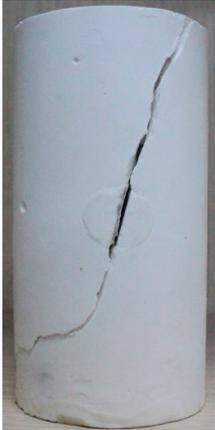
Table 2. Fracturing trajectories of dry cracks and coupled cracks.

As shown in the left column of Table 2, the failure statuses and crack trajectories of dry cracks are quite similar to the outcomes of uniaxial compression loading tests [39] and numerical simulation results. There was no secondary cracks or anti-wing cracks occurred, but only two primary cracks developed from the crack tips throughout the whole loading processes no matter how large the inclination angle was. It should be noted that these primary cracks were not simply equivalent to wing cracks even if they were similar on crack trajectories. Wong and Einstein [40] proposed that wing crack is an item to describe the shape of crack pattern and it should be only used for tensile cracks. When the primary cracks initiated, tensile properties of them were predominant. However, with the cracking propagation, shear properties of these cracks became more and more obvious. Moreover, in some specimens with large inclination angles, like 60° specimen and 75° specimen, shear cracks would initiate from the outer

tips of pre-existing cracks and led to the specimen failure. Actually, the primary dry cracks in this paper consisted of tensile cracks, shear cracks, and mixed cracks. Based on our previous experimental and numerical study [39,41], the types of dry cracks can be separated by macroscopic observation and analysis on the tensile/shear strain field. Considering this is not the focus of this paper, the mechanical properties and crack nature of dry cracks are directly marked in Table 2 without more analysis ('T' for tensile cracks and 'S' for shear cracks). While both the tensile cracks and shear cracks can be further divided into many subtypes, this paper only use items tensile and shear in the figures.

In general, the mechanical properties of cracks can be reflected from the observable cracking behaviors to a great extent. Therefore, the authors are willing to first have a qualitative understanding on the tensile or shear properties of HCC on a macro scale. HCC did not show various crack initiation directions with respect to the pre-existing crack, which were controlled by the water pressure and

stress field around the crack tips. Moreover, these HCC generally inclined at an angle of about 10° – 15° and propagated nearly parallel with the confining compression direction and follow well-defined paths. These phenomena were very consistent with the cracking behaviors of tensile cracks. According to the Mohr-Coulomb yielding criterion, the angle between the shear failure plane and the minimum principal stress should be $45^{\circ} + \varphi/2$, where φ is the angle of internal friction angle of the specimen. In this study, φ is 30° , which indicates if HCC were shear cracks, the initiation direction should be 60° instead of 10° – 15° . Based on the above analysis on cracking initiation direction and propagation processes, HCCs are more like tensile cracks than shear cracks, and this further confirms that HCC are not a type of secondary cracks or anti-wing cracks.

To draw conclusion of the mechanical properties of HCC comprehensively, the fracture surfaces of them were investigated. Observing the HCC near the pre-existing crack, the fracture surface was clean and smooth, which indicated that a large number of tensile cracks appeared in this area. The HCC were tensile cracks at the initiation moment. However, when observing the HCC near the edges of the specimen, some rough and stepped fracture surfaces was found. In addition, many narrow zones consisting of small staggered cracks were observed around interface of HCC and specimen boundaries, which suggested that shear stress was concentrated at the end of the propagation processes. It can be inferred that a large number of shear cracks initiated and developed quickly at this time and the specimen failure was caused by the interaction of tensile cracks and shear cracks. Based on the above analysis on fracture surfaces, HCC are more like tensile and shear mixed cracks, which are different from tensile cracks.

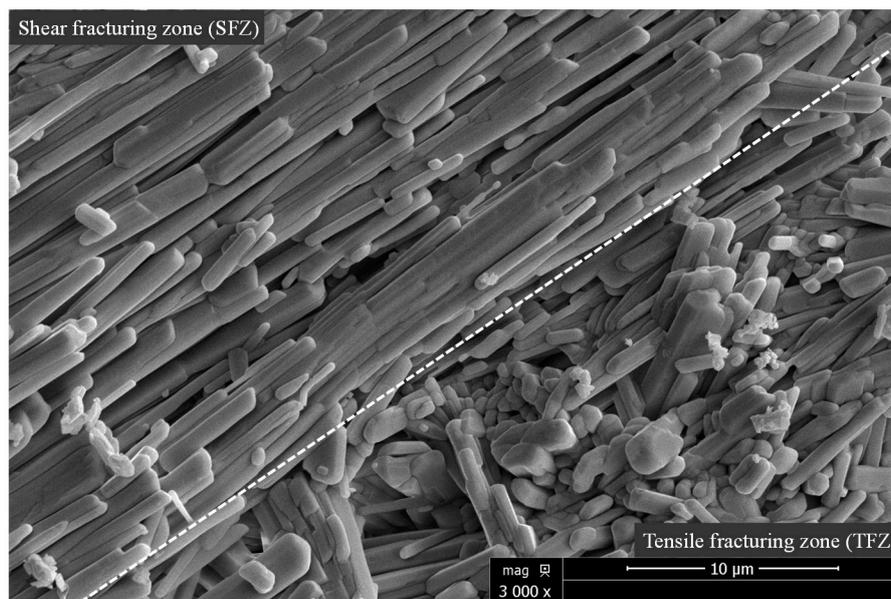
As shown in Figure 5, where the magnification is 3000 times, the microscopic shear fractures and tensile fractures appear in the upper left and the lower right, respectively, and they perform quite differently. Firstly, in shear fracturing zone (SFZ), almost all the gypsum grains are in the same direction, which directly reflects the orientation of shear stress. Intuitively, the SFZ is smooth and neat. On the contrary, in tensile fracturing zone (TFZ), although many gypsum grains orient towards the outside plane, the directions are quite chaotic and irregular. The TFZ is observed to be rough and uneven. Moreover, the length of the gypsum grains are basically the same in SFZ, more than 80% of them are around $15\ \mu\text{m}$ long. However, in TFA, the length of the gypsum grains are different, ranging from $2\ \mu\text{m}$ to $12\ \mu\text{m}$. Third, there are no obvious boundary lines between many gypsum grains in SFZ, they are gathered together to form a larger grain set. This phenomenon

is caused by the simultaneous action of both compression stress and shear stress on the interfaces of grains, which reduces the gaps among grains. In contrast, the gypsum grains in TFZ are more independent, the boundary lines of them are obvious and there are a large number of gaps among grains. This phenomenon is caused by the tensile stress which applied in TFZ during the cracking processes, and many gaps are formed by tensile dislocation of grains. Based on the above judgement criteria, the tensile fracture and shear fracture can be separated easily and accurately on a micro scale using SEM system, and this is the basis of the further microscopic study. It is worth emphasizing that due to many other factors like stress statuses and boundary conditions, the micro characteristics of TFZ and SFZ are not equal to macroscopic characteristics of tensile cracks and shear cracks, which are presented in our previous studies [39,41].

Figure 5. SEM scanning image of SFZ and TFZ.

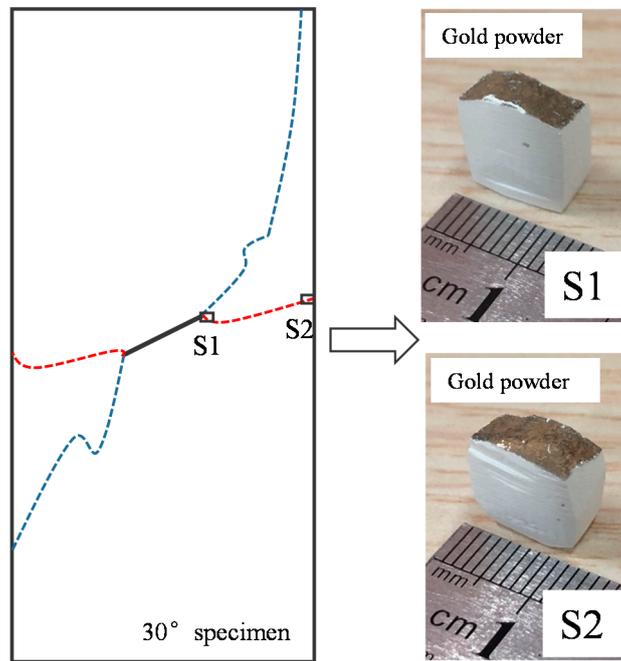
As reported before, the HCC only developed in the specimens with low inclination angles. In this section, the SEM tests were then carried out on the fracture surfaces of HCC in 15°, 30°, and 45° specimen. To help demonstrate the analysis method and reveal the mechanical properties of HCC, the authors select 30° specimen as a representative (Figure 6). As shown in Figure 6, two pieces of scanning specimens ($10 \times 5 \times 8 \text{ mm}^3$), S1 and S2, were trimmed down near the outer tip of the pre-existing crack and the edge of the specimen, respectively. Considering that when a new crack propagates to a certain region, this region will be damaged, and its structure will lose stability and can not bear any external loading. Therefore, the fracture surfaces will be well preserved, and final failure statuses of this region can directly reflect the mechanical properties of a segment of new crack. On this basis, it is regarded that S1 and S2 can reflect the tensile and shear properties of HCC when (1) it just initiated from the outer tip of pre-existing crack, and (2) it reached the edge of the specimen and led to the failure of the specimen.

Figure 6. SEM scanning specimens of HCC in a 30° specimen.

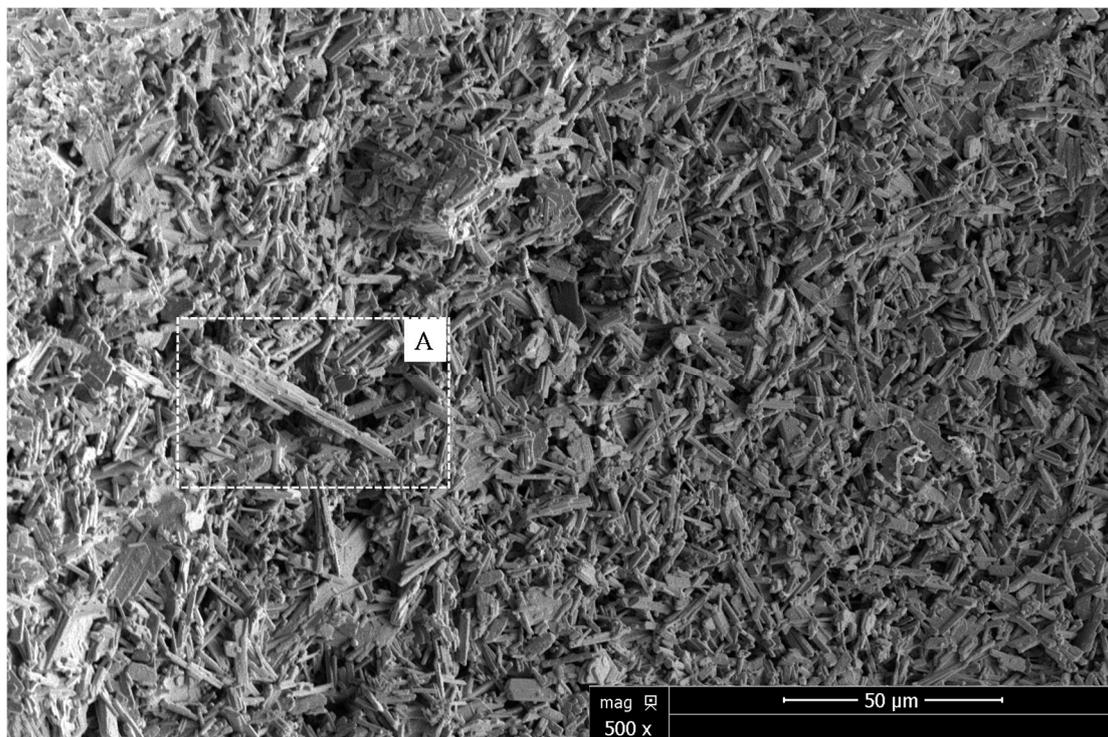
Figure 7 is one of the SEM scanning areas of S1 with the magnification of 500 times. Nearly all the information of gypsum grains can be clearly observed, including their shapes, orientations, length, relative positions, and gaps among grains. Based on the judgment criteria in Section 4.1, the mechanical properties of this scanning area can be obtained from the following aspects. The orientations of grains are chaotic and irregular, more than half of them orient towards the outside plane. The overall observation feeling of this area is rough and uneven. Subsequently, the length of the grains are quite different, although more than 90% of them ranges from 2 μm to 12 μm , some grains are even longer than

50 μm , like Area A, which have been framed in the figure. Moreover, the grains in the scanning section are independent, the boundary lines and gaps among them are clearly enough. These characteristics indicate that this area is caused by tensile stress and exhibits obvious tensile fracture properties.

Figure 7. SEM scanning image of S1 (500 times).

The authors then scanned the rest areas of S1 and found that the remaining areas are almost the same as Figure 7, all the scanning sections show obvious tensile properties, and no shear properties are observed. It can be concluded that only tensile stress, which was caused by the coupled hydro-mechanical effects, was applied on the S1. The water pressure has a significant influence on the internal stress state of coupled cracks compared with triaxial compression loading tests. At the initiation moment, the water pressure resisted the effect of confining pressure and enhanced the effect of vertical loading. The tensile stress around the pre-crack tip reached the critical tensile strength, and then led to the fracture of this area. As a summary, the coupled crack was a tensile crack when it just initiated from the outer tip of the pre-existing crack. This is consistent with the macroscopic observation.

With reference to Figures 7–10 and the above analysis, we can briefly describe the cracking processes of HCC under coupled hydro-mechanical effect. At the beginning of the loading test, the tensile stress highly concentrates around the outer tips of pre-existing crack. Subsequently, due to the water pressure, a horizontal coupled crack initiates when the tensile stress reaches the critical tensile strength of the specimen and gradually propagates towards the edges of the specimen. While tensile stress makes a major contribution to the crack propagation, shear stress gradually increases with the vertical loading. When the specimen is about to fail, the proportion of shear stress reaches 20–30%. Additionally, the coupled crack, which exhibit both tensile and shear fracturing properties simultaneously, is a mixed crack at this time. Meanwhile, the reason for the absence of HCC in 60° specimen and 75° specimen can also be explained. Many previous studies [40,46,47] have revealed that the external loading will favor further propagation of shear cracks in the specimens with steeply-inclined cracks. Considering that the HHC were tensile cracks when they initiated, the large inclination angles (60° and 75°) would strongly inhibit the occurrence of HCC.

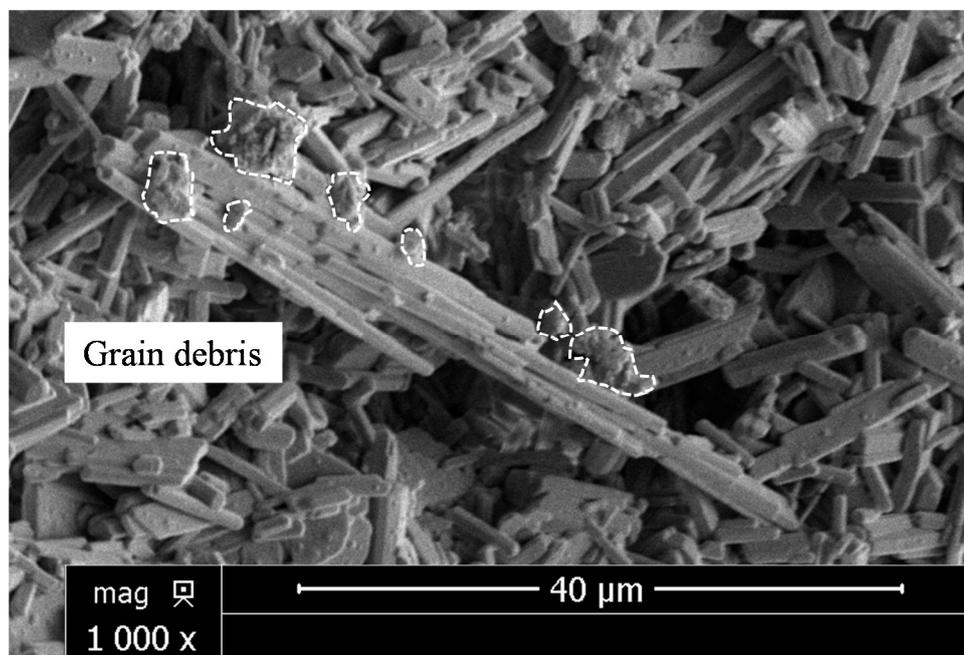
For a further understanding of the stress states applied in this area, the authors magnified the observation multiple to 1000 times of Area A (Figure 8). In addition to the grain orientations, length, and gaps, a large number of debris are observed to be scattered randomly around the tips of gypsum

grains. These grain debris are caused by the pullout effect between the inlaid grains. While the applied pullout stress is not sufficient to reach the critical value of intergranular fracture, some debris will also occur with the relative displacement between the grains. The occurrence of scattered grain debris further confirms the tensile properties of this area.

Figure 8. SEM scanning image of S1 (1000 times).

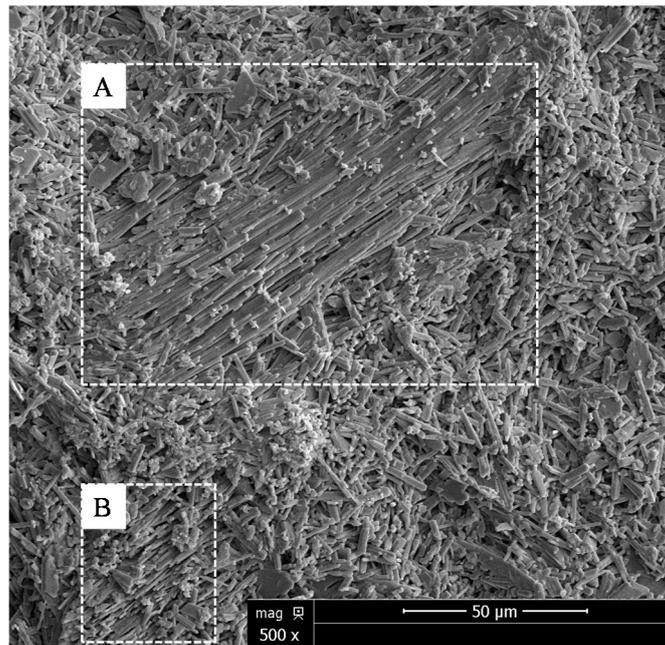
Figure 9 is one of the SEM scanning areas of S2 with the magnification of 500 times. As presented before, all the detailed information, including grain shapes, orientations, and length can be observed. It can be investigated that more than 70% of the scanning areas are basically the same as Figure 7, which indicates that these areas were caused by tensile stress, and exhibit tensile fracture properties. However, nearly 30% of the scanning areas show different micro characteristics, like Area A and B. In order to study the mechanical properties of these areas more directly and precisely, the observation multiple of Area A was then magnified to 1000 times (Figure 10) and the center of the scanning section is highlighted. The following statements are all aimed at the center area. As shown in Figure 10, all the gypsum grains orient towards the same direction, the overall observation feeling of this area is smooth and neat. Subsequently, the length of grains are very uniform, more than 80% of them are around 15 μm . Moreover, there are no obvious boundary lines among many grains, most of them are gathered together to form a larger grain set, and the grain gaps are almost disappeared. Based on the judgment criteria in Section 4.1, this area was caused by shear stress and exhibits obvious shear fracture properties.

Figure 9. SEM scanning image of S2 (500 times).

The authors then scanned the rest areas of S2 and found that the remaining areas were almost the same as Figure 9. Although most of the scanning sections were caused by tensile stress, about 20–30% of the scanning sections showed shear fracture properties. It can be inferred that both tensile stress and shear stress were applied on the S2. At this critical moment of specimen failure, the coupled cracks propagated close to the edges of specimens. Compared with the initiation moment, the resistance

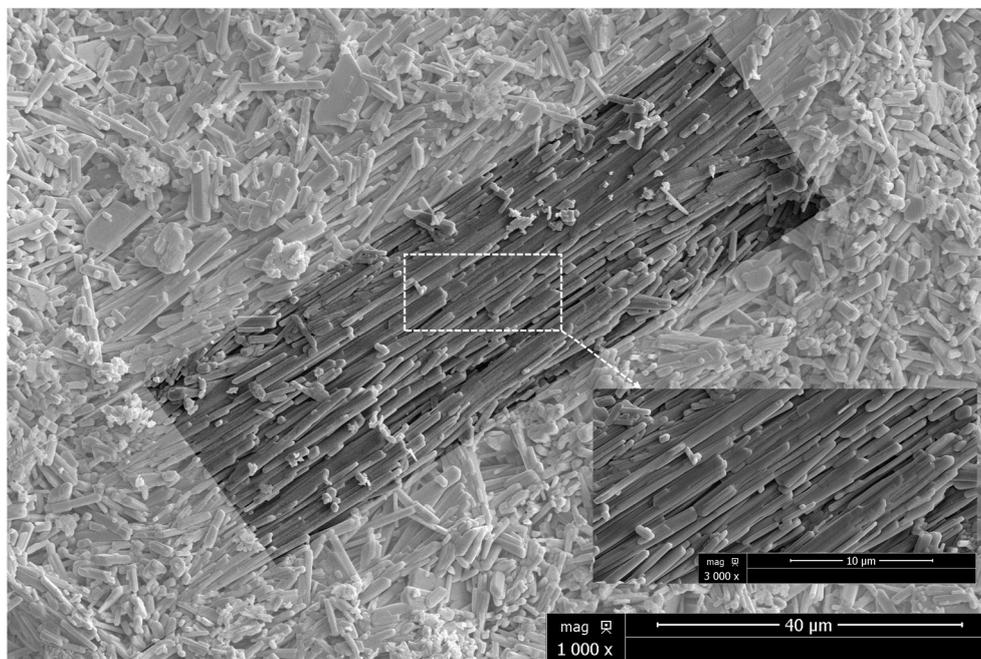
Figure 10. SEM scanning image of S2 (1000 times and 3000 times).

In order to further study the stress states applied in this SFZ and the distribution of grain debris, the authors continue to magnify Area A to 3000 times (Figure 10). Different from Figure 8, there is few grain debris appeared in the scanning area, and the surfaces of grains are flat and intact. This phenomenon indicates that there is only slippage displacement between gypsum grains without any pullout trend. The disappearance of grain debris further confirms the shear properties of this area.
