Case Study: Effects of a Partial-Debris Dam on Riverbank Erosion in the Parlung Tsangpo River, China

Abstract: This paper examines two successive debris flows that deposited a total of 1.4 million m³ of sediment into the Parlung Tsangpo River in China in 2010. As a result of these deposits, a partial-debris dam was formed in the river. This dam rerouted the discharge in the river along one of the riverbanks, which supported a highway. The rerouted discharge eroded the riverbank and the highway eventually collapsed. To enhance our understanding of the threat posed by partial-debris dams, a field investigation was carried out to measure the discharge in the river and to collect soil samples of the collapsed riverbank. Findings from the field investigation were then used to back-analyze fluvial erosion along the riverbank using a combined erosion framework proposed in this study. This combined framework adopts a dam-breach erosion model which can capture the progressive nature of fluvial erosion by considering the particle size distribution of the soil being eroded. The results from the back-analysis were then evaluated against unique high-resolution images obtained from satellites.

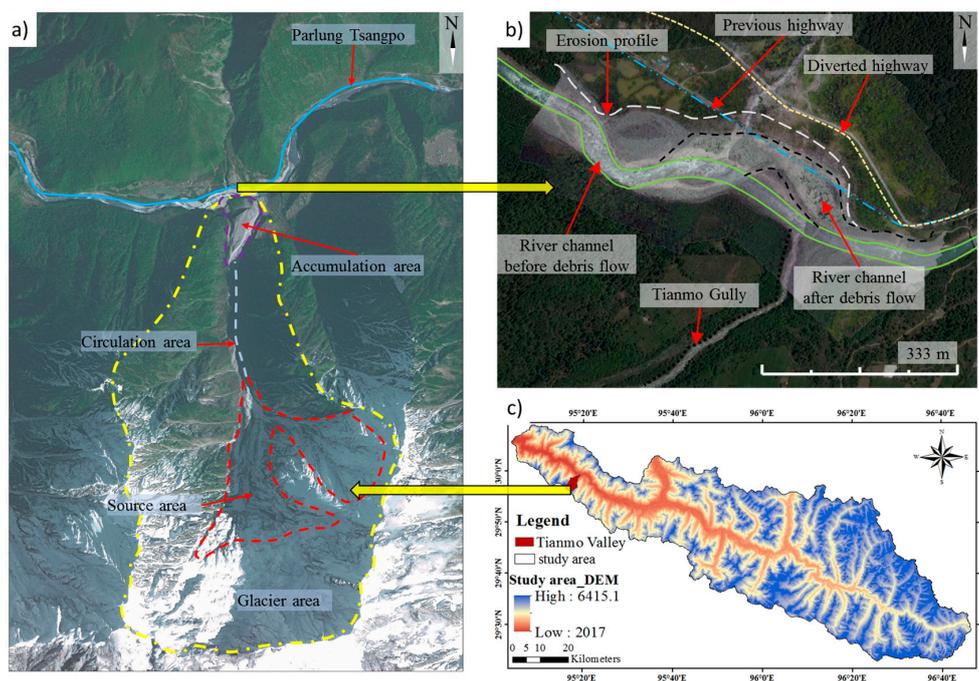
Figure 1. (a) High-resolution image of Tianmo Watershed; (b) Plan view junction between Tianmo tributary and Parlung Tsangpo River in 2010 and 2017 in Google Earth Imagery (acquisition date: 10 January, Image © 2018 DigitalGlobe); (c) Geomorphologic information of Parlung Tsangpo River and the related tributary.

The Tianmo Watershed is situated in Bomi County, Tibet, China and serves as a tributary to the Parlung Tsangpo River (Figure 1a). The watershed has an area of 17.8 km² and a maximum elevation difference of about 2460 m (Figure 1c). Frequently occurring monsoons, which develop in the Indian Ocean, provide precipitation that can last up to six months. The annual average rainfall intensity is about 880 mm [26]. In addition to rainfall, snow-melt and glacial recession provide additional sources of runoff in the watershed. Glacial recession also provides an abundance of deposits in this watershed. The combination of ample rainfall and runoff, and thick deposits provide ideal conditions for the development of large-scale debris flows.

The 25 July 2010 and 4 September 2010 debris flows deposited about 900,000 m³ and 450,000 m³ of sediments into the Parlung Tsangpo River [22], respectively. The deposits partially blocked the river and formed a partial-debris dam. The width of the river channel was reduced from 180 m to 100 m [22,28]. The location where the debris flow entered the river is shown in Figure 1b. Solid lines are used to illustrate the original configuration of the river channel before the debris flows. The diverted route of the river is also shown using dashed lines. The erosion damaged about 900 m of the highway (G318) adjacent to the river. This section of the damaged highway was eventually diverted 170 m north of the existing alignment.

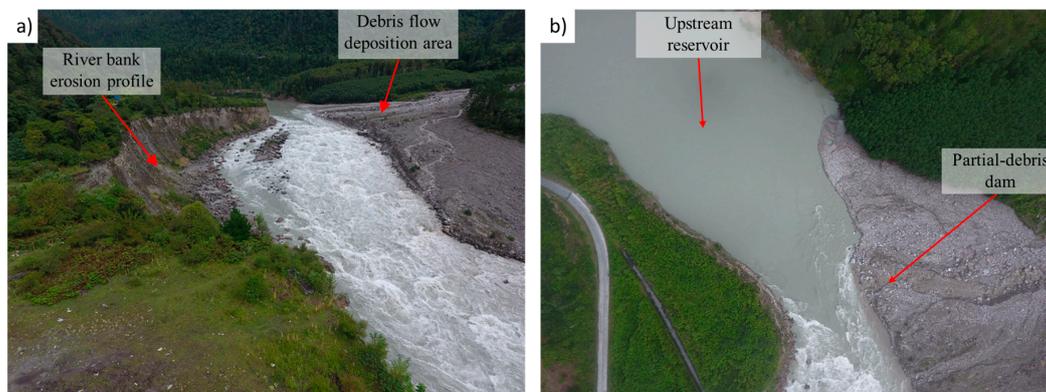
Figure 2. Field investigation of (a) river bank erosion profile; (b) upstream reservoir (unmanned aerial vehicle (UAV) photo taken on 12 September 2017).

It is acknowledged that the morphology has changed significantly since the debris flow events in 2010. However, a qualitative analysis on the effects of the particle debris dam on fluvial transport capacity was carried out in September 2017 to try to obtain a better understanding of the fluvial characteristics of the study area (Figure 2a). Figure 2a shows that a partial-debris dam impounded water (Figure 2b). This feature generally alters the ability of the river to transport sediment downstream [33]. If the transport capacity of the river exceeds that of the available supply of sediments, then sediment-starvation may occur, which enhances the erosion of the river banks and river bed downstream of the partial debris dam. In this study, a slight back water effect induced a reduction in the flow velocity immediately upstream of the partial-debris dam. Correspondingly, a decrease in drag forces on the suspended particles is expected, which would increase sediment deposition and sedimentation velocity. This effect greatly reduces the sediment concentration downstream of the dam [34]. The decrease in total suspended solid concentration downstream of the partial-debris dam in this study could be considered as a clear-water-erosion condition (low sediment concentration). Notwithstanding, detailed measurements of the sediment loads in the river were not monitored in 2010 immediately after the debris flow events.

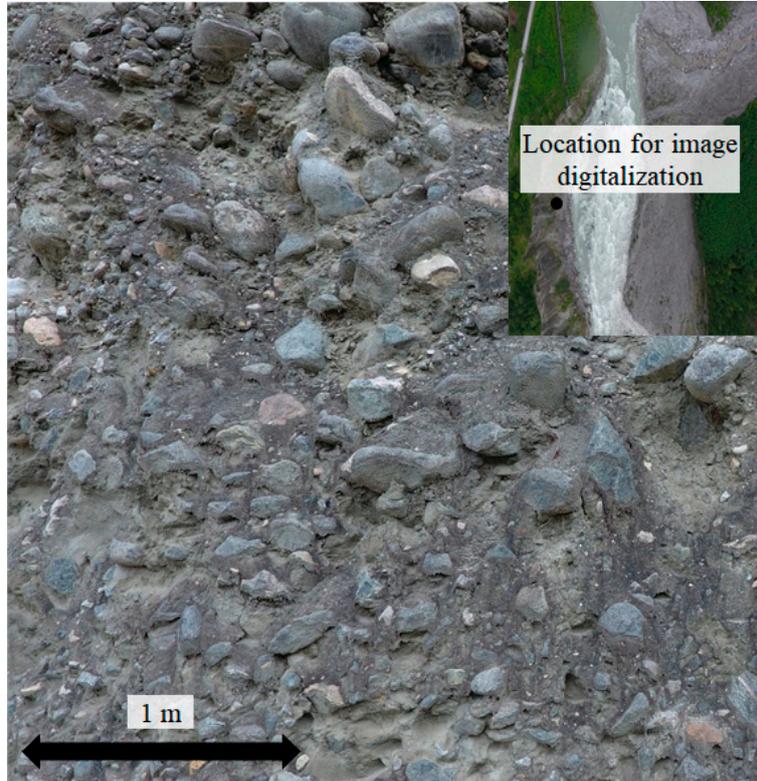
Figure 3. Riverbank soil from the Parlung Tsangpo River: image of the particles.

Aside from discharge measurements from the river, soil samples were taken from the riverbank (Figure 3). The unit weight, friction angle, and cohesion of the riverbank soil were measured as 20 kN/m³, 37°, and 33 kPa, respectively. The in situ particle size distribution was obtained using an image digitization (Figure 3), which is discussed in detail in [35]. This technique requires defining threshold values for filtering and calculations of the area and perimeter of each soil particle, which can then be used to determine the particle size distribution (Figure 4). The soil sample is granular and contains a great volume of cobbles and boulders. The median particle diameter, D_{50} , of the soil sample is

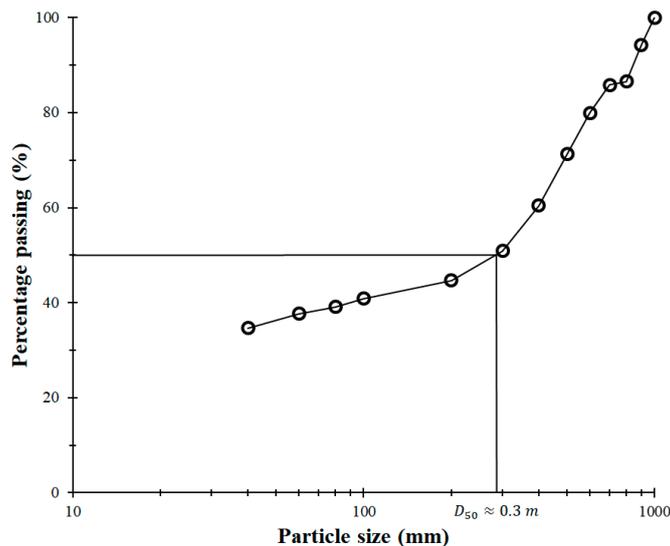
Figure 4. Particle size distribution of the soil sample from image digitalization.

about 0.3 m. This characteristic diameter is dissimilar to the conventional D_{50} obtained in geotechnical laboratory testing since the cobbles and boulders embedded inside the riverbank could not be sampled. Notwithstanding, obtaining a realistic D_{50} from the field would undoubtedly provide a better estimation of the erosion process.

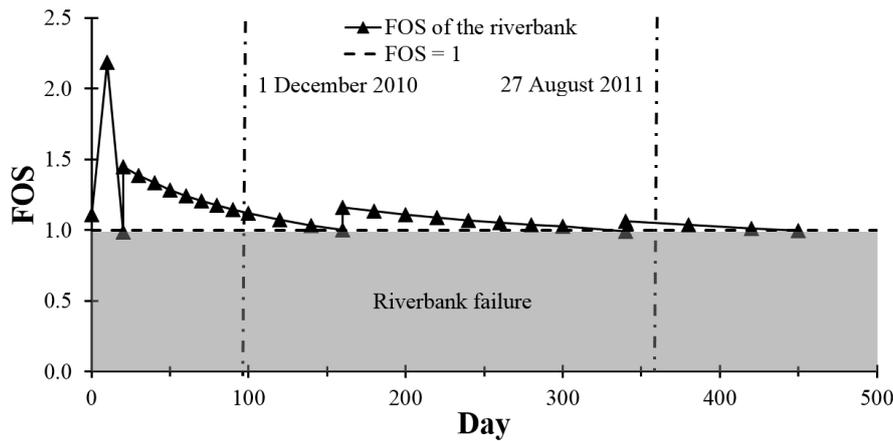
Figure 5. Time history of the riverbank stability of the junction between the Parlung Tsangpo River and Tianmo Gully; Factor of Safety (FOS) less than 1 denotes riverbank failure.

The erosion of the Parlung Tsangpo riverbank was analyzed using the new combined framework proposed in this study. The lateral erosion distance from 2010 to 2011 was around 135 m. Figure 5 shows

the calculated time history, using limit equilibrium analysis, of the riverbank stability at the junction between the Parlung Tsangpo River and Tianmo Gully. The riverbank stability is expressed as the FOS of the riverbank. The time history starts just after the second debris flow on 4 September 2010 where the initial width, height, slope of the riverbank, and slope above the riverbank were 82 m, 19 m, 90°, and 13°, respectively. The riverbank profile was initially assumed to be vertical, and the depth of the river was measured as about 4 m, while the water table in the riverbank was assumed to be constant and hydrostatic. Furthermore, the soil properties such as the unit weight, angle of friction, and cohesion of the riverbank were obtained from the field investigation discussed previously. In addition, the method of ordinary slices [18] was selected for limit equilibrium analysis. This entails 30 slices and a minimum failure thickness of 0.1 m.

Based on the results from the above settings and assumptions, the FOS at 10 days after the debris second flow event on 4 September 2010 exhibited an approximately twofold increase. This is because of the initial assumption that the riverbank profile is vertical, which is highly unstable. After the first iteration, the vertical profile becomes a shallower sloping profile. As erosion progresses, the riverbank exhibits cycles of collapse and subsequent stabilization. More specifically, the FOS rapidly decreases to less than unity at around 20 days. As the riverbank profile stabilizes to a shallower gradient, the FOS increases thereafter. The riverbank fails again at around 160 days. Subsequent increases in FOS are always less than that of the previous collapse (by up to 65%). The riverbank exhibits failure at about 340 days. Results also indicate that the duration between failure increases. This is plausible since erosion is a process that scours away fines, which increases the strength of the riverbank with time. Furthermore, a subsequent increase in FOS after the third failure of the riverbank was less than the FOS after second collapse by about 57%. Riverbank stability and instability continues to occur until almost no change in FOS was observed at 420 days. At this point, the riverbank is deemed to have stabilized. The final distance of riverbank erosion over 340 days is about 135 m. Figure 6 shows an evolution of the riverbank profile from 0 days to 340 days. The profile of the riverbank was vertical on 4 September 2010. Lateral erosion occurred until the riverbank became unstable after about 20 days. The riverbank profile then failed and the profile was approximated as an inclined surface. This profile was eroded horizontally until 160 days when the riverbank failed again, thereby forming an arc shape. Furthermore, erosion occurred until the riverbank failed at around 340 days and formed an arc shape again. The failure profile is observed to be consistent with the FOS calculation in Figure 5.

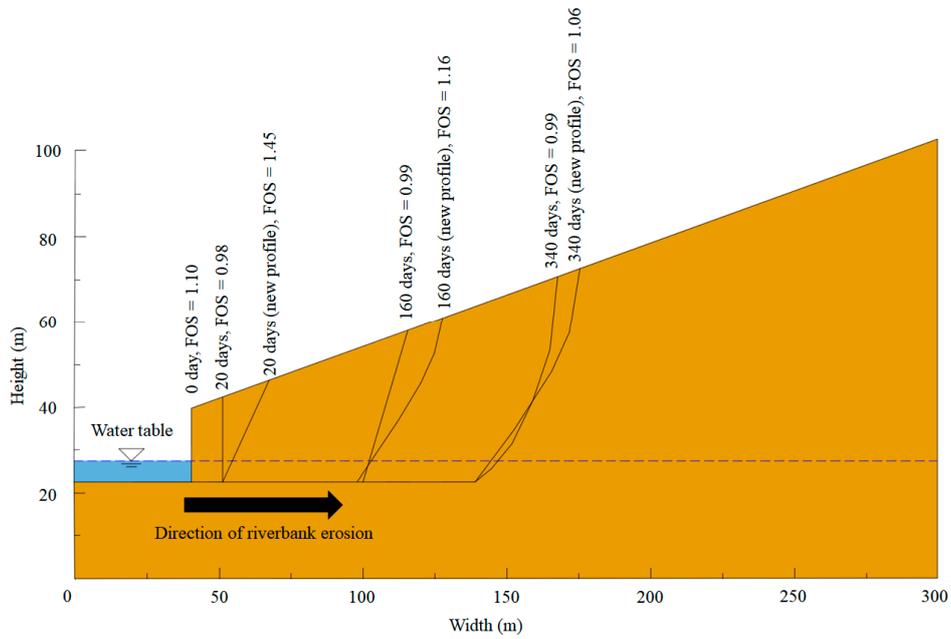
Figure 6. Evolution of the riverbank from 0 days to 340 days after the debris flow event on 4 September 2010.

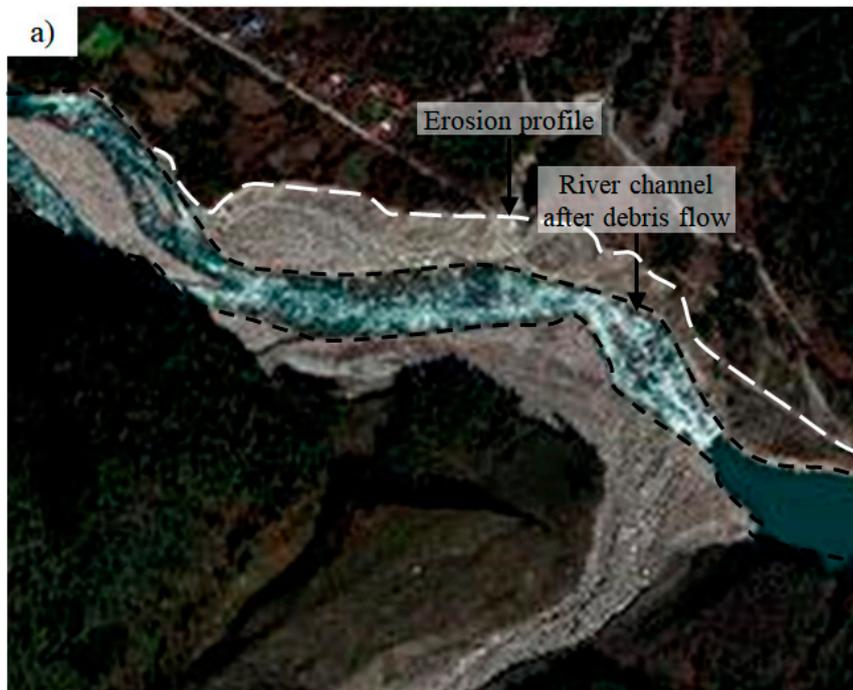
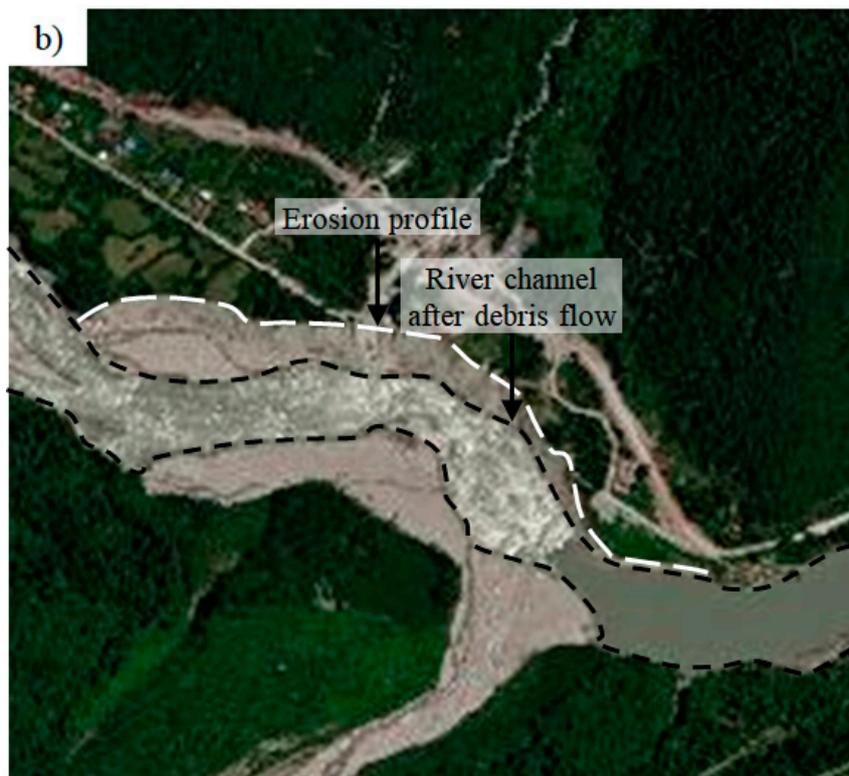
Figure 8. Satellite images: (a) 1 December 2010 and (b) 27 August 2011.

The back-analyzed lateral riverbank erosion was compared with two unique high-resolution satellite images taken on 1 December 2010 (Figure 8a) and 27 August 2011 (Figure 8b). The satellite images show that the riverbank profile at the junction between the tributary from the Tianmo Watershed and the Parlung Tsangpo River had shifted about 100 m from the original profile.

The image taken in 2010 shows that the lateral erosion distance is about 85 m, which differs from the analysis in this study by up to 55%. The erosion in 2011 enlarged to 110 m, which differs by 18% compared to the analysis in this study. Obvious factors that may have caused the discrepancy between the measured and computed results are the empirical factors adopted in this study. For example, the C_l parameter in this study was obtained from the morphological and geological settings based on an amalgamation of rivers from Mainland China. Since the value of C_l is site-specific, this parameter needs clear physical meaning and to be fine-tuned for the Parlung Tsangpo River [24].
