# Assessment of Practices for Controlling Shallow Valley-Bottom Gullies in the Sub-Humid Ethiopian Highlands

**Abstract:** Rehabilitation of large valley bottom gullies in developing countries is hampered by high cost. Stopping head cuts at the time of initiation will prevent large gullies from forming and is affordable. However, research on practices to control shallow gully heads with local materials is limited. The objective of this research was therefore to identify cost-effective shallow gully head stabilization practices. The four-year study was conducted on 14 shallow gullies (<3 m deep) in the central Ethiopian highlands. Six gullies were used as a control. Heads in the remaining eight gullies were regraded to a 1:1 slope. Additional practices implemented were adding either riprap or vegetation or both on the regraded heads and stabilizing the gully bed downstream. Gully heads were enclosed by fencing to prohibit cattle access to the planted vegetation. The median yearly head retreat of the control gullies was 3.6 m a<sup>-1</sup> with a maximum of 23 m a<sup>-1</sup>. Vegetative treatments without riprap prevented gully incision by trapping sediments but did not stop the

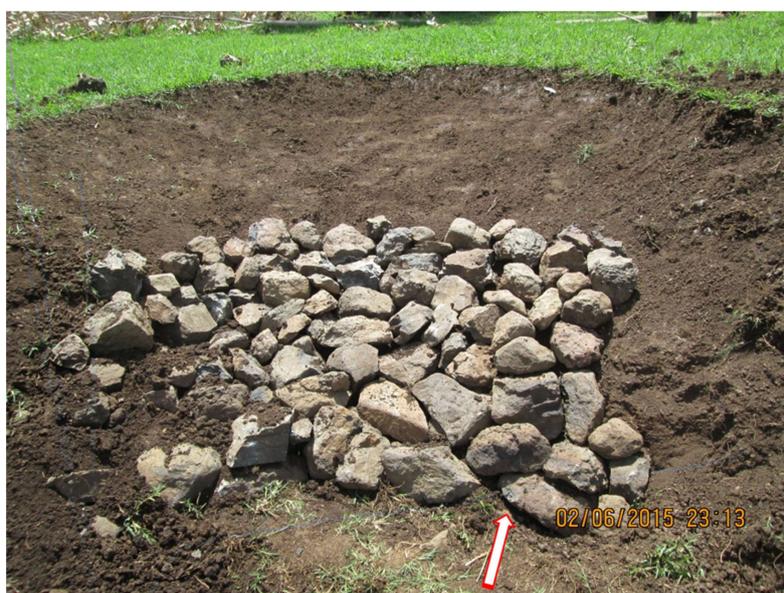
**Figure 2.** Initial stages of placing stones at the foot of the gully head to prevent any local gully bed and toe erosion.

Riprap (R) made up of 15–20 cm cobbles, were placed on the regraded gully heads (Table 1, Figure 2) with the larger cobbles at the lower end to prevent toe erosion. The cobbles were collected from the nearby eroded farm fields.

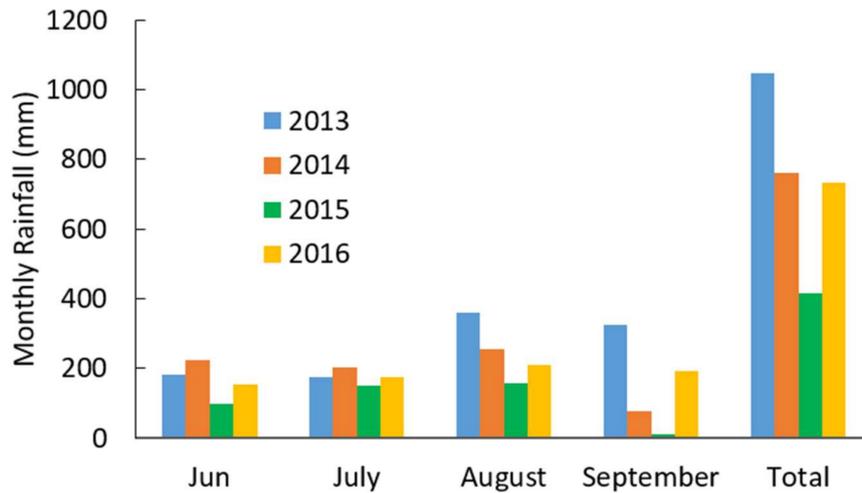
**Figure 3.** Monthly rainfall during the monsoon rain phase for the Ene-Chilala watershed from 2013–2016.

first rainy season as compared to the control gullies, but steepening of the head resulted in a larger retreat of  $1.1 \text{ m a}^{-1}$  in 2015 (Table 2). In 2016, the overland flow into the gully was diverted to gully C5 and grasses in and around the gully emerged that resulted in a reduced gully retreat of  $0.4 \text{ m a}^{-1}$  compared to 2015 despite the higher precipitation in 2016 (Figure 3).

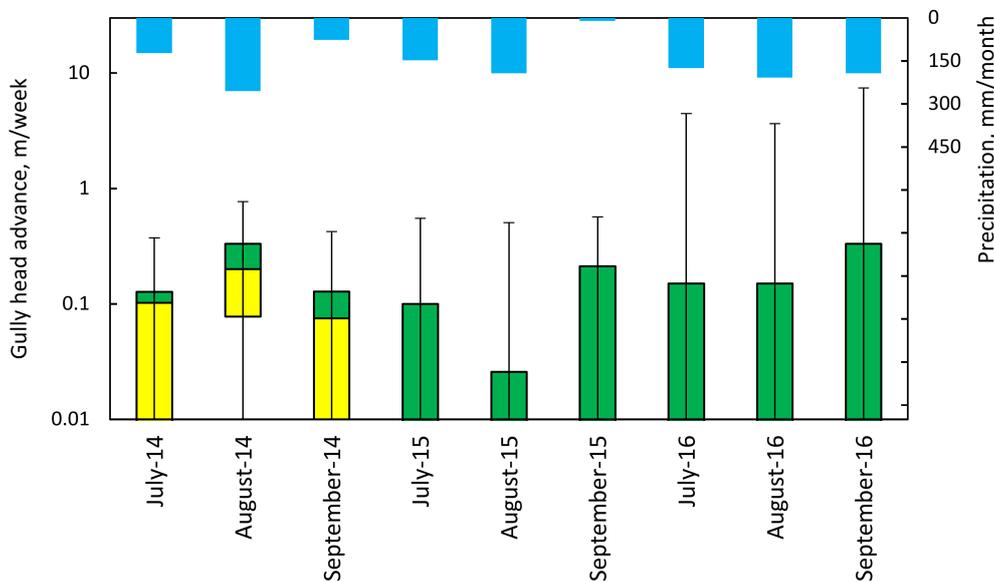
**Figure 4.** Relationship between weekly retreat of all control gullies and monthly rainfall from 2014 to 2016 in the Ene-Chilala watershed. The T of the whisker in the maximum weekly retreat in a particular month. The green color are the values in the third quartile of observation of weekly retreats. The boundary between green and yellow is the median, yellow represents the second quartile and the lower whisker is the first quartile. Since it is a logarithmic scale, the gullies with zero retreat are not shown.

Control gullies (C1–C6): Over the three-year study period, the median head retreat for all control gullies was 1.2 m a<sup>-1</sup> and the average 2.5 m a<sup>-1</sup>. The annual median rate varied between 0.4 m a<sup>-1</sup> in 2015 and 2.3 m a<sup>-1</sup> in 2014 (Table 2). The surface area of the control gullies expanded by an average rate of 8.6 m<sup>2</sup> a<sup>-1</sup> and the average volume increase was almost 20 m<sup>3</sup> a<sup>-1</sup>. The combined area of gully head expansion was 154 ± 36 m<sup>2</sup>. Gully expansion was smallest in 2015, which had the least amount of rain in the rain phase (414 mm, Figure 3), while the median retreat and surface area expansion were largest for 2014 with 730 mm of rainfall (Table 2). In addition, the monthly rainfall and weekly gully head retreat of all six gullies in Figure 4 showed that the wettest month (August 2014) had greatest head retreat. Despite lower amounts of rainfall in September, relative retreat rates in the upper tow

quartiles were elevated (Figure 4) because water tables were near the surface in the valley bottoms (data not shown) due to interflow from the higher areas.

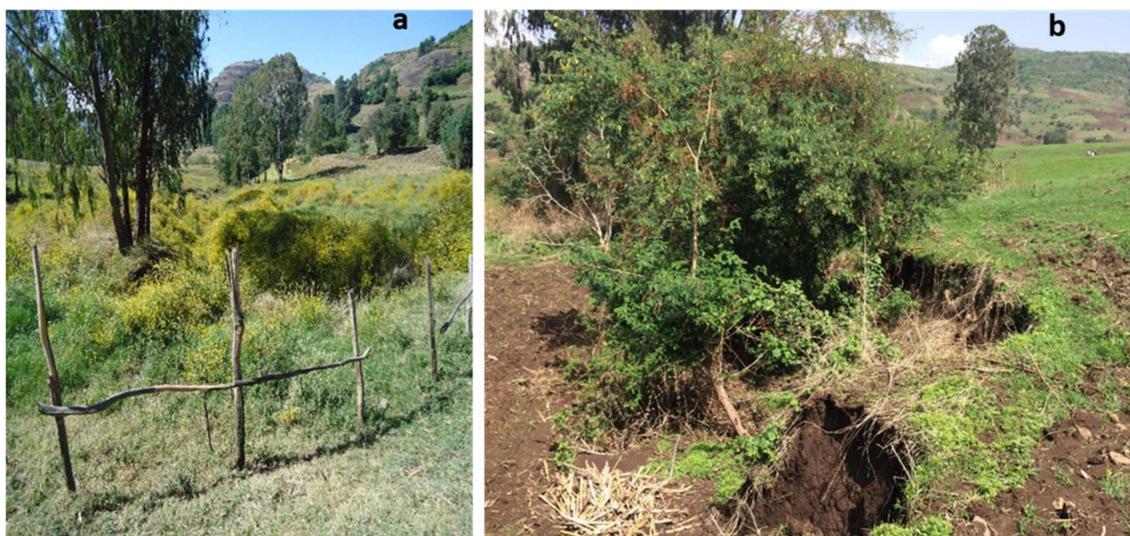
**Figure 5.** Gully V1: (a) the enclosure with fence and vegetation; and (b) the gully head moved upslope and connected to cultivated fields.

Gullies with regraded heads and planted with grasses (V): Gully V1 was the first gully treated in the watershed in 2013, so baseline data were not available. Gully V2 was remedied in 2014. These two gullies were planted with *Sesbania sesban* (river hemp) and *Pennisetum purpureum* (elephant grass) (Figure 5a). These gullies are located on the main river branch (see Figure 1), and the overall soil losses are greater than the soil losses for the control gullies. Table 2 shows a continuous head cut retreat before and after the vegetative treatment. The median increase in length for both gullies was  $7 \text{ m a}^{-1}$  after treatment. Gully V2 grew by  $23 \text{ m a}^{-1}$  before treatment and  $4.7 \text{ m a}^{-1}$  after treatment (Table 2 and Table S1). Gully V2 expanded within the saturated soil area that received runoff from upland farmer installed Fesses. The *Chrysopogon zizanioides* grass was 35 cm tall after three months and 60 to 75 cm tall after five months following planting. The growth rate of *Chrysopogon zizanioides* was slower than *Sesbania sesban* and *Pennisetum purpureum*. Natural grasses grew better compared to planted *Chrysopogon zizanioides* (Figure 5a). Although vegetation has excellent potential to trap sediments, vegetation in both gullies could not stop the upslope migration of the gully heads (Table 2, Figure 5b), but it likely limited gully incision.

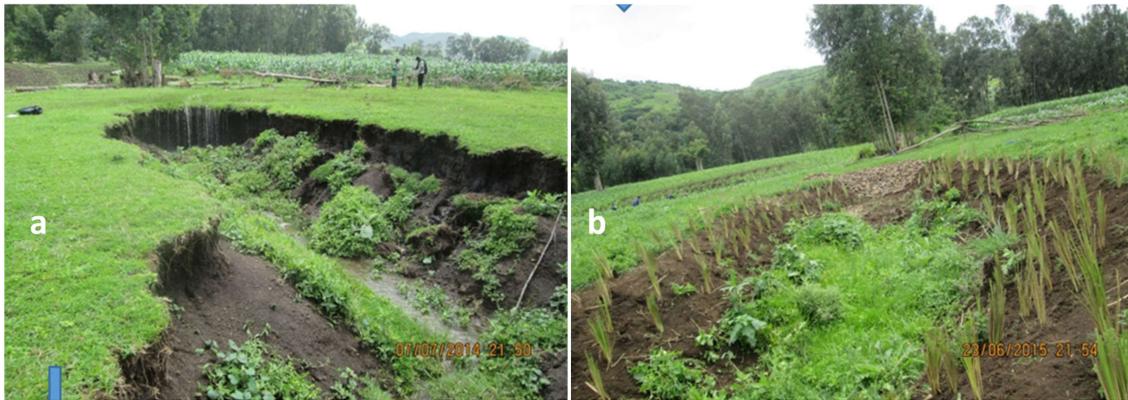
**Figure 6.** Gully RV2: (a) without treatment in July 2014 and (b) integrated gully head protection with regrading, stone riprap and vegetation in 2015.

Gullies with regraded heads protected with riprap and planted with grasses (RV): The heads of gullies RV1 and RV2 were regraded, covered with rock and planted with grasses in 2015. *Chrysopogon zizanioides* was planted on the regraded head. The retreat stopped after these gullies were riprapped and vegetated (Table 2). Before the practice was installed in 2014, RV1 retreated by 22.5 m and RV2 by 2 m (Table 2) indicating that riprap with vegetation is effective in halting gully head migration (Figure 6).

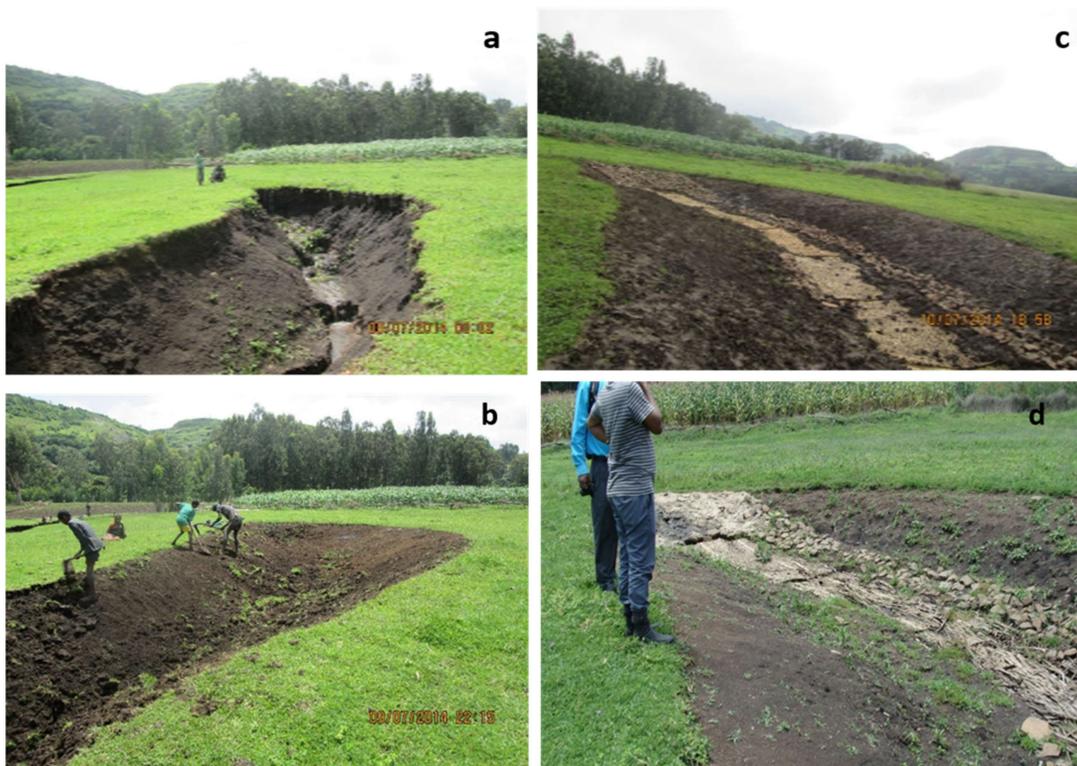
**Figure 7.** Gully RVB1 treated with head, bank and bed stabilization measures: (a) the original gully, (b) start of regrading the gully head and bank, (c) after the gully is treated in June 2014, and (d) in October 2014 the bamboo sheet covering the bed has broken down, but the head protection remained in place.

Gully with regraded heads, protected with riprap, planted with grasses, and bed stabilized (RVB1): In 2014, the head of gully RVB1 was regraded, covered with riprap and vegetated. In addition, the gully bed downstream of the head was stabilized. *Sesbania sesban* and natural grasses grew in the gully. Regrading the gully head and bank increased the top width by 1.3 m (Figure 7a,b). After a year of monitoring, the gully cross section and head position did not change. The reworked soil was compacted in June 2014 during the start of the rainy season; however, the soil strength was low due to soil wetness. In the first three weeks of the rainy season, the bamboo sheets provided effective

protection (Figure 7c). The sheets deteriorated and broke up after these three weeks with the remnants kept in place by grasses (Figure 7d). At the end of September 2014, the channel depth had increased by 25 cm (Figure 7d). The time of intervention for regrading and compaction was important because cutting the black soil column into a proper angle in the dry period was challenging. Waiting until the soil gets moist preserves the reshaped loss section, but it is difficult to compact due to soil wetness.
