# An Investigation on Performance and Structure of Ecological Revetment in a Sub-Tropical Area: A Case Study on Cuatien River, Vinh City, Vietnam

**Abstract:** The current study was performed with an aim to investigate the performance of ecological revetments implemented on the bank of the Cuatien River in Vinh city, Vietnam. Based on the ecological, topographical, and hydrological conditions of the Cuatien River, the gabion and riprap models were introduced to investigate the effect of ecological revetment on the slope stability and ecological restoration characteristics. The effect of prevailing climatic indicators, such as temperature, precipitation, sunlight hours, and humidity were investigated to ascertain the characteristics of weather conditions on the subtropical area. On the surface soil layer of the gabion and riprap, the nutrient indicators of soil organic matter (SOM) and available nitrogen (AN) increased in the spring, summer, and winter, but decreased in autumn, and available phosphorus (AP) did not show an obvious change in the four seasons. The biomass growth rate of Vetiver grass on the gabion and riprap revetments was found to be the highest during the summer, a

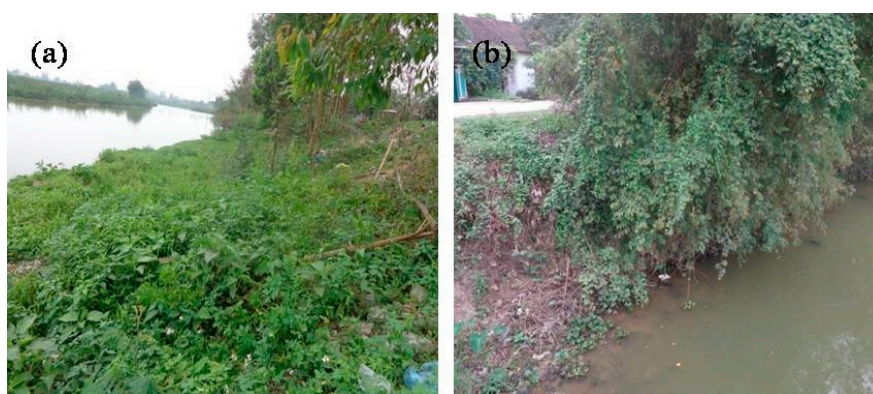
Figure 2. Experimental site at Cuatien River bank: (a) low slope bank; and (b) high slope bank (photos were taken on 9 November 2015).

A water flow meter, fitted with a flow probe (Xiuyan Precision Instrument Factory, Anshan Liaoning, China) was used to determine the velocity of the river flow. The flow meter was fixed to the boat to determine the flow velocity along the river. The velocity of the river flow ranged from 0.05–0.09 m/s during the dry season and 0.31–0.53 m/s during the rainy season. Although the flow velocity is not high in Cuatien River, the hydrological behavior is significantly affected by the exchange of tide regime at the mouth of the Lam River. Therefore, the water level changes frequently, which is the main cause of erosion in the river banks (Figure 2). Hence, the prevailing river hydrological conditions were considered to design and construct the ecological revetments. In addition, on both sides of the river, the soil levee work was constructed to prevent flood that is too easy to convert and construct the ecological revetment work. Sandy clay soil with the following characteristics: cohesion  $C = 6.8$  (kPa), internal friction angle  $\Phi = 23^{\circ}$ , and proportion  $\gamma = 1.8$  (t/m<sup>3</sup>), was used as the main construction material to build the levee structures. Since the slope along the river bank is different from the topography, which has a slope rate of  $18^{\circ}$ – $63^{\circ}$ , a proper design of the ecological revetment to transform the bank structure is extremely important. Riprap is relatively easy to install, is flexible and can be easily repaired, requires low maintenance, and has a natural appearance. Side slopes from 1:3 ( $18^{\circ}$ ) to 1:2 ( $26^{\circ}$ ) are recommended for riprap stability [13]. The riprap revetment structure was applied in the low slope banks where the slope is lower than  $26^{\circ}$  (steepness  $m = 0.5$ ), whereas

the gabion revetment structure was applied on a high slope bank where the slope is higher than  $26^\circ$  (steepness  $m = 0.5$ ) [14].

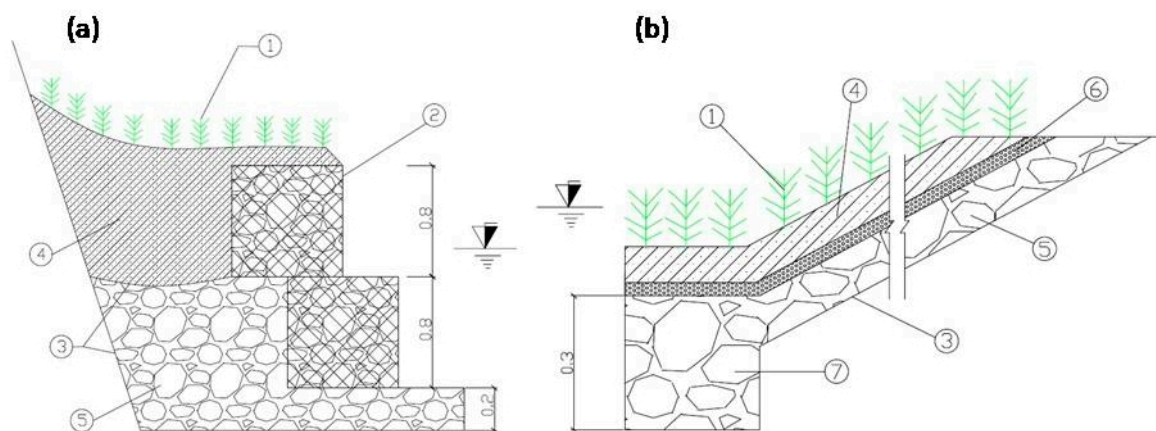
**Figure 3.** Schematic design of: (a) gabion revetment structure; and (b) riprap revetment structure (1. Vetiver plants; 2. gabion; 3. geotextile; 4. fill soil; 5. limestone; 6. gravel; and 7. base structure).

polyethylene nets, geotextile, mesh wire  $5 \times 5$  cm). The construction of riprap and gabion revetments were done in accordance with the design presented in Figure 3.

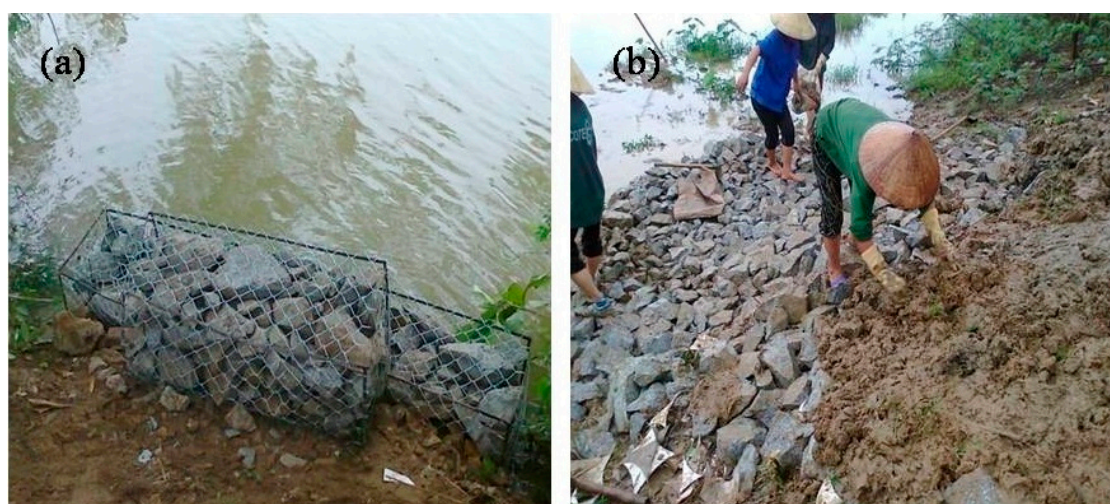
**Figure 4.** Experimental site: (a) gabion; and (b) riprap revetments (photos were taken on 19 November 2015).

The river bank was selected to construct the gabion at a slope of approximate  $57^\circ$  (steepness  $m = 1.54$ ). The gabion revetment was constructed as shown in Figure 4a. Firstly, the surface soil layer was excavated at a depth of 0.15 m, and then the geo-textiles were covered on the pit, and the stones were used as filling material to form the stable base. Three gabion structures with the following dimension:  $0.5 \times 0.5 \times 0.8$  m of length, height, and width were installed to form the gabion revetment. In order to ensure sufficient porosity and stability of the gabion revetment, which is beneficial for the development of plants on the gabion, the diameter of the stones was selected in the range of 8–12 cm ( $>5$  cm) to fill the steel-framed structure [15]. These structures were installed at a stable position and then filled with limestone. In the next step, the soil was used to cover the top of the gabion structure.

The riprap revetment structure was installed in an area of  $4 \times 8$  m. The sloping bank was selected to construct the riprap revetment, with a slope of approximately  $22^\circ$  (steepness  $m = 0.42$ ). The riprap revetment was constructed as shown in Figure 4b. In the first step, the surface soil layer was excavated up to a depth of 0.1 m. Then, geo-textiles were used to separate the soil and the limestone layer.

In order to ensure proper porosity and stability of the revetment, the limestone diameter was selected in the range of 0.15–0.2 m, as a heap, for covering the ground surface. Thereafter, the polyethylene net was covered on the surface of the limestone layer to prevent erosion caused due to the water flow [16]. In the bottom of the riprap, the soil layer was excavated to a depth of 0.3 m and filled with stones to increase the stability of the revetment structure [17].

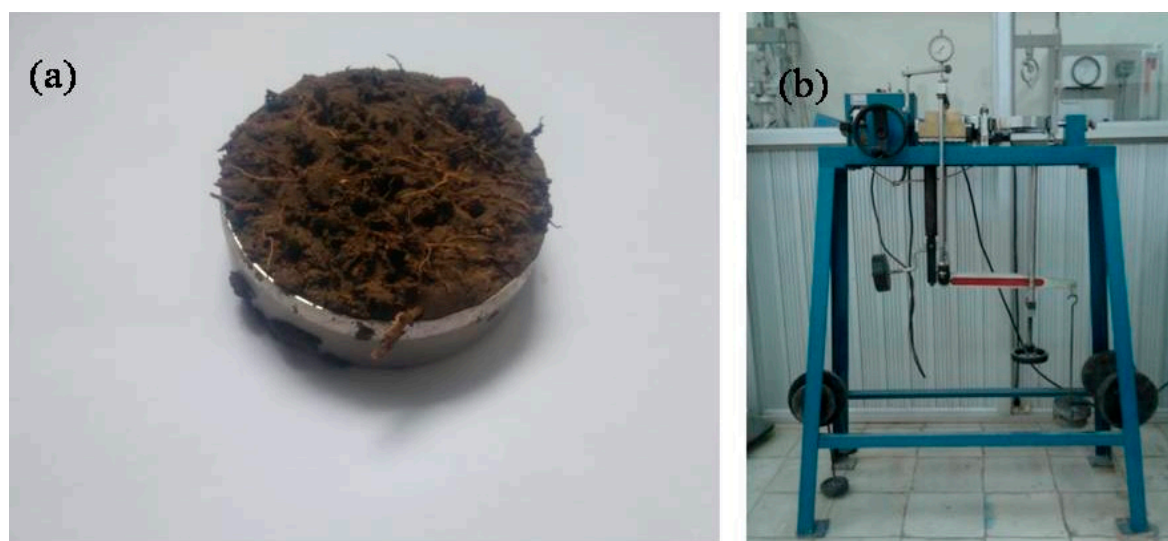
**Figure 5.** Experimental setup for determining the direct shear strength of the soil: (a) soil sample; and (b) experimental device for measuring the direct shear strength (photos were taken on 26 May 2016).

The center riprap surface point beneath the riprap rock layer and sites behind the gabion wall were selected as sites to collect the soil samples. Soil layer with a depth of 10 cm was dug out to make the space for experimental sampling. Shear soil ring with 80 mm diameter and 20 mm height was used to collect the soil samples. The soil samples were collected at the initial stage of the experimental work, i.e., after six months and after 12 months, respectively. The soil direct shear strength experiment was performed at the soil mechanics laboratory of Vinh University (Figure 5). The shear strength ( $\tau$ ) of the soil samples was determined by a direct shear strength experimental device EDJ-2 (Yueke Instrument Co., Ltd., Hangzhou, Zhejiang, China) with normal stress ( $\delta$ ) values of 10, 20, 50, and 100 kPa, respectively. The tests were performed according to the ASTM D3080 standards with a shear rate of 1.5 mm/min. The cohesion  $C$  and internal friction angle  $\Phi$  were determined according to the Coulomb formula shown in Equation (1) [20]:

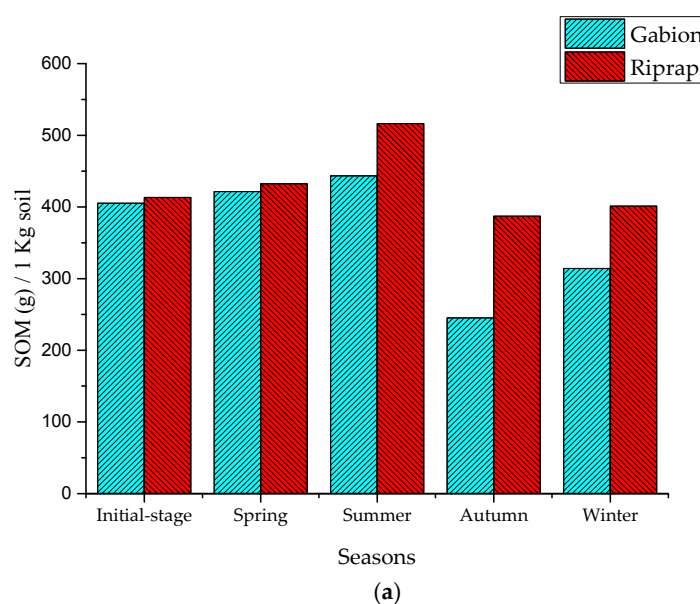
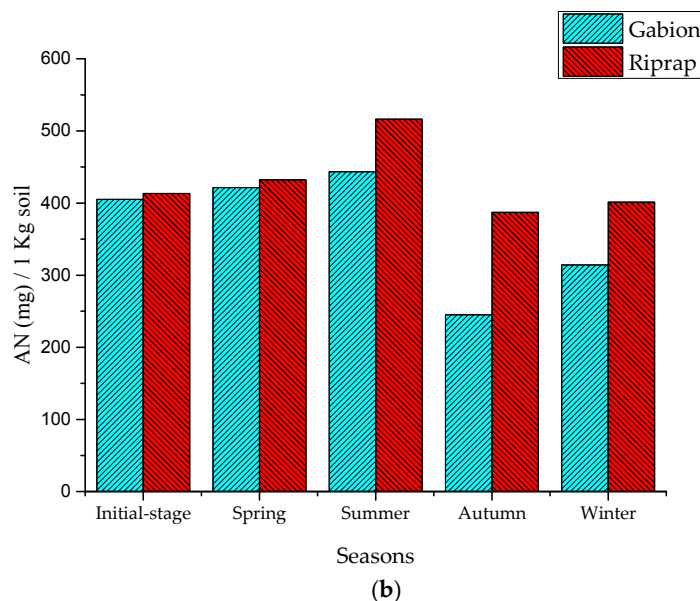
**Figure 6.** Nutrient indicators in the slope soil layer: (a) SOM indicators; and (b) AN indicators.

The results show that the SOM and AN levels were increasing in the seasons of spring and summer. In the three months of spring, the riprap's SOM and AN indicator values of the surface soil layer increased to 3.74 g/kg and 19.02 mg/kg, while the gabion's SOM and AN indicator values increased to 2.75 g/kg and 19.02 mg/kg, respectively (Figure 6). During the three months of summer, the riprap's SOM and AN indicator values increased to 7.06 g/kg and 84.08 mg/kg, while the gabion's SOM and AN indicator values increased to 3.86 g/kg and 21.95 mg/kg, respectively.

This increase is presumably because, during the spring and summer periods of small and medium rainfall, the pollutants present in the road surface were scoured and transferred to the revetment surface by storm runoff, and the pollutants accumulated in the revetment surface soil layer [4]. The amount of SOM and AN accumulated in the riprap revetment surface soil layer was higher than the gabion revetment. The riprap has a gentle slope and, therefore, the water runoff velocity was slow on the surface soil layer. Hence, the sediments and the pollutants were easily captured by the plant system [22].

During the period of three months in autumn, the SOM and AN indicator values in the riprap revetment decreased to 9.69 g/kg and 129.21 mg/kg, respectively, while the gabion's SOM and AN indicator values decreased to 13.75 g/kg and 198.19 mg/kg, respectively. The autumn season, with the continuous occurrence of heavy storms, caused extreme runoff periods which had diluted the scoured sediments and nutrients on the surface soil layer of the revetment [22,23]. This eventually led to a decrease in the nutrient concentration, subsequently leading to a decrease in the SOM and AN indicator values. Khan et al. [23] reported nutrient losses of 8.46 kg mineral nitrogen (N), 19 kg phosphorus (P), and 220 kg organic matter ha<sup>-1</sup> due to water erosion from maize crops in the upland sloping soil. The amount of SOM and AN lost in the gabion revetment was higher than the riprap revetment. With its vertical form and porous structure, the nutrients and organic matters easily permeated through the voids of the gabion, and this structural configuration caused the soil layer to easily lose its nutrients. Concerning the riprap, it has a gentle slope that was covered with high floral diversity and distribution. This feature caused the riprap soil to improve its nutrient accumulation capacity, and avoided the nutrient scouring effect from stormwater [22]. Nevertheless, during the winter season, with the decrease in rainfall intensity, the SOM and AN indicator values showed a steep increase. It is noteworthy to mention that, during all the four seasons, AP indicator values were not significant because the P index in the soil was high (85.24–87.63 mg/kg), and the P content in storm water did not show any effect on the AP of the soil. These results clearly prove that the storm runoff has a significant effect on the slope soil nutrient concentration. This was also reflected on the good growth of Vetiver grass on the riprap surface. The SOM and AN indicator values significantly increased during the spring, summer, and winter periods; however, they decreased during the autumn season.

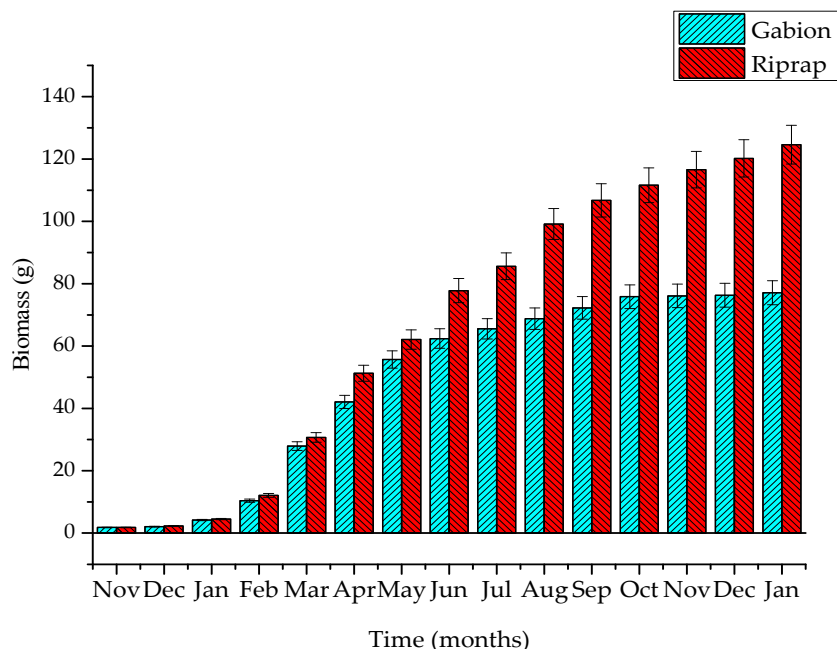
**Figure 7.** Growth of Vetiver grass on two types of ecological revetments (the error bars represent the standard deviation for the weight of Vetiver grass).

The experimental data obtained for the five samples (S1–S5), the average and SD values for Vetiver biomass grown on the gabion and the riprap revetments are shown in Tables 2 and 3, and Figures 7 and 8, respectively.

At the beginning of the plantation time, on the gabion and riprap revetments, the average weight of Vetiver grass was  $2.31 \pm 0.28$  g. During the spring season (from February to April), with a mild warm climate ( $21.3$  °C), high humidity (89.3%), the Vetiver grass began to develop, and its biomass weight on the gabion and riprap revetments was  $10.41 \pm 0.52$  and  $12.13 \pm 0.61$  g, respectively. The rate of Vetiver biomass growth on the gabion and riprap revetments was 2.70 and 3.27 g/month, respectively. In summer (from May to July), under high rainfall (131.2 mm/month), relatively warm temperature ( $29.4$  °C), and sunshine hour (224.7 h/month) conditions, the tropical flora showed the best growth conditions. In addition, the soil nutrients in terms of SOM and AN reached the highest value during this period. Therefore, the Vetiver grass could strongly grow on the riprap and gabion revetment surfaces and yield higher biomass. The Vetiver grass biomass weighed  $55.74 \pm 2.79$  and  $64.1 \pm 3.11$  g, respectively, in the gabion and riprap revetments. The results from this study shows that the rate

of Vetiver biomass growth on the gabion and riprap revetments were 15.11 and 17.32 g/month, respectively. The storm runoff scours containing high nutrient concentrations and pollutants from the road surface caused the amount of SOM and AN to reach its highest values in the gabion and riprap soil layers [4].

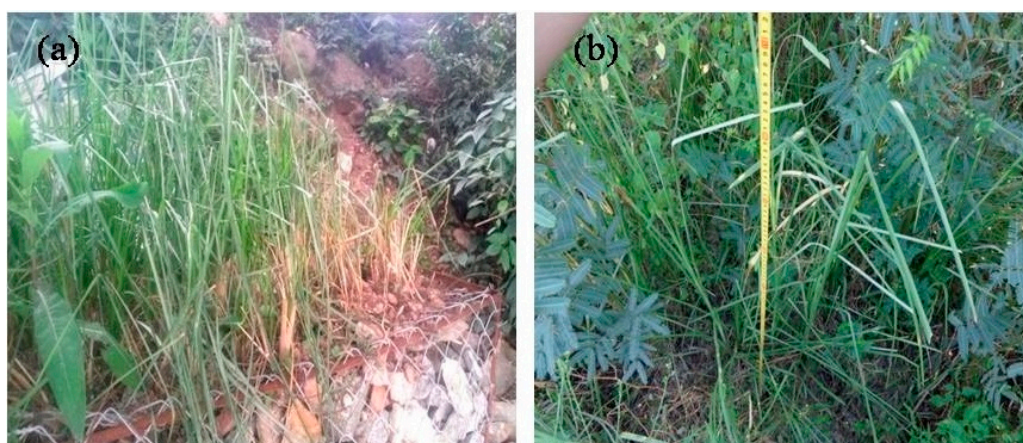
**Figure 8.** Vetiver growth on: (a) gabion; and (b) riprap revetments (photos were taken on 23 October 2016).

During the autumn season (from August to October), the growth of Vetiver grass on the gabion and riprap revetments were  $68.79 \pm 3.43$  and  $99.14 \pm 4.96$  g, respectively. The Vetiver biomass growth rate in the gabion and riprap revetments was 4.35 and 11.68 g/month, respectively. During the autumn season, the continuous heavy storms (332.6 mm/month) caused a reduction in the soil nutrient concentrations, leading to low values of SOM and AN. This adversely affected the Vetiver grass biomass on the gabion and riprap revetments. With a vertical form and porous structure, the gabion soil layer lost nutrient and soil particles significantly, causing dissatisfaction of Vetiver grass nutrition.

However, after a planting period of eight months, the riprap's Vetiver grass root pierced through the stone layer and directly absorbed nutrients from beneath the riprap stone layer. Therefore, Vetiver did not primarily depend on the nutrient source from the riprap surface soil layer. Under such conditions, the biomass weight of the gabion's Vetiver grass was significantly lower than the riprap's. During the winter season (from November to January), with lower temperatures ( $19.9\text{ }^{\circ}\text{C}$ ), rainfall ( $111.8\text{ mm/month}$ ), and low sunshine hours ( $88.5\text{ h/month}$ ), Vetiver plant biomass growth in the gabion and riprap revetments significantly declined. The biomass of Vetiver grass on the gabion and riprap revetments were  $77.12 \pm 3.94$  and  $124.61 \pm 6.23\text{ g}$ , respectively. The Vetiver plant biomass growth rate in gabion and riprap revetments were  $2.78$  and  $8.49\text{ g/month}$ , respectively. Riprap's Vetiver grass showed rapid growth in spring, summer, autumn, and slow growth in winter. On the other hand, the gabion's Vetiver grass showed rapid growth in spring, summer, and slow growth in autumn and winter. Mickovski et al. [24] showed that the dry shoots of 22 Vetiver plants could reach a weight of  $70.05 \pm 8.04\text{ g}$  with in a period of one year (2012–2013) when grown on different types of ecological revetments. The experimental results from this study revealed that Vetiver grass has good ability for growth and reproduction on the ecological revetments. The results indicated that high values of temperature and humidity, long sunshine hours. And soil nutrient content during the spring and the summer season, will facilitate the rapid development of the Vetiver biomass. However, the Vetiver biomass began to decrease with rainfall, due to the decline of the nutrient content during the autumn season.

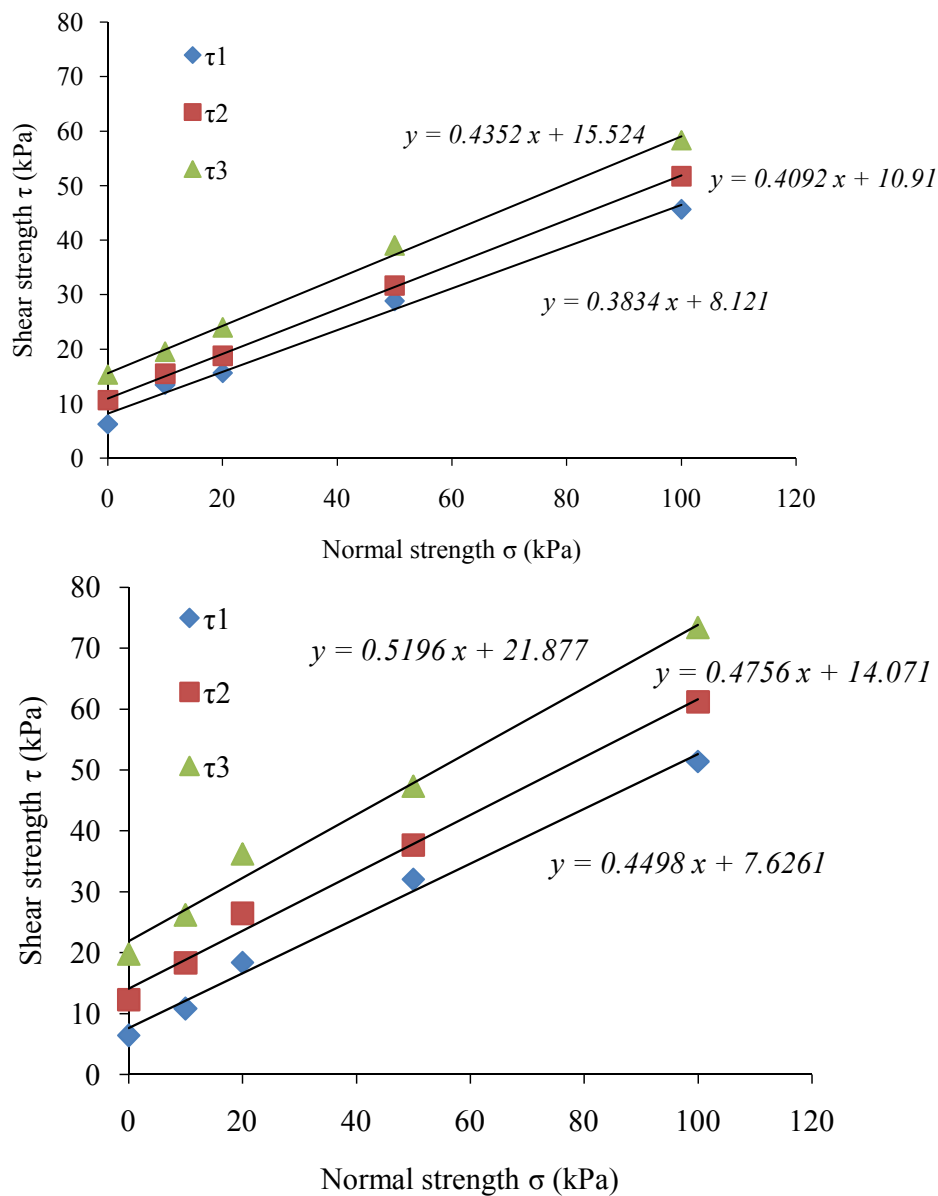
**Figure 9.** Normal strength and shear strength values for: (a) gabion; and (b) riprap revetments.

To investigate the effect of shear strengths ( $\tau_1$ ,  $\tau_2$ , and  $\tau_3$ ) of the soil samples during 0, 6, and 12 months, the soil samples were subjected to direct shear test under normal strength as  $\sigma_1 = 10\text{ kPa}$ ,  $\sigma_2 = 20\text{ kPa}$ ,  $\sigma_3 = 50\text{ kPa}$ , and  $\sigma_4 = 100\text{ kPa}$ . The results of the shear strength experiments are shown in Figure 9. The cohesion  $C$ , and internal friction angle  $\Phi$ , calculated through the Coulomb formula (Equation (1)) are presented in Table 4.

The results of direct shear strength tests revealed that the cohesion of soil increased, but the internal friction angle showed a rather slow increase by only  $1\text{--}3^{\circ}$ . After a period of 6 and 12 months, the cohesion of soil samples collected from the gabion revetment increased by  $59.6\%$  and  $162.9\%$ , respectively. The cohesion in soil samples collected from the riprap revetment after 6 and 12 months increased by  $115.6\%$  and  $239.1\%$ , respectively. Therefore, the shear strength results proved that the root system of Vetiver grass and native plants could increase the cohesion and internal friction angle of soil, and enhance the bank slope stability.

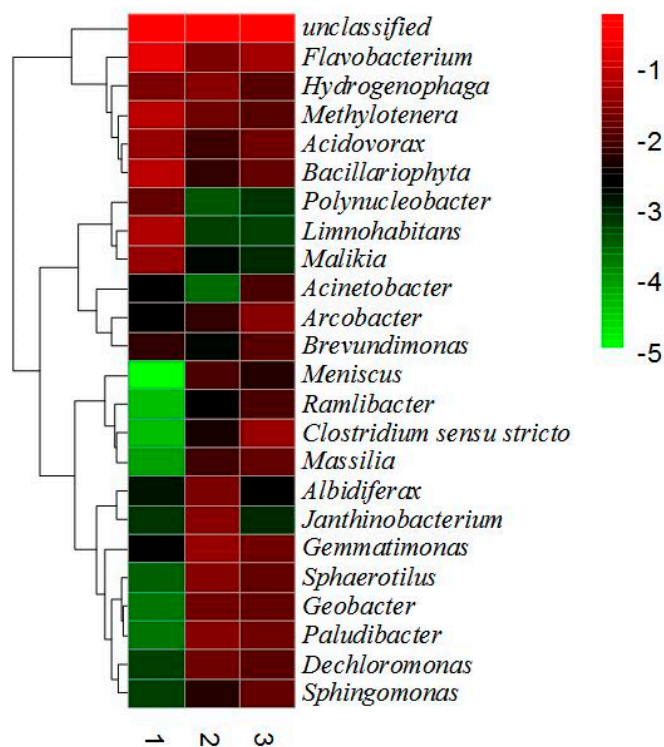
Figure 10. The classification at the genus level.

The results showed that the total number and diversity of microorganisms attached on the gabion and riprap revetments were much higher than that of the suspended microorganisms in the water. The results revealed that the total number of microbial communities and their diversity in the riprap revetment was highest, because the riprap revetment is suitable for the growth of plants, it has a rather strong root systems, and the gap between the stones also provide adequate conditions for the growth of microorganisms. It is one of the main reasons for rich microbial diversity in the riprap revetment [33]. Through high sequencing technology, the number of bacteria was estimated at 198, 332, and 351 in water #1, gabion #2 and riprap #3 samples, respectively. The results of species composition, based on its detection and classification at the genus level, is shown in Figure 10.

It can be seen from Figure 10 that the total amount of microbes and the relative content of dominant microorganisms on the two kinds of ecological bank revetments are obviously higher than those in the water body. This clearly indicates that the gaps and plant roots can provide good habitat for microbial attachment and growth.
