Article

Case Study: Model Test on the Effects of Grade Control Datum Drop on the Upstream Bed Morphology in Shiting River

Xudong Ma, Lu Wang *, Ruihua Nie, Kejun Yang and Xingnian Liu

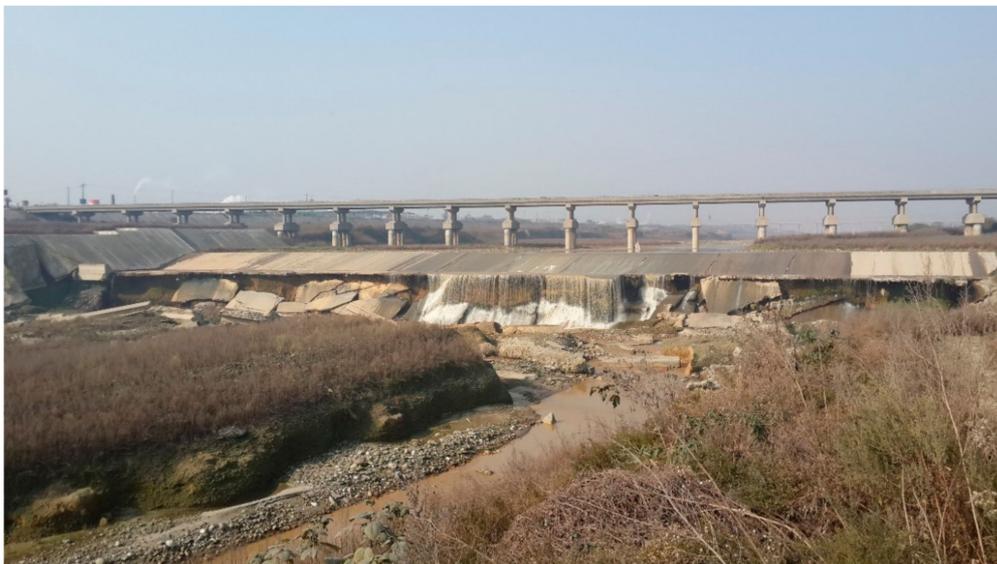
Figure 1. Scour at the grade control structure (GCS) downstream of the 105th Provincial Highway Bridge after the flood event on 9 July 2013 (discharge $Q = 2710 \text{ m}^3/\text{s}$).

However, the flow over GCSs can cause local scour [8–12], and the downstream general scour may continue if there are no further downstream GCSs, leading to structural damages or failures

(Figure 1). The failure of a GCS induces a drop in GCD, accelerating the adverse impacts they are initially built to prevent [16]. Thus, it is important to understand the scour process at GCDs for safe design. Also, understanding the impacts of GCD drop on the upstream bed morphology can help to assess the stability of the upstream riverbanks and instream structures if the GCS fails.

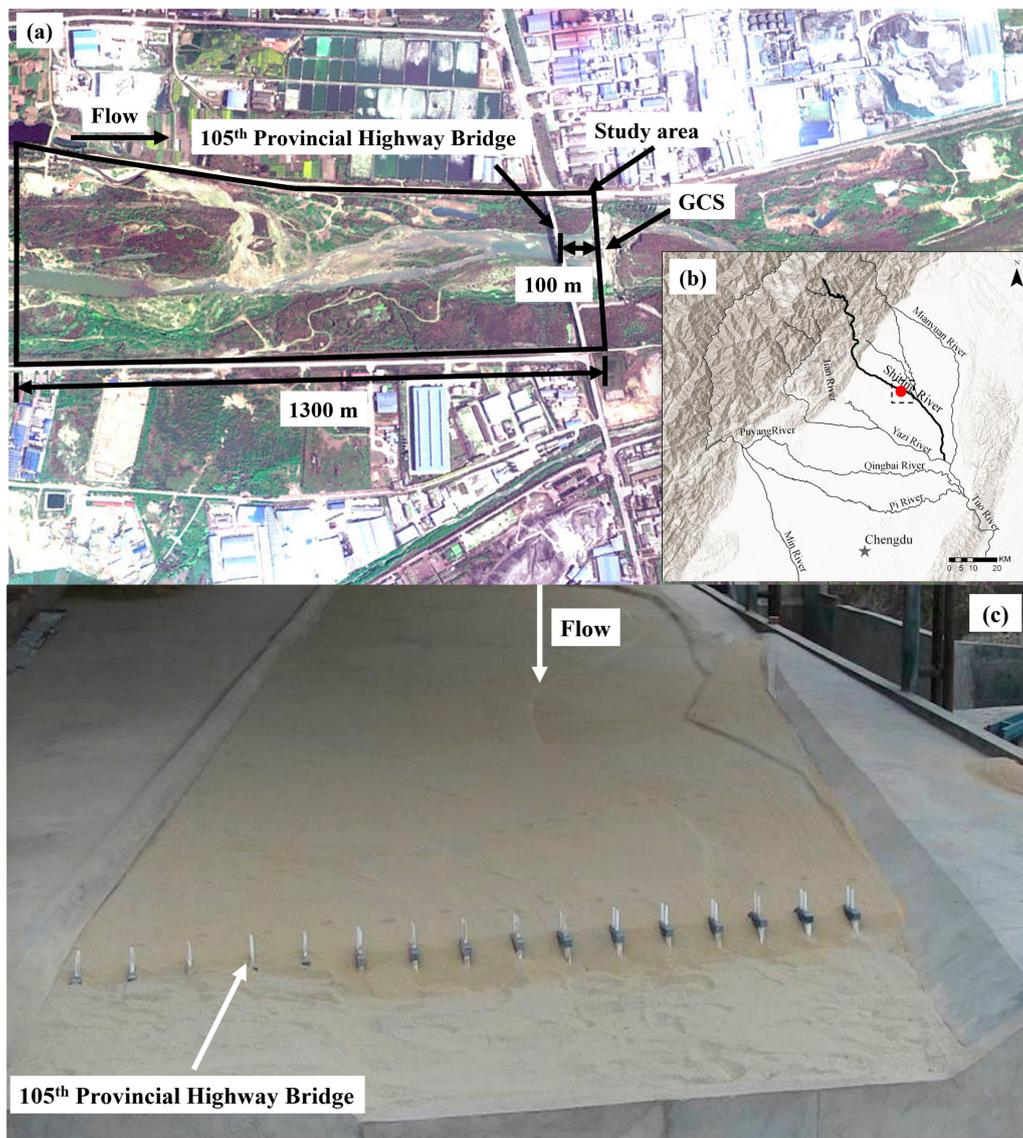
Figure 2. Plan view of the studied reach of Shiting River (a); location of Shiting River (b); a photo of the model (c).

The studied reach is about 13 km downstream of the mountainous area with a gradient of around 4‰, in which the 105th Provincial Highway Bridge is located (Figure 2). The studied reach is about 1.3 km upstream of the 105th Provincial Highway bridge, and has a channel width between 300–400 m. This reach is a quasi-straight channel and has no instream structures upstream of the 105th Provincial Highway Bridge. Thus, the impacts of stream curve and other instream structures on the bed morphology are negligible. As mentioned previously, significant bed degradation occurred in the piedmont reach of Shiting River after 2008 [39,40]. Thus, an 18 m high grade control structure was built upstream of the studied reach (2 km upstream of the 105th Provincial Highway Bridge) for stabilizing the upstream riverbed. The flood events during the period of 2009–2012 degraded the river bed at the 105th provincial Highway Bridge to an elevation of 539 m (544 m before the Wenchuan Earthquake). In 2012, for protecting the upstream river reach and the bridge, a grade control

An undistorted model based on the prototype shown in Figure 2 was built with a geometry scale $\lambda_L = 1:80$ in the State Key Laboratory of Hydraulics and Mountain River Engineering, Sichuan University, China. The scaled model was implemented into a water-recirculating system. The bank revetments were built in concrete and had a 0.5 m-deep non-cohesive sediment bed. The flow passed through a triangular weir for flowrate measurement before entering the model, and exited the model through the concrete grade control datum as a free flow which is the same as that of the prototype.
