Article

Survey of Damage Investigation of Babbitted Industrial Bearings

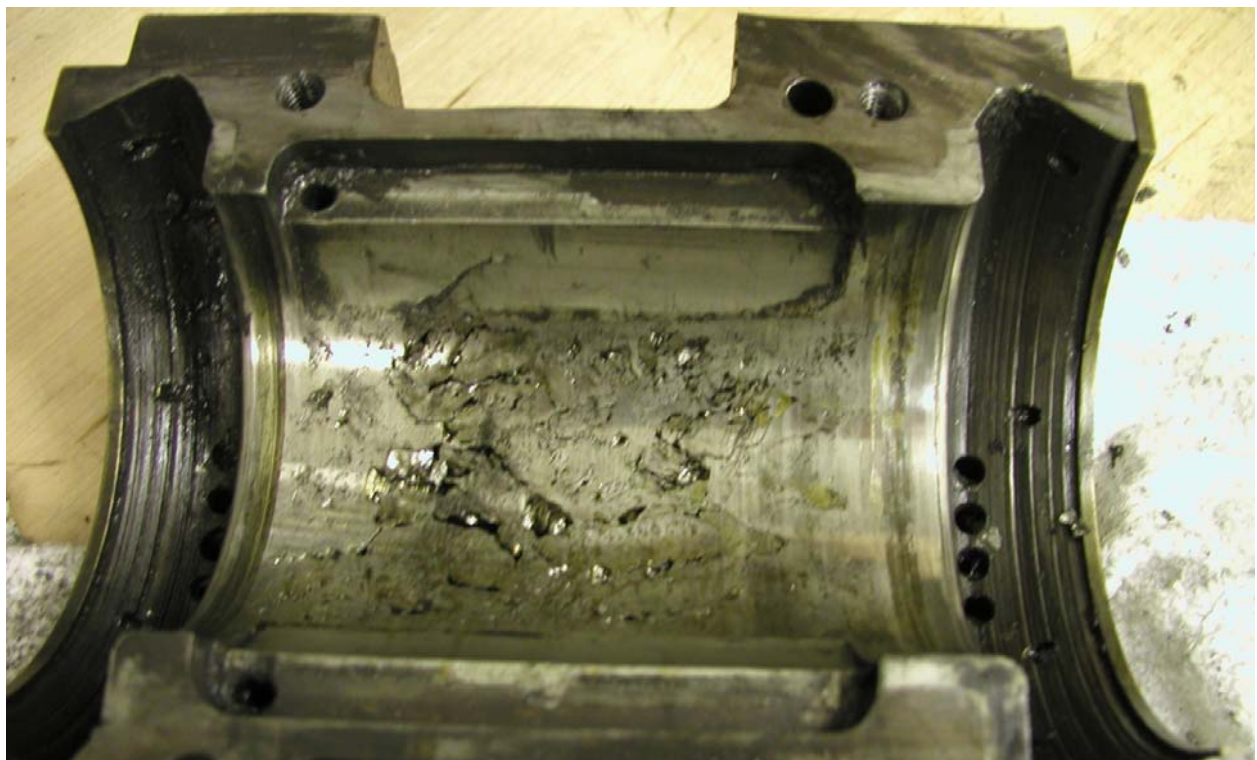
Figure 3. Distributed deep cracking of loaded surface forming an equivalent bulk loss of material.

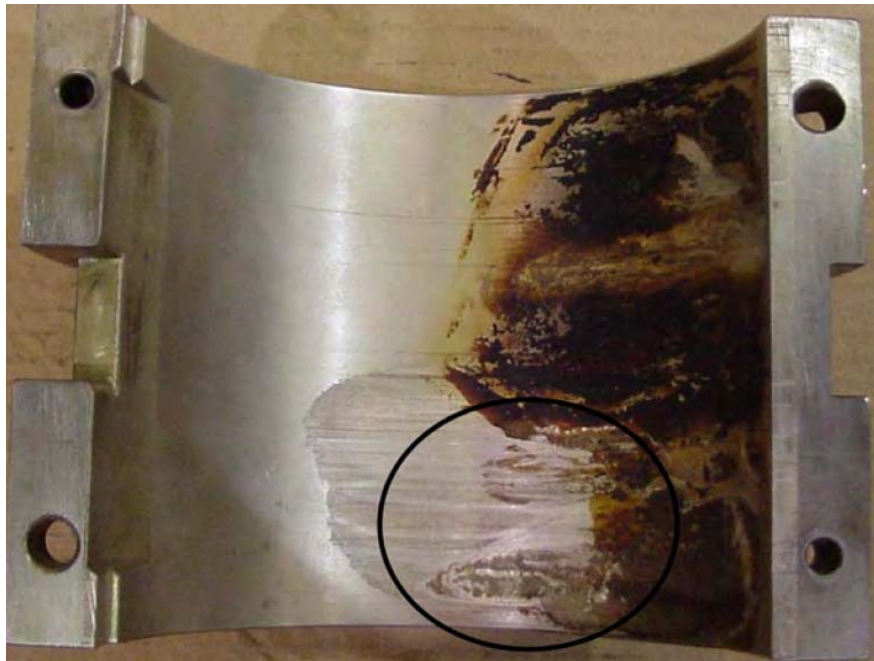
- Creep would be the surface movement of the babbitt due to a combination of high local pressure and high local temperature which exceeds the local yield strength of the babbitt [20]. Movement of babbitt occurs from the loaded region (high material compressive stress) towards an unloaded region (lower compressive stress) (see region circled in Figure 5).

Figure 5. Regions of babbitt material creep in a hot-running region of a cylindrical bearing.

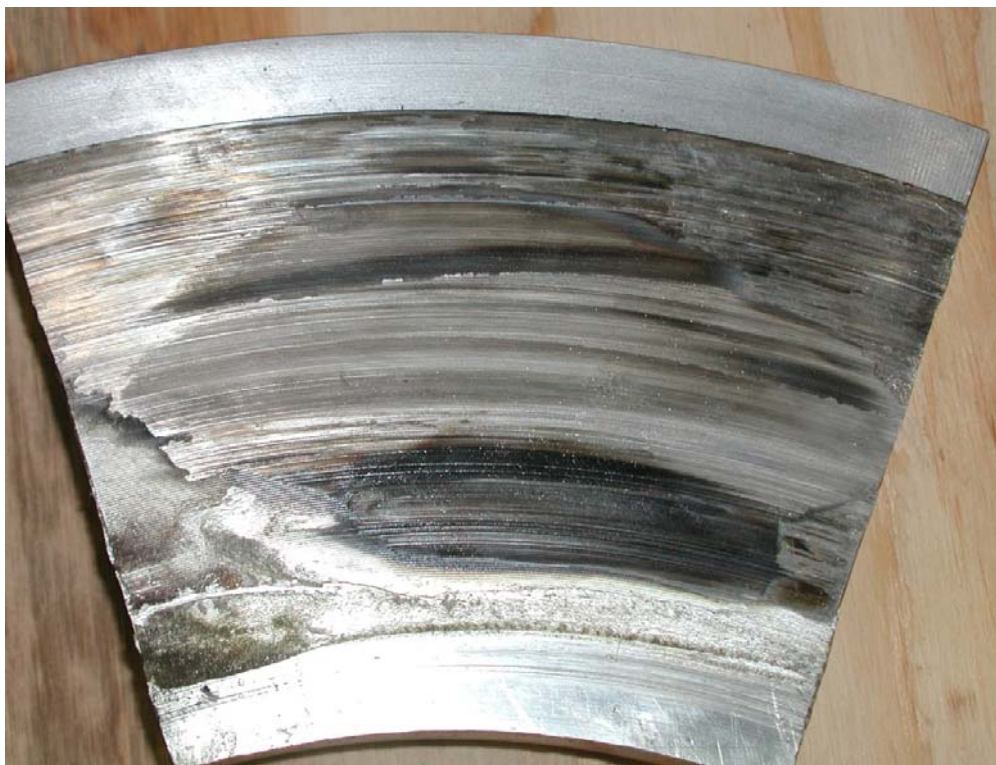
- Occurring more often than creep, wiping represents surface displacement due to contact between the rotating journal (thrust collar) and the babbitt surface (Figure 6). Babbitt may be only slightly displaced or may be moved and deposited to a different region of the bearing (Figure 7). Movement of the babbitt occurs from the region of contact (minimum film thickness) towards a region of larger film thickness.

Figure 6. Severe wiping on a thrust shoe (circumferential scratching, narrow lines, also visible).

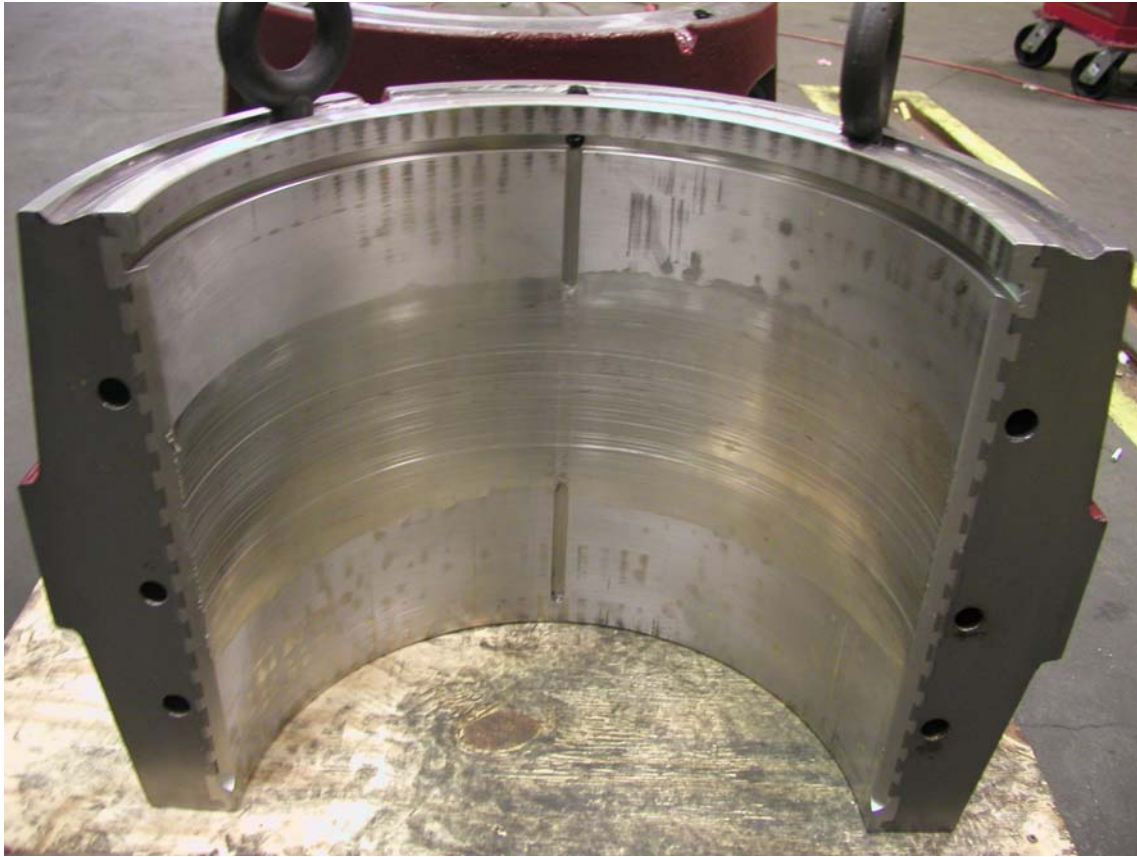
Figure 8. Wiping has covered the axial oil distribution groove on this vertical guide bearing blocking oil flow to the wiped region.

The immediate impact of displacement on the hydrodynamic film can be negligible due to the reformation of the working surface on the babbitt (Figure 7). Where significant displacement occurs, the effect would be similar to wear (above). Another concern with displacement is the obstruction of oil flow features, such as grooves, side-wells, slots or ports, which compromises the operation of the hydrodynamic film due to the loss of oil supply (Figure 8).

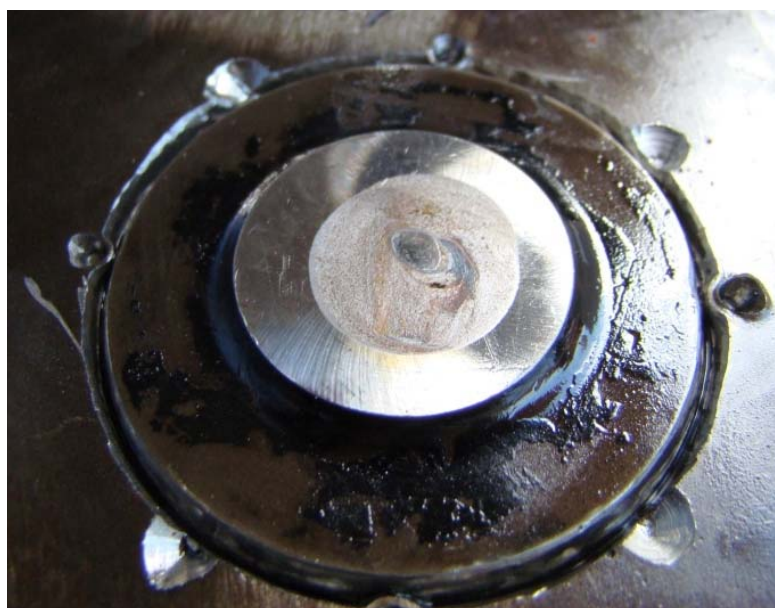
Figure 9. Worn thrust shoe pivot contact showing roughened area (fretting) and material transfer (galling).

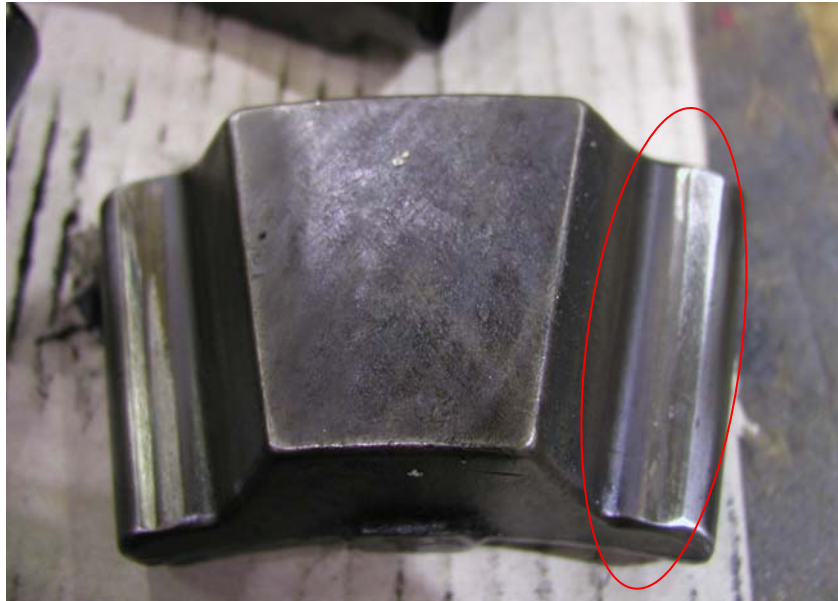
Figure 10. Lower equalizing link from equalized thrust bearing showing mild wear along the contacts.

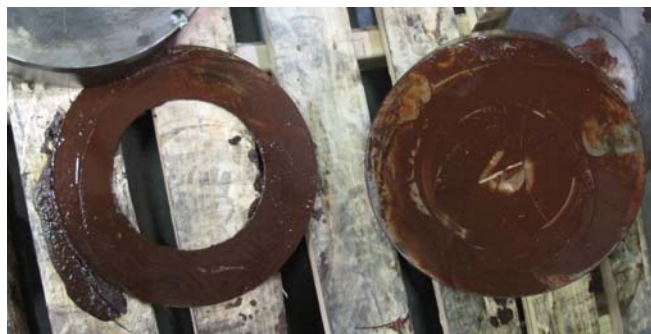
- Tilting shoe thrust and tilting pad radial bearings may use shims under the pivots or under the bearing carrier for position adjustment of the rotor. Poor contact with the shims may allow fretting wear to release hard particles into the lubricant (severe example shown in Figure 11).

Figure 11. Brown (oily) fretting debris generated between shim (**left**) and pivot support (**right**).

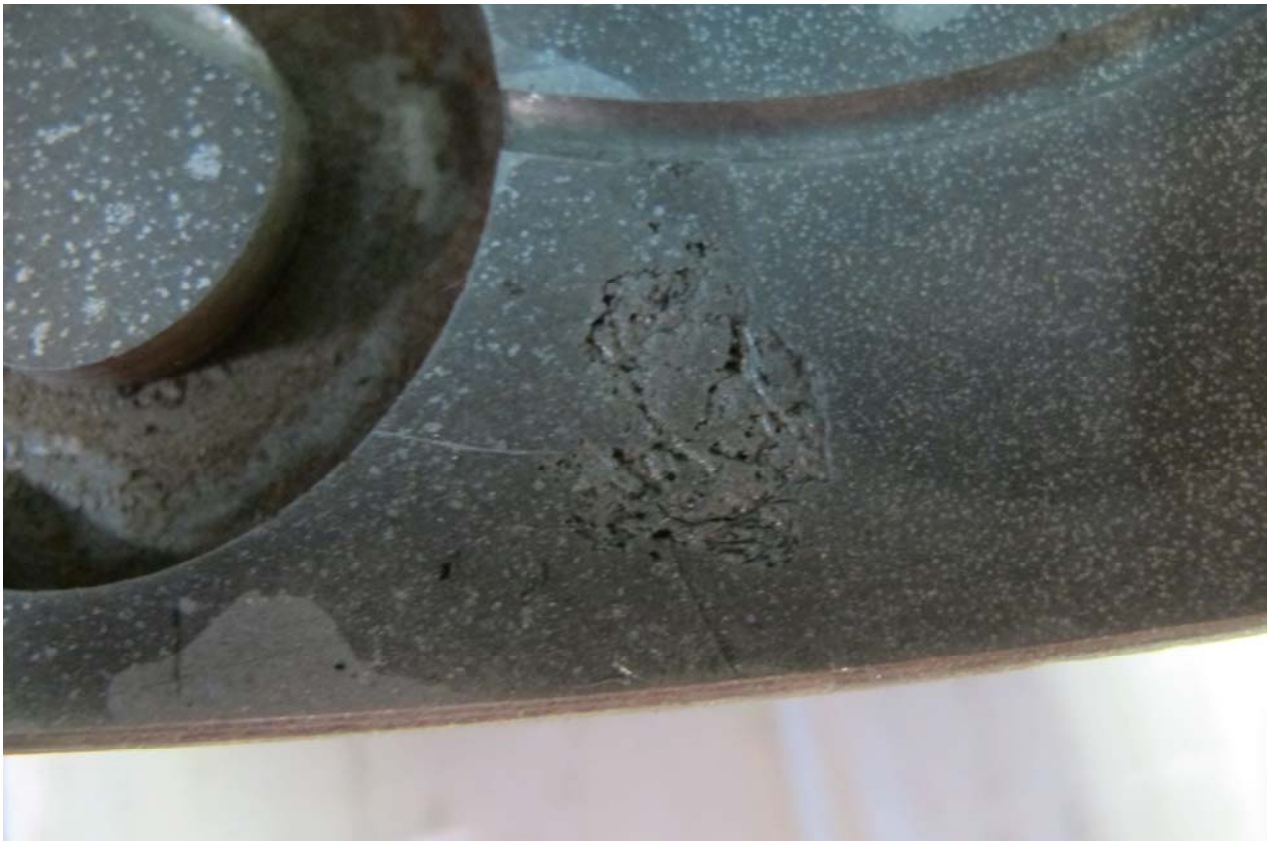
Figure 14. Large region of visual surface porosity with multiple linear indications from static casting observed on a test sample.

- Speckling—Some harder babbitt alloys contain antimony in excess of the saturation level for antimony in tin (about 7%). This results in the formation of additional antimony-tin cuboids during the casting process. After long-term operation of a bearing with this material at hotter temperatures, although consistent with the design operating temperatures, additional antimony-tin cuboids may be observed on the babbitt surface. The shiny aspects of these cuboids will give the surface a more speckled appearance. No impact on the hydrodynamic film is anticipated although the harder cuboids will alter any wear progress of the surface. Speckling can be observed around the porosity shown in Figure 14.
