Review

# Large Panel System Technology in the Second Half of the Twentieth Century—Literature Review, Recycling Possibilities and Research Gaps

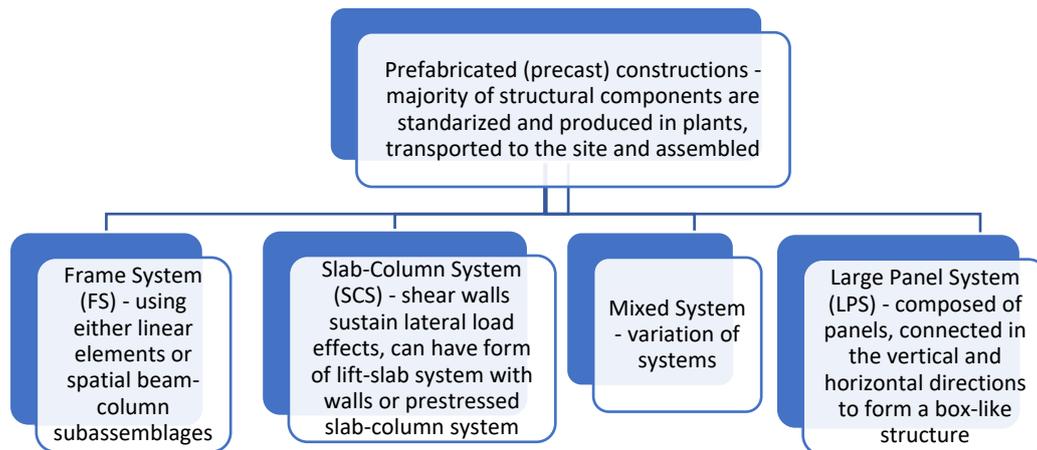
**Figure 1.** Four typical types of prefabricated constructions based of the load bearing structure (based on the information provided in [10,11]).

Prefabricated (also known as “precast”) systems can be divided into four categories, as shown in Figure 1, based on the load bearing structure. Below are the characteristics of the individual systems.

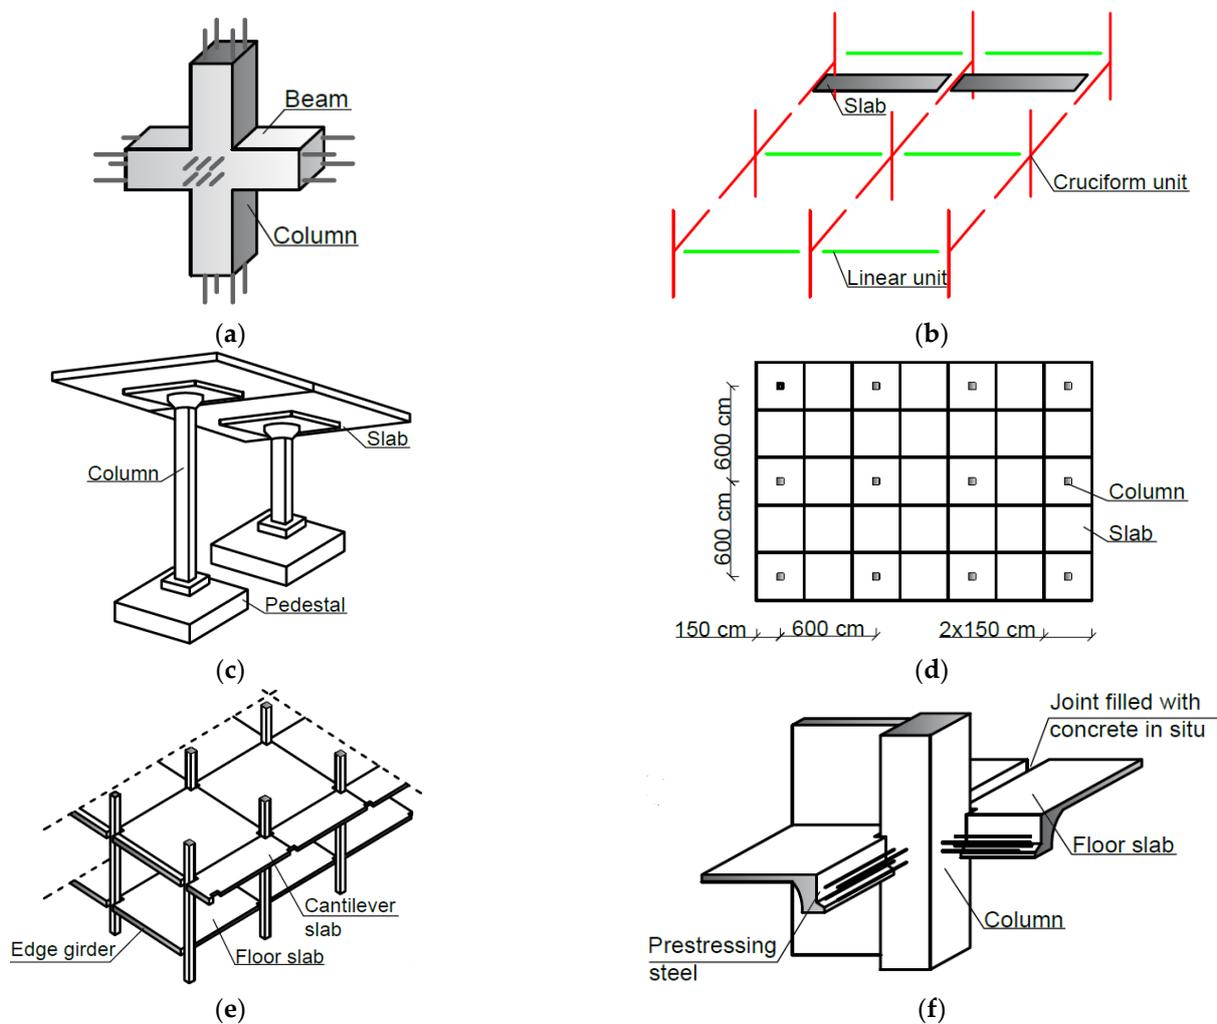
**Figure 2.** Elements of frame system: (a) a cruciform, (b) key load-bearing elements in a perspective. Elements of lift-slab: (c) key load-bearing elements (d) plan of a typical building. Elements of slab-column or IMS system: (e) axonometric view of basic components (f) column-slab joint (based on the information provided in [4]).

Frame system sub-assemblages can be placed away from the critical frame regions; linear elements are easier to assemble in terms of forming, handling and erecting spatial elements [1]. Linear elements are generally preferred and their assembly means placing the connecting faces at the beam–column junctions. The beams that are seated on corbels at the columns to aid the shear transfer from the beam to the column are called hinged. Rigid beam–column connection can be used when the continuity of longitudinal reinforcement through the joint must be provided. Figure 2a,b present elements of a frame system [2,3].

The lift-slab system consists of prefabricated concrete columns (usually two storeys high) and slabs [4]. All precast elements are connected by using joints. Slabs are poured in forms on the ground, then lifted by cranes to the final height (Figure 2c,d) [5].

Another category is a system based on prefabricated slabs and columns to form a frame structure–slab-column system. (shown in Figure 2e). Slabs and columns are prestressed in two directions so the whole construction can be stable and continuous. (Figure 2f) [4]. Although the slab-column system was designed particularly for high-rise buildings, it can be applied in public utility buildings (schools, hospitals, offices) and single-family row housing units [6–9].

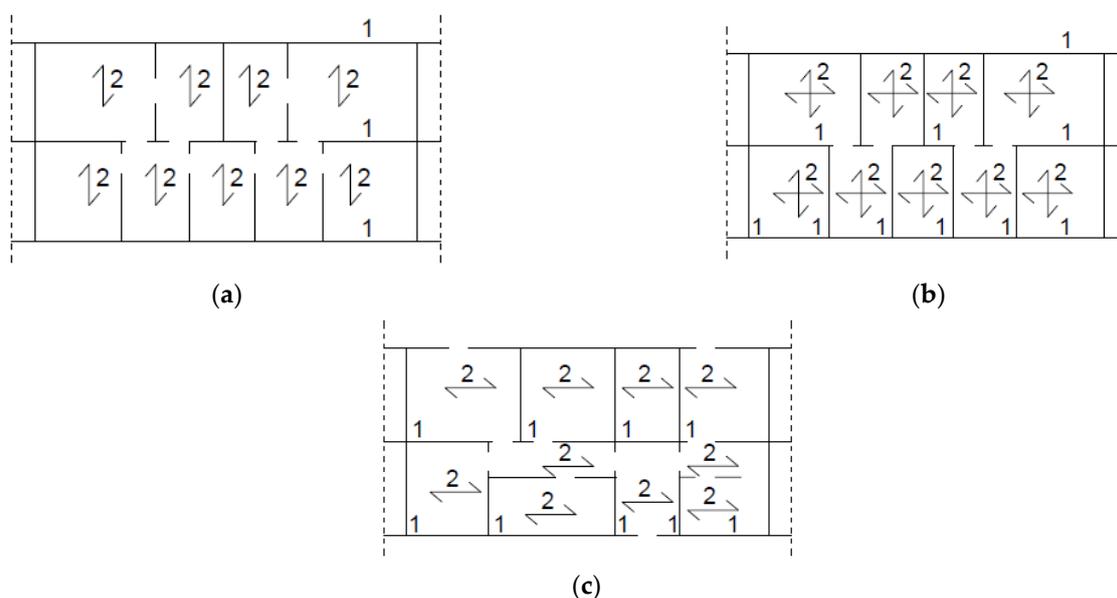
**Figure 3.** Typical configuration of panels: (a) longitudinal (b) cross-wall (c) transverse, where 1—load bearing walls and 2—direction of floor spans.

LPS can be typically divided into three categories based on wall layout: longitudinal, cross-wall and transverse, as showed in Figure 3. The key structural components in these structures are panel connections—joints [13]. They can be classified based on their location and construction method, as shown in Table 1.

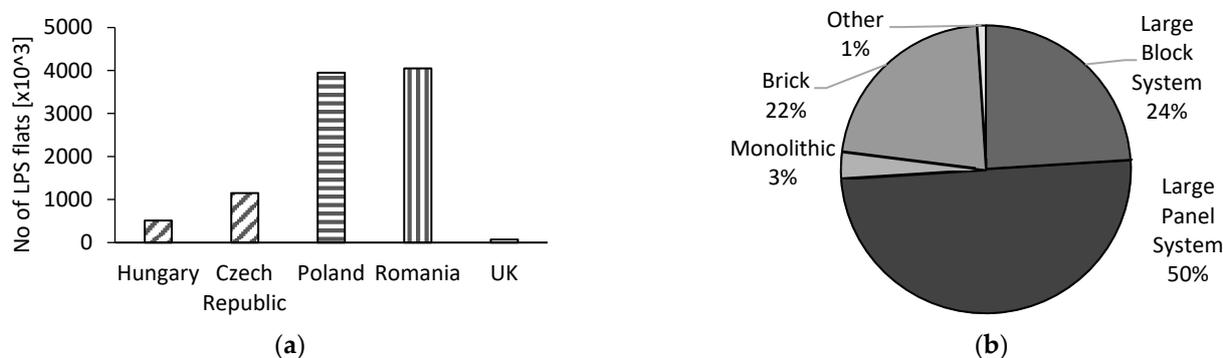
**Figure 4.** Contribution of LPS flats: (a) in selected EU countries (b) in Poland in years 1946–1992 (based on the information provided in [18,19]).

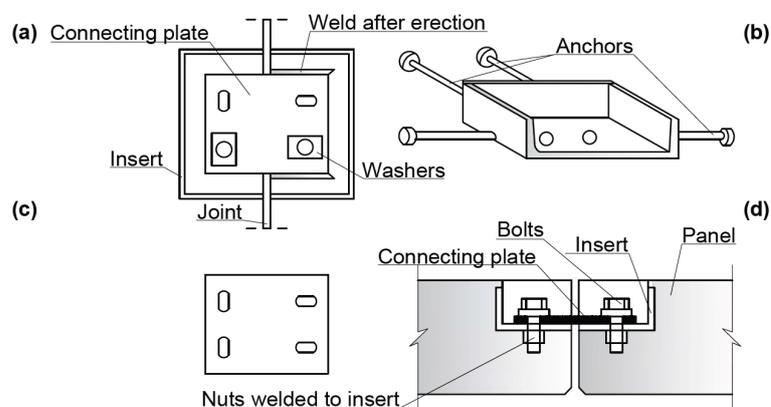
**Figure 8.** Details of limited wall-to-wall slip bolted joint: (a) elevation (b) insert (c) connecting plate (d) section (based on the information provided in [53]).

Unfortunately, especially in the beginning of designing LPS buildings, in areas where earthquake is marked as a major risk, because of no codes available, seismic resistance of buildings was no major concern. As an example, in Bosnia and Hercegovina, structures built up to about 1965 had no seismic code applied, as no such regulations existed in that time there [51]. Another example is North Macedonia, where a lot of LPS multi-storey family houses suffered a wide range of damage or collapsed, implicating serious casualties during the 1963 earthquake [52]. The remaining ones were subject to structural rehabilitation and strengthening by means of inserting new extra horizontal and vertical reinforced concrete strips and throwing in supporting pillars within massive structural walls [53]. After 1963, LPS buildings in North Macedonia started to be better quality and safer to resist strong seismic activity in the region. According to the survey, buildings that were built after the earthquake (the most in the 1970s, around 70% of national stock) are mostly in good condition [54,55]. Still, no evidence was found that LPS waste from the earthquake was somehow re-used or recycled, which would be beneficial if such events ever occurred again.

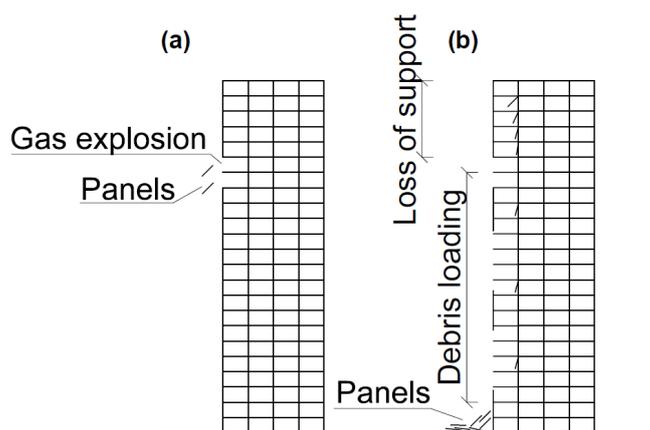
**Figure 9.** Problems with structural integrity in LPS buildings: (a) immediate local damage followed by (b) progressive collapse (based on the information provided in [64]).

The Ronan Point example showed that progressive or disproportionate collapse (Figure 9) occurs when a small part of the building is damaged by any form of abnormal load, and the whole structure loses its stability. LPS buildings are structures vulnerable to it, lacking flexural ductility and continuity [56]. Because identifying and eliminating the hazard can be in some cases impossible, designing all elements to be robust to withstand abnormal loads is expensive; the most acceptable solution seems to be designing alternative paths to redirect the load while the local failure occurs [57].

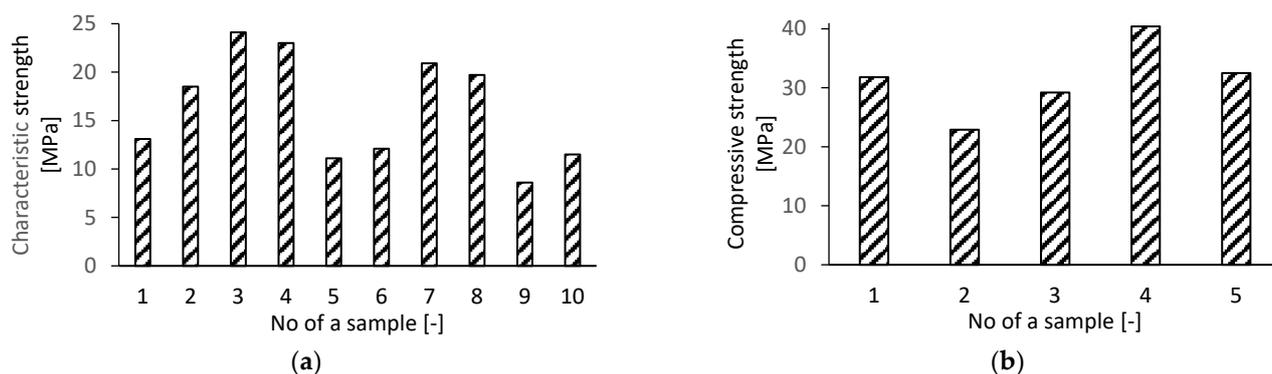
**Figure 10.** Results of concrete strength parameters: (a) hardness using Schmidt hammer (b) compressive strength using SATEC machine (based on the information provided in [72]).

Jasiczak and Girus, in [72], examined the external layer of the external wall of the edifice completed in 1986 with LPS technology (R-76, version of *Rataje* closed variant) with 13 overground storeys in Poznan, Poland. The thickness of triple-layer curtain wall layers were: external concrete layer of 6cm (expanded clay concrete C12/15 or standard concrete C16/20), thermal insulation of 9cm and structural concrete layer of 21 cm (expanded clay concrete C12/15 or standard concrete C16/20). The structure was transverse and longitudinal, with 4.8 m and 2.4 m spacing of load-bearing walls. The condition of concrete was determined by hardness and compressive strength. For a non-destructive test, authors used a Schmidt sclerometer. The tested concrete was in the air-dry state, and the temperature was 20–25 °C. The surface was prepared for measurement by splitting the surface layer of grit and grinding with smoothing with a wire end. Significant differences may result from conducting the test on the not-rigid-enough component (minimum thickness of the element, according to recommendations, should be 100 mm). Results are presented in Figure 10a. To determine compressive strength, the cored boreholes of 43–44 mm diameter were taken from the same structure. In order to avoid reinforcement in the samples, the location of steel rods was determined using a ferromagnetic device. For testing, a universal testing machine SATEC was used, and the results are shown in Figure 10b. Errors during construction stages, years of exploitation and poor maintenance [73] resulted in a great number of scratched panels, falling grit, visible hangers and pins in the examined building. However, results regarding the state of concrete are favourable.

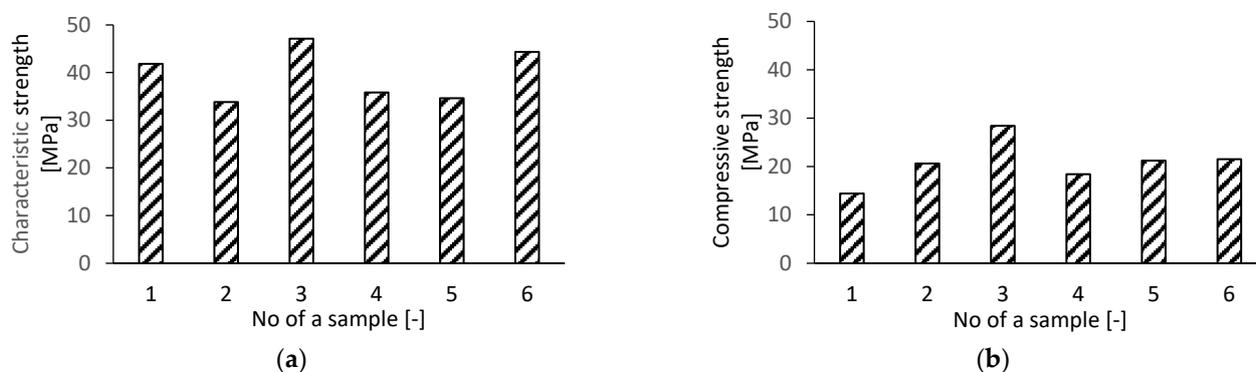
**Figure 11.** Results of concrete strength parameters: (a) on loggia wall, using Schmidt hammer, based on [80] (b) on external wall, using SATEC machine (based on the information provided in [79]).

Krentowski et al. [80] examined the condition of external curtain walls used in common late LPS systems (1980s) in Poland. He stated that the durability of the external partition (concrete structural layer, thermal insulation, outer layer of textured concrete) is highly influenced by the quality of the connections of layers. The state of the external partition is important as it affects LPS resistance to the possibility of a progressive collapse of the whole building. The conducted research and observations of buildings proved that the tested concrete of precast wall elements had sufficient tightness. It has been noticed that the internal structural concrete layer is not exposed to the direct weather influence and, from the external side of the building, it is covered by insulation material. In terms of durability estimation, the work conditions of the wall panels are good.

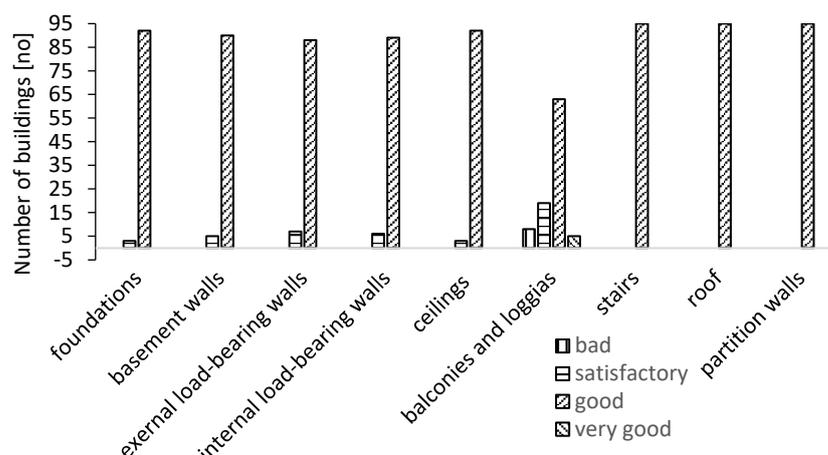
Figure 12. Technical state of bearing elements (based on the information provided in [76]).

Knyziak [76] analysed the durability of 95 apartment buildings in Warsaw, Poland—33 in large block technology and 62 in large panel technology. Although he noted several defects, including insufficient thermal insulation, devastated window frames, bad condition of water drains and old building's infrastructure, the conclusion was that concrete load-bearing elements are in good condition. The results from the research are shown in Figure 12. The vast majority of elements present good condition. The inspection was carried out according to [77].

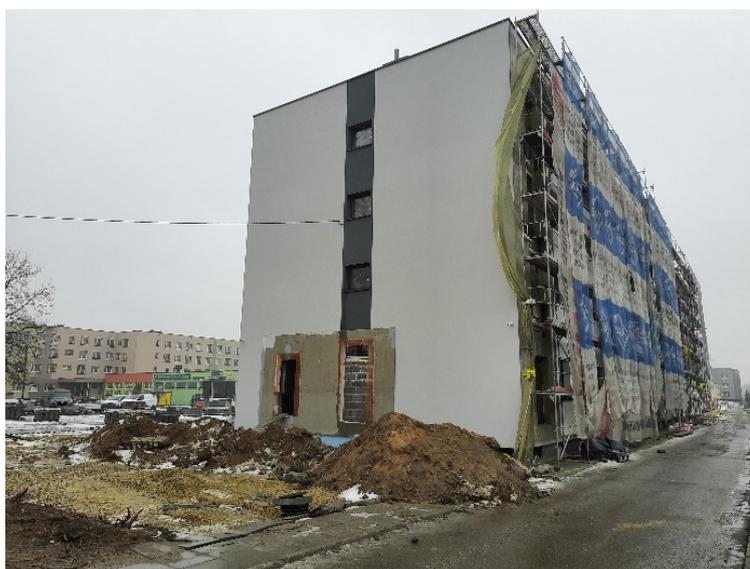
**Figure 13.** Example of improving residential functions—thermo-modernization of the estate.

There are many techniques of structural retrofit, depending on the country and region. In Poland, this usually takes the form of modernization works, similar to ones presented

in Figure 13. Meanwhile, research studies pay attention to, still, a lack of knowledge in those techniques. Nowakowski, in [45], concludes that it is necessary to develop new construction and technological solutions to properly organise renovation of LPS buildings. Protection of the natural environment, energy and other resources should be taken into consideration. The review of LPS retrofit techniques was presented in [14]. The authors demonstrated the need for more precise characterization of LPS buildings subjected to blast. It was stated that structural deficiencies in LPS blocks are still evident in all of Europe. In [54], the authors admitted that a huge number of analysed blocks have undergone, more or less, unskilled renovation. Special attention should be considered by the government, architects and urban designers, taking into account also cultural and social issues.

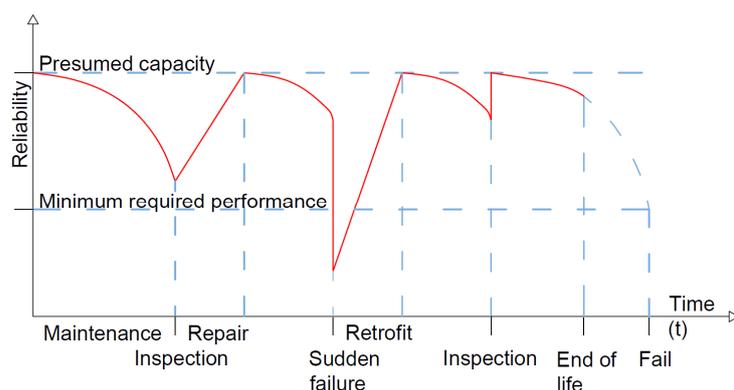
**Figure 14.** Reliability of construction over time.

Additionally, to still present lack of full knowledge of retrofit techniques, these actions cannot fully stop the end of service life. LPS buildings were designed to last 50 years. It is assumed, theoretically, that properly managed maintenance can extend the service life for another 50 years [86]. At the same time, some of the buildings are already older than their design age. Exceeding their service life brings us inevitably to the prognosed end of service life. According to provisions of the Paris Agreement, the civil engineering sector should decarbonise globally by 2050. Thus, effective strategies, based on the lifecycle of redesigned materials to be less resource intensive, acquiring waste as a resource to manufacture new materials, are needed. Antonini et al. [87] assumed that reversibility and durability features can improve the circular resource flow. The durability was defined as the *intensive correlation between the maintenance of a building object and its features and the ability to maintain technical efficiency*. Thus, the aging of materials due to exploitation and environmental impact results in the process of gradual durability loss. The durability of load-bearing elements, according to [88], is determined by two parameters: the ultimate limit state (strength and stability) and the limit of stiffness (serviceability limit state). Konior, in his research on durability [89], stated that the durability of building materials and their components depends on the period in which a properly operated product remains fit for the intended use. If the serviceability falls below the established minimum standard, this results in a partial or complete loss of durability, thus a renovation is needed (Figure 14).

Furthermore, the actual technical wear in the initial stage of an element's exploitation is greater than the theoretical one and represents *overdurability*. When time  $t_p$  reaches a certain value (which can be calculated), the wear ratio is reversed and remains in this state until the end value of the age of the structure  $t_{max}$ , which represents *infradurability*. With age, the disproportion only increases, exposing a great discrepancy in calculations using theoretical time methods. However, according to [90], buildings with errors, flaws during design, construction and exploitation stages are much more complicated cases. Unforeseen degradation phenomena, difficult to diagnose and remove, can take place, which does not satisfy the durability condition. This makes it possible to correctly calculate the remaining service life, including  $t_{max}$  and  $t_p$ , for properly constructed and designed buildings only. In Section 4.4, it was proven that LPS buildings built in the years 1950–1990 had many errors during all construction phases. In Section 4.3, it was emphasized that maintenance is often of poor performance. Thus, it seems impossible to correctly assess remaining service life of many large panel system buildings.

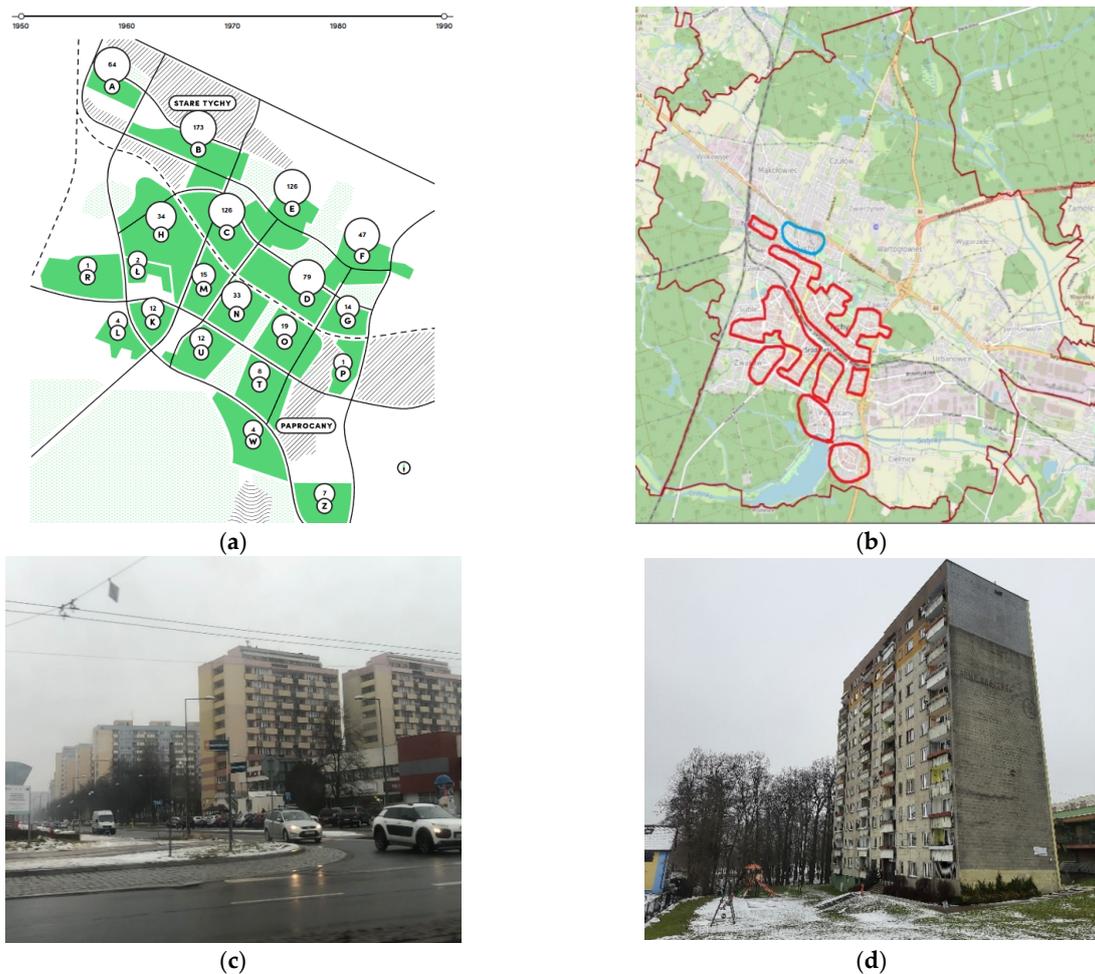
**Figure 15.** Example of LPS technology in Tychy, Poland: (a) housing estates built in 1950–1990. The letters of the alphabet stand for the names of the estate [93] (b) administrative borders of the city in 2022. The red colour shows housing estates from (a), blue colour indicates the historical centre [94] (c,d) estate O buildings.

Undoubtedly, a major problem in the future demolition of tower blocks is their location. LPS technology in Poland was considered a “mass solution” to satisfy the growing housing need. The policy of the post-war government resulted in the construction of new housing estates and reconstruction from war damages in a new architectural style. Due to social changes, sometimes whole cities were built of prefabricated panels. An example of such a solution is Tychy. A rural commune until 1954, the expansion of the city of Tychy began, which was to fulfil the role of a *bedroom city* for the Upper Silesian Industrial District. The first housing estate built was marked with the letter “A”. The next housing estates were named according to the letters of the alphabet (Figure 15a). According to data from the Central Statistical Office of Poland from 31 December 2020, the city is inhabited by 126,871 people [91]. The problem of large panel location is shown in Figure 15b. In the event of demolition, all LPS housing estates of the city of Tychy are located in the centre, complicating the entire operation logistically. Additionally, two housing estates are located in the immediate vicinity of the historic city centre. This is just one example out of thousands of cities in the country. In [92], the author stated that intensive economic growth forces finding an alternative approach to the development of the world that next generations will use. According to the author, eco-towns are the only sure and safe direction towards a sustainable approach. The presented example of Tychy and thousands of more towns with LPS estates unfortunately do not fit into the concept of eco-towns anymore.
