# Experimental Evaluation of Brick Masonry Walls Strengthened with TRM (Textile Reinforced Mortar) Renders

**Citation:** Marques, A.I.; Ferreira, J.G.; Candeias, P.; Veiga, M.d.R. Experimental Evaluation of Brick Masonry Walls Strengthened with TRM (Textile Reinforced Mortar) Renders. *Buildings* **2022**, *12*, 840. <https://doi.org/10.3390/buildings12060840>

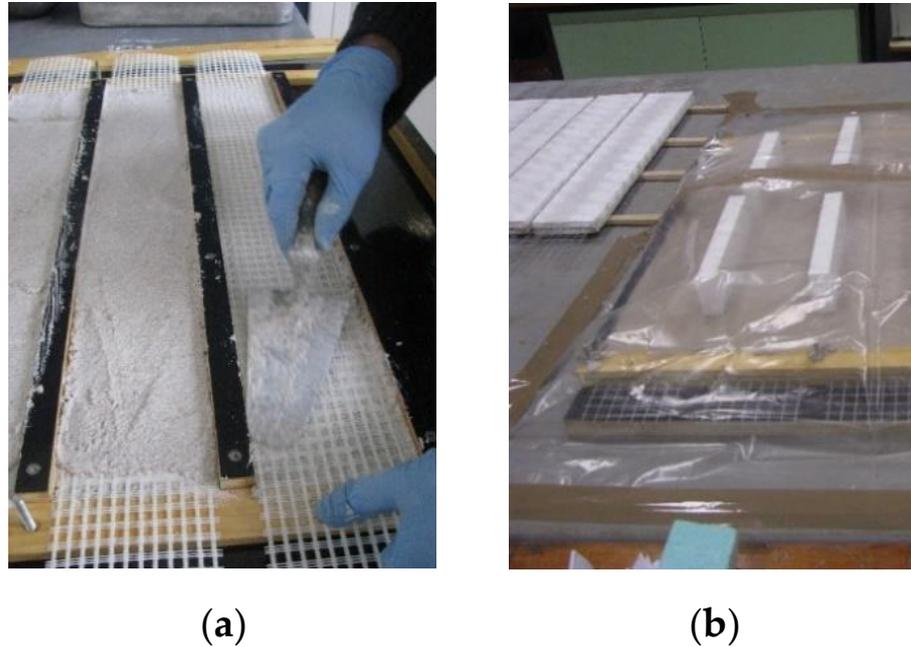
The reinforced mortar specimens were molded in two layers using maritime plywood formwork. The first layer is approximately 1 cm thick, the mesh is then deployed, as shown in Figure 1a, and, finally, the second layer is applied and leveled.

**Figure 1.** Reinforced render specimens: execution (a) and curing (b).

The type and time of curing (Figure 1b) followed the standard EN 1015-11 [10]. After the initial curing procedures, the specimens were placed in a conditioning room at a temperature of  $20\text{ }^{\circ}\text{C} \pm 2\%$ , and relative humidity of  $65\% \pm 5\%$  until the date of the test. Cement specimens were cured for 28 days, while lime specimens were cured for 90 days.

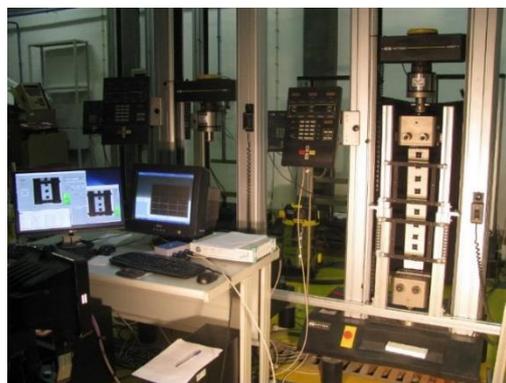
The tensile tests were conducted with displacement control with a speed of  $0.6\text{ mm/min}$  and a sampling frequency of  $50\text{ Hz}$ . Figure 2 shows the execution of one of the tensile tests at the specimen's rupture.

**Figure 2.** Execution of the tensile tests on reinforced mortar specimens.

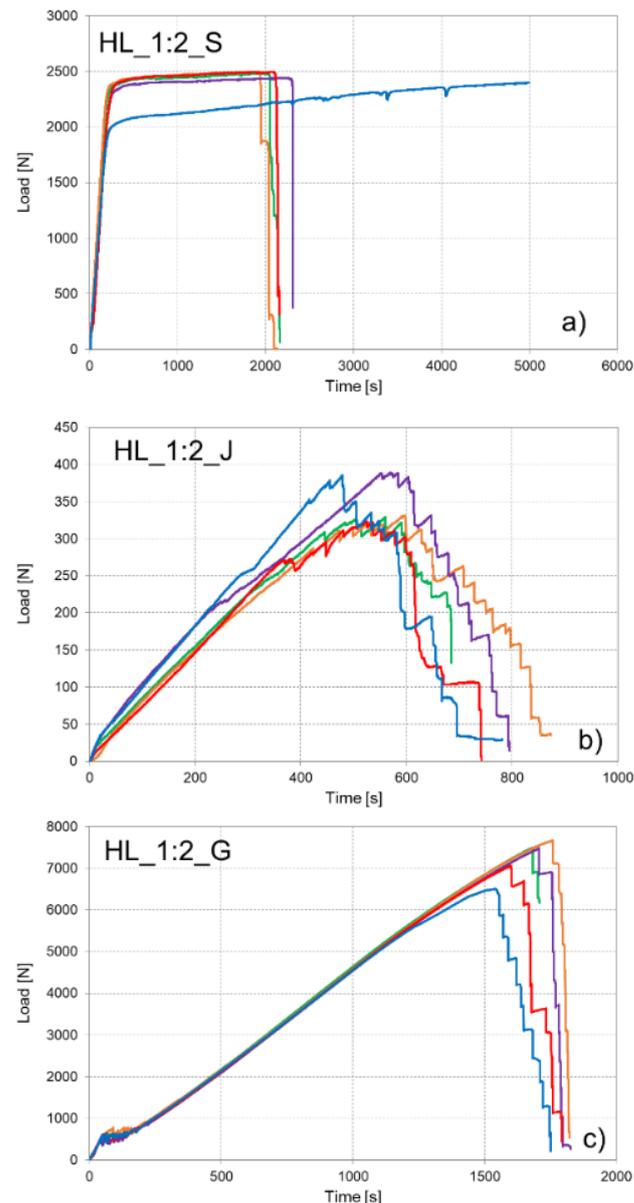
Figure 3 shows examples of a load vs. time diagram obtained in reinforced mortars of natural hydraulic lime mortar in the 1/2 binder/sand ratio in each of the three studied meshes. It should be noted that the diagrams are not on the same scale because the strengths obtained are quite different.

**Figure 3.** Load vs. Time diagrams obtained for reinforced renders with mortar of natural hydraulic lime with 1/2 binder/sand ratio: (a) steel mesh, (b) jute fiber mesh, and (c) glass fiber mesh.

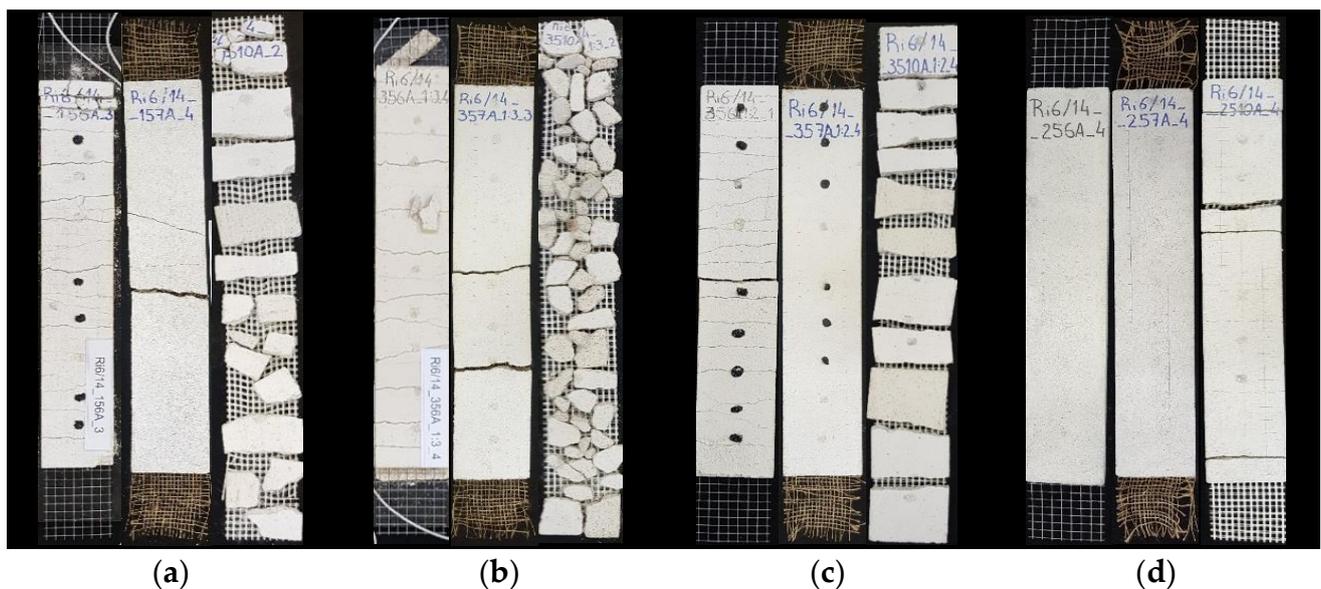
Table 2 shows the average value and standard deviation of the ultimate (maximum) stress, specific mass, and an estimate of the dynamic elastic modulus for each type of specimen (based on ultrasound tests). Figure 4 shows the typical rupture mechanisms for each group of specimens of reinforced renders (grouped by type of mortar).

**Figure 4.** Rupture mechanisms for each type of reinforced render with different mortar binder and different type of mesh (steel, jute, glass fiber, in this order from left to right in each group). (a) Hydrated lime. (b) Natural hydraulic lime 1/3 Binder/Sand ratio. (c) Natural hydraulic lime 1/2 binder/sand ratio. (d) Portland cement.

The rupture mechanisms obtained in the tensile tests are similar to those observed in similar tests in other research works [11–15]. It should also be pointed out that the occurrence of a certain rupture mechanism among those represented strongly depends on the shear stress installed at the ends of the specimen, as well as on the tensile performance of the mesh and the effectiveness of the connection between the reinforcing mesh and the mortar [16].

It was possible to observe that the specimens' failure due to slipping of the mesh never occurred, which shows the efficacy of the connection between the mortar and these reinforcing meshes. However, in some of the reinforced mortars, the tensile strength of the mortar was inconveniently higher than that of the fiber mesh. In these cases, the mesh breaks soon after the first crack occurs without mobilizing again the tensile strength of the mortar and thus without promoting crack propagation. Such were the cases of renders with natural lime mortar at a 1/2 binder/sand ratio reinforced with jute fiber mesh or that of cement mortars, both with jute and metallic meshes.

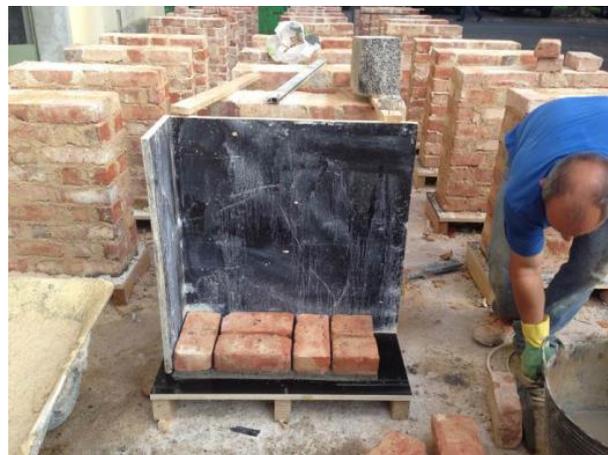
New small specimens of solid ceramic brick masonry, named wallettes, were produced, at  $70 \times 70 \text{ cm}^2$ , simulating the constitution and behavior of original wallettes (previously taken from a real building), which were previously characterized through an experimental campaign. The brick layout pattern is shown in Figure 5 (the wall thickness, of 21 cm, corresponds to the longest brick edge). Bricks obtained from the demolition of an old building (the same from which the other wallettes had been taken) were used, and previously characterized. The laying mortar used was composed of hydrated lime, a mixture of river and sandpit sand, half weight of each (with 1:3 binder/sand ratio), and water. The mortar constitution was equivalent to that of the old building from where the bricks were obtained. Three wallettes were selected, prepared, and instrumented to perform diagonal compression tests. The laying mortars underwent a curing process of approximately six months before the application of the reinforced render.

Figure 5. Execution of new solid brick wallettes.

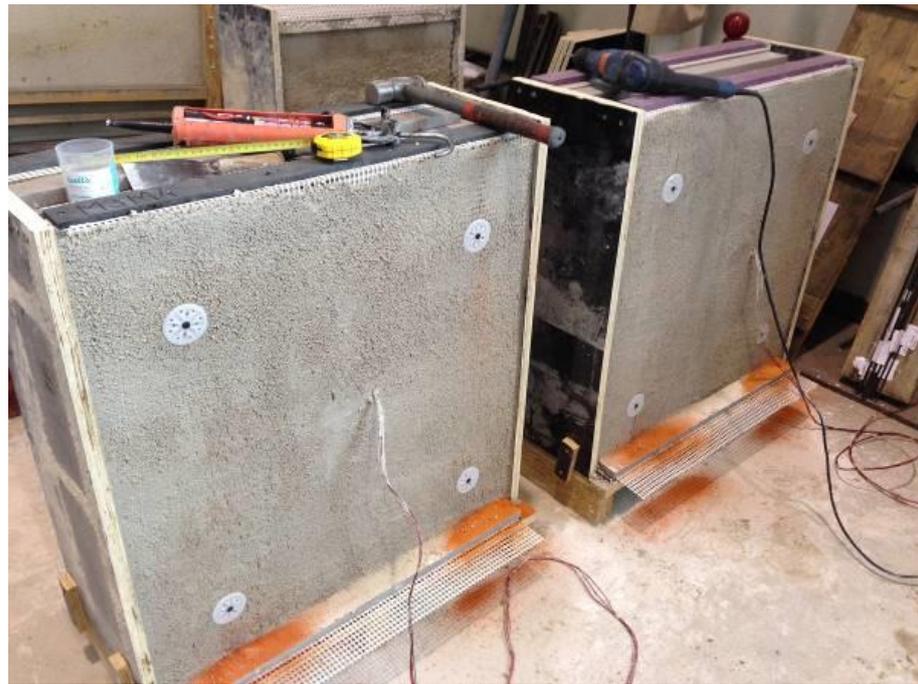
The reinforced renders were applied to both sides of the wallettes with a thickness of 3 cm (2 cm for the leveling layer + 1 cm for the finishing layer). A wooden structure was created around the wallettes to anchor the rendered mesh, so it remained stretched during the application and curing of the mortar. The mesh was affixed to the wallette through four plastic connectors, approximately 7 cm long, forming a  $50 \times 50$  cm square centered on the wallette, as shown in Figure 6.

**Figure 6.** Wallettes with the reinforced render.

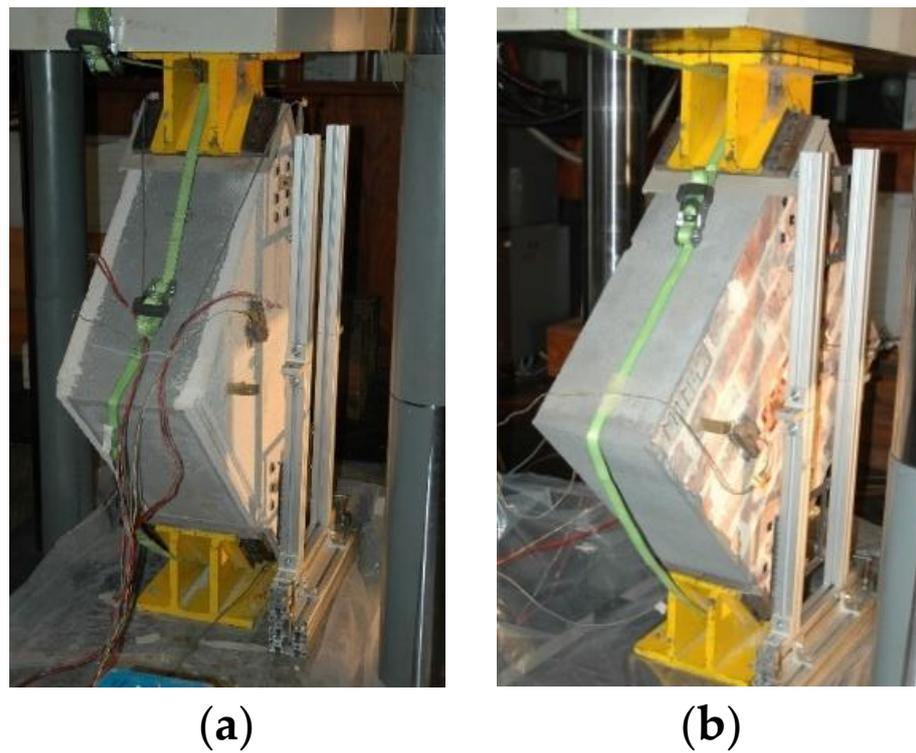
The test method basically consisted of gradually applying the load with a controlled speed of 0.005 mm/s, sampling the data at a 50 Hz. rate. Loading was performed vertically with the wallette positioned at 45 °C, as shown in Figure 7.

**Figure 7.** Diagonal compression test of strengthened (a) and plain (b) wallettes.

After placing each wallette in the correct position, it was instrumented with two displacement transducers of type W50 (50 mm course) on each face to measure the deformation in the horizontal and vertical directions.

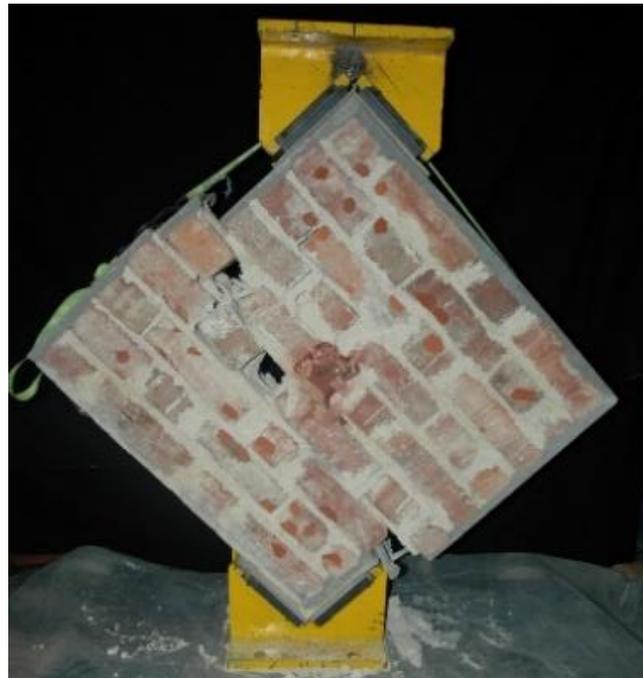
**Figure 8.** Collapse mode of the plain (non-strengthened) wallette M1M5.

As seen in the images of the collapse mechanisms, the ruptures in both reinforced renders are associated with diagonal cracks (towards the opposite vertices of the wallettes), typical of shear collapse. The collapse mechanisms observed in the wall core are in accordance with those observed in the render, resulting in a main diagonal crack, zigzagging along the mortar joints, which is also typical of a shear collapse mode.

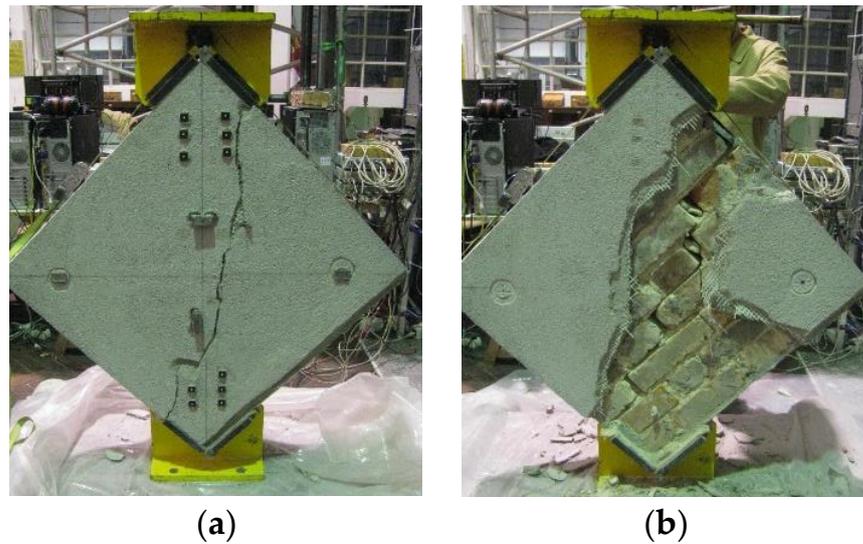
**Figure 9.** Collapse mode of wallette M2M3 (with cement mortar reinforced render) at the render (a) and at the wall core (b).

After the test, it was found that some zones of the render were not adhering to the wall, showing a lack of compatibility between the render and the brickwork. This effect was more significant for the cement mortar render.

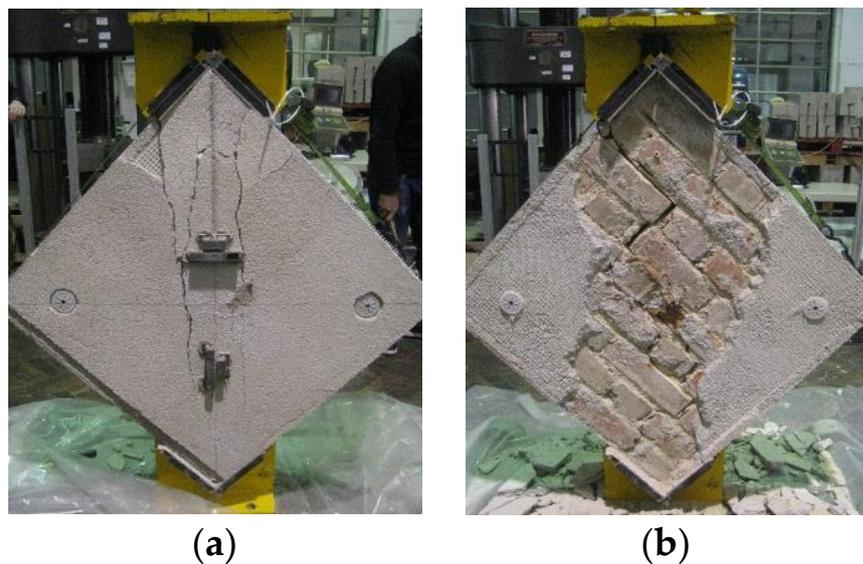
**Figure 10.** Collapse mode of wallette M3M3 (with NHL mortar reinforced render) at the render (a) and at the wall core (b).

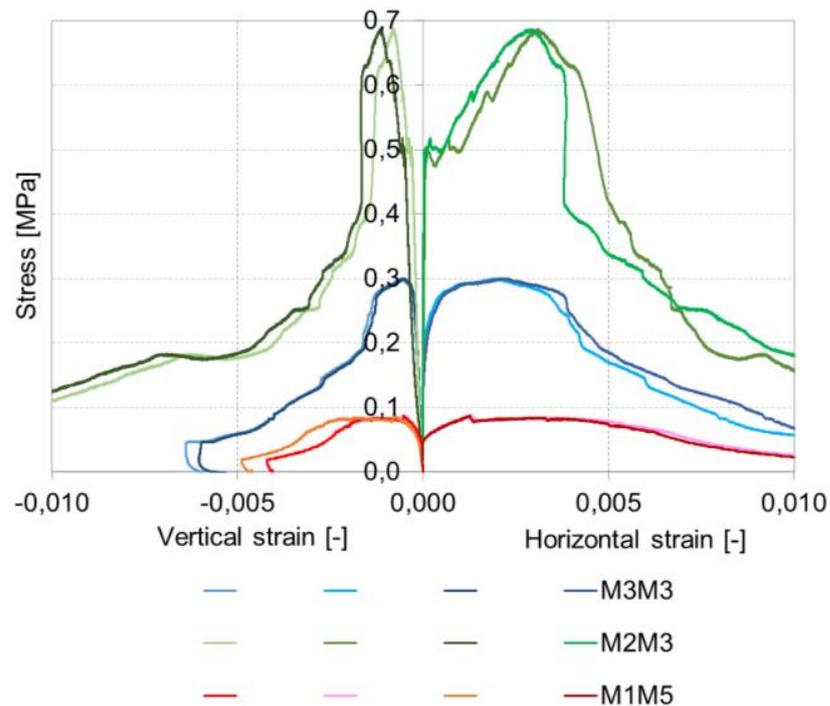
Figure 11 shows the diagram of the applied stress as a function of vertical and horizontal deformation for the three tested wallettes (plain and strengthened). Table 3 shows the calculated parameters resulting from these diagonal compression tests.

**Figure 11.** Stress-strain diagram for the wallettes.

Reinforced render with natural hydraulic lime increased the shear strength by about 2.25 times while cement mortar reinforced render increased it by about 6.5 times. This significantly higher strength increase in the cement mortar render when compared to natural the hydraulic lime render shows that, besides the type of fiber (the fiber meshes were similar), the mortar properties also strongly influence the strengthening effect of the reinforced render solution.
