Architectural Characteristics and Seismic Vulnerability Assessment of a Historical Masonry Minaret under Different Seismic Risks and Probabilities of Exceedance

Figure 1. Bitlis Ulu Mosque's minaret parts.

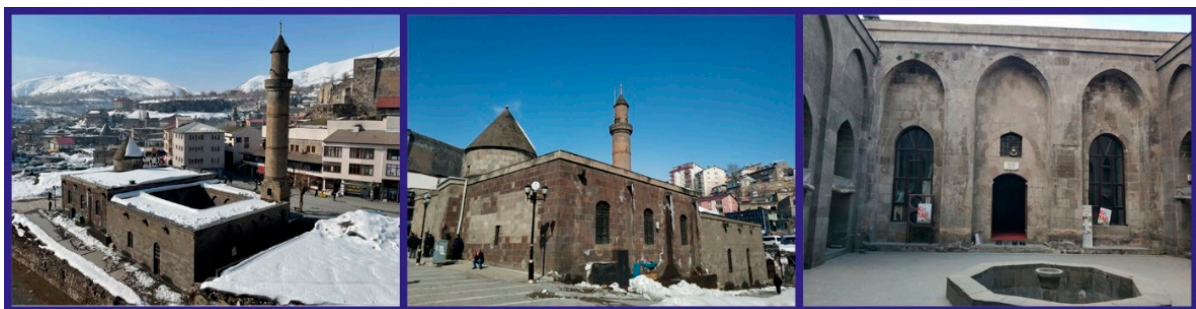
Figure 2. The Ulu (Grand) Mosque and its minaret.

Although Bitlis is located on a strategic transition corridor in the Eastern Anatolia region of Turkey, it has been the cradle of many civilizations. There are many historical and monumental buildings and artifacts belonging to different civilizations in the province. One of the most important of them is the Bitlis Grand Mosque and its minaret. Different images of the Ulu (Grand) Mosque and its minaret are shown in Figure 2.

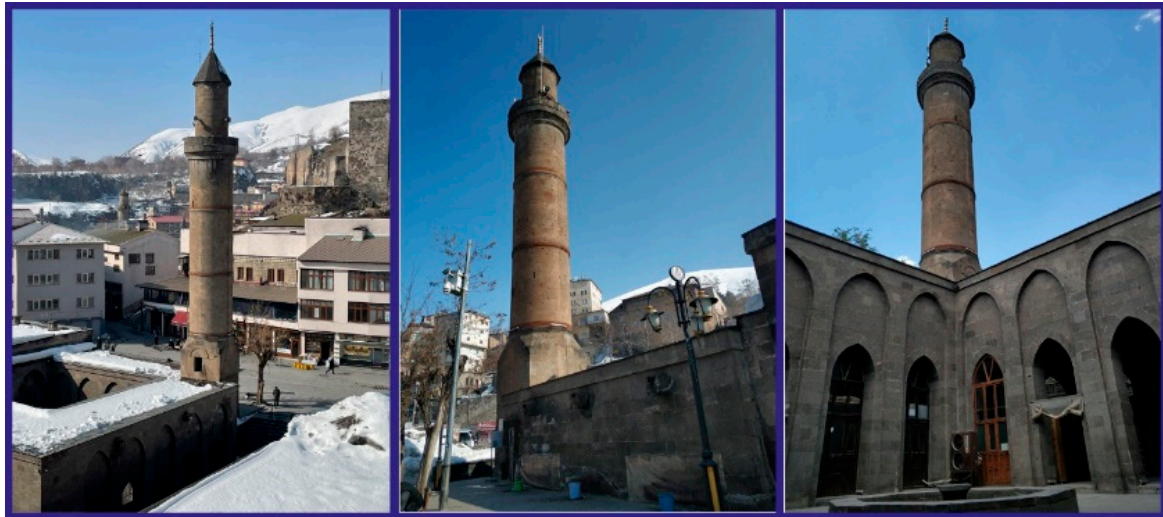
Figure 3. The minaret of the Ulu Mosque.

Minarets are tall and slender structures in the form of towers, which are generally built adjacent to mosques and in a separate area, in which the call to prayer is made. For the scope of this study, the Ulu Mosque's minaret, which is located in the province of Bitlis built from unreinforced masonry, was chosen. Different images of the minaret are shown in Figure 3.

The Ulu Mosque and its minaret were built with a single balcony by local masters and workers, using the Bitlis stone. The dimensions of the Ulu Mosque's minaret are 3.10×3.10 m and it was built on a square foundation. It has a cylindrical body shape and has a body diameter of 3.10 m. The body wall thickness of the minaret is 0.60 m. The total height for this minaret was determined as 30.48 m. These features of the Bitlis Ulu Mosque's minaret are shown in Table 1.

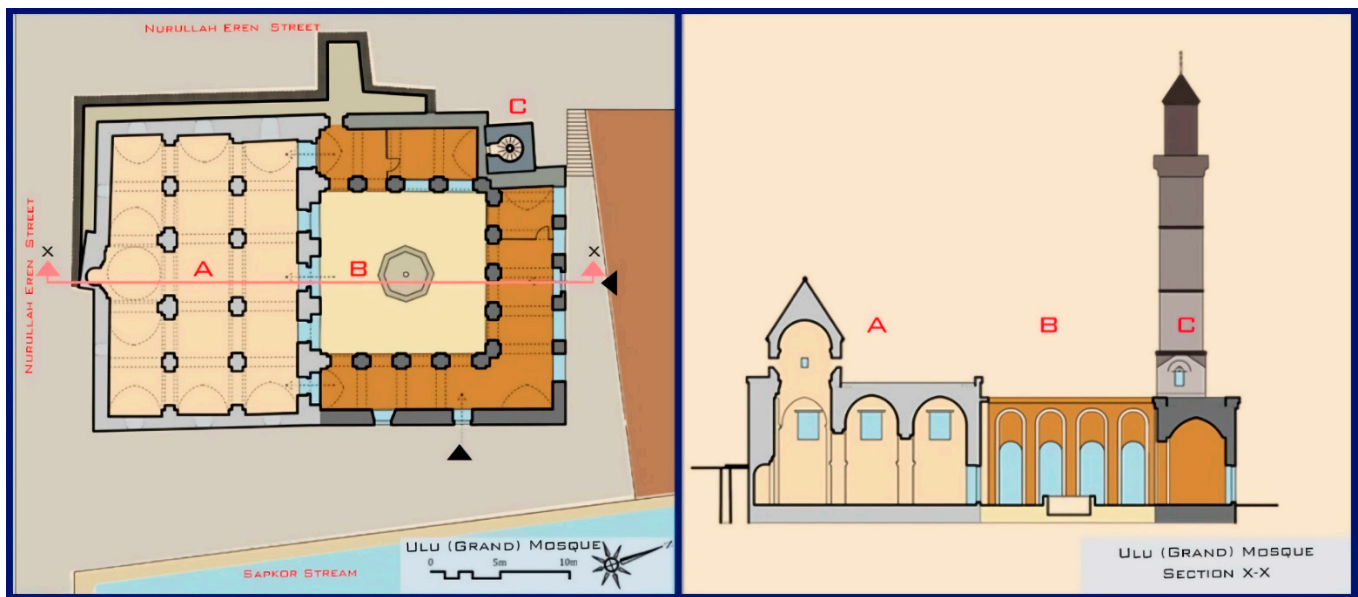
Figure 5. Bitlis Ulu Mosque's plan and section: (A) sanctuary; (B) portico court; (C) minaret.

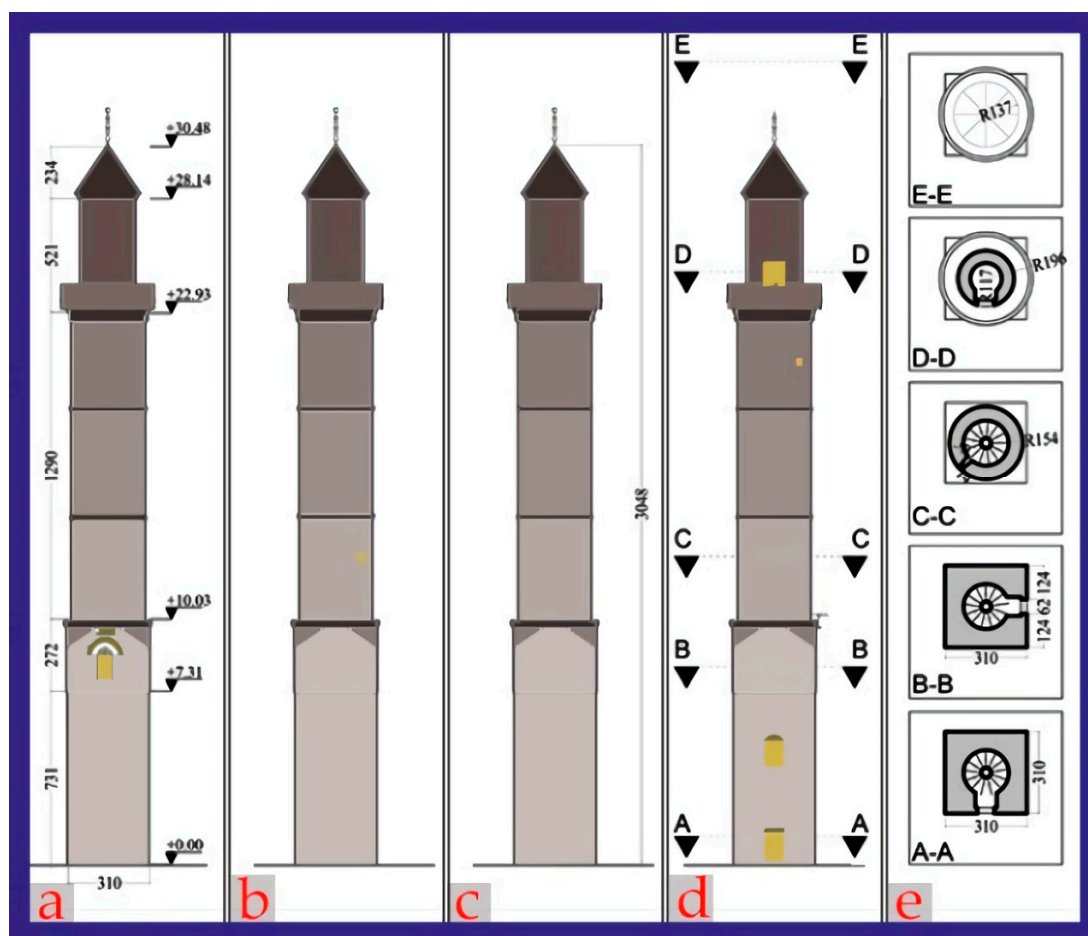
Figure 8. Bitlis Ulu Mosque's minaret view and plans: (a) east elevation; (b) west elevation; (c) north elevation; (d) south elevation; (e) plans.

Within the scope of this study, the appearance and plans of the minaret of the Great Mosque, one of the most important historical structures of Bitlis Province, are shown in Figure 8.

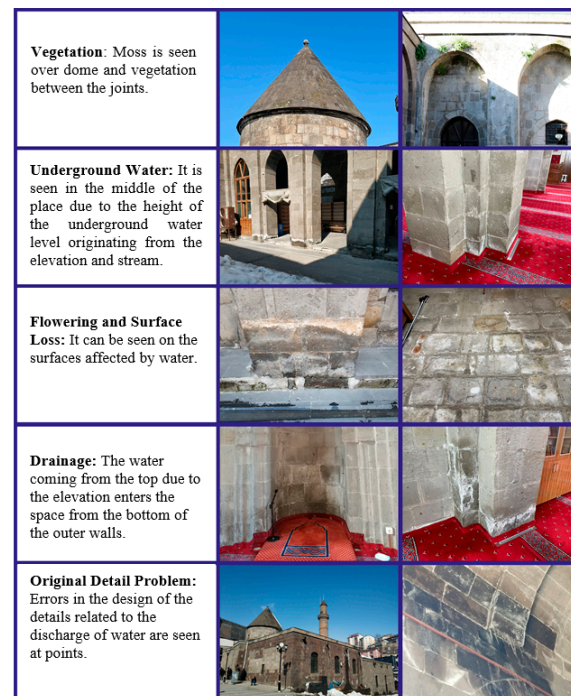
Figure 10. Damages observed in the Ulu Mosque.

Due to its location at the lowest elevation of the province, Ulu Mosque is also affected by the high groundwater level. This effect is an important factor causing a moisture problem with minor partial settlements in the structure. It is possible to see this effect in the lower parts of almost all vertical load-bearing elements in the mosque. In addition, calcifications are clearly observed on the exterior walls of the mosque due to rain and snow waters. The mosque has recently been repaired and renovated. Negligible mass losses and wall joint losses occurred on the outer walls of the mosque. There are plant formations in some parts of the dome of the mosque. Precipitation water coming from the canals, which were built to remove rain and snow water on the roof of the mosque, known as coratan in its local name, creates a moisture effect in these parts by making a collision effect on the walls of the exterior part. The fact that the mosque is very close to the Bitlis stream bed causes groundwater to be influential inside the mosque. It can be said that the biggest problem for the mosque today is the underground and precipitation waters. A drainage system surrounding the structure can be suggested to prevent possible damage induced by ground surface water that may cause partial settlements. No cracks or damage were observed on the elements of the mosque load-bearing system. The visuals of the damages observed in different parts of the Bitlis Ulu Mosque are shown in Figure 10.

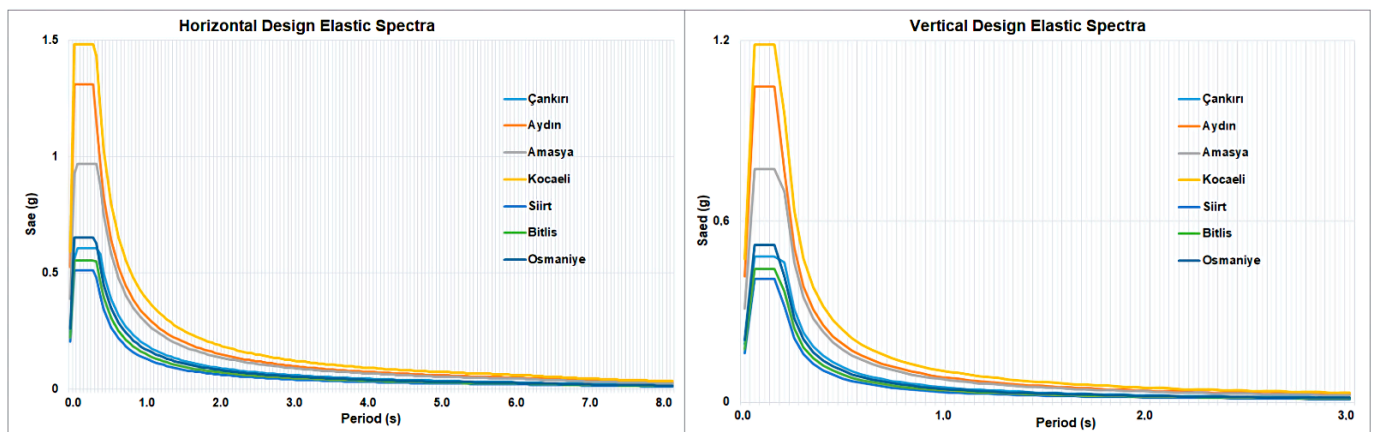
Figure 15. Comparison of horizontal and vertical elastic design spectra.

There was no change in the local ground effect coefficients obtained for the different probability of exceedance levels for the province of Bitlis. However, as the probability of exceedance levels increased, the S_S , S_1 , S_{DS} and S_{D1} values decreased. This is due to the fact that very rare earthquakes have higher magnitudes. The design spectra, on the other hand, were obtained by fitting a smoothed envelope curve to the response spectra calculated from different ground motion acceleration records in order to take into account the maximum earthquake effects that may occur, by taking into account the seismic characteristics and local site conditions of any region [54,55]. The change in the design spectrum curves also affected the displacement demands in the buildings. It is obvious that damage estimations and building performances would deviate from the realistic values in buildings when displacement demands are not met [56,57]. A comparison of the obtained horizontal and vertical elastic design spectra is given in Figure 15.

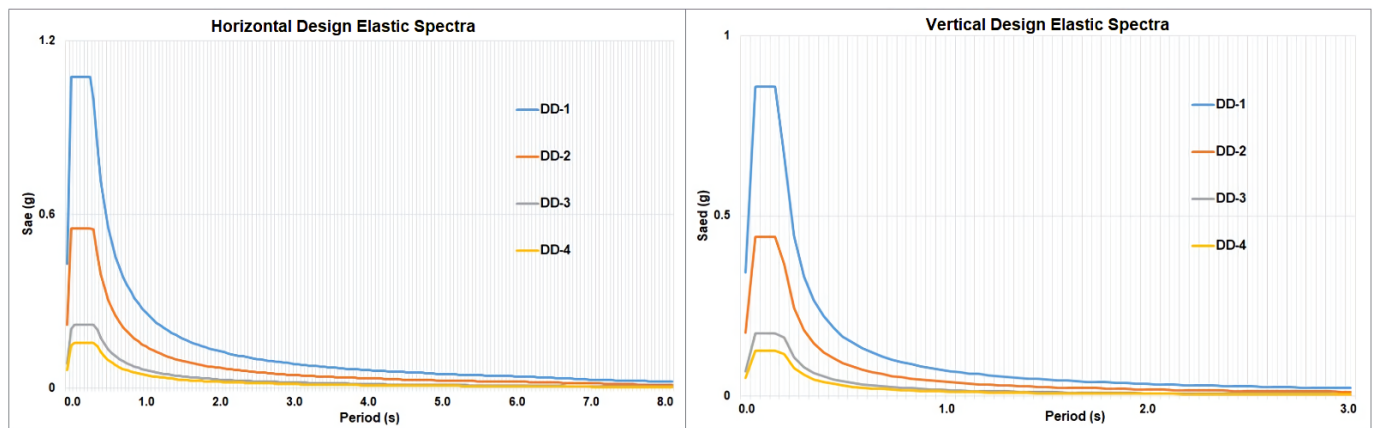
Figure 16. Comparison of horizontal and vertical elastic design spectra obtained for different probabilities of exceedance.

Since the vertical elastic design spectrum was used for the first time with the current regulation, it was not possible to compare it with the previous regulation. While a single design spectrum was used for the settlements selected in the previous map, a design spectrum specific to each geographical location was used together with the current regulation. A comparison of the obtained horizontal elastic design spectra revealed this difference. The comparison of the horizontal and vertical elastic design spectra obtained by considering the different probabilities of exceedance for the minaret is given in Figure 16.

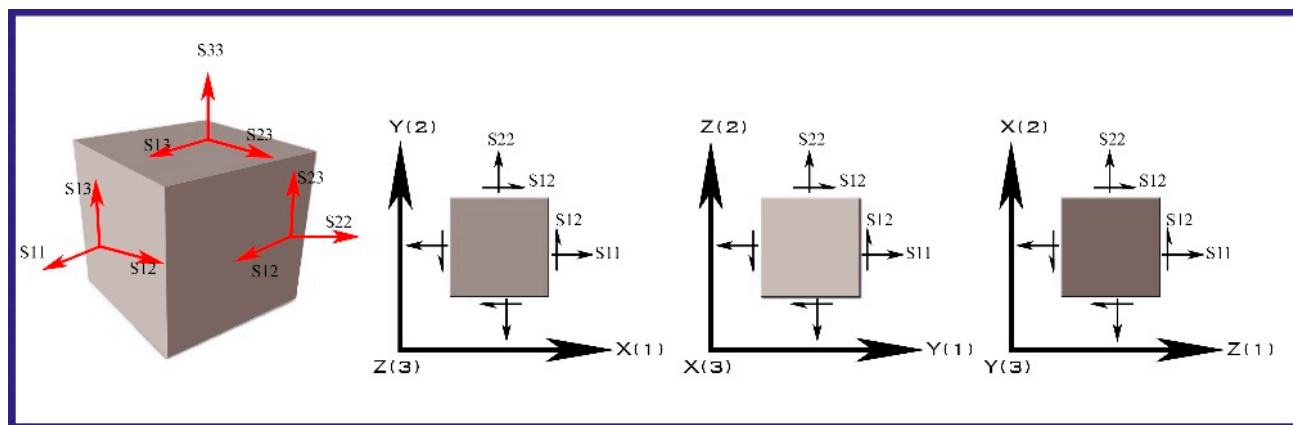
Figure 17. Sign convention in the analyses.

As indicated in Figure 17: S11: vertical stress in (x) direction, S22: axial stress in (y) direction, S33: axial stress in (z) direction, (S12 = S21): shear stresses in x–y plane. While determining the material properties for the minaret, the following literature works were followed Işık et al. (2020) [62] and Işık et al. (2022) [13]. The elastic modulus (E) and unit weight (γ) values of Bitlis stone were taken as a single value in all structures. The properties of the material used are given in Table 8.

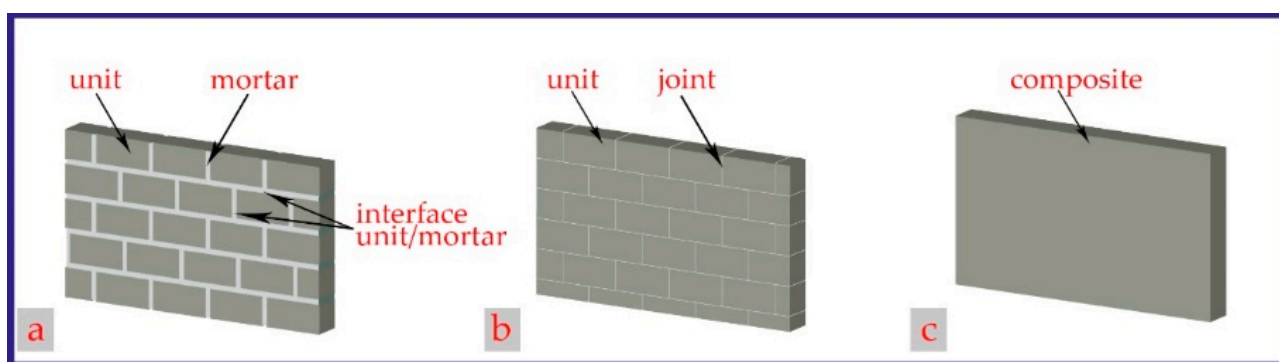
Figure 18. Modeling methods of masonry: (a) detailed micro modeling; (b) simplified micro modeling; (c) macro modeling.

In this study, a finite element model of the minaret was created using the macro modeling technique. The macro modeling technique is one of the commonly used masonry structural modeling techniques in the literature. The historical masonry bell towers in South-East Lombardy in Italy [63], historical fortified masonry palaces in Switzerland and Northern Italy [64], Emir Bayındır Bridge in Turkey [65], San Pietro and San Benedetto churches in Italy [66], Torre De la Vela in Spain [67], Gaskar brick minaret in Iran [68] and five historical masonry minarets in Antalya (Turkey) [69] are some of the studies examining the seismic behavior of different types of structures using this type of structural

modeling technique. While doing this type of modeling, analyses are carried out without making any distinction between the binding material (mortar, etc.) used in the building and the structural elements. In this modeling, the masonry unit and the properties of the mortar are homogenized and considered as masonry composite material. The mechanical properties of this model are the values obtained as a result of the homogenization process. Macro modeling is more convenient in practice because it requires less computational cost. However, with macro modeling, stress distributions in masonry units and mortar can be obtained accurately [70–72]. The Bitlis stone used in the minaret and the mortar that connects them were considered as a single material, and the material properties of the Bitlis stone were taken into account in the analyses for these two materials.

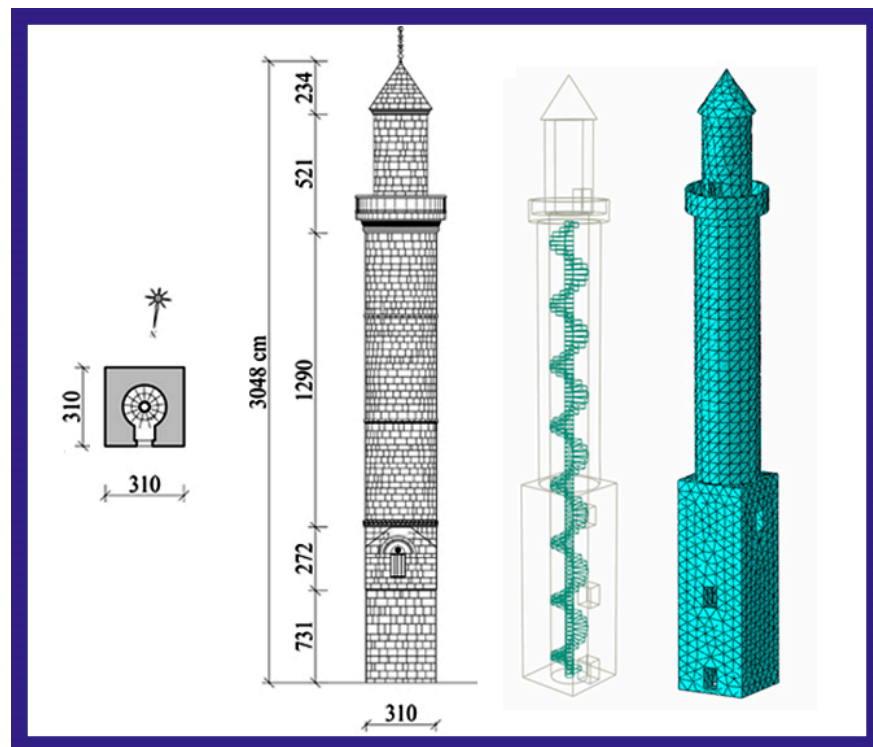
Figure 19. Bitlis Ulu Mosque's minaret and 3D minaret models developed by the software program.

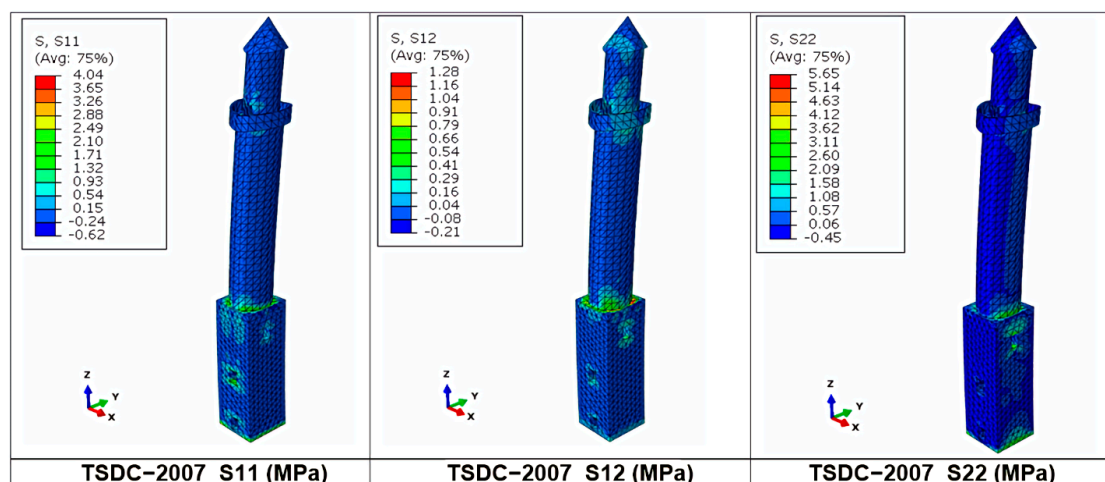
Figure 21. Stress distribution according to TSDC-2007.

An Abaqus response spectrum analysis was used to estimate the peak response parameters (displacement, stress and base shear force) of the minaret. The stresses distribution in the minaret is shown in Figure 21. Since the same design spectrum curve was used for seven different settlements considered in the study and located in the same earthquake zone, the same stresses would be obtained. The stress diagrams obtained for the largest earthquake ground motion level (DD-1) with a 2% probability of exceedance in 50 years are shown in Figure 22. The stress diagrams obtained for the standard design earthquake ground motion level (DD-2) with a 10% probability of exceedance in 50 years and a recurrence period of 475 years are shown in Figure 23. The stress diagrams obtained for the frequent earthquake ground motion level (DD-3), which has a 50% probability of exceedance in 50 years, are shown in Figure 24. The stress diagrams obtained for the service earthquake ground motion level (DD-4), which has a 68% probability of exceedance in 50 years, are shown in Figure 25.

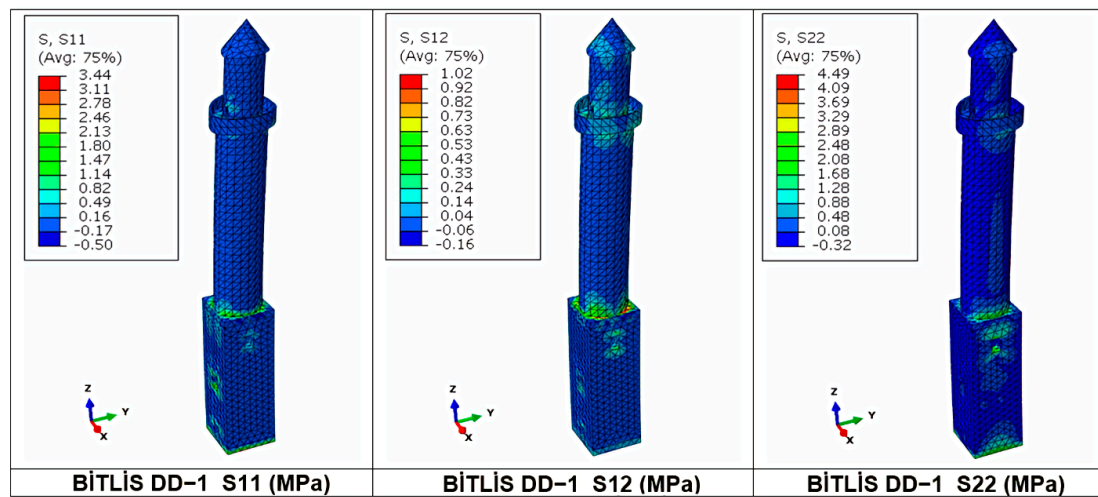
Figure 22. Relative stresses for DD-1 ground motion level.

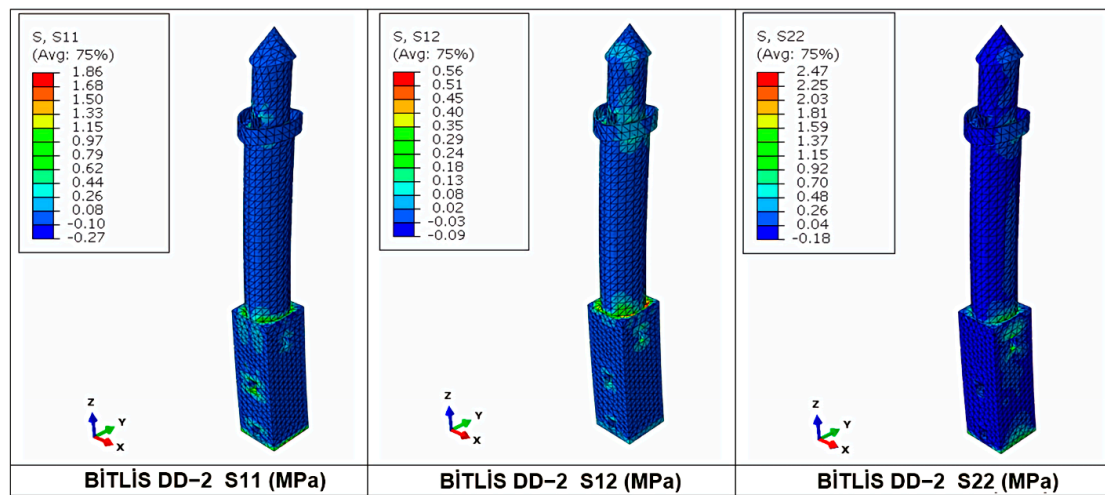
Figure 23. Stresses for DD-2 ground motion level.

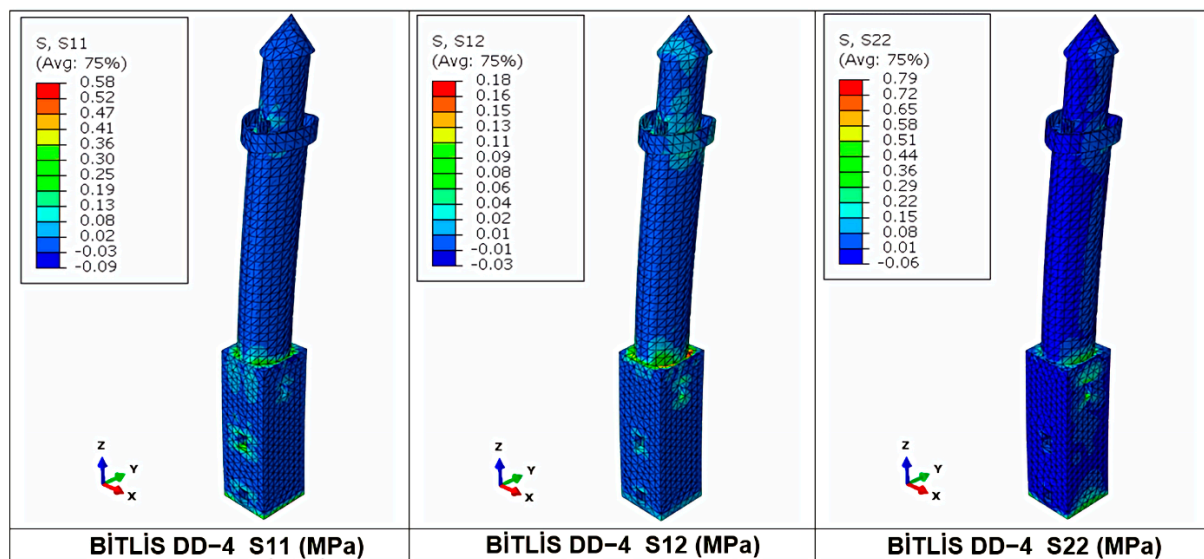
Figure 25. Stresses for DD-4 ground motion level.

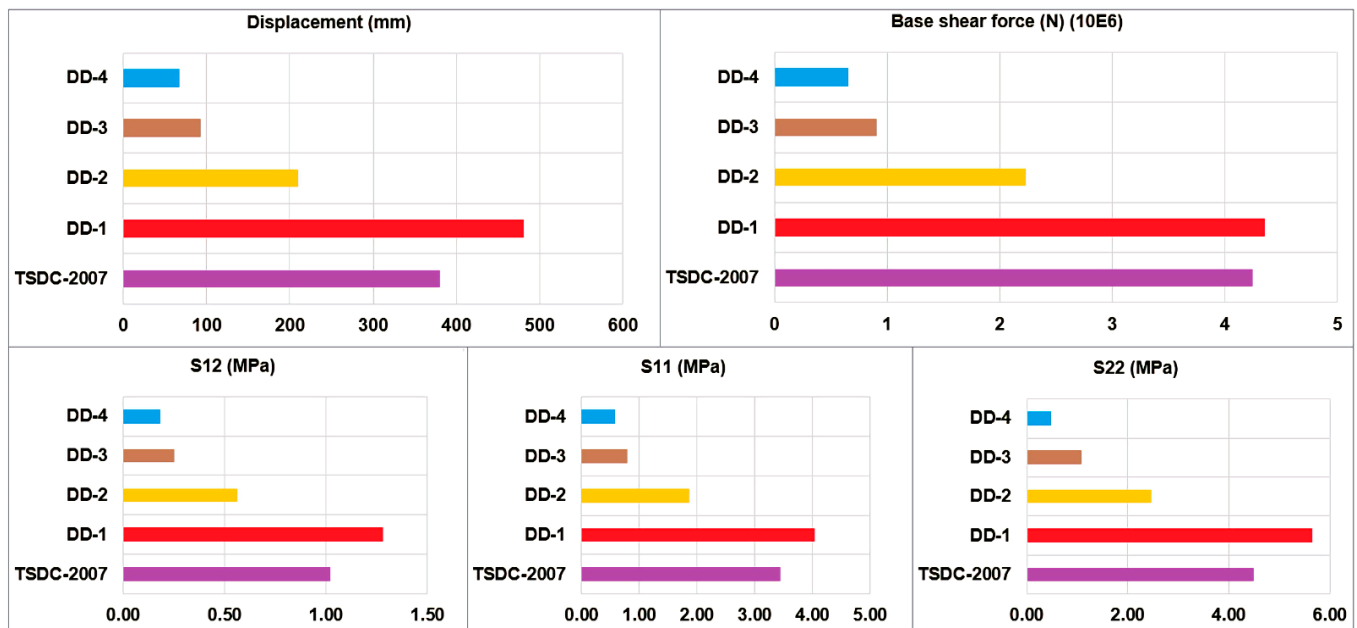
Figure 26. Comparison of result values for different probabilities.

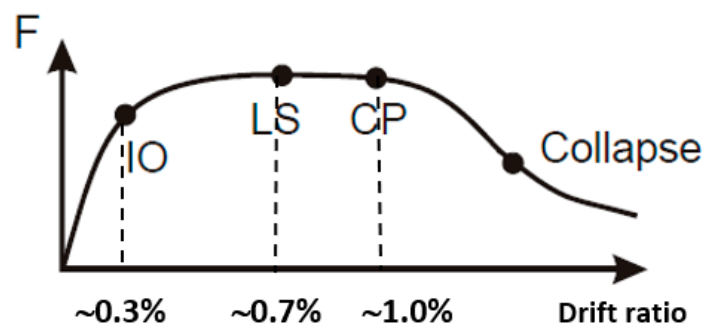
Figure 27. Pushover curve and limit states.

Performance levels were also determined by using the displacement values obtained in the study. For this purpose, the limit value assumptions specified in the Earthquake Risk Management Guide for Historical Buildings (TYDRYK-2017) [78] were used and these values are presented in Figure 27. It is stated that it is sufficient to use linear calculation for the immediate occupancy (IO) performance level, and one of the linear or nonlinear calculation methods for the life safety (LS) and collapse prevention (CP) performance levels. If one of these calculation methods is selected, the minimum limit values that must be provided are shown.

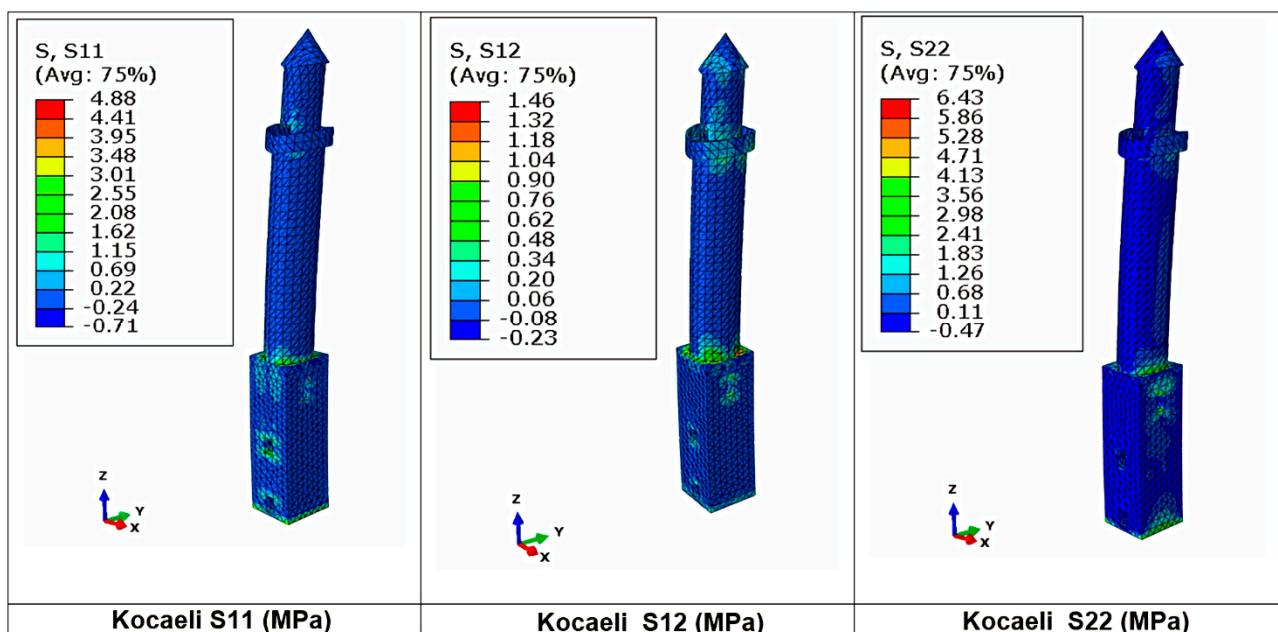
Figure 28. Stresses for Kocaeli (Central) Province.

In this part of the study, the effect of the site-specific design spectrum, which is one of the important changes between the last two earthquake codes, is examined. In the previous regulation, site-specific seismicity effects were neglected by using the same design spectrum for the same earthquake zone. The fact that each geographical location has unique seismic parameters requires a differentiation of the design spectra. In order to show the difference, the stresses occurring for Kocaeli Province, which has the highest PGA value among the settlement units considered within the scope of the study, are shown in Figure 28, while the stresses occurring in the minaret of the Ulu Mosque, which was chosen as an example for Siirt with the lowest PGA value, are shown in Figure 29. During this comparison, no changes were made in the structural characteristics, material properties and local soil class of the minaret. The only variable was the design spectrum specific to each settlement. The importance of using the site-specific design spectra is shown.

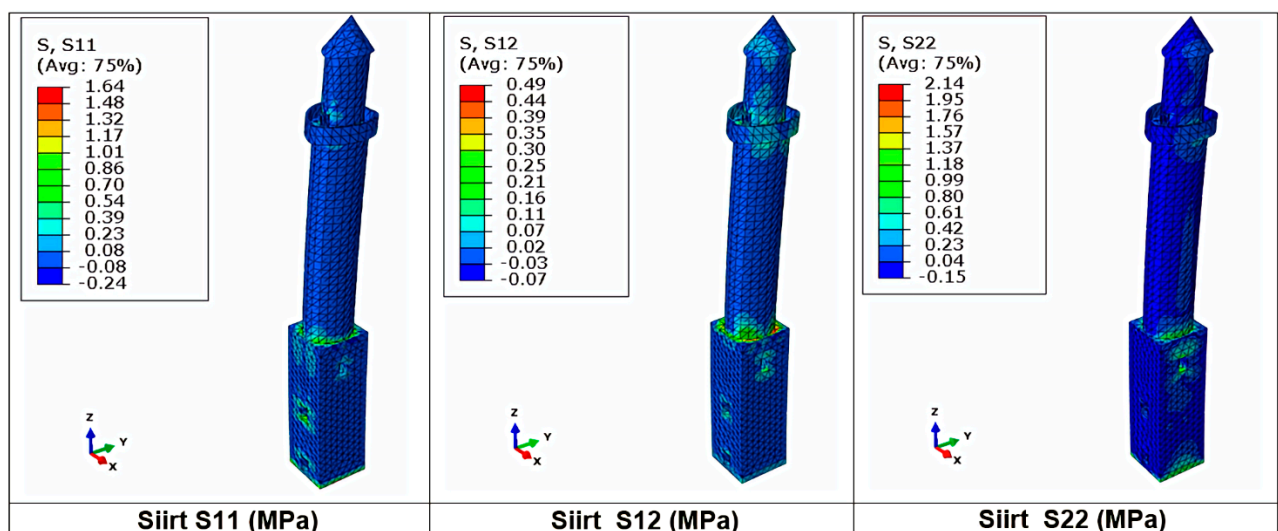
Figure 29. Stresses for the province of Siirt (Center).

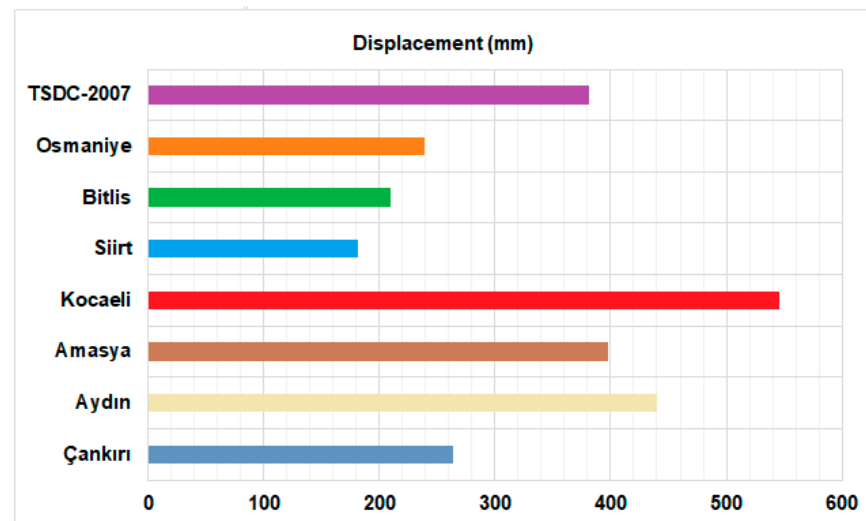
Figure 30. Comparison of displacement values for each settlement.

The comparison of the result values obtained for all settlements considered in the study is shown in Table 13. The comparison of the displacement values obtained for the settlements is shown in Figure 30.

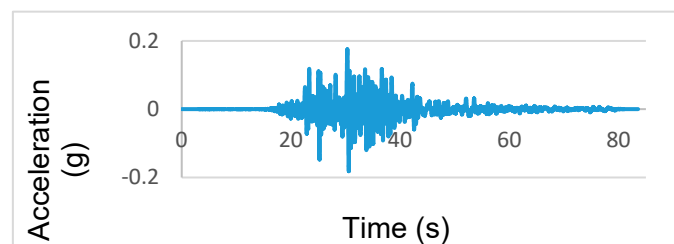
**Figure 31.** 2011 Van earthquake south–north acceleration–time graph.

Time history analysis is the numerical analysis of the equation of motion, which is created by considering the mass, damping and stiffness properties of the structure, under a selected ground motion. In this part of the study, time history analyses were carried out by using the acceleration records of the 2011 Van earthquake, which occurred recently in the closest region to the Bitlis Ulu Mosque's minaret. The Van Earthquake south–north acceleration–time curve of this considered earthquake is shown in Figure 31. Solid elements were used in the construction of the finite element model under the presumption that the structure's materials were homogeneous, and a linear elastic material model was used for the time history analysis.

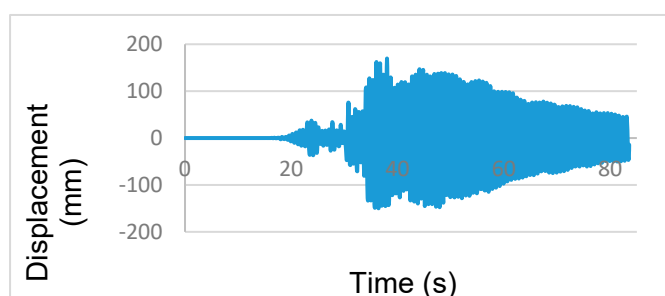
**Figure 32.** Time history analysis (Van earthquake) (max = 169.64 mm).

The displacement–time graph obtained as a result of the time history analysis is shown in Figure 32 by using the 2011 Van earthquake south–north acceleration–time curve.

As a result of the 2011 Van earthquake acceleration record, it was obtained that the minaret of the Ulu Mosque's minaret had a maximum displacement of 0.17 m. This value was lower than the displacement values of 0.38 m and 0.21 m determined for the last two earthquake codes. Considering the displacement value obtained for the 2011 Van earthquake, the performance levels are shown in Table 15.
