# Seismic Performance of Composite Shear Walls Filled with Demolished Concrete Lumps and Self-Compacting Concrete after Fire

**Abstract:** In order to provide a good solution for the treatment and utilization of construction waste, especially waste concrete and to promote the development of green construction to some extent, in this paper, a new composite shear wall filled with demolished concrete lumps (DCLs) and self-compacting concrete (SCC) was proposed, and its seismic performance after fire was investigated. Based on quasi-static tests of four composite shear walls filled with DCLs and SCC, three after a standard fire and one contrastive specimen without fire, the effects of fire exposure time, fire-retardant coating on the edge constraint steel pipe column, and the width-thickness ratio on seismic performance of composite shear walls after fire were studied. The failure patterns, bearing capacity, hysteretic loops, ductility, skeleton curves, rigidity degradation curves, and energy dissipation of shear walls were analyzed and compared. Test results indicate that the bearing capacity of the shear wall after 60 min of standard fire is slightly lower than the contrastive speci

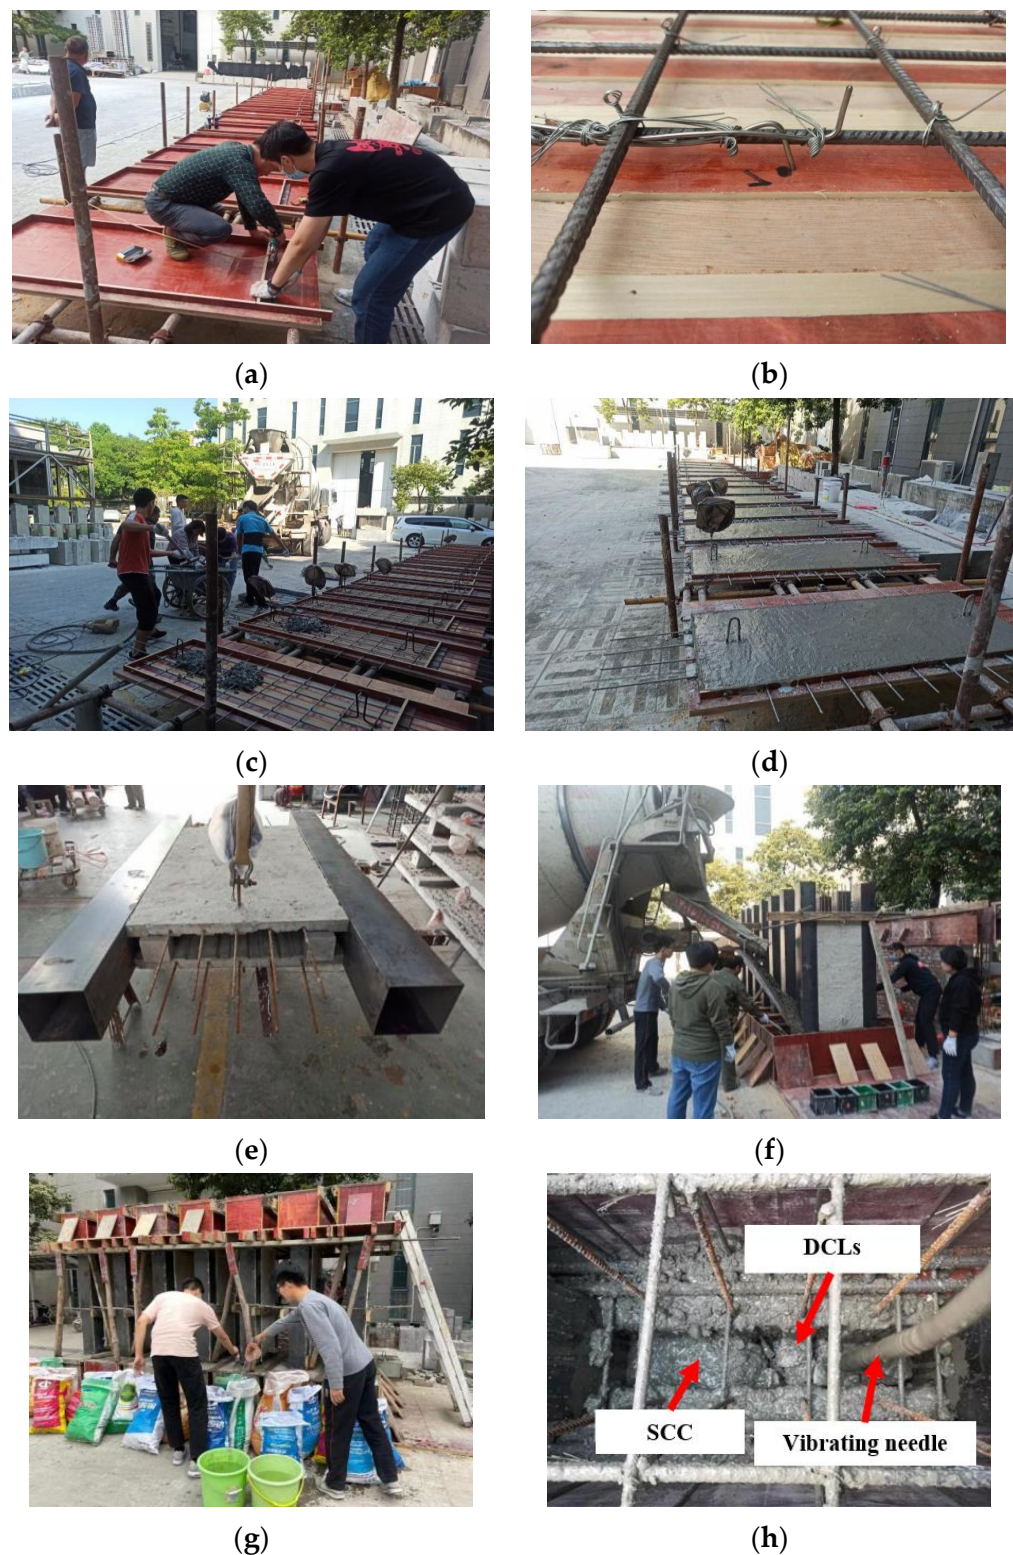
**Figure 2.** Concrete casting of specimens. (a) Formwork; (b) Thermocouple arrangement; (c) Precast wallboard pouring; (d) Precast wallboard pouring completed; (e) Precast wallboard and steel pipe assembling; (f) Casting of foundation beam; (g) Wet DCLs; (h) Cavity pouring. The variables studied experimentally included fire exposure time, fire-retardant coating on the edge constraint steel pipe column, and the width-thickness ratio. The basic parameters of each specimen are detailed in Table 1.

The concrete casting of specimens is shown in Figure 2.

the finished DCLs and SCC were placed alternately into the cavity of the precast wall panels and the square steel pipes, with auxiliary vibration. The detailed casting process of specimens can be found in reference [34].

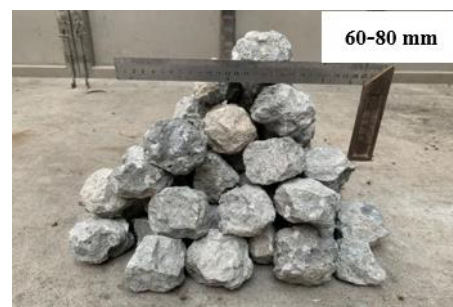
**Figure 3.** Demolished concrete lumps (DCLs).

The core samples of 75 × 75 mm (diameter × height) were obtained from the waste foundation beams by the core drilling method before the waste concrete was broken, and the compressive strength of the core samples was measured on the test day. According to the Technical specification for testing concrete strength with drilled core, the cubic compressive strength was converted to 39.7 MPa. The waste concrete used in this experiment was artificially broken into DCLs with characteristic dimensions of 60–80 mm (Figure 3). Then,

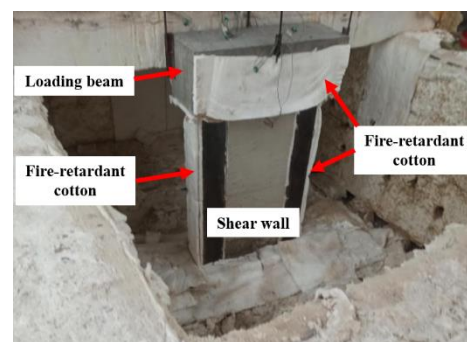
**Figure 4.** Fire protection treatment of specimen.

This test was carried out in two stages. The first stage was the open fire test. To ensure that the loading beams and foundation beams avoided damage during the open fire test, two layers of fire-retardant coating were wrapped on the concrete surface of loading beams and foundation beams from SW2 to SW4. The ends of the wall restrained columns were coated with two layers of fire-retardant coating to ensure that both sides of shear wall specimens were exposed to the fire (Figure 4).

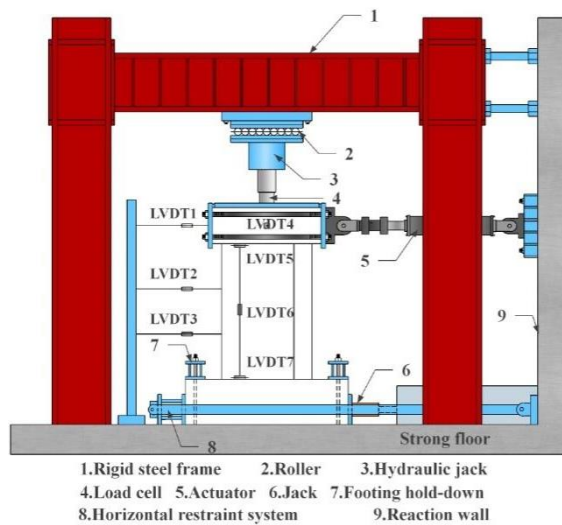
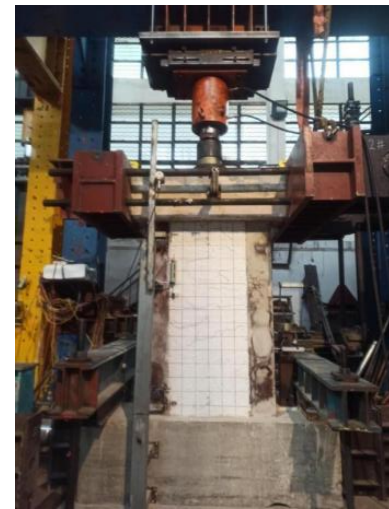
**Figure 5.** Test setup. (a) Schematic diagram of test setup; (b) Specimen installation site.

The second stage was the quasi-static test of shear walls after a standard fire. Specimens SW2 to SW4 were placed indoors for 30 days after the open fire test. Then, the quasi-static test was carried out on all specimens (SW1 to SW4). The vertical load was applied by a hydraulic jack with a range of 3200 kN, and the pressure sensor was placed under the jack. The repeated horizontal push–pull load was applied by MTS electro-hydraulic

servo actuator with a range of 1600 kN, fixed to the reaction wall. The test setup is shown in Figure 5.

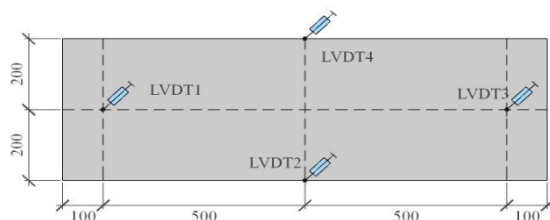
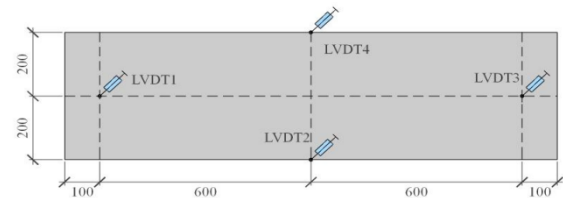
**Figure 6.** Arrangement of LVDTs on specimens (unit: mm). (a) Arrangement of LVDTs on SW2 and SW3; (b) Arrangement of LVDTs on SW4.

To obtain the axial deformation of specimens during the open fire test, vertical displacement gauges were set around the top of loading beams, as shown in Figure 6.

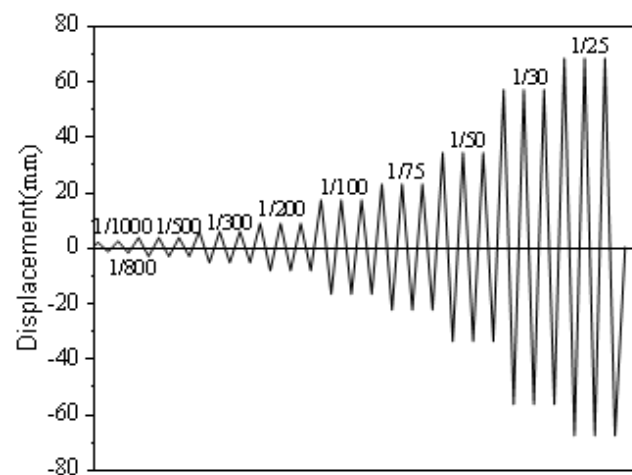
**Figure 8.** Horizontal loading system.

At the beginning of the test, a predetermined vertical load was first applied to the shear wall specimen and then a repeated push–pull horizontal load was applied under the condition that the vertical load was basically stable. In this test, we adopted displacement control [35], and the specific loading system is shown in Figure 8. The displacement angle values of each stage are shown in Table 3.

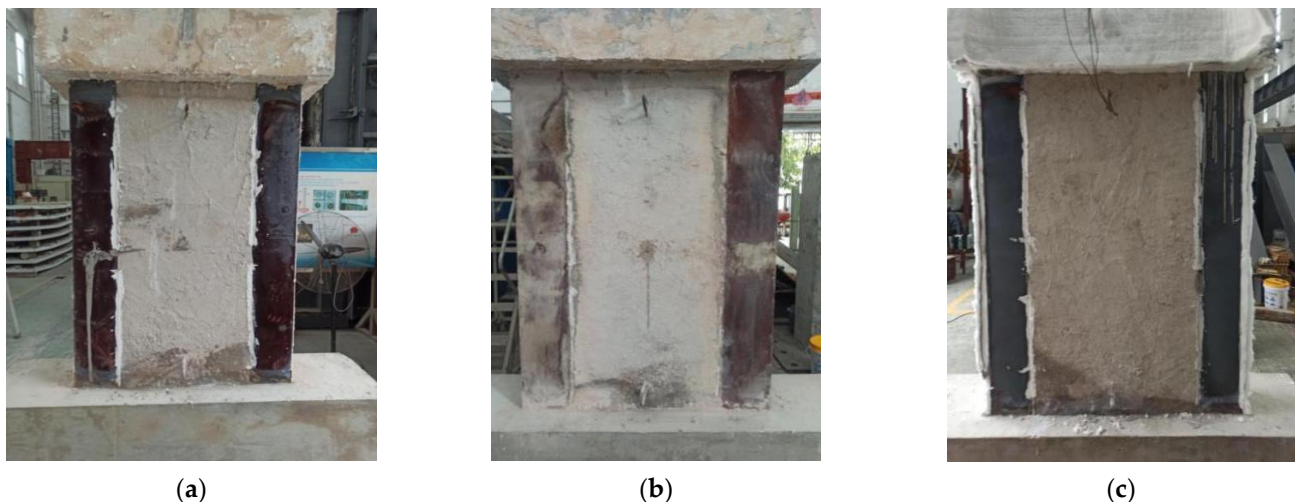
**Figure 9.** Patterns of specimen after fire. (a) SW2; (b) SW3; (c) SW4.

The patterns of specimens after the open fire test are shown in Figure 9. It can be observed from the figure that the concrete of the three specimens was light yellow after 60 min of fire, and a few horizontal cracks appeared on the concrete surface of precast wall panels on both sides of the shear walls, and the steel bars in walls were not exposed. The outer surface of steel tubes on the concealed columns of SW2 and SW4 were mostly dark black, and steel tubes had a slight buckling phenomenon; SW3 was equipped with fire-retardant coating on the steel tubes of concealed columns, so the steel tubes did not appear bulging and were relatively flat.

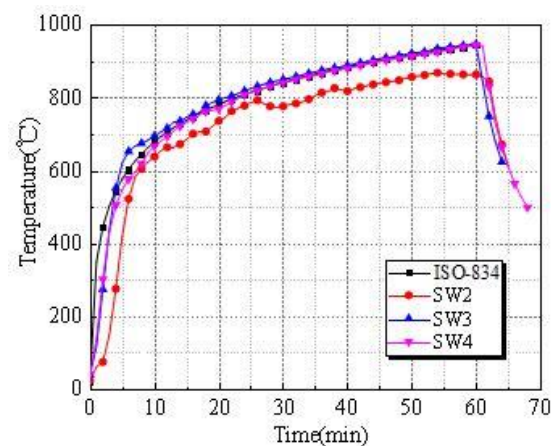
**Figure 10.** Comparison of measured temperature–time curves in furnace and ISO 834 standard curve.

Figure 10 shows the comparison of the measured average air temperature–exposure time curves in the furnace and ISO-834 standard fire curve, the actual fire heating curves have diversity, in order to unify and compare, many countries and organizations have formulated the standard fire heating curve for the component fire resistance test to assess the component fire resistance limit [36], during the open fire test of SW2 to SW4 in this test. It can be seen that the measured heating curves of SW3 and SW4 were generally consistent with the standard fire curve, while there were certain deviations in the furnace heating curve of specimen SW2. This was because the experimental furnace had not been used for four months before this test, and the workability of this experimental furnace was affected by moisture. After the open fire test of SW2, the workability of this furnace returned to normal.

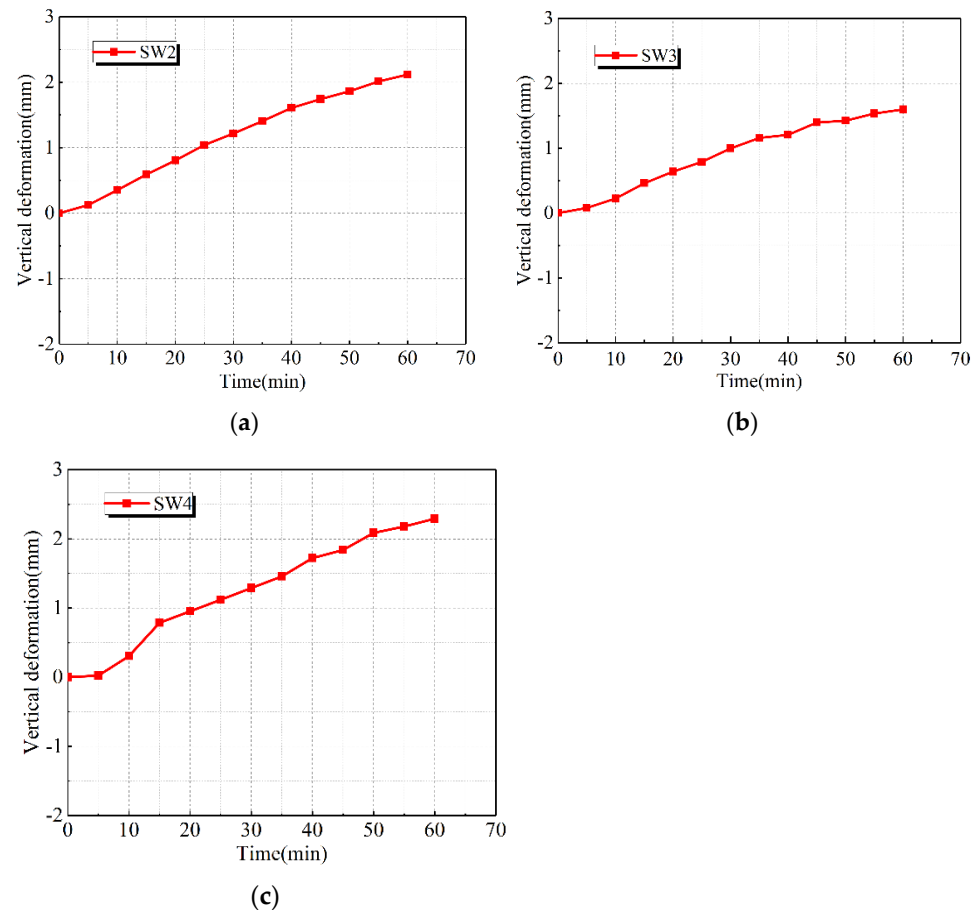
**Figure 12.** Vertical deformation–time curves of specimens. (a) SW2; (b) SW3; (c) SW4.

The axial deformation–fire time curves of specimens are shown in Figure 12, and the axial deformation was positive with expansion deformation. It can be seen from the figure that the axial deformation of SW2, SW3, and SW4 were 2.12 mm, 1.6 mm, and 2.29 mm, respectively. The axial deformation variation of the three specimens were basically the same, and they were all in the expansion stage.

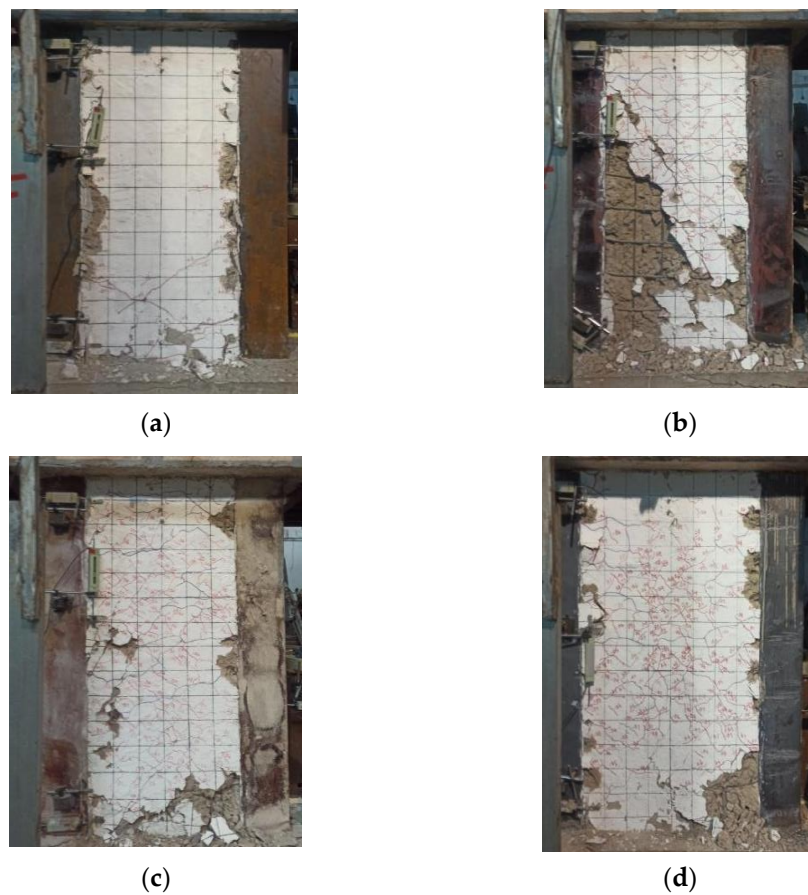
**Figure 13.** Failure patterns of specimens. (a) SW1; (b) SW2; (c) SW3; (d) SW4.

loads, micro-cracks originally generated during fire time continued to expand, resulting in eventual failure without forming the principal diagonal cracks. [37–39]). The failure patterns of specimens are shown in Figure 13. The cracks depicted in blue were those generated during the open fire test, and the cracks depicted in red were those generated in this seismic test.

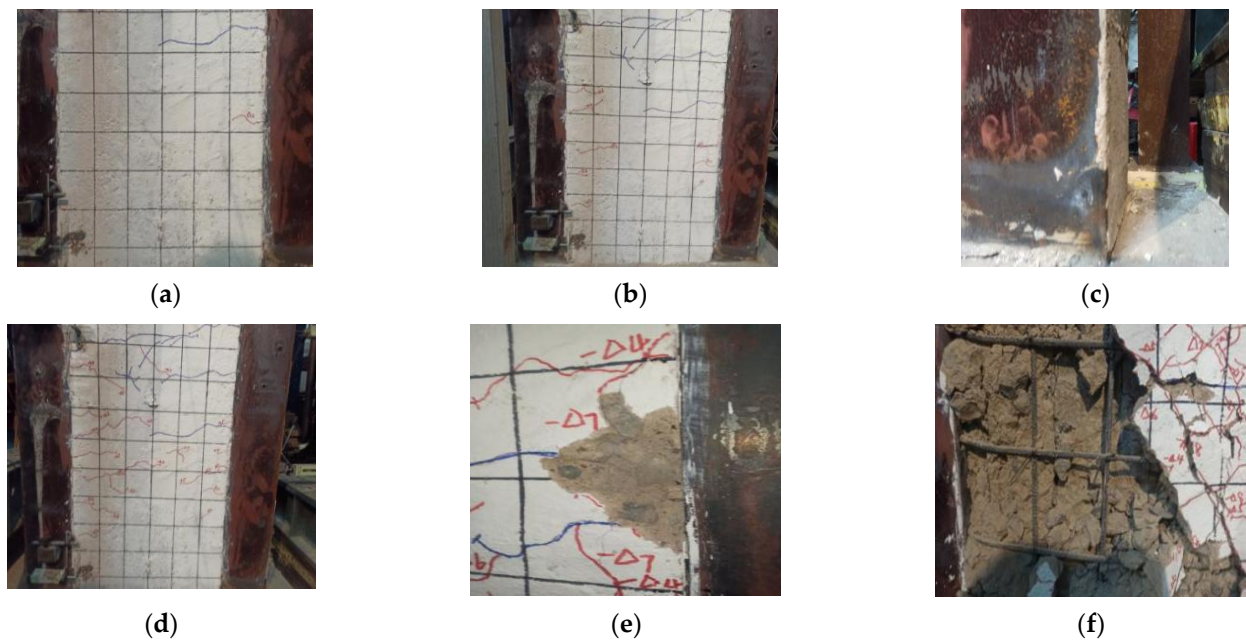
**Figure 14.** Failure processes and modes of specimen SW2. (a) Displacement angle 1/800; (b) Displacement angle 1/500; (c) Displacement angle 1/300; (d) Displacement angle 1/200; (e) Displacement angle 1/50; (f) Displacement angle 1/30.

In the test process, the failure characteristics of SW1 were similar to those in reference [34], and the failure characteristics of SW2 to SW4 were roughly the same. Taking specimen SW2 as an example, the failure process, phenomenon, and characteristics were analyzed and introduced. Figure 14 shows the failure process and phenomenon of SW2.

(1) When the displacement angle was 1/1000, specimen was in the elastic stage, there was no visible crack on the concrete surface of the wall panel and no bulge on the steel tubes of concealed columns;

(2) When the displacement angle was 1/800, the first horizontal crack occurred at the junction of the prefabricated wall panel and steel tubes, which was 280 mm above the foundation beam;

(3) When the displacement angle was 1/500, the concrete cracks on the surface of the precast wall panel began to increase, and the steel tubes did not bulge;

(4) When the displacement angles were 1/300 and 1/200, steel tubes on both sides of specimen showed slight bulges under compression, but the bulges disappeared under an opposite side loading condition. At the same time, diagonal cracks began to appear on the surface of the precast wall panel;

(5) When the displacement angle was 1/50, the horizontal displacement reached 34 mm, diagonal cracks of concrete on the surface of the precast wall panel did not form

the principal diagonal cracks. The wall was divided into some diamond-shaped pieces by several crossed diagonal cracks, and the concrete began to peel off;

(6) When the displacement angle was  $1/30$  till failure, lateral deformation of the specimen was severe. The concrete peeled off over a large area and steel bars were exposed under bending. In addition, there were two bulges on the left side of specimen and one on the right side, but no penetrating crack was formed.

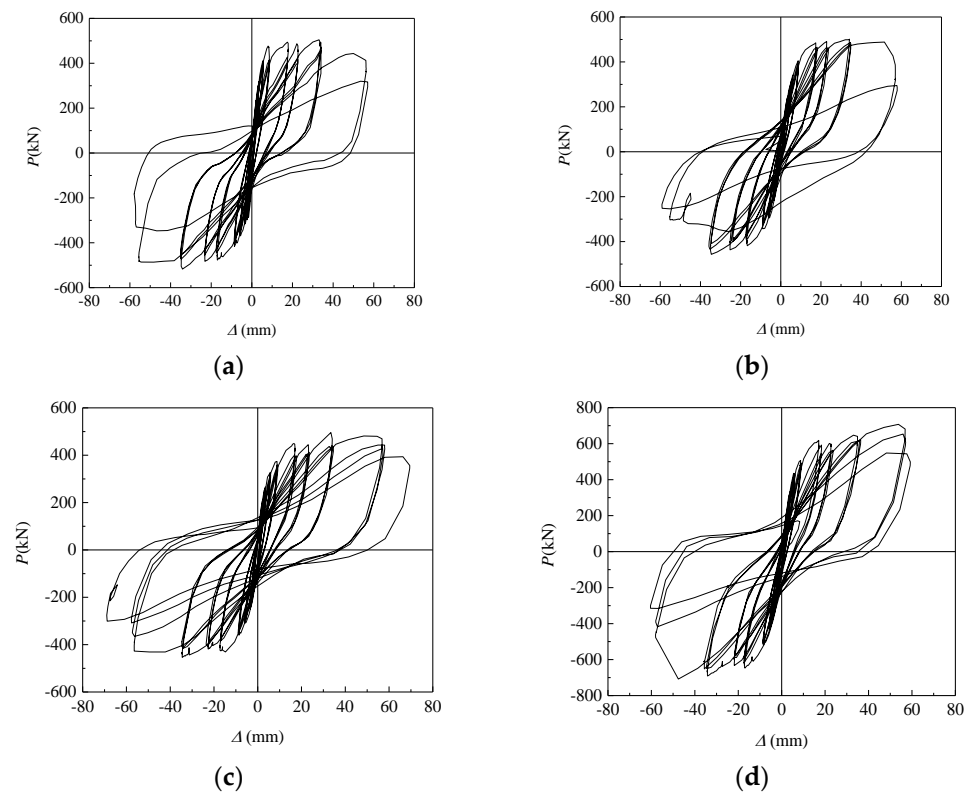
Figure 15. Hysteretic curves of specimen. (a) SW1; (b) SW2; (c) SW3; (d) SW4.

The horizontal load-displacement hysteretic loops of composite shear walls are shown in Figure 15 from which the following conclusions can be drawn:

(1) At the initial stage of loading, the hysteretic loops were long and narrow, and the surrounding area was small. The specimens were in the elastic stage without residual deformation; when the specimens entered the yield stage, cracks appeared on the surface of precast wall panels and steel tubes of concealed columns bulged. The hysteretic loops had a platform section near the peak load and a “pinching” phenomenon appeared. The area of hysteretic loops increased rapidly, showing good energy dissipation capacity; with the further increase of the displacement angle, the horizontal bearing capacity decreased obviously, and the hysteretic loops presented an inverse S shape when the ultimate bearing capacity was reached;

(2) The hysteretic loops of SW2 were similar to those of SW1 in general, and the maximum horizontal load was almost the same. It can indicate that infilling DCLs and SCC composite shear walls with edge constraint square steel tubes still retained good seismic performance after a fire for 60 min.
