Role of In-Field Experimental Diagnostic Analysis for the Derivation of Residual Capacity Indexes in Existing Pedestrian Glass Systems

Keywords: laminated glass (LG); pedestrian systems; walk-induced vibrations; glass fracture; non-destructive in-field experiments; Finite Element (FE) numerical modelling; damage measure; residual capacity

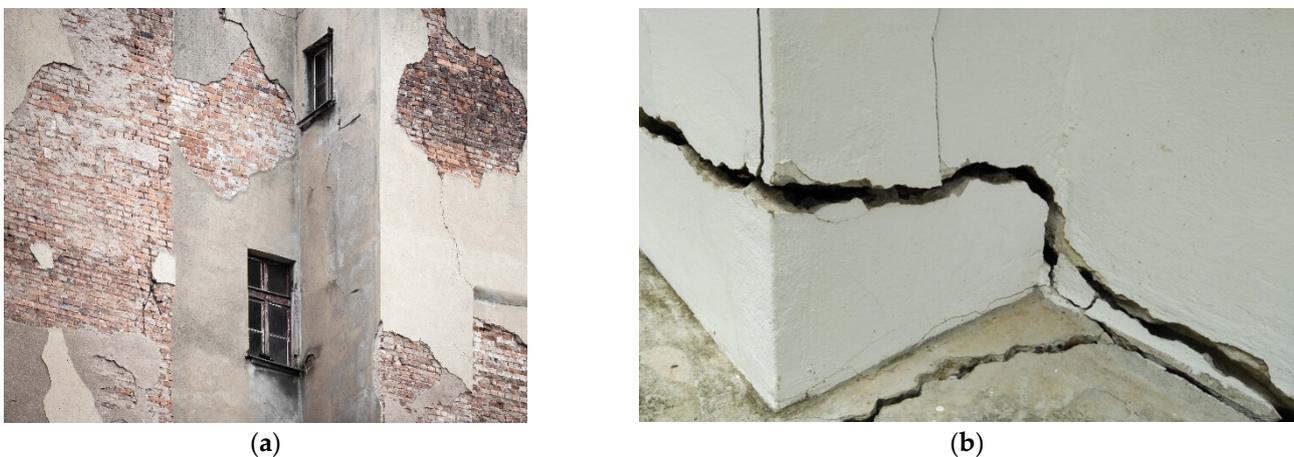
Figure 1. Examples of damage in (a) masonry or (b) concrete structures (figures reproduced with permission from Unsplash).

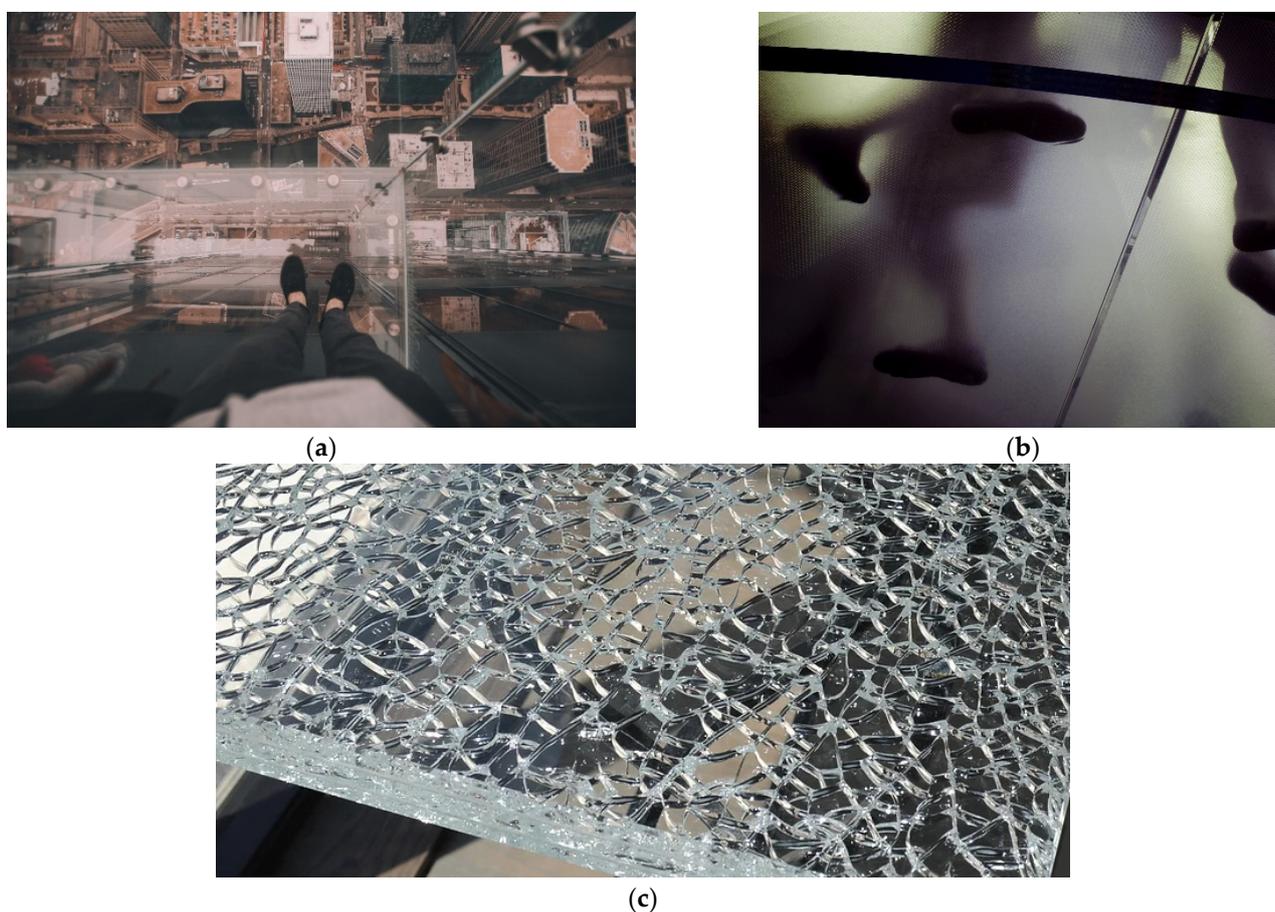
Figure 2. Examples of (a,b) glass pedestrian systems and (c) LG fracture (figures reproduced with permission from Unsplash).

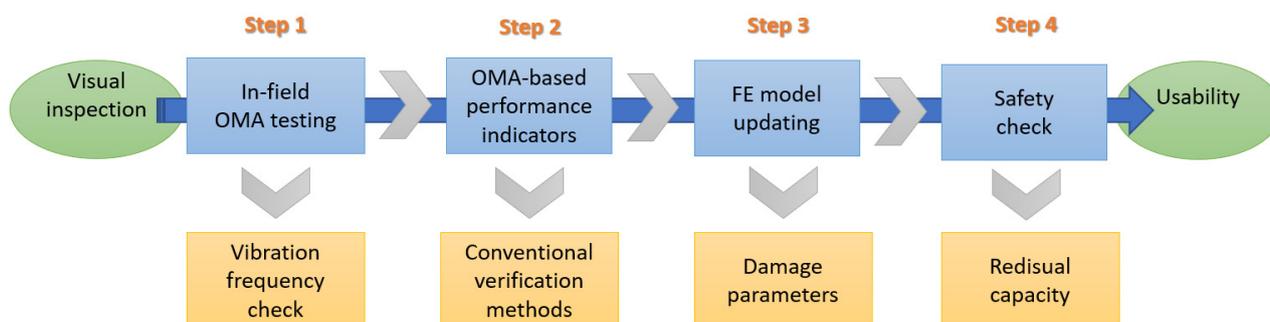
Figure 3. Proposed procedural steps for safety and residual capacity assessment of existing, in-service LG pedestrian systems.

Differing from “ad hoc” laboratory protocols and testing configurations, the experimental assessment of in-service LG systems is notoriously affected by several technical challenges and restrictions, which suggest the use of a minimum number of instruments and the maximization of experimental outputs (Step 1 in Figure 3). To this aim, a preliminary visual inspection is also recommended (Figure 3).

Once the most relevant performance indicators are extrapolated from in-field testing, specific limits and indicators are required for safety assessment (Step 2 in Figure 3). To note, LG systems may offer relatively “high vibration frequency”, according to definitions from ISO 10137:2007 [25], but they still suffer from marked sensitivity to vibrations or even damage. In this context, the preliminary knowledge of the real vibration frequency for an in-service structural system (and its possible sensitivity and modification under external loads) notoriously represents a powerful indicator for structural diagnostics [16,17,19]. At the same time, the vibration frequency itself is limited in interpretation as single parameter for monitoring purposes. A more refined analysis of experimental evidence, based on post-processing elaboration of basic in-field data, is thus recommended to derive possible quantification of damage parameters under real-time operational conditions.

Operational Modal Analysis (OMA) for structures and building components—Step 1 in Figure 3—is known to represent a robust and efficient technique, able to offer a multitude of material and damage parameters (Figure 4a). Major benefits of OMA techniques are related to possible application in various structural components without the need of destructive interventions and service interruptions [26]. The optimal setup definition is a critical step to capture relevant dynamic mechanical parameters, especially for complex assemblies. OMA is, in fact, very attractive because tests are generally cheap and fast, and they do not usually interfere with the normal use of the structure. Moreover, the identified modal parameters are representative of the actual behaviour of the structure under in-service conditions since they refer to realistic levels of vibration in the structure and not to artificially generated vibrations [27]. Successful experimental research studies can be found in the literature for a multitude of civil engineering applications, most of them consisting in towers and minarets [28,29], bridges [30,31], or special structures [32,33]. For glass structures, practical OMA evidence can also be coupled to different customers behaviours and reactions for comfort analysis [34,35].

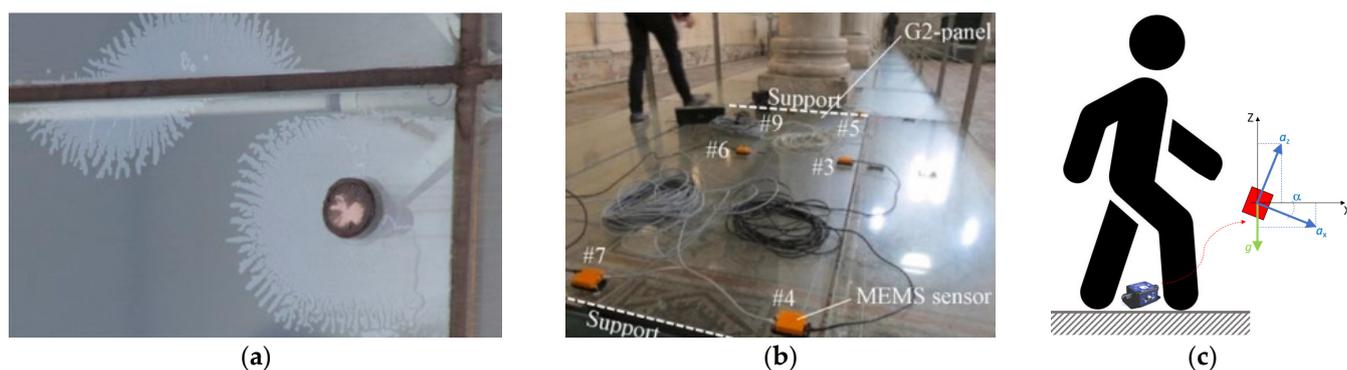
Figure 4. Application of Operational Modal Analysis to in-service LG pedestrian systems: (a) example of delamination in LG (figure reproduced from [36] under the terms and conditions of CC-BY license agreement); (b) overview of past experimental study with multiple MEMS sensors (figure reproduced from [19] under the terms and conditions of CC-BY license agreement); and (c) schematic representation of in-field assessment based on single MEMS setup.

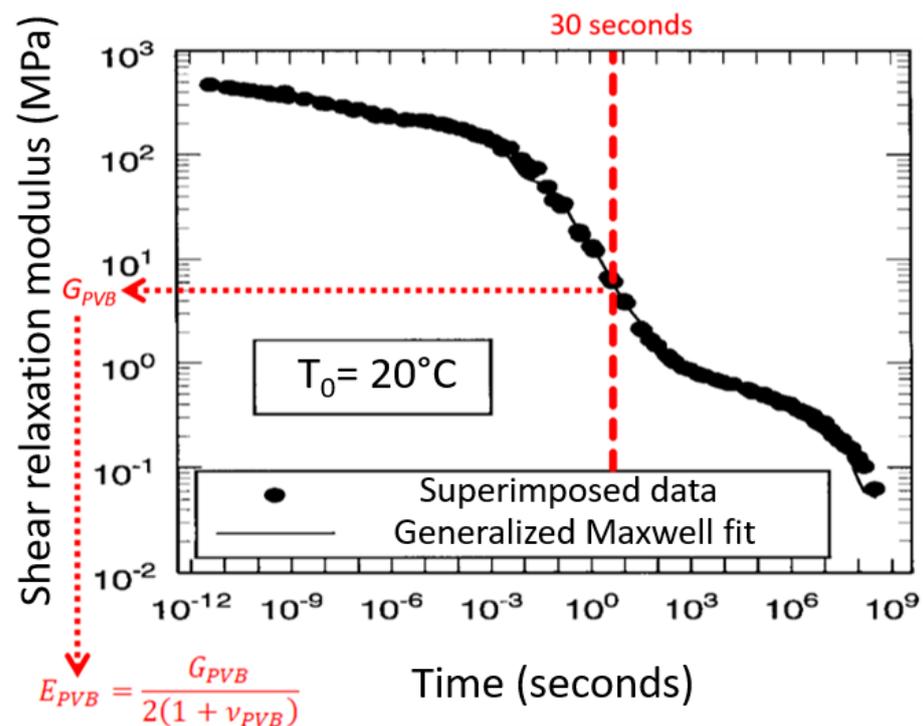
Figure 5. Example of practical derivation of equivalent shear relaxation modulus for PVB interlayer based on experimental master-curve (original figure adapted from [40] under permission from John Wiley and Sons©, Copyright license number 5327091377077, June 2022).

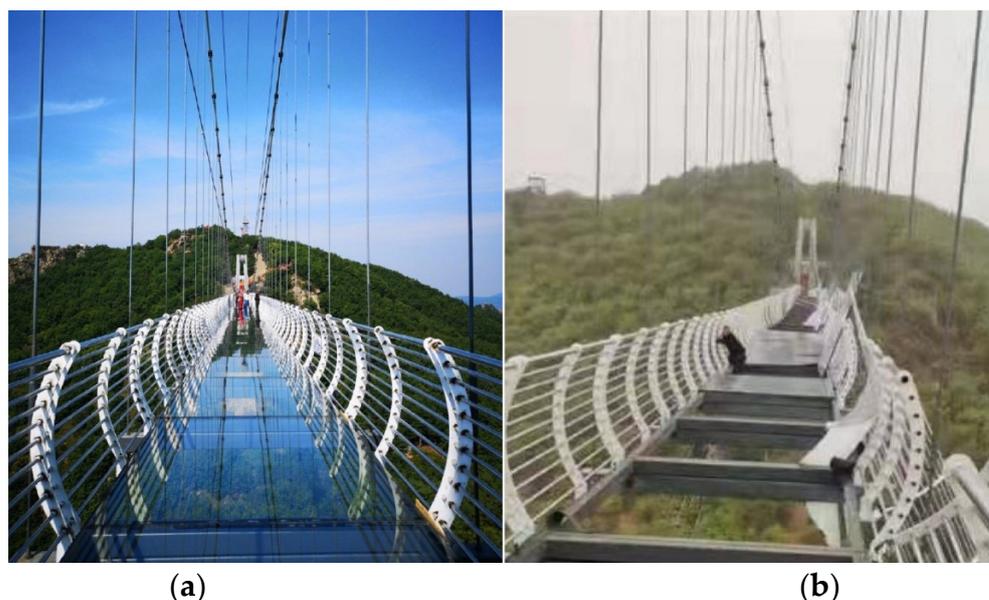
Figure 6. Example of accident in a 100 m high bridge in China due to wind loading: (a) initial configuration for the intact bridge and (b) post-accident configuration.

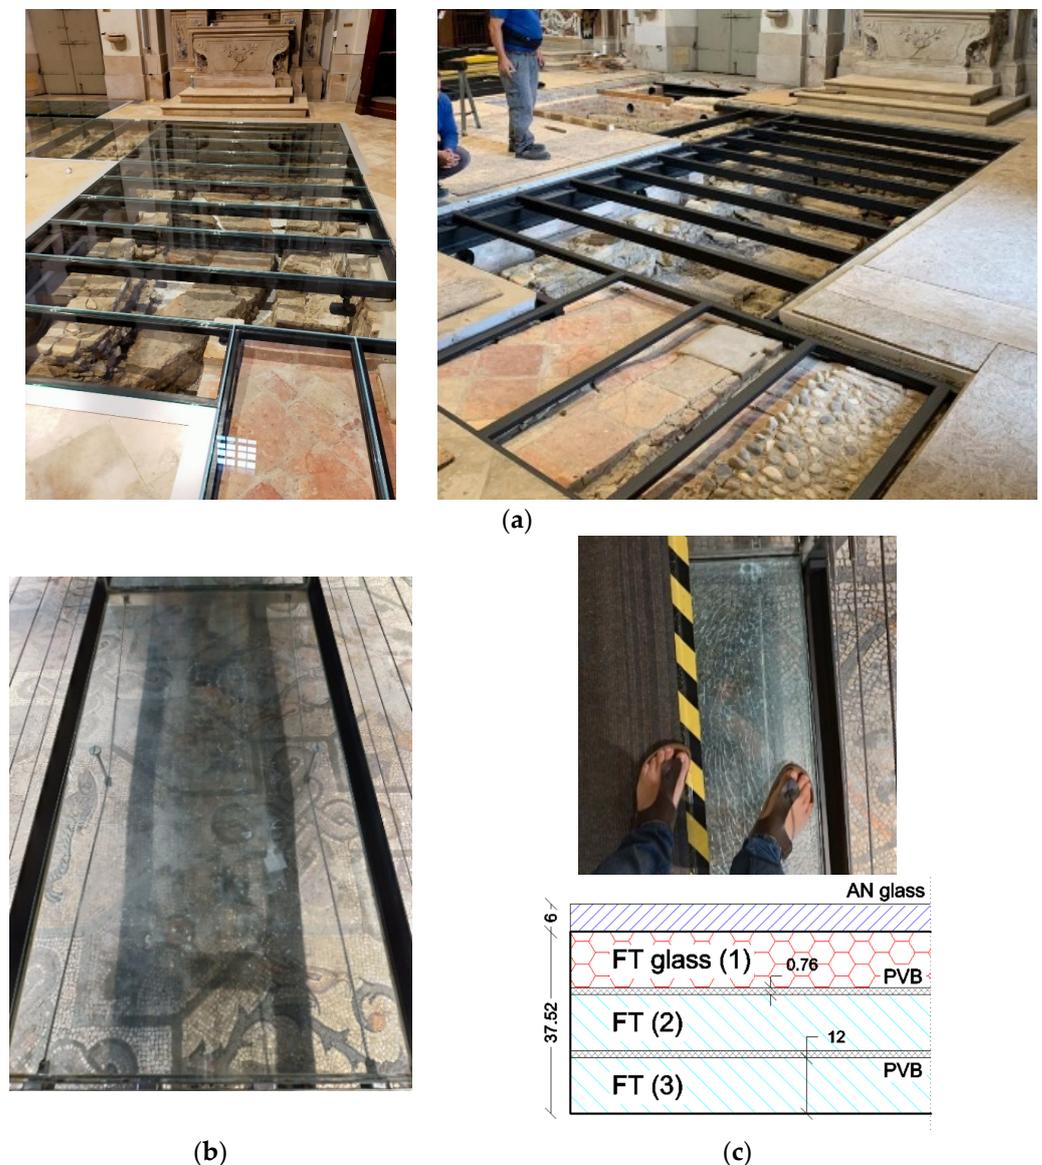
Figure 7. Overview of selected modular units for the examined LG pedestrian systems: (a) SM#1-LGU layout (pictures taken during retrofit interventions in Spring 2021, Courtesy of Seretti Vettoarchitettura); (b) top view of SM#2-LGU modular unit (reproduced from [19] under the terms and conditions of CC-BY license); and (c) schematic representation of glass fracture detail for SM#3-LGF panel.

The first examined system, SM#1-LGU, is located in San Giorgio di Nogaro (Udine). The in-field experiments were carried out in December 2020, ≈ 15 years apart from its original construction, on a reference modular unit characterized by 8/10/8 mm thick, fully tempered (FT) glass layers (0.76 mm PVB bonds). The dimensions of modules were $L = 2.80$ m in length by $B = 0.51$ m in width, and LG panels were linearly restrained at the edges by hollow box steel members (60 mm × 100 mm in section, 5 mm in thickness), specifically properly arranged to create a grid for LG modules. To note, the original pedestrian system object of experiments was retrofitted, starting from Spring 2021, and

replaced by newly designed LG components with similar geometrical and mechanical properties (Figure 7a).

The second and third examined LG samples are presently located in Aquileia (Udine) and are part of the suspension walkway investigated in [16,17]. Each module is characterized by dimensions of $L = 2.65$ m in length by $B = 1.35$ m in width (Figure 7b). To note, an additional sacrificial, protective layer of annealed (AN) glass (6 mm in thickness) was positioned on the top surface of LG panels (Table 2). As for the SM#1-LGU system, the case-study examples in Aquileia were subjected to in-field testing ≈ 15 years apart from its original construction. At the time of the experiments, moreover, the difference of two selected modular systems was represented by the presence of intact glass layers (SM#2-LGU), or by the presence of (accidental) partial fracture for one of the constituent glass layers in the resisting LG section (SM#3-LGF, which was replaced after testing, see Figure 7c).

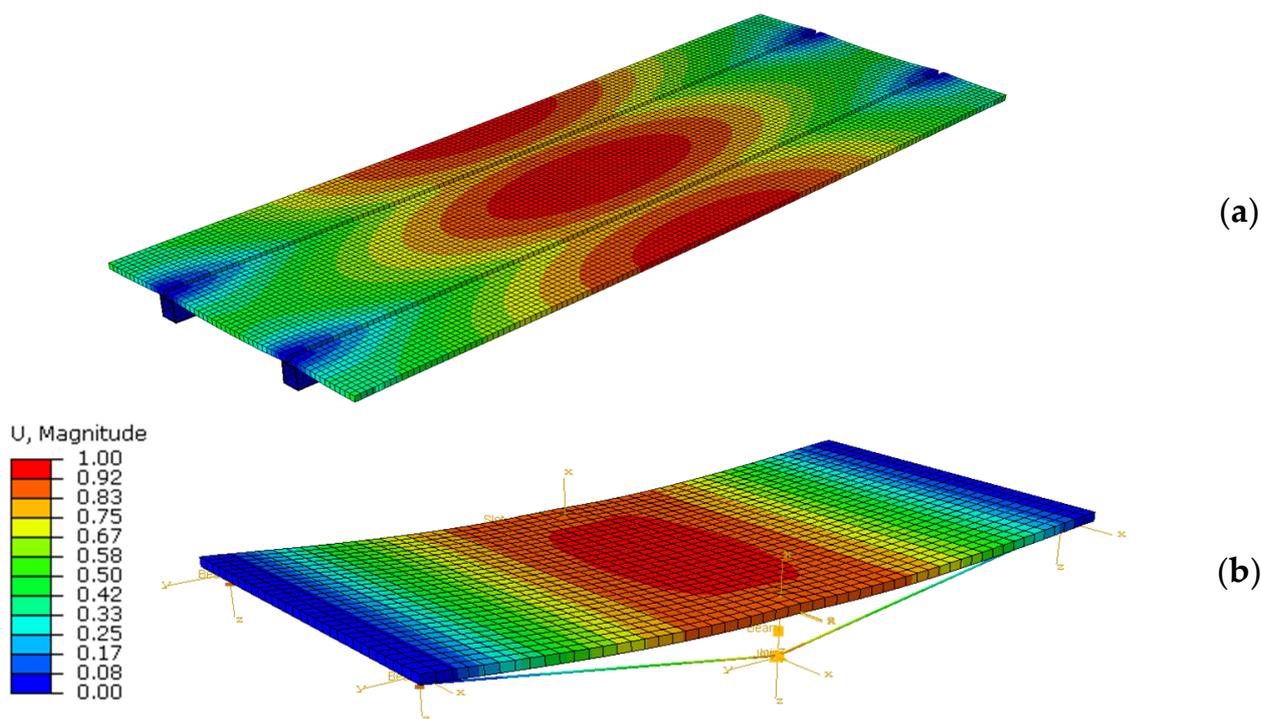
For the present practical application, Figure 8 shows an example of assembled modules, with evidence of vertical (out-of-plane) displacement contour plots of fundamental modal shape of their first vibration mode.

Figure 8. Qualitative comparison of fundamental modal shapes (out-of-scale) based on linear modal frequency response analysis of (a) SM#1-LGU module and (b) SM#2-LGU or SM#3-LGF modules (ABAQUS).

For example, based on FE systems like in Figure 8, one could pose the attention on the inverse characterization of the equivalent shear stiffness for the bonding PVB foils, or, even (in case of glass fracture) on the calibration of an equivalent, reduced E_{crack} modulus for the fractured glass layer (as it is for the SM#3–LGF system). Typical comparative results are proposed in Figure 14. To note, the other input material properties were kept fixed in $E = 70$ GPa for intact glass, $\nu = 0.23$ and $\rho = 2500$ kg/m³, with $\nu_{PVB} = 0.49$ and $\rho_{PVB} = 1000$ kg/m³ for PVB foils (Table 1).

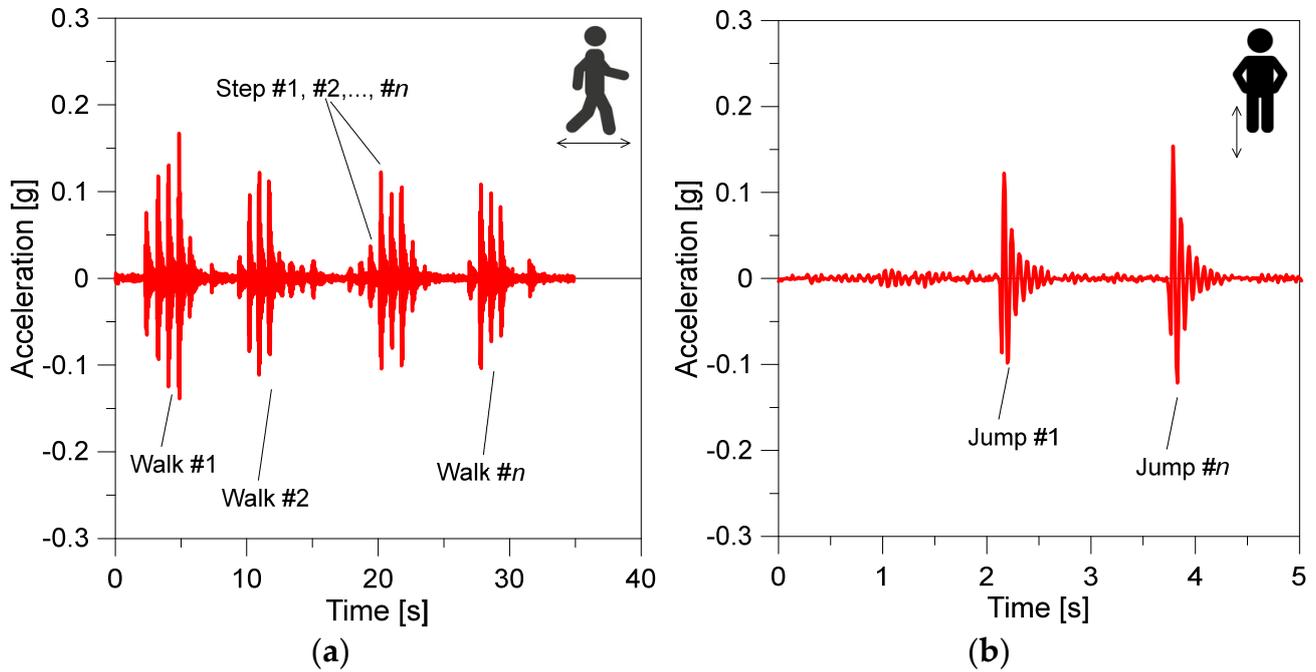
Figure 9. Example of in-field acquisition (selection) of acceleration records (vertical component) un-der (a) linear walking path or (b) on-site jump.

Based on experimental evidence like in Figure 9, the results in Figure 10 show selected examples of corresponding FFT signals. At a preliminary stage, a major difference in the vibration response of examined modules can be easily perceived, for example. Compared to existing design standards to prevent severe vibration issues in pedestrian systems, it is possible to see that the measured FFT peaks are associated to vibration frequencies that are significantly higher than the recommended minimum value of 5 Hz [25,34]. Moreover, typical LGs are characterized by intrinsic features that assign them a particular dynamic behaviour compared to other systems [16,17].

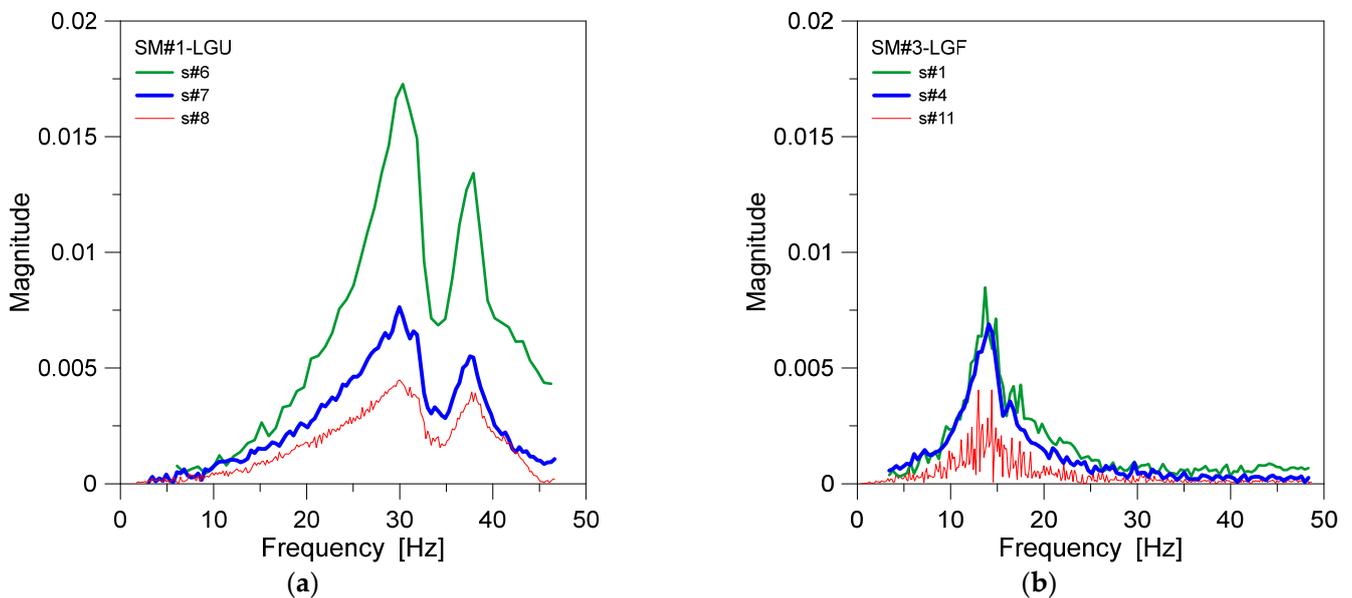
For the presently examined LG systems, the fundamental frequency was experimentally quantified in 30 Hz (± 0.39) for the SM#1-LGU system. For the SM#2-LGU and SM#3-LGF slabs with similar geometrical and mechanical properties, but different damage severity, it resulted in 15.05 Hz (± 0.2) and 13.8 Hz (± 0.21), thus up to -8.3% vibration frequency decrease due to glass fracture [19]. Often, no interventions and verifications are required for traditional slabs and floors with a fundamental frequency higher than 5–8 Hz

Figure 10. Frequency domain response of the examined systems: example of selected experimental signals for the (a) SM#1-LGU and (b) SM#3-LGF modules.

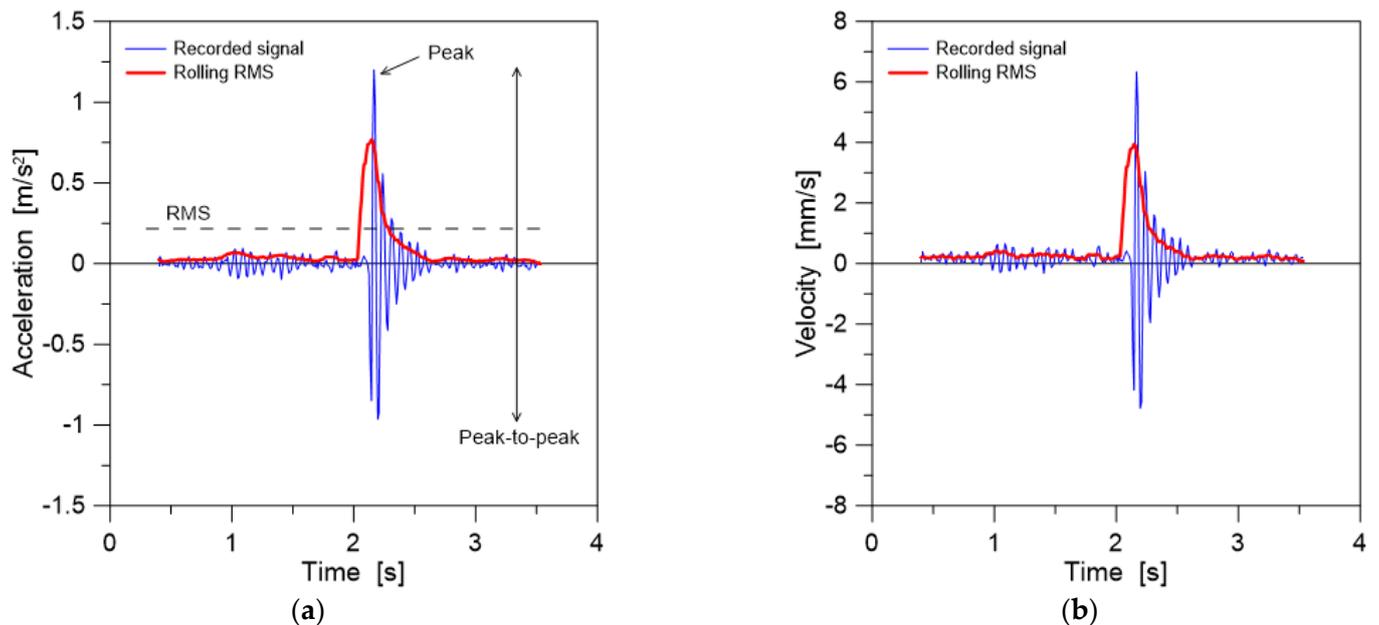
Figure 11. Qualitative example of typical (a) acceleration and (b) velocity experimental signal due to a single footfall of the involved volunteer.

An example can be seen in Figure 11, as obtained from a single footfall of the involved volunteer (SM#3–LGF). To note, multiple design standards are available in support of the vibration serviceability assessment of pedestrian systems, but no specific rules and recommendations are available for glass structures. In the present application, for example, the reference limits were derived from ISO 10137:2007 [25] and compared to available experimental indicators based on post-processed signals.

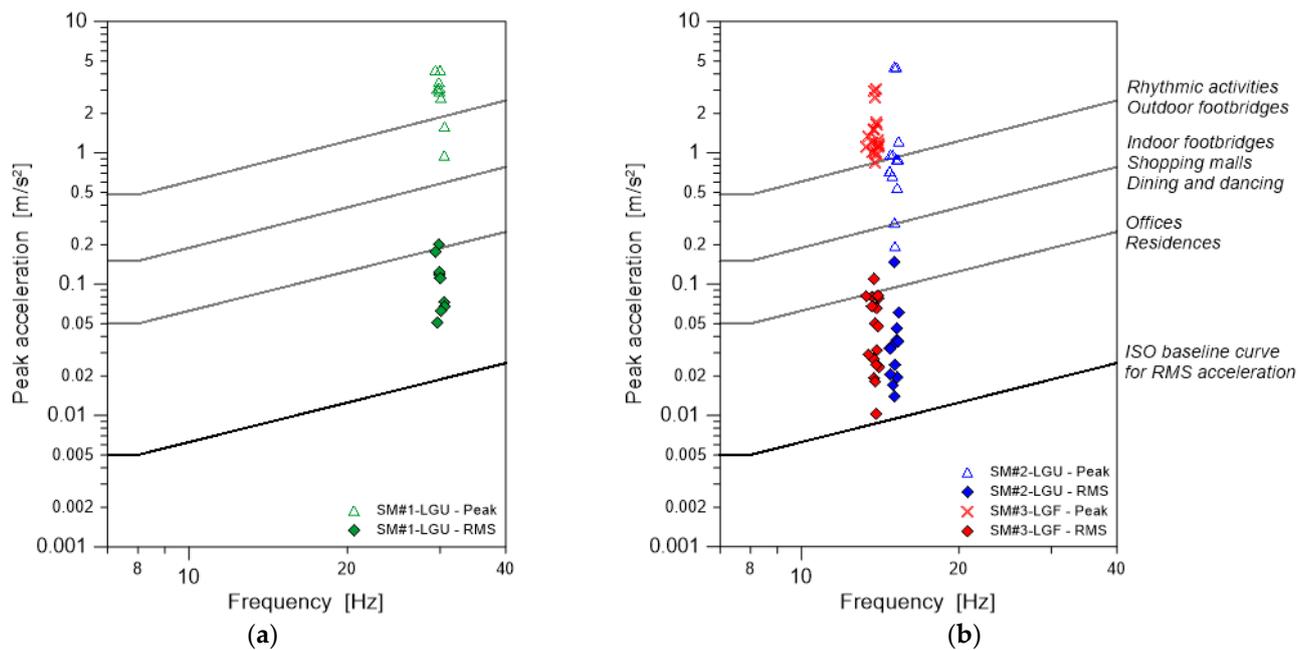
As far as the acceleration values are considered, typical results take the form as in Figure 12, where data are grouped for SM#1–LGU and SM#2–LGU or SM#3–LGF systems, respectively. Regardless of the constructional details, and even possible damage, it is possible to see that the dynamic response of the three different LG systems under random normal walks is associated to absolute vertical acceleration peaks, which exceed the limit values for “indoor footbridges”. The mean peak was, in fact, measured in 2.921 m/s^2 for the SM#1–LGU system, 1.315 m/s^2 for SM#2–LGU, and 1.512 m/s^2 for SM#3–LGF.

Figure 12. Reference ISO 10137:2007 [25] acceleration curves for RMS and peak acceleration on floors. Application of recommended limits to the presently examined (a) SM#1-LGU and (b) SM#2-LGU, SM#3-LGF systems.

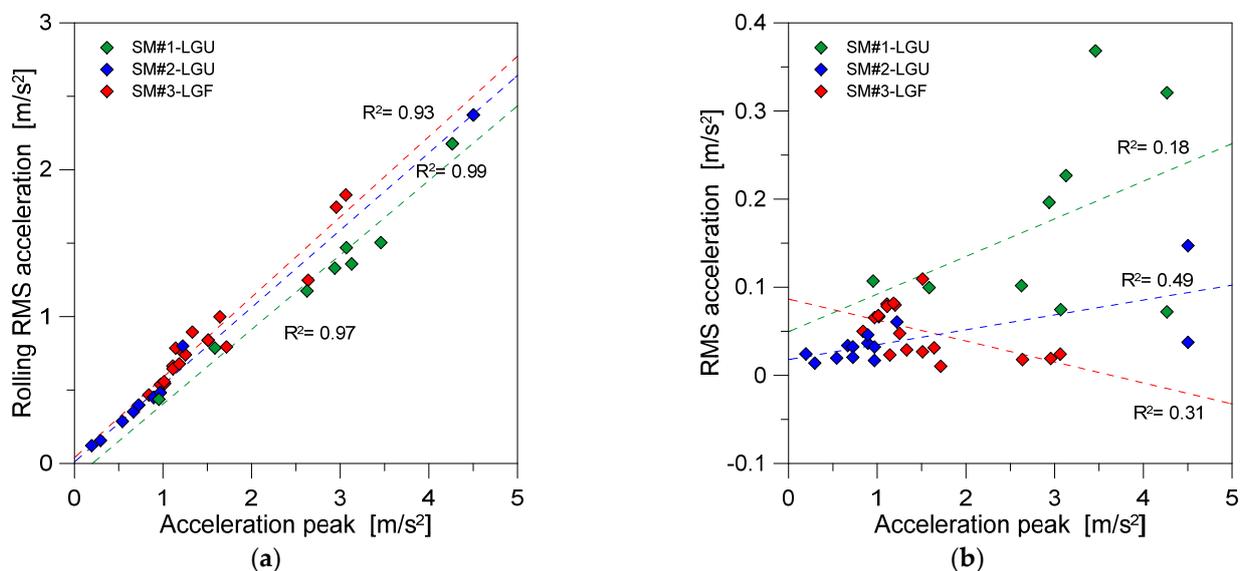
In Figure 13a, the vertical acceleration peak is shown as a function of the rolling RMS value, where each dot corresponds to a test configuration. A rather linear correlation for all experiments can also generally be noted, as suggested by the reported R -square correlation coefficient. Moreover, the SM#3–LGF system with glass fracture has the lowest correlation of experimental results (R -square = 0.93), which is relatively low compared to intact systems. While such a comparison should be extended to multiple slab units with different damage scenarios, such a correlation could be a parameter of practical feedback for diagnostic purposes. In addition, a correlation coefficient tending to 1 could represent an optimum for a safety check and integrity assessment. At this stage, moreover, the minimum number of experimental repetitions and configurations required for “robust” feedback is still uncertain to be generalized.

Figure 13. Correlation analysis of experimental performance indicators for the examined slab units: (a) rolling RMS acceleration as a function of the vertical acceleration peak; and (b) RMS acceleration as a function of the vertical acceleration peak.

In Figure 13b, the RMS acceleration value is indeed shown as a function of the vertical acceleration peak. Differing from Figure 13a, a major scatter from the linear regression method can be noticed for the SM#3–LGF sample affected by glass fracture, which has a relatively low R -square correlation coefficient but also a substantially different trend

of experimental dots compared to the intact SM#1–LGU and SM#2–LGU samples. The potential of such a kind of comparative analysis should be elaborated further, including multiple LG systems and testing configurations. To note, the trend of vibration frequency with acceleration peak can also reveal major structural modifications and damage severity, as well as particular discomfort under ordinary loads, as it was for the example discussed in [16,17].

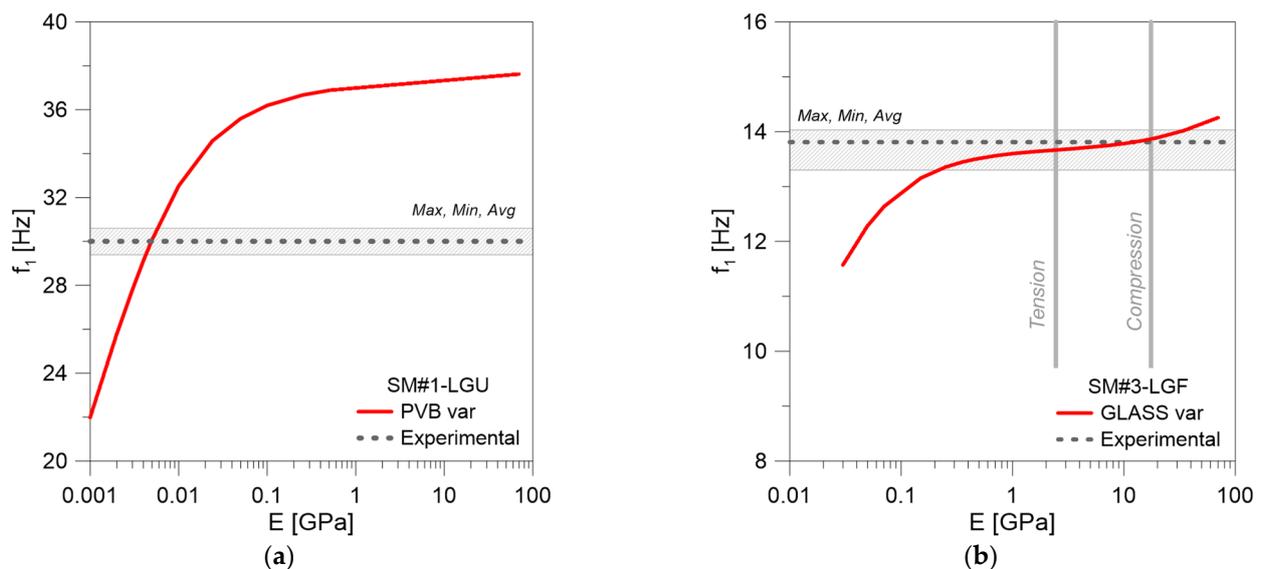
Figure 14. Material characterization based on FE model updating: (a) derivation of equivalent interlayer stiffness for SM#1–LGU system; and (b) equivalent modulus for fractured glass layer (SM#3–LGF system).

Figure 14a shows the effect of PVB stiffness on the fundamental frequency of the SM#1–LGU module. Compared to the average experimental vibration frequency, it can be seen that the best match is found for E_{PVB} modulus for PVB foils in the order of ≈ 4 – 5 MPa. Interestingly, the so-calculated equivalent modulus for PVB is in the same order of magnitude of the study reported in [16,19].

In Figure 14b, curve-fitting based on model updating is proposed for the fractured SM#3–LGF system in which the degradation of PVB foils acts in combination with glass fracture. The parametric FE analysis shows that the best match of experimentally derived frequency is in the order of $E_{crack} \approx 15$ GPa for the fractured glass layer, and this finding is in close correlation with the compressive fractured glass modulus calibrated in [18]. Further support from FE model updating could derive also from analysis of local effects in vibrational and dynamic terms, such as, for example, deriving from special fixing systems of typical use in LG applications [34].
