Article

Full-Scale Field Tests on Concrete Slabs Subjected to Close-In Blast Loads

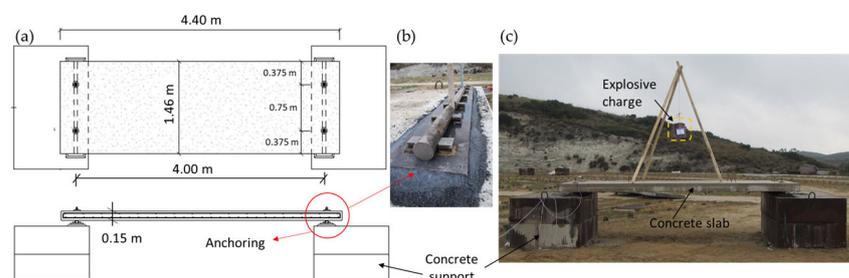
Figure 1. Main dimensions of the concrete slab and details of the boundary conditions: (a) concrete slab layout; (b) anchorage detail; (c) photo of the experimental setup before the test.

Regarding the boundary conditions, the concrete slabs were supported on two steel-clad concrete blocks designed to withstand repeated explosions. The span between supports was 4.00 m. The anchoring system was intended to simulate a supported slab with fixed supports. Figure 1 shows a scheme of the concrete slab with its main dimensions and the details of the boundary conditions.

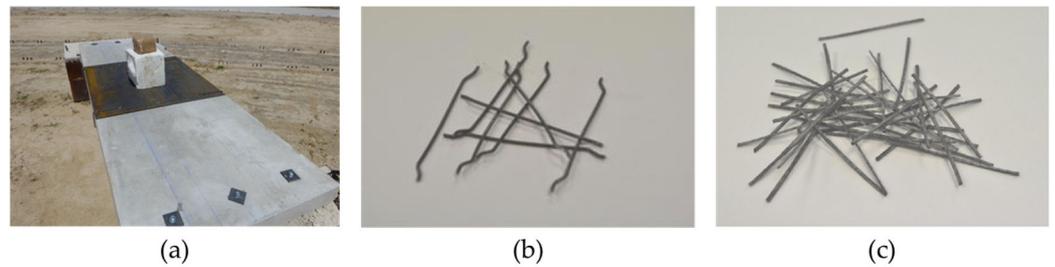
Figure 2. (a) Steel sheet; (b) steel fibers; (c) polypropylene fibers.

In the SEGTRANS project, three different reinforcement solutions were tested (Figure 2):

- Slab S6: A steel sheet (SS) made of S-275 JR steel was located at the center of the span on the side facing the blast charge, with dimensions of 1.50×1.46 m and a thickness of 10 mm. The steel sheet was fixed by using an epoxy adhesive.
- Slab S7: The concrete used in this slab was a steel-fiber-reinforced concrete (SFRC) with a fiber content of 120 kg/m^3 .
- Slab S8: The concrete used in this slab was a polypropylene-fiber-reinforced concrete (PPFRC) with a fiber content of 9 kg/m^3 .

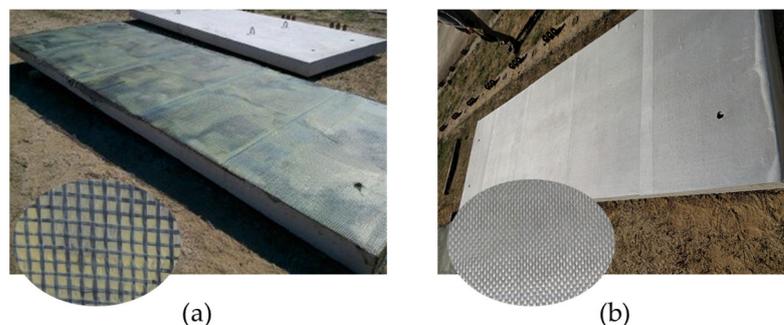
Figure 3. (a) Slab protected with CFRP; (b) slab protected with GFRP.

In the PICAEX project, two other protective solutions (Figure 3) were tested:

- Slabs P3 and P5: These slabs were protected with a glass-fiber-reinforced polymer (GFRP) composed of a bi-directional primed glass-fiber-reinforcing sheet with a one-component ready-to-use water and polyurethane-based adhesive. In this case, the GFRP was placed on the side of the slab that was not facing the explosive charge, which was the face where the tensile stresses occurred.
- Slabs P4, P6, and P8: These slabs were protected by using a carbon-fiber-reinforced polymer (CFRP) composed of a high-strength carbon fiber mesh with a thixotropic epoxy adhesive. As in the GFRP, the protected solution was placed on the tensile face of the slabs.

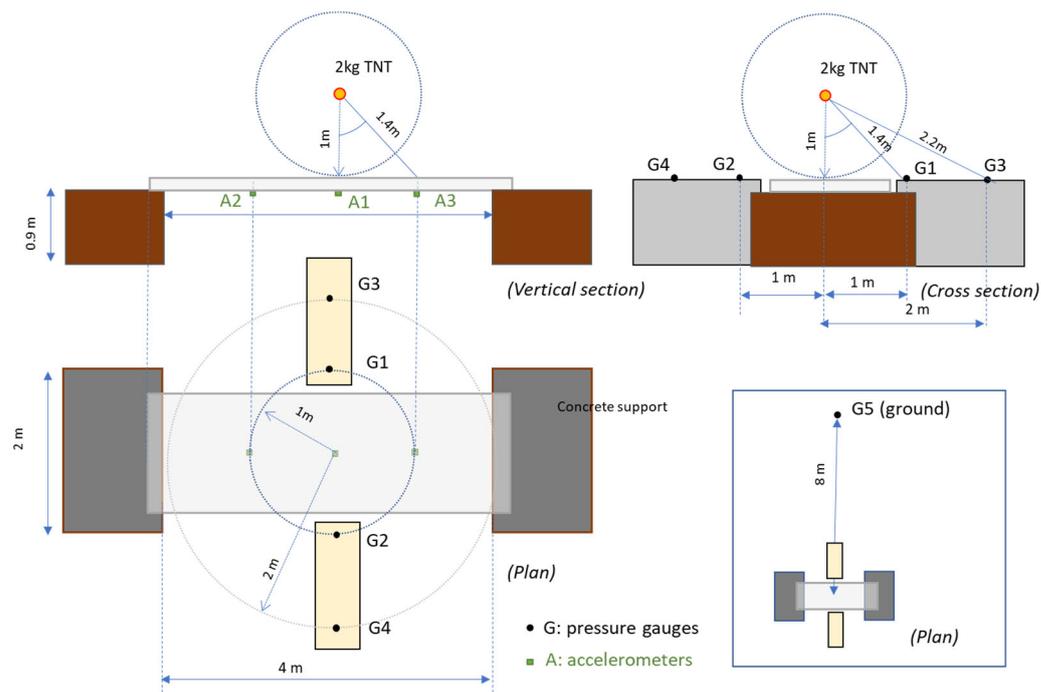
Figure 4. Test setup for the calibration test.

As mentioned above, the tests with the higher scaled distance were designed to evaluate and characterize the blast waves. For this purpose, the tests were monitored with pressure gauges and accelerometers. The number of pressure sensors used varied between two and five depending on the test. Pressure transducers were located at the same level as the top surface of the slab. The pressure gauges had a high frequency with ablative protection and a range of 5000 psi (34.5 MPa). As can be seen in Figure 4, the sensors were located within radii of 1 m and 2 m from the center of the slab and at distances of 1.4 m and 2.2 m from the charge, respectively. In addition, a fifth sensor was located on the ground at eight meters from the charge in the horizontal direction.

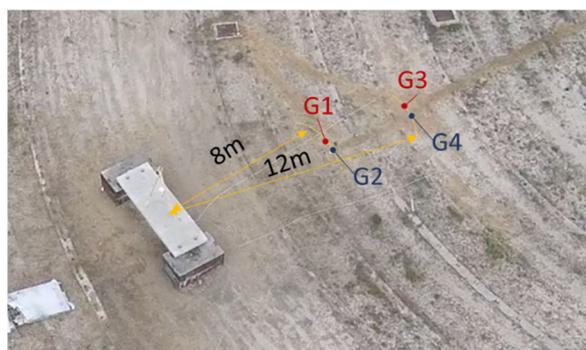
Figure 5. Test setup for test with 15 kg of TNT.

To measure accelerations in the slab, two or three accelerometers (depending on the test) were located on the rear face of the slab, with one of them in the center of the slab and the other two 1 m from the center (see Figure 4). In the tests with smaller scaled distances, accelerometers were not used due to the risk of damaging the sensors. To register the shockwave in these tests, pressure gauges were placed on the ground at standoff distances of between 8 and 12 m, as shown in Figure 5.

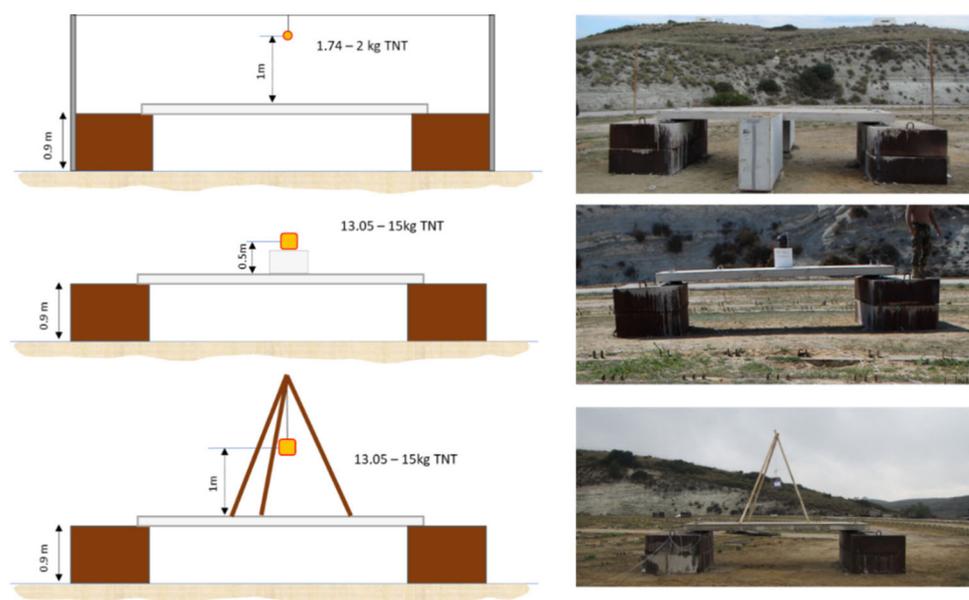
Figure 6. Charge details for the different tests.

For slabs S1 to S8, the explosive used in the experimental trials was PG2, an RDX-based plastic explosive for military use with a TNT equivalence calculated on the basis of an experimental pressure of 1.16. For slabs P1 to P8, the explosive used was dynamite (gelatin type), with a TNT equivalence that was also calculated based on peak pressure of 0.87. The charge mass was placed on an expanded polystyrene cube when the standoff distance was 0.5 m and was hung from a rope or a wooden tripod when the standoff distance was 1 m (see Figure 6). Regarding the charge's shape, it was a spherical shape for lighter loads and cubic with round corners for the others. The explosive was initiated in all cases with a detonator that was inserted into the center of the charge.

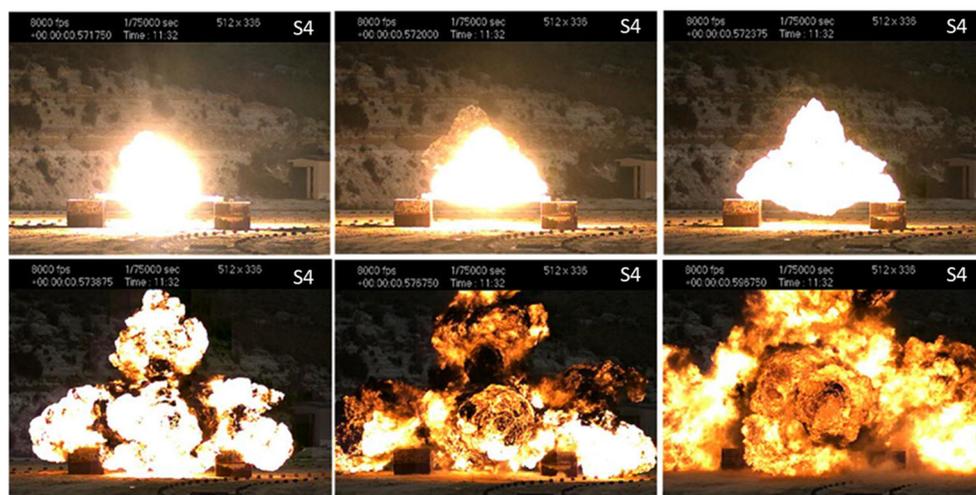
Figure 7. Image sequence of the high-speed camera during test S4 (15 kg eq. TNT at 1 m).

In addition to all the instrumentation, the tests were recorded with a high-speed camera. Since an explosive event is a phenomenon with a very short duration, the images obtained with the high-speed camera (Figure 7) provided valuable information about the event. For instance, it was verified in the high-speed camera images that the shockwaves of both charge shapes (spherical and cubic) were similar in terms of pressure distribution.

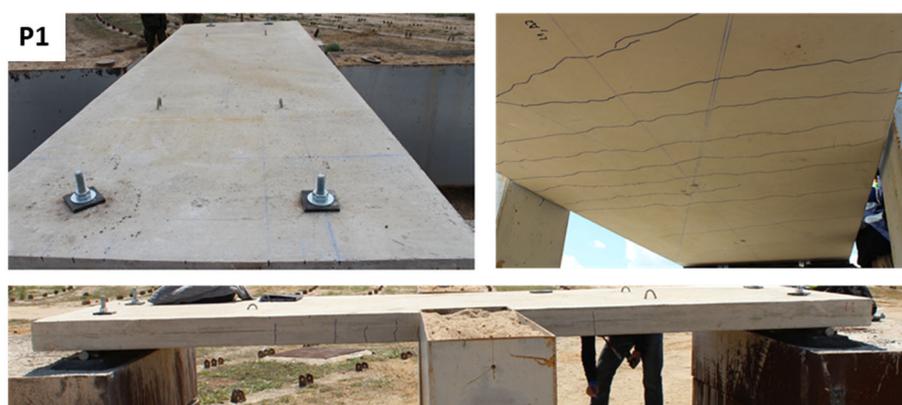
Figure 8. Images of the result of the P1 test.

Of the 16 slabs tested, eight of them were non-reinforced, and of those eight, four were used in calibration tests that were carried out with a light load, i.e., 1.74–2 kg of TNT equivalent. The result in these cases was only minor cracks, which were mainly in the tensile face of the slabs. As an example, Figure 8 shows the images of slab P1 after a test. The results of these tests were used for the subsequent calibration of the numerical models [14,25,26], as pressure and acceleration data were available for these tests. However, numerical simulation is not within the scope of this work, so the models that were used will not be described here.

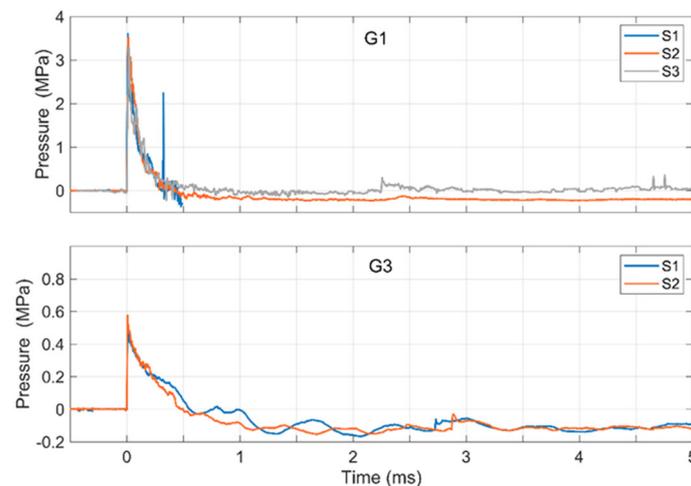
Figure 9. Pressure signal results of the tests on S1, S2, and S3 from pressure gauges G1 and G3.

The recording of the pressures during the tests allowed the characterization of the shockwaves and the evaluation of the pressures to which the slabs were subjected. In the calibration tests, a pressure of 2500 kPa was recorded on the pressure gauge located 1 m from the load, and a pressure of 500 kPa was recorded on that located 2 m from it. The recorded pressures were then used to include the load in the subsequent test simulation. Figure 9 shows the pressure–time histories obtained in tests S1, S2, and S3 on pressure gauges G1 and G3 (1 and 2 m from the load, respectively).

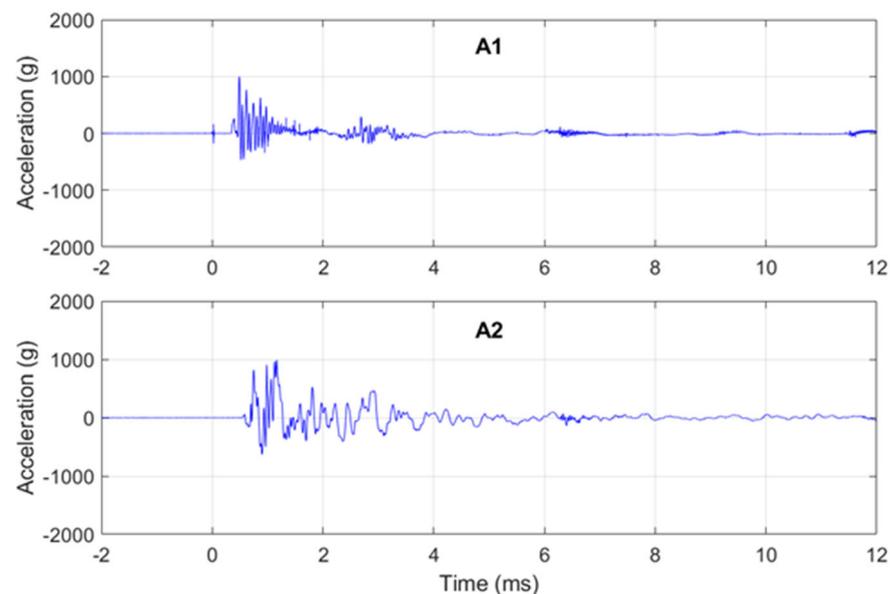
Figure 10. Acceleration signals from test P1 with sensors A1 and A2.

Figure 10 shows the acceleration recordings obtained by sensors A1 and A2 during the P1 test. Peak accelerations ranging from -629 g to 997 g were observed. These acceleration values were also used for the comparison and subsequent calibration of the numerical simulation models.

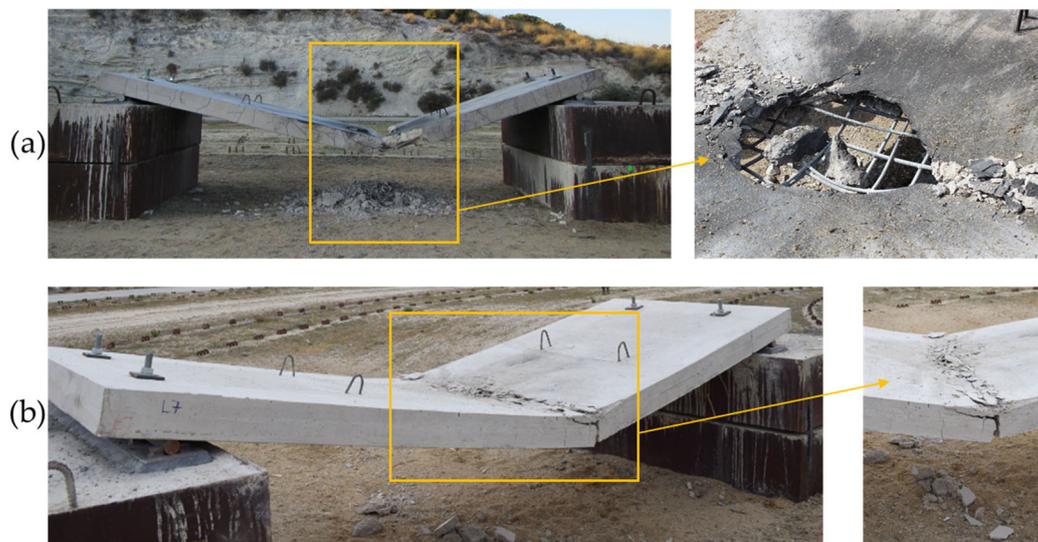
Figure 11. Post-blast images of non-reinforced slabs with an explosive charge of 15 kg TNT eq. (a) at 0.5 m and (b) at 1 m.

After the calibration tests, the non-reinforced slabs were tested with a greater charge at standoff distances of 0.5 and 1 m. The different behaviors of the slabs between the two distances can be seen in Figure 11. When the charge was located 0.5 m from the slab, local damage was observed due to a punching failure. On the contrary, when the charge was located 1 m from the slab surface, a bending failure occurred at the central part of the slab. In this case, the resistance mechanism of the anchored slab corresponded to a membrane mechanism. In the most stressed section, the concrete fails, but the reinforcement, if properly anchored, allows the formation of a resistance mechanism, as shown in Figure 11b. The strength is limited only by the deformation capacity of the reinforcement, which, in turn, limits the value of the deflection.

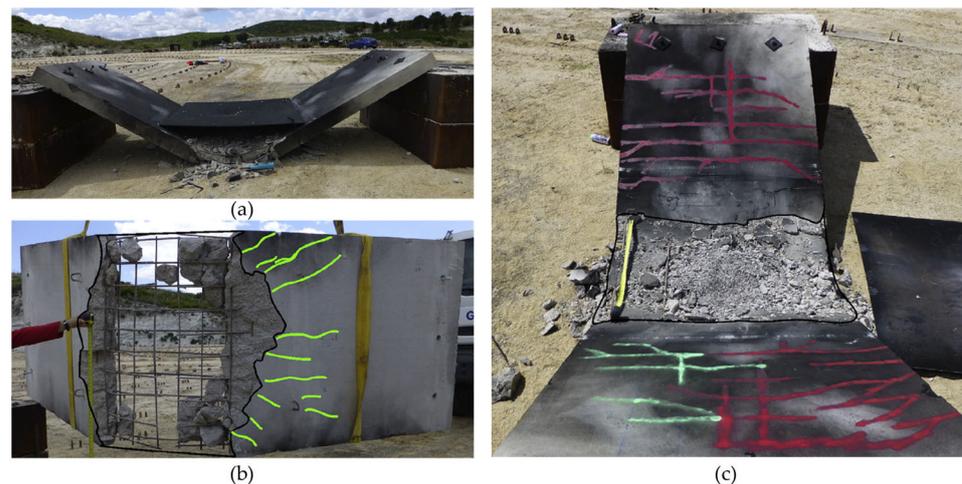
Figure 12. Post-blast images of slab S6, which was protected with a steel sheet: (a) lateral view; (b) top view without the steel sheet; (c) bottom view of the slab.

The use of a steel sheet facing the explosive charge as a protective solution resulted in much greater damage than that of the unreinforced slab. Figure 12 shows how the slab was completely bent and rested on the ground. Under the steel plate, the crater generated by the detonation was larger than that formed in the unreinforced slabs, covering the entire central part of the slab.

It was shown that this type of protection was not effective against close-in explosive charges, at least in the form used here. Instead of dissipating energy, the steel plate in this case acted as an amplifier of the shock wave, concentrating all of the damage in the central part of the slab. Perhaps if the steel plate had retrofitted the entire surface of the slab, the behavior would have been different.

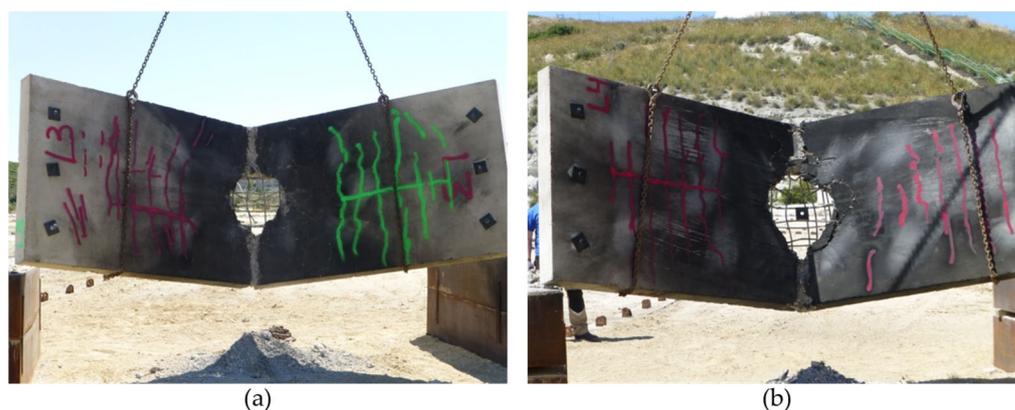
Figure 13. Post-blast images of slabs protected with fiber-reinforced concrete: (a) S7 with steel fibers; (b) S8 with polypropylene fibers.

Slabs S7 and S8 were constructed with fiber-reinforced concrete. In the case of S7, the fibers used were steel, and for S8, they were polypropylene. The results were very similar in both cases, as shown in Figure 13. The protective solutions did not prevent a punching failure in the slab. However, the inclusion of the fibers in the concrete resulted in a considerable increase in both the tensile and compressive strength, as shown in Table 2. While the compressive strength of the concrete was 25 MPa, in these cases, the values were higher than 40 MPa. The tensile strength achieved was 8.12 MPa for the SFRC and 5.62 MPa for the PPFRC, while the mean value for a plane concrete C25/30 would be around 2.6–2.9 MPa [27]. This increase in strength and, particularly, in tensile strength could mean that the reinforcement may be effective for blast loads that are not so close to the concrete slab.

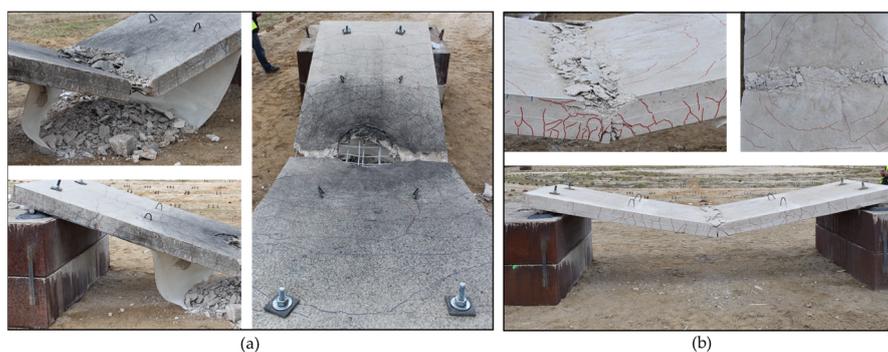
Figure 14. Post-blast images of slabs protected with GFRP: (a) result with the charge at a standoff distance of 0.5 m; (b) result with the charge at a standoff distance of 1 m.

As in the previous cases, the GFRP failed to retain the fragments when the charge was located 0.5 m from the concrete slab (Figure 14a). It can be seen how the GFRP was broken and peeled off in the central part of the slab. However, when the charge was located at 1 m (Figure 14b), the behavior of the slab slightly improves with respect to the unreinforced specimen. In this case, the permanent deflection was smaller and there was no debris due to the fiber sheet.

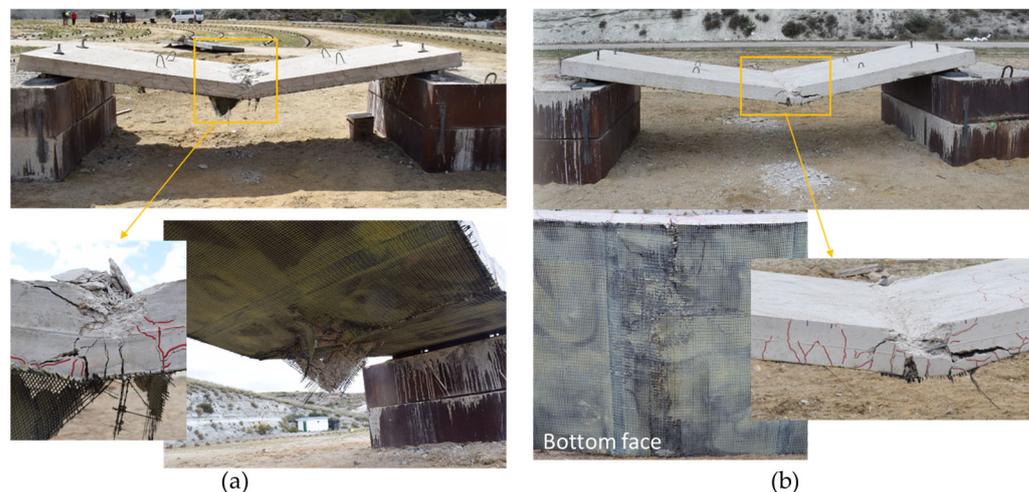
Figure 15. Post-blast images of slabs protected with CFRP with the charge at a standoff distance of 1 m: (a) test P6; (b) test P8.

The last reinforcement that was tested was a carbon fiber mesh. There were two tests with the charge located 1 m from the slab (Figure 15). In these cases, the behavior was similar to that of the unreinforced slab, but with less deflection in the central part. In the case of test P6 (Figure 15a), the carbon fiber was torn and some debris was found on the ground. As for test P8 (Figure 15b), the fiber managed to retain the fragments.

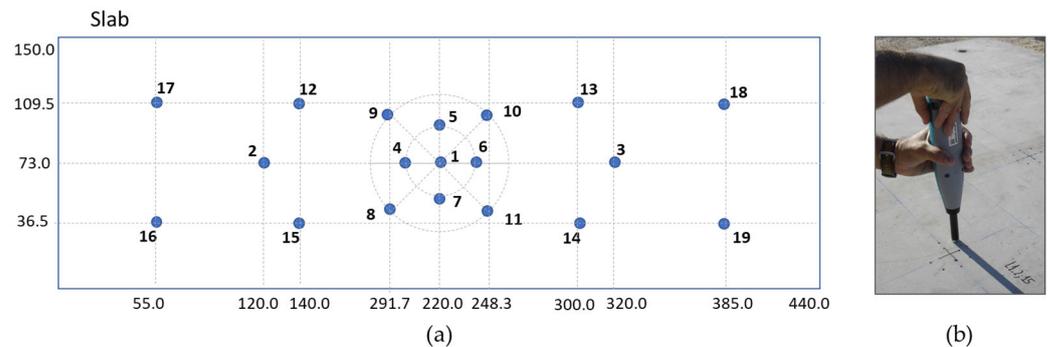
Figure 16. (a) Measurement locations on the slab; (b) measurement with the Schmidt hammer.

To analyze the surface damage, a methodology based on the rebound principle with a Schmidt hammer was used. A whole description of the methodology is included in the study by López et al. [28]. The objective was to find variations in the rebound number. The rebound number was measured at 19 different (previously determined) locations on the top surface of the concrete slab (Figure 16). In turn, each measurement point was defined with a template containing twelve points. Six of these points were used for evaluation before (obtaining the value of their median Q_B), and the other six were used to obtain the median after the explosion (Q_A). Then, it was checked whether there were statistically significant differences between the values from before and after by applying the one-tailed Wilcoxon rank-sum test. A p -value of less than 0.05 showed a decrease in the rebound number; therefore, there was a decrease in the quality of the material. A p -value of greater than 0.05 meant that there was no damage. Damage was defined as follows [28]:

where Q_1 and Q_2 refer to the mean of the six values before and after the test, respectively. The damage values ranged from 0 for a 'no damage' point to 1 for a 'total damage' point. Finally, to obtain an index for comparing the surface damage on the slabs, a grid of 200 uniformly spaced points was created to interpolate the damage values obtained. The surface damage index (d_{200}) can be defined as the mean of the interpolated values.

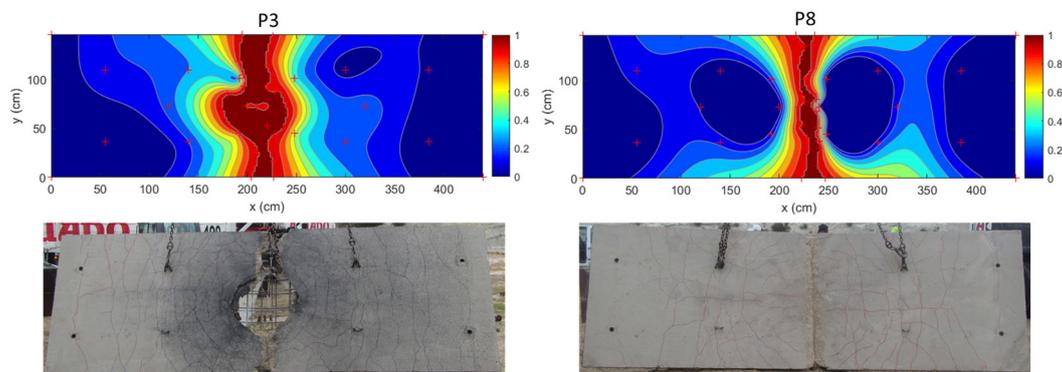
Figure 17. Damage maps for tests P3 and P8 and a comparison with the experimental results.

In addition to the surface damage index, damage maps were created. The damage maps provide an idea of the final state of the slabs and the surface damage caused by the explosion. Example of these maps are shown in Figure 17 for slabs P3 (unreinforced) and P8 (reinforced with CFRP).
