# Ground Surface Deformation Detection in Complex Landslide Area—Bobonaro, Timor-Leste—Using SBAS DInSAR, UAV Photogrammetry, and Field Observations

**Abstract:** During the past 10 years, Timor-Leste has concentrated all its efforts on infrastructure development. However, it has not achieved enough due to unexpected ground deformation in mountainous areas that is seriously affecting road constructions, etc. In order to design roads and other infrastructure under such difficult conditions, it is important to know the present and future ground conditions. Continuous monitoring is a significant methods of detecting ground deformation and providing essential information to realize an effective design. The problem arises of “How can ground deformation be monitored in extensive areas, which are generally located in mountain areas that are difficult to access?” Differential Interferometry Synthetic Aperture Radar (DInSAR) has recently been applied to monitor displacement in extensive areas. In addition, Unmanned Aerial Vehicle (UAV) photogrammetry is useful for detecting the deformation in detail. Both methods are advantageous in that they do not require any sensors. Therefore, the comb

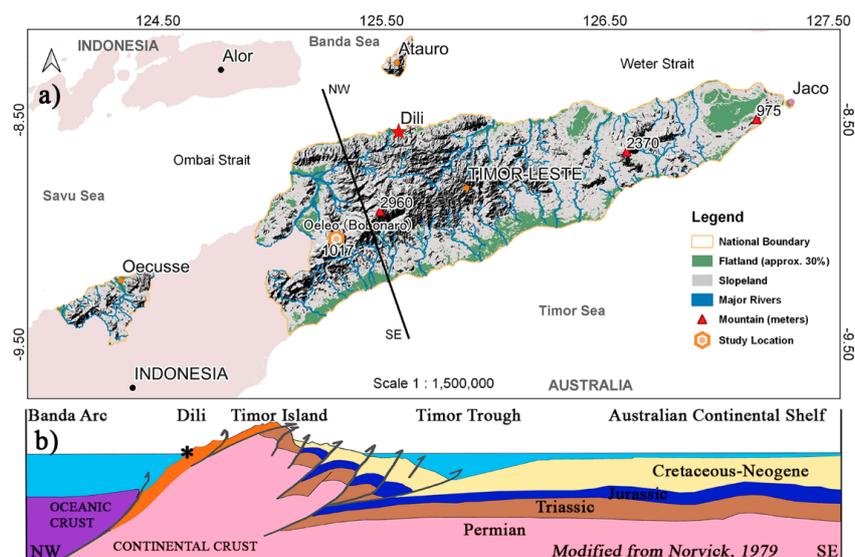
**Figure 1.** (a) Simplified geomorphology of Timor-Leste and (b) illustration of the mountainous characteristics of the island, with fragmented and chaotic structures of thrust and fold zones [68].

Some previous works have confirmed these factors that influence the dynamic process of the geological and tectonic formations of the island. Audley-Charles [55] considered the tropical rainfall as the factor responsible for the rugged topography of the Bobonaro region characterized by deep gullies, landslides, and knobby hillsides, as shown in Figure 3. Due to the location of Timor Island in the arc-collision zone [55,63–69], Norvick [68] illustrated the tectonic mechanism and high seismic activity reflected in the mountain characteristics, followed by the fragmented and chaotic structures of the thrust and fold zones shown in Figure 1b.

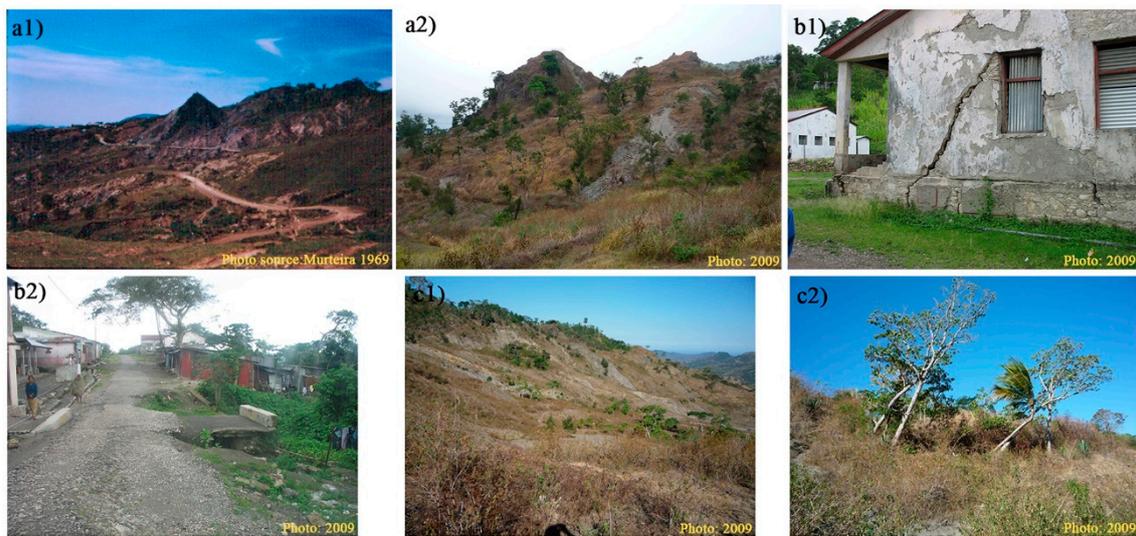
**Figure 2.** (a1,a2) Locations of old landslides at end of 18th century; (a1) road built in 1918 which has been impassable since 1969; (a2) present condition with no traces of the road, slope movement remained active on a small scale. (b1,b2) Examples of damage due to ground movement in 1983. (c1,c2) Locations of landslides occurring in 2003 and the condition of a tilted tree after adaptation over a period of six years as a natural witness.

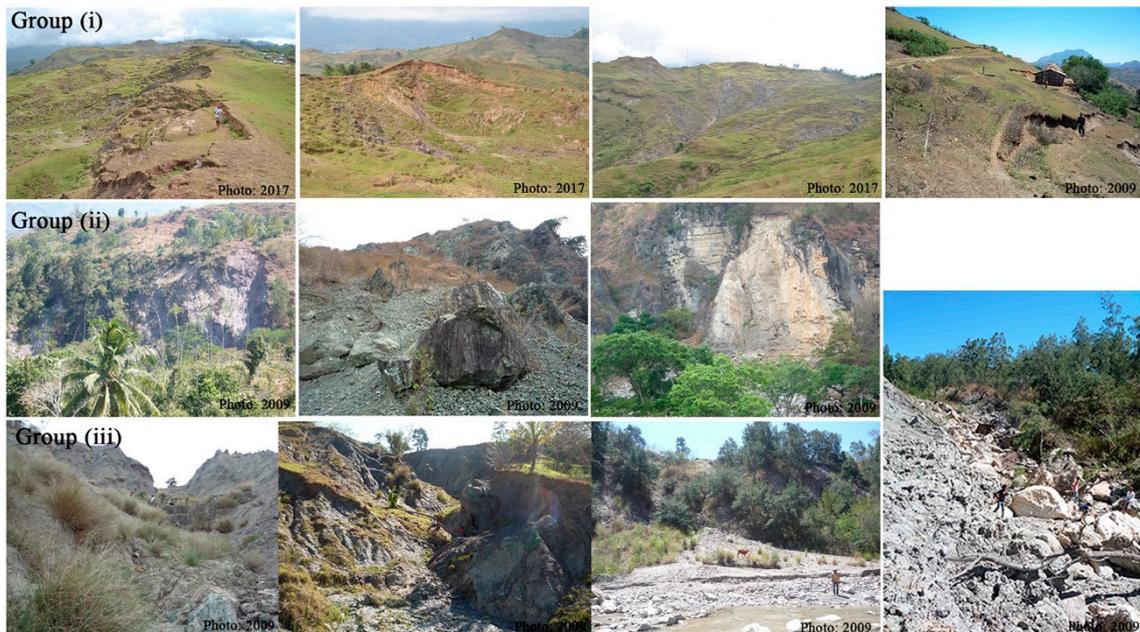
**Figure 3.** Types of ground deformation mechanisms in the Bobonaro Region: **Group (i)** located closest to crest of a mountain, **Group (ii)** on a steep slope, and **Group (iii)** at the base of slopes and close to water courses.

Alongside the riverbank, the slope became unstable and consequently it collapsed and was followed by other types of slope movements such as fall, topple, spread, sliding, and flow. It also resulted in the appearance of the deposition of detritus material close to the watercourses as a result of the flow-type movement. Normally, sliding movements (translational or rotational) and debris flows contain large amounts of materials that can intercept the main streamline, consequently generating a natural dam with the capacity to temporarily flood a wide area until the sediment is removed and transported naturally by the water stream.

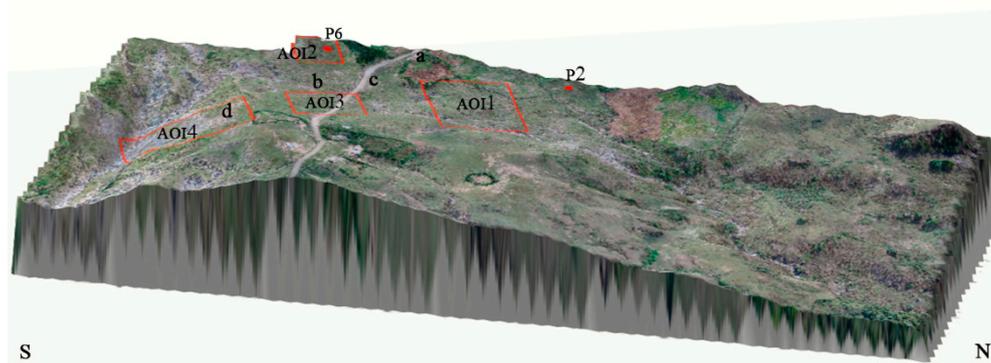
**Figure 4.** Representation of the study area in a 3D model and the positions of Points of Interest (POIs), Areas of Interest (AOIs), and photos of evidence.

The next step will focus on the ground surface interpretation, based on the very high-resolution of the UAV orthomosaic and DEM (Figures 4 and 12). P6 is located at the highest location at an elevation of 1030 m, and P2 is located at a lower location at an elevation of 990 m. AOI2 and AOI3 are located near P6 and AOI1 is located near P2. Based on the landslide morphology presented by Varnes [74], it was possible to identify the typical features of the ground movement or landslide. In Figure 12, some important ground morphology features—such as the main fracture, transverse fracture, internal fracture, pond water, and watercourses—can be identified. AOI2 and AOI3 are situated in the depletion zone and are characterized by crowns, main scarps, heads, and flanks. Two main scarps, several heads, and discrete flanks were identified. AOI1 lies in the accumulation zone, which is characterized by radial cracks, transverse cracks, toe ridges, and transverse ridges. Based on this ground morphology, it was assumed that the ground surface deformation occurred during the first period and that the process continued until the end of the second period. The ground is seen to be moving down, following the natural streamline in the NE direction. The ground at AOI4 is seen to be moving in the opposite direction. The slope is steeper and characterized by translational movement, and no water pond was found.

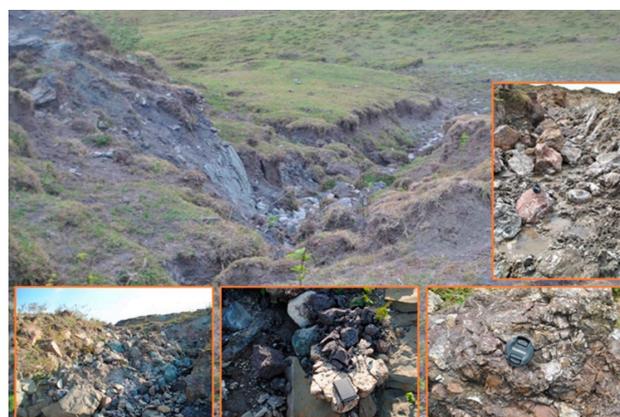
**Figure 5.** Types of material outcrops essentially composed of serpentinites and metaigneous rocks and surrounded by a clay matrix.

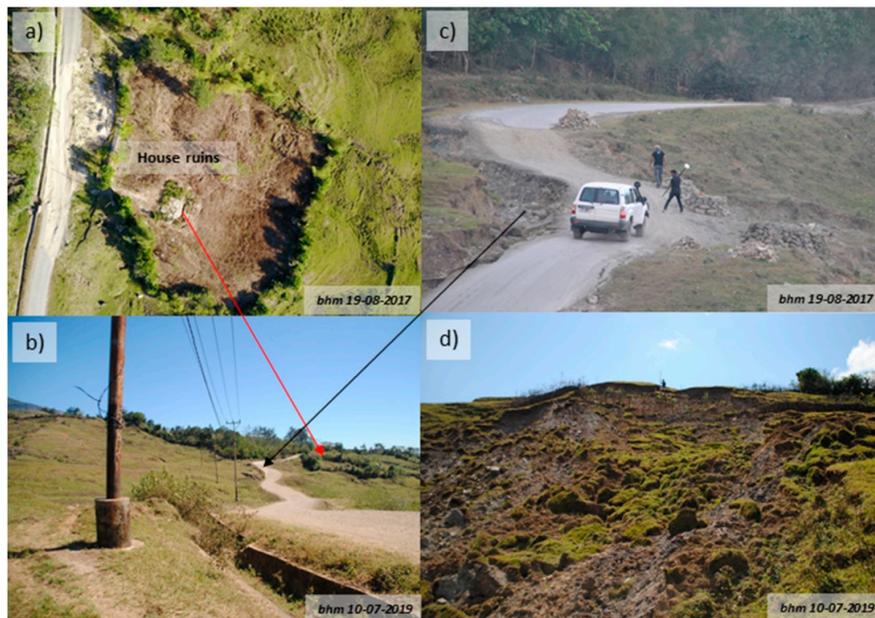
**Figure 6.** Evidence of ground deformation and its impact: (a) house ruins, (b) electrical pole that moved and tilted, (c) degraded road conditions, and (d) small landslide induced by an earthquake.

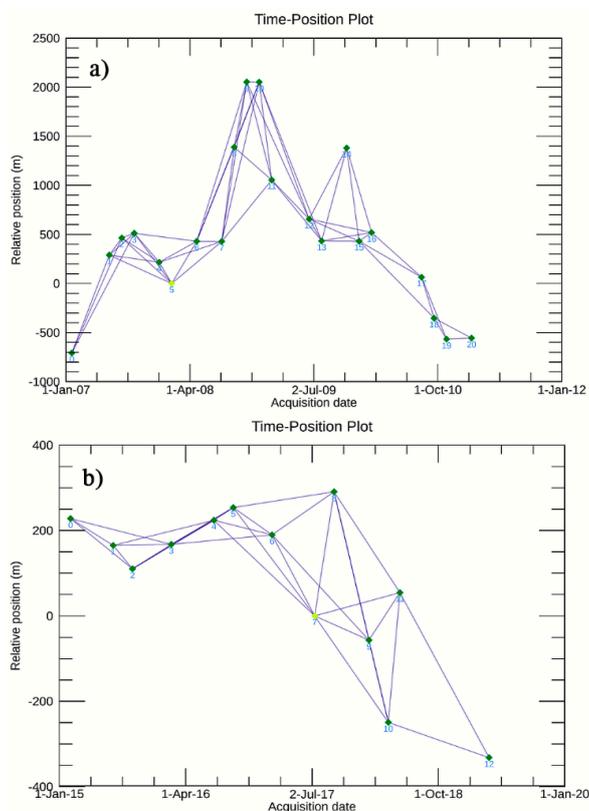
**Figure 7.** Small Baseline Subset (SBAS) Differential Interferometry Synthetic Aperture Radar (DInSAR) baseline tables: (a) Phased Array type L-band Synthetic Aperture Radar (PALSAR) 1 for first period and (b) PALSAR2 for the second period.

For the PALSAR1 data, the maximum perpendicular and temporal baselines of the interferogram for SBAS processing are  $\pm 2000$  m and 270 days, respectively. Accordingly, 55 pairs of interferograms met the criteria. For the PALSAR2 data, the maximum perpendicular and temporal baselines of the interferogram for the SBAS processing are  $\pm 400$  m and 365 days, respectively. Thus, 33 pairs of interferograms met the criteria for further processing. Figure 7a,b shows the baseline table of SBAS DInSAR for PALSAR1 and PALSAR2, respectively.

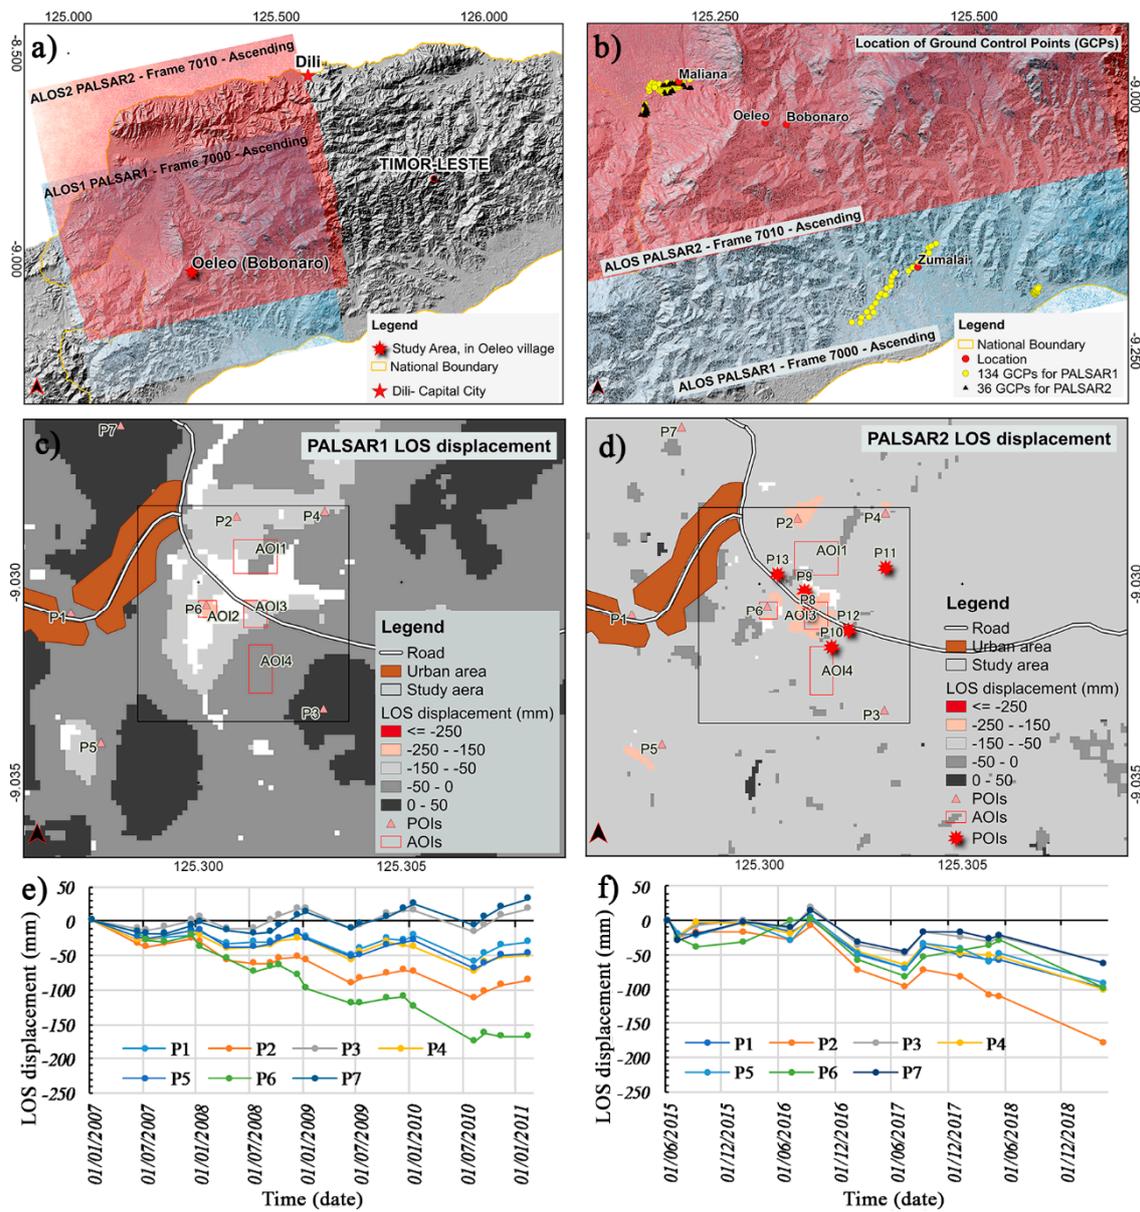
**Figure 8.** (a) PALSAR1 and PALSAR2 data frames covering study area, (b) spatial distribution of ground control points (GCPs), (c) spatial distribution of line of sight (LOS) displacement from PALSAR1, (d) spatial distribution of LOS displacement from PALSAR2, (e) LOS displacement time-series from PALSAR1, and (f) LOS displacement time-series from PALSAR2.

The ground deformation detected by SBAS DInSAR from both PALSAR1 and PALSAR2 is presented in line of sight (LOS) displacement values and their spatial distribution (Figure 8c,d). These LOS displacement values were furthermore used for geoprocessing in GIS software environments. Seven points of interest (POIs)—namely, P1, P2, P3, P4, P5, P6, and P7—were defined around the study area near the village of Oeleo (Figure 8c,d). In order to identify the distribution of ground deformation with more detail, four areas of interest (AOIs)—AOI1, AOI2, AOI3, and AOI4—were defined (Figure 8c,d). These AOIs were applied for the first period. Six more POIs—namely, P8, P9, P10, P11, P12, and P13—were defined for the second period (Figure 8d). The definitions of the additional POIs and AOIs were based on the LOS displacement images, the recent field observations, and UAV orthomosaic image interpretation. The LOS displacement values were extracted and converted to points for further analysis. The PALSAR1 and PALSAR2 LOS displacement time-series related to P1, P2, P3, P4, P5, P6, and P7 are presented in Figure 8e,f respectively.

The LOS displacement time-series clearly shows a trend in the ground deformation during these two periods of study (Figure 8e,f). The tendency was to move in the negative direction, and the LOS displacement values varied among the POIs. From Figure 8d, it is seen that the POIs have been classified into three groups—namely, Group 1 (P3 and P7), Group 2 (P1, P4 and P5), and Group 3 (P2 and P6). Group 1 was more stable during the first period. However, during the second period the LOS displacements were increasing or moving down, starting from 9 February 2016 until the end of the period. Group 2 presented uniform displacements during the first period and continued until March 2016. After that, the LOS displacements increased drastically. Group 3 presented the highest values of the LOS displacements during the first period. During the second period, the POIs in this group differed from the LOS displacement values. P6 tended to be stabilized, while P2 showed a continuous increase in the LOS displacement values during the second period. The differences in behavior between P2 and P6 reveal important information for understanding and describing the relative movement and direction of the ground deformation in this location. For this purpose, the latest PALSAR2 LOS displacements were overlaid on the UAV DEM. The results showed a good coherence between the LOS displacements and the ground surface conditions (Figure 11). As can be observed in Figure 9e, something interesting occurred in relation to the additional POIs. P8 and P9 reached LOS displacement values of above 200 mm. Further investigation will focus on the area of interest 3 (AOI3).

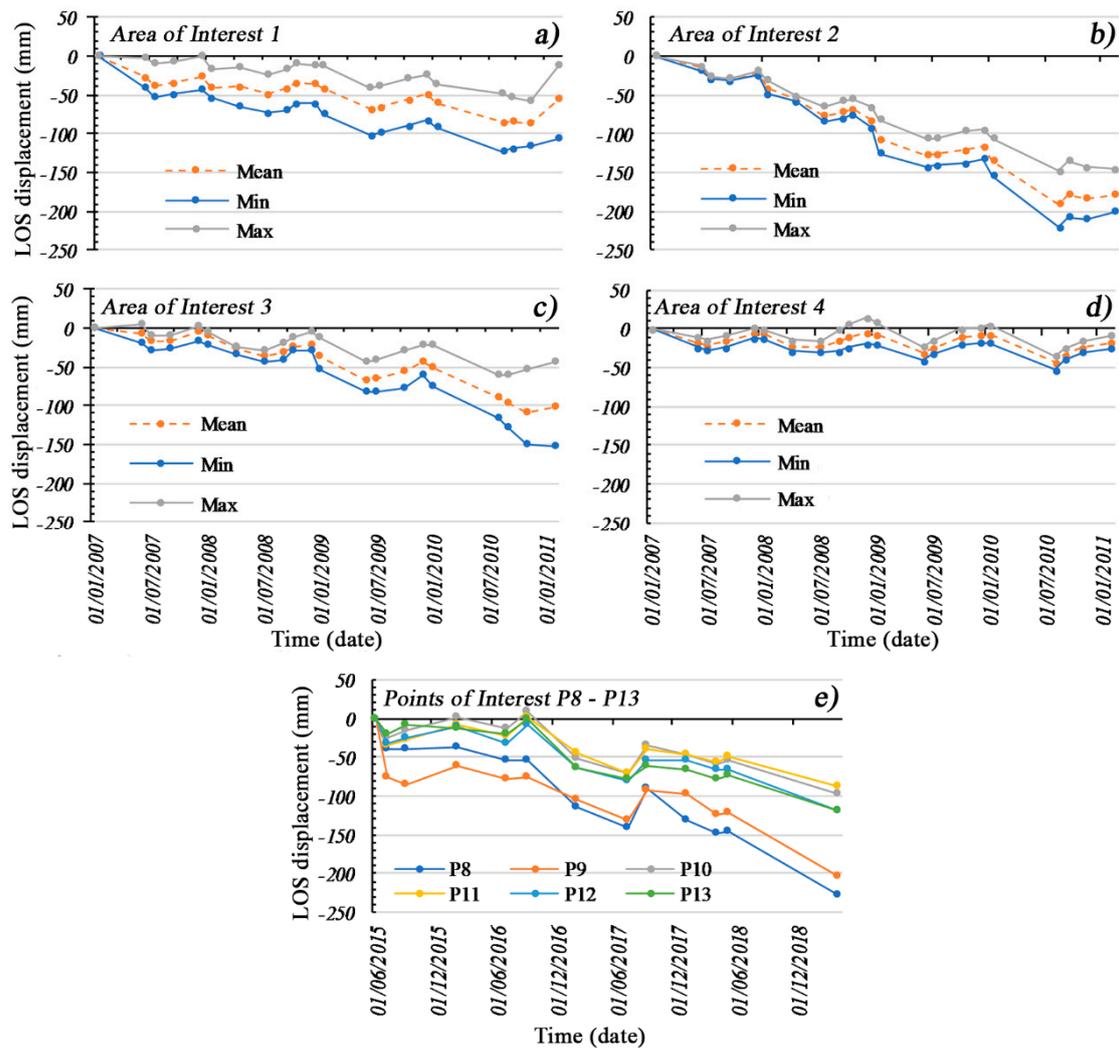
**Figure 9.** PALSAR1 LOS displacement time-series: (a) AOI1, (b) AOI2, (c) AOI3, (d) AOI4, and PALSAR2 LOS displacement time-series; (e) POIs P8–P13.

The PALSAR1 LOS displacement time-series values related to AOI1, AOI2, AOI3, and AOI4 were extracted and applied to calculate the mean, minimum, and maximum values. These values were used to show the ground deformation trend in Figure 9a–d, respectively. AOI2 and AOI3 show high displacement values, while AOI4 seems more stable.

The PALSAR2 LOS displacement time-series values related to P8, P9, P10, P11, P12, and P13 were extracted and are presented in Figure 9e. Based on the LOS displacement values, both POIs—P3 and P7—seemed more constant than the others during the first period. However, during the second period, P3 and P7 presented displacements as well. POIs P2 and P6 presented very high values of LOS displacement during the two periods (Figure 8e,f). In Figure 9e, P8 and P9 showed LOS displacement values of more than 200 mm compared to other POIs.

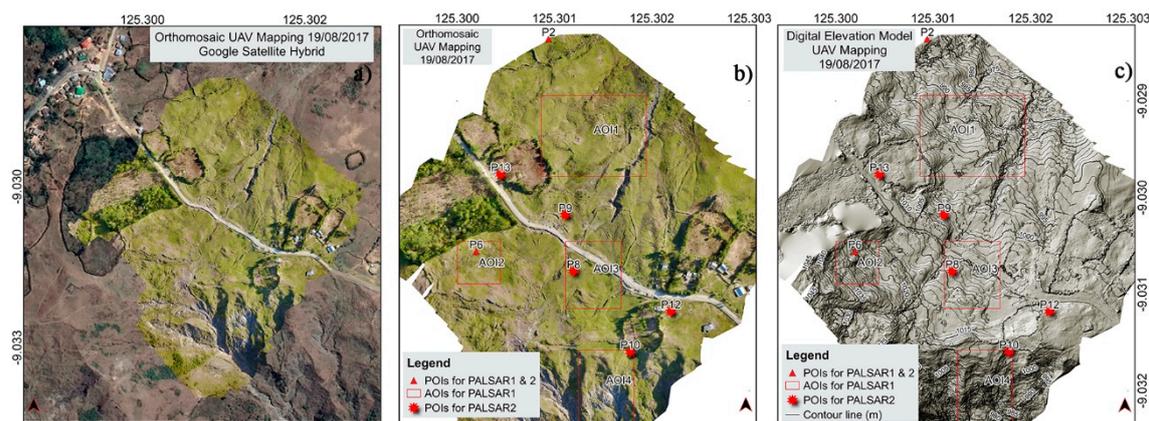
**Figure 10.** (a) Unmanned Aerial Vehicle (UAV) orthomosaic overlaid on Google Maps Hybrid, (b) UAV orthomosaic, and (c) UAV Digital Elevation Model.

For this study, a UAV aerial mapping mission was conducted on 19 August 2017 without the application of GCPs. The positioning system was based on a single built-in unit GPS/GLONASS module installed inside the drone. Thus, a minimum of 12 numbers from the satellite had to be achieved to get a strong signal from the GPS before starting the flight for survey mapping. This requirement is very important for obtaining good quality georeferencing images. For most of the acquired images, the quality was good, with values of quality estimation coefficients greater than 0.8, as analyzed by the Agisoft PhotoScan 1.4.5 software. It was necessary to check the image quality before proceeding to the image processing stage. For the next step, the workflow presented in the Agisoft PhotoScan software was followed. The result presented very high-resolution orthomosaic images and digital elevation models for both (Figure 10b,c). Figure 10a shows the acceptable georeferencing quality of the orthomosaic image, which matched the Google Maps Hybrid. From the orthomosaic image, it was possible to interpret and measure the ground fissures in the GIS environment with a centimeter-order accuracy. The digital elevation model allows for other spatial information, such as contour lines and surface profiles, to be generated.

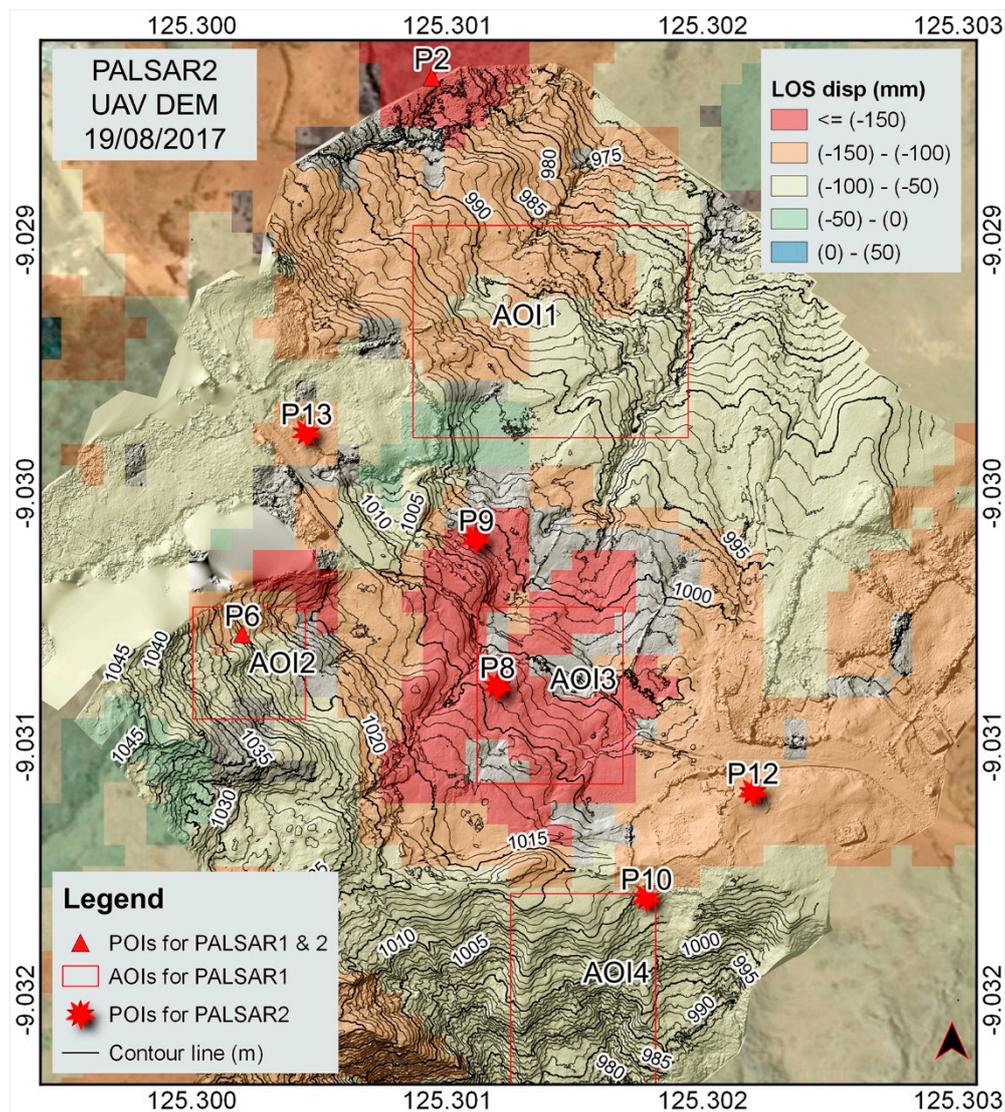
**Figure 11.** Latest PALSAR2 LOS displacement image overlaid on UAV Unmanned Aerial Vehicle (DEM) acquired on 19 August 2017.

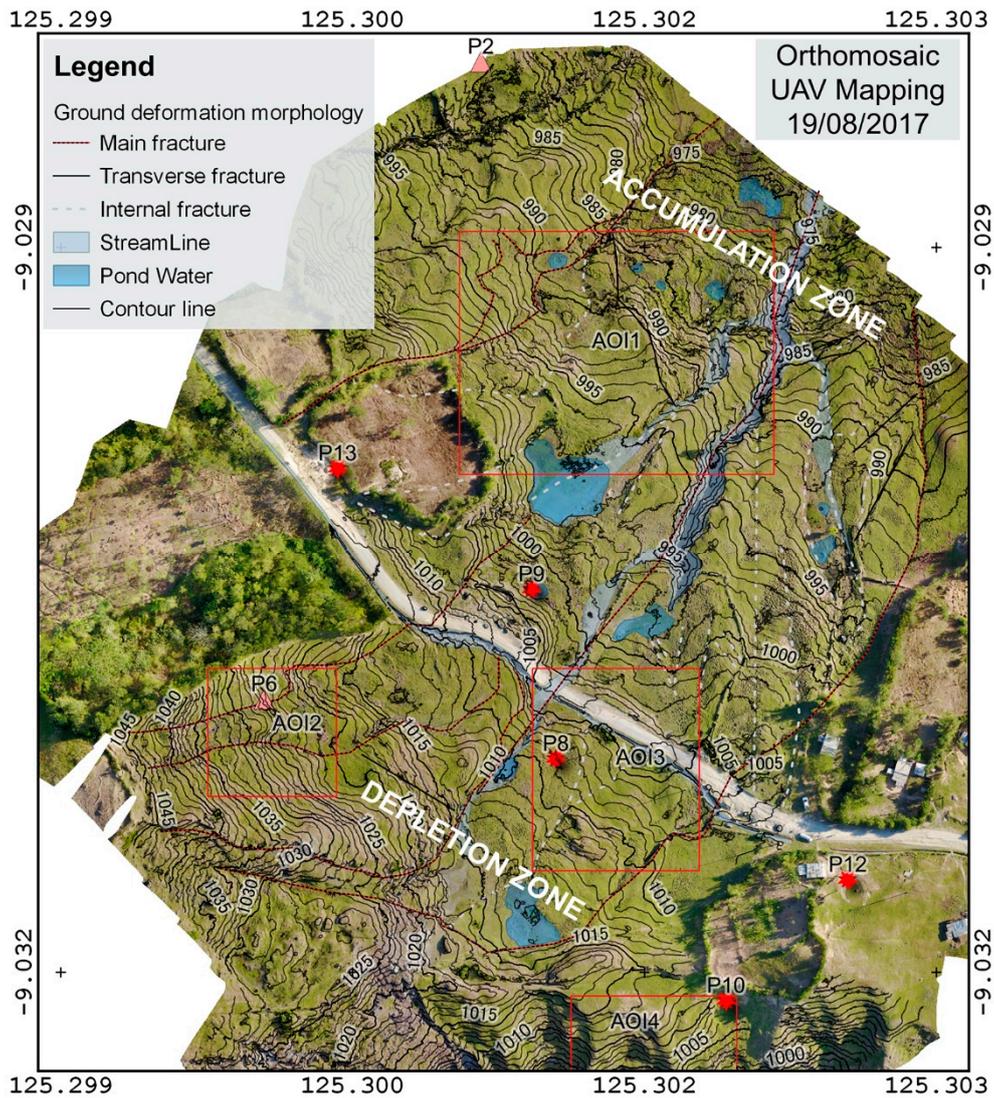
**Figure 12.** Ground surface deformation morphology interpretation based on the UAV orthomosaic images acquired on 19 August 2017.

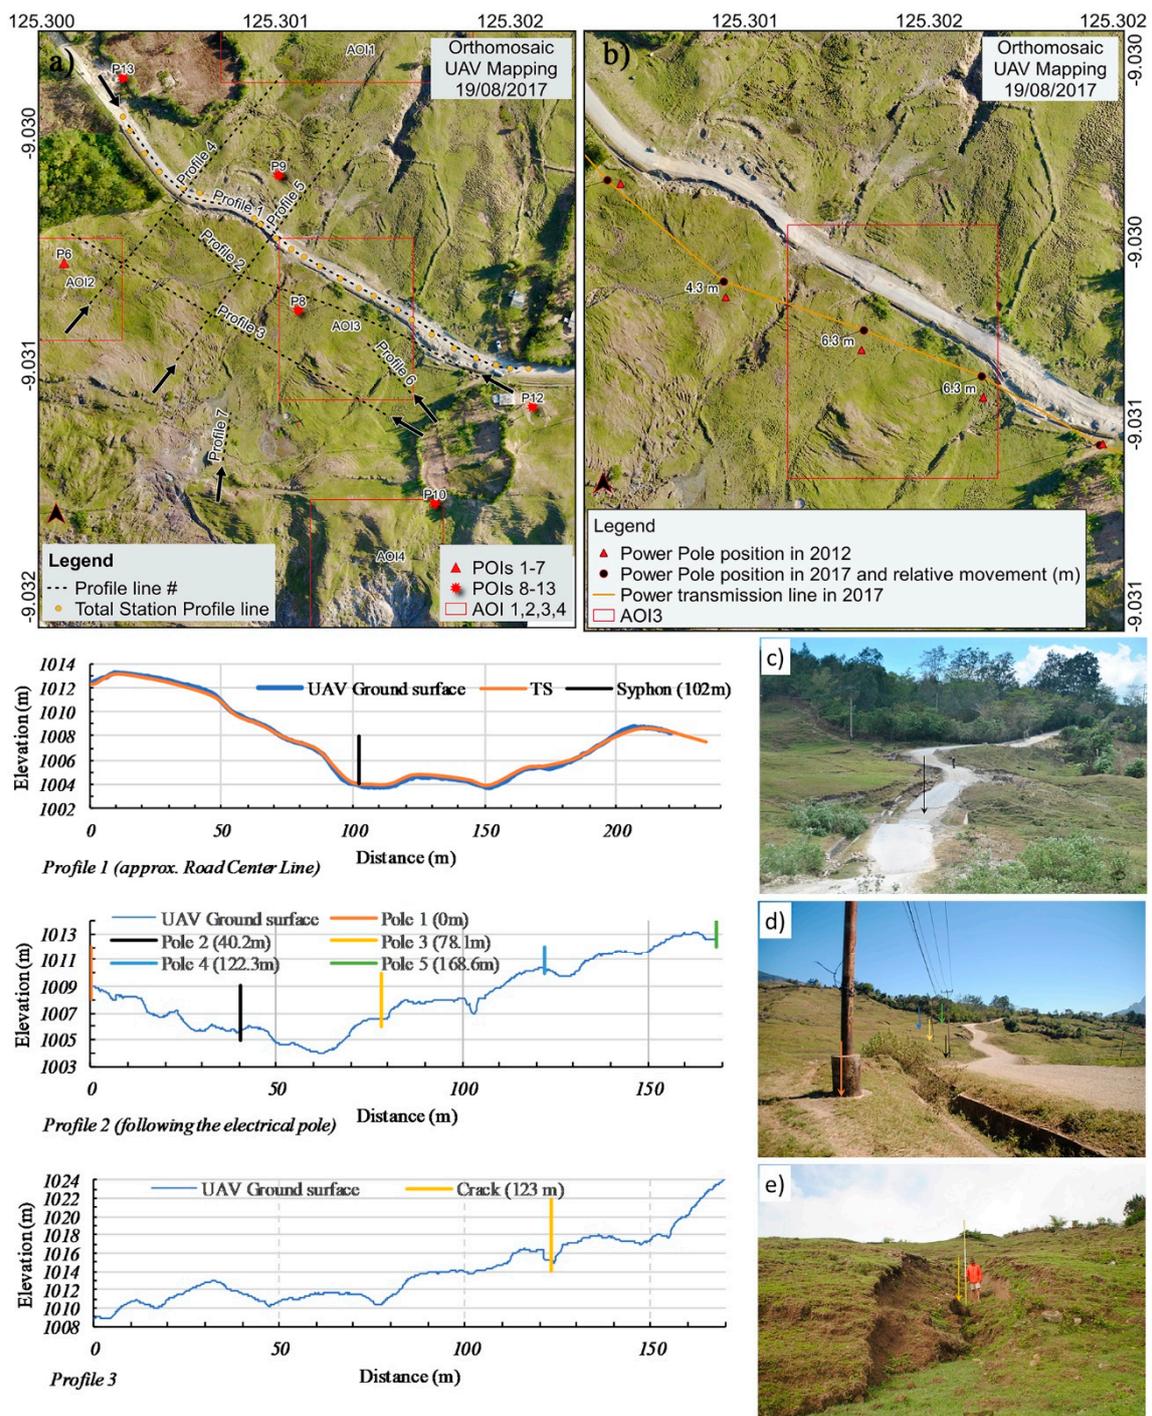
**Figure 13.** (a) Position of terrain profile section, (b) relative horizontal movement of electrical pole, (c) illustration of Profile 1, (d) illustration of Profile 2, and (e) illustration of Profile 3.

The very high-resolution orthomosaic images and DEM allowed for a more detailed interpretation of the morphology of the ground surface deformation [39]. Specific terrain profile sections were extracted from the UAV DEM (Figure 13a). For each profile section, the ground surface as well as the remarkable ground features and objects are presented in the graphs (Figures 13 and 14). The results show that the ground surface deformation measurements vary from centimeters to meters in both the vertical and horizontal directions. From Profile 1, the results of the road surface elevation extracted from UAV DEM are presented and compared with the total station measurements. The graph shows a good coherence between these two measurement methods (Figure 13c). The line of Profile 2 follows the electrical pole line. It is noted that the electrical pole moved horizontally more than 4 m from the initial position (Figure 13b,d). Profile 3 represents the natural ground surface condition and a ground crack, shown in Figure 13e. Profiles 4 and 5 represent some parts of the roads that were affected by the ground deformation (Figure 14f,g). Profiles 6 and 7 represent the main scarps that were measured and illustrated in Figure 14h,i, respectively.

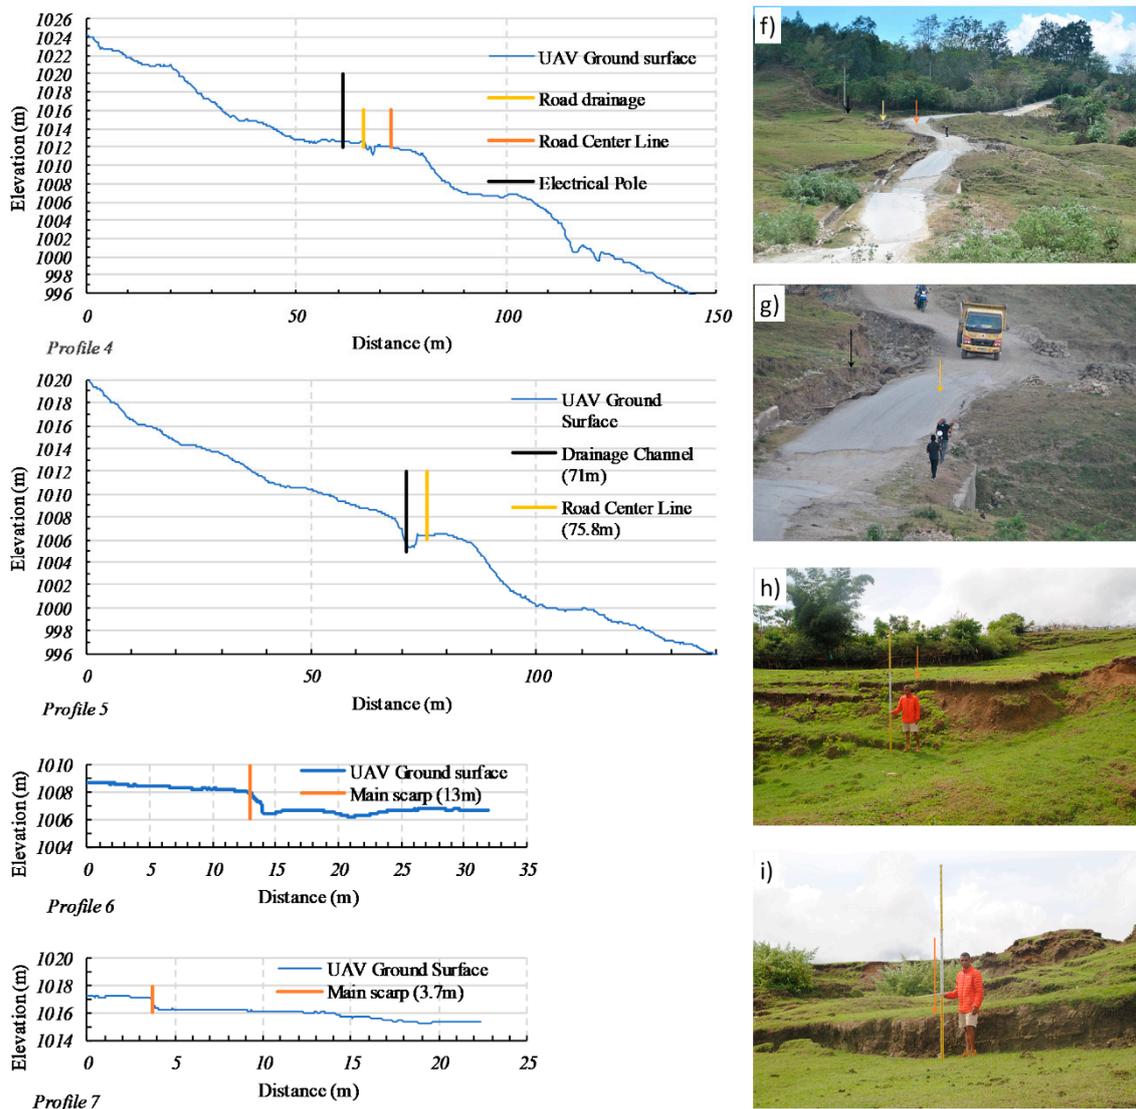
**Figure 14.** (f) Illustration of Profile 4, (g) illustration of Profile 5, (h) illustration of Profile 6, and (i) illustration of Profile 7.

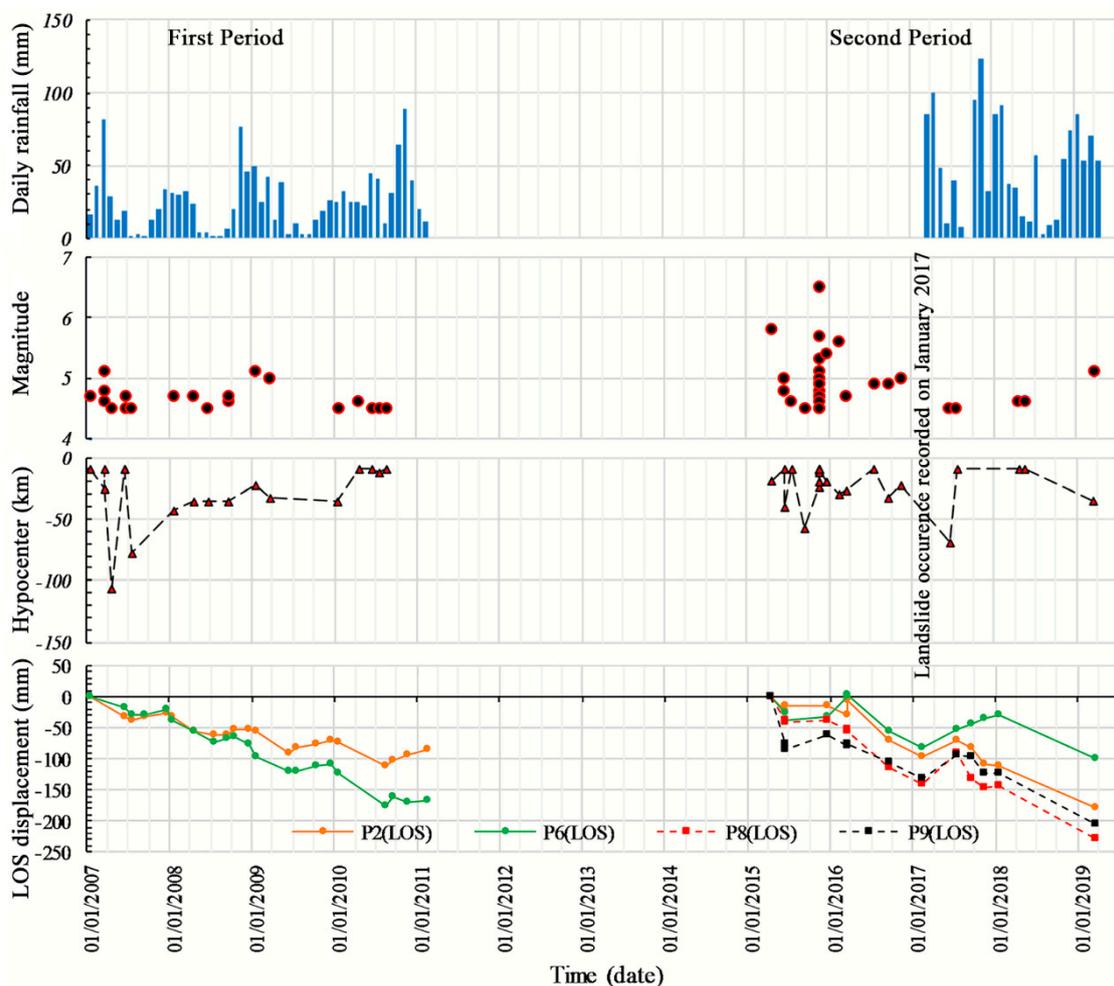
**Figure 15.** Relationship in time occurrences of PALSAR1 and PALSAR2 LOS displacement time-series with earthquake events and daily rainfall data.

In this study, some interpretations are presented based on Figure 15. During the first year, from 1 January 2007 to 1 July 2007 eight earthquake events were recorded, one with a maximum magnitude of 5.1 and practically all occurring during rainy months, however with low amounts of rainfall. The ground deformation presented the maximum value of  $-38.1$  mm. During the fourth year, January 2010 to January 2011, six earthquake events were recorded with an average magnitude of 4.5, and the rainfall amount was higher than that of the previous years. The ground deformation presented the maximum value of  $-65.7$  mm. However, for the third year—January 2009 to January 2010—only two earthquakes were recorded, with magnitudes of 5.1 and 5.0 and a moderate amount of rainfall. The ground deformation presented the maximum value of  $-46.9$  mm. During the sequences of events in the second period, the earthquake reached the maximum magnitude of 6.5 and the hypocenter depth

of 20 km on 4 November 2015. In the same month, 16 earthquake events were recorded, with an average magnitude of 5.0. At this stage, no rainfall contribution could be found. However, one landslide occurrence was recorded in January 2017 during heavy rainfall. Based on this evidence, it was assumed that the rainfall in 2017 was high. From November 2015 to March 2017, the ground deformation presented the maximum value of  $-102.6$  mm. For the next few years, the LOS displacement values showed positive evolution linked with the rainy season and seismic activity until the end of the study period. From January 2018 to April 2019, the ground deformation presented the maximum value of  $-82.4$  mm.

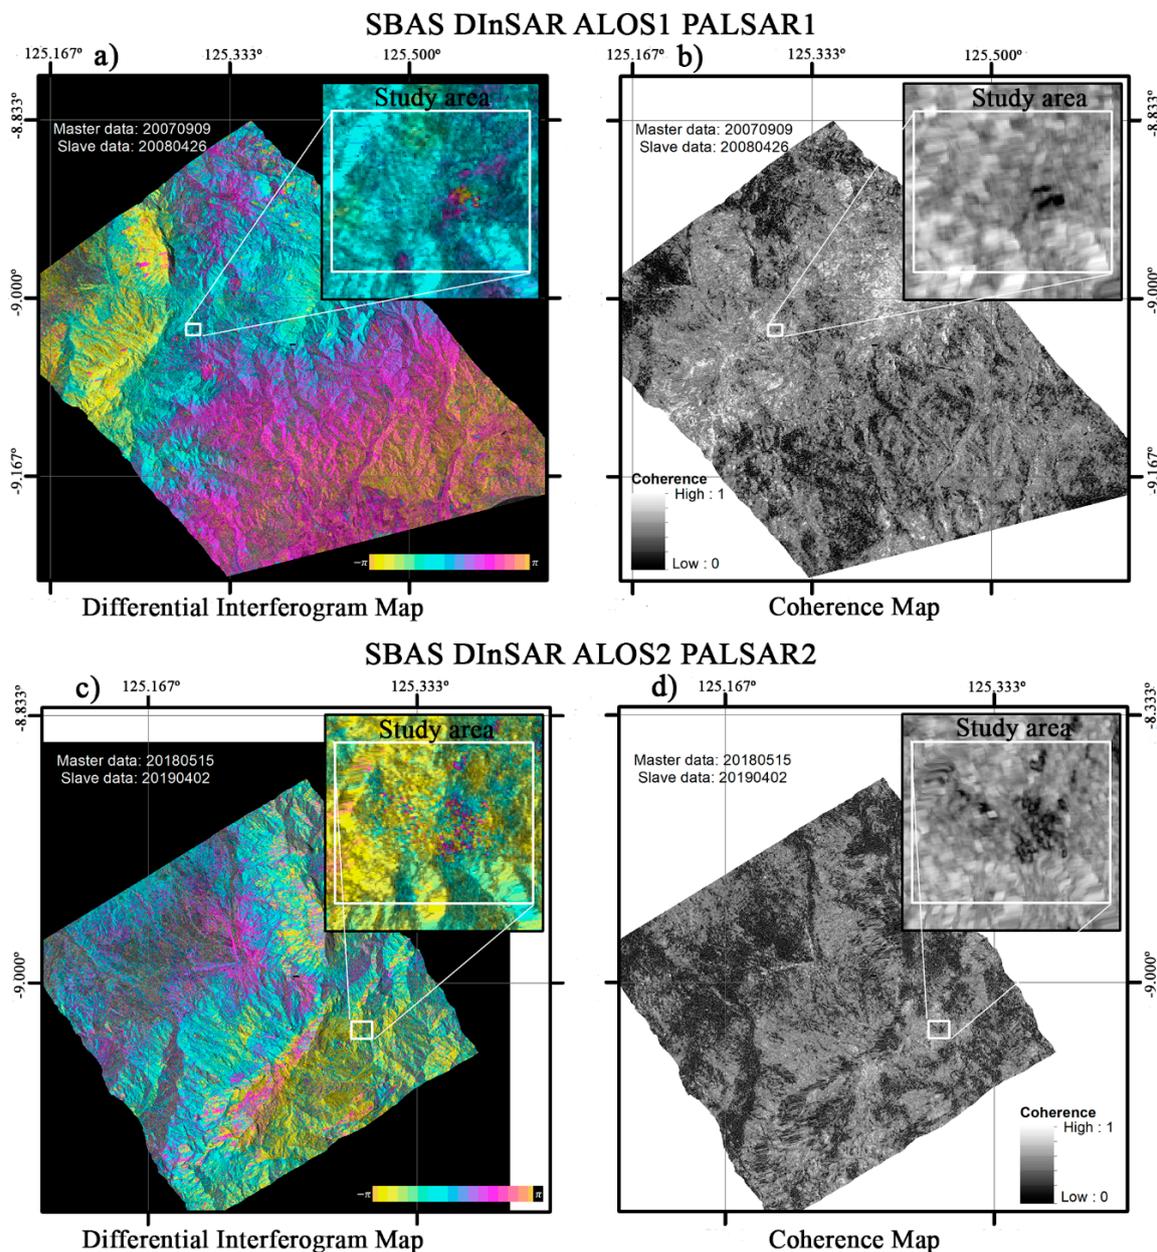
**Figure A1.** (a) PALSAR1 Interferogram map, (b) PALSAR1 Coherence map, (c) PALSAR2 Interferogram map and (d) PALSAR2 Coherence map.

The orbital error fringes interfered in some interferograms [75]. To redefine these orbital fringe errors, a 2nd order polynomial estimation in the azimuth and range directions was applied and calibrated with the number of ground control points (GCPs). A total of 134 GCPs located in Maliana and Zumalae were used for PALSAR1, and 36 GCPs located in Maliana were used for PALSAR2 (Figure 8b). The GCPs are located on flat land where the unwrapped phase error is minimum. A repeated unwrapping process will redefine the interferograms. The atmospheric phase screen (APS) is the dominant error source for InSAR [82]. A custom spatio-temporal filter—whose spatial low pass window size is 1.2 km × 1.2 km and whose temporal high pass size is 365 days—was applied to reduce those errors. After minimizing all the associated errors, the next step was the geocoding process and image resampling. For this process, the temporal coherence threshold coefficient was defined at 0.4 for PALSAR1 and 0.2 for PALSAR2. Finally, the maps for the time-series LOS displacement were generated by each dataset. The spatial resolution was 15 m × 15 m for PALSAR1 and 10 m × 10 m for PALSAR2. An example of an interferogram map, coherence map, and LOS mean displacement velocity map for both PALSAR1 and PALSAR2 are presented in Appendix A.

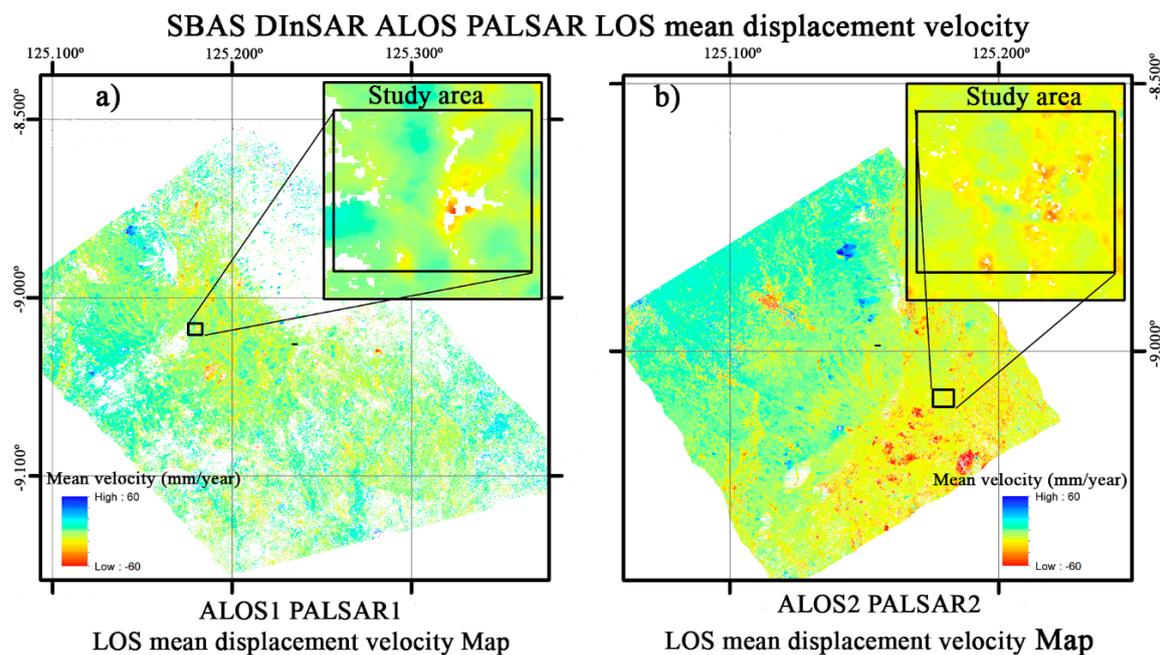
**Figure A2.** (a) PALSAR1 LOS mean displacement velocity for the first period of study and (b) PALSAR2 LOS mean displacement velocity for the second period of study.
