Article

Geomorphological Evolution of Volcanic Cliffs in Coastal Areas: The Case of Maronti Bay (Ischia Island)

Keywords: coastal areas; beach dynamics; cliff retreat; landslide; erosion rates

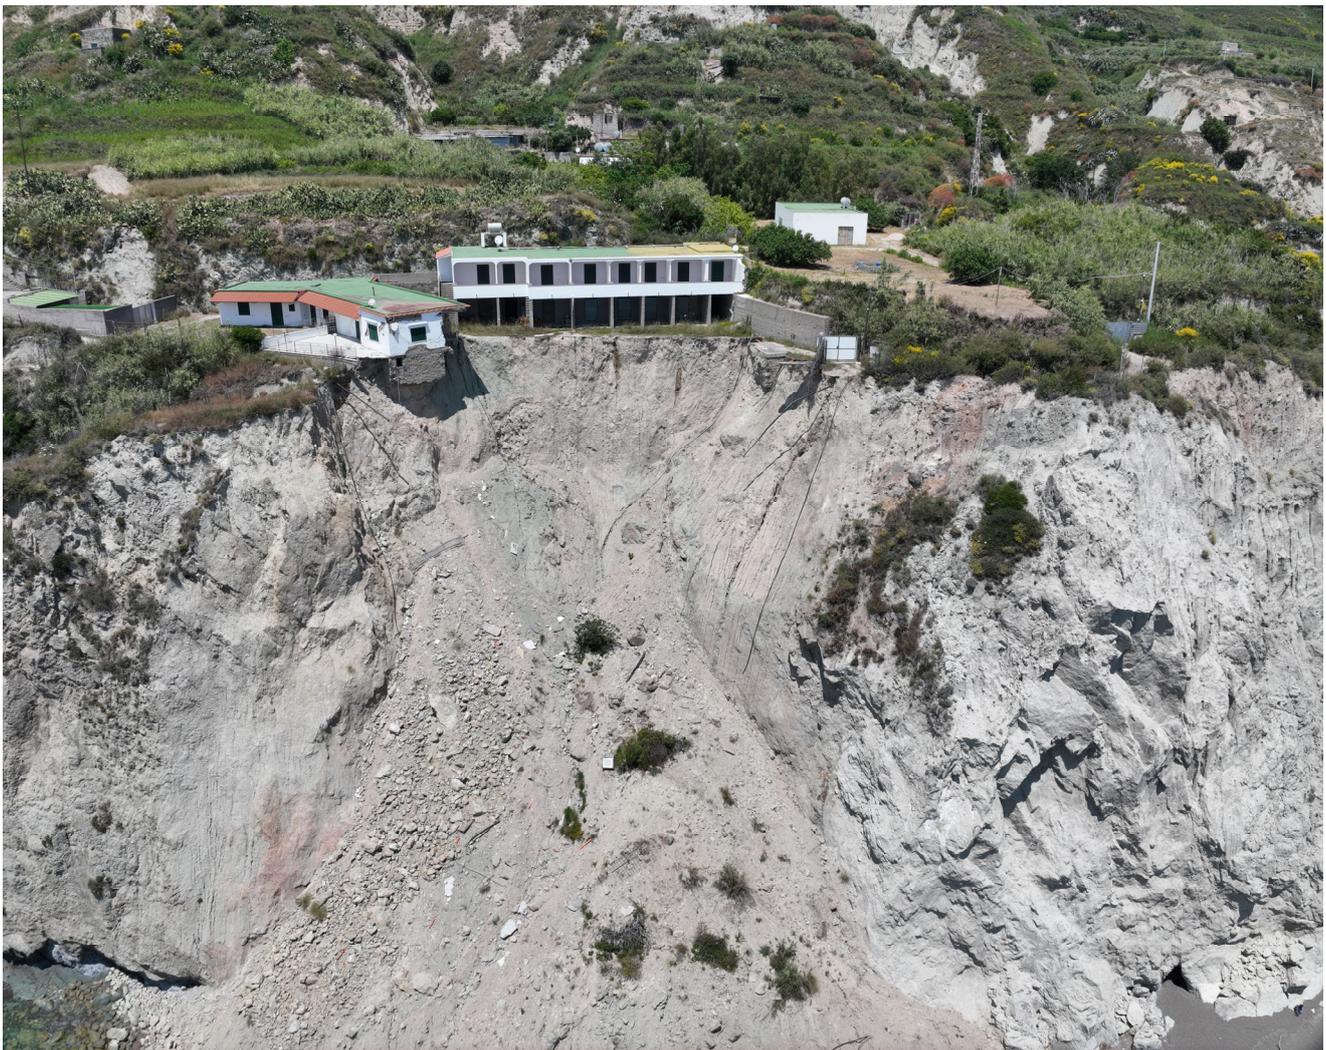
Figure 1. Aerial photograph of the 26th November 2022 landslide with the affected buildings on the cliff top.

This study focused on the coastal evolution of Maronti Bay (on the southern part of Ischia Island) in the municipalities of Barano and Serrara Fontana. Ischia Island has been intensely affected by slope stability phenomena connected to volcanic activity, earthquakes, stormy rains, and/or coastal erosion [22–28]. In particular, this area was historically characterised by coastal erosion processes as well as slope instabilities and is currently affected by a wide retrogressive debris avalanche threatening the uphill urban centre (Figure 1).

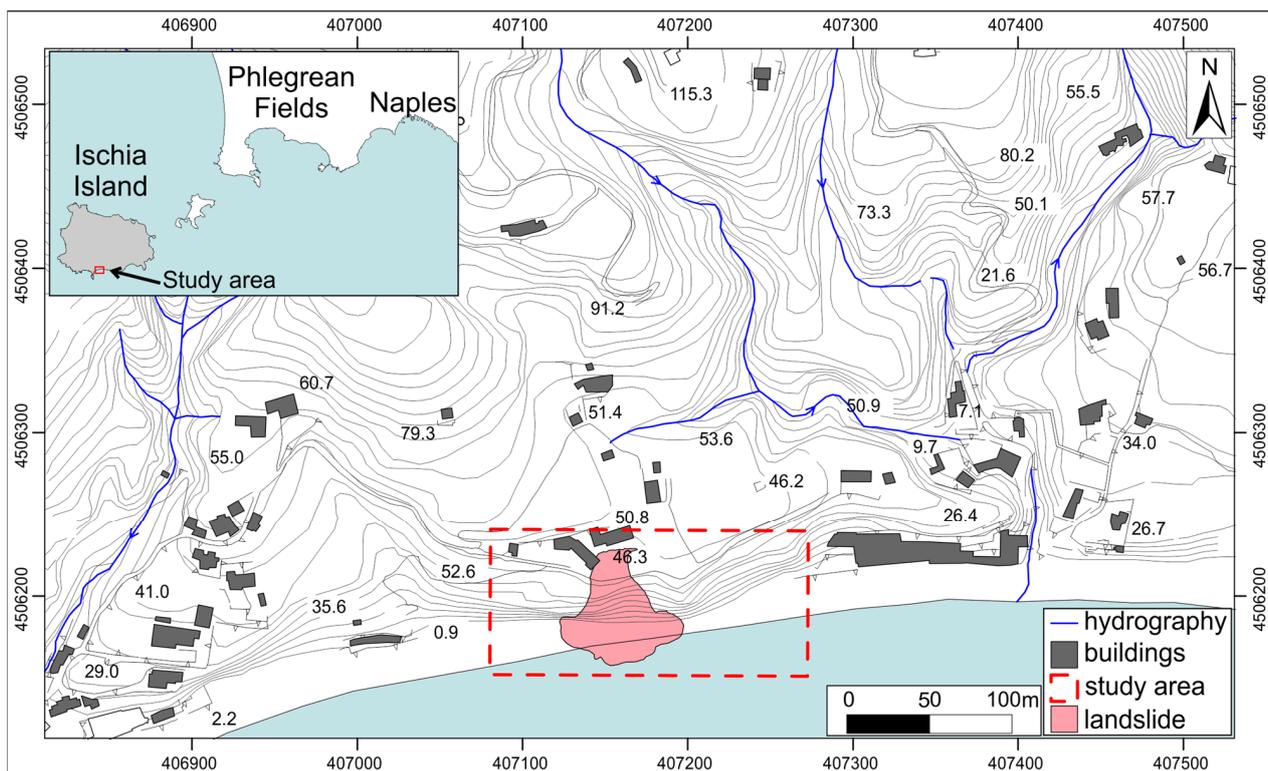
Figure 2. Topographic map (2015) of Maronti Bay with the location of the study area and the 2020 landslide body.

Ischia Island is part of the Phlegraean Fields volcanic complex, and it extends for about 42 km² into the Gulf of Naples (Figure 2). The geological and geomorphological characteristics of the island make it highly susceptible to various instability events, including earthquakes, flow-like landslides, rockfalls, flash floods, and tsunamis, resulting in a multi-hazard environment [24,29]. The prevalent lithologies on the island are trachytes and latite-phonolites lavas, accompanied by pyroclastic soils and ancient mudflow deposits [30,31].

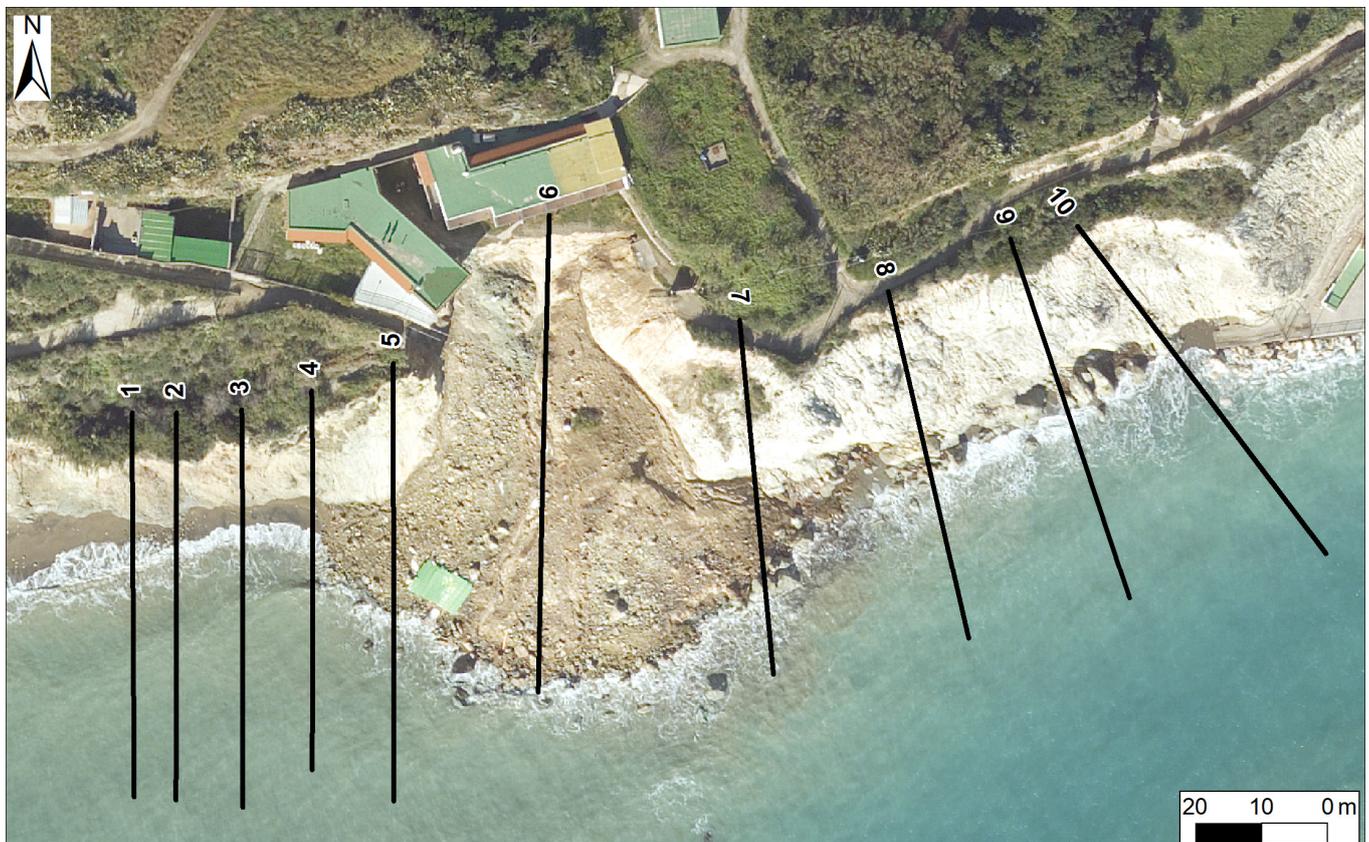
Figure 3. Measurement lines (T1–T10) disposed along the cliff and the beach edges for the measurement of their progradation/regression evolution. Example of the 2022 orthophoto.

The satellite images were georeferenced by means of GIS software based on the Topographic Map (1:5000), using fixed reference points (e.g., buildings and crossroads). Successively, the cliff perimeter and the beach limits were digitised for each year on the available orthophotos, satellite images, and topographic maps, enabling the analysis of their temporal evolution and the assessment of coastal retreat (i.e., sea cliff-orthogonal translation from its initial position). The shoreline position was identified as the water line at the time of the individual images since the study area is located in a microtidal environment [38,39]. The progradation/regression trends of the cliff and beach edges were quantified by measuring their variation in sequential images. These values were collected along 10 measurement lines (transect, T) perpendicularly arranged with respect to the cliff and the beach (Figure 3).

- The amount of cliff retreat is higher for the transects T4–T6, which represent the central part of the cliff (Figure 3) where the landslide events mainly occurred.
- The highest regression rate is registered in the 2015–2022 period on the T6 (about 271 cm year⁻¹), with the landslide event of the 26 November 2022 playing a primary role.
- On average, the 2022–2023 and the 2009–2015 intervals show the highest (about 61 cm year⁻¹) and the lowest (about 8 cm year⁻¹) cliff retreat rates, respectively.

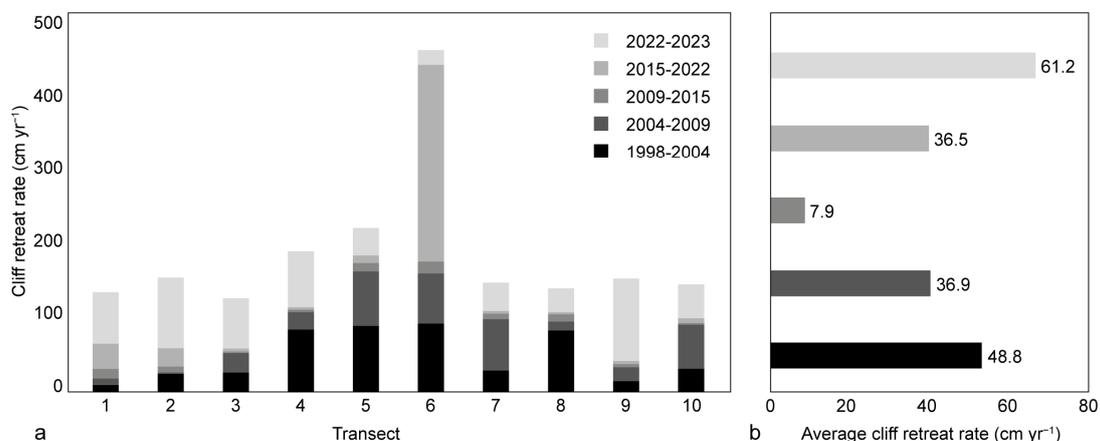
Figure 4. Cliff retreat rate (cm year⁻¹) measured on the 10 measurement lines at different time intervals. (a) Cumulative cliff retreat rate for each transect through the time; (b) average cliff retreat rate for each time interval.

The cliff retreat rate was calculated and compared between time intervals for each transect (Figure 4). Since the 2023 drone survey was performed in June, the annual rate was calculated by considering that the cliff retreat measurements are not referring to an entire year. From this comparison, the following observations can be derived:

Again, to ensure a proper comparison between the measurements, the rate of beach width variation was calculated (Figure 5). It can be noticed that the negative variation rates (beach decrease in width) symmetrically increase towards the external areas of the beach, with the T1–T2 and T10 displaying the highest values. This trend, as expected, is the opposite of what was observed for the cliff retreat (Figure 4). The trends of beach regression (negative values) and progradation (positive values) show a regular oscillation through time. In particular, the 2014–2015 and 2015–2016 time intervals show very high values of progradation (about 10 m yr^{−1}) and regression (about 16 m yr^{−1}), respectively. On the contrary, the average beach regression rate of the interval 2021–2022 was mitigated by the occurrence of the 26th November landslide, which created a remarkable cliff retreat (Figure 4) in T5–T8.

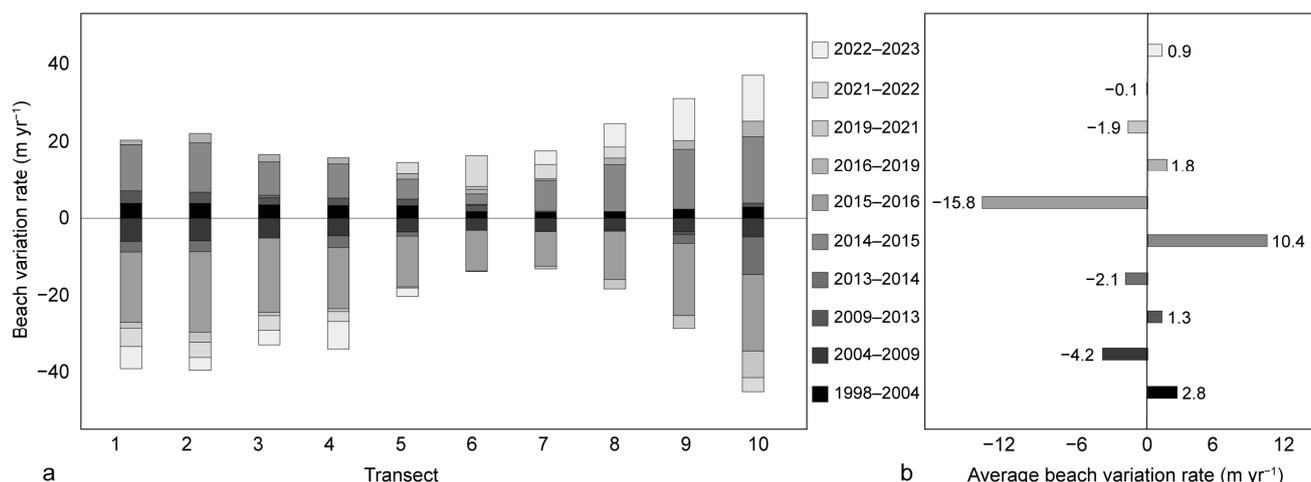
Figure 5. Beach width variation rate (m yr^{−1}) measured on the 10 measurement lines at different time intervals. (a) Cumulative beach width variation rate for each transect through the time; (b) average beach width variation rate for each time interval. The positive values indicate progradation, and the negative values indicate regression.

The evolution of the beach width showed an alternation of regression and progradation trends. In detail, the regression trends (the negative parts of the chart in Figure 5) can be correlated with the cliff retreat trends (Figure 4). In fact, the areas where the highest cliff retreat rates were registered (T4–T6) showed lower beach regression rates with respect to the other transects. The trends of beach regression and progradation showed low or no correlation with the cliff retreat rate, with the increase/decrease of beach width alternating independently of the cliff.

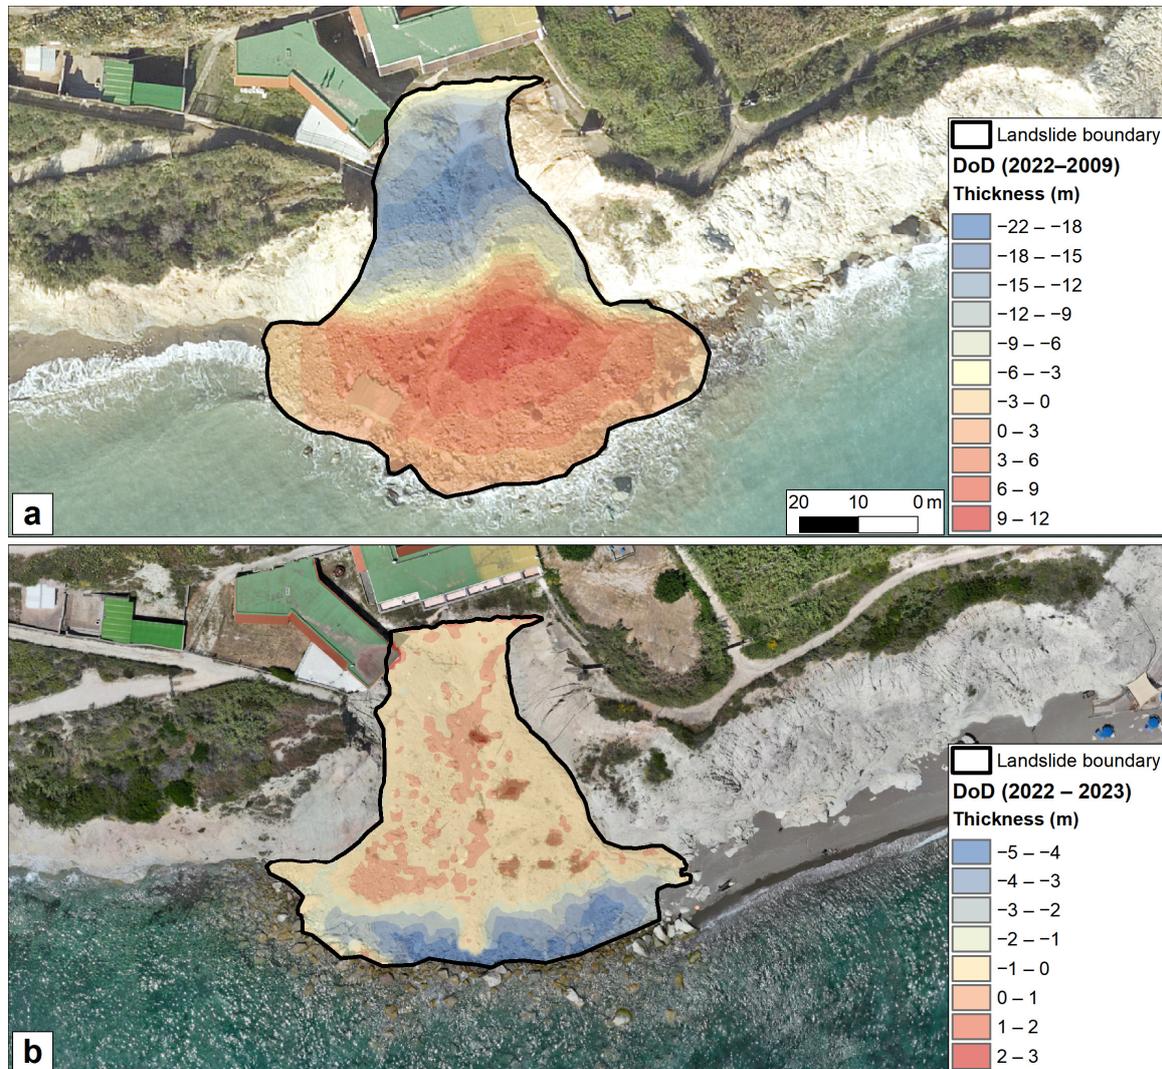
Figure 6. Orthophotos of the November 2022 landslide area with the landslide perimeter and the results of the DoD analyses between (a) 2009–2022 and (b) 2022–2023 DEMs.

DoDs were analysed to estimate the mobilised volumes and to identify the areas of erosion and accumulation. The comparison with the pre-landslide model (2009) defines a clear separation between the crown and the deposition areas (Figure 6a). In this case, an eroded volume of 29,700 m³ and a deposited volume of 13,000 m³ were estimated from the DoD (Table 5), assuming average values of thickness of 10.5 m eroded and 4.6 m deposited.

Successively, the 2022–2023 DoD was computed, and a different scenario was observed. In this time range, the original crown area underwent minor movement of material, while the landslide toe showed high erosion (Figure 6b), mainly due to the action of the waves. In this case, the estimation of the eroded volume was 2600 m³, and the deposited volume was 650 m³ (Table 5), with an average eroded thickness of 1.2 m and an average deposited thickness of 0.3 m.

The landslide event of 26 November 2022 represented a main event within a complex deformation process that started in 2019 and is still ongoing. The 2009–2022 DoD analysis provided a pre-landslide comparison, allowing us to estimate the total mobilised volume at about 29,700 m³. On the other hand, the 2022–2023 DoD highlighted the current reactivation of the landslide, with deposition of new material in the proximal part and erosion by the wave action in the distal part (toe).

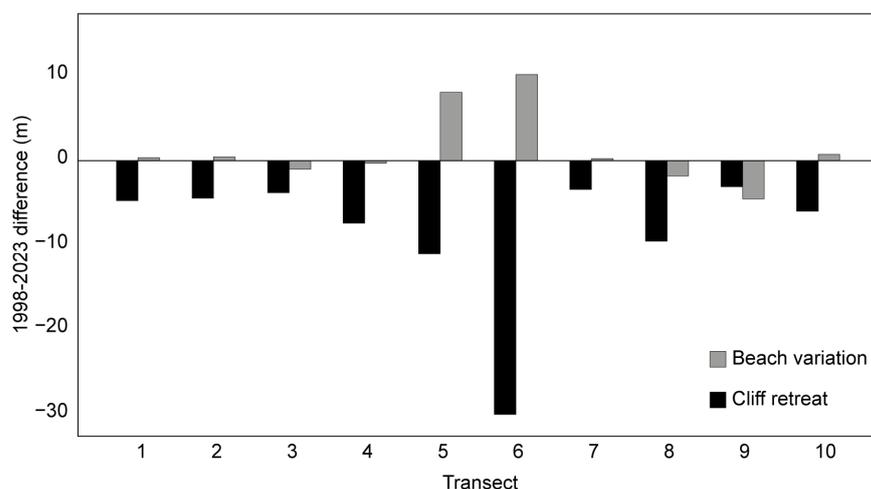
Figure 7. Absolute cliff and beach width variations from 1998 to 2023.

The total balance of the 25-year comparison (Figure 7) showed that the cliff retreated from a minimum of 3.0 m (T9) to a maximum of 29.1 m (T6), while the beach increased in width in the central part of the analysed area (T6, 10.0 m) and displayed a maximum decrease of 4.4 m (T9). This shoreline evolution can be considered as part of the same process observed by Giordano, Ferrante, Marsella and Vicinanza [37], who found that the area of Maronti is characterised by strong seaward sediment transport.

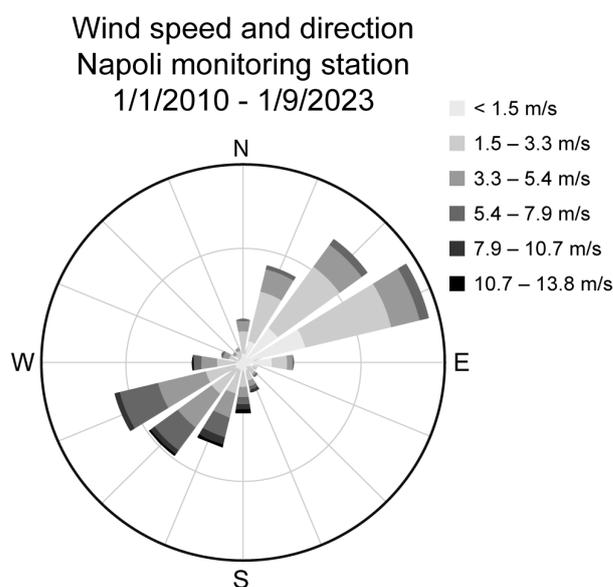
Figure 8. Wind direction and intensity recorded at Napoli monitoring station in the 2010–2023 time interval (ISPRA).

In both cases, the total mobilised volume is not as directly distributed as the deposited one (Table 5), defining a difference in volume (56% and 75% of the total eroded volumes in 2009–2022 and 2022–2023, respectively). These different results can be explained by the actions of the different processes. In the first time interval, the erosion volume was mainly due to the landslide events and, in a minor part, to the wave action. Conversely, in the second time interval, the eroded volume was determined mainly by the wave action. The role played by the wave action was confirmed by the wind data collected from the Naples monitoring station (ISPRA) for the 2010–2023 interval (Figure 8). These data showed that the winds from the SW represented the most intense (up to 13.9 m s⁻¹) winds affecting the coastal area of Maronti. Also, the sea storm recorded in the 1998–2023 time interval on Maronti beach showed that the wave motion from the SW represented the most intense (>3 m wave height) and frequent trend [37].
