Article

Fluvial Geomorphology, Root Distribution, and Tensile Strength of the Invasive Giant Reed, *Arundo donax* and Its Role on Stream Bank Stability in the Santa Clara River, Southern California

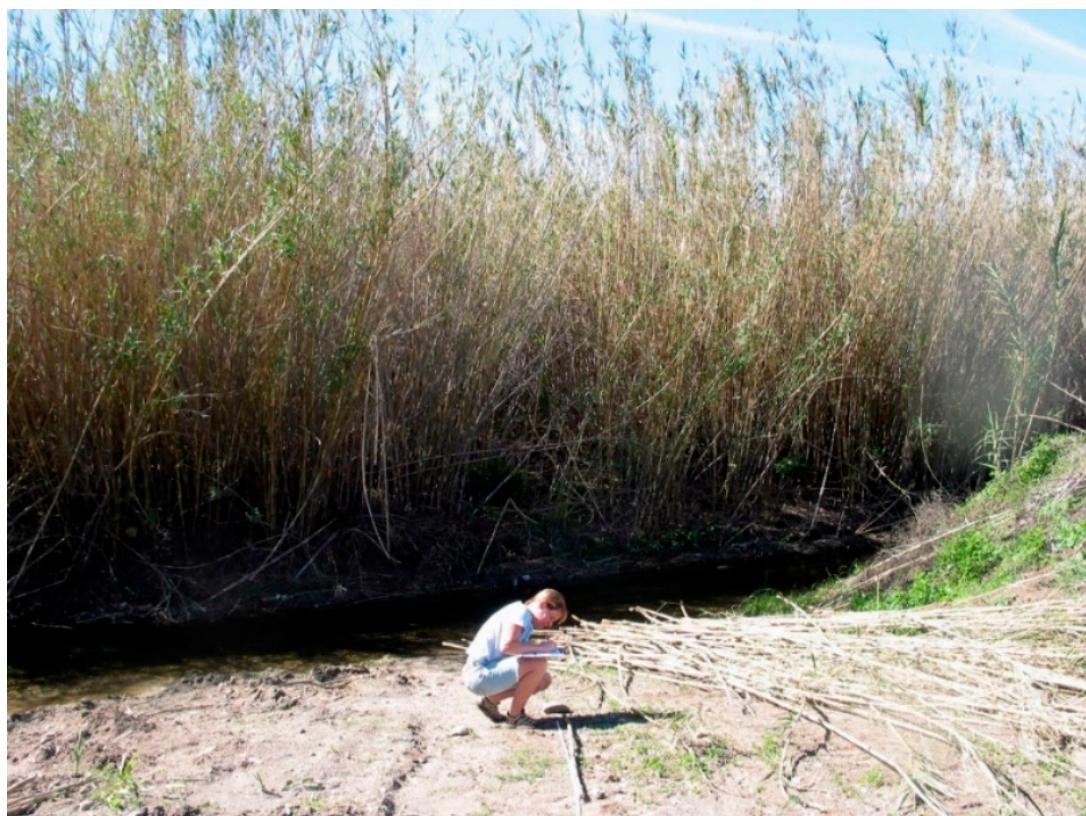
Figure 2. Photograph of *A. donax* in the floodplain of the Santa Clara River at study site S1. Height of plants in this picture exceeds 5 m tall.

Arundo donax is a perennial grass in the family Poaceae, which forms dense, clonal stands that can reach heights of >6 m (Figure 2). *A. donax* is native to tropical and subtropical regions in Europe and Asia but is an invasive, non-native species in Mediterranean climate regions, including California [1]. *A. donax* has spread rapidly during the last 40 years due to anthropogenic disturbances, such as flood control, cultivation of river floodplains and increased wildfire in riparian systems in California [4]. While there has been very little quantification of the depth and sizes of the root-rhizome complex for *A. donax*, it is generally known to produce a massive, shallow (<0.5 m deep) and laterally spreading rhizome [1,3].

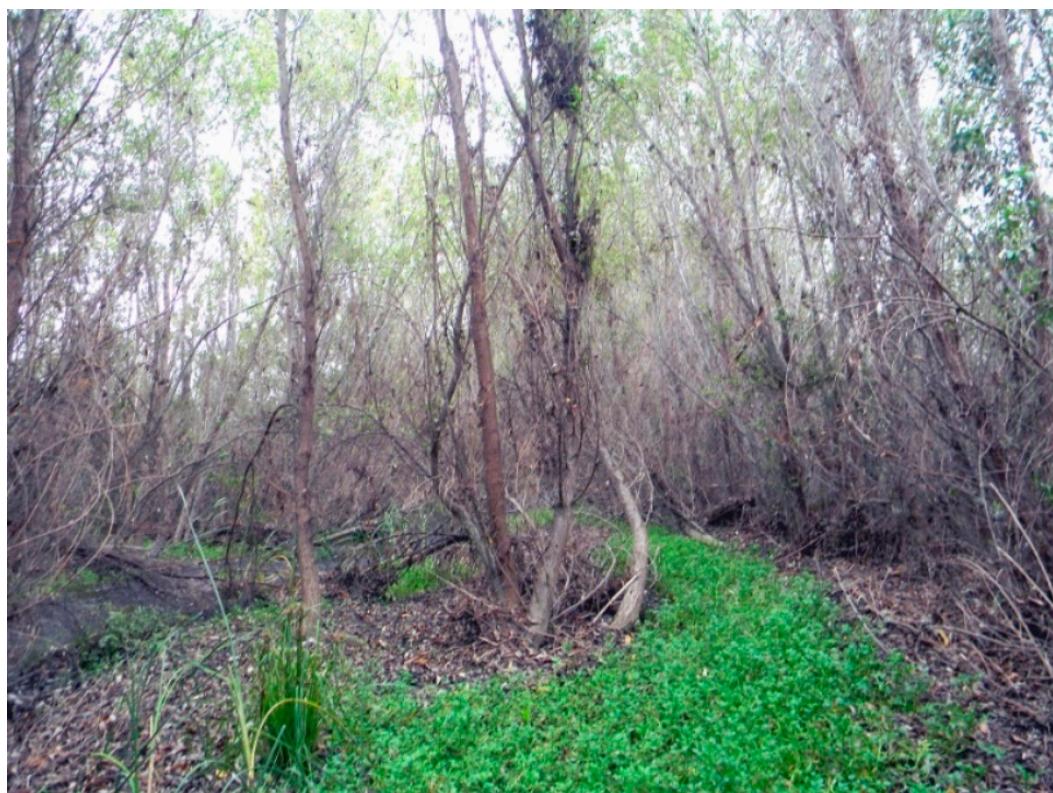
Figure 3. Stand of native vegetation containing *S. laevigata* at study site S2.

The Santa Clara River is the focus of this study because the prominence of *A. donax* (Figure 2): allows for evaluation of channel form changes resulting from Arundo and testing of the hypothesis that *A. donax* alters bank strength characteristics and stability compared to other types of native vegetation, specifically *S. laevigata* (red willow, Figure 3), due to differences in its below-ground architecture.

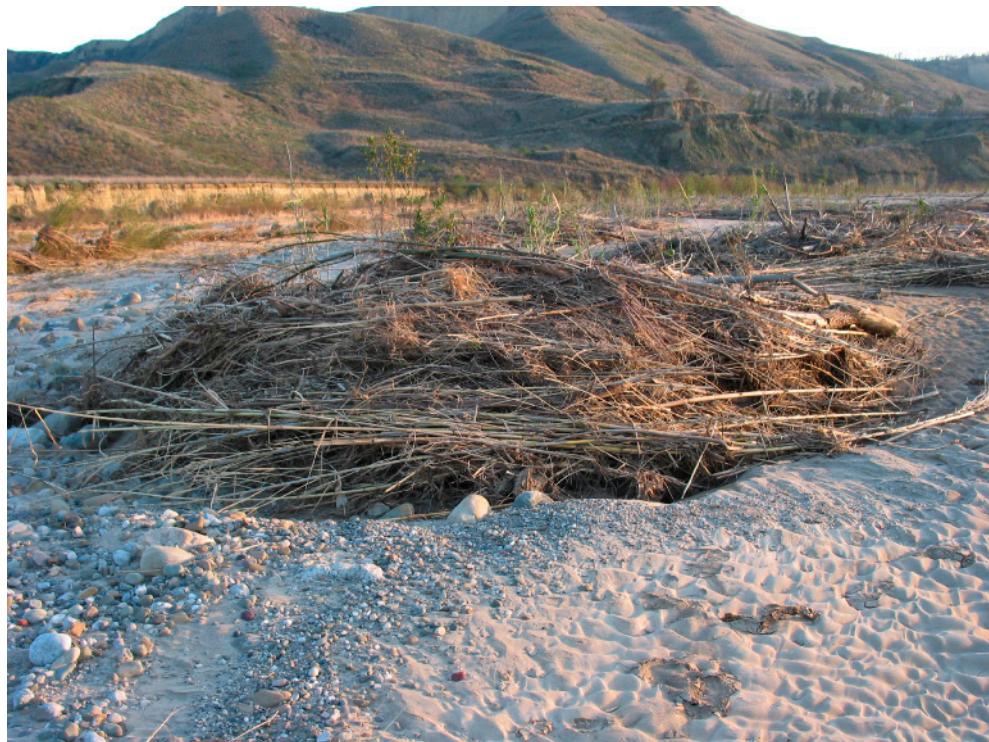
Figure 4. *A. donax* debris wrapped around and defending a small island from erosion in the Santa Clara River (S2) following a flood. The debris may later sprout and further defend the island.

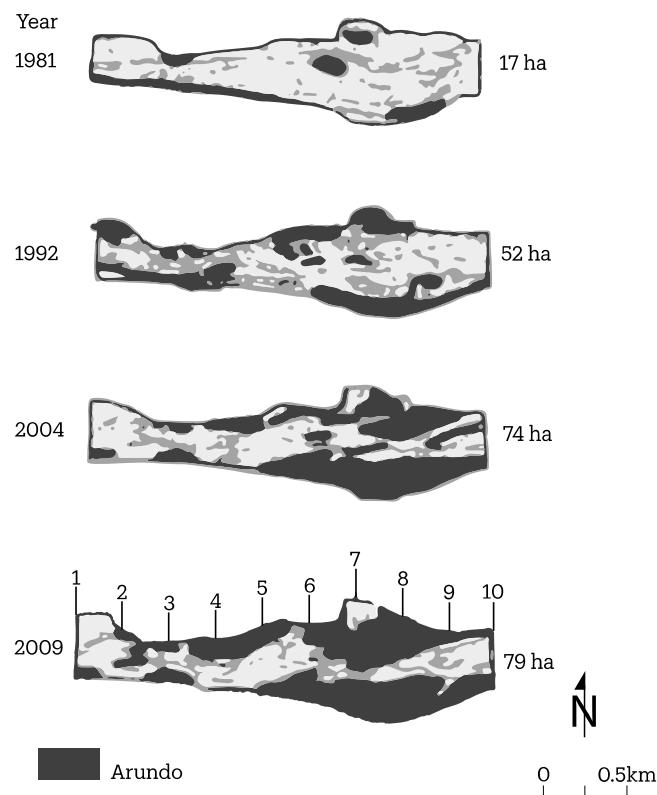
Figure 5. Maximum extent of *Arundo donax* (black) and other vegetation (grey) at site S1 measured from aerial photograph years that represent the maximum amount of time since the last major flood. *A. donax* has increased 350% at a growth rate of 2.2 ha/year. Flow is from right to left. Locations of cross sections where channel characteristics were measured are shown.

The area of *A. donax* increased five-fold at site S1 over the course of 28 years, from 0.17 km^2 to 0.79 km^2 (Figures 5 and 6). Site 1 from cross sections 7–8 on the north bank is the site of a large perennial wetland where significant spring flow occurs, nourishing a large area of *A. donax* as well as *S. laevigata*. Some of the large *S. laevigata* trees have produced islands—like mounds, often surrounded by *A. donax*. At site S2, the amount of *A. donax* has increased four-fold over the course of 15 years from 0.05 km^2 to 0.23 km^2 . In terms of community composition, *A. donax* has displaced native vegetation at each site over two decades of evaluation and by 2009 represented over 50% of the total vegetation present at each site (Figures 5 and 6 and Table 6).

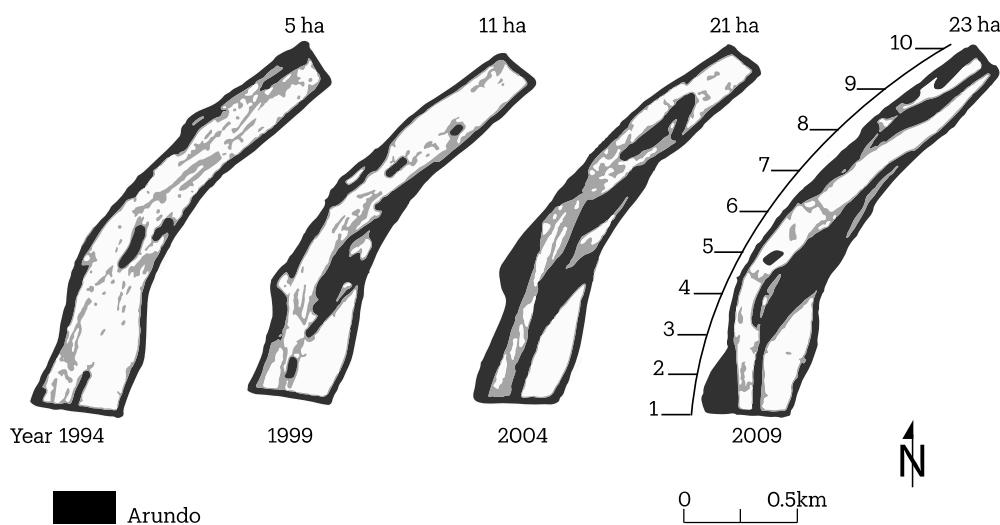
Figure 6. Maximum extent of *Arundo donax* (black) and native vegetation (grey) for site S2 mapped from aerial photograph years that represent the maximum amount of time since the last flood. Flow is from bottom to top. Locations of cross sections where channel characteristics were measured are shown.

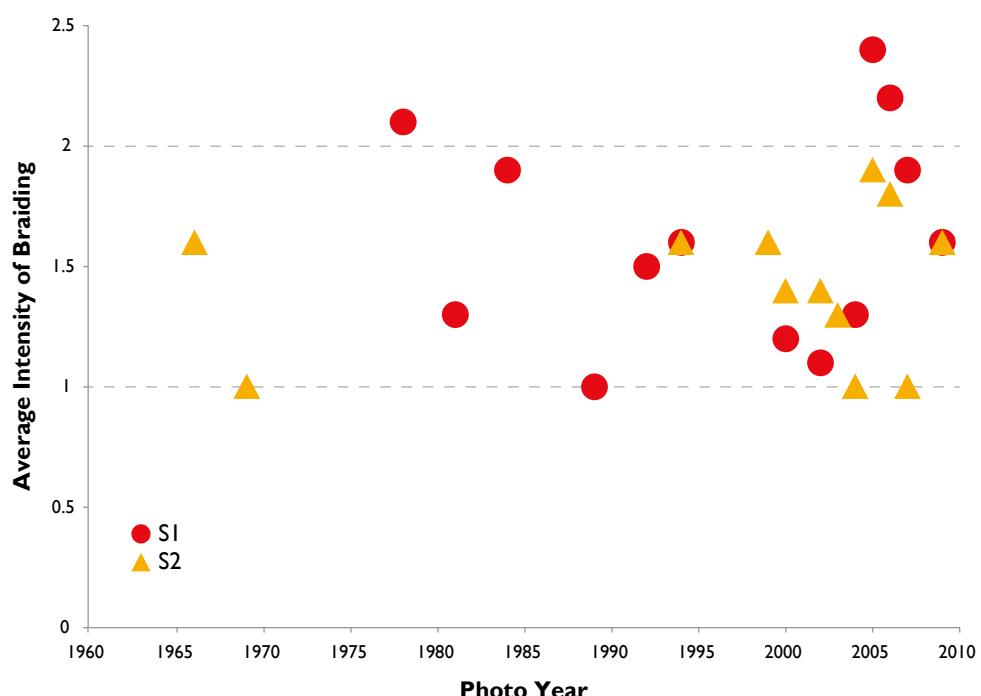
Figure 7. Average intensity of braiding over time for sites S1 and S2. Intensity of braiding is the mean number of channels measured from cross sections (see Figure 1) for a given reach. Dotted lines at $y = 2.0$ and 1.0 show a braiding envelope where most values lie between these points. High magnitude floods occurred at S1 in 1978, 1983, 2005, 2006 and S2 in 1969, 1998 and 2005.

of these channel characteristics over time are shown on Figures 7–9. For both sites, vegetation width and active channel width are related, where increases in vegetation (and, thus, vegetation width) are associated with a decrease in active channel width.

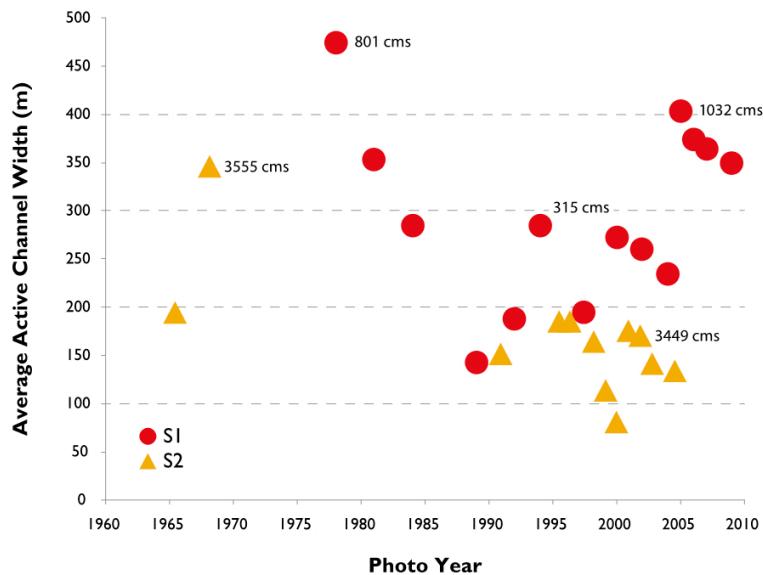
Figure 8. Average active channel width over time for sites S1 and S2. Selected flood discharges are shown.

Measuring change of active channel and vegetation width shows that successive floods of similar magnitude have been less able to widen the channel and the amount of vegetation has increased over time. At site S1, intensity of braiding is highly variable and fluctuates within an envelope of 1–2 channels, except for flood events exceeding 15–20 year recurrence intervals (such as 1978 and 2005, Figure 7). Site 1 experienced decreasing braiding activity with successive flood years until the 2005 flooding event. Site 2 has an incomplete record for years between 1969 and 1994, making it hard to compare against site S1 for which there is a more complete record. However, braiding in this reach is more restricted as the channel is narrower, yet, similar to the S1 site, the 2005 flood event was the highest braiding index value recorded in the series of aerial photographs (Figure 7). Therefore, there is a tendency for the intensity of braiding to increase during large floods, but, over decades (1960s to 2009), the active channel width has decreased as *A. donax* has increased (Figure 8). Vegetation width over time (Figure 9) has generally increased at both sites.

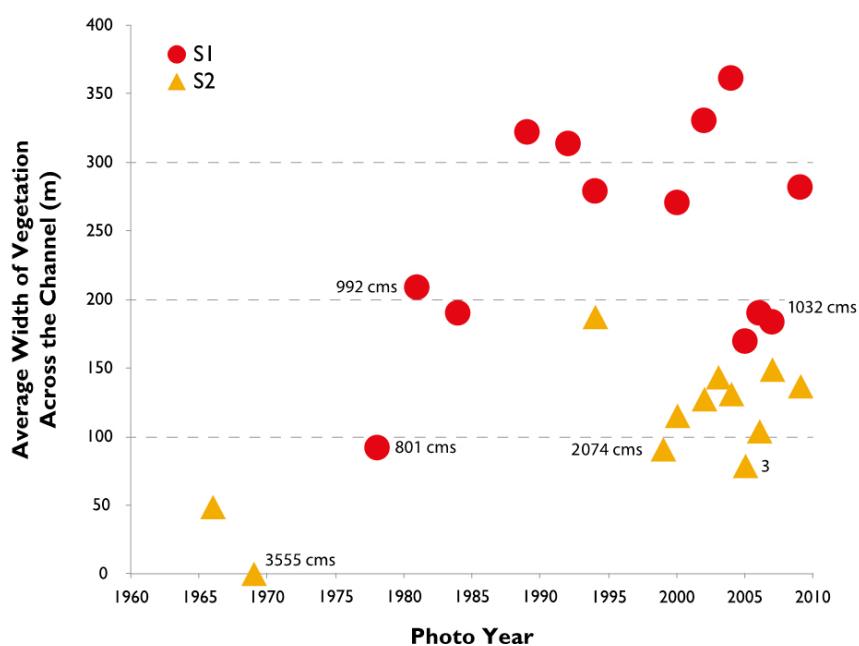
Figure 9. Average vegetation width over time for sites S1 and S2. Selected flood discharges are shown.

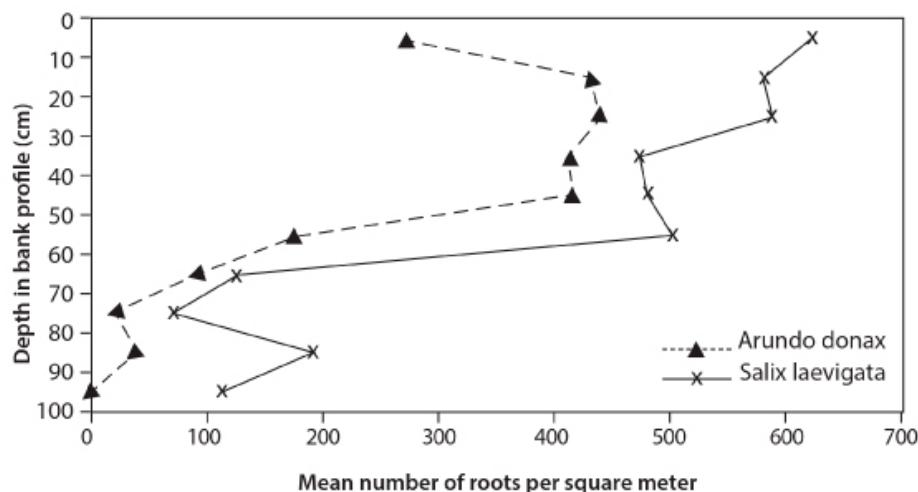
Figure 10. The mean number of roots (per square meter) for *A. donax* and *S. laevigata* at different depths in the bank profile.

Statistical analysis suggests that there is a significant difference between the mean number of roots per meter squared of *A. donax* versus *S. laevigata*. *S. laevigata* has a higher number of roots per unit area at all depths in the soil profile than *A. donax* (Figure 10). However, comparing only roots larger than 10 mm shows a key difference between *A. donax* and *S. laevigata*, with *A. donax* having more large roots per unit area in the top 20 cm of the profile (Figure 11).

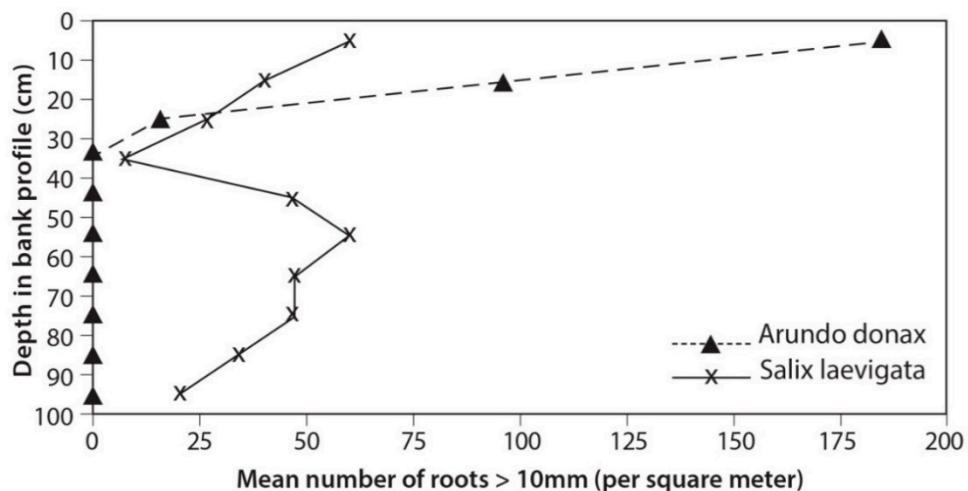
Figure 11. The mean number of roots greater than 10 mm in diameter (per square meter) for *A. donax* and *S. laevigata*.

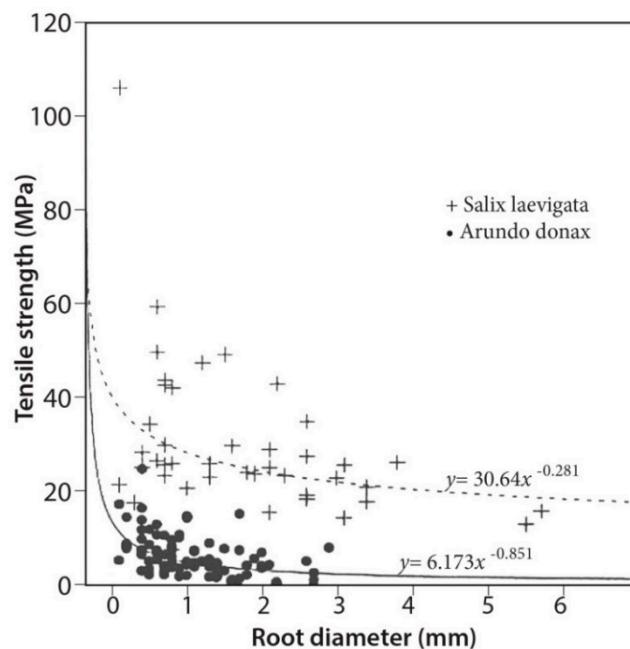
Figure 12. Regression of root diameter (mm) to tensile strength (MPa) for both *A. donax* and *S. laevigata*. *S. laevigata* is the top equation and *A. donax* is the bottom equation.

The regression of tensile strength and diameter is a negative, non-linear power relationship, such that larger roots have less strength per unit area than small roots (Figure 12). These findings are in agreement with those of other studies [24,25,37]. The coefficients of determination for the regression of *A. donax* and *S. laevigata* are 0.24 and 0.17, respectively. These values fall within the range of those found in the literature for other types of riparian vegetation ($0.14 < r^2 < 0.75$; [36]). When compared across the same distribution of sizes, a Kolmogorov-Smirnov test shows that there is a significant difference in the strength between the species, with *S. laevigata* having stronger roots across all sizes than *A. donax*.

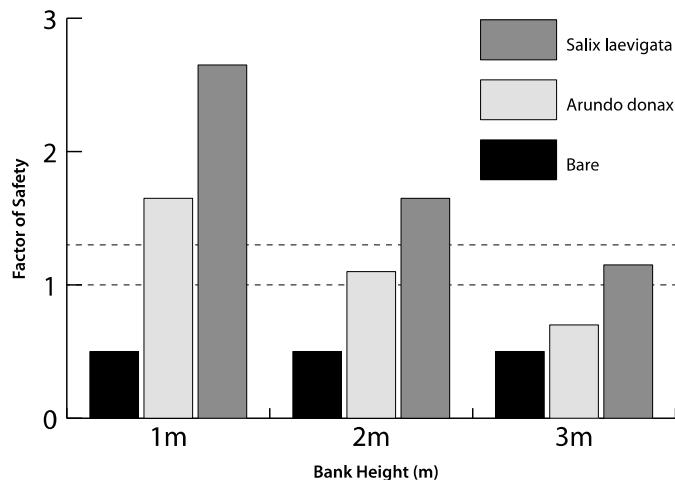
Figure 13. Factor of Safety for a coarse sand bank of 30 degrees, unsaturated conditions with bare bank soils (no vegetation), *A. donax* vegetation, or *S. laevigata* vegetation. Dashed lines at FS 1.0 and 1.3 are critical value when driving and resisting forces are equal (FS = 1) and conditional stability (FS = 1.3).

Experimental modeling bank stability, for coarse sandbanks of variable height, suggests that *S. laevigata*, compared to *A. donax*, increased the factor of safety (FS) by ~60% for banks 1 m high, ~55% for banks 2 m high and ~40% for banks 3 m high. For 3 m high banks, the FS for banks with *Arundo donax* is <1 (Figure 13). Therefore, there may be a decrease in the lateral stability of channels if the mixed riparian forest is transformed from being diverse to becoming a monoculture of *A. donax*.

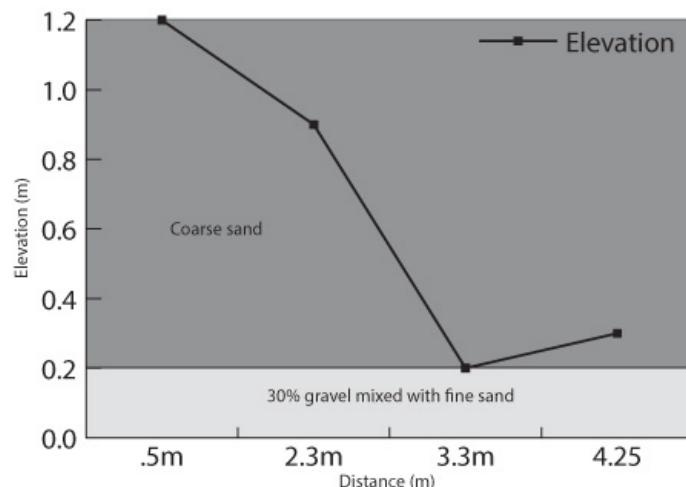
Figure 14. Profile and soils of a surveyed bank on a channel bar in the Santa Clara River measured at site S2.

One bank was characterized at site S2 in the Santa Clara River. The site is on a sand bar in the main channel and analyzed in the bank stability model. The 2-layer bank profile (Figure 14) is composed of fine sand on the toe, a mixture of sand and gravel and then coarse sand up to the top. The results show that, under saturated conditions, *A. donax* creates a factor of safety of 2.4, while *S. laevigata* creates a factor of safety of 6.2.

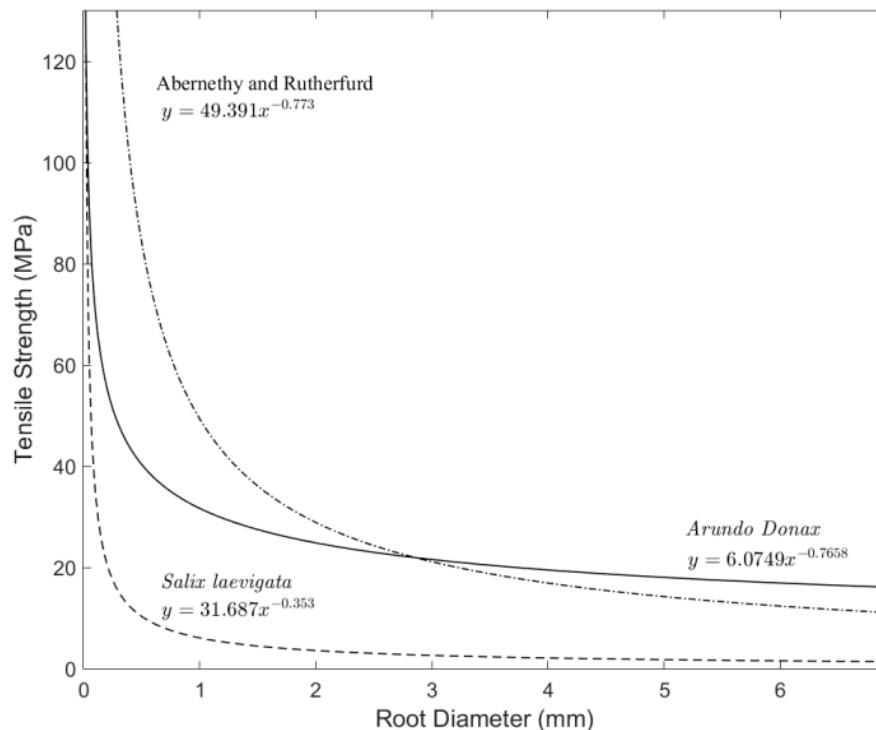
Figure 15. Comparison of tensile strength and root diameter relationship to the relationship found [24] for two large Australian trees, Red River Gum and Swamp Paperbark to those found in this study for *A. donax* and *S. laevigata*.

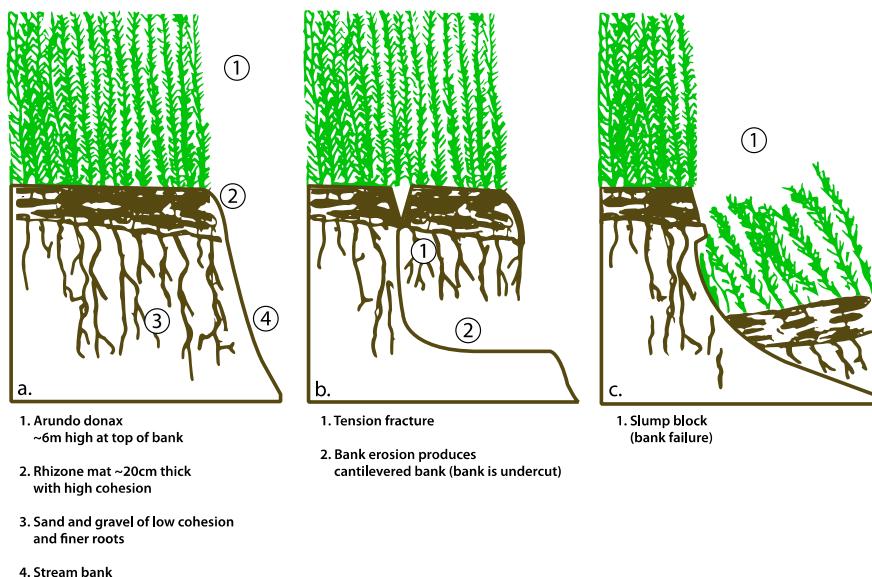
Figure 16. Idealized diagram of how bank failures may develop with channel banks and floodplain dominated by *A. donax*.

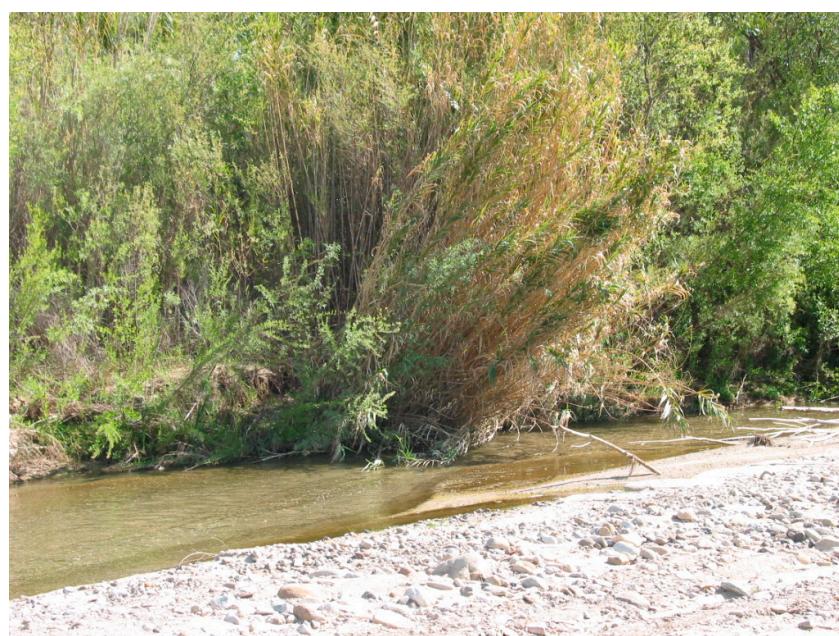
Figure 17. Bank failure: Cantilever bank failure in 2009 (site S1) caused by *A. donax* being undercut below the tough near-surface root system.
