Advances in the Restoration of Buildings with LIDAR Technology and 3D Reconstruction: Forged and Vaults of the Refectory of Santo Domingo de Orihuela (16th Century)

Abstract: This research presents a new intervention methodology on arches and vaults of a Renaissance factory in the Colegio Santo Domingo de Orihuela (16th century) using 3D software LIDAR technology that verifies the execution process of the works studying the different charges states and structure behavior. This document aims to explain a working methodology in the monitoring of structural repair interventions in the architectural heritage, in the specific case of the replacement of traditional one-way timber joist frame slabs on structures of former, splay and groin arches between vaults. This involves the compilation and processing of two types of data: on the one hand, the analysis of the different load states to which the intervention is exposed in its different phases: initial, dismantling of the different layers of traditional construction and replacement by the new structural system; and, on the other hand, the graphic information provided by the photogrammetry techniques used to dimension and define the spat

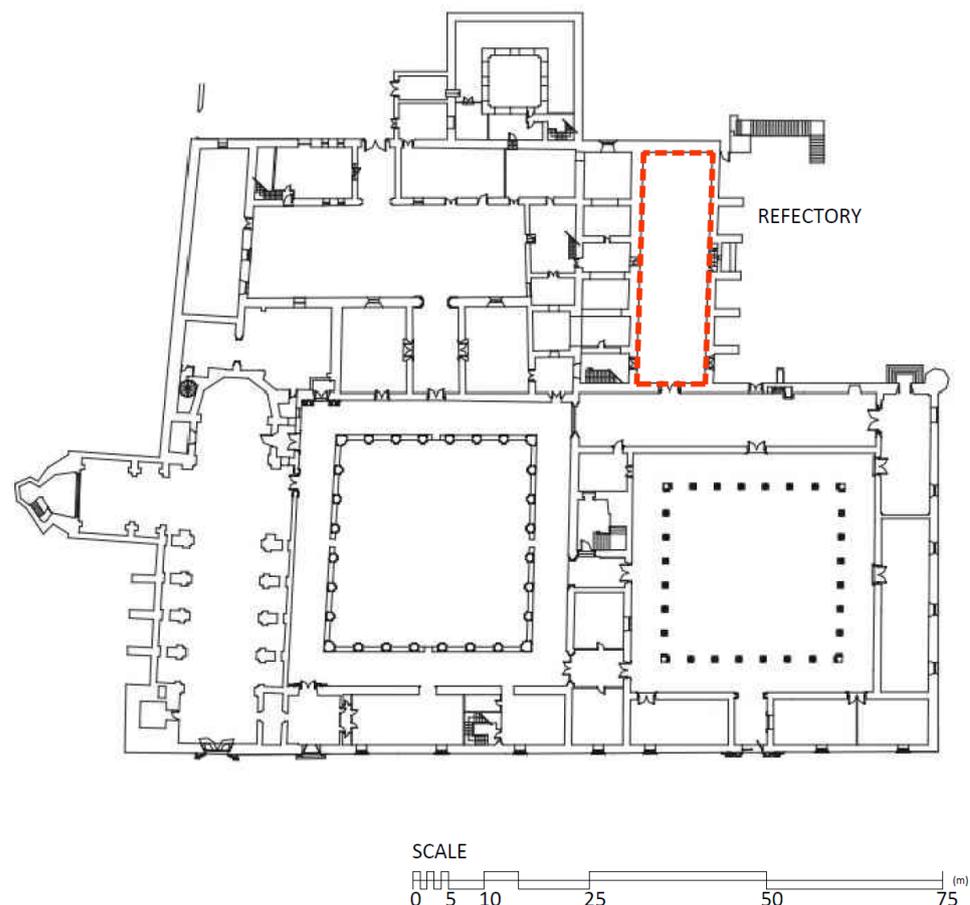
Figure 1. Floor plan of Santo Domingo de Orihuela.

The Santo Domingo School in Orihuela is one of the most important 16th century architectural complexes in the Valencian Community, both for its layout and for the quality of its execution. Located between Adolfo Clavarana street and the city's Sierra, it has a built surface area of 21,000 m². The building was designed by the architect Jerónimo Quijano in 1552 and 3 of the 4 parts of the original plans and "traces" have been preserved, with the area where the Refectory is located today being precisely missing. The architect Juan Inglés directed the works at Santo Domingo from 1566, after Quijano's death, designing and building the famous staircase that forms part of the complex (Figure 1).

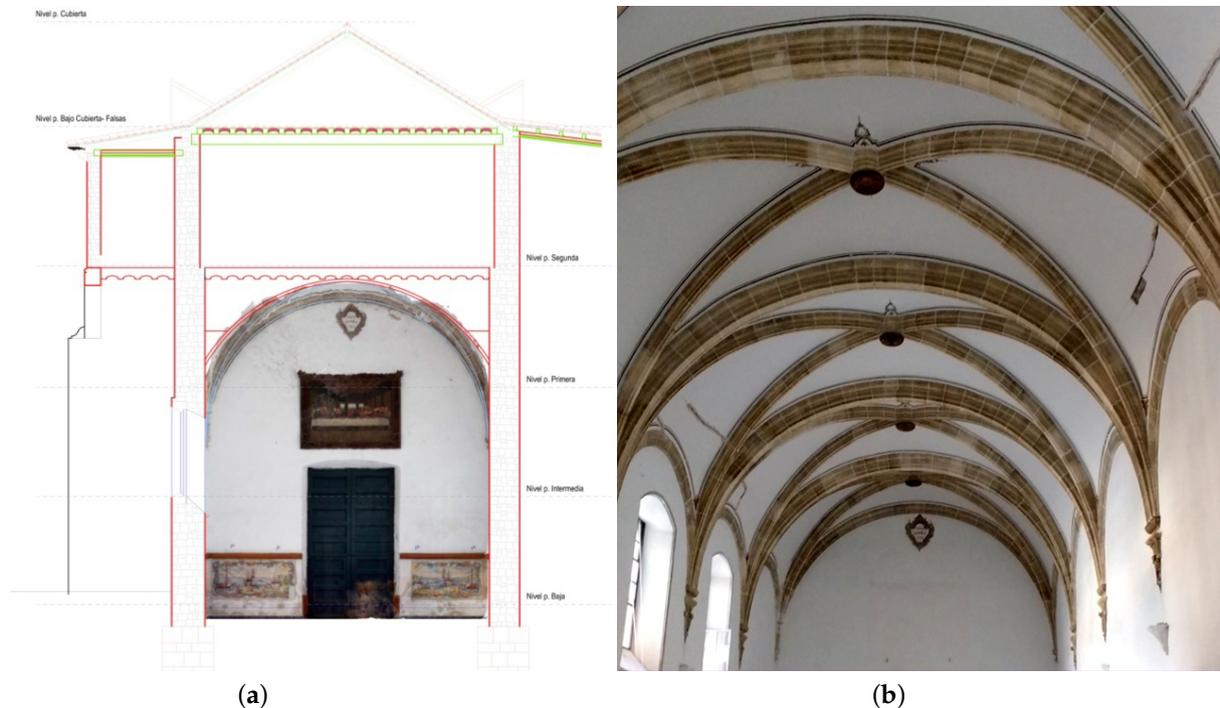
Figure 2. The spatial distribution of arches and vaults in the refectory area. (a) the sketch of vertical cross-section (b) vaults directional arrangement.

The refectory is covered by a ribbed vault with semicircular arches that span the width of the nave and former arches on both longitudinal walls. The north side is finished off with a flared semicircular arch, with geometrical coffers in deviation. The refectory contains a plinth of 18th century Valencian tiles (Manises) that must be protected as an element of great value that forms part of this architectural space.

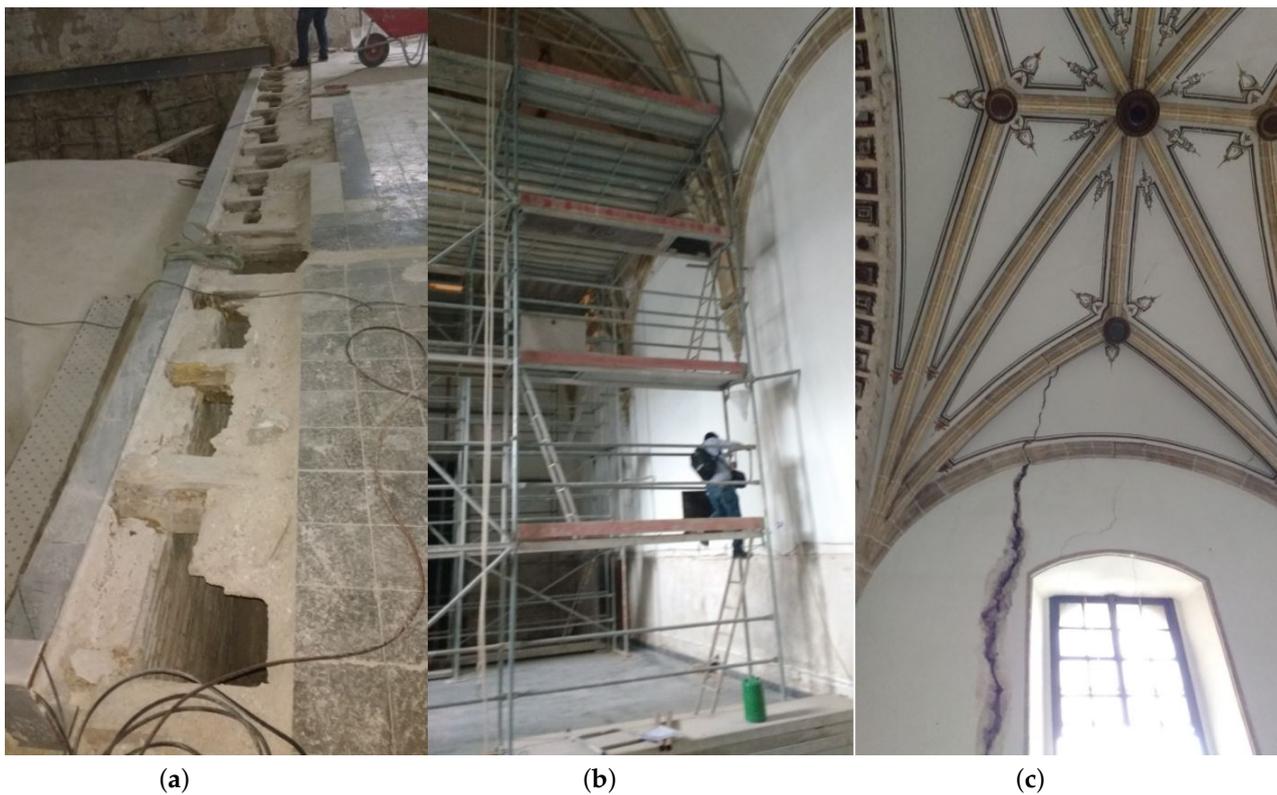
Figure 3. Construction process in the restoration. (a) Original slab floor with horizontal wood joists (b) Falsework for stability guarantee in the works (c) the active vertical fracture along wall and vaults disturb stability of the study complex that must be consolidated.

2. Prior to the demolition work on the floor slabs resting on semicircular arches, false-work has been installed to ensure the safety and stability of the vaults and arches;

5. In the exterior lateral area, adjacent to the refectory, on the buttresses, there are reinforced concrete joist-beam slabs built in situ. All of them are tied perimetrically by means of reinforced concrete strapping and metal profiles, with the aim of organising a perimeter framework tying all the floor slabs both on the arches and on the walls that delimit it (Figures 3 and 4).

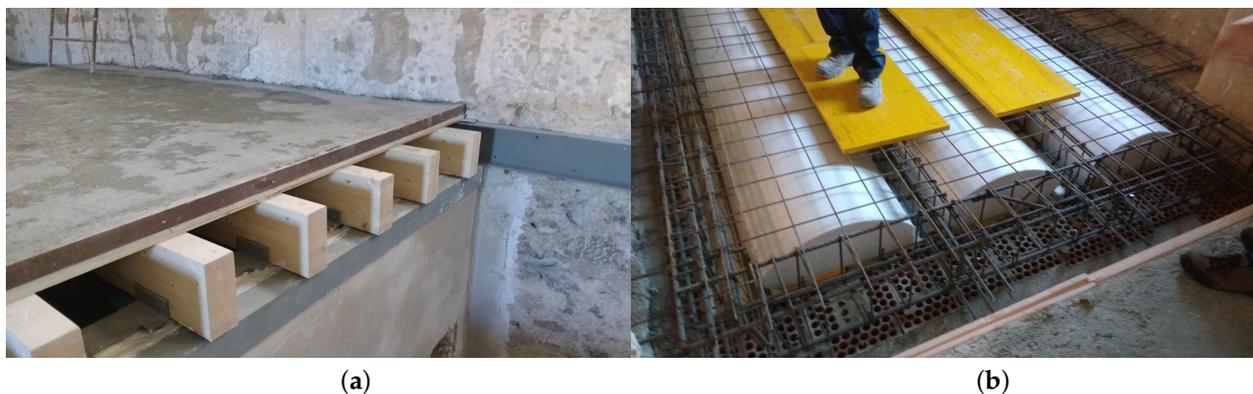
Figure 4. (a): Slabs using laminated wood beams. (b): Joists-beam concrete slab built in situ.

4. Subsequently, the new horizontal frameworks of the second floor (floor slab over the refectory) with one-way floor slabs using laminated wood beams with a double waterproof board beam and a compression layer of 8 cm thick lightened concrete, reinforced with electro-welded mesh, were installed;

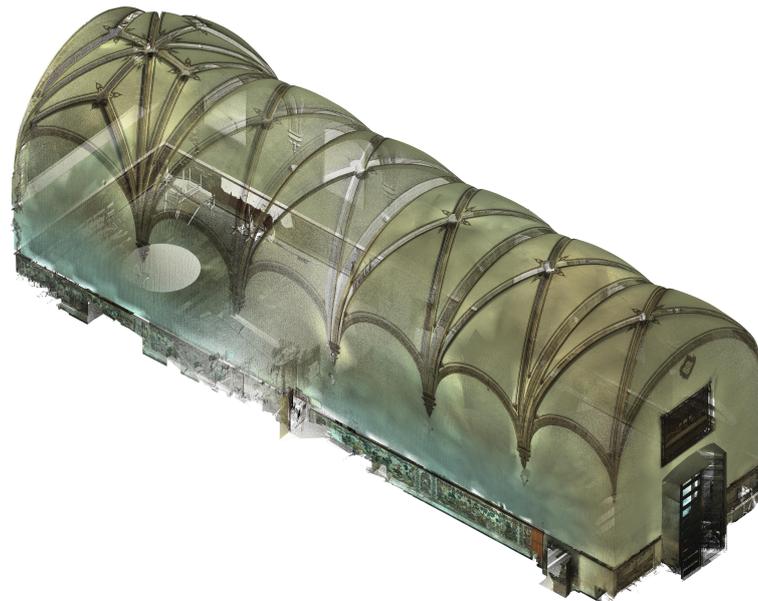
Figure 5. Top axonometric view of the geometrical vaults arrangement.

On the other hand, SfM photogrammetry [27,28] is employed, with digital photography by taking photographs using a Canon EOS 600D SLR camera with a Canon EF-S 18–55mm standard lens. The photographs were processed using Photoscan software and metashape [29–34] (Figure 5).

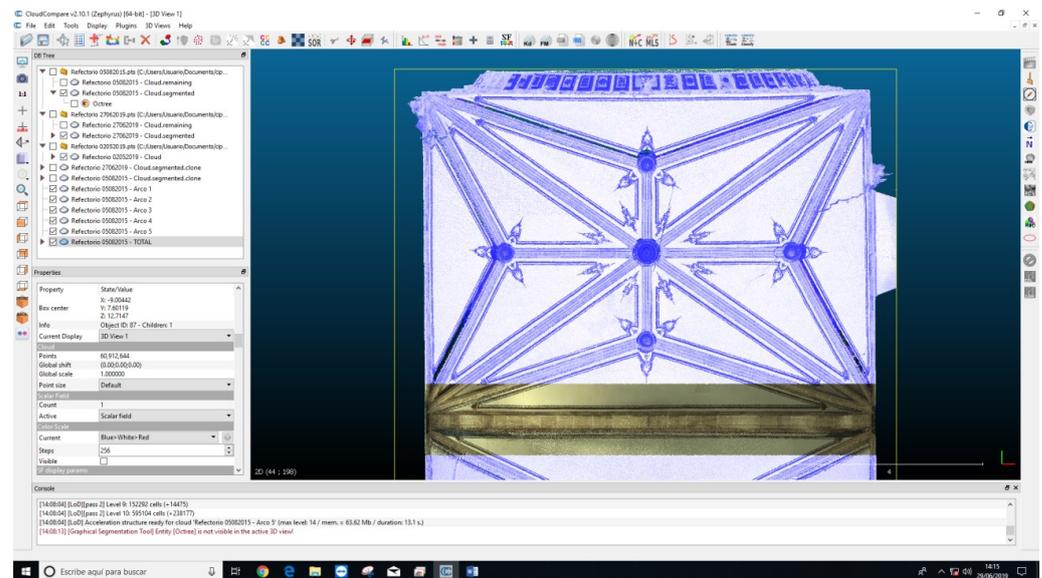
Figure 6. Strip corresponding to one arches studied with CloudCompare V2.10.1 software.

Data collection with the Laica Scan Station C10 Laser Scanner was carried out at different times, before the start of the works (2015) and after completion of the works (2019), choosing a position centred in the Refectory on a tripod, so that the scanning distances were, at most, of the order of 15 m. The intermediate state of the works was recorded with six locations on different dates (2018 and 2019) given that the demolition and reconstruction process took place in different phases, each one corresponding to each span (five arches and six vaults). Similarly, and coinciding with the days on which it was scanned, the state of the work was also recorded with the Canon 600D SLR digital camera. Using the Cyclone Leica software for cloud recording and 3DReshaper for cloud analysis and deformation control, the point cloud obtained from the different scans was processed, and above all, the “Cloudcompare” software was used to analyse the data from the different states of the work, taking certain characteristic points as a reference, and carrying out verification tests so that the distances between them were constant in the stages compared. After taking the data by means of on-site scanning, the point clouds and the images were made compatible using Photoscan and Metashape software, in order to visualise them using orthophotos, which can be scaled based on the measurements obtained from the point cloud; in all cases, photogrammetric work was carried out in which each image coincided at least 50% with the previous one, defining characteristic points (which remain invariable throughout the construction process) in such a way that the key points can be recognised from the image to the point cloud, obtaining all the graphic data that record the process. Once the definitive positions of the compared point clouds had been defined, and with the same reference coordinate system, the data were exported to AutoCAD files. Finally, the data of the analysed points are transferred from Cloudcompare to AutoCAD, showing the x , y coordinates of each of the compared points. The point cloud was divided by means of strips parallel to the segmental arches to make a section on the axis of each of

them (Figure 6). The arches are made of limestone voussoirs whose surface is the result of the original tiling work (without facing), so that the data obtained in the scan reflects small irregularities resulting from the stone micro-grains that generate an envelope with small jumps between the points (Figure 7). The process implies an error in the measurements that can be estimated to be in the order of 2 mm (distance between the scanning points and irregularities of the sectioned surface), so it can be considered acceptable as we are in a range of measurements of less than 1/1000 of the span of the arc.

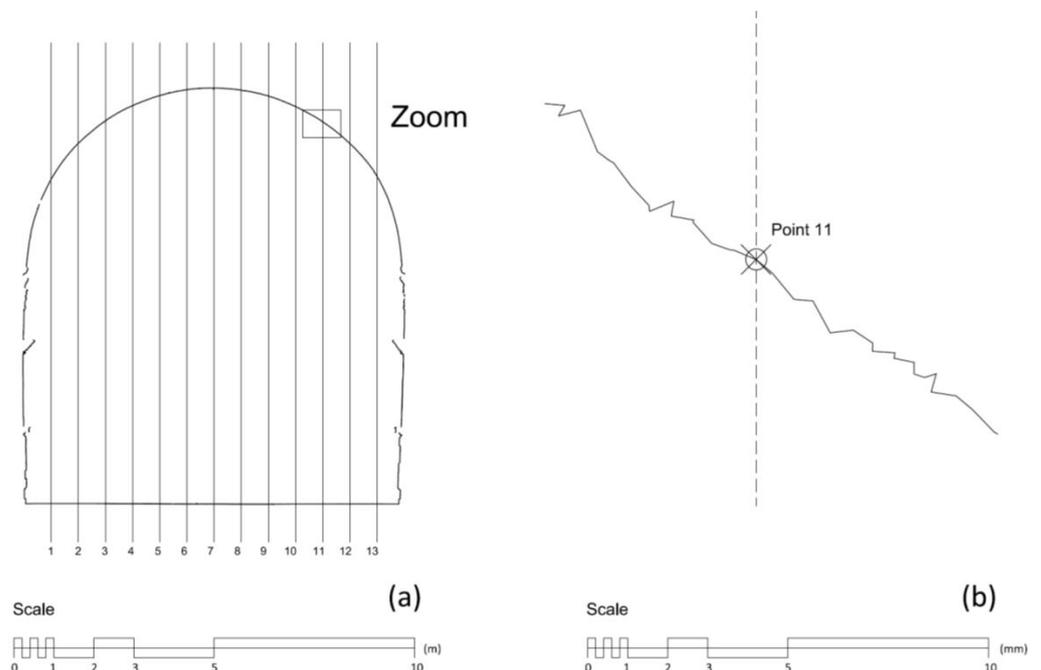
Figure 7. Graphic representation of standard arch coordinates points offered in Table 4 (a) the arch is divided in 14 equidistant sections including the key (b) a point zoom of the lower arch path to obtain the coordinates (x,y) with the AutoCad program.

The coordinates (height) of each of the points observed in the comparison of the 5 arches analysed before (2015) and after (2019) the works are shown below (Table 4 and Figure 7). Having established the position of a certain point (always the same) in each of the keys clearly referenced to another point fixed in the space of the refectory and without any possibility of movement, in order to take the measurements that register the possible differential movements in three-dimensional coordinates of one stage with respect to the other.

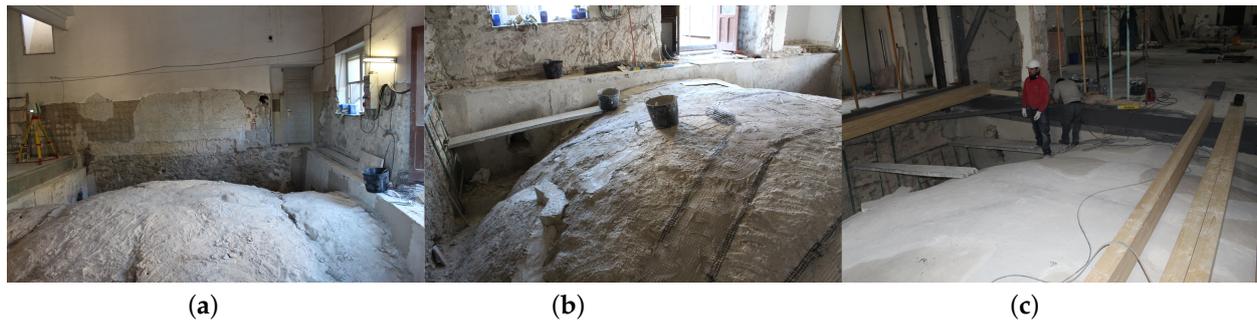
Figure 8. Principal vault extrados on its different restoration states: (a) Original (b) Reinforcement application on nerves (c) Finished.

At this stage, the moment analysed collects the information at the moment when the partition walls, floors, and ceramic revolts have been demolished and the wooden joists have been removed, so that the floor slab has disappeared. We can consider that this is the moment when the structure formed by arches and vaults is unloaded and only subjected to its own weight (Figure 8).

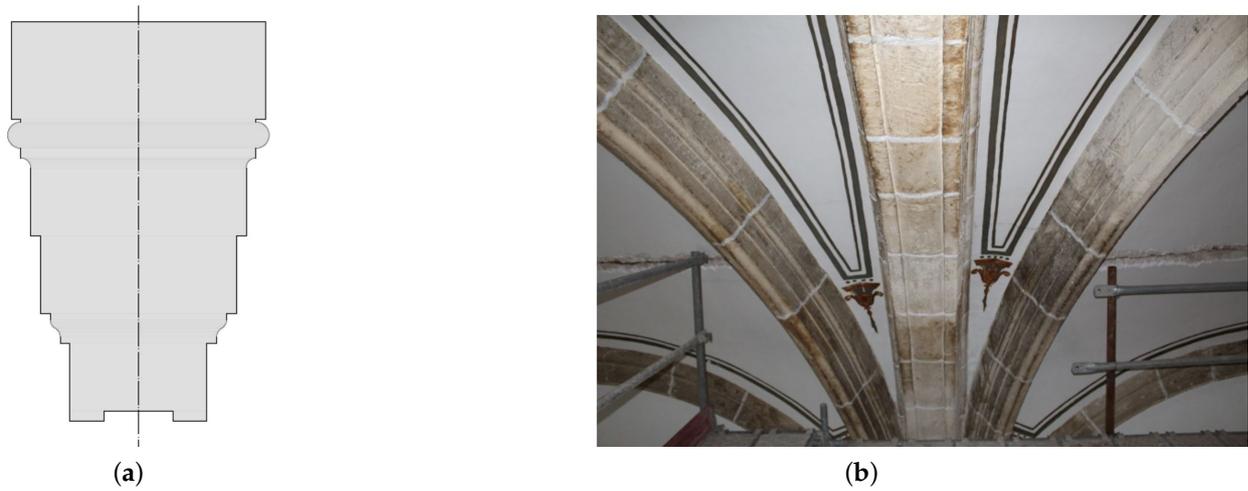
Figure 9. (a): Typical cross-section of the transverse arches. (b): transverse and diagonal arches (in addition to the former arches).

- **Self-weight of the rib-arches** made of limestone with a cross-section of approximately $0.20 \text{ m} \times 0.40 \text{ m}$ would have a uniformly distributed linear load of $Q_{\text{rib-arches}} = 0.20 \text{ m} \times 0.40 \text{ m} \times 28 \text{ KN/m}^3 = 2.24 \text{ KN/m}$, considered constant over the entire arch (Figure 9);

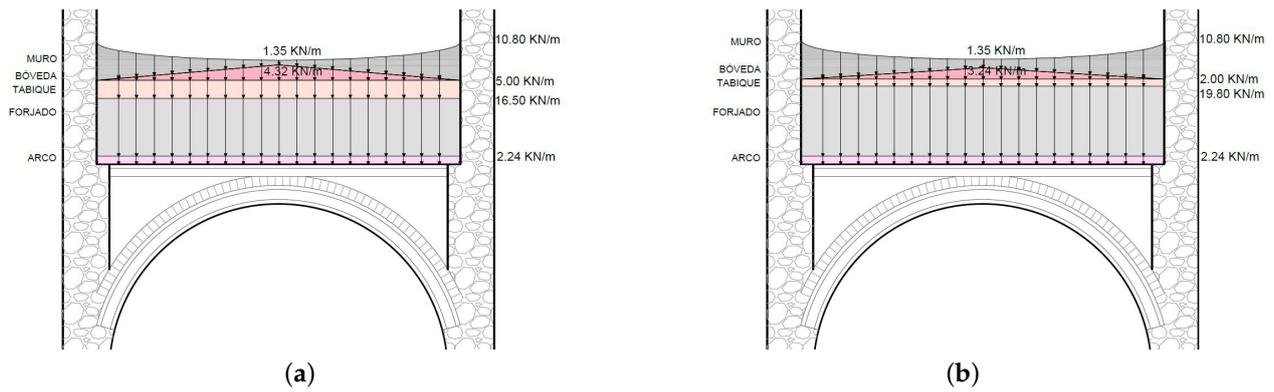
Figure 10. Initial state force diagram (a): arcs 1, 2, 3, and 4; (b) arc 5.

In the first phase, the state of charge results about original materials and elements (Table 1, Figure 10):

Arches Initial State (STAGE 1)	Loads KN/m	Arc KN/m	Floor slab KN/m	Partition KN/m	Vault KN/m	Wall KN/m	Total Load KN/m
Arches 1-2-3-4	Q_k	2.24	16.5	5.00	4.32	1.35	29.41
	Q_s	2.24	16.5	5.00	-	10.8	34.54
Arc 5	Q_k	2.24	19.8	2.00	3.24	1.35	28.63
	Q_s	2.24	19.8	2.00	-	10.8	34.84

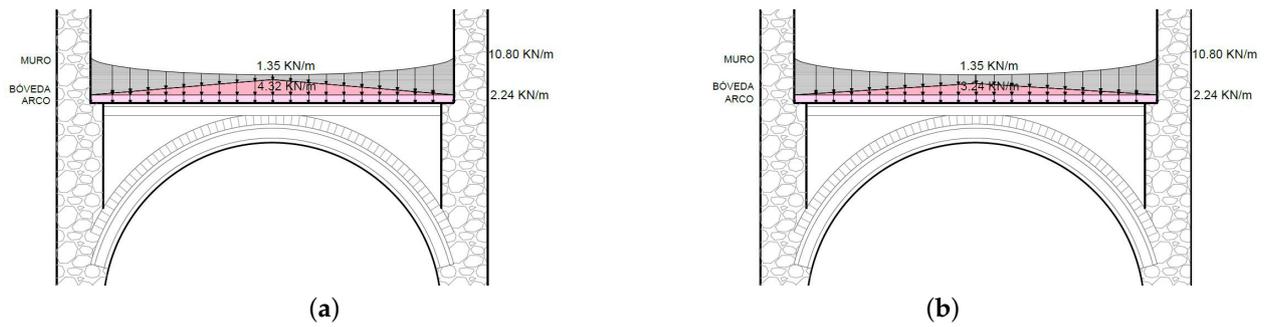
Figure 11. Force diagram of the intermediate state (a): arcs 1, 2, 3, and 4; (b): arc 5.

In the second phase considered, the initial slab and the partition walls have been demolished, and, therefore, the load state will correspond to the sum of the own weights of arches, walls over arches, and vaults (Table 2, Figure 11).

Arches Initial State (STAGE 2)	Loads KN/m	Arc KN/m	Floor slab KN/m	Partition KN/m	Vault KN/m	Wall KN/m	Total Load KN/m
Arches 1-2-3-4	Q_k	2.24	-	-	4.32	1.35	7.91
	Q_s	2.24	-	-	-	10.8	13.04
Arc 5	Q_k	2.24	-	-	3.24	1.35	6.83
	Q_s	2.24	-	-	-	10.8	13.04

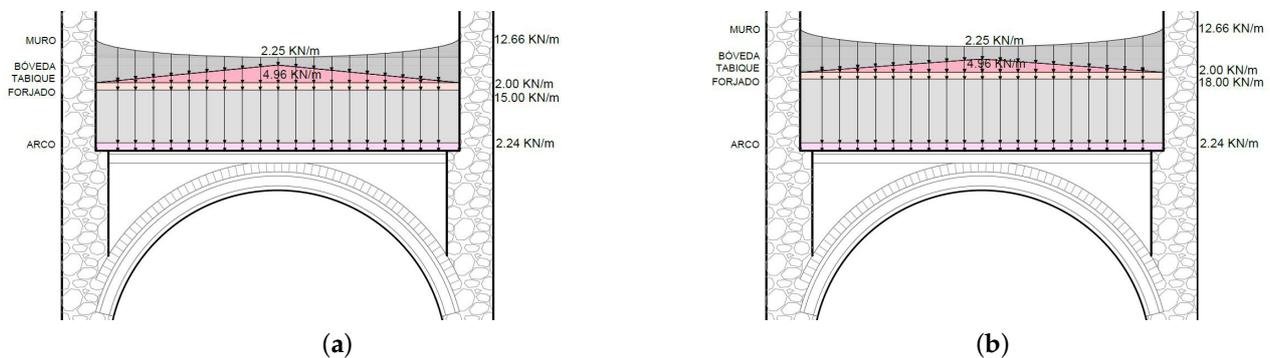
Figure 12. Final state force diagram (a): arcs 1, 2, 3, and 4; (b): arc 5.

In the third phase, the definitive state of the loads will be the weight of the new slab and its paving and the reinforcement based on a 2 L 140 metal section as the top of the one-foot wall above the transverse arches. In addition, the reinforcements on vaults and walls are considered (Table 3, Figure 12).

Arches Initial State (STAGE 3)	Loads KN/m	Arc KN/m	Floor slab KN/m	Partition KN/m	Vault KN/m	Wall KN/m	Total Load KN/m
Arches 1-2-3-4	Q_k	2.24	15.00	2.00	4.96	2.25	26.45
	Q_s	2.24	15.00	2.00	-	12.66	31.90
Arc 5	Q_k	2.24	18.00	2.00	3.72	2.25	28.21
	Q_s	2.24	18.00	2.00	-	12.66	34.90

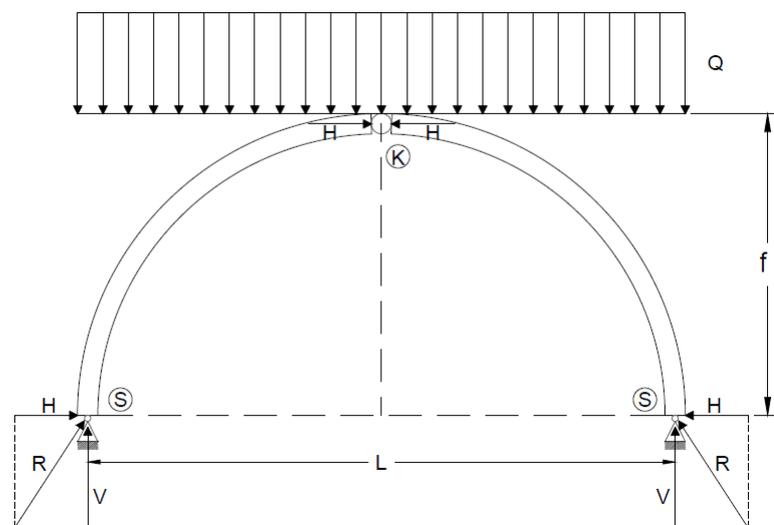
Figure 13. Tri-articulated isostatic arch. Graphical sketch of tri-articulated isostatic arch. (S= salmer, support stone; K= keystone; L= light of the arch; H= horizontal reaction; V=vertical reaction; R= Resultant reaction; Q= linear distributed load; f= deflection of the arch).

Considering the arch as a tri-articulated isostatic structure (Figure 13), we can calculate the support reactions from the three equations of plane statics [39–41].

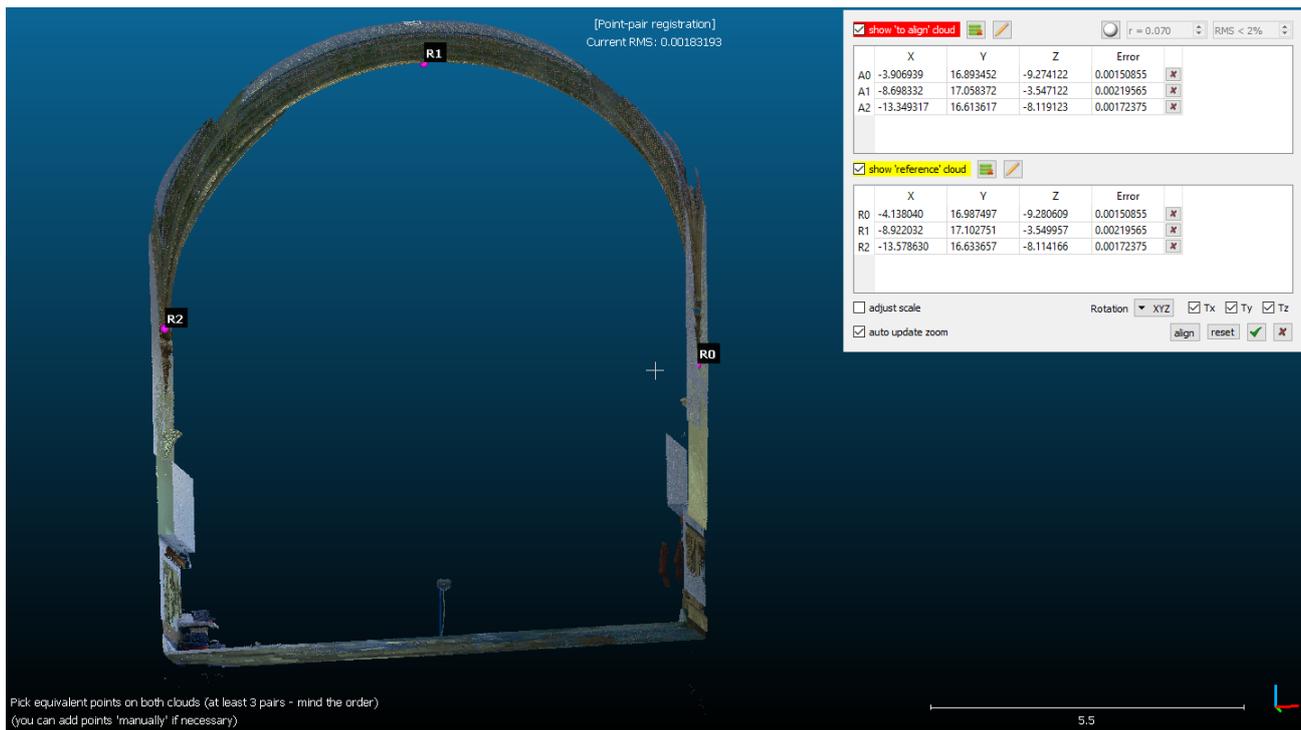
Figure 14. The ordinates are obtained, at least, with 3 fixed reference points (R_0 , R_1 , R_2) in the arches studied with CloudCompare software.

Throughout the process described in the three stages considered, the graphic documentation of the arches has been recorded, based on the point clouds obtained at the beginning (Stage 1) and at the end of the works (Stage 3). In the intermediate stage (Stage 2), the soffits of arches and vaults were found with falsework guaranteeing their stability in the demolition phase (only the soffit was scanned), representing the elevations obtained in each of the cases and with the means and techniques already mentioned (Figure 14):

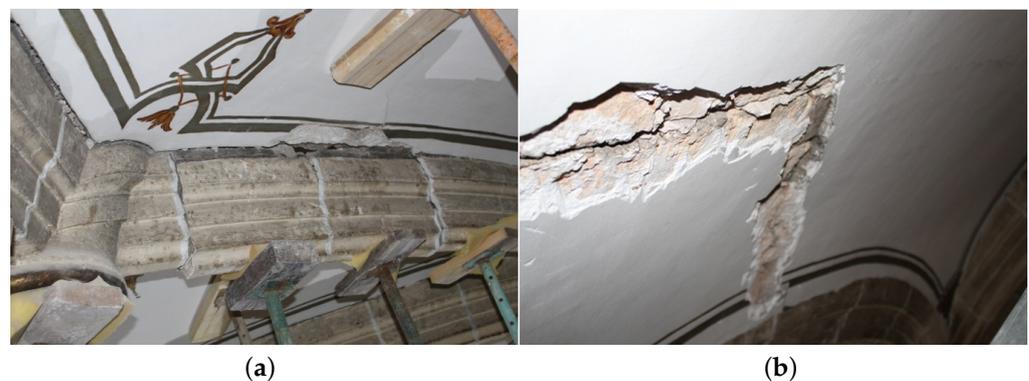
Figure 15. (a): Downturned voussoirs of diagonal arches. (b): Deformations and cracks in vaults.

Movements have been observed both in the vaults and in the diagonal rib arches, and some cracks and displacements of construction elements have been observed, even some detachments in fragments of vaults; information that was already included in the Master Plan of the Santo Domingo School: "it has been observed that the upper slab is occasionally supported by pilasters on the vault's backside...", but these movements have not affected the transverse arches studied (Figure 15).

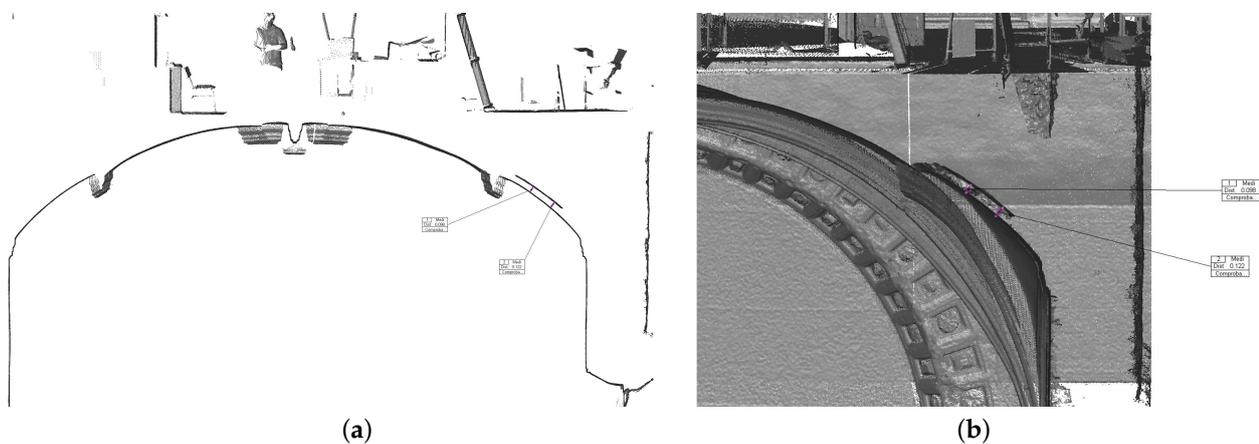
Figure 16. Point cloud section during the restoration works. (a) The measure of the vault section can be obtained. (b) In detail.
