# Experimental Study on the Behavior of Existing Reinforced Concrete Multi-Column Piers under Earthquake Loading

**Citation:** Kim, J.H.; Kim, I.-H.; Lee, J.H. Experimental Study on the Behavior of Existing Reinforced Concrete Multi-Column Piers under Earthquake Loading. *Appl. Sci.* **2021**, *11*, 2652. <https://doi.org/10.3390/app11062652>

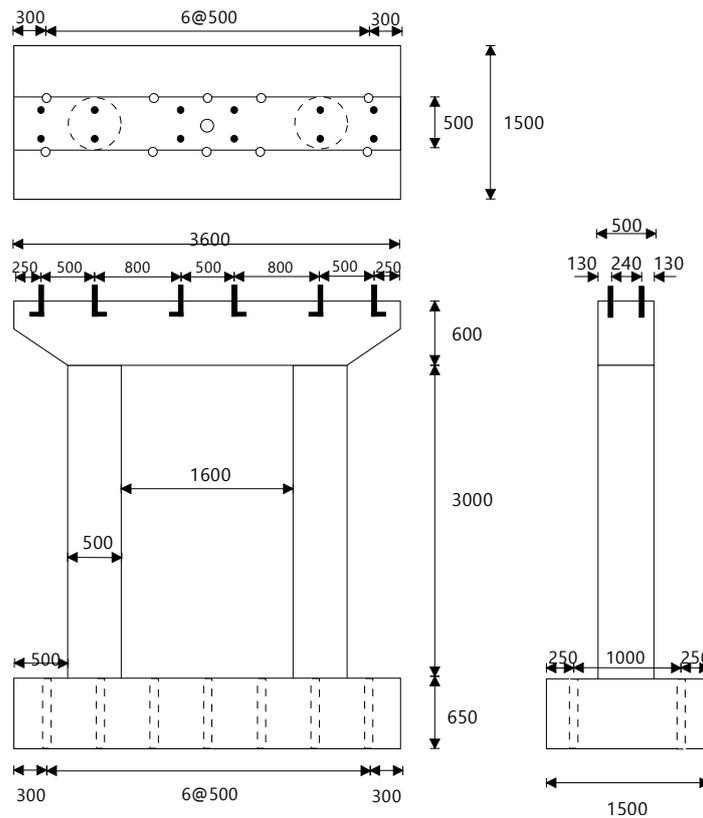
Figure 1. Geometry of the test specimen (units: mm).

Three sets of test specimens were constructed. They were designed to be one-fourth-scale models of the existing two-column piers on Korean highways. The height of prototype is determined to be 12 m to induce flexural failure for transverse direction loading. The diameter of the column section of scale model is 500 mm and the height is 3000 mm. In the case of the scale model, reinforcement with a diameter of 10 mm was used for the longitudinal reinforcement due to the limitations of size of commercial reinforcement bar. Instead, the reinforcement bar ratio was the same for the full-scale model and the one-fourth-scale model as 1.174%. For the lateral reinforcement, a reinforcement bar with a diameter of 4 mm was fabricated. The concrete strength was 24 MPa, which is the same value applied to the prototype model. Therefore, it is judged that the Young's modulus as determined by the concrete strength was similar between the scale model and prototype. However, the geometrical mix design of the concrete could not be properly scaled because of commercial concrete limitations. The properties of the test specimens are summarized in Table 1, and Figure 1 illustrates the geometry of the test specimen.

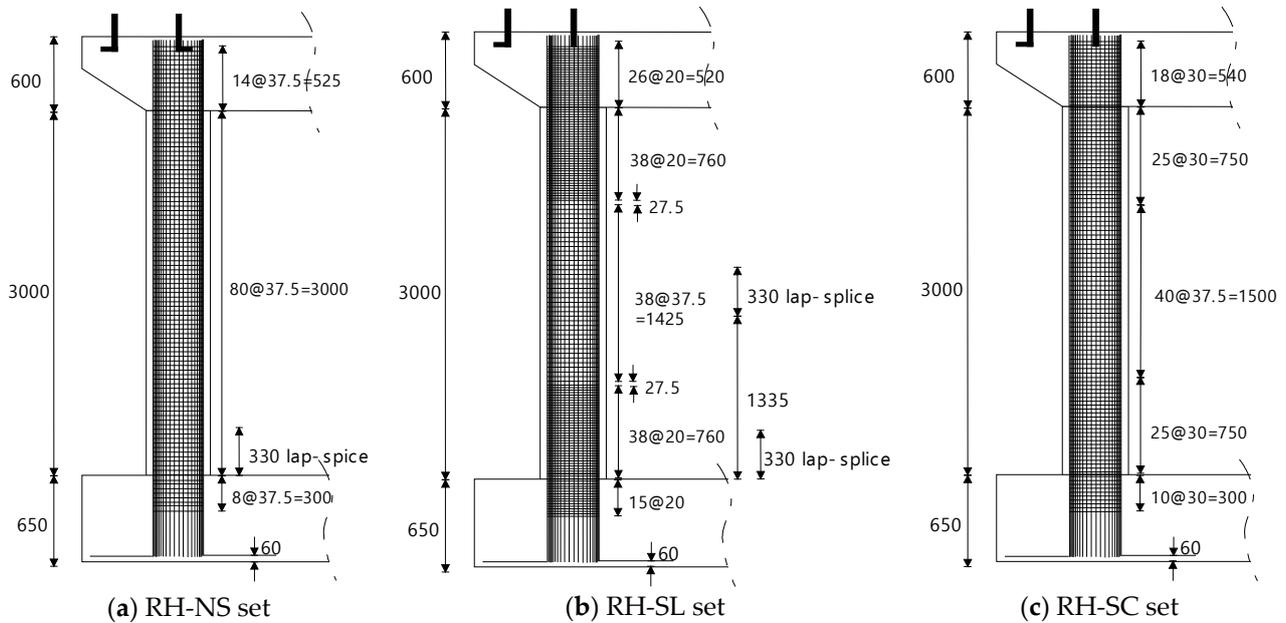
Figure 2. Reinforcement details (unit: mm).

The reinforcement details for each set are shown in Figure 2. Each specimen of the RH-NS set was designed as a prototype without any consideration of seismic performance.

For the RH-SL set, the volumetric transverse reinforcement ratio for this set is 50% of what is required by AASHTO (American association of state highway and transportation officials) specifications [28]. The volumetric transverse reinforcement ratio is defined as the ratio of the volume of the transverse reinforcing bar to the volume of the concrete confined by it. In case of the RH-SC set, minimum lateral reinforcement was used to prevent the local buckling of the longitudinal reinforcement.

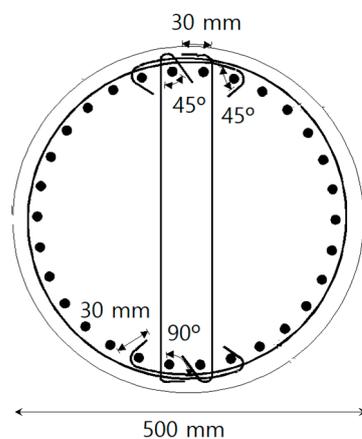
Figure 3. Transverse reinforcement details with hook.

The volumetric transverse reinforcement ratio was 0.268% for the RH-NS set. For the RH-SL set and the RH-SC set, the volumetric transverse reinforcement ratio in the lower and higher regions was 0.503% and 0.335%, respectively. The volumetric transverse reinforcement for these sets was 0.268% except for these regions. For the lateral confinement, two bars of semicircle were used with 135-degree hooks and augmented with two cross ties with a 135-degree hook and a 90-degree hook, as in Figure 3. The cross ties were used in the longitudinal direction and the transverse direction in turns.

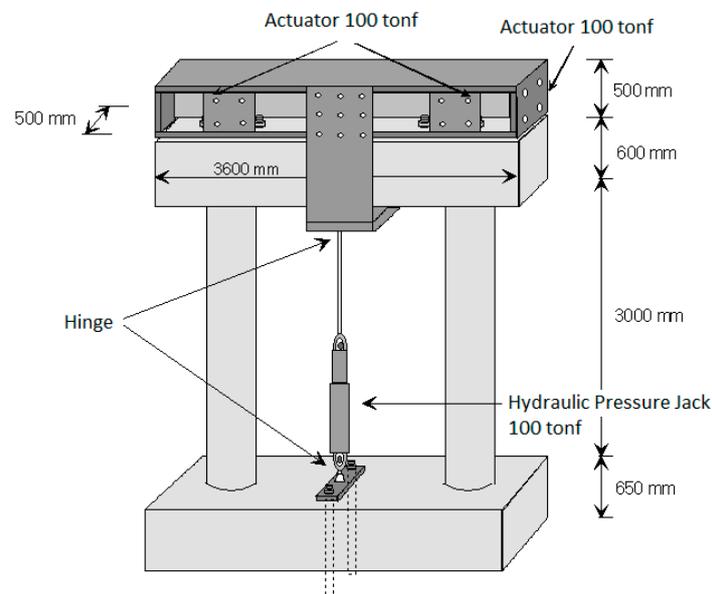
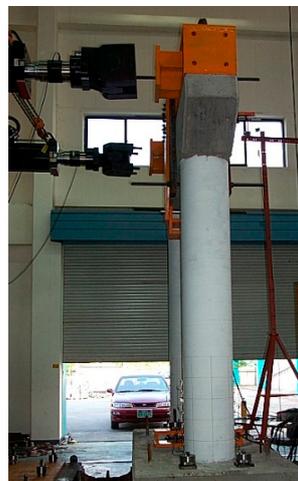
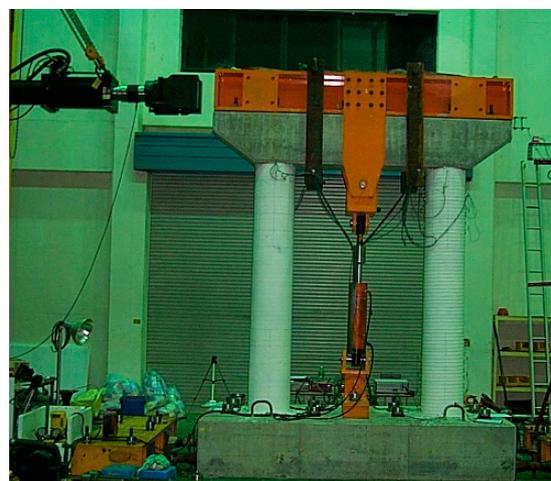
(a) Schematic view

(b) Longitudinal loading

(c) Transverse loading

Figure 4. Test setup for lateral loading and axial loading.

The axial force was applied with a hydraulic pressure jack. Axial force was determined to be 5.2% of the compressive stress of the concrete of the columns, which corresponds with existing bridge structures. The lateral loading was applied with an actuator of 1000 kN (100 tonf) capacity. When longitudinal direction loading was applied, 2 actuators were set and controlled with displacement to prevent torsional behavior. The height at which the horizontal load corresponded to the inertia force of the superstructure was reflected in the existing bridge model. The height from the foundation to the point of loading is 3850 mm, therefore the aspect ratio is 7.7 for longitudinal direction. The aspect ratio for the transverse direction is 3.0 because only column parts are considered to be deformed by rigid joints at both the top and bottom ends. Figure 4 shows the installation of the test specimen for longitudinal loading and transverse loading.

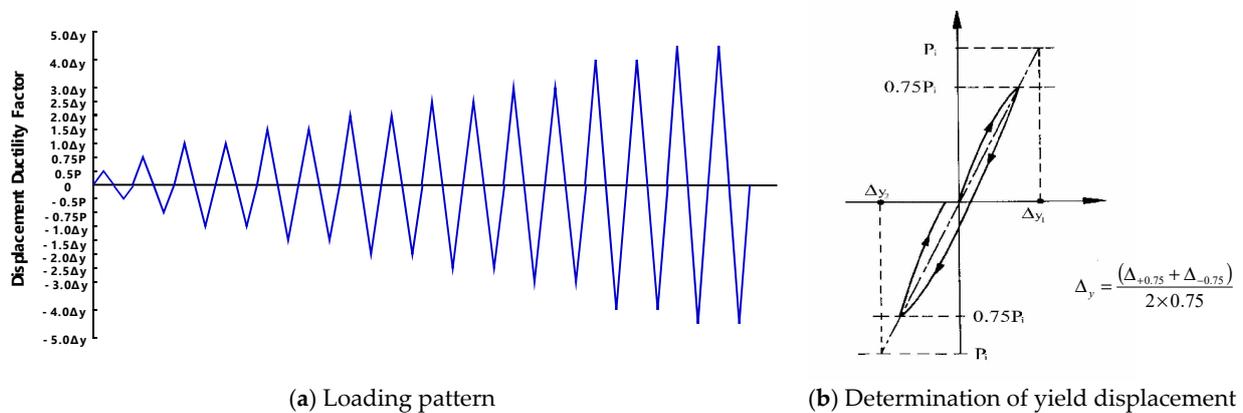
Figure 5. Loading patterns of lateral displacement.

The load patterns are illustrated schematically in Figure 5. The formula proposed in Equation (1) was used to determine the yielding displacement [29].

The lateral strength  $P_i$  is obtained from analysis at the ultimate compressive strain of 0.003. The displacements  $\Delta_{+0.75}$  and  $\Delta_{-0.75}$  are displacements when the load  $0.75P_i$  is applied in the push and pull directions, respectively. For the comparison of each specimen, the yield displacement was assigned the same value in spite of the differences in reinforcement detail. At the small displacement level of  $1.0\Delta_y \sim 3.0\Delta_y$ , the loading displacement was applied in  $0.5\Delta_y$  increments. Two cycles were applied at each loading step. After the  $3.0\Delta_y$  displacement level, the load was applied in  $1.0\Delta_y$  increments until failure. The displacement was applied at a low speed that was close to the static load. Therefore, during the test, pictures could be taken at each loading step and cracks were checked.

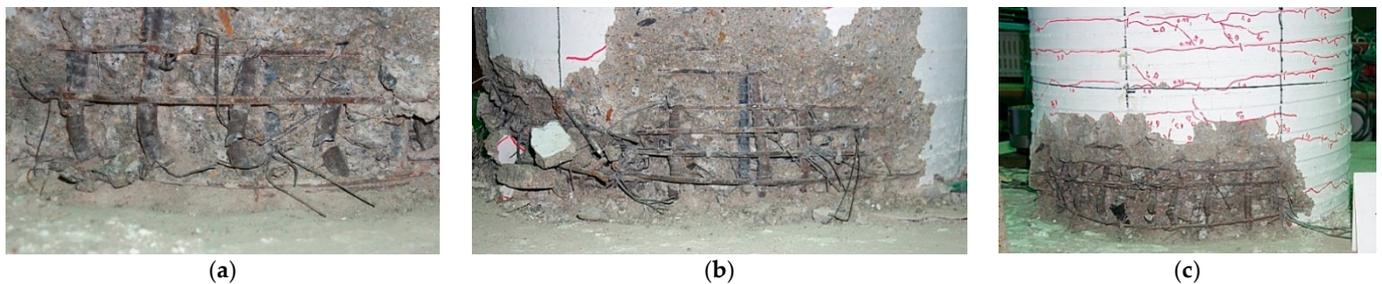
**Figure 6.** Failure of the longitudinal loading specimens. (a) Buckling and fracture of the longitudinal reinforcement bar of the RH-NS-L specimen ( $5\Delta_y$ ); (b) Fracture of the longitudinal reinforcement bar of the RH-SL-L specimen ( $7\Delta_y$ ); (c) Buckling and fracture of the longitudinal reinforcement bar of the RH-SC-L specimen ( $7\Delta_y$ ).

Figure 6 shows an image of the failure of the longitudinal loading specimens. In the case of the RH-NS-L specimen, concrete cracks hardly occurred up to the height of 330 mm when the loading was applied corresponding to the yield displacement because the ratio of the longitudinal reinforcement was twice that of the other heights by the lap-splicing of the longitudinal reinforcement bars. At  $1.5\Delta_y$ , the construction joint at the bottom began to crack. At  $3.5 \sim 4.0\Delta_y$ , the crack in the construction joint was intensified and the concrete adjacent to the foundation was gradually damaged by compression. At  $5.0\Delta_y$ , the buckling of the reinforcing bar was observed, and spalling occurred. In general, longitudinal reinforcing bars resist tensile forces in flexural members. However, when the surrounding concrete undergoes compression failure, the longitudinal reinforcing bar at

the compression section may buckle. In addition, the shear force of the transverse load could cause the longitudinal reinforcing bar itself to bend and contribute to the damage.

In the case of the RH-SL-L specimen, since the longitudinal reinforcement ratio of the lap-splice region was relatively smaller than that of the RH-NS-L specimen, cracks occurred earlier at the bottom. At  $6.0\Delta_y$ , spalling of the compression part was intensified and the concrete cover began to fall off severely. In the case of the RH-SC-L specimen, several cracks occurred even under 350 mm because the ratio of the longitudinal reinforcement was the same for all sections. At  $7.0\Delta_y$ , the transverse reinforcement bar at the bottom was deformed due to the buckling of the longitudinal reinforcing bar. However, the gap between the transverse reinforcement bars was determined to prevent buckling of the longitudinal reinforcement bars, so excessive buckling did not occur.

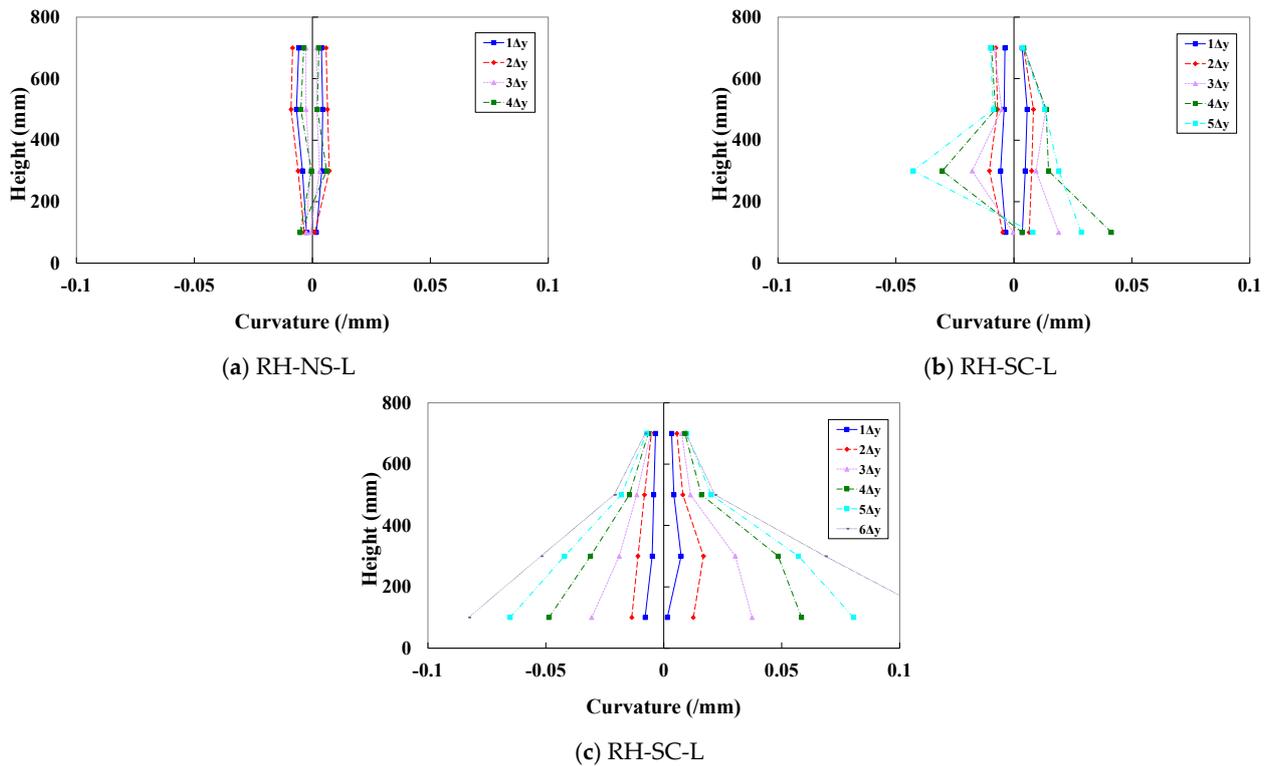
**Figure 7.** Distribution of curvature of the longitudinal loading test.

Figure 7 shows the distribution of curvature along the height from the bottom of the column for the longitudinal loading test specimen. The lap-splice of longitudinal reinforcements increases the longitudinal reinforcement ratio. Because lap-splices increase the longitudinal reinforcement ratio, the curvature of the corresponding region decreases. Therefore, the RH-NS-L specimen has the smallest curvature and the RH-SC-L specimen has the largest curvature. This does not mean that the RH-NS-L specimen does not have small amounts of damage, but it does mean that the damage is concentrated in the lowermost part, where the curvature was not measured.

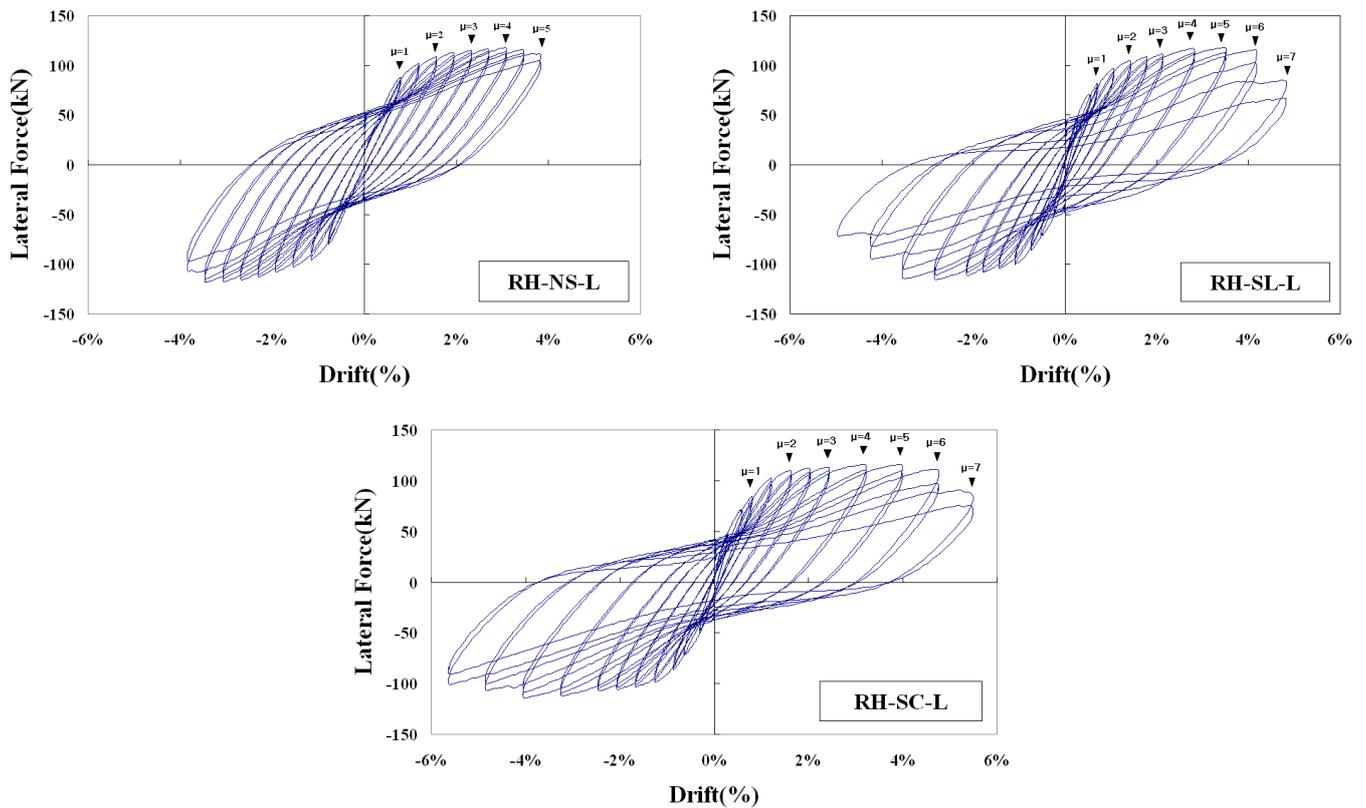
Figure 8. Load-displacement hysteresis curve of the longitudinal loading specimens.

Figure 8 shows the load-drift ratio hysteresis curve of the longitudinal loading specimens. For the RH-NS-L specimen, even after the maximum load, it shows a relatively smooth decrease in the hysteresis curve. According to the results of various experiments performed so far, it is expected that the non-ductile behavior will occur due to the bond failure of the reinforcement bar. However, in this test, even if the hysteresis curve goes up to  $5.0\Delta_y$ , it can be seen that the curve is almost stable. This is because there was no slip between the reinforcement bars raised from the foundation and the column reinforcement bars, and fracturing occurred like with the continuous reinforcement bars. The load-drift ratio curve of RH-SL-L specimen shows a very stable hysteresis up to a ductility of 6.0. It shows more stable behavior than the RH-SL-L specimen because larger a transverse reinforcement ratio affected the confinement of the core concrete. In the load-drift ratio curve for RH-SC-L, displacement ductility at the maximum load capacity was  $5.3\Delta_y$  and the fracture ductility was  $6.6\Delta_y$ . This test specimen shows the most stable hysteresis curve because no lap-splicing of the reinforcing bars was applied.

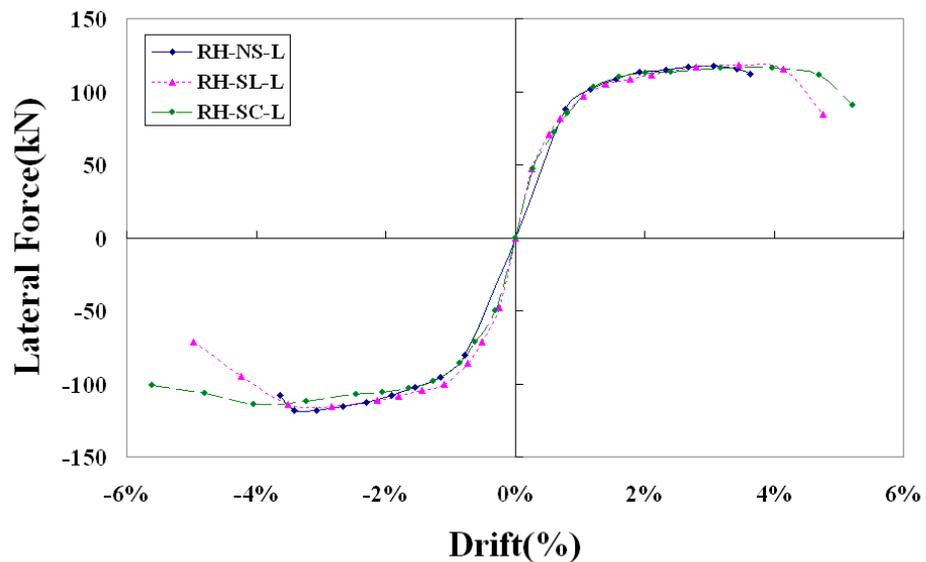
Figure 9. Load-displacement envelop curve of the longitudinal loading specimens.

Figure 9 compares the envelope curve of the hysteresis loop for each longitudinal loading specimen. As can be seen in the figure, there was little difference in the load carrying capacity of each specimen. There was a slight difference in the displacement at failure. This is estimated to be the effect of the curvature according to the lap-splice of the reinforcing bars on the ductility. In general, because lap-splice bond failure occurs, lap-spliced specimens have remarkably low ductility. However, if bond failure does not occur, the lap-spliced section has twice the longitudinal reinforcing bar ratio, resulting in less flexural deformation. Failure will occur at the bottom section of the lap-spliced range. In this section, the longitudinal reinforcing bar ratio is the same without the lap-splice, so the strength of the member does not change significantly.

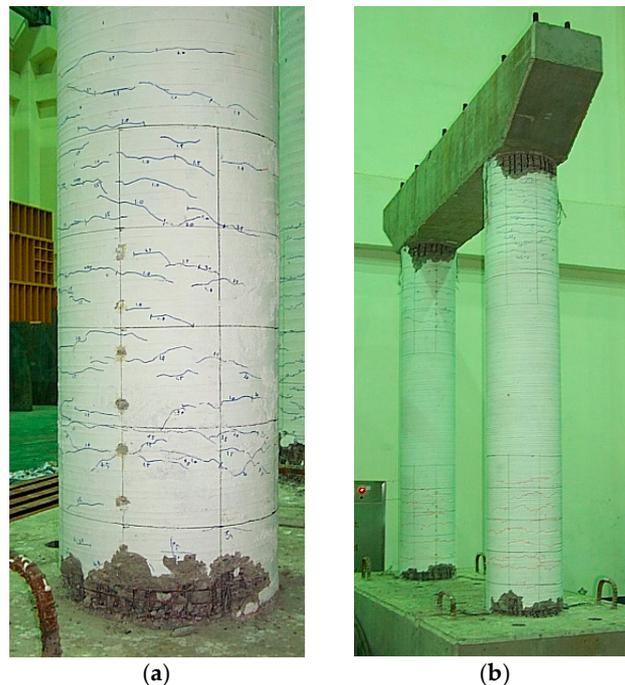
**Figure 10.** Failure of a longitudinal loading specimen and a transverse loading specimen. (a) Failure at the bottom of the column of the RH-NS-L specimen; (b) Failure at the top and bottom of the column of the RH-NS-T specimen.

Since the two-column piers show behavior similar to frames, the behavior of two-column piers in the transverse direction is different from the behavior in the longitudinal direction, as shown in Figure 10. In the longitudinal loading specimens, damage occurs only at the bottom of the column, whereas the transverse loading specimens are damaged at both the top and bottom of the column. The specimens loaded in the transverse direction failed through flexural failure, not through bond-failure of the lap-splices as with the

longitudinal loading specimens. Because plastic hinges were formed at both the top and bottom of the column, the ductility is greater than that of the longitudinal loading case. Since the cap beam is not a rigid body, it caused some deformation. Therefore, the moment at the top of the column could be absorbed by the bending deformation of the cap beam, so the failure occurred later than at the bottom, which is fixed to the foundation. The outside of the bottom experienced compression failure and the breakage of the reinforcement bar first, and then failure occurred in the inside of the bottom. Even if the bottom of the column was damaged, the top of the column was not severely damaged. When the resistant moment at bottom was weakened, the resistant moment acted on the top of the column as well, so it could absorb a large displacement. Therefore, in the case of a load in the transverse direction, the displacement ductility could be greater than that in the case of a load in the longitudinal direction.

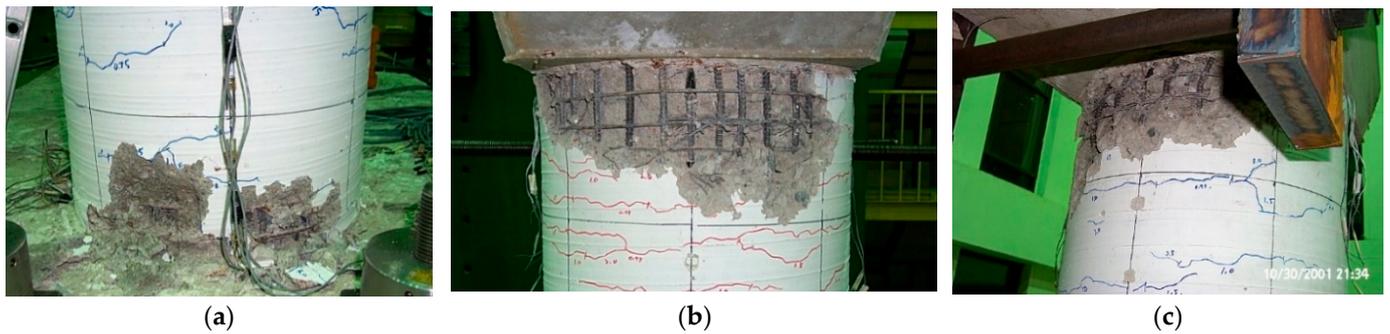
**Figure 11.** Failure of the transverse loading specimens (RH-NS-T). (a) Spalling of the concrete on the outside face of the bottom ( $5\Delta_y$ ); (b) Failure of the concrete cover concrete on the outside face of the top ( $8\Delta_y$ ); (c) Failure of the concrete cover concrete on the inside face of the top ( $8\Delta_y$ ).

Figure 11 shows images of the failure of the RH-NS-T specimen. The cracks were evenly distributed in the upper part of the column from 50 mm to 400 mm when the loading was applied corresponding to the yield displacement. At the bottom of the column, the lap-splice was located up to 330 mm high. In this range, the longitudinal reinforcing bar ratio is doubled, so there is little cracking, and the cracks are evenly distributed in the location from 300 mm to 700 mm at the bottom of the column. At  $5.0\Delta_y$ , the outside face of the bottom of the column had spalling first by the compressive force, and the concrete cover was damaged and fell off. Buckling of the reinforcing bar was observed at about 5 mm height. At the top of the column, many vertical cracks occurred between about 0 mm and 100 mm in height, and spalling began to appear insignificantly. At  $6.0\Delta_y$ , the longitudinal reinforcement bar was first broken in a column that was subjected to tensile force during loading. At  $8.0\Delta_y$ , the longitudinal reinforcement bar was broken at the top of the column at the time of loading. At this time, the longitudinal reinforcement bar at the bottom of the column was almost completely broken where the concrete cover was damaged.

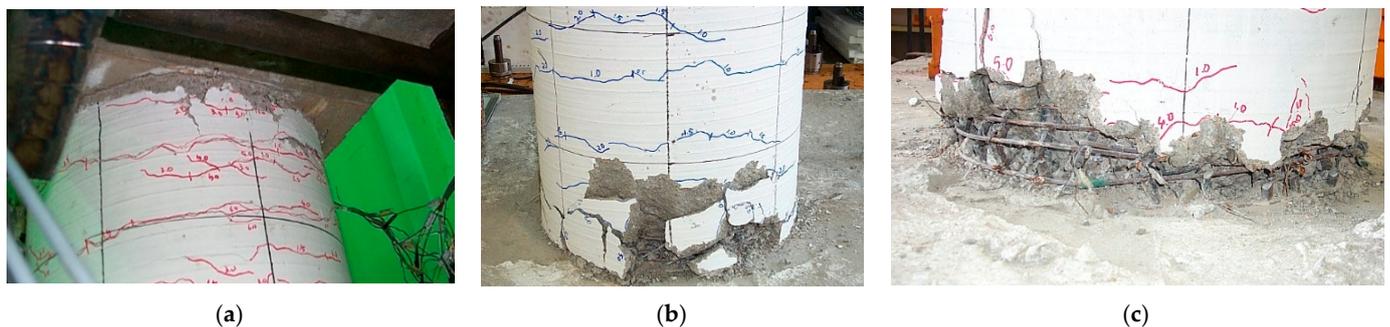
**Figure 12.** Failure of the transverse loading specimens (RH-SL-T). (a) Concrete crack on the inside face of the top ( $7\Delta_y$ ); (b) Spalling of the concrete on the inside face of the bottom ( $9\Delta_y$ ); (c) Fracture of the longitudinal reinforcement bar on the inside face of the bottom ( $9\Delta_y$ ).

Figure 12 shows images of the failure of the RH-SL-T specimen. The top of the column was evenly cracked in the plastic hinge area, and the bottom of the column had many cracks between 200 mm and 800 mm in height when the loading was applied corresponding to the yield displacement. At the bottom of column, the largest crack occurred at a height of about 350 mm, just above the height of the lap-splice. At  $6.07\Delta_y$ , the longitudinal reinforcement bar was first broken in a column that was subjected to tensile force during loading, as like the RH-NS-T specimen. At  $8.07\Delta_y$ , the top of the column was not broken much in spite of the severe fracture of the longitudinal reinforcement bar at the bottom of the column.

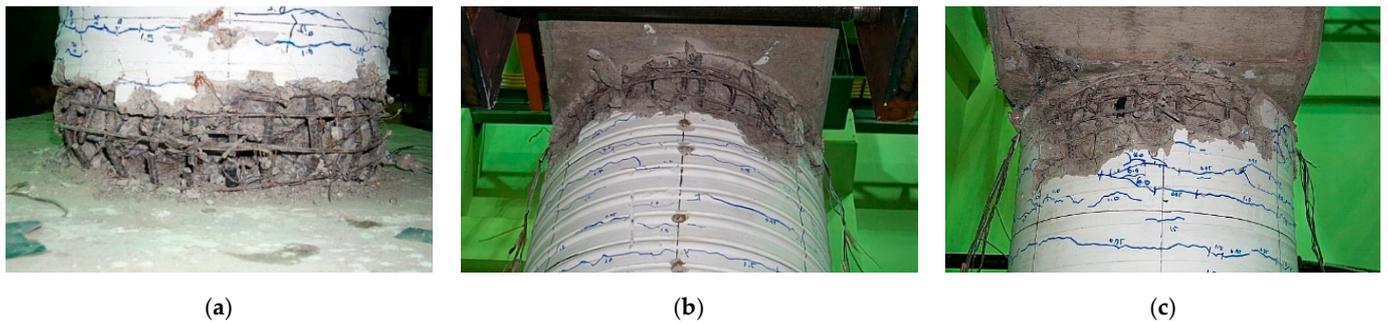
**Figure 13.** Failure of the transverse loading specimens (RH-SC-T). (a) Failure of the concrete and the reinforcement bar on the outside face of the bottom ( $9\Delta_y$ ); (b) Failure of the concrete on the inside face of the top ( $9\Delta_y$ ); (c) Failure of the concrete on the outside face of the top ( $9\Delta_y$ ).

Figure 13 shows images of the failure of the RH-SC-T specimen. Unlike in the other specimens, many cracks occur below the height of 300 mm at the bottom of the column. At  $7.07\Delta_y$ , the longitudinal reinforcement bar was broken at the outside face of the column subjected to tensile force when the loading was applied. At  $9.07\Delta_y$ , the longitudinal reinforcement bar at the bottom of the column was severely fractured. The top of the column was not broken much, as like the RH-SL-T specimen.

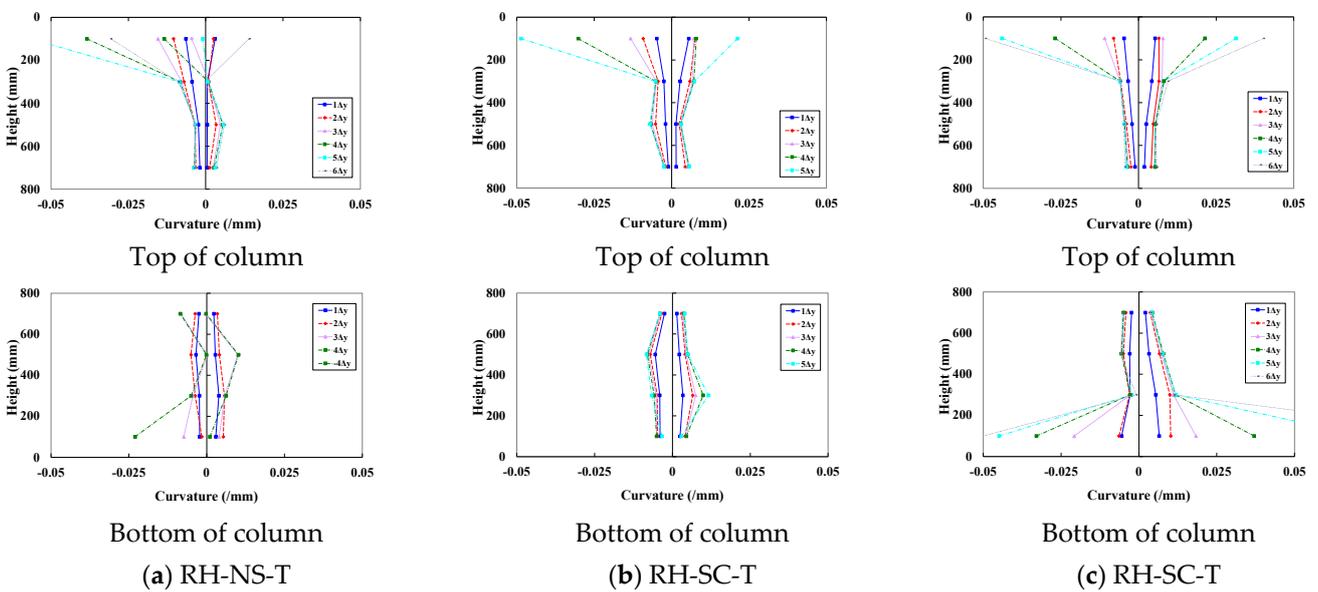
**Figure 14.** Distribution of curvature of a transverse loading test.

Figure 14 shows the distribution of curvature along the height for the transverse loading test specimen. Like the longitudinal loading specimen, the RH-SC-T specimen without lap-splicing had the largest curvature at the bottom of the column. On the other hand, at the top of the column, all specimens have relatively the same curvature because there is no lap-splicing. For the transverse loading specimen, double curvature occurred along the column up and down. This means that the aspect ratio is small. Therefore, the height of plastic hinge region that has a large curvature is relatively lower than that of the longitudinal loading specimen.

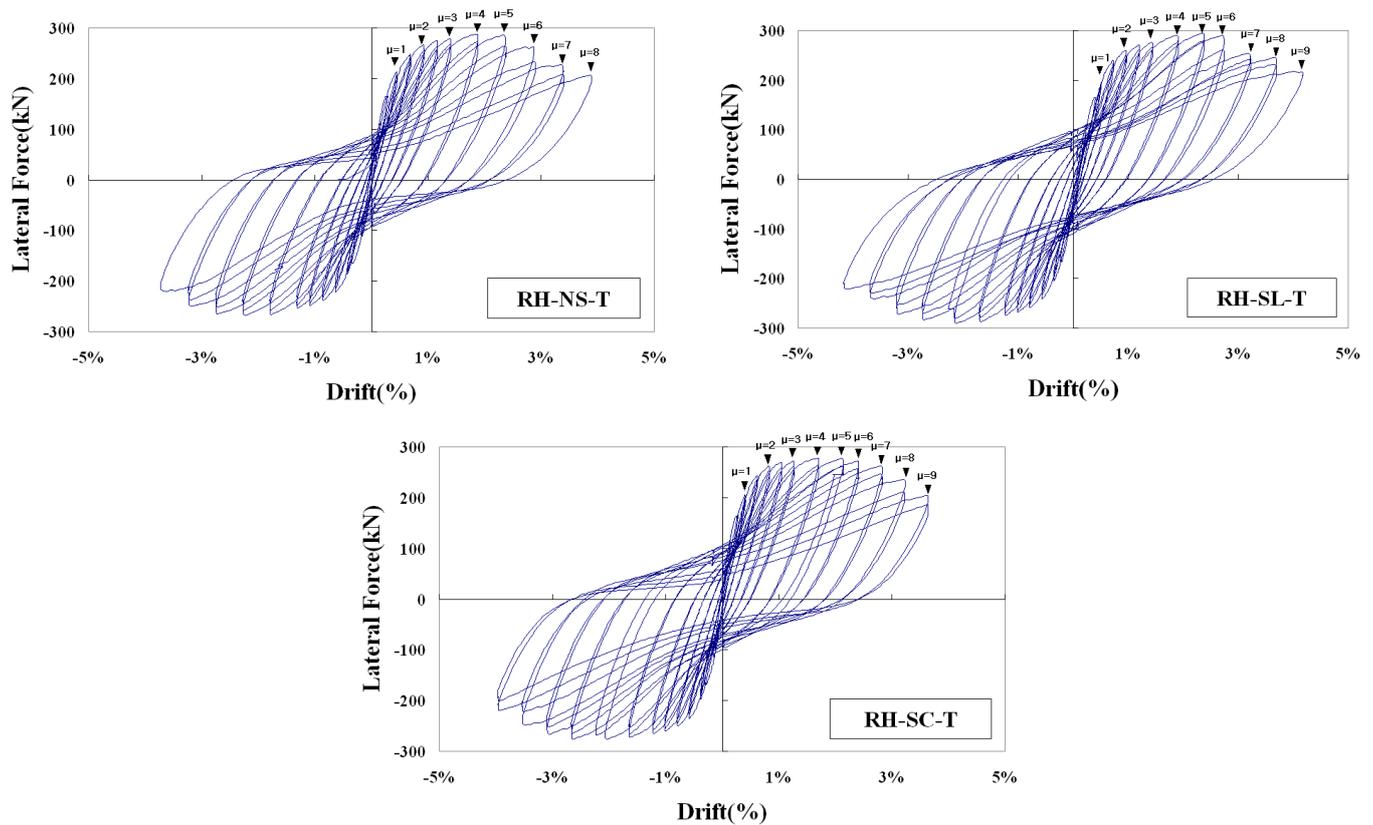
**Figure 15.** Load-displacement hysteresis curve of transverse loading specimens.

Figure 15 shows the load-drift ratio hysteresis curve of the transverse loading specimens. For the RH-NS-T specimens, it can be seen that the horizontal load capacity gradually decreases after a stable hysteresis curve up to  $5.0\Delta_y$ . In contrast to the fact that the resisting force dropped after the breakage of the longitudinal reinforcement bar in the longitudinal loading test, the lateral load was endured more by the moment resistance force, even if the reinforcing bar breaks at the bottom of the column in the transverse loading test. This is because the top of the column can resist the bending moment as the plastic hinge. Thus, it was shown that even if the displacement was applied up to  $8.0\Delta_y$ , the lateral load carrying capacity was reduced by only about 30%.

For the RH-SL-T specimens, a stable hysteresis curve was shown up to  $6.0\Delta_y$ . However, at  $7.0\Delta_y$ , the resisting force decreased significantly. After  $7.0\Delta_y$ , the resisting force decreased more slightly. In the case of these test specimens, unlike other transverse loading test specimens, even after  $6\Delta_y$ , where the fracture progressed to some extent, the lateral load-bearing capacity decreased gradually. This is because the ductility capacity of the top of the column is high, as the transverse reinforcement bar ratio is larger than that of other test specimens.

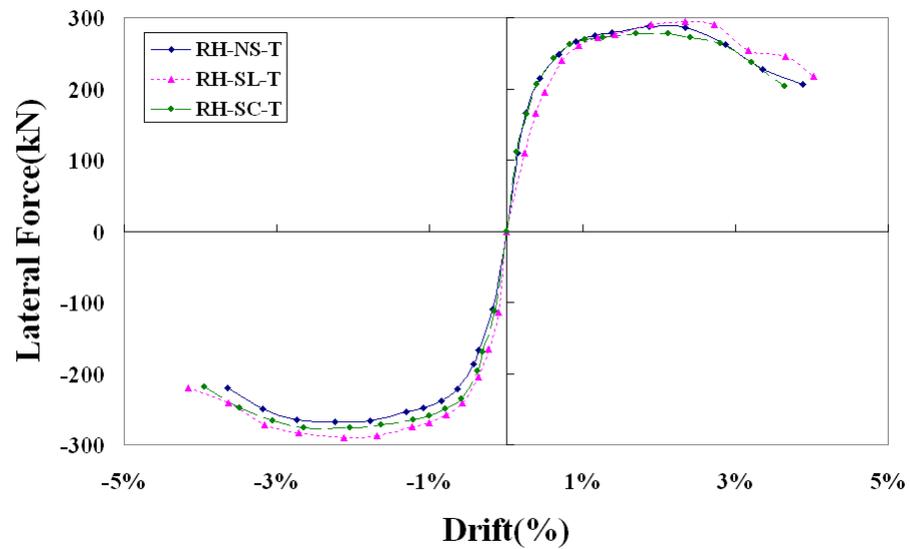
Figure 16. Load-displacement envelope curve of transverse loading specimens.

Figure 16 compares the envelope curve of the hysteresis loops of each transverse loading specimen. As can be seen in the figure, there was little difference in the lateral load carrying capacity of each specimen. This is because bond failure by lap-splice did not occur as in the longitudinal loading test. The reduction of the lateral load-bearing force after the failure of the bottom is determined by the failure of the top of the column. Since there is no lap-splice at the top of the column, the ductility difference due to the transverse reinforcement bar changes the difference in the failure drift ratio.

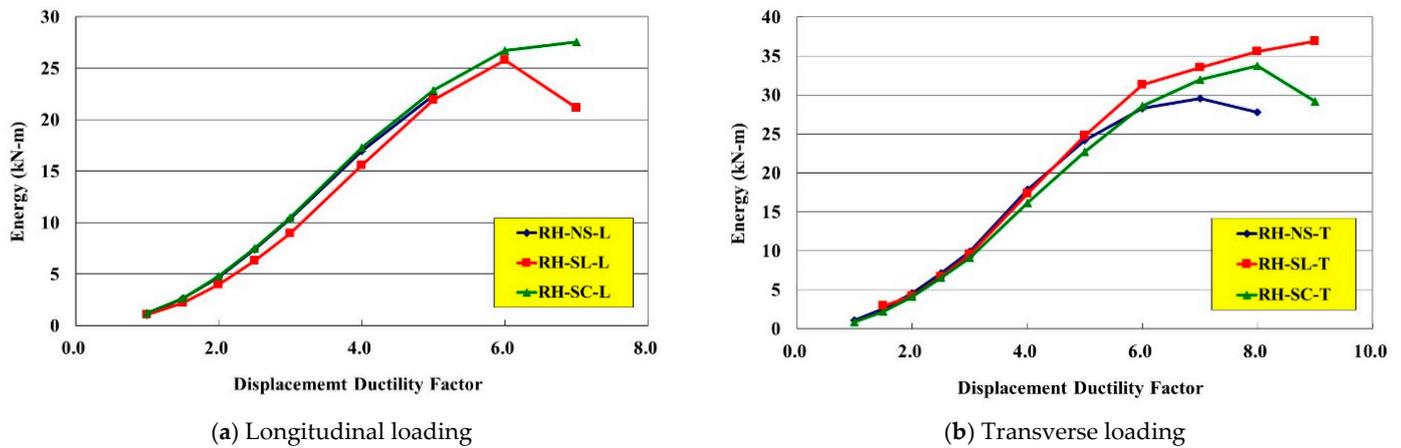
Figure 17. Energy absorption with respect to displacement ductility factor.

The seismic capacity of a member with nonlinear behavior can be expressed as the energy absorption and ductility factor during hysteretic behavior. The absorbing energy according to the ductility factor was calculated as the area of the hysteresis loop at each loading step. The energy absorption of each specimen is shown in Figure 17. For the case of the longitudinal loading, the energy absorption of the RH-SC-L specimen is higher because the displacement at the failure is slightly larger. For the case of transverse loading, the RH-SL-T specimen is larger than those of any other specimens. It is almost the same until 5.0, before failure occurs at the bottom of the column. After the bottom part of the column fractured, the energy absorption capacity at the top of the column contributed to the seismic performance. It is also confirmed in the failure mode that the top of the column withstands the load in the transverse direction even after damage. The energy absorption capacity at the top of the column is determined by the transverse reinforcing bar ratio at the plastic hinge region. Therefore, even if the specimen RH-SC-T without lap-splicing at the bottom of the column has the largest displacement when the initial damage occurred, the specimen RH-SL-T, which has larger transverse reinforcing bar ratio, has better seismic performance.
