# Modernization of Heavy Loaded Tram Radial Effect on Noise and Vibration

**Abstract:** The noise and vibration that cause deterioration of comfort at specific locations can be reduced by modernisation of tram lines in some large cities where dense development surrounds tram lines. The paper deals with the impact of noise and vibration produced by tram traffic. Its aim was to verify whether the modernisation of one of the busiest tram lines in the capital of Slovakia had an impact on the reduction of noise and vibration emissions arising in its surroundings. The paper analysed experimental measurements conducted at the busiest locations of the studied tram line, focusing on the parameters  $L_{Aeq}$  and  $v_{rms}$ . The methodology for reducing the adverse effects of noise and vibration is based on the modernisation of the tramway line, characterised in detail in the paper. The presentation and analysis of the measurement results are followed by conclusions that underline the importance of reducing noise and vibration emissions generated by tram traffic by modernising the tram line network.

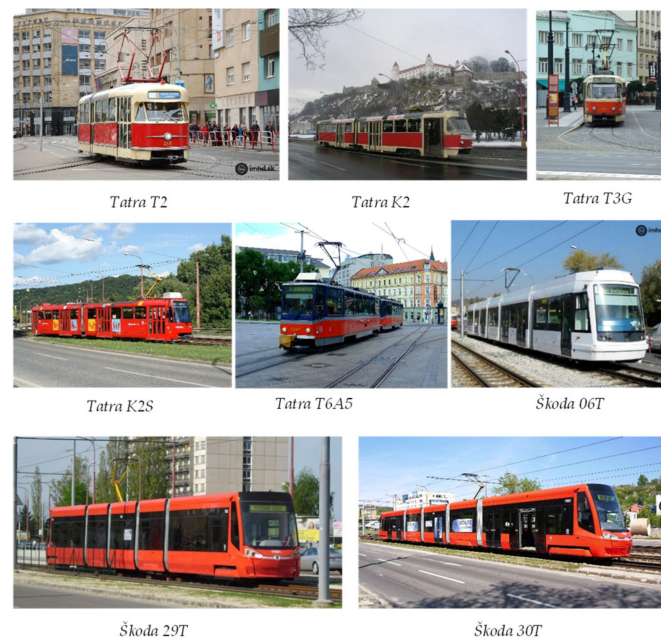
**Figure 1.** Currently operated tram vehicles in Bratislava [26–28].

The first stage of the modernisation of the city's public transport system in Bratislava started in 2013. At the end of this year, a work contract was signed for the reconstruction of the Old Bridge and the construction of a tram line to Petržalka. At the end of 2014, a prototype of the Škoda 30 T type two-way tram was delivered and put into operation in 2015. In 2015, a one-way tram type Škoda 29 T was also put into service. Test runs were performed on the Bratislava tram gauge (1000 mm) with a Škoda 30 T tram with a set of Tatra T6 vehicles and on the standard gauge (1435 mm) with a Tatra T3 tram (specially modified for this purpose) [25]. Figure 1 demonstrates tram types that are currently operated on tram lines in Bratislava.

The dominant noise effects in the location are caused by tram and road traffic. The intensity of car traffic is low and the resulting dynamic effects are negligible, while the passage of trams has a more significant effect. At the time of the measurement, several types of trams were operated on the line. Older noisier construction types Tatra—T3G, K2, and T6A5 were supplemented by more modern types, Škoda—29T and 30T ForCity Plus (Figure 1). Noise from their passage is significantly affected by several factors:

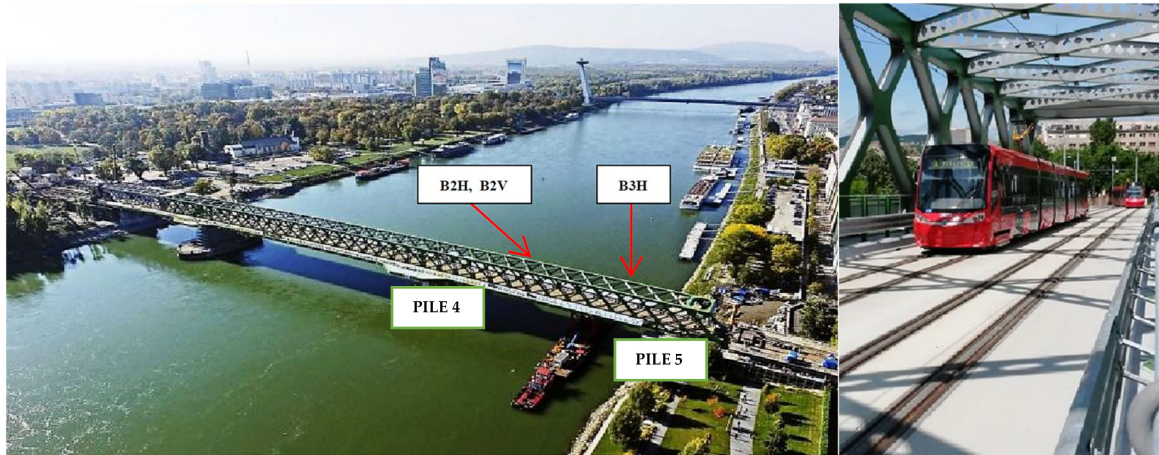
The new load-bearing steel structure of the bridge is a welded truss rhombic system. Unlike the original bridge structure, the sidewalks for pedestrians and cyclists were widened to 4.5 m on both sides of the bridge. Above pillars no. 4 and no. 5, viewing platforms were designed (Figure 14). The middle part of the bridge with a railway track placed in a concrete roadway is used exclusively for tram transport and rescue and safety units. The tram superstructure on the bridge is designed as a ballastless track with contactless rails, using Ri60R2 (for 1000 mm gauge) and Ri67R1 (for 1435 mm gauge) groove rails, equipped with a simple, flexible compensated catenary. Engineering networks (water supply, gas pipeline, high-voltage cables, and optical cables) are led in the space under the construction of the tram line. As part of the bridge reconstruction, two original pillars

were demolished at the same time, and one new pillar was built in their place outside the fairway profile.

**Figure 14.** View of the reconstructed Old Bridge over the Danube in Bratislava and the tram line placed in the concrete roadway and its transverse profile.

The first objective was, similarly to the measurements mentioned in Section 3.1.3, to determine the current noise situation on the reconstructed bridge and the new carriageway caused by the tram passage. There is no car traffic on the bridge structure, and therefore the only relevant source of noise is the trams, which are the two-way Škoda 30T trams (Figure 1). These vehicles are 32.5 m long and reach a maximum design speed of 65 km/h (in standard traffic approximately 50 km/h, as they operate in the urban area of the city). The assessed double-track section of the tram line is placed on a reinforced concrete supporting structure—a ballastless track with contactless rails. This type of construction of the tram surface as well as the position of the measuring points is specified in Figures 3 and 14.
