Article

Stability Study of the Roof Plate of the Yuanjue Cave Based on the Equivalent Support Stiffness Method

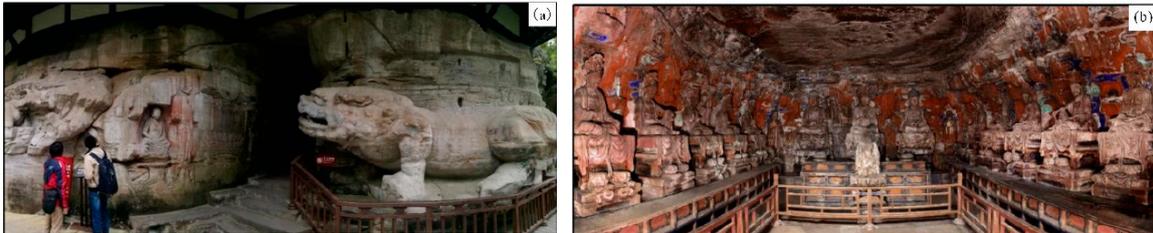
Figure 1. Yuanjue Cave Cultural Relics Protection Zone (a) outside the cave and (b) inside the cave.

difficult to preserve. The overall depth of the cave is long and wide, and the top is prone to collapse, but it is carefully designed with a slightly curved arch span and the use of four stone walls to disperse the forces, reducing the pressure on the rocks at the top of the cave and dispersing the overall forces on the top of the cave, resulting in the internal structure of the cave remaining intact despite hundreds of years of natural environmental changes and erosion.

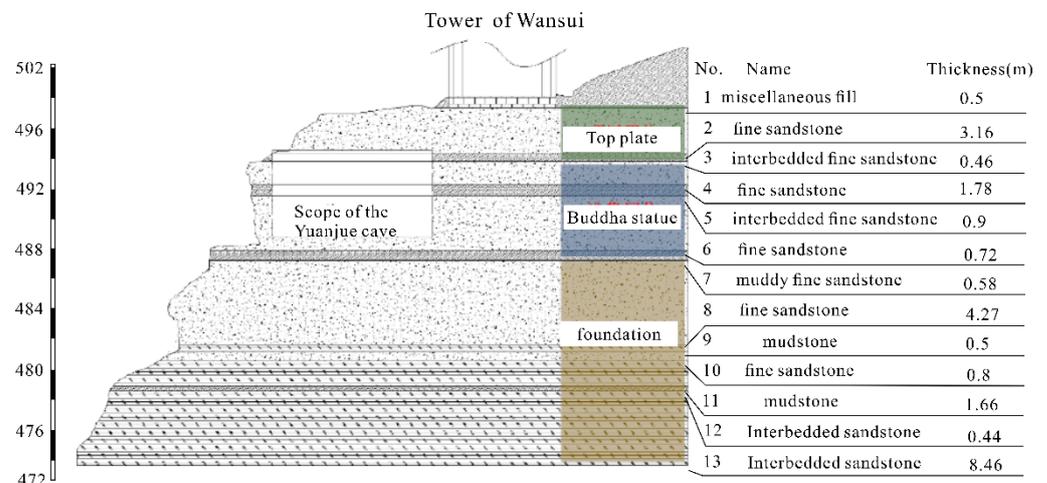
Figure 2. Detailed geological stratification of the south cliff wall on which Yuanjue Cave is located.

The stratigraphy of Yuanjue Cave is typical of the red-bedded sandstone of the Sichuan Basin, which is a river–lake sedimentary environment, with horizontal fine-grained sandstone and mudstone interlayers as the main stratigraphic layers, and local sandstone layers which contain more schistose mica in thin layers. The lithological distribution of the stratigraphy of the south cliff where Yuanjue Cave is located and the relative relationship between Yuanjue Cave and the cliff wall are shown in Figure 2.

The cliff's stratigraphy is mainly horizontal fine-grained sandstone and mudstone interstratification, which can be divided into 13 geological strata. The natures of hard rock and soft rock are extremely different, and the development of the cliff structure fissure derivation is closely related to the distribution of these soft and weak strata, and the weak layer mainly plays the role of blocking and offsetting the fissure development. The rock structure of the surrounding rock of Yuanjue Cave is dominated by tension-type fissures, and no fault or other large geological structure traces are found to exist. Through on-site geological investigation, there are 23 fissures in total on the south cliff wall where Yuanjue Cave is located. These fissures are mainly damaged by tension, with the outcrop showing tension and the width of the opening ranging from a few millimeters to several meters; among them, the giant fissures are mostly filled (powder and sand left with water migration, etc.), but the fissures with smaller openings are usually filled with less or no filling.

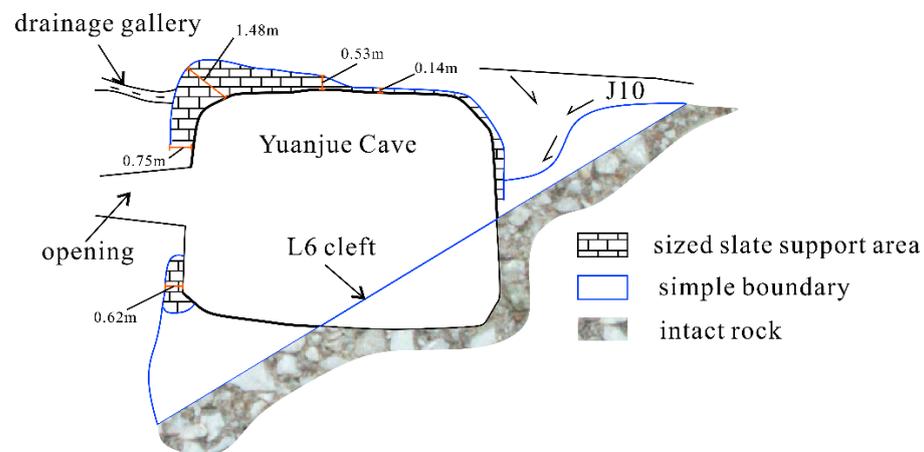
Figure 3. Development of internal slates and fissures in Yuanjue Cave.

The characteristics of the roof slab and supporting structure of Yuanjue Cave were obtained through detailed on-site investigation and research, which were greatly influenced by the process of cave excavation and the long-surviving process, and the history of the force evolution of the roof slab of Yuanjue Cave was influenced by the joint action of man and nature. There are several fissures in a direct cutting relationship with Yuanjue Cave, in which the L6 fissure has developed in the top slab of Yuanjue Cave, and the J10 fissure cuts the top slab rock into independent blocks (Figure 3); the volume of this independent block is 256.03 m³ with a total weight of 570.88 tons. There are a large number of overhanging, broken, and fractured slates in Yuanjue Cave, which have a great impact on the stability of the roof of Yuanjue Cave. It is necessary to carry out theoretical calculations and numerical simulations on the support and the effect of vertical stress on the slates.

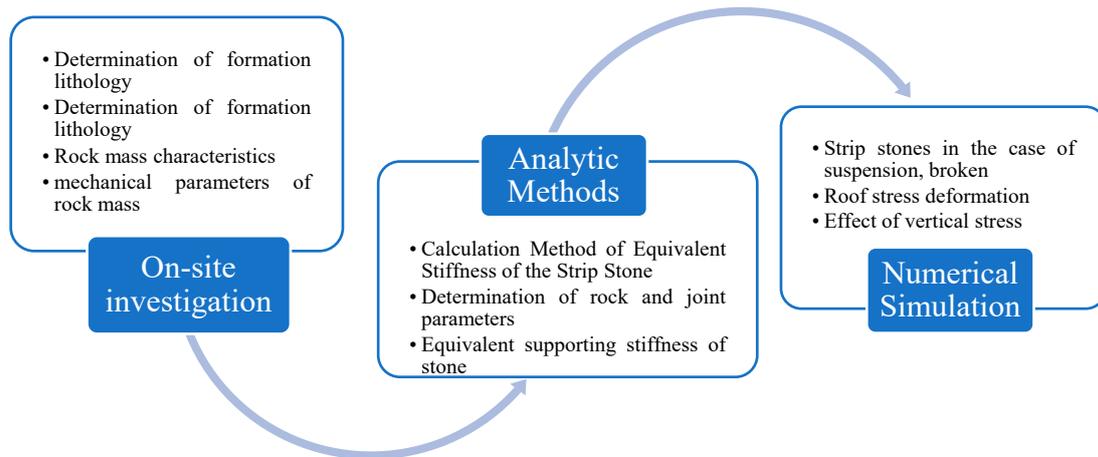
Figure 4. Flow chart showing the available data and methods used in this study.

To calculate the equivalent stiffness of each group of boulders in Yuanjue Cave, the distributions of boulders in Yuanjue Cave are different, and there are cases of overhanging crushing and fracturing, etc. The stress conditions in the cave are complicated. In this paper, we proposed an equivalent stiffness method for calculating the stability of boulders [44,45]. Based on the definition of equivalent bearing stiffness and the main distribution of supporting boulders in the roof of the cave, we equated the boulders in Yuanjue Cave into series and parallel arrangements and established analytical solutions for the effective bearing stiffness of boulders in series and parallel forms under different contact areas on the upper and lower surfaces of the boulders. The effective bearing stiffness of each stone grouping was obtained after the contact relations of the stones in the cave were fully counted. The effect of the number of overhanging, broken, and damaged slates on the force–deformation characteristics and stability of the top slab of Yuanjue Cave was revealed through numerical simulation, which is shown in Figure 4.

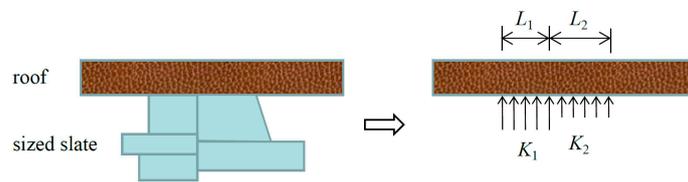
Figure 5. Schematic diagram of the grouping of supporting slates in the lower part of the roof plate.

The slates in direct contact with the roof slab were grouped according to their distribution (as shown in Figure 5), and the overall stiffness of the slate and all its lower supporting slates is taken as the equivalent supporting stiffness of the group.

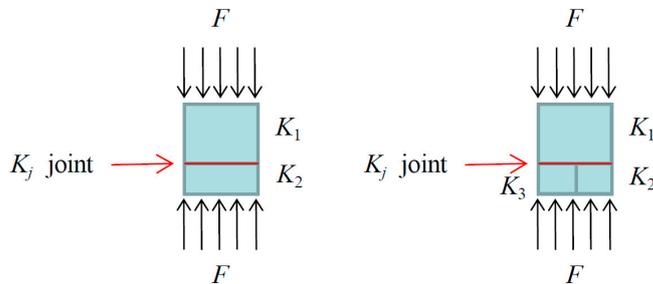
Figure 6. Sketch of equivalent support stiffness calculation.

The method of direct contact between the strips and the top plate can be mainly divided into two basic forms: series and parallel connection, as shown in Figure 6.

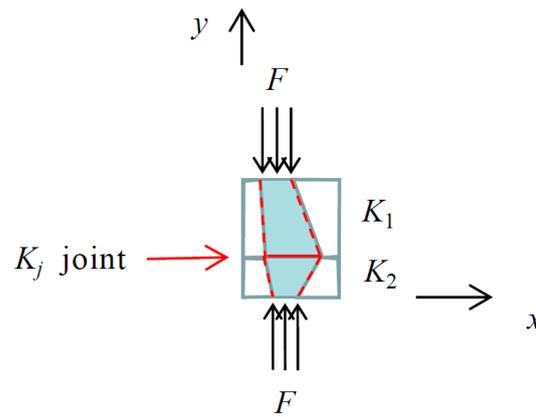
Figure 7. Sketch of the calculation of the series arrangement with different contact areas.

In the tandem arrangement, if the total area of the upper slates is A , the ratio of the effective contact area of each contact surface to the total area of the upper slates are $\alpha_1, \alpha_2, \alpha_3$, and the modulus of elasticity of the slates and joints are E_1, E_2, E_j . For the convenience of calculation, it is assumed that the internal stress influence range varies linearly, and the stress is uniformly distributed within the influence range, and its calculation sketch is shown in Figure 7.

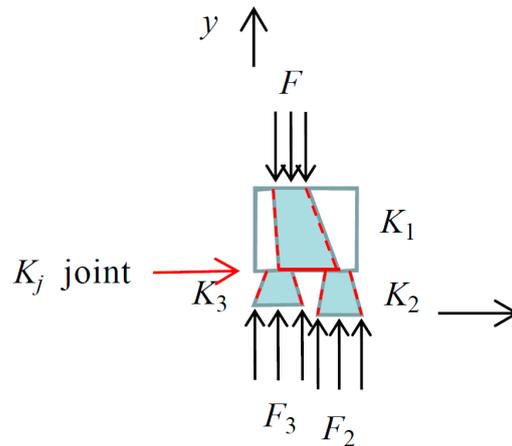
Figure 8. Sketch of the parallel arrangement calculation with different contact areas.

In parallel arrangement, if the total area of the upper slates is A, the ratio of the effective contact areas of each contact surface to the total area of the upper slates are $\alpha_1, \alpha_{21}, \alpha_{22}, \alpha_{31}, \alpha_{32}$, and the moduli of elasticity of the sized slates and joints are E_1, E_2, E_3, E_j , and the ratio of the height of slate 3 to that of slate 2 is β_h . For the convenience of calculation, it is still assumed that the internal stress influence range varies linearly and the stress is uniformly distributed within the influence range, whose calculation sketch is shown in Figure 8, where the contact area of the lower surface of the upper slate is equal to the sum of the contact area of the upper surface of the two stones below.

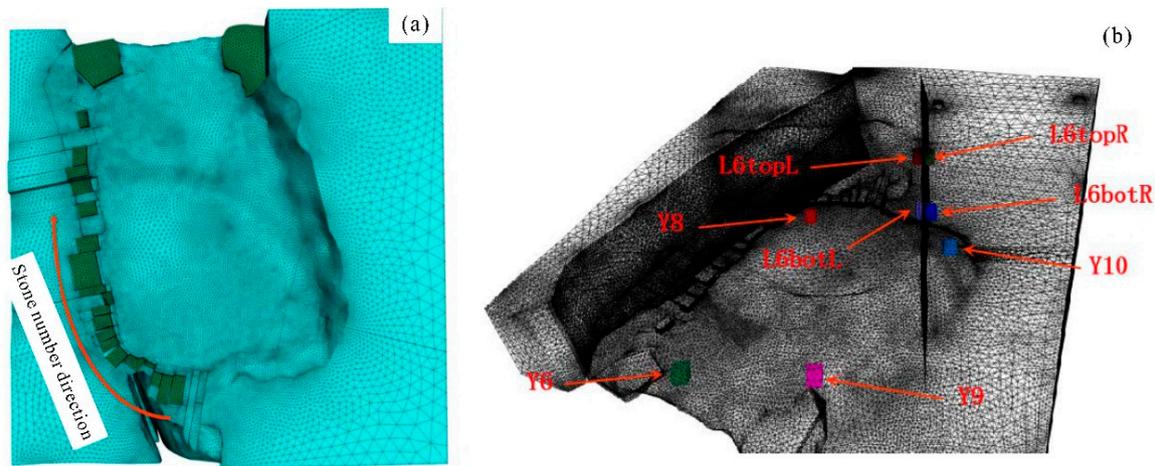
Figure 9. Three-dimensional geological model. (a) Schematic diagram of the development of overhanging slates. (b) Location layout of the monitoring points.

The parameters of rock mechanics required for the numerical simulation were obtained after the aforementioned evolutionary law and geomechanical qualitative analysis (Table 3). The boundary conditions of the rock body of the roof slab of Yuanjue Cave are very clear, and this chapter analyzes them from the perspective of 3D modeling and numerical simulation for a precise quantitative perspective [46]. Combined with the aforementioned stratigraphic distribution characteristics and physical and mechanical parameters of the rock body [47,48], the final stability study was conducted by finite difference software for the effect of overhanging, crushing, and damage of the roof slab on the overall top slab of Yuanjue Cave, respectively. In the aforementioned study, it is given that the top plate of the Yuanjue Cave has formed a relatively independent block structure in the form of a “triangular thick plate” (Figure 3), in which the J10 fissure forms a natural cutting boundary on the east side, so the model boundary on the east side can be extended 5 m eastward as the boundary of the J10 fissure. The rock body of the top slab on the west side forms a fracture boundary along the L6 fissure, but this boundary intersects the axis of the cave chamber horizontally at a large angle to accommodate the space of the cave chamber, so the west side extends westward to the end of the cliff wall of the L6 fissure with the west boundary of the cave chamber. The northern boundary is the hollow surface of the cliff wall, and the entrance of the cave canal can be used as the boundary; the southern side is bounded by the convergence angle of the roof slab. The rock supporting the top slab is the image formation, which is relatively stable and intact, so it can be extended below the top slab to the bottom part of Yuanjue Cave, and the three-dimensional model is shown in Figure 9. The model of the top slab of the Yuanjue Cave was established with 109,524 units and 19,856 nodes.

During the numerical simulation, the vertical displacement and the maximum principal stress location distribution of the roof slab were monitored at the four edge measurement points above the roof slab of Yuanjue Cave. By comparing and analyzing the vertical displacement and the maximum principal stress development trend of the roof slab at the four measurement points, the effect of the number of overhanging, broken, and damaged boulders on the force deformation characteristics and stability of the roof slab of Yuanjue Cave was revealed. In addition, since the L6 crack developed in the roof of the Yuanjue Cave, it was formed by the gradual cracking of the filling slate after the excavation of Yuanjue Cave and the increase of the bending moment of the roof slab, which can reflect the force deformation and stable state of the roof slab. Therefore, in the process of numerical simulation, the L6 crack width was monitored as a focus, and the changing trend of the L6 crack width was mainly analyzed.

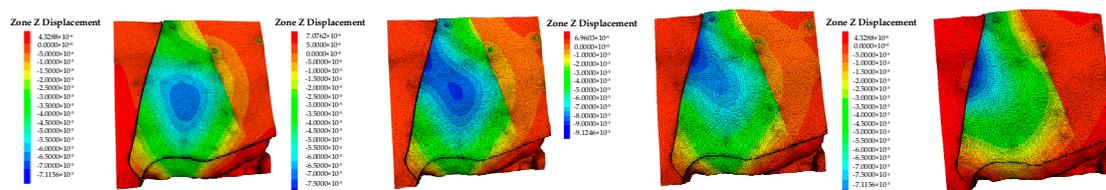
Figure 10. Cloud diagram of vertical displacement of the top slab when the number of overhanging slates is different.

Figure 10 shows, from left to right, the vertical displacement clouds of the top slab of Yuanjue Cave in the case of 1, 4, 10, and 15 overhanging slates. It can be seen that with the increase in the number of overhanging boulders, the top slab of Yuanjue Cave underwent uneven settlement, and the maximum settlement position was shifted from the central area to the left rear of Yuanjue Cave (boulder overhanging side).

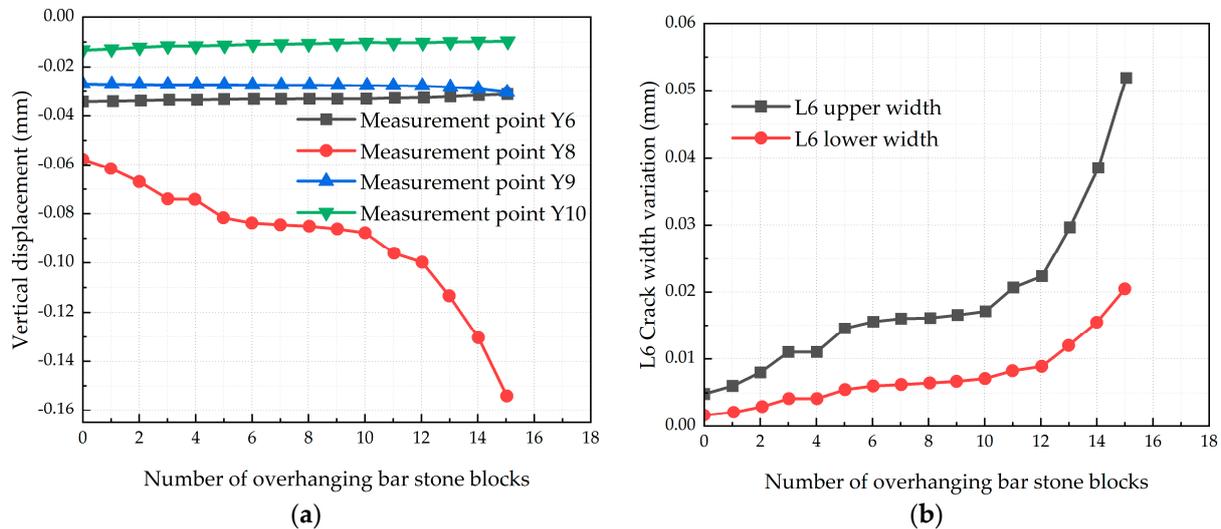
Figure 11. (a) The variation curve of vertical displacement of each measurement point with the number of overhanging slate blocks; (b) the variation curve of the increase of L6 crack width with the number of overhanging slate blocks.

According to the numerical simulation results, the variation curve of vertical displacement of each measurement point with the number of overhanging slate blocks was made

with the number of overhanging slate blocks as the horizontal coordinate (Figure 11a). The horizontal displacement in the x and y directions of the two pairs of measurement points above and below the L6 crack was decomposed and differentiated along the vertical direction of the L6 crack to obtain the variation curve of the width above and below the L6 crack with the number of overhanging slate blocks (Figure 11b).

With the increase of the number of overhanging slates, the settlement of Y6 and Y10 measuring points on the roof of the Yuanjue Cave decreased, the settlement of Y8 and Y9 measuring points increased, the width of L6 cracks kept increasing, and the change rate increased with the increase of the number of overhanging boulder blocks. The settlement of the Y8 measuring point was the largest and the most significant change (Figure 11a), and the settlement of Y6, Y9, and Y10 were smaller because the Y8 measuring point was close to the development area of overhanging slates. The settlement of Y8 and Y9 began to increase sharply when the overhanging boulders exceeded 12 (TS30) and entered the stage of rapid change.

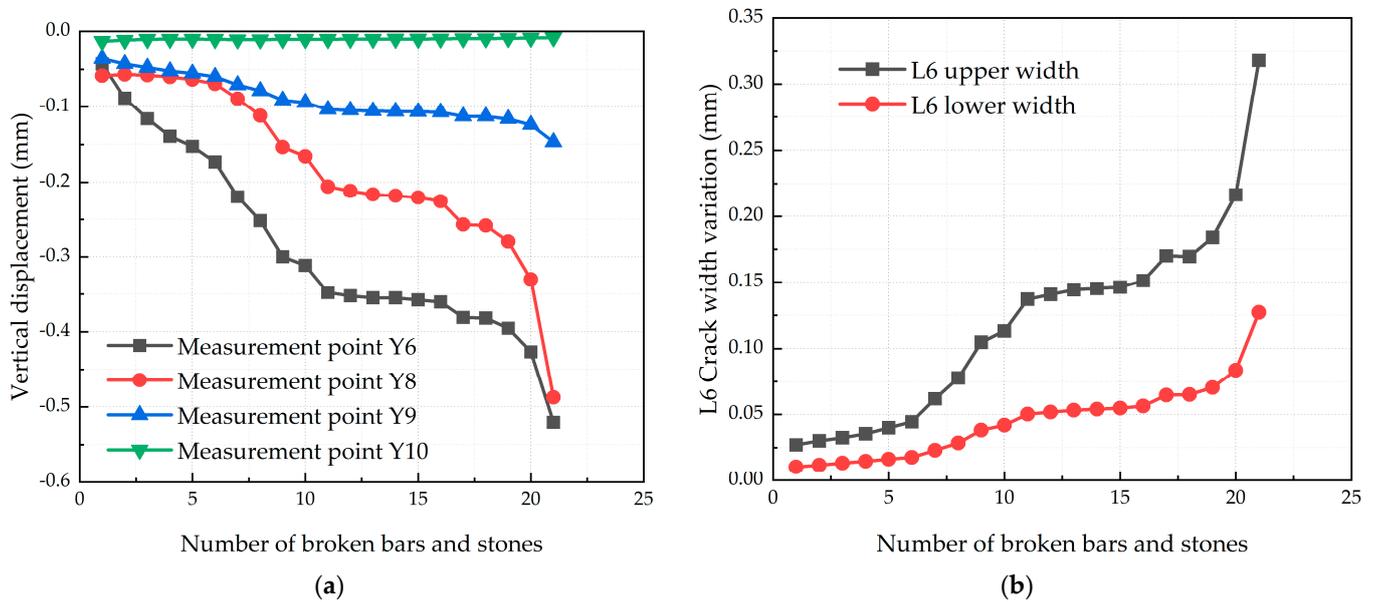
Figure 14. (a) Variation curve of vertical displacement of each measurement point with the number of broken slate blocks; (b) variation curve of the increase of L6 crack width with the number of broken slate blocks.

With the increase in the number of broken slate blocks, the settlement of Y6, Y8, and Y9 on the top plate of Yuanjue Cave gradually increased, the settlement of Y10 decreased, and the width of L6 cracks kept increasing. The settlement of the four monitored ones had the characteristics of $Y6 > Y8 > Y9 > Y10$ (Figure 14a), which is mainly since the monitoring points of Y6, Y9, and Y8 were closer to the broken slate area; when the broken slate exceeded 18 pieces (TS46), the settlement of Y6, Y8, and Y9 started to increase sharply and entered the stage of rapid change.

The L6 crack still showed the characteristic of being “wide at the top and narrow at the bottom”, and the width of the L6 crack increased with the increase of broken boulders, and when the number of broken boulders exceeded 18 (TS46), the width of the L6 crack started to increase sharply and entered the rapid change stage (Figure 14b). According to the evolution law of vertical displacement and the L6 width change rate of measurement points, the change process can be divided into three stages: the initial uniform change stage (less than 11 pieces of broken slates), the middle stable change stage (the number of broken slates is between 11 and 18 pieces), and the late rapid change stage (broken slates have more than 18 pieces).

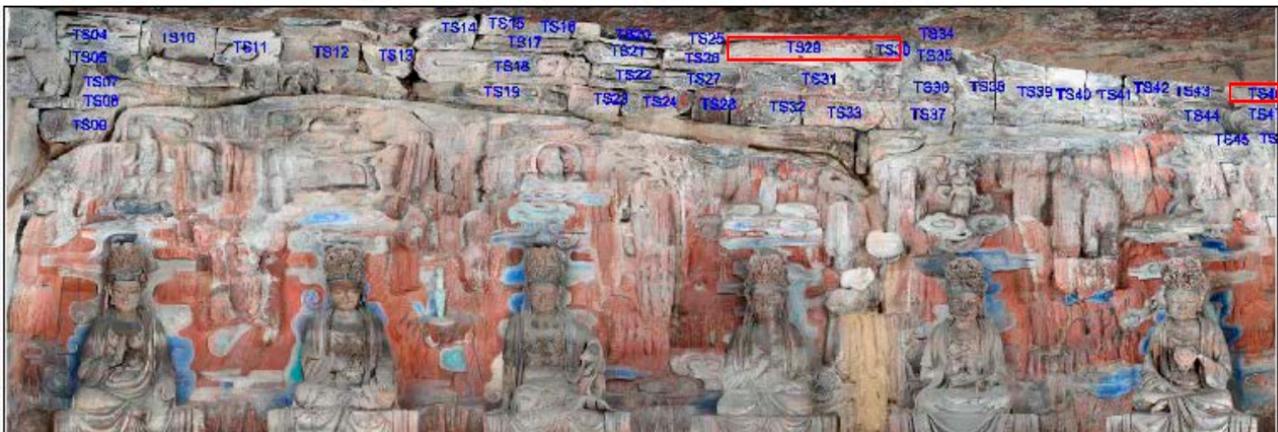
Figure 15. Characteristic points of broken slates and destabilization warning points.

of preventive protection, the broken slate reaching 18 pieces can be taken as a sign that the top plate of the Yuanjue Cave has entered the destabilization warning state, i.e., the critical number of the broken slate is 18 pieces (Figure 15).

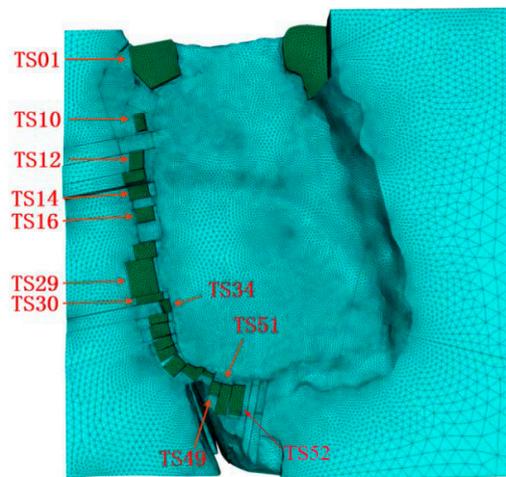
Figure 16. Distribution of the location of the current cracked and damaged boulders.

Through the preliminary cave investigation, it was found that the single blocks of cracked boulders included TS01, TS02, TS03, TS04, TS07, TS08, TS10, TS11, TS12, TS14, TS17, TS31, TS32, TS36, TS52, and TS53. According to the contact area and grouping of the boulders, the groups where the cracked boulders are located were TS01, TS10, TS12, TS14, TS16, TS29, TS30, TS34, TS49, TS51, TS52, as shown in Figure 16. The cracked and damaged boulders were mainly distributed in the middle and front parts of the boulder-filled area.

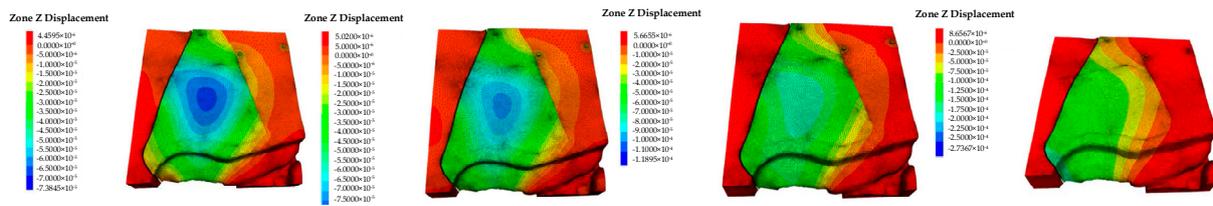
Figure 17. Vertical displacement clouds of the top slab of the damage factor of different broken slates.

Figure 17 shows the vertical displacement of the roof slab of the cave from left to right when the damage factor was 0.5, 0.8, 0.9, and complete damage. With the increase of the damage of the cracked slate, the uneven settlement of the roof plate of the cave occurred, and the maximum settlement position was shifted from the central area to the left front of the cave, which had a significant effect on the force deformation and stability of the roof plate of the cave. According to the numerical simulation results, the vertical displacement curve of each measurement point with the damage factor was made in the horizontal coordinate of the cracked stone damage factor (Figure 18a). The horizontal displacement in the x and y directions of the two pairs of measurement points above and below the L6 crack was decomposed and differentiated along the vertical direction of the L6 crack. The change curve of the width of the L6 crack above and below the damage factor was obtained (Figure 18b).

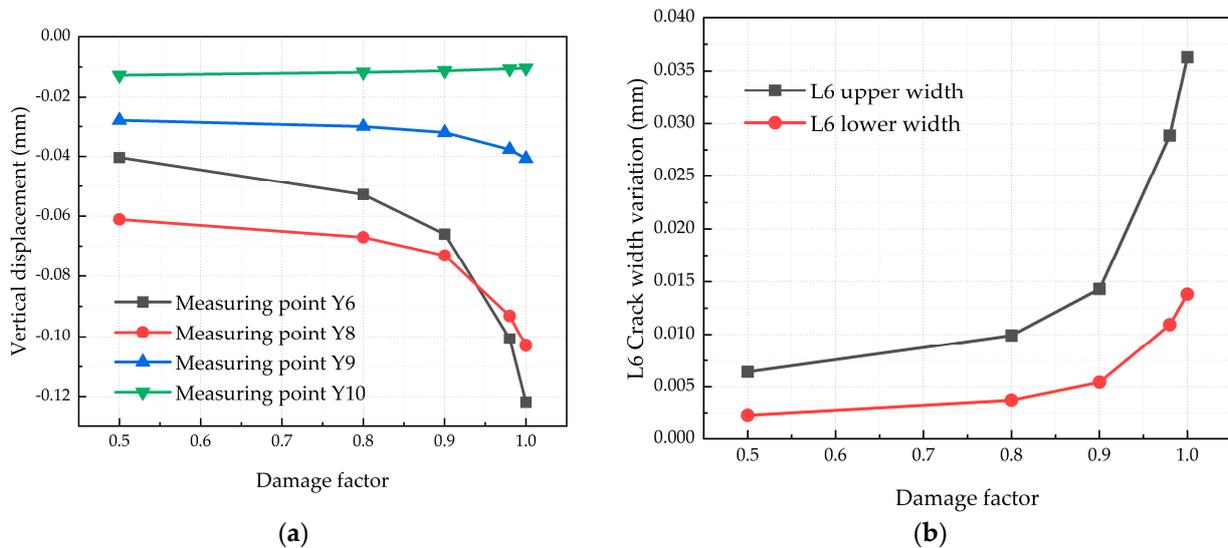
Figure 18. (a) Variation curve of the vertical displacement of each measurement point with the damage factor of cracked slates; (b) variation curve of the increase of the L6 crack width with the damage factor of cracked slates.

The settlement of Y6, Y8, and Y9 gradually increased and the settlement of Y10 decreased with the increase of damage factor, and the change rate increased with the increase of the damage factor of L6. Y9 settlement started to increase sharply and entered the stage of rapid change. At the same time, the L6 cracks still showed the typical tensile fracture characteristics of “wide at the top and narrow at the bottom”, and the width of the cracks kept increasing as the damage of the cracked rocks intensified. When the damage factor of the cracked slate exceeded 0.9, the L6 crack width started to increase sharply and entered the stage of rapid change.

According to the evolution law of vertical displacement and the L6 width change rate of measurement points, the change process can be divided into three stages: the initial uniform change stage (damage factor less than 0.8), the middle accelerated change stage (damage factor between 0.8 and 0.9), and the late rapid change stage (damage factor greater than 0.9). When the damage factor exceeded 0.9, the vertical displacement of each measurement point and L6 crack width entered the late rapid change stage; based on the principle of preventive protection, the damage factor could reach 0.9 blocks, serving as a sign that the top plate of the Yuanjue Cave is entering the early warning state of instability, that is, the critical value of the damage factor is 0.9.

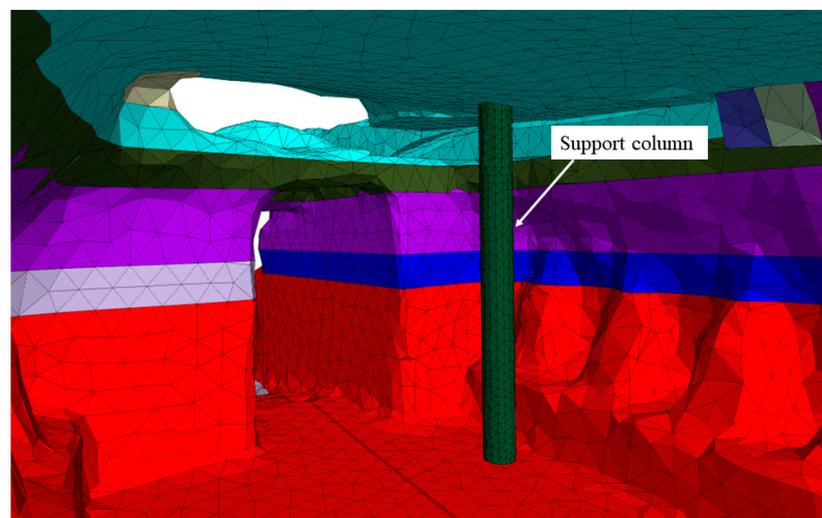
Figure 19. Three-dimensional geological model of Yuanjue Cave with a support column.

(2) Set the support column: firstly, the position where the roof support stress is the largest or close to the bearing capacity was analyzed, and the reasonable support position in the cave was determined according to the position requirement of the support member in the cave space (Figure 19). According to the previous survey results, the severely damaged stones are mainly distributed in the front and middle of the left side of the entrance of Yuanjue Cave, and the maximum displacement of the damaged slates in the numerical simulation results is also in the area. Therefore, it is proposed to adopt a support column with strong vertical stability as the support scheme. A circular support column should be set between the first and second Buddha statues on the right side of the cave entrance.
