# Effect of Thin Cement-Based Renders on the Structural Response of Masonry Wall Panels

Marco Corradi \*

Department of Engineering, University of Perugia, Via Duranti 93, 06125 Perugia, Italy;  
rominasisti@hotmail.it (R.S.); antonio.borri@unipg.it (A.B.)

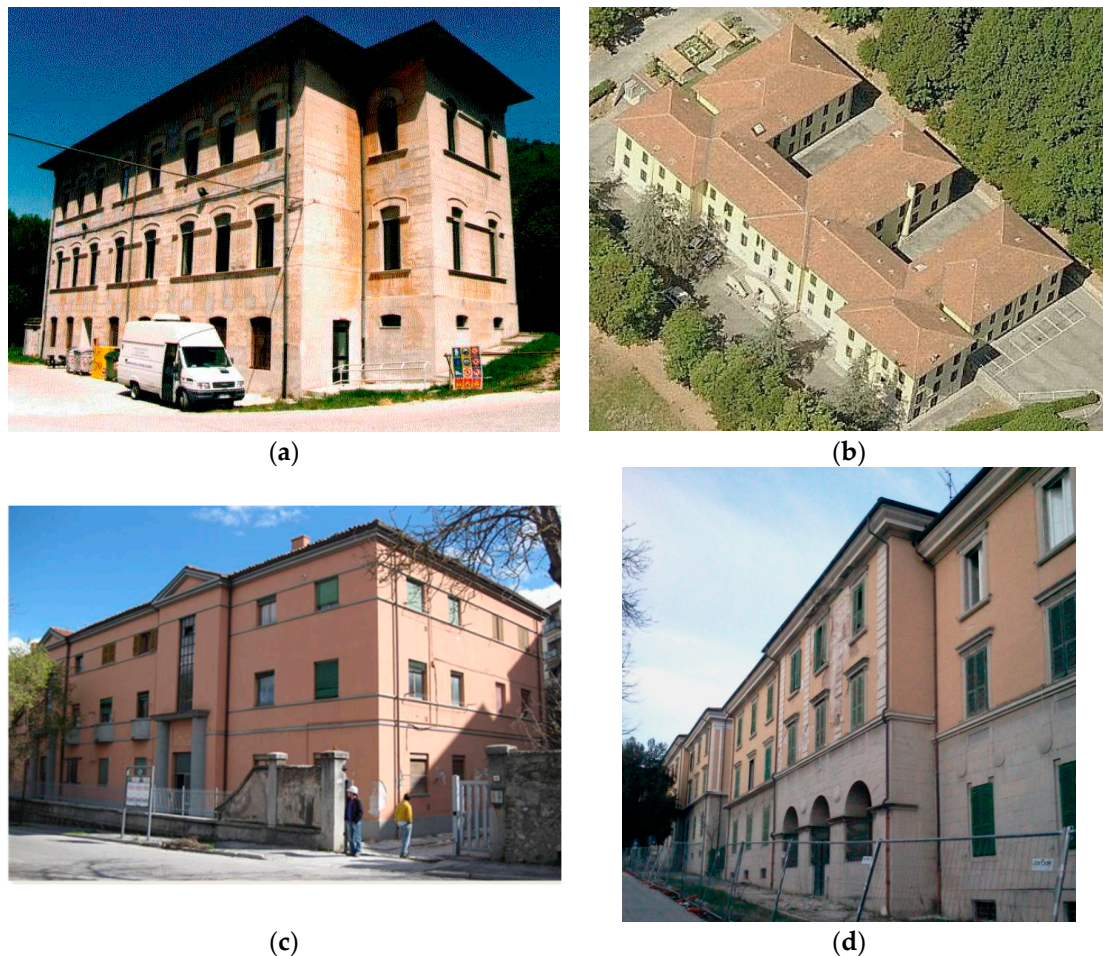
**Figure 1.** The four historic buildings where tests were carried out: (a) Building No. 1 (located in Belfiore, Foligno, Italy); (b) Building No. 2 (located in Lucca, Italy); (c) Building No. 3 (located in Porta Napoli, L'Aquila, Italy); (d) Building No. 4 (located in Via 20 Settembre, L'Aquila, Italy).

An experimental testing program was implemented to investigate the effect of thin cement-based renders on the structural behaviour of historic wall panels. Four masonry buildings have been selected for the experimental campaign. All of them were erected in the 1900–1920s, using barely-cut stones, solid engineering bricks and a lime based mortar. Figure 1 shows the four buildings.

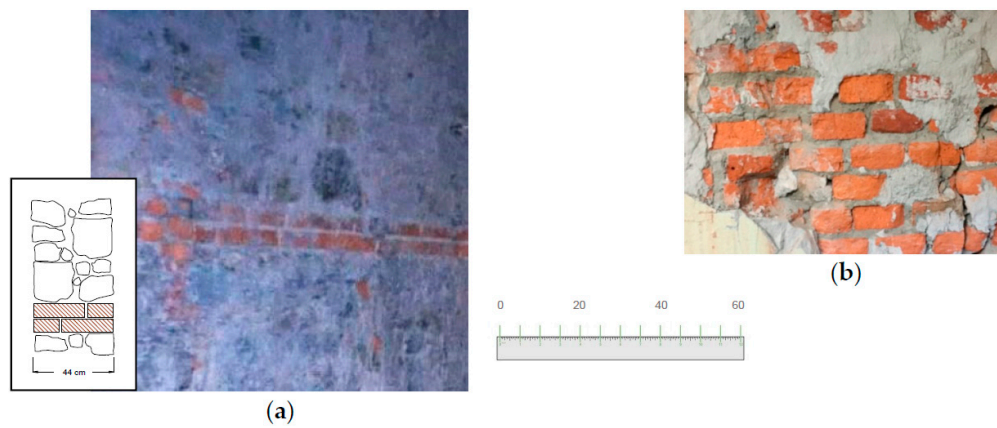
**Figure 3.** Masonry typologies of Building No. 2: (a) Stone work; (b) Brickwork, (dimensions in cm).

The buildings are comparatively simple functional structures built from locally available materials with a minimum of decoration. Walls were made of stones (Figures 2a, 3a and 4) or solid bricks (Figures 2b and 3b). The stone panels, typically used for the ground floor walls, were approximately 45–70 cm thick and were made of similar barely-cut calcareous stones with a high weight density (approx.  $2540 \text{ kg/m}^3$ , Coefficient of variation 14.1%). These were double-leaf walls, with no through stones between the leaves. Two courses of solid bricks were placed at regular intervals of 90–110 cm. The dimensions and the shape of the stones were also similar for the buildings: stones had a parallelepiped shape with longest dimensions of approx. 35–45 cm, placed horizontally and parallel to the plane of the wall.

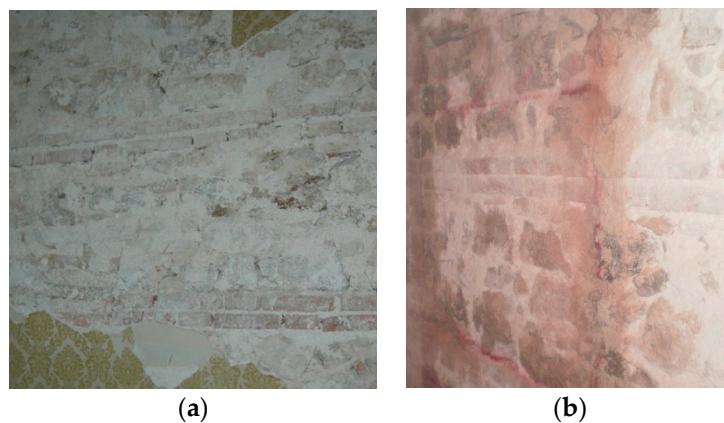
**Figure 4.** Stone masonry typologies: (a) Building No. 3; (b) Building No. 4.

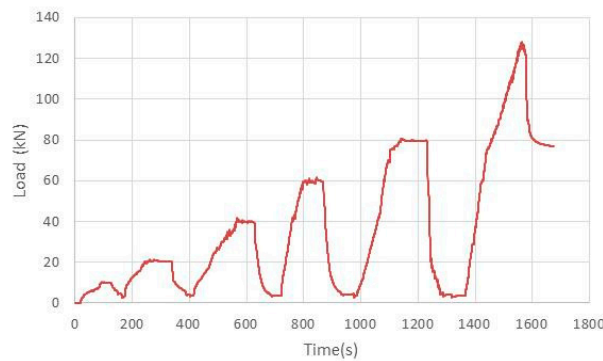
Figure 5. Typical load history of a diagonal tension test.

For both compression and shear tests, load was applied using manually controlled load steps. Wall specimens were subjected to cyclic loading by means of 100 tons-hydraulic jacks which were fixed to a steel reaction frame. A typical load history of a diagonal tension test is shown in Figure 5. All tests were carried out on-site. Figure 6 shows the location of either the instrument itself (hydraulic jacks, loading frames, etc.) or the attachment point to the wall panel for the instrumentation that was common to all specimens subjected to a compression or shear test, respectively.

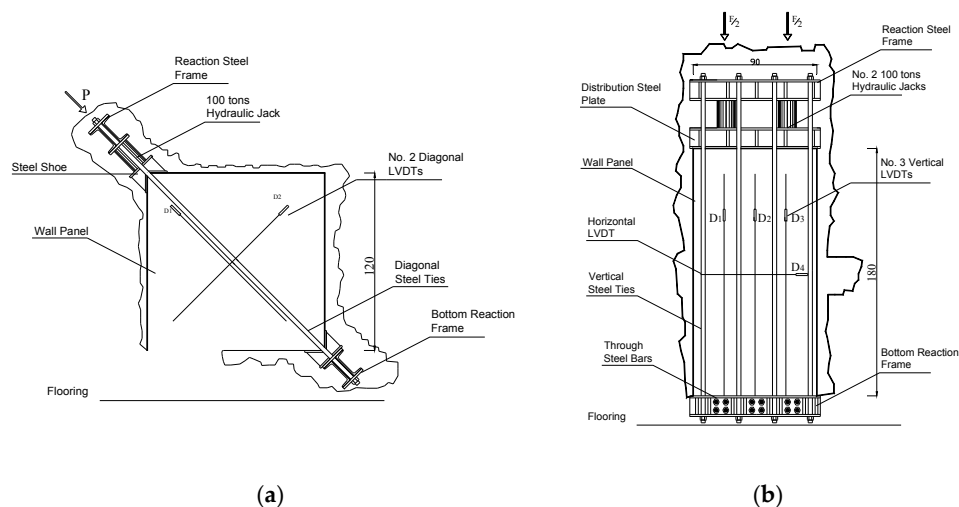
Figure 6. Instrumentation and test layout: (a) Diagonal tension test; (b) Compression test (dimensions in cm).

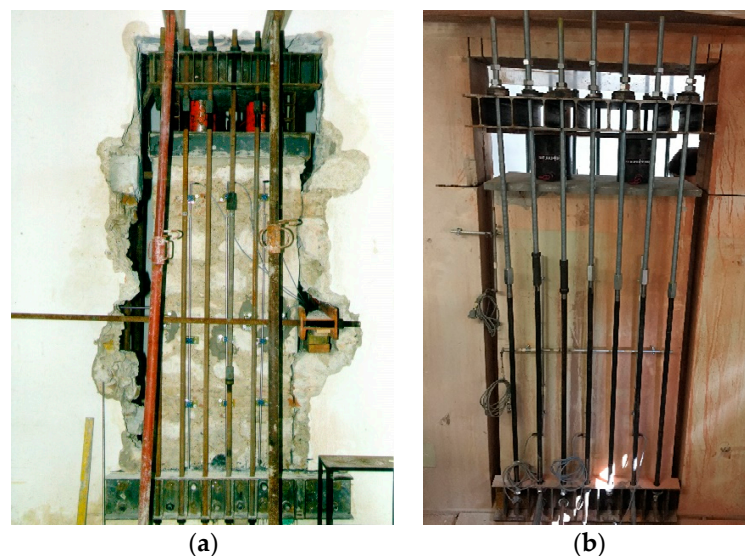
Figure 7. Compression tests: (a) C-01-S; (b) C-06-B.

Non-rendered wall panels were loaded until vertical cracks formed in the mortar joints, then loading continued and the compressive strength was determined. This typical failure mode is shown in Figure 7a. For the stone panel, a compressive strength of 0.796 MPa was found and, for the brickwork one, a value of 1.84 MPa could be calculated. Corresponding strain values were found to be 0.00158 and 0.00146, respectively. The deformation response of both stone and brick masonry walls was incrementally nonlinear and dependant upon the level of the compressive load.

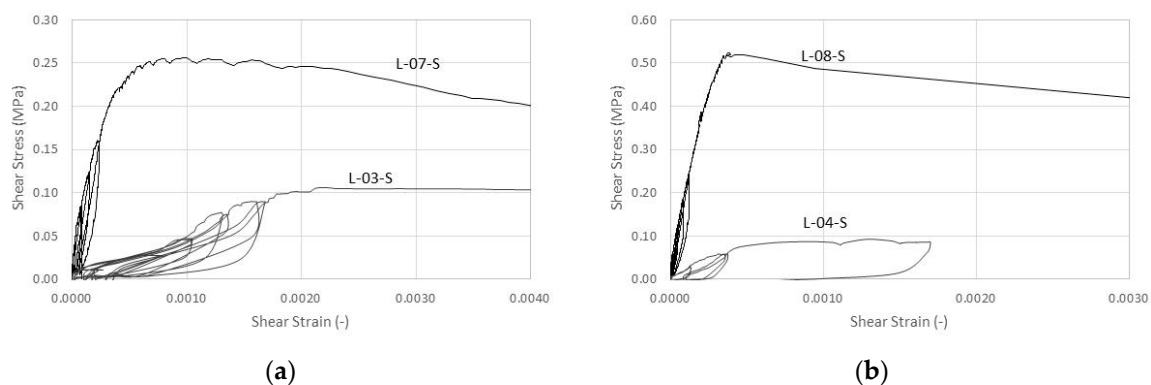
**Figure 8.** Shear tests carried out on panels cut off from Building No. 1 (non-rendered panels) and 2 (rendered panels): (a) Stone work panels; (b) Brickwork panels.

Contrary to compression tests, ultimate strengths were noted to have significantly increased when a cement-based render was utilized (Figure 8). Interestingly, these shear strengths ( $\tau_0$ ) were higher—on the order of 0.081 and 0.165 MPa for stone and brickwork panels, respectively—than was expected considering the existing literature. With regard to the softening branch of the response curves shown in Figure 8, limited qualitative information is available from the tests. Tests were carried out using hydraulic jacks with little control on the displacement rate. For stone non-rendered masonry panels, the maximum loads are similar in magnitude to the ultimate load (residual strength). This is typical for masonry of low quality [38]. The softening branch of the rendered stone and brick panels was slightly different with a larger reduction in strength.

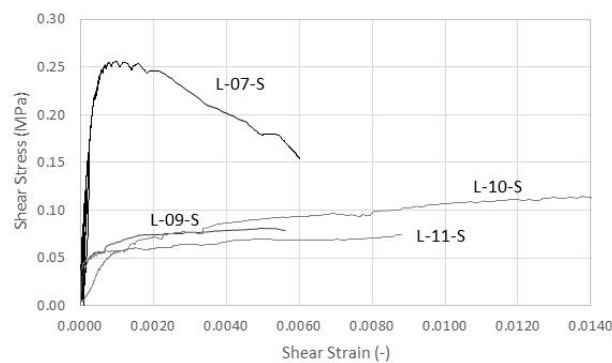
**Figure 9.** Shear tests carried out on stone work panels cut off from Building No. 2 (rendered panels) and Nos. 3 and 4 (non-rendered).

The Italian Building Code (Guidelines [37]) and the long experience of the authors [13,14,22] demonstrate that the shear strength of an irregular double-leaf stone wall is rarely higher than 0.03–0.04 MPa. All un-rendered stone work panels exhibited a shear strength in the range of 0.022–0.036 MPa (Figure 9). The average value of the shear strength was for these panel 0.0283 MPa.

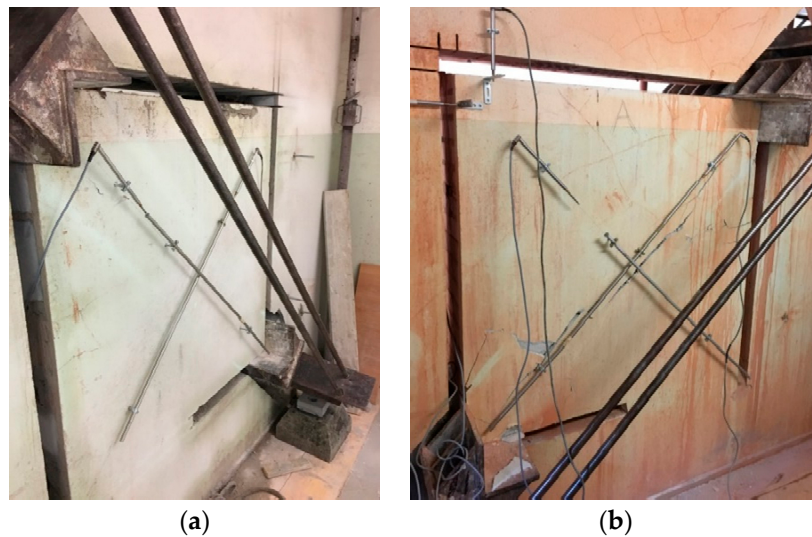
**Figure 10.** Shear tests (rendered wall panels): (a) L-07-S; (b) L-08-B.

The predominant failure mode of rendered and non-rendered panels was in shear, which can be classified as a type of brittle tension failure with characteristic diagonal cracks along the diagonal in compression (Figure 10). Diagonal failure denoted tensile shear cracking at the center of the wall panel which afterwards began to behave as a rigid body, i.e., without further demolition of the wall specimen. The render did not detach from the masonry substrate during the test (Figure 10b).

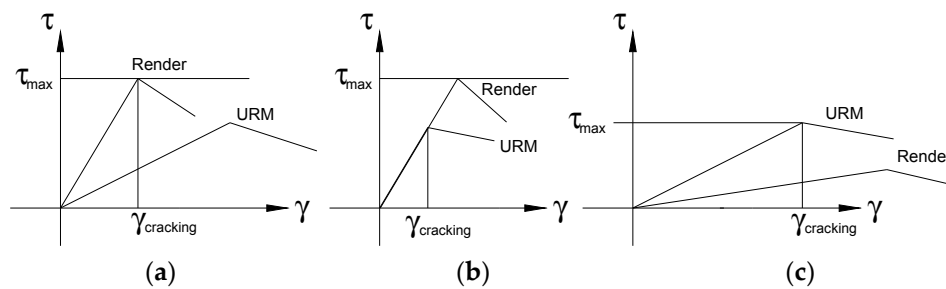
**Figure 11.** Effect of non-perfect plastic behavior: (a) typical case for high-strength (cement-based) render; (b) typical case of a lime-based render; (c) typical case of low-strength (i.e., soft thermal-insulating coating).

Clearly, the error produced by using Equation (14) for non-perfect-plastic elastic materials depends on how scattered the  $\tau$ - $\gamma$  plots are (and therefore the ratio between the shear moduli), the shear strengths  $\tau_0$  of the two materials and the post-elastic behaviour. This can partially explain the overestimation of the lateral capacity found for stone panels.
