# Failure Monitoring and Condition Assessment of Steel-Concrete Adhesive Connection Using Ultrasonic Waves

Magdalena Rucka

Department of Mechanics of Materials and Structures, Faculty of Civil and Environmental Engineering,  
Gdansk University of Technology, Narutowicza 11/12, 80-233 Gdansk, Poland;  
magdalena.rucka@pg.edu.pl or mrucka@pg.edu.pl; Tel.: +48-58-347-2497

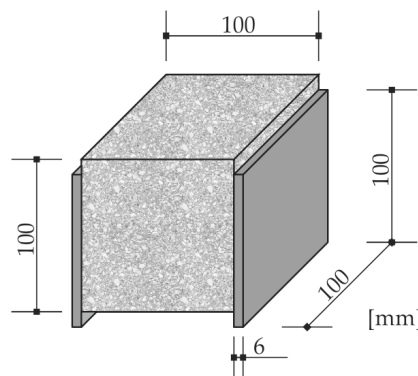
Nine steel-concrete specimens (#1 to #9) were tested in this study. Each push-out specimen consisted of two steel plates and a concrete cube (Figure 1). The plates of dimensions  $6 \times 100 \times 100 \text{ mm}^3$  were made of structural steel S235. The cube of dimensions  $100 \times 100 \times 100 \text{ mm}^3$  was made of concrete including the following ingredients: Portland cement type CEM I 42.5R ( $325 \text{ kg/m}^3$ ), sand 0–2 mm ( $764 \text{ kg/m}^3$ ), fine aggregate 2–8 mm ( $573 \text{ kg/m}^3$ ), coarse aggregate 8–16 mm ( $573 \text{ kg/m}^3$ ) and water ( $175 \text{ kg/m}^3$ ). The adhesive connection at the steel-concrete interface was made with the use of high-strength, two-component structural epoxy paste adhesive SIKADUR 30. The bonded area was  $100 \text{ mm} \times 90 \text{ mm}$  on each surface of the concrete cube and the lap-joint thickness was about 1 mm.

Figure 1. Geometry of push-out specimen.

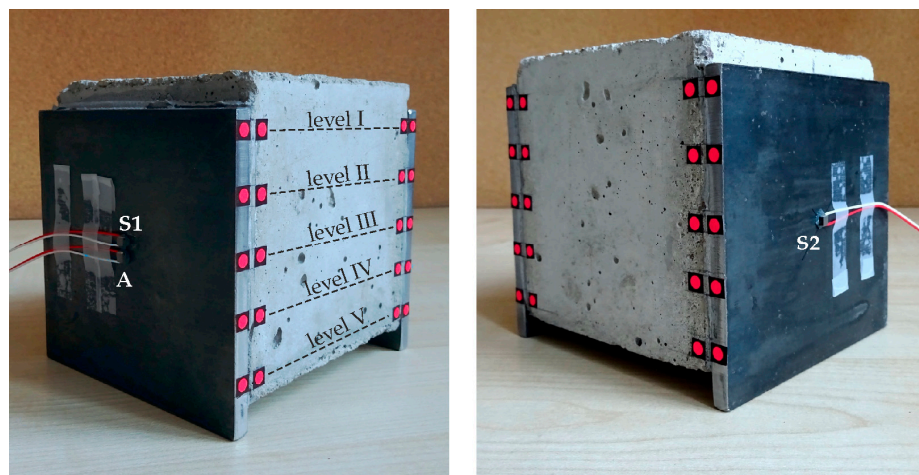
piezoelectric actuators NAC2024 manufactured by Noliac were used for both excitation and registration of wave propagation signals. They were adhesively bonded to the steel plates using petro wax (PCB 080A109). The configuration of piezoelectric transducers is given in Figure 2. The actuator (A) was bonded at the center of the left steel plate. The first sensor (S1) was attached next to the actuator, while the second one (S2) was attached at the center of the right steel plate. An arbitrary waveform generator (Tektronix AFG3022C) created an excitation signal in the form of a wave packet composed of a 5-cycle sine with a central frequency of 60 kHz modulated by the Hanning window (Figure 4). Then the signal was amplified 20 times by a high voltage amplifier (FLC Electronics AB A400DI). A digital oscilloscope (PicoScope 4824) was used to collect time signals of propagating waves with a sampling frequency of 20 MHz.

**Figure 2.** Steel-concrete specimen with attached piezoelectric actuator (A) and sensors (S1, S2).

Experimental procedure included simultaneous push-out and wave propagation testing. Push-out tests were performed in the testing machine Zwick Z400 equipped with a compression test kit. The force and the displacement of the cross-head were recorded. The preload applied to the specimen was equal to 100 N. Then, each steel-concrete specimen was loaded with the speed of the crosshead of 0.1 mm/min up to the failure. Additionally, photographs were taken every 2 s on the front side of the specimen by the Canon EOS 5D III digital camera to observe the damage evolution and to determine the slip between steel and concrete. At each specimen, 10 pairs of magenta points with a diameter of 4 mm were attached at five levels (levels I to V, as indicated in Figure 2).

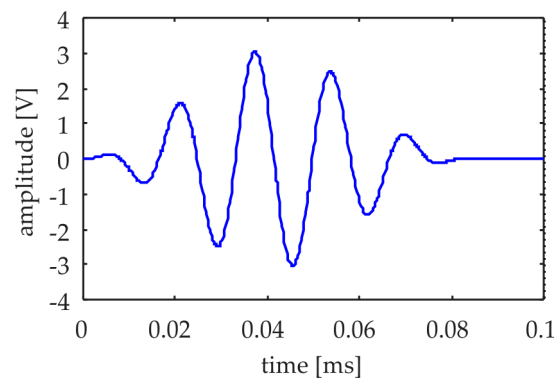
Figure 4. Excitation signal.

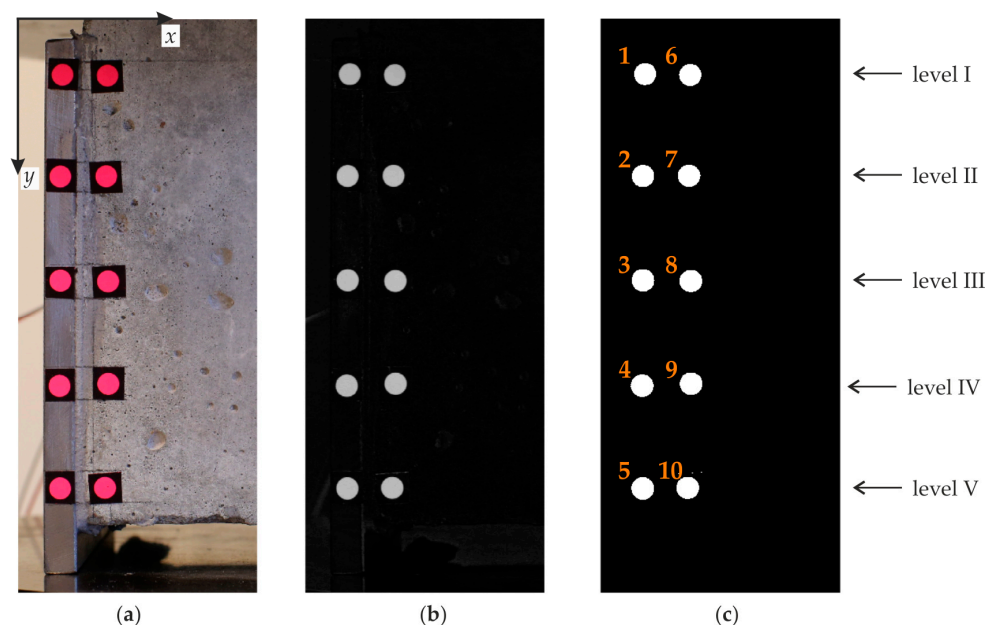
The interface slip between the steel plate and concrete cube was determined using a photogrammetric technique (c.f. [34]). The digital RGB photograph (Figure 5a) was transformed into the CMYK space according to the formula

where colors are marked as follows:  $c$ —cyan,  $m$ —magenta,  $y$ —yellow,  $k$ —black,  $r$ —red,  $g$ —green,  $b$ —blue. From the CMYK space, a component connected with magenta color was chosen for further processing (Figure 5b) in which the photograph was converted into a binary image with a threshold of 0.25 (Figure 5c). Then, for given points, the centers of gravity were calculated and the interface slips in  $x$  and  $y$  directions were determined at five levels (levels I to V).

Figure 5. Digital photograph of the left adhesive joint: (a) RGB photograph; (b) magenta component; (c) binary image.

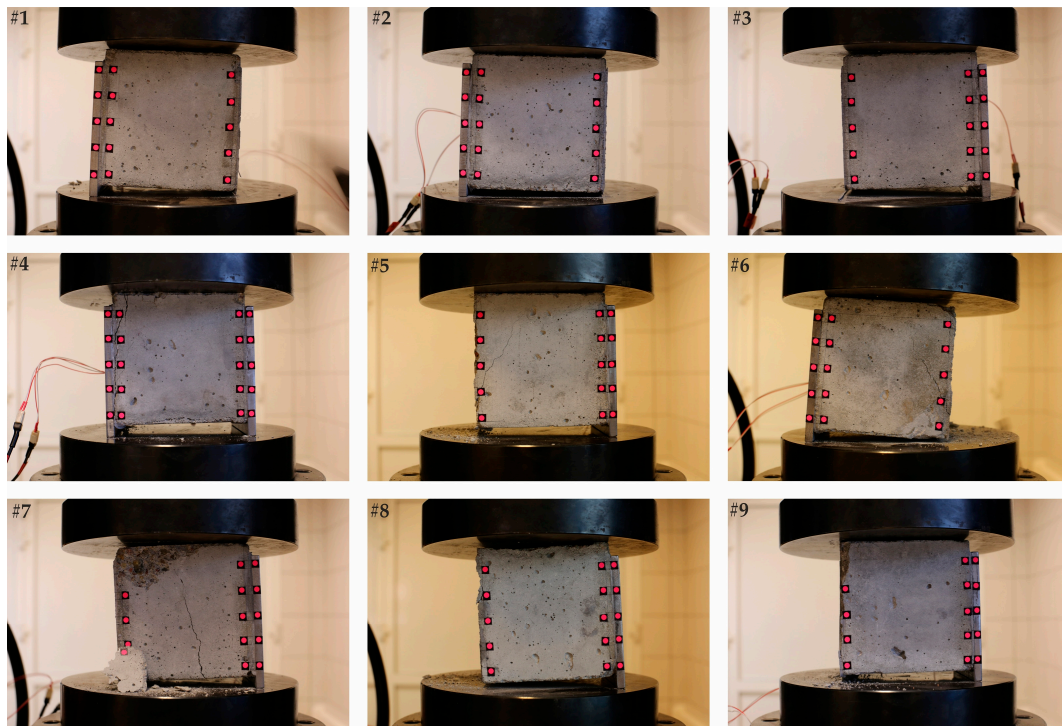
Figures 6 and 7 illustrate all push-out specimens after failure. The specimens were divided into two sets according to observed failure modes. Mode I (specimens #1–#3) was an adhesive-type failure occurring at the interface between the steel plate and the adhesive layer. No damage was observed in the concrete cube. The entire adhesive layer remained on the concrete. Mode II (specimens #4–#10) included a cohesive-type failure or mixed cohesive-adhesive failure. In mode II, three sub-groups were distinguished: mode IIa (specimens #4–#6), mode IIb (specimen #7) and mode IIc (specimens #9–#10). The damage in modes IIa and IIb included two phases. In the first phase, the damage was mainly cohesive with a failure in the bulk of the concrete cube. The second phase was a separation of the steel plate from the concrete. In mode IIa, a single diagonal crack originated from the interface between steel and concrete, and then the cohesive (specimen #6) or mixed cohesive-adhesive failure (specimens #4, #5) occurred in the bulk of the adhesive layer. In mode IIb, a crack appeared in the middle of the concrete cube and then the adhesive failure occurred. The failure in mode IIc was cohesive (specimen #8) and mixed adhesive-cohesive (specimen #9) with a separation in the bulk of the adhesive layer.

**Figure 6.** Failure modes of tested steel-concrete specimens (last stage in the testing machine): mode I including specimens #1 to #3—adhesive failure and mode II including specimens #4 to #10—cohesive-type failure or mixed cohesive-adhesive failure.

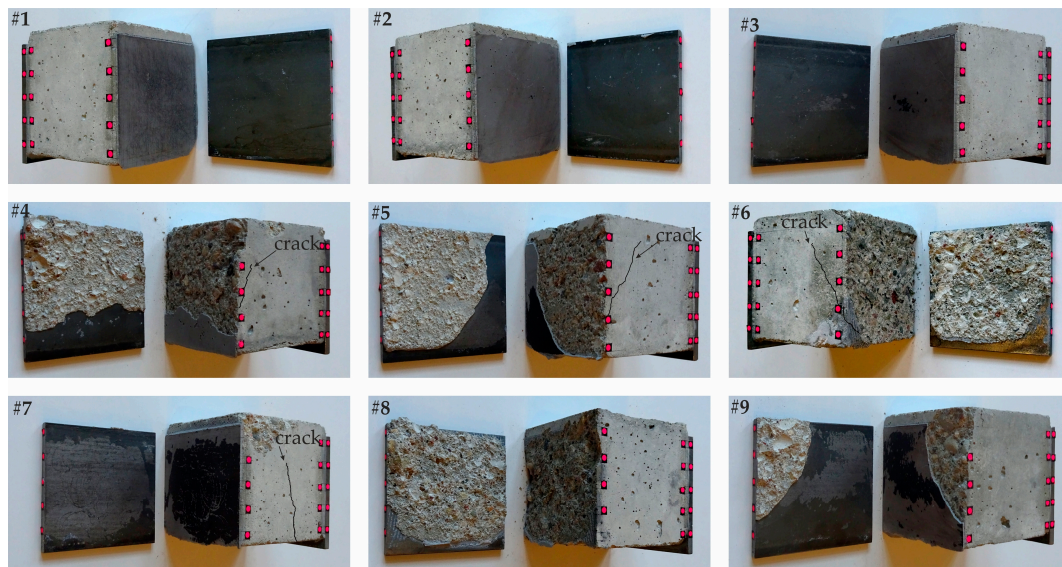
**Figure 7.** Failure modes of tested steel-concrete specimens (photographs of the damaged steel-concrete interface after removing from the testing machine): mode I including specimens #1 to #3—adhesive failure and mode II including specimens #4 to #10—cohesive-type failure or mixed cohesive-adhesive failure.

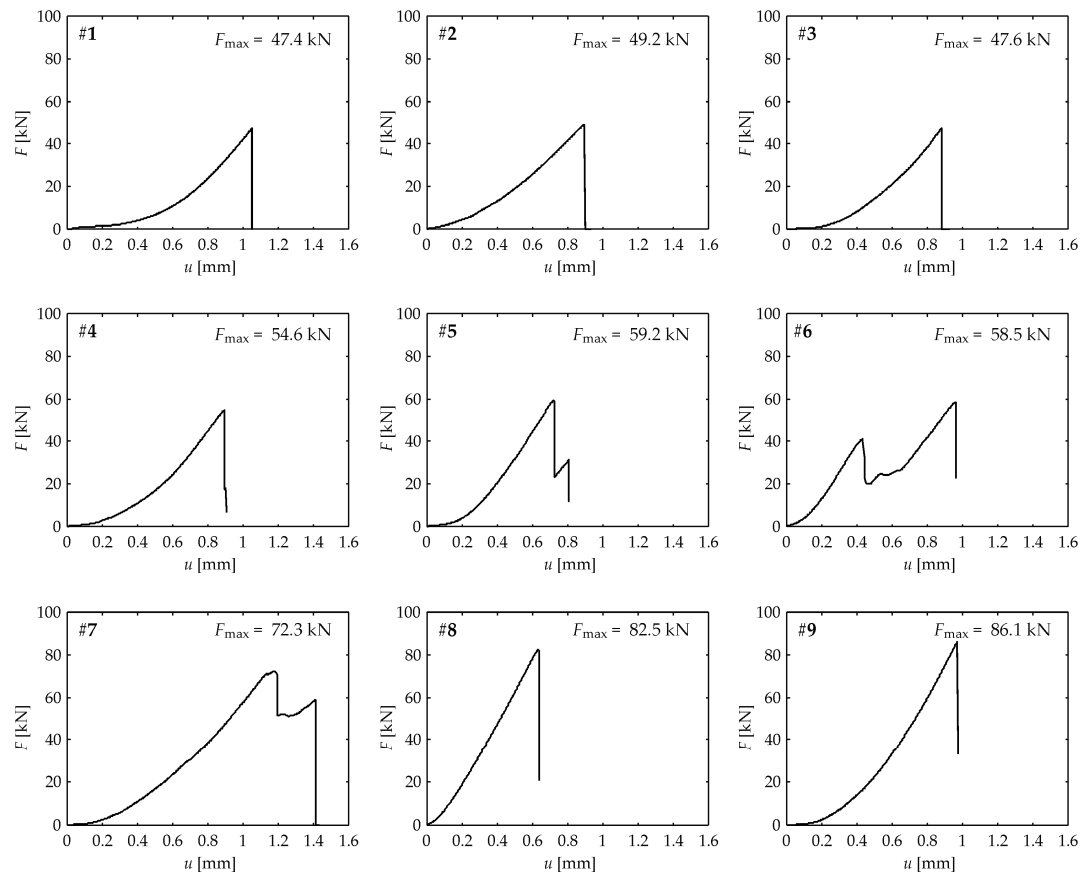
Figure 8 shows the force-displacement curves for all tested specimens. In mode I, the shape of curves for each specimen is similar. The sudden drop of the force at the moment of the adhesive failure can be observed. The maximum force was 47.4 kN (specimen #1), 49.2 kN (specimen #2) and 47.6 kN (specimen #3). The curves for the specimen failures categorized as modes IIa and IIb exhibited two drops of the force. The first drop is associated with the appearance of the crack in the concrete,

while the second is associated with the separation of the steel plate. In the case of specimens with diagonal cracks, the maximum force was 54.6 kN (specimen #4), 59.2 kN (specimen #5), 58.5 kN (specimen #6). For the specimen with the crack in the middle of the concrete cube (specimen #7), the maximum force was 72.3 kN. The last two curves corresponding to mode IIc are characterized by the sudden drop of the force at the moment of the cohesive or mixed adhesive-cohesive failure. The maximum force was 82.5 kN (specimen #8) and 86.1 kN (specimen #9).

**Figure 8.** Experimental force-displacement ( $F$ - $u$ ) curves of tested push-out specimens (#1–#9).

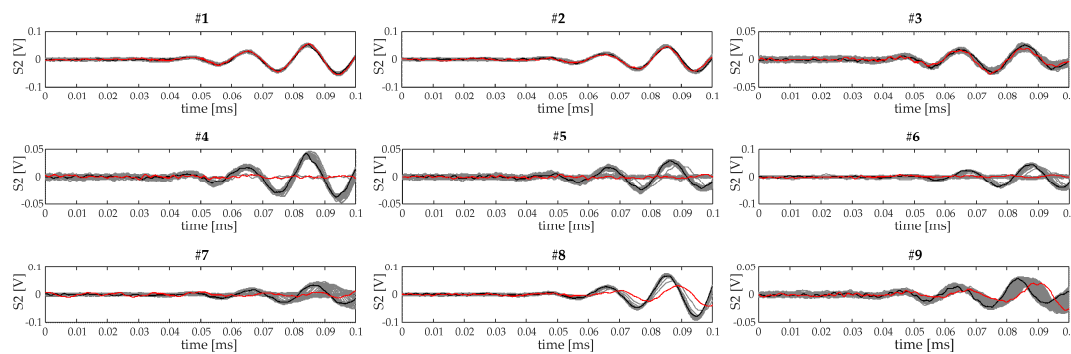
The ultrasonic waves were registered automatically every 2 seconds during push-out testing. All signals acquired by sensor S2 for specimens #1 to #9 are illustrated in Figure 10. Only an initial part of the signal with a length of 0.1 ms was analyzed to reduce the influence of interactions of waves with the compression test kit of the testing machine. The reference signal, i.e., the signal registered at the beginning of the push-out test is marked in black and the last acquired signal is marked in red. For specimens #1–#3, representing the adhesive-type failure (mode I), signals relating to successive states of mechanical degradation are similar and no significant changes in the magnitude or phase can be observed. In the case of push-out specimens #4–#10, for which the cohesive or mixed adhesive-cohesive failure occurred (mode II), experimental waveforms changed considerably during mechanical degradation.

**Figure 10.** Wave propagation signals registered during monitoring of steel-concrete push-out specimens (#1–#9); the first signal (reference) is given in black, the last registered signal in given in red, all other signals are given in grey.

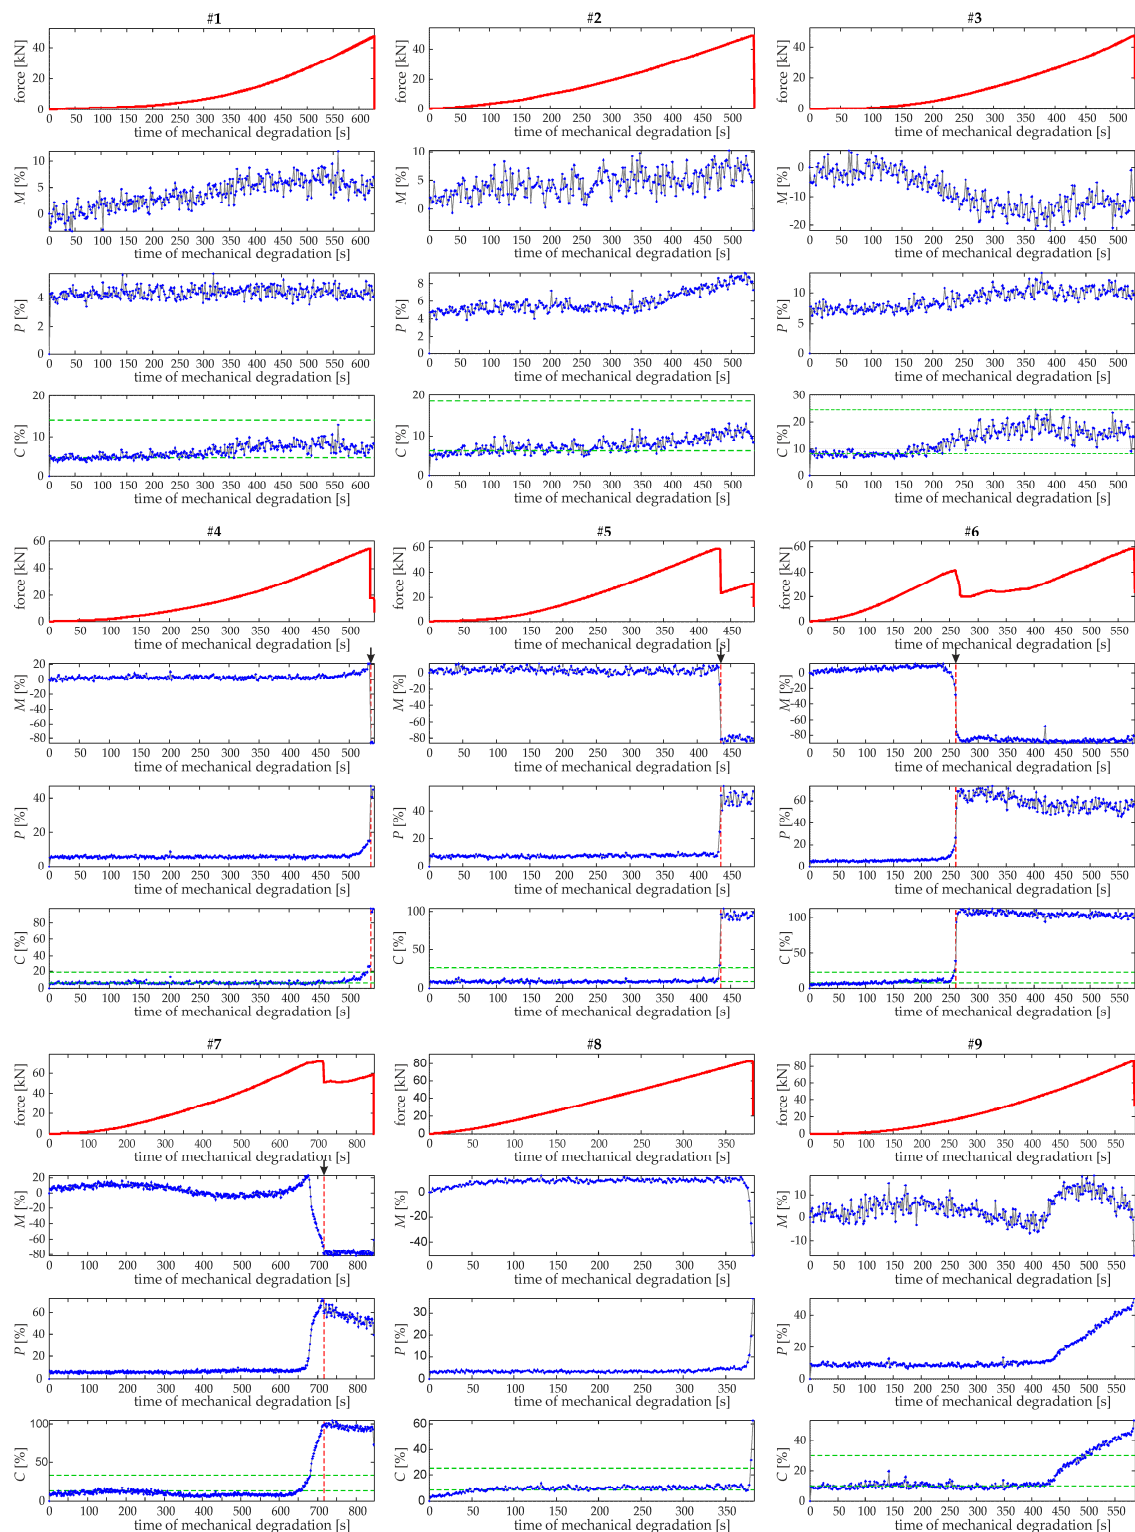
The results of applying the Sprague and Geers metric to all signals registered during the monitoring of the push-out test are presented in Figure 11. For clarity of observation, the load-time curves were provided for each specimen. Additionally, for specimens #4–#7, red dashed lines were drawn at the moment of initiation of the crack in the concrete cube. The S&G metric expresses the difference between the reference signal and the other signals registered during the push-out test. The error measures can range from 0 to 1 or more. The perfect agreement of time histories results in a zero value of the error measures, while the value of unity indicates a difference of 100%. The value of the *P*-error is always positive while the value of the *M*-error can be positive or negative, depending on whether the monitored signal has higher or lower amplitude than the reference signal. At the beginning of the process, the *P*-error fluctuated around the value of about 5% and the *M*-error around the value of about 0%. These values resulted from the presence of measuring noise in the subsequently triggered measuring signals.

Considering the specimens with the adhesive-type damage (the first row in Figure 11), all error measures are rather constant during the entire push-out test. A slight increase in the *P*-error value was observed for specimen #6; however, based on these errors it was not possible to detect incoming damage before the failure.

The second group are specimens belonging to failure modes IIa and IIb, for which the separation between the steel plate and concrete was preceded by the cracking of concrete. For specimens #4, #5 and #6, the increase in the *P*-error can be observed before the initiation of the diagonal cracks. This increase was quite sudden for specimen #5, but for specimens #4 and #6 it was gradual signaling incoming damage. Moreover, for specimen #6, the *M*-error gradually decreased before the initiation of the diagonal cracks. In the case of specimen #7, for which the crack appeared in the middle of the concrete cube, the gradual increase of the *P*-error and the decrease in the *M*-error can be seen, enabling detection of the micro-crack zones in the concrete long before the appearance of the macro-crack.

The last two specimens represented the failure of mode IIc. For the specimen #8, the detection of the cohesive failure was possible based on both the *M* and *P*-errors. In the case of specimen #9, the gradual increase of the *P*-error was observed (similarly as for specimen #2) indicating the increase in the load but not the appearance of the failure. This was because, the failure of specimen #9 was mainly adhesive, with a small area at which the cohesive failure occurred.

As a damage indicator, the C-error is proposed because it contains both the magnitude and phase errors. For each specimen, two horizontal lines were drawn in the plots of the comprehensive error (Figure 11). The first line is a mean of the 100 first values of the C-error and it determines a baseline. The second line is the baseline multiplied by a coefficient and it represents the state of possible damage. In this study, the value of the coefficient was set a priori as 3, however, in potential applications of structural monitoring, it should be verified based on comprehensive experimental data. Based on the indicator, it was not possible to recognize the upcoming separation between steel and concrete in any specimen with the adhesive failure (specimens #1–#3). In the case of specimens exhibiting the cohesive

or mixed adhesive-cohesive failure, the gradual increase of the C-error enabled earlier detection of potential damage.

**Figure 11.** S&G metric errors (magnitude error  $M$ , phase error  $P$ , comprehensive error  $C$ ) during subsequent phases of degradation of push-out specimens (#1–#9).
