Article

Experimental Study on Corrosion Development Model and Fatigue Performance of Strand Steel for Coastal Structures

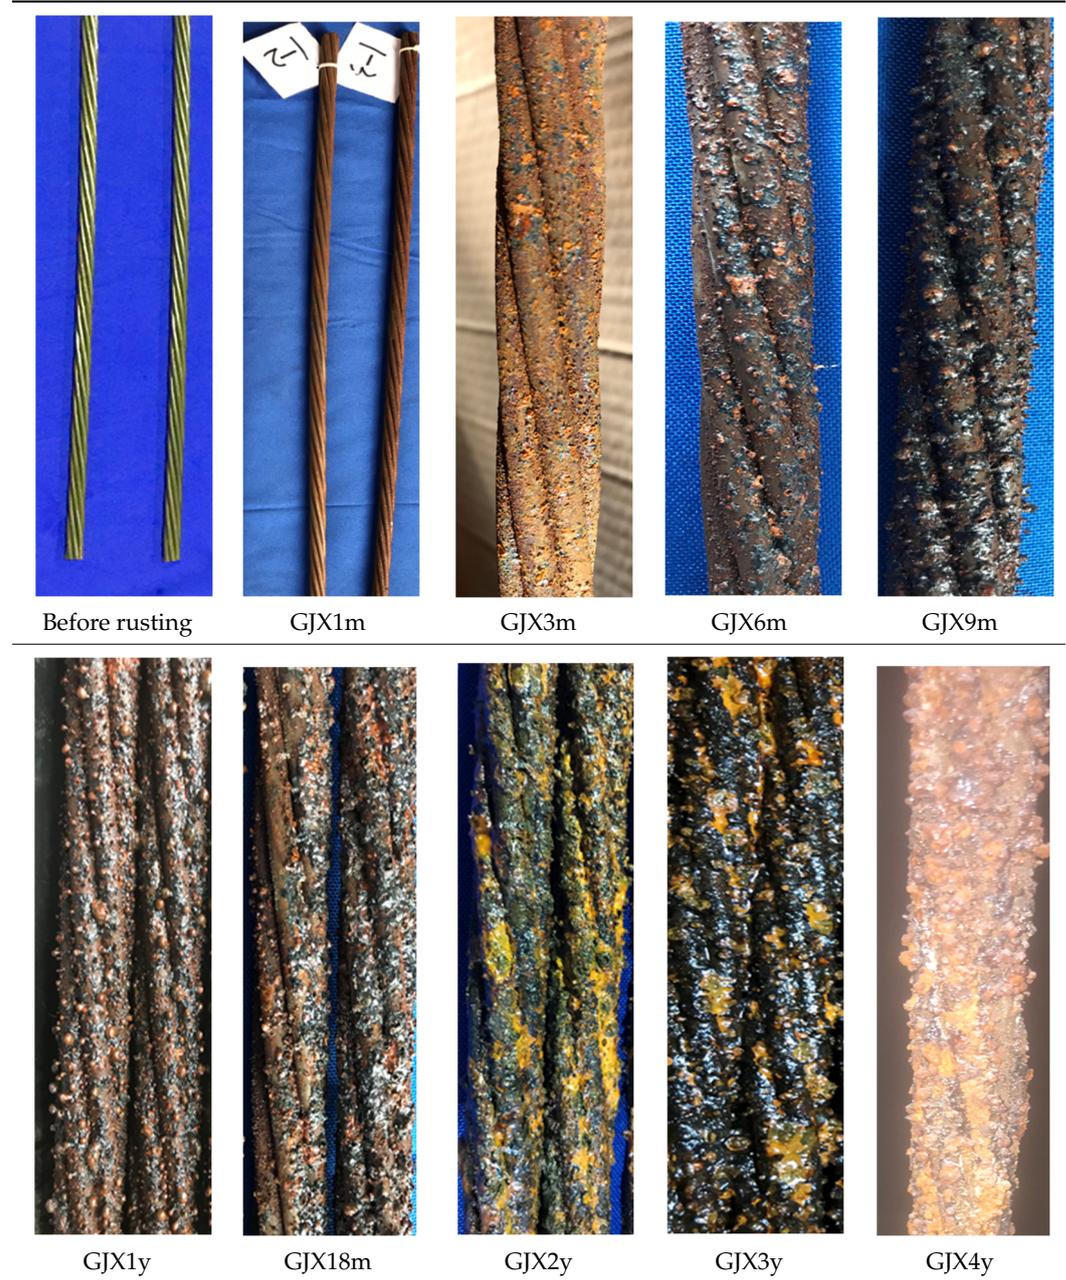
Table 2. Corrosion of unstressed steel strands at different corrosion times.

The corrosion appearance of the samples is shown in Table 2. Steel strands with different corrosion times were weighed and measured. Then, the test data were analyzed, and the time-varying model of the average mass corrosion rate of the steel strand and the corrosion pit development model were obtained.

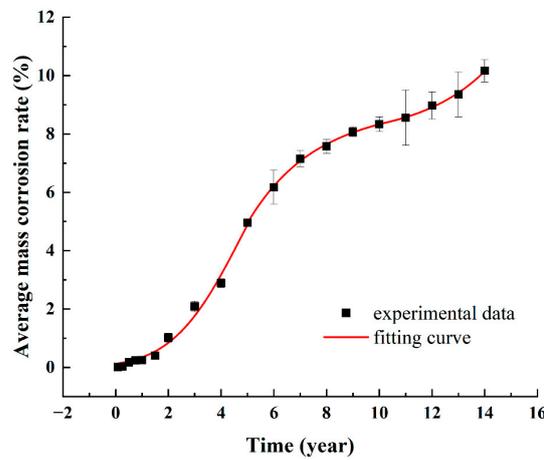
The corrosion time in the laboratory environment was converted to the service time of the steel strand in the real environment. The curve of the corrosion ratio of the steel strand in the real environment versus the service time is shown in Figure 1. The time-varying model of the average mass corrosion ratio of the steel strand is expressed in Formula (2).

Figure 1. Variation curve of average mass corrosion ratio with time.

$$\eta = \begin{cases} e^{-2.113+1.125t-0.077t^2} & t \leq 5 \\ 8.914 - 26.682 \times 0.683^t & 5 < t < 10 \\ e^{2.720-0.137t+0.008t^2} & t \geq 10 \end{cases} \tag{2}$$

Figure 1 shows that the corrosion of the steel strand develops considerably slowly in the first year, relatively slowly from the first to second years, and rapidly from the second to eighth years. The average corrosion ratio at 8–12 years remains at approximately 8.5%, indicating that the corrosion degree is relatively stagnant at this time. At 12–15 years, the slope of the average ratio increases. Compared with that in the previous years, the corrosion rate significantly increases. The above piecewise rusting pattern is more intuitively shown in Figure 2.

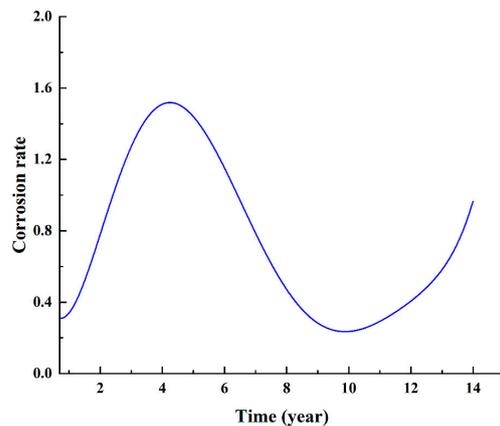
Figure 2. Variation curve of average mass corrosion rate with time.

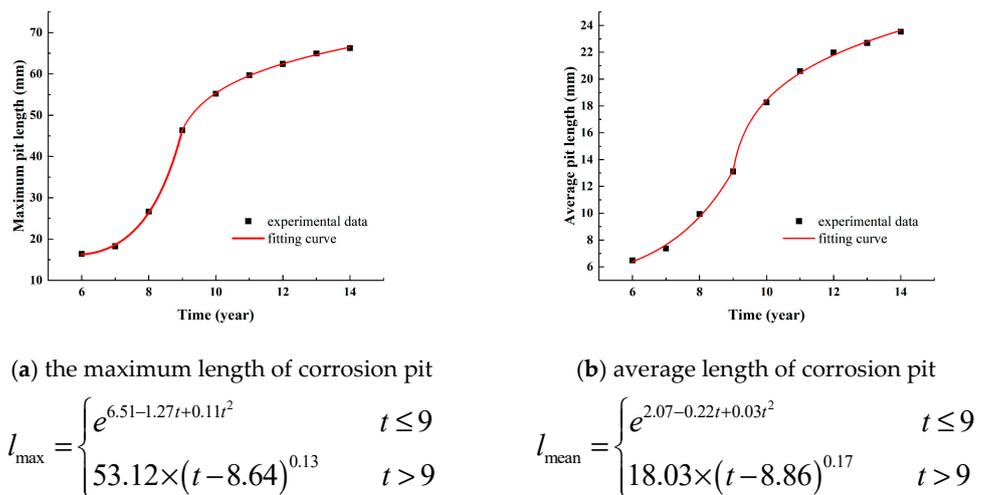
Figure 3. Time-varying fitting curve of corrosion pit length.

The size of the corrosion pit on the surface of a parallel steel wire can be observed by using a Bruker surface profile roughness tester; however, the steel strand was a spiral. With the extension of the length direction, the height of the outer surface of the steel wire changes. Measuring the corrosion pit becomes difficult, and the corrosion pit data cannot be automatically obtained by the machine. For pits with a length or width less than 10 mm, the surface size of them can be accurately measured. For pits with a length or width greater than 10 mm, the surface sizes of these pits cannot be accurately measured by the instrument. Thus, a ruler was used to measure the length and width of the pits. To ensure accuracy, the readings were kept to one decimal place, and the accuracy control bit was 0.01 mm. A micrometer with an accuracy of 0.001 mm was used to measure the difference between the bottom and the outside of the corrosion pit, and the depth of the corrosion pit was determined by performing calculations. The length of the corrosion pit was measured along the length of the steel strand, and the width of the corrosion pit was measured along the radial dimension of the steel strand. The curves of the maximum length and average length of the corrosion pit of the steel strand versus the corrosion time are shown in Figure 3. The curves of the maximum width and average width of the corrosion pit of the steel strand versus the corrosion time are shown in Figure 4. The curves of the maximum depth and average depth of the corrosion pit of the steel strand versus the corrosion time are shown in Figure 5, which are similar to those with the earlier date [8].

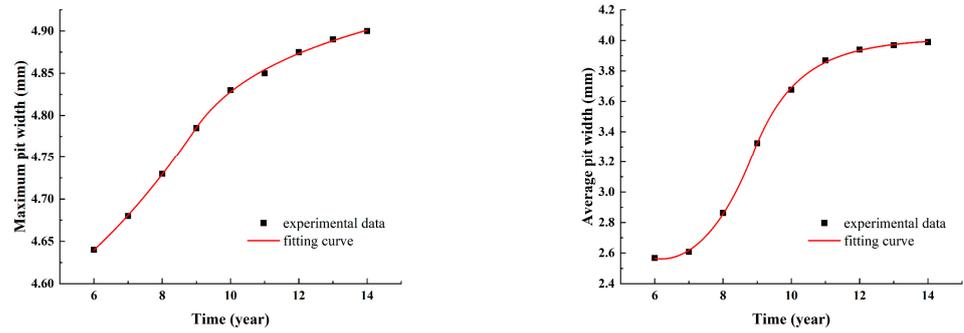
(a) the maximum pit width

(b) average pit width

$$W_{\max} = \begin{cases} e^{1.51-8.44t+7.43t^2} & t \leq 9 \\ 4.77 \times (t + 7.81)^{0.01} & t > 9 \end{cases} \quad W_{\text{mean}} = \begin{cases} e^{2.22-0.41t-0.03t^2} & t \leq 9 \\ 4.02t^{-3902477.99t^{-8.02}} & t > 9 \end{cases}$$

Figure 4. Time-varying fitting curve of the corrosion pit width.

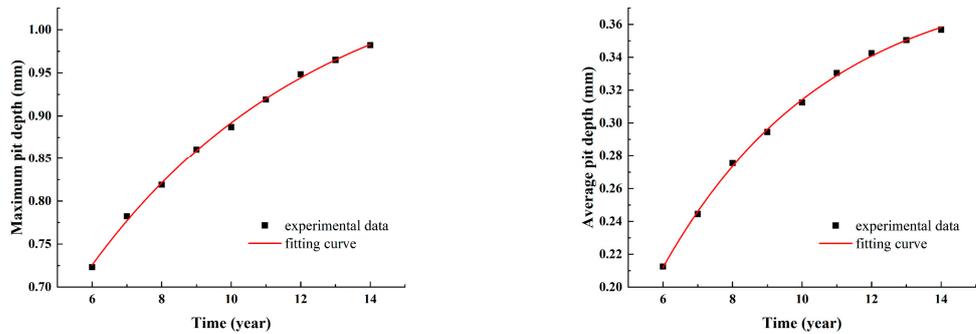
$$d_{\max} = 1.09 - 0.91 \times 0.86^t$$

$$d_{\text{mean}} = 0.39 - 0.63 \times 0.81^t$$

(a) maximum pit depth

(b) average corrosion pit depth

Figure 5. Time-varying fitting curve of corrosion pit depth.

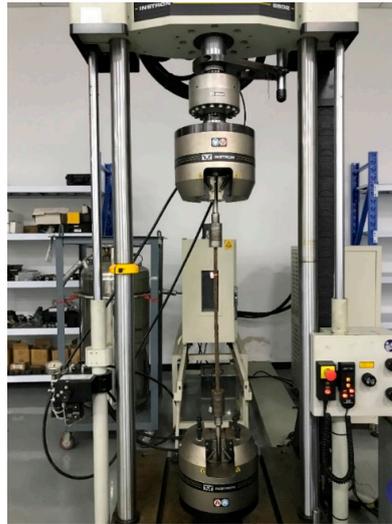
The test equipment used was an 8802 electro-hydraulic fatigue testing machine manufactured by the British INSTRON Company. As shown in Figure 6, it has a precision positioning and a highly stiff frame, and it is used for testing fracture mechanics, steel bars, aerospace plates, steel cables, civil components or structures, small concrete samples, and rock mechanics. A specially designed clamp was used in this test, and a utility model patent was applied to prevent the fracture or bending damage of the clamping end caused by the uneven stress of the steel strand material in the clamping section. Figure 7 shows a photograph of the clamp.

Figure 6. Fatigue test equipment for rusted steel strand.

The specific test parameters were as follows: the average stress was 630 MPa, the stress amplitude was 210 MPa, the maximum stress was 840 MPa, the minimum stress was 420 MPa, and the stress ratio was 0.5. The sectional area of the steel strand was 140 mm². According to stress control during loading, the average load of this test was 88.2 kN, and the load amplitude was 29.4 kN. The test was stopped when the number of fatigue cycles reached 2 million times. The limit displacement was set at 20 mm, and the loading frequency was 5 times/s. The test was terminated when the displacement of the upper chuck was considerably large and the test piece was damaged. The final fatigue life can be directly obtained from the number of cycles recorded by the control system.

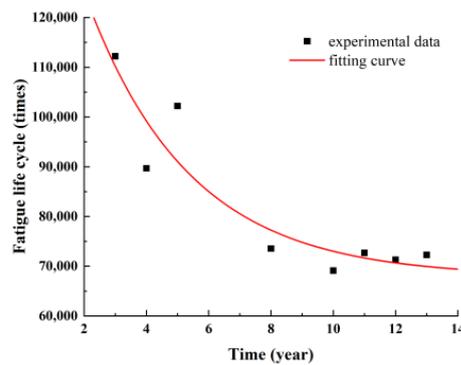
The least squares method was used to fit the fatigue test data. The change curve of fatigue cycle times with time is shown in Figure 8, and the fitting formula is shown in Formula (3). The change curve of fatigue cycle times with the corrosion rate is shown in Figure 8, and the fitting formula is shown in Formula (4).

$$N = 67854.838 + 104547.976 \times 0.74^t \tag{3}$$

(a) N-t fitting curve.

Figure 8. Curve of fatigue cycle numbers with time(t)/corrosion rate (η).

The fatigue life change data of corroded steel strand specimens indicate that the fatigue life decreases as the service life increases. Before the service life of the steel strand reaches 8 years, number of fatigue cycles is more than 100,000 times, the steel strand has been in service for 8–13 years, and the fatigue life is maintained at 80,000–50,000 times. Subsequently, it rapidly decreases. The main reason is that the etch pits are connected by a

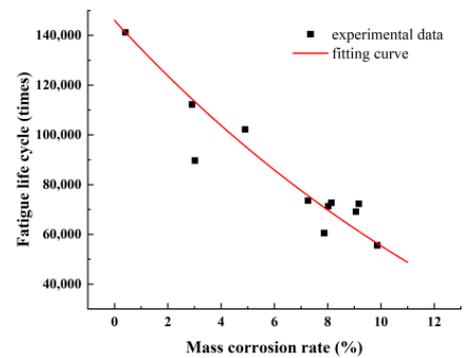
$$N = -70321.12 + 216366.4 \times 0.947^\eta \tag{4}$$

(b) N-η fitting curve.

According to the requirements of relevant specifications, the fatigue life of intact steel strand specimens should reach 2,000,000. The fatigue life of the corroded steel strand is significantly reduced compared with that of the intact steel strand, indicating that the local stress concentration caused by corrosion pits is significant and the local corrosion pits rapidly develop into cracks under the effect of fatigue loading, leading to fatigue fracture of the steel strand.

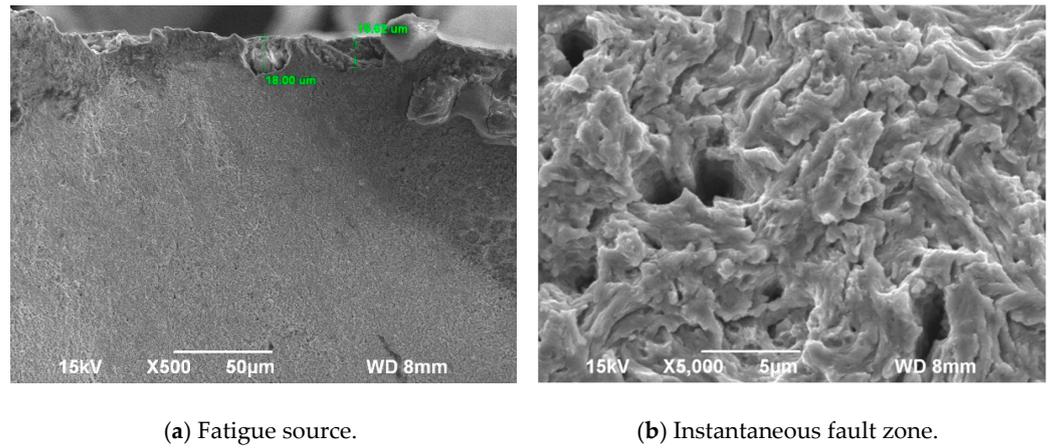
Figure 9. GJX12m fatigue fracture morphology.

The micromorphology of the fatigue source, fatigue propagation zone, and transient fracture zone of the sample fracture surface were observed by using a local scanning electron microscope, as shown in Figures 9–13.

The results of the SEM indicate that on the fatigue fracture surface of each steel strand, the fatigue source is at the location of the corrosion pit; thus, the corrosion pit is the source of fatigue crack growth. The crack starts at the bottom or inner wall of the corrosion pit and expands until it becomes a smooth area, including the corrosion pit. The fatigue source etch pits have various shapes, and the surface etch pits on the steel strand have different shapes. Determining the location where the stress concentration effect is most obvious is challenging. Multiple etch pits can initiate cracks in a single area, and a single etch pit

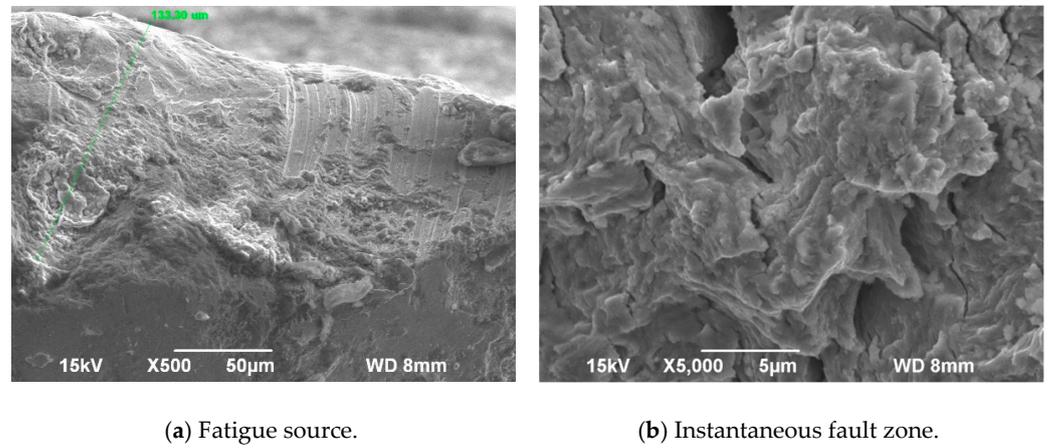
Figure 10. GJX18m fatigue fracture morphology.

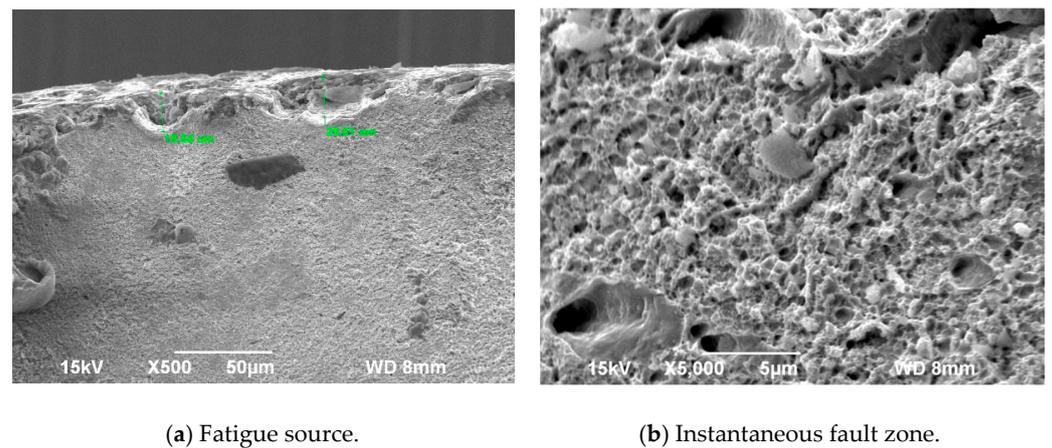
Figure 11. GJX2y fatigue fracture morphology.

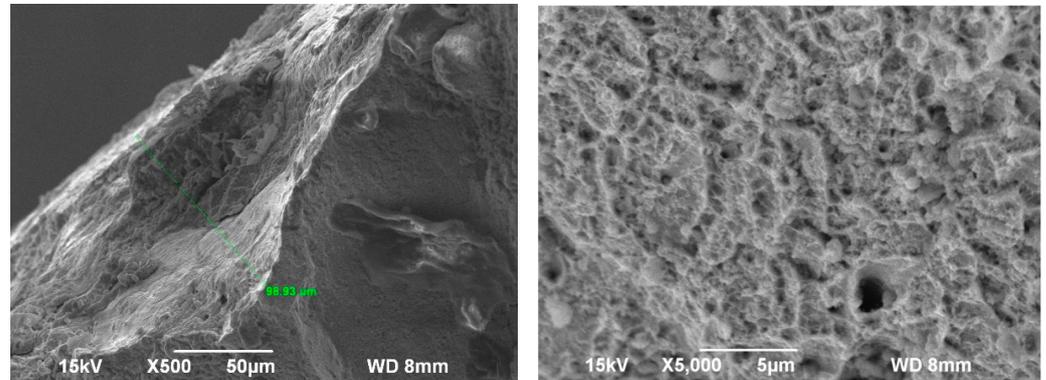
(a) Fatigue source.

(b) Instantaneous fault zone.

Figure 12. GJX3y fatigue fracture morphology.

The morphology of the fatigue growth zone is flat, the pearlite lamellar transgranular fracture is visible, and individual fracture pits exist. Plastic deformation occurs during the process of crack growth, which reflects the characteristics of fatigue fracture under complex stress cases. The fatigue transient fracture zone is the area where the fatigue crack grows to a critical size. Figures 9–13 reveal that the torn edge of the fatigue strip is clearly visible. The crystal is torn owing to a high level of stress, resulting in distinctive cracks. Because of the existence of many dislocations and twins, the lattice is severely distorted, and the crack cannot expand inside the crystal. Relatively large plastic deformation connected by tearing occurs at the adjacent boundaries when crack growth is present inside the crystal, with a severely distorted lattice, forming microporous polymerization dimples or torn edges. The appearance of dimples and torn edges indicates that the brittleness of the corroded steel strands gradually increases, resulting in greater plastic deformation, and ultimately, fatigue failure.

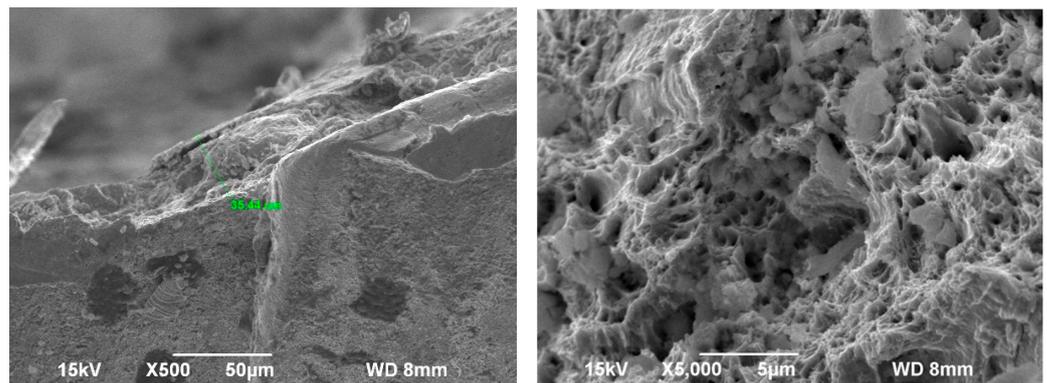
(a) Fatigue source.

(b) Instantaneous fault zone.

Figure 13. GJX6y fatigue fracture morphology.
