# Biorock Electric Reefs Grow Back Severely Eroded Beaches in Months

**Abstract:** Severely eroded beaches on low lying islands in Indonesia were grown back in a few months—believed to be a record—using an innovative method of shore protection, Biorock electric reef technology. Biorock shore protection reefs are growing limestone structures that get stronger with age and repair themselves, are cheaper than concrete or rock sea walls and breakwaters, and are much more effective at shore protection and beach growth. Biorock reefs are permeable, porous, growing, self-repairing structures of any size or shape, which dissipate wave energy by internal refraction, diffraction, and frictional dissipation. They do not cause reflection of waves like hard sea walls and breakwaters, which erodes the sand in front of, and then underneath, such structures, until they collapse. Biorock reefs stimulate settlement, growth, survival, and resistance to the environmental stress of all forms of marine life, restoring coral reefs, sea grasses, biological sand production, and fisheries habitat. Biorock reefs can grow back eroded beaches and islands faster than the rate of sea level rise, and are the mos

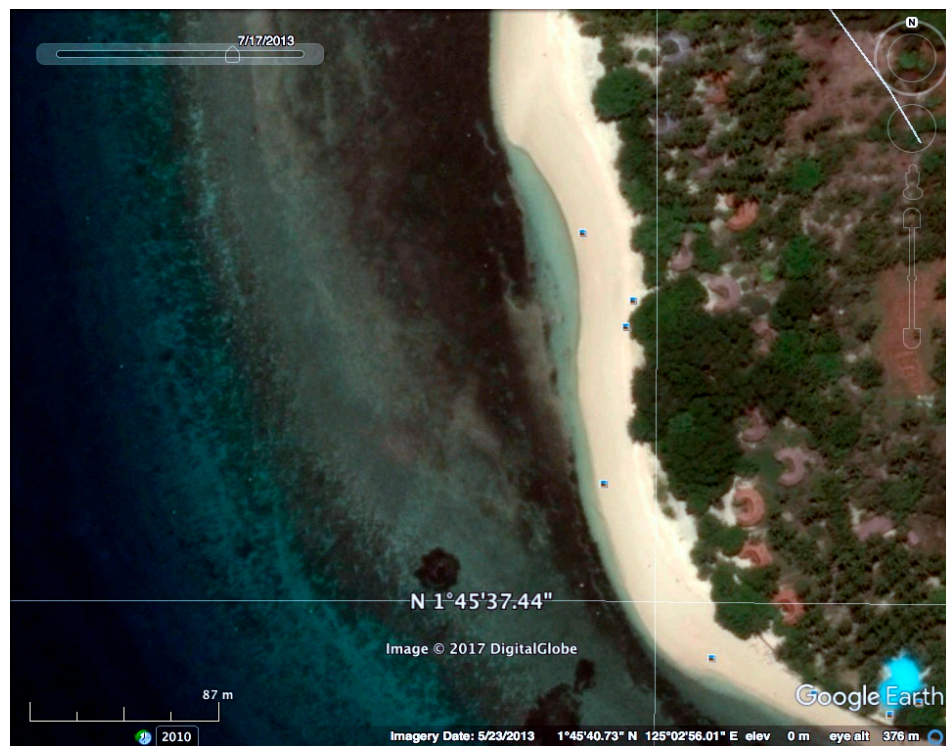
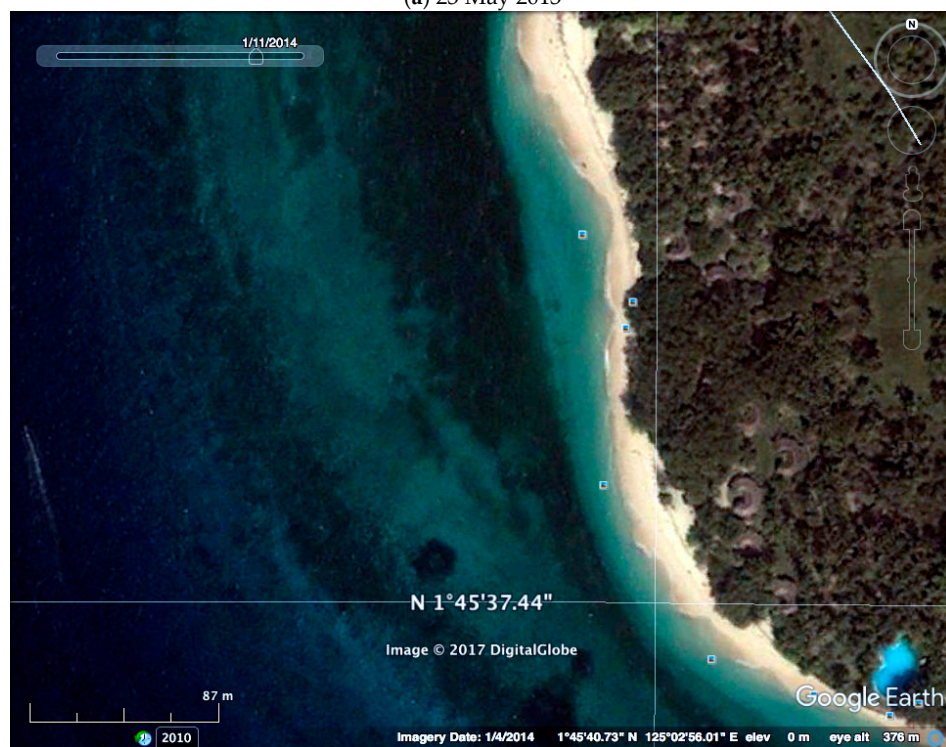
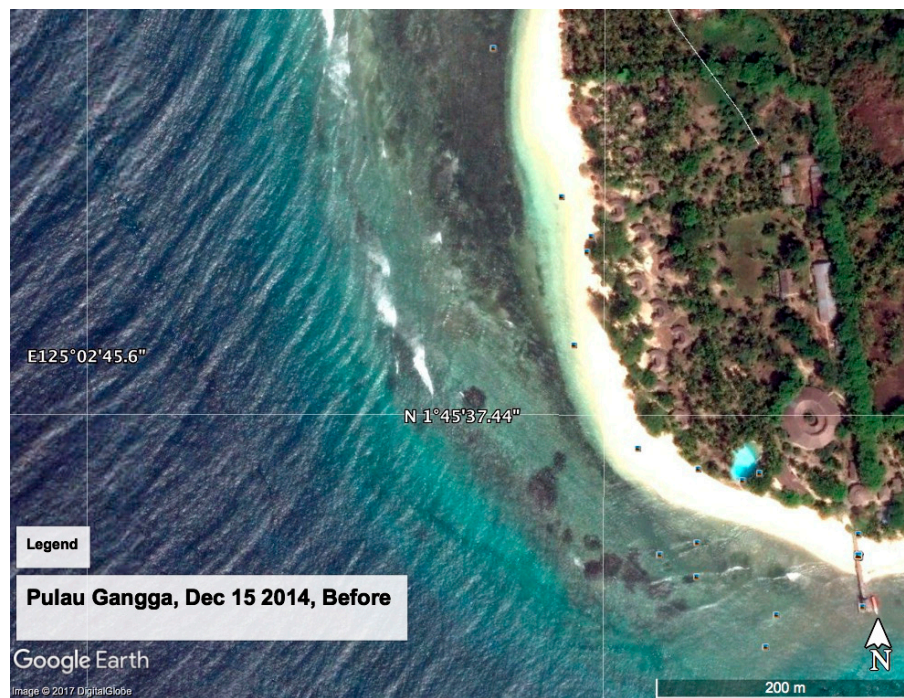
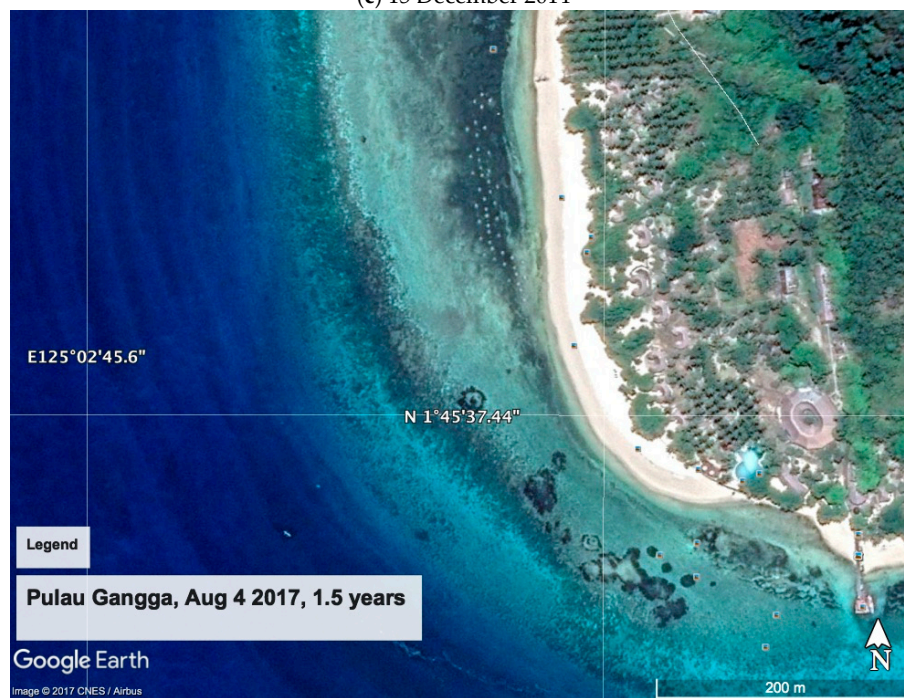
**Figure 2.** Erosion of the beach prior to the project. Google Earth images from 2013 (a) and 2014 (b) showing short term changes in the beach before the project, the last available image taken near low tide a year before the project began in early 2016 (c), and the first image after the project, taken near high tide 1.5 years after (d). Notice the cores of the Biorock Anti Wave modules as white spots in the seagrass off the regenerated beach. Beach erosion beyond the project near the pier at the south was caused by storm waves from the southeast and longshore drift sand blockage by the solid rock pier. Waves from the northwest shown in (c) are typical during erosion of this westward facing beach. Note the row of pavilions (dark spots) on the edge of the beach erosion scarp and brown dying trees with roots exposed in (c) and how in (d) the roofs are now hidden by new leaf canopies due to prolific tree leaf regrowth after sand buildup around their roots.

Pulau Gangga, North Sulawesi, Indonesia, has suffered progressive beach erosion. The index maps show its location on various scales (Figure 1a–d), and Google Earth images show the rapid erosion of the beach between 2013 and 2014 (Figure 2a,b). The site is outside the typhoon belt because it is close to the Equator, but it is affected by both the Australian and Indo-China Monsoons. From around December through May the winds and waves are usually from the southeast. A strong southward tidally-modulated current normally sweeps sand from north to south at the site.

The speed of beach regrowth astonished local residents. The formerly concave beach, ending in an eroding cliff, is now convex in its profile and growing. Large trees that had been dying after sand washed away, exposing their roots to sea water, have leafed out new canopies since the sand built up around their roots.

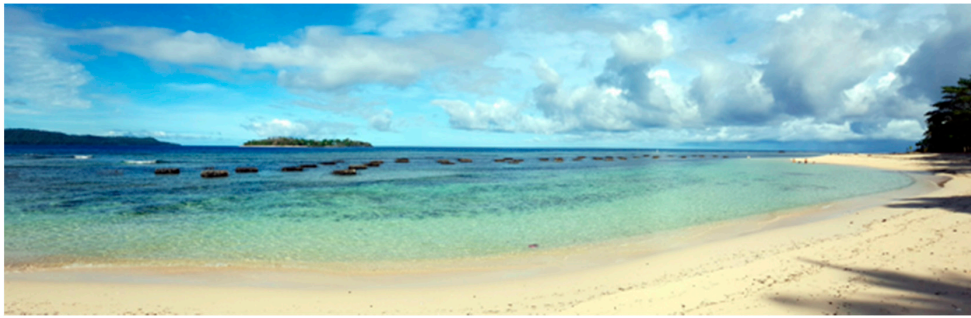
**Figure 3.** Soon after start of the project, at low tide (wide angle image). The tops of the reef restoration structures are clearly visible. The eroded curve is the area where the beach grew back.

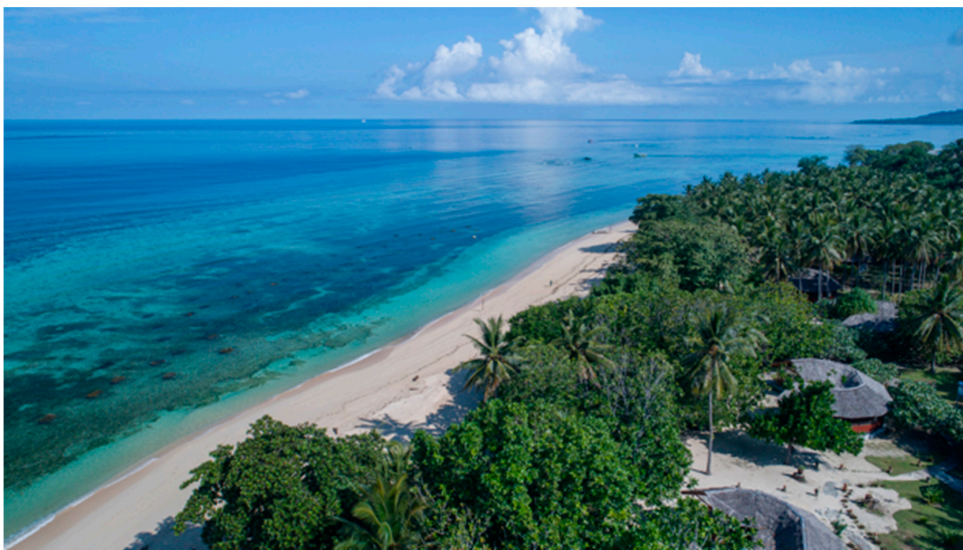
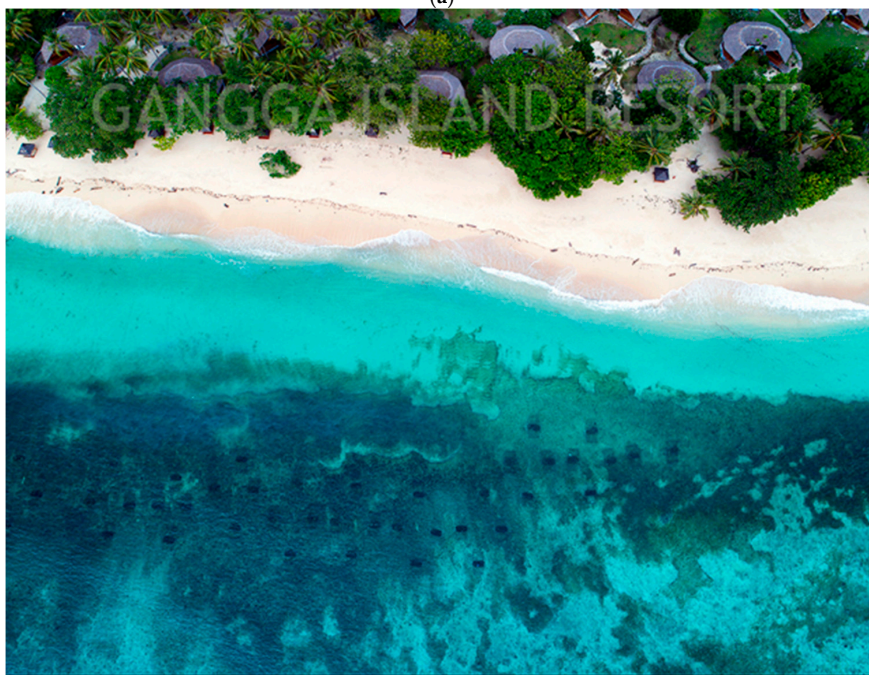
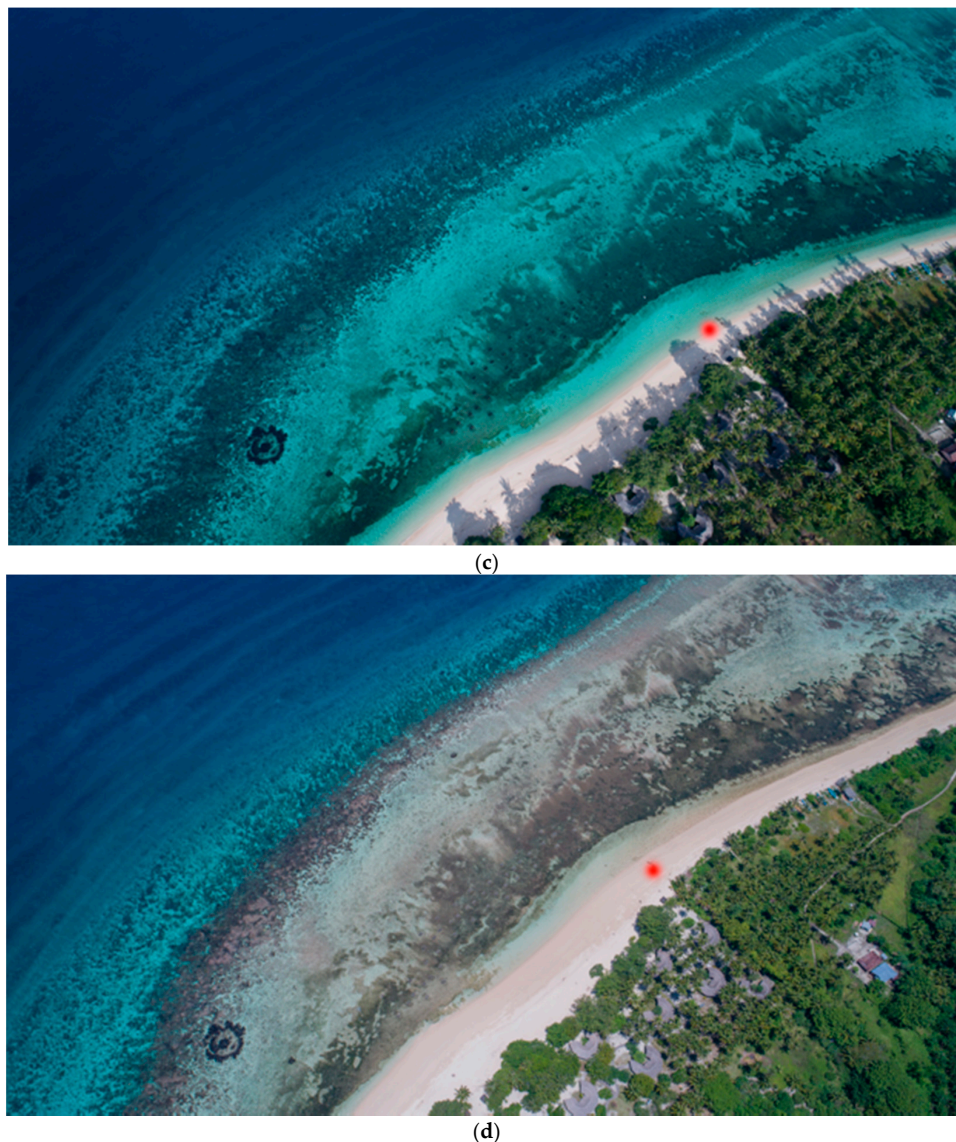
**Figure 4.** Aerial views, oblique at low tide (a) and vertical at high tide (b) on 12 March 2017, fourteen months after the installation, showing the Biorock Anti Wave structures (dark spots in sea grass beds). The northern edge of the project, on the same day at high (c) and low (d) tides. The Red spot in the last image two images is the northern limit of the project.

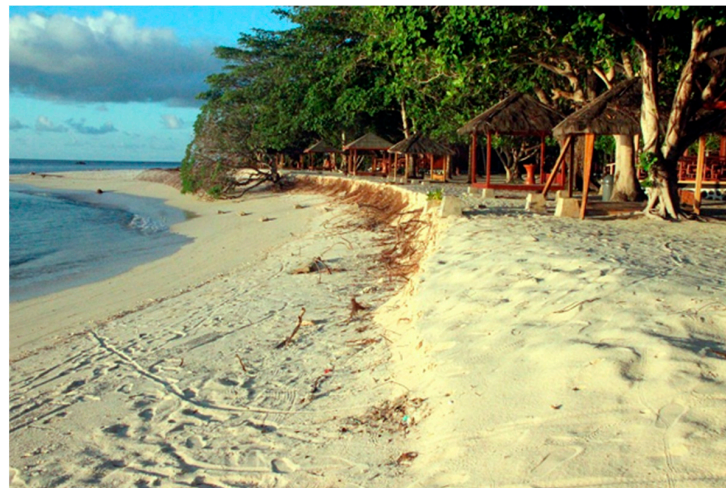
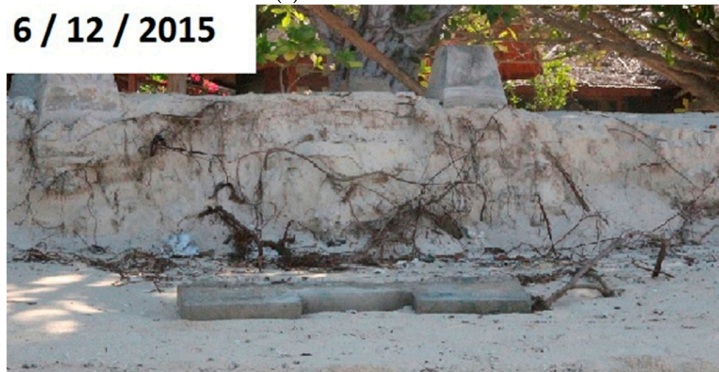
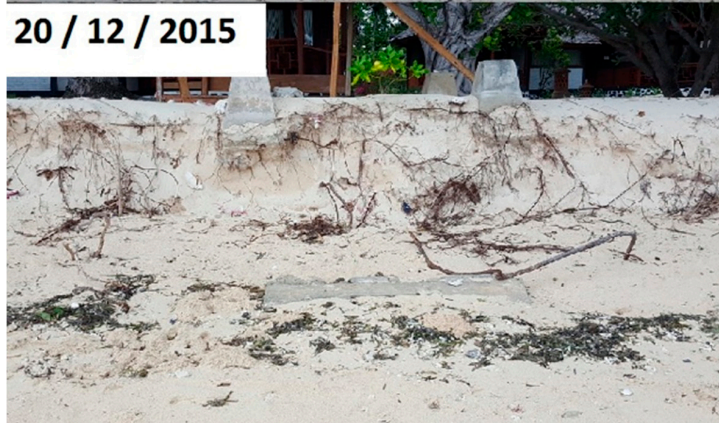
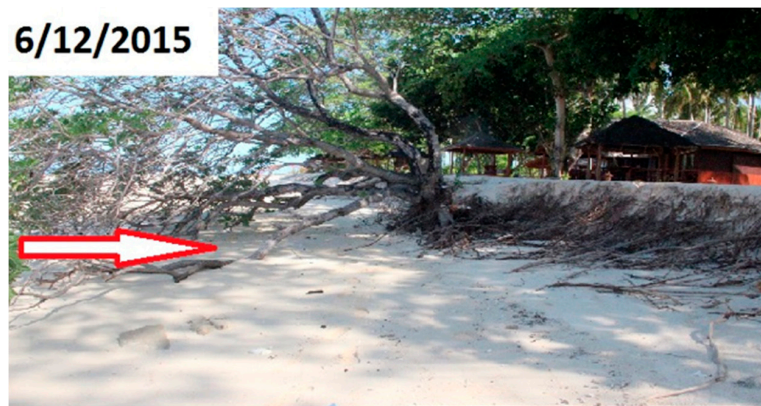
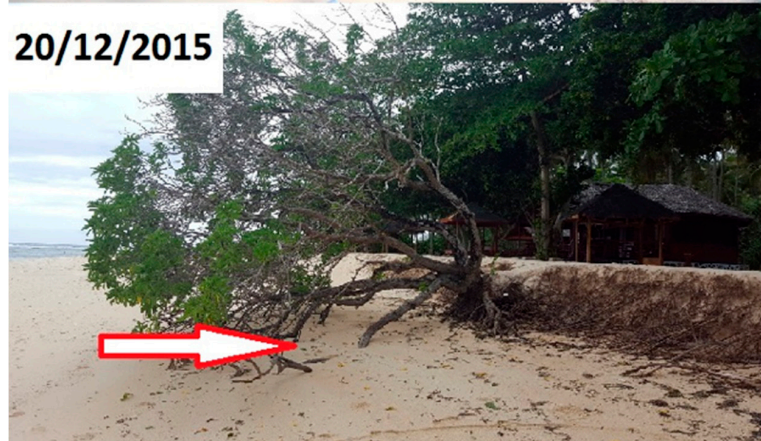
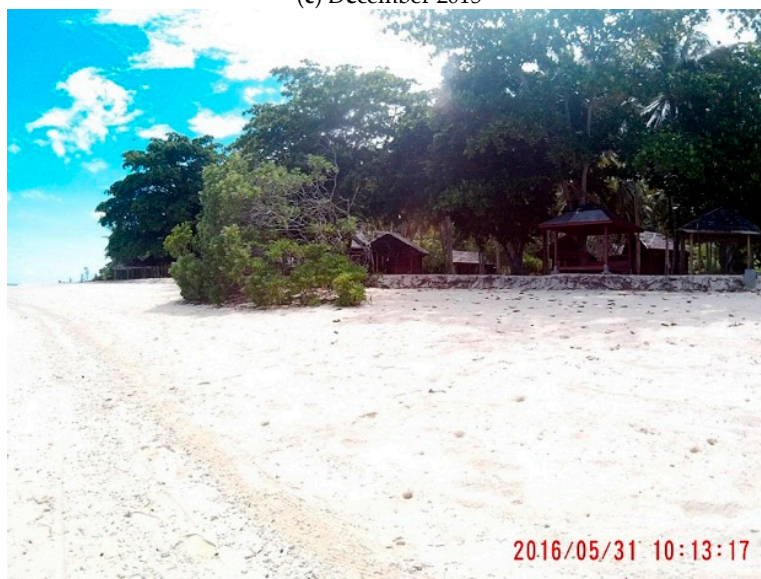
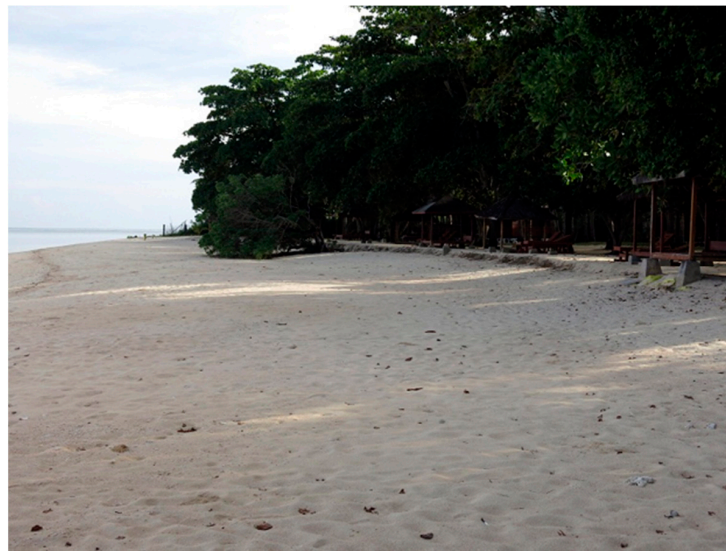
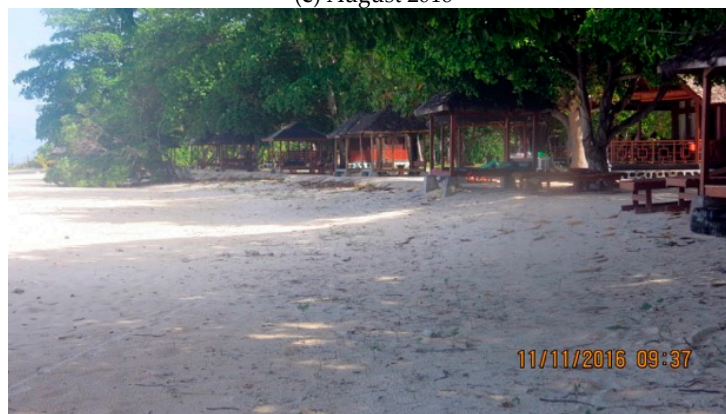
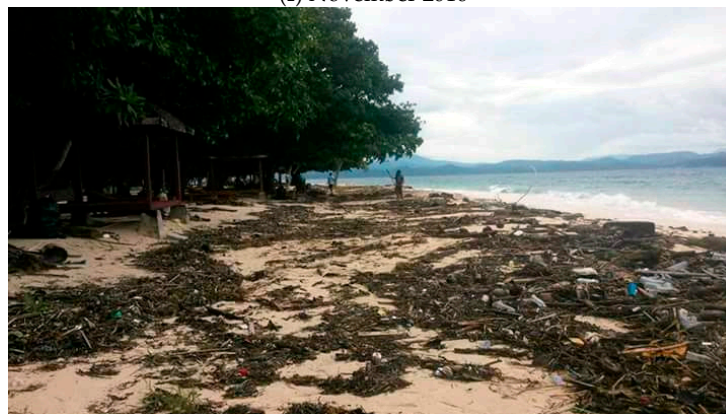
**Figure 5.** Before & after photos of beach taken at various times: (a) November 2015, beach looking north two months before start of project, tree falling into the sea and roots exposed at beach erosion scarp, (b) December 2015, one month before project, 1.36 m high erosion scarp and foundations of beach pavilions about to collapse near center of beach, (c) December 2015, one month before project, large old tree collapsing into the sea, leaves dying, roots exposed, (d) May 2016, 4 months after project installation, lower branches of fallen tree buried in new beach sand growth, roots buried, new growth, (e) August 2016, seven months after, (f) November 2016, ten months after, (g) January 2017, Twelve months after, soon after a severe storm, looking south. Most of the beach grew after the storm, even though this was the sort of event that had caused heavy erosion in the past. The south end, shown here, was worst affected.

By the time of the first beach profile measurements the eroded beach had almost completely grown back and the erosion scarp, 1.36 m tall, was reduced to about 10 cm. About 80% of the beach grew back in less than 3 months and has continued to grow ever since, even during strong storm conditions that in the past caused severe erosion. Over the course of a year the beach has increased in height by more than a meter, and in width by more than 15 m, over a two hundred meter length, a conservative estimate of an increase of beach sand volume of 3000 cubic meters. Most of the gains occurred in the first two months, but have continued since (Figure 5a–g).

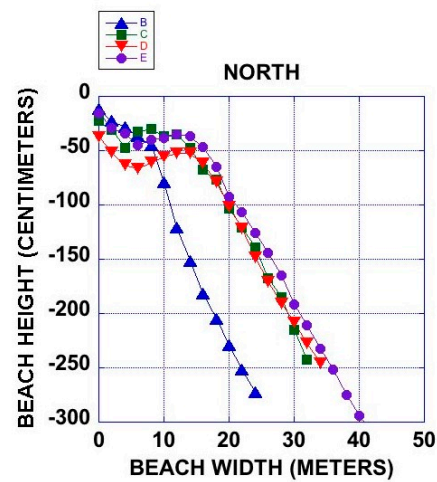
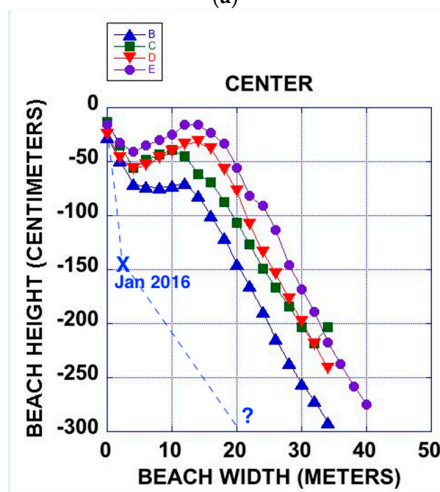
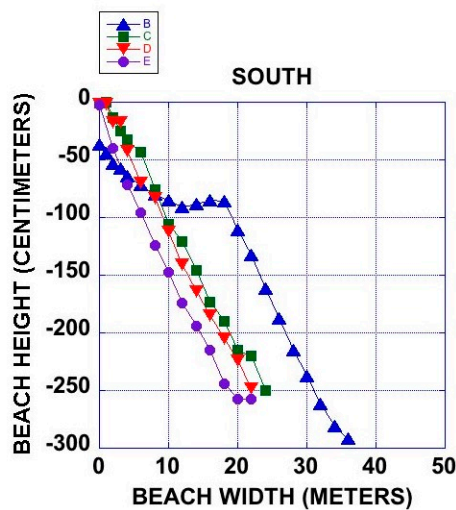
**Figure 6.** Beach profiles, measured at different times for the north (a), center (b), and south (c). The Zero reference datum for the central profile is the top of the concrete pillar foundation at the left of the December 2015 photograph. A 1.36 m vertical cliff stood at what is now the zero distance, based on measurements from photographs. Dates of measurements: X and dashed line estimate from January 2016; KEY to symbols: B upward triangle, 21 September 2016; C square, 11 January 2017; D downward triangle, 11 March 2017, E circle, 10 July 2017.

The beach growth in the first year was wider at the south than at the north. But there were interesting differences after a severe storm in early January, which caused some erosion of the southern end of the beach, while there was substantial growth of the central and northern sections. Since then the center and north have continued to grow, while the south has continued to erode slowly (Figure 6a–c).

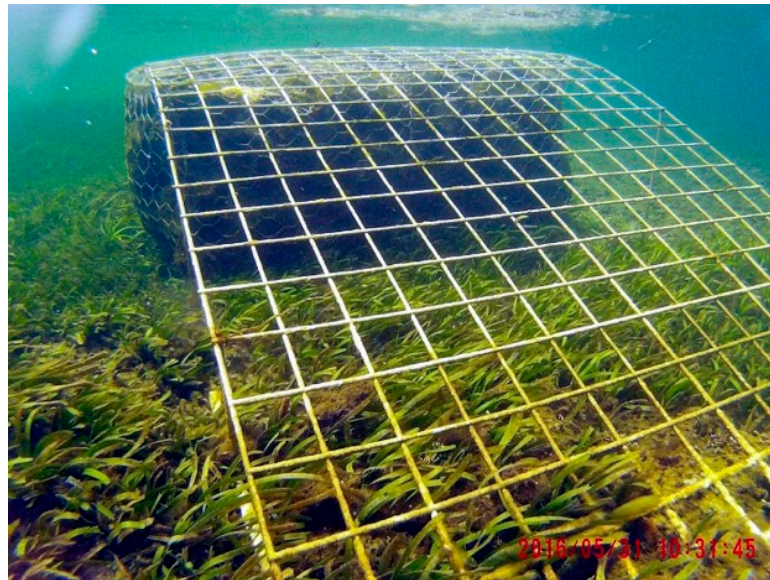
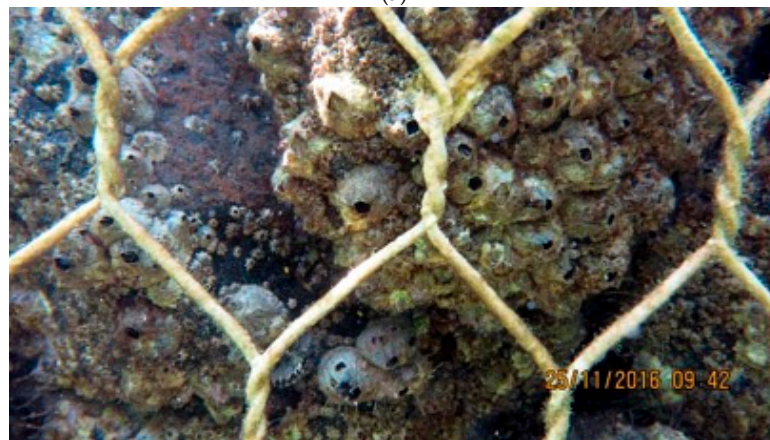
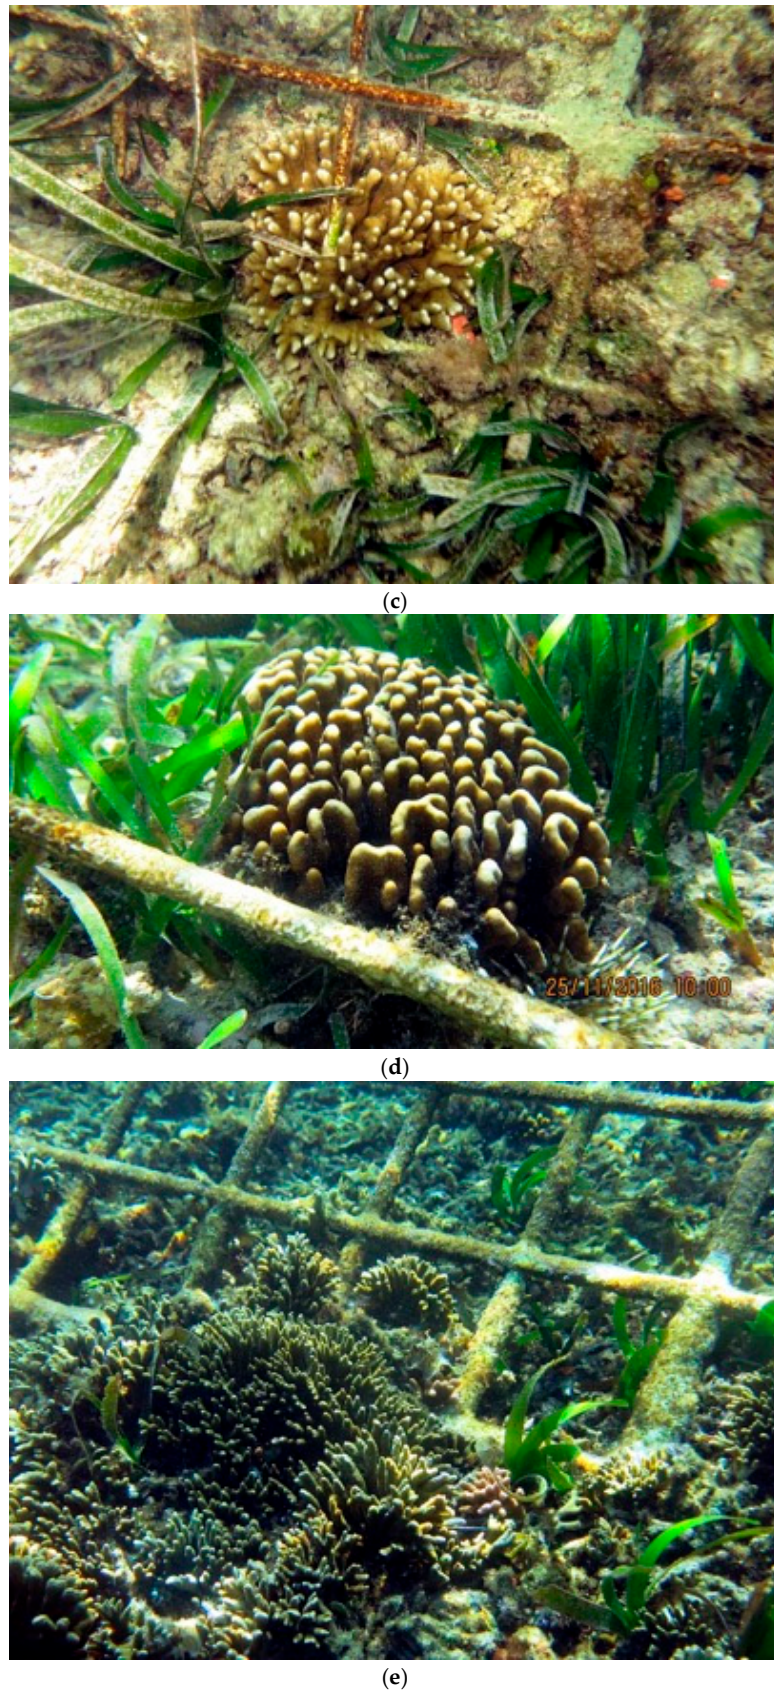
**Figure 7.** Underwater images: One end of a Biorock Anti Wave structures at high tide soon after installation (a), growth of barnacles over smooth river stones inside the gabions (b), examples of rapid growth of corals, sea grasses, and other organisms under, over, and around their bases (c–e).

There has been prolific growth of hard and soft corals all over the bases of the structures and in intervening areas (Figure 7a–e), prolific growth of sea grasses all around them, dense settlement and growth of barnacles, mussels, and clams on the rocks in the core of the BAW structures, and a rapid increase in juvenile fish and echinoderm populations. In addition, there has been prolific growth of sand-producing calcareous green and red algae around and between the structures.

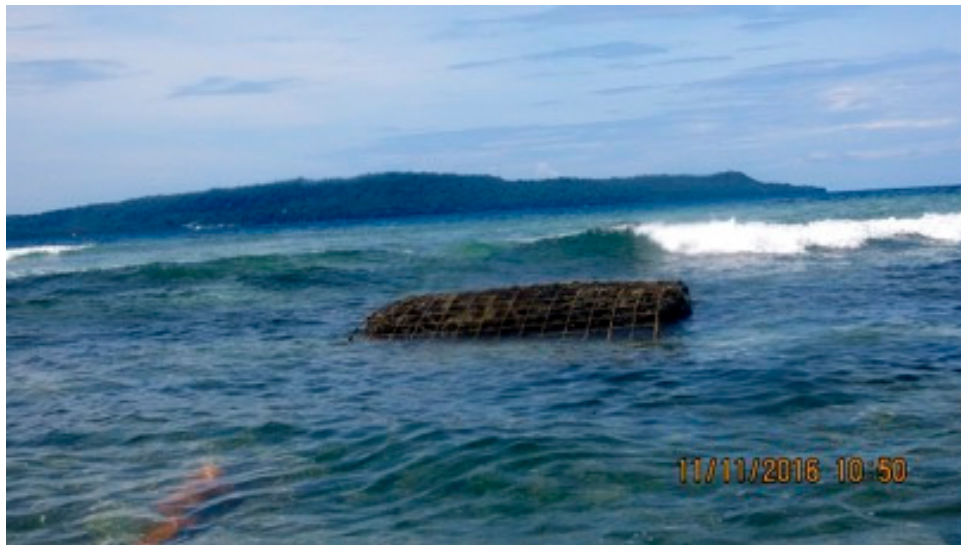
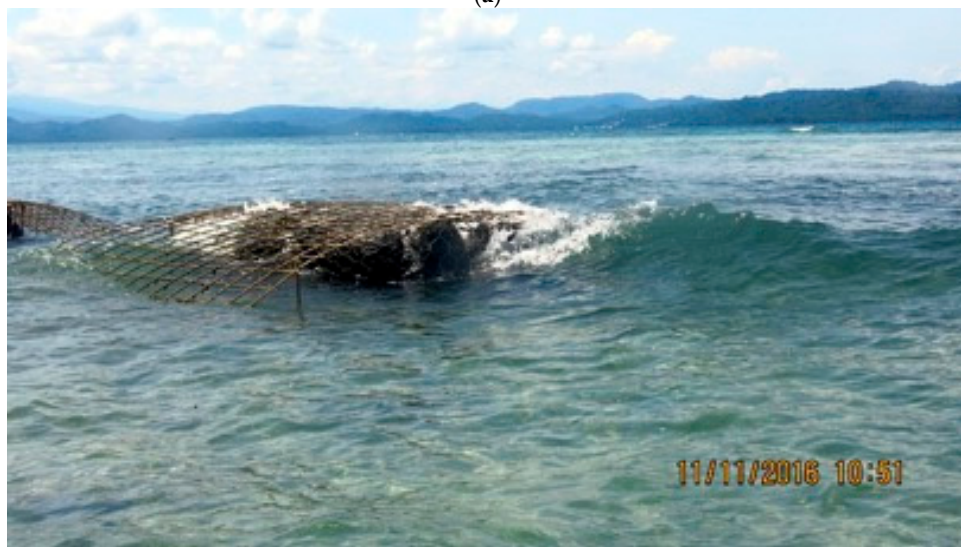
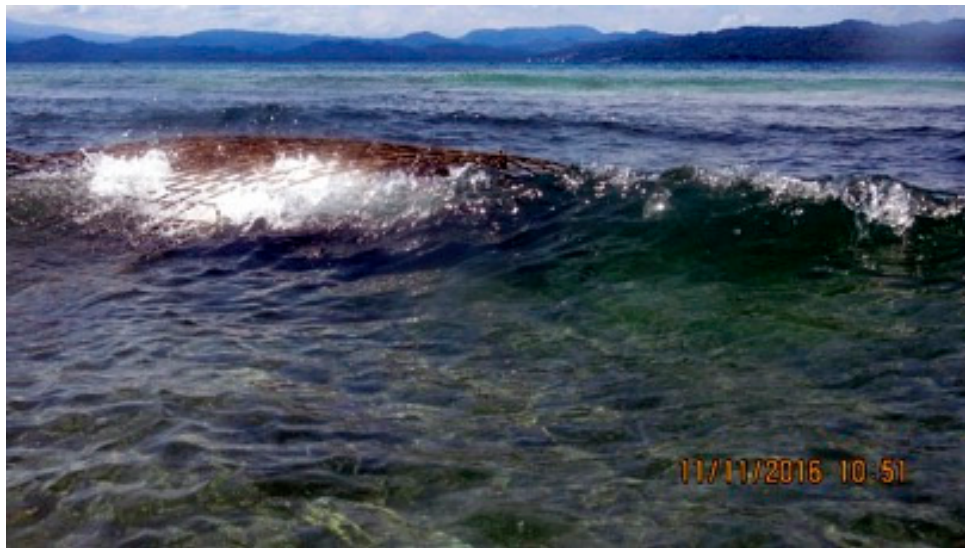
**Figure 8.** Diffraction of energy. Incoming wave energy dissipated by interaction with structure these photographs were taken in rapid succession, the middle picture appears brighter because of break in the clouds, and the photographer moved between the first two images. (a) approaching wave, (b) wave starting to interact with mesh, (c) wave energy dissipated by friction.

Wave fronts are dissipated as they pass through the structures, breaking up the coherence of incoming wave fronts (Figure 8a–c). This dissipation behaves as refraction through permeable structures. But the wave interaction can include a reflective component once structures have grown to be solid with all pores filled in, or if the rock fill is too impermeable to transmit wave pressure through intervening spaces. In that case, sand-eroding scour will be caused, while purely refractive dissipation increases sand accumulation underneath and behind the structure. There is also a diffractive component caused by wave interaction with the metal structure spacing and lattice spacing, which appeared to damp waves at spatial scales that range from the spacing of the metal grid used (0.1 m), the size of the modules (1–5 m), and the spacing of the modules (roughly 10 m).
