Historical Photographs of Kucha: Retracing Lost Caves and Related Thoughts

Vignato Giuseppe

Abstract: Historical photographs of Kucha, mostly those taken by the Turfan German Expedition (1902–1914), can be used to recover information concerning the caves lost over the last century and features that cannot be seen any longer. The analysis of photographic material can help to individuate patterns and trigger thoughts leading to a better understanding of the sites, appreciate lost features, reveal the likely location of caves presently covered by debris, understand how caves were restored in antiquity, and suggest better ways to preserve and use rock monastery sites. Though this article focuses on Kucha, the proposed method can be used at other archaeological sites.

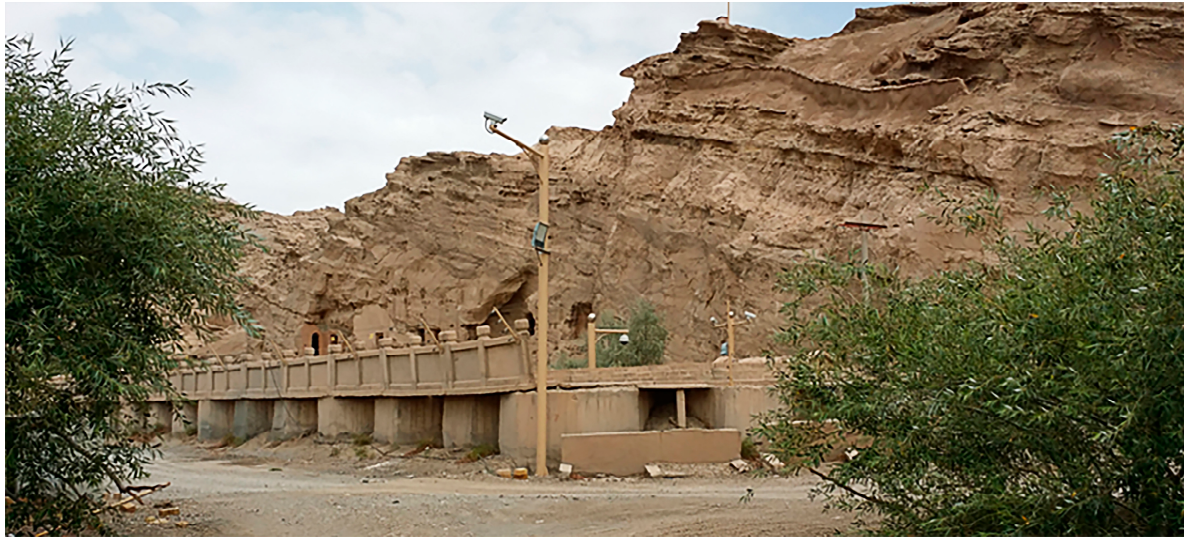
caves and definitively ruined the atmosphere of the setting; they not only hinder the view of the caves from a distance, but they also obstruct the view of the surroundings from the caves (Figure 2).

Figure 2. Kuntura North Monastery, area between Caves 7 and 33. Photograph by the author, 2016.

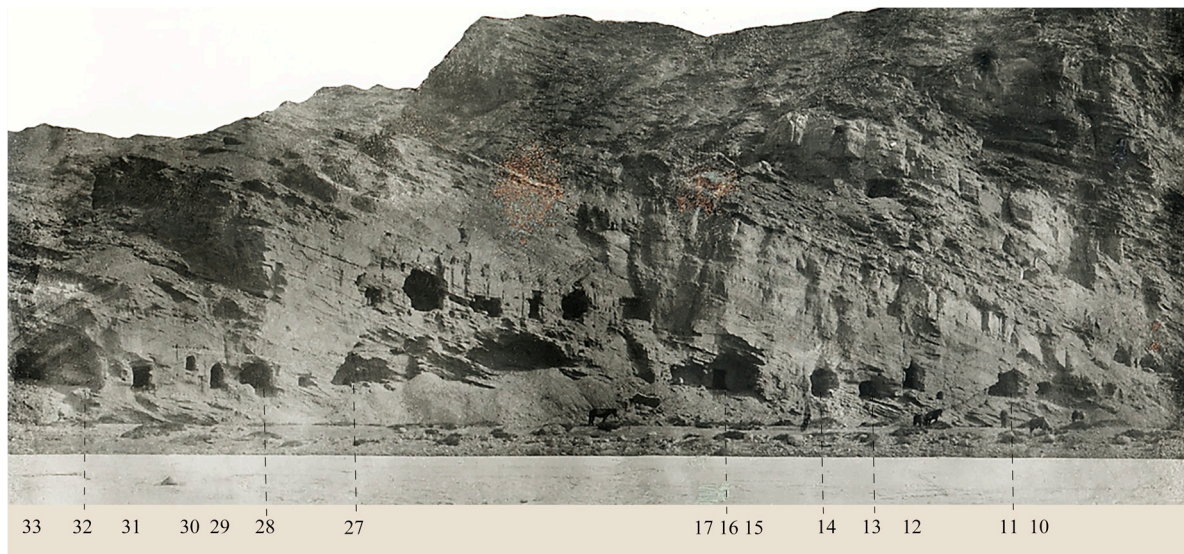
The caves facing the Muzart River have been divided into two districts (Southern District 南区 Caves 1–39, partially seen in Figure 3, Northern District 北区 Caves 53–72). Large sections of the cliff between Caves 6 to 33 had already collapsed.⁵ Most of the antechambers had already suffered much damage and, in some cases, sections of the main chambers too.⁶ The damage started occurring to the caves while the site was still in use and continued through the centuries.⁷

Figure 3. Kuntura North Monastery, Caves 7–33. Photograph adapted from B 1553 © SMB, Museum für Asiatische Kunst.

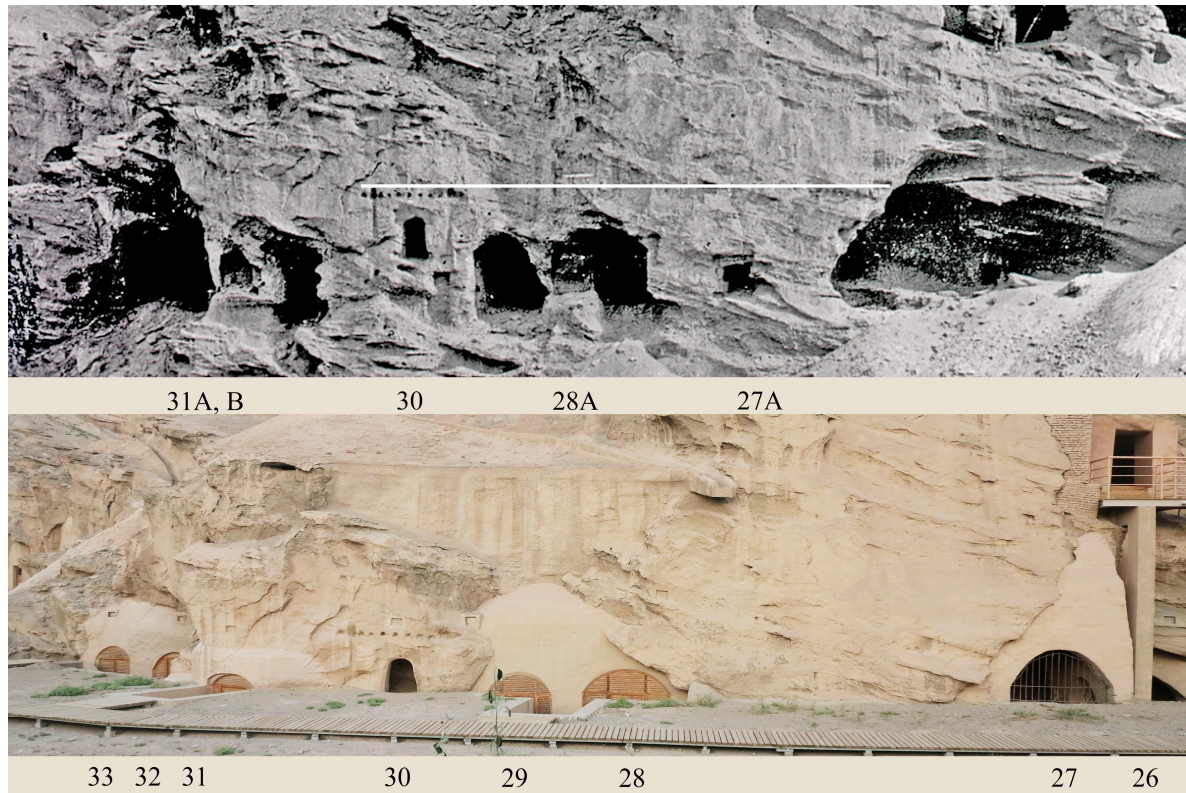
Photographic enlargement allows for a detailed analysis of the section of the cliff between Caves 23 to 33 (Figure 4).⁸ After a collapse of the cliff that wiped away the rock-carved antechambers, a timber balcony was set up in their place; the presence of this structure is indicated by the row of rafter holes carved at the same height across the cliff, preserved above Caves 30 and 27. This timber structure would have provided a roofed activity

area for all the caves in this section.⁹ Interestingly enough, the historical photographs reveal the presence of five small niches in this relatively short section of the cliff; we will mention them as they are provisionally referred to.¹⁰ Only one niche, Cave 30, is now visible; it was carved in a higher position than the other four.¹¹

Figure 4. Kumtura North Monastery, Caves 27–33. Above, the caves at the time of the Third German expedition (1906). Photograph adapted from B 1553 © SMB, Museum für Asiatische Kunst. Below, the caves today. Photograph courtesy of the Kizil Cave Institute, 2022.

The second niche, carved between Caves 27 and 28, Cave 27A, displays grooves on the four sides, indicating that it was fitted with a small door. The third niche, Cave 28A, was carved between the central pillar Caves 28 and 29; it was carved in a section of the rock exposed following the collapse of the antechambers and a section of the front walls of the main chambers of the two larger caves at its sides. The fourth niche, Cave 31A, was carved after the collapse of the front wall of the main chamber of Caves 31 and 32, a situation comparable to that of Cave 28A (Figure 5). The fifth niche, Cave 31B, was then carved beside it, partially overcutting it.¹²

The analysis of the historical photographs of the cliff between Caves 27 and 33 has revealed some crucial facts. It has shown that the carving of the niches and the installation of the porch must have been carried out after the damage incurred earlier by the larger caves. Therefore, the caves continued to be locations of religious observance after restoration was carried out.

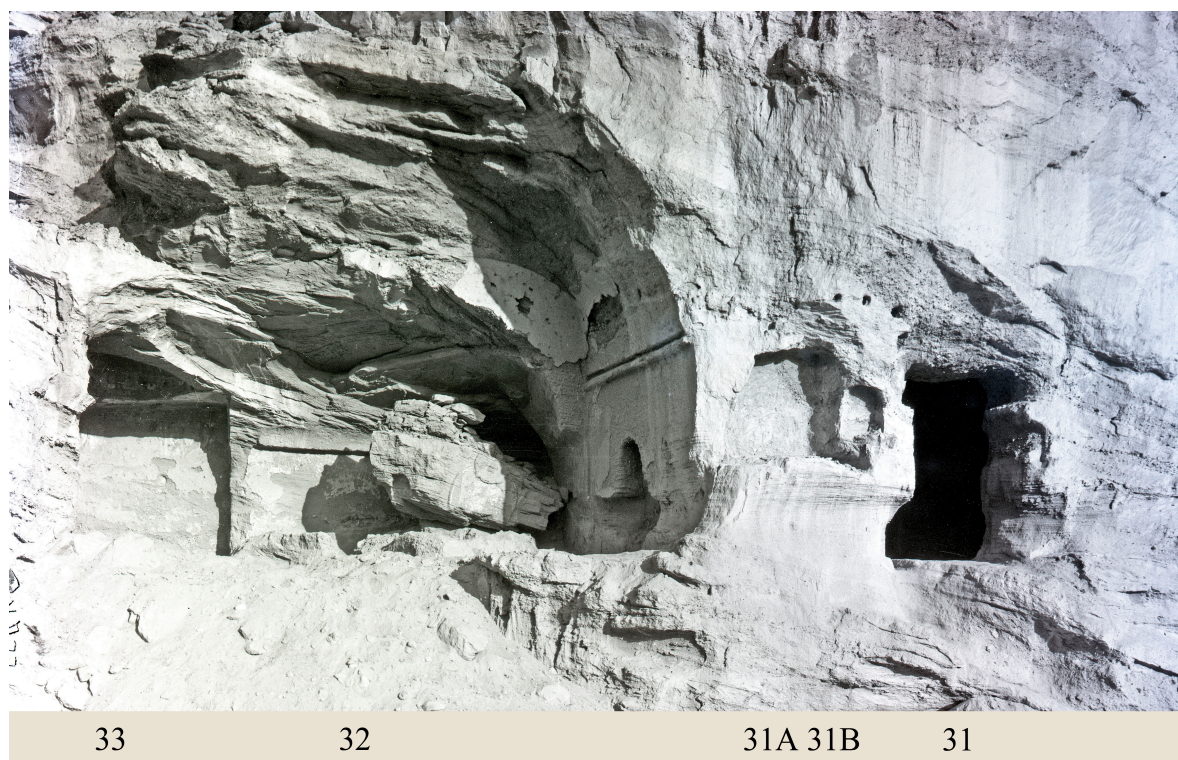
Figure 5. Kumtura North Monastery, Caves 31 (right) and 32 (left). Niche Caves 31A and 31B were carved in between. The peg holes carved in a curved line above the niches are a possible later feature. Photograph adapted from B 1259 © SMB, Museum für Asiatische Kunst.

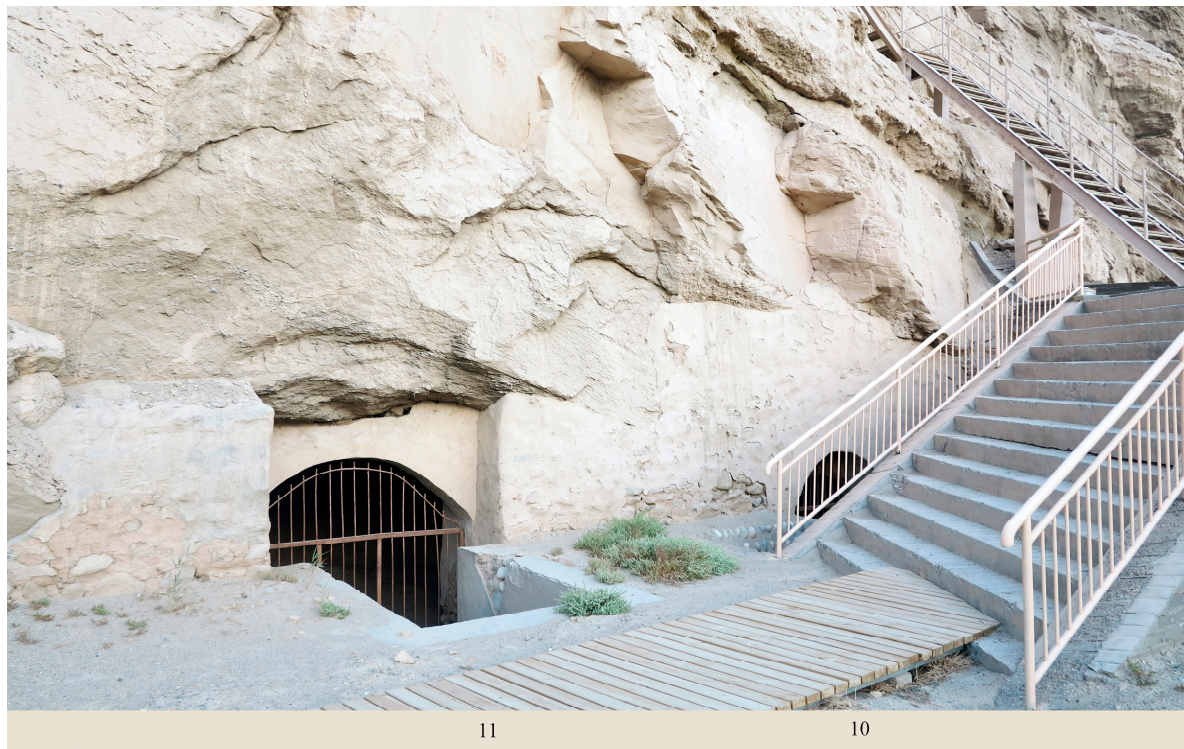
Figure 6. Kumtura North Monastery, Caves 10 (right) and 11 (left). Photograph courtesy of the Kizil Cave Institute.

Access to Cave 10 was granted by a doorway dug through the right wall of the antechamber of Cave 11. Thereafter, a passage hewn into the right wall of the antechamber of Cave 10 allowed access to Caves 10A, 10B, and 10C. A small niche (11C) was carved into

a newly exposed section of the cliff after a large collapse of the cliff, which revealed the stairway and devastated the antechambers of both Caves 10 and 11. The absence of grooves and postholes suggests that these caves were not restored after suffering damage.¹⁹

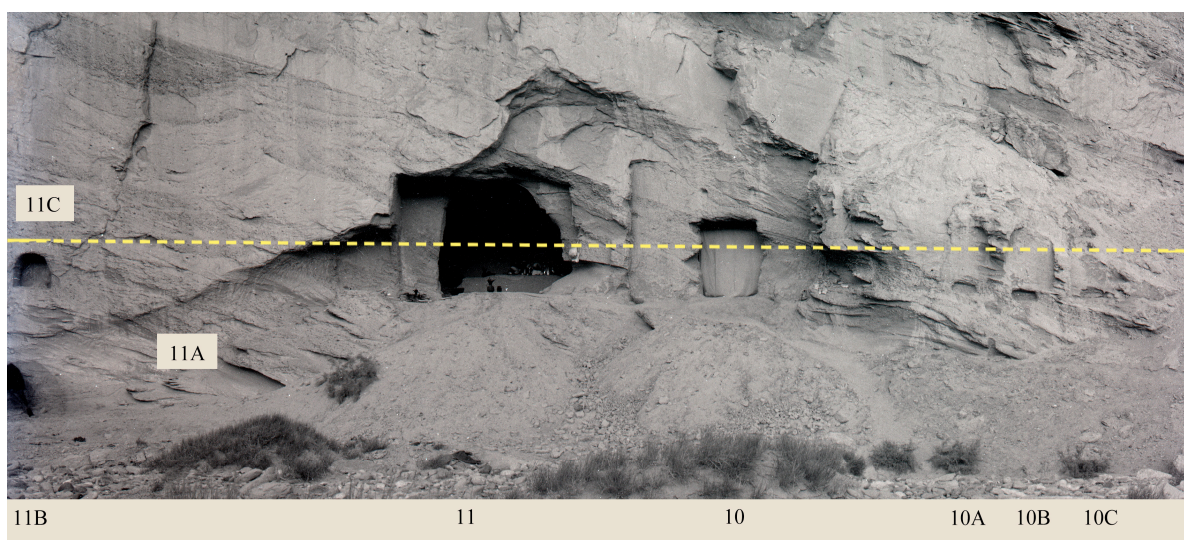
Figure 7. Kumtura North Monastery at the time of the Fourth Turfan Expedition (1913–1914). At the center are Caves 10 and 11. From the left, Cave 11B and Cave 11C above it, and the stairway Cave 11A. On the right of Cave 10 are the three niches Cave 10A, 10B, and 10C. Adapted from B 1093 © SMB, Museum für Asiatische Kunst.

After the outer portion of the cliff collapsed, the lower flight of steps was completely lost, while the upper flight became exposed. Note the very small niche above it, slightly to the right (11C). If we consider the depth of this niche and compare it with the original cliff facade (note 16), we realize that the niche itself could only have been carved after the collapse of the outer section of the cliff.

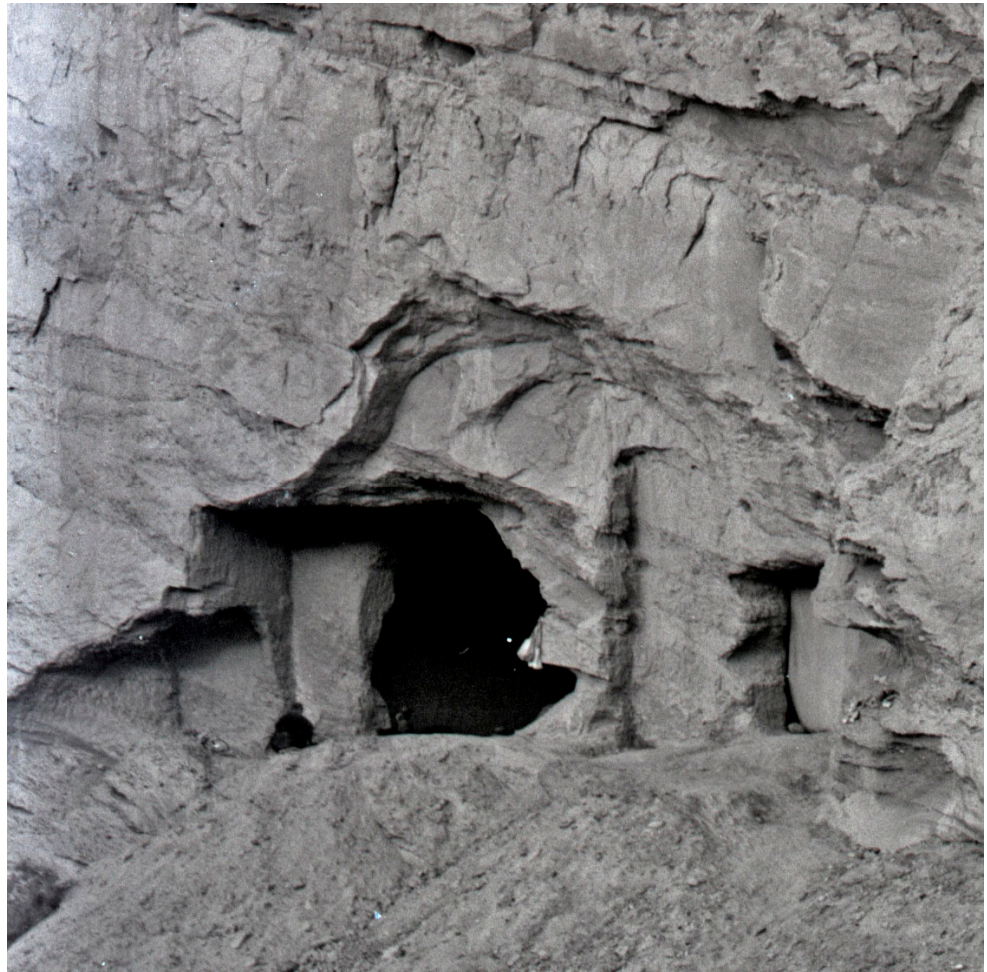
Figure 8. Kumtura North Monastery, the individual antechambers of Caves 10 and 11. On the left, the upper end of the stairway opens on the left wall of the antechamber of Cave 11. Marks of a doorframe are also seen in the section of the rock separating the antechambers of Cave 11 from those of Cave 10, indicating a connection between the two caves. Photograph adapted from B 1202 © SMB, Museum für Asiatische Kunst.

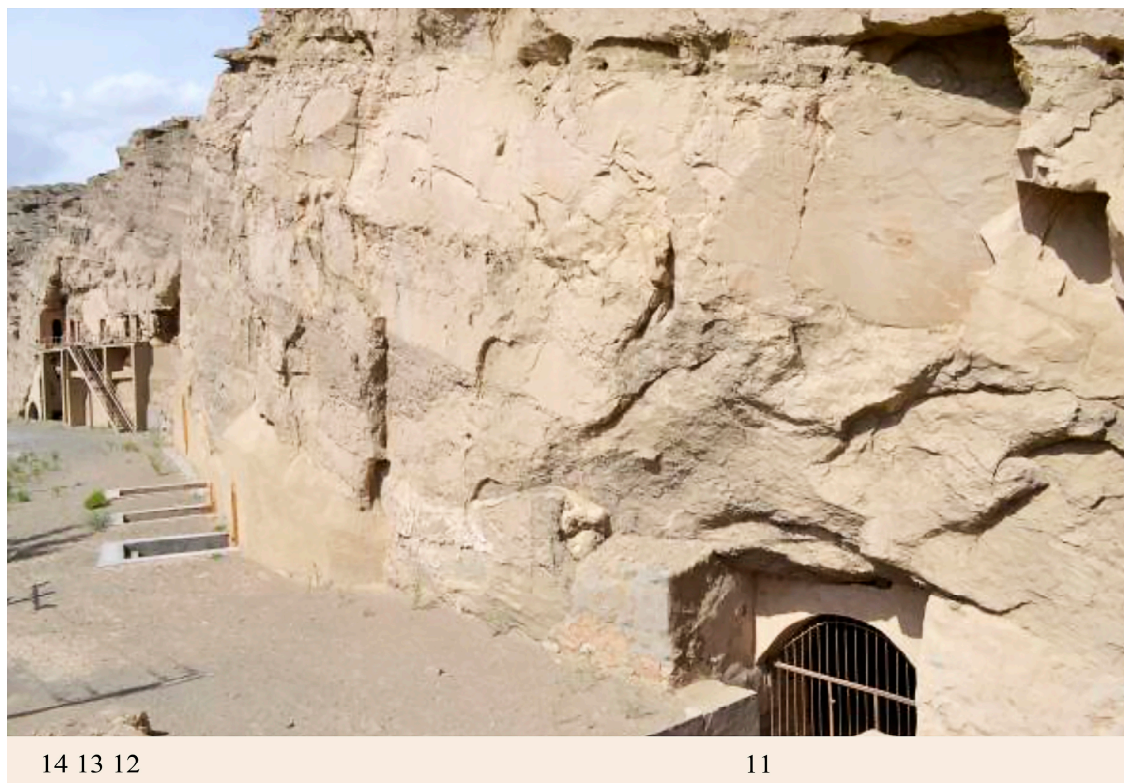
Figure 9. Kumtura North Monastery, Caves 11, 12, 13, and 14. Presently the caves are accessed by descending cement stairways constructed at the end of the last century. Photograph courtesy of the Kizil Cave Institute, 2022.

Slightly to the north of this group are Caves 12, 13, and 14. In modern times, the area in front of them has been filled with strata of pebbles and can now be accessed by descending three separate stairways (Figure 9). Through examination of historical photographs (Figure 10), it has become possible to determine their relationship. It can be seen that the central pillar Cave 13 and square Cave 14 were carved at the same level in a relatively high position on the cliff and were presumably reached via a stairway. The floor joist holes and rafter holes indicate that the two caves were repaired after the collapse of their rock antechambers and were connected through the installation of a timber balcony. Therefore, these two caves formed a group similar to the one comprising central pillar Cave 10 and square Cave 11. Cave 12 was carved close to Cave 13 but at a slightly higher position on the cliff. It is an independent later cave, as can be assessed from the Uighur-style paintings.²⁰

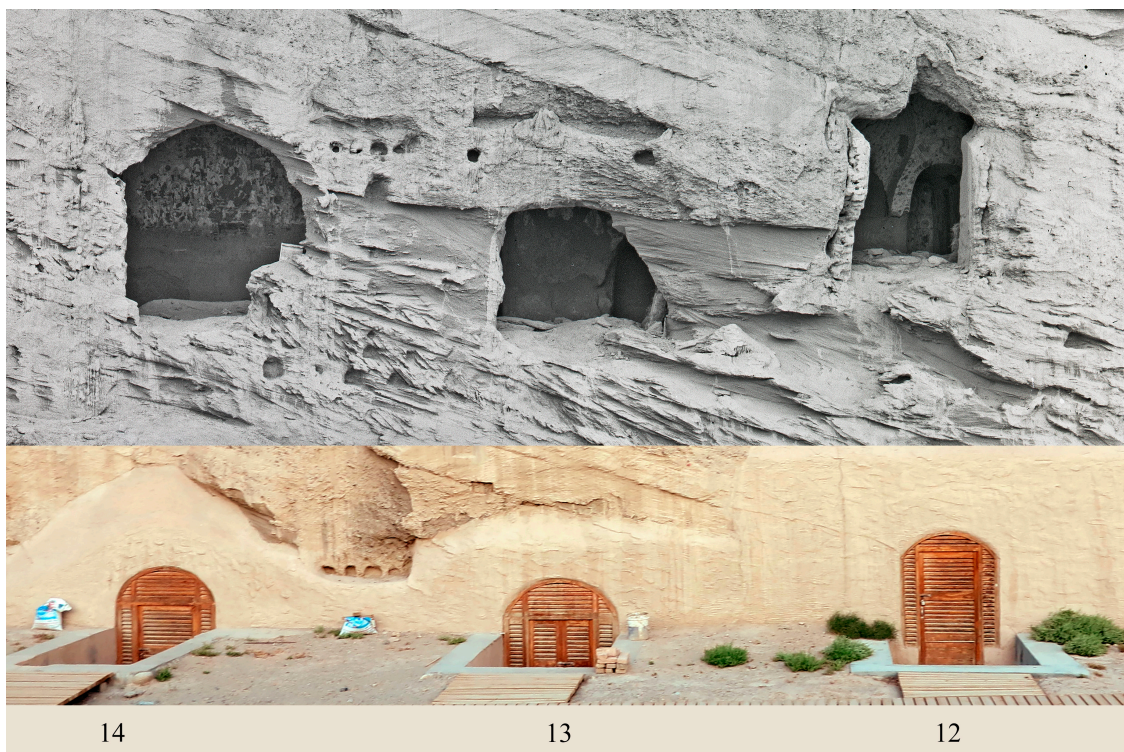
Figure 10. Kumtura North Monastery, Caves 12 (right), 13 (center), and 14 (left). Above, photograph adapted from B 1236 © SMB, Museum für Asiatische Kunst; below, photograph courtesy of the Kizil Cave Institute, 2022.

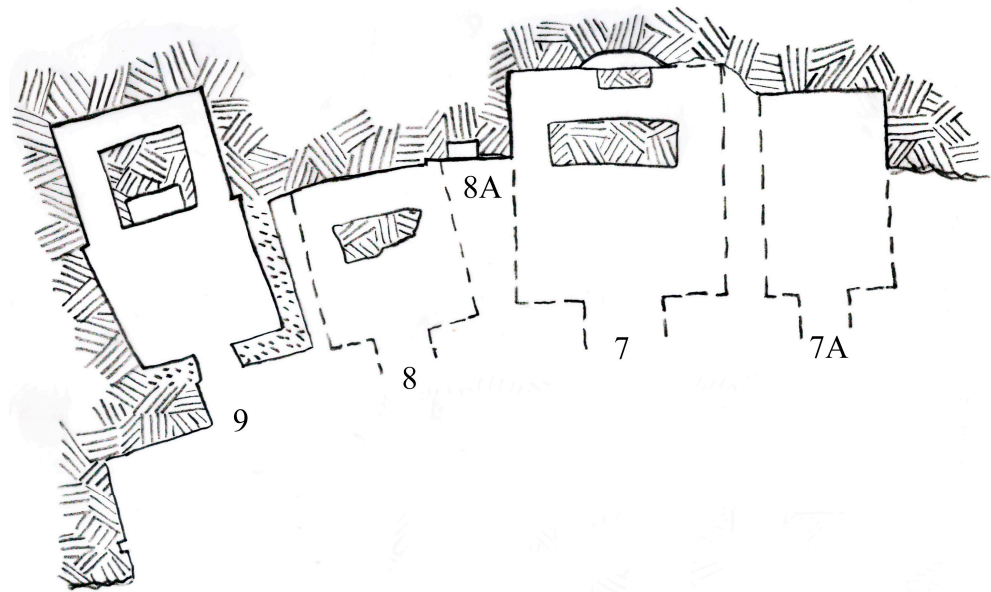
The clearest example showing that niches were carved after the collapse of earlier larger caves is the niche carved between Caves 7 and 8, provisionally numbered Cave 8A. The caves have almost completely collapsed; the area in between the rear walls of the rear corridors of the two caves was exposed by the collapse. The exposed section of rock between them was subsequently chiseled even, and within this rectified space a niche was then carved (Figure 11).

Figure 11. Kumtura North Monastery, Caves 7A–9. Note the location of the niche 8A. Diagram by the author.

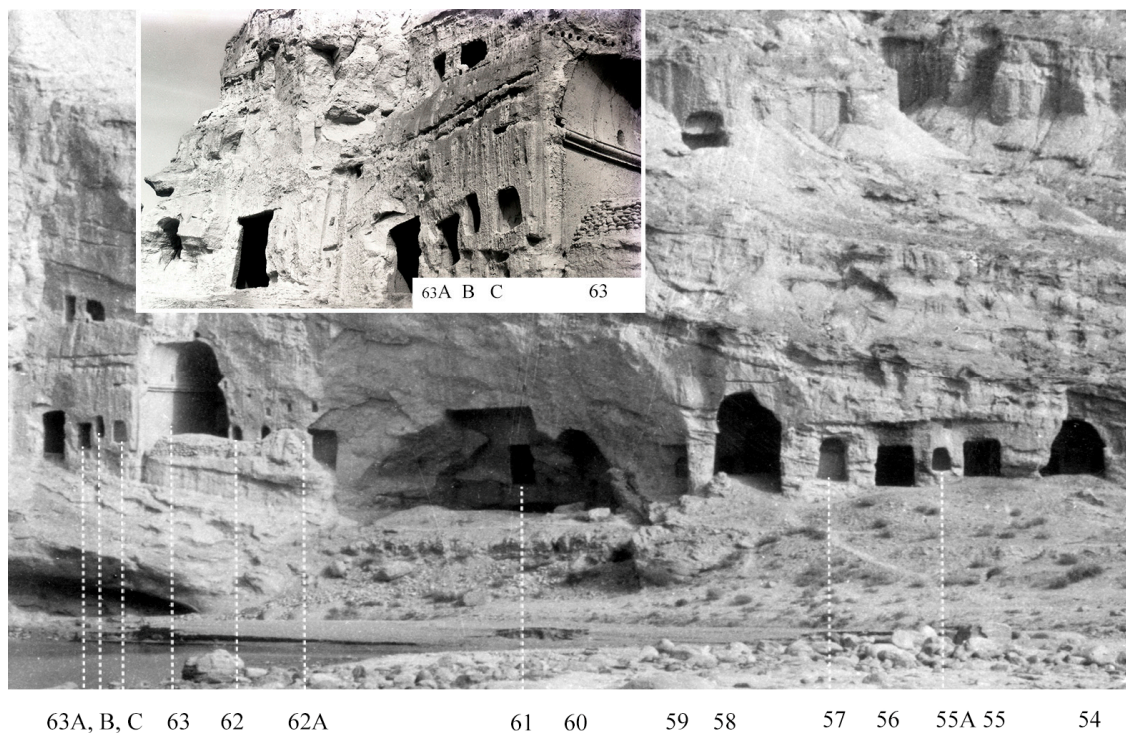
Aside from the large cement wall and the pebble filling in front of the caves, there have been significantly fewer changes in the Northern District (Caves 52–72, Figure 12). The niches carved in between the larger caves are still visible today and have, therefore, received an official number. These niches reveal similarities with the ones discussed above. Starting from the right in the photograph, Caves 55A and 57 are two niches carved on each side of Cave 56. Since symmetry is a paramount feature in the art and architecture of Kucha, these niches' different size suggests they were not the result of a unified plan. The state of the cliff indicates that the two niches were carved after the antechambers were damaged. Further north, past the heavily damaged Cave 63, there are three niches: Cave 64A, 64B, and 64C. They were protected by the large wooden antechamber that extended from Cave 63 to Cave 65. These three niches are likewise different in size and shape. Cave 64A is a fully painted shallow cave. Cave 64B hosted a clay statue set against the rear wall. Cave 64C presents an opening on its left wall connecting it with Cave 64. Although the relative chronology of the above-mentioned niches remains to be ascertained, the asymmetry and difference in size and shape indicate the lack of a unified plan and suggest they were carved in different periods.

Figure 12. Kumtura North Monastery, Caves 54–65. Photograph adapted from B 1617 © SMB, Museum für Asiatische Kunst. The smaller photograph is adapted from B 1170 © SMB, Museum für Asiatische Kunst.

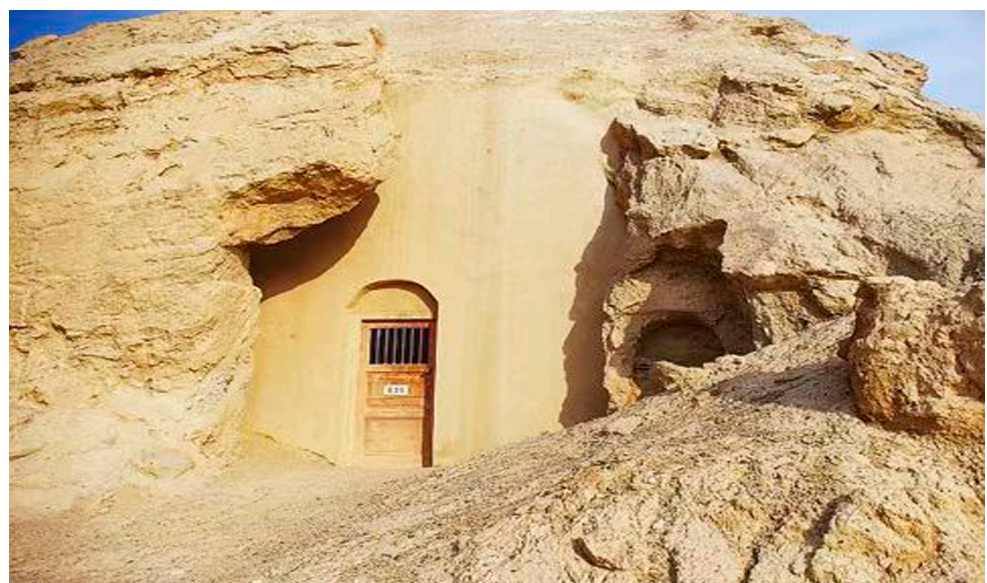
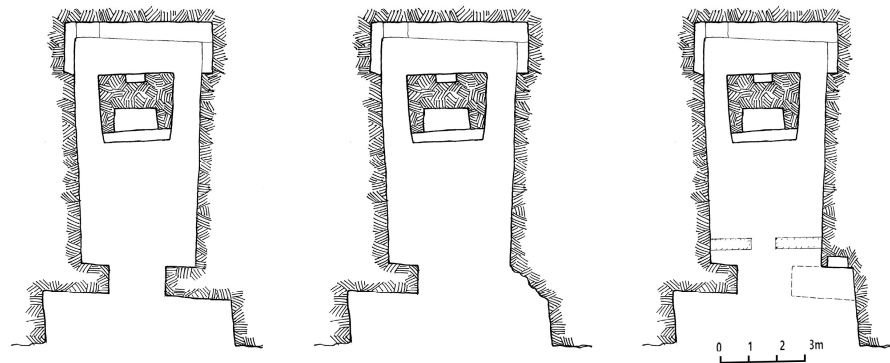
A full discussion of the Simsim monastery is beyond the remit of this study.²¹ In this context, we only examine three caves: Caves 36, 32, and Cave 8. Cave 36 is a small niche carved next to the central pillar Cave 35, the largest of this type on the site, which is almost completely preserved except for its antechamber and a small section of the main chamber. The modern cement wall, meant to prevent further collapse, has foreshortened the internal space significantly. Cave 36 is a niche carved on a section of rock exposed by the collapse of the front part of Cave 35; again, the placement of this niche means that it could not have been part of the original cave (Figure 13).

Figure 13. Simsim, Central pillar Cave 35 and niche Cave 36. The diagrams represent Cave 35 at three different stages: as it was originally carved (left); after the collapse of its front part (center); after the carving of niche Cave 36 (right). Photograph courtesy of the Kizil Cave Institute, 2022; diagrams by the author.

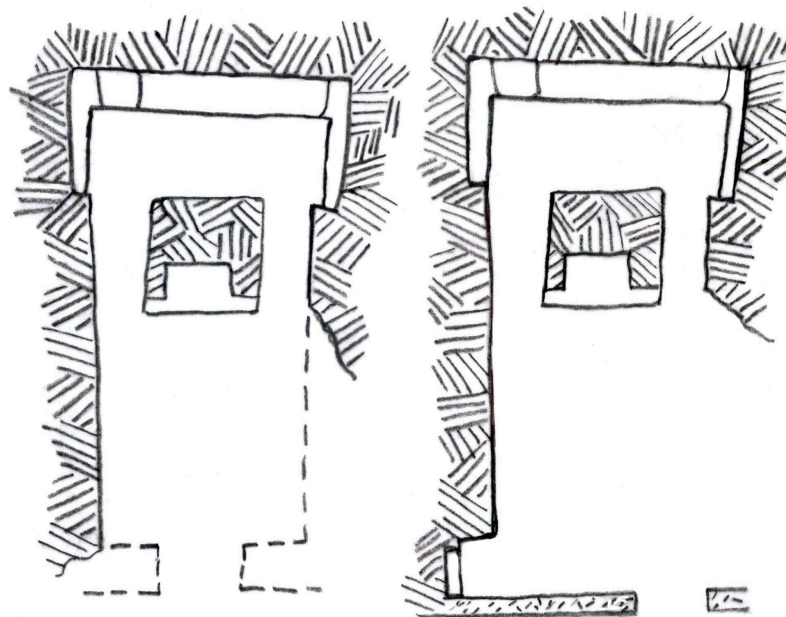
Simsim central pillar Cave 32A illustrates a similar situation. After the collapse of the cave, only the left and main wall of the main chamber and most of its rear areas remained intact. The location of the small niche on the left indicates it was undisputedly carved after the large collapse affecting the front part of the cave (Figure 14).

Figure 14. Simsim, reconstruction of Cave 32. To the left, the original cave; to the right, the way the cave was after it suffered a collapse and a niche was carved. Diagrams by the author.

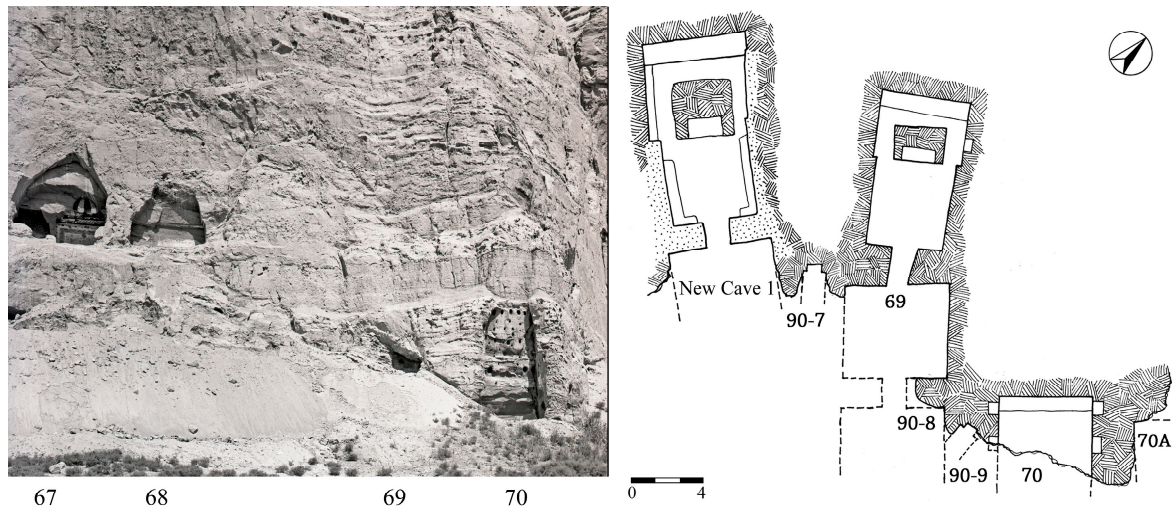
The tallest cliffs used to carve rock monasteries in Kucha are in Kizil. Large and deep scars in the rock are witnesses to the extent to which weathering has affected the site. The section of the cliff above New Cave 1 and Cave 69 shows marks of a large landslide that damaged both caves (Figure 16). Originally, these were two square caves, here numbered New Cave 1[1] and 69[1]. After the collapse, niches Caves 90-7 and 90-9 were carved between New Cave 1 and Cave 69, and between Caves 69 and 70, respectively. Then, the two larger caves were repurposed into central pillar caves, New Cave 1[2] and Cave 69[2].²² The niche's similarity in size and structure, the fact that each niche had a recess for the installation of a small statue in the rear wall, and their being decorated with the same colors suggest the two niches were carved at the same time. The relative location of the two niches stipulates that they could have been carved only after the collapse of the section of the cliff comprising New Cave 1[1] and Cave 69[1]. Ensuing collapses sealed the caves and niches with debris that contributed to their preservation, since further deterioration would

Figure 16. Kizil. The diagram shows the relative position of Caves New Cave 1 and 69, as well as that of the niches Cave 90-7 and 90-9. Photograph adapted from B 1381 © SMB, Museum für Asiatische Kunst; diagram by the author.

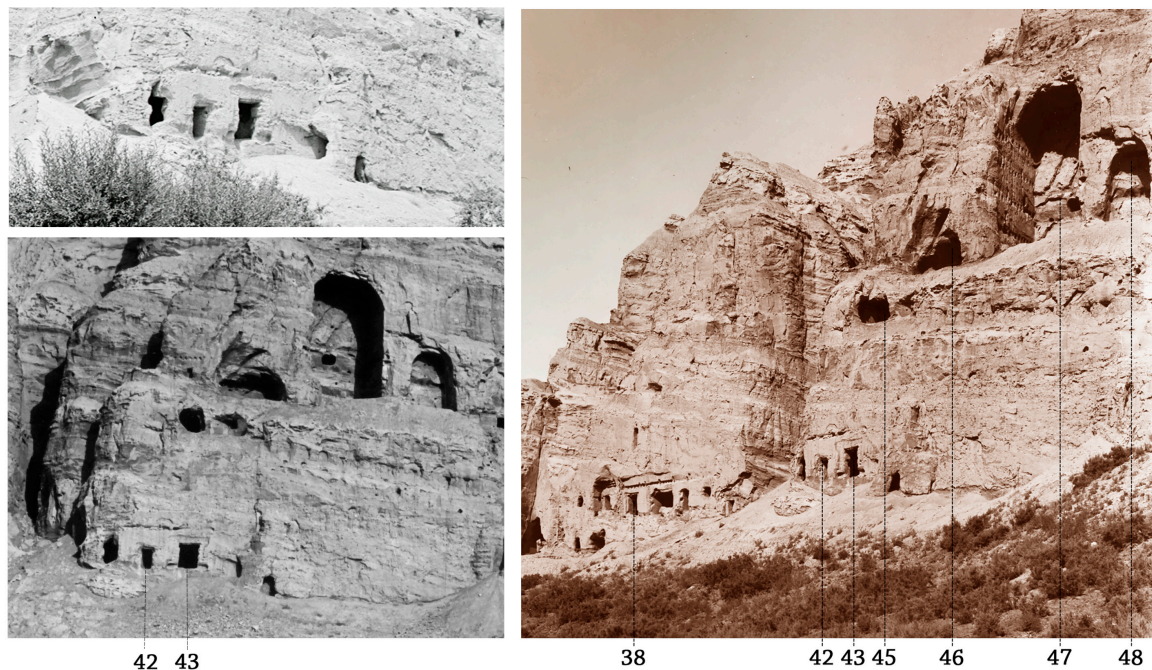
Figure 17. Kizil, Caves 42–43. Close scrutiny of several historical photographs clearly indicates the presence of a stairway leading to Cave 43. Photographs adapted from B 1418 (**upper left**), B 0643 (**lower left**) adapted from, B 0607 (**right**) © SMB, Museum für Asiatische Kunst.

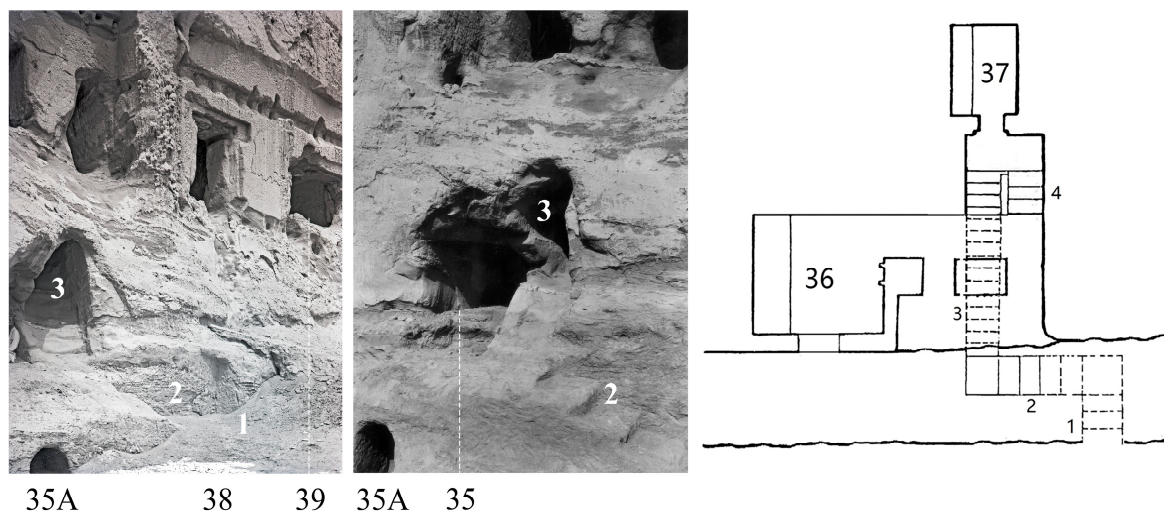
Figure 18. Kizil, the section of the cliff next to Cave 38. The photographs show the flights of steps 1, 2, and 3, and the presence of the currently unseen Cave 35A below (**left**), and the same area seen from a different perspective (**center**). The diagram by the author of the proposed reconstruction of the complete stairway starting from Grünwedel's drawing (Grünwedel 1912, Fig. 121 p. 62), on the basis of data emerging from several relevant historical photographs, and the systematic study of stairways in Kucha (**right**). Photographs adapted from B 1305 (left), B 1828 (right) © SMB, Museum für Asiatische Kunst.

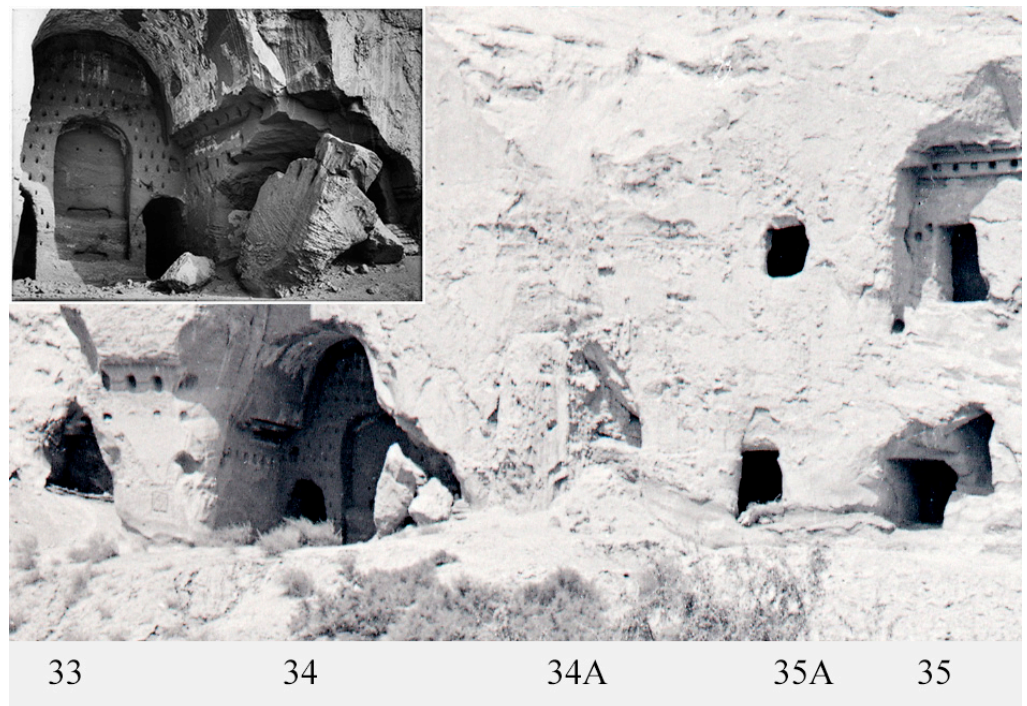
Caves 33–35 formed a complex group that developed over time.³⁰ The extant rafter holes and floor joist holes indicate the presence of a cantilevered timber balcony. This implies that the group was carved in a relatively high position on the cliff, since a cantilevered wooden structure would have been useless for caves carved at ground level (Figure 19). The high location of the group on the cliff means that the presence of caves below it cannot be excluded, especially considering the closeness of Cave 35A; a likeliness that deserves to be investigated by clearing the area in front of the cliff. Concerning the westernmost section of the cliff in Kizil (Guxi), there might be another row of caves below the present surface, approximately between Caves 32 and 43 (Figure 20).

Figure 19. Kizil, Caves 33–36. The postholes between Cave 33 and 34 indicate the presence of a timber structure in front of the cave. Unseen in the photograph is a lower row of corresponding joist holes. These sets of holes indicate a cantilevered structure was installed in front of these caves; therefore, they were built in a high position on the cliff and likely reached through a stairway. It cannot be excluded that there were other caves carved below. See the approximate location of Cave 35A (see also Figure 18). Photographs adapted from B 0788, B 0703 © SMB, Museum für Asiatische Kunst.

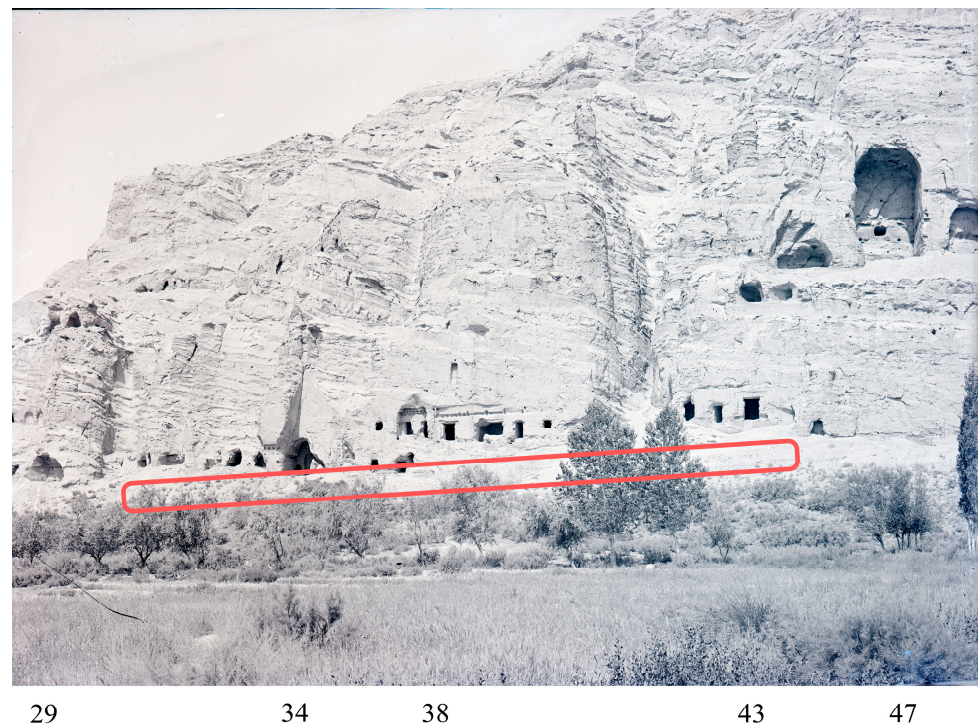
Figure 20. Kizil, the area between Caves 29 and 48. The box indicates the area where there are possibly more caves covered by the thick layer of debris. Photograph adapted from B 0788 © SMB, Museum für Asiatische Kunst.

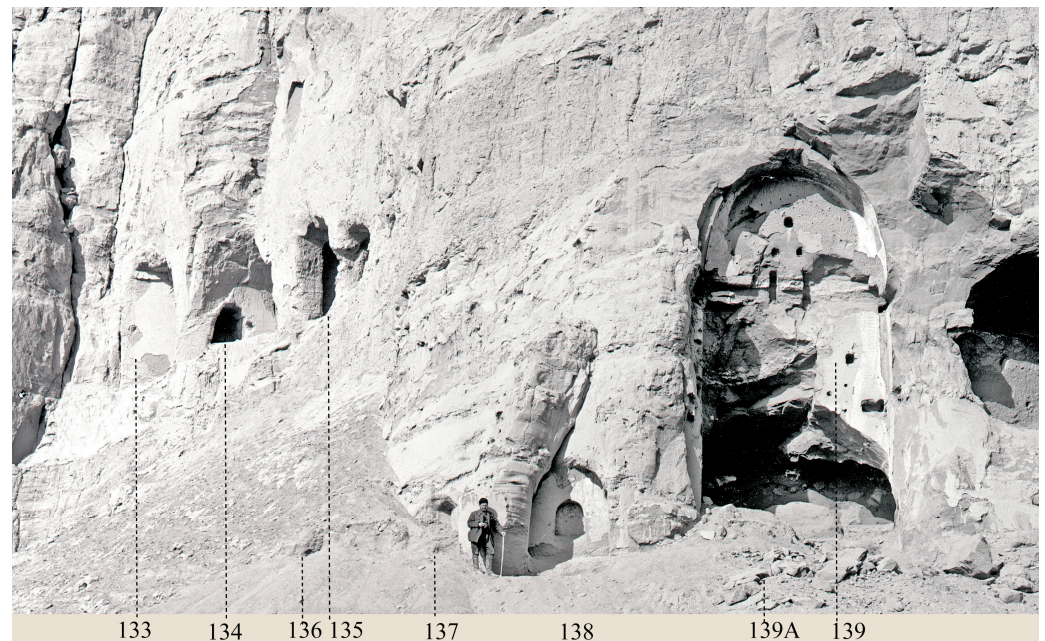
Figure 21. Kizil, Caves 133–140. The area in front of Cave 139 was cleared from the debris and revealed the presence of Cave 139A just below it. Presently Caves 136 and 137 are partially in view. These data strongly suggest there might be another row of caves presently covered by debris. Photograph adapted from B 1795 © SMB, Museum für Asiatische Kunst.

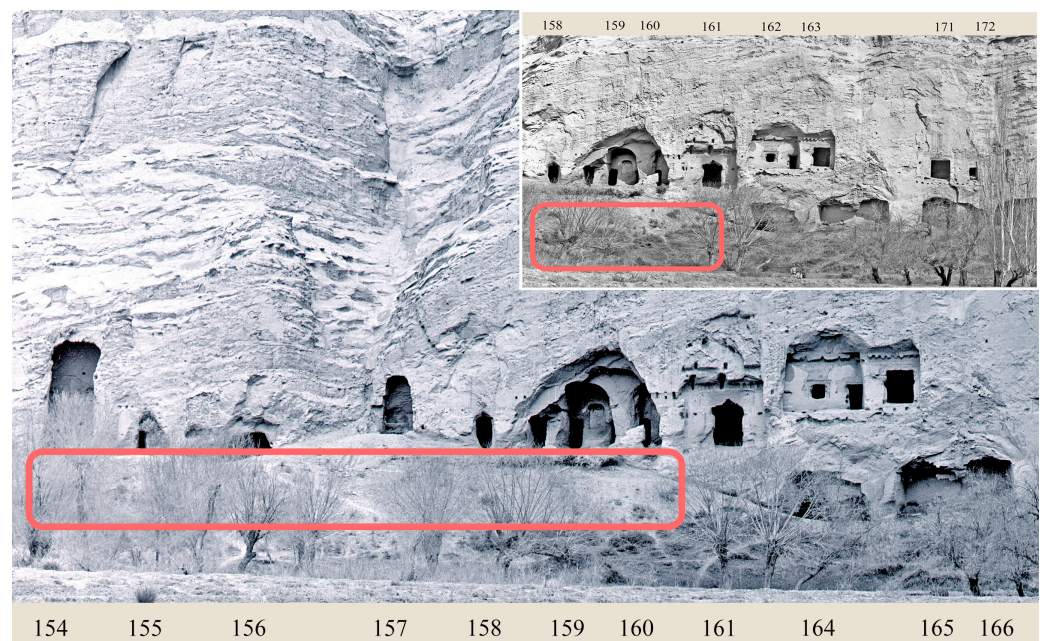
Figure 22. Kizil, Caves 154–172. The two photographs show the location of the likely presence of a lower row of caves in the lower right section and a thick layer of debris on the lower left. To the left of Cave 154, not visible in the photograph, is a cave partially emerging from the ground, while another cave was discovered in this general area when consolidating the cliff (both caves are unrecorded). These data suggest there might be a lower row of caves from below Cave 181 to the left of Cave 154. Photographs adapted from B 1766, B 1386 © SMB, Museum für Asiatische Kunst.

Cliffs are in a constant state of erosion, caused by weathering and earthquakes, as well as human activity. When monasteries were in use, damaged caves were promptly repaired, and no effort was spared in order to keep the monastery operational. Depending on the severity of the damage, different restoration techniques were used. Their marks were more visible a century ago and recorded in photographs. They deserve to be thoroughly inventoried and seriously studied. They range from small repairs, such as the application of new plaster in place of fallen plaster⁴⁰ and the filling of large and smaller cracks in the rock,⁴¹ to large interventions, such as the excavation of a new cave through the rear wall of an earlier cave that had incurred heavy damage (Kizil Cave 69, Figure 16), the rebuilding of walls and ceiling with mudbricks and wooden beams (Kumtura North Monastery Cave 63), the setting up of cantilevered timber balconies for caves located in a high position (Figure 22), or light porches for caves carved next to the ground (Figure 4).

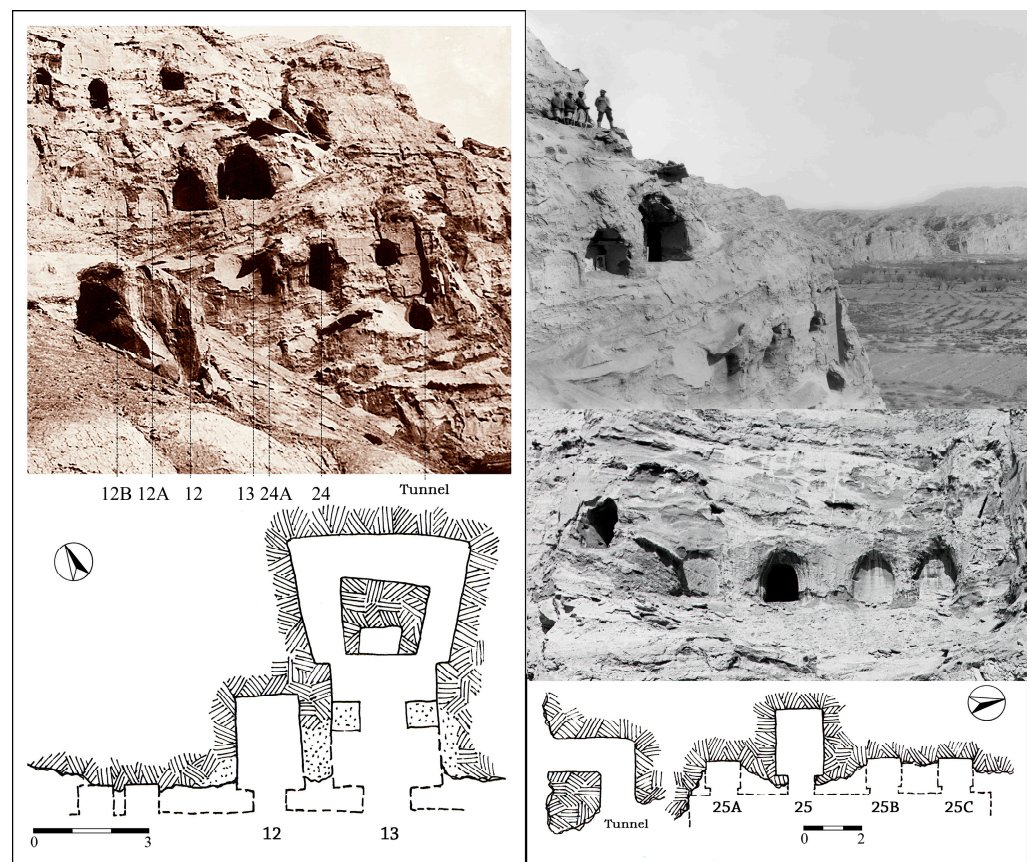
The cave type that has suffered the most damage in Kizil is the small individual meditation cell. We can see this in the group comprising Caves 12 and 13, and Cave 24. This group also included several meditation cells: two on the left of Cave 12 are still visible today, as well as one on the left of the monastic cell Cave 24. The latter is a much-damaged feature that can be identified as a meditation cell on the basis of the historical photographs (Figure 23). The rear wall of the large antechamber of Cave 24 can be clearly seen in the photograph and shows that the tunnel used to reach meditation cells Caves 25, 25A, 25B, 25C started from within the antechamber of Cave 24, indicating that the four meditation cells were part of the same complex group. Historical photographs have been crucial for gaining a thorough understanding of this group, which included at least seven meditation cells.

Figure 23. Kizil, the group formed of Caves 12, 13, and 24, and the monastic cells connected with them: Caves 12A, 12B, 24A, 25A, 25B, 25C, and 25D. Photographs adapted from B 0786 (upper left), B 2158 (upper right), B 1253 (center right) © SMB, Museum für Asiatische Kunst; diagram by the author.

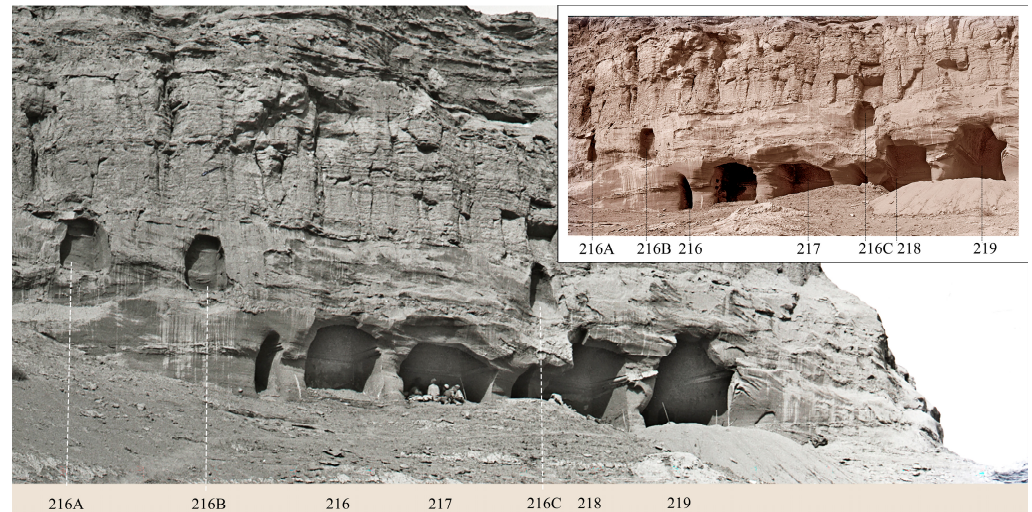
The group comprising Caves 216–218 in Kizil also included three meditation cells, respectively Caves 216A, B, and C, carved above the larger caves (Figure 24). The three caves are presently damaged to the point where it has become almost impossible to identify whether they were natural formations of the rock or man-made structures, but the latter hypothesis can be confirmed on the basis of the historical photographs that clearly show straight contours.³⁶

Figure 24. Kizil, the group formed of Caves 216–219. Above these large caves, there are three smaller meditation cells: Caves 216A and 216B to the left of Cave 216, and Cave 216C between Cave 217 and Cave 218. Photographs adapted from B 1738 (above), B 1383 (below) © SMB, Museum für Asiatische Kunst.

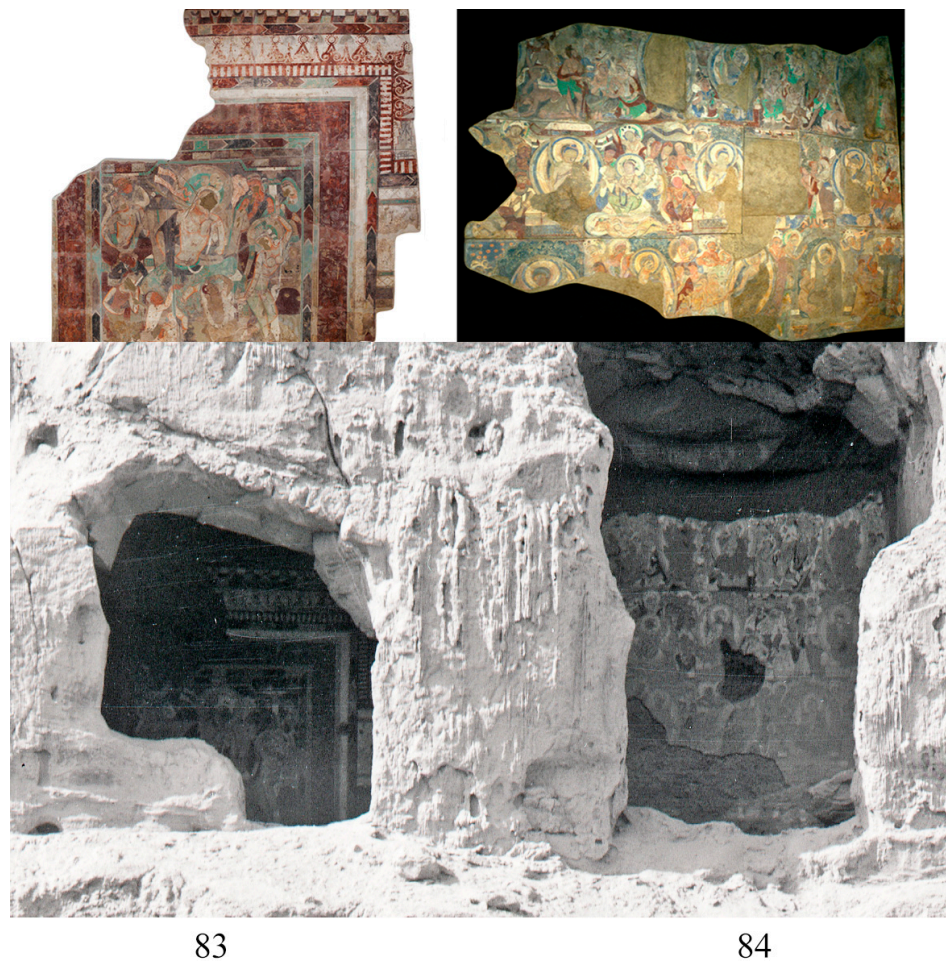
Figure 25. Kizil, Caves 83 and 84. The enlargement of the photograph below shows the paintings in their original location within the caves. Photograph adapted from B 0611 © SMB, Museum für Asiatische Kunst. Most of the paintings from these two caves were subsequently detached and brought to Berlin, where they are presently preserved. Photographs adapted from III 8443 (left), III 8444 (right) © SMB, Museum für Asiatische Kunst. A similar situation is seen also in Figures 9 and 14.
