Historical Photographs of Kucha: Retracing Lost Caves and Related Thoughts

Vignato Giuseppe

Abstract: Historical photographs of Kucha, mostly those taken by the Turfan German Expedition (1902–1914), can be used to recover information concerning the caves lost over the last century and features that cannot be seen any longer. The analysis of photographic material can help to individuate patterns and trigger thoughts leading to a better understanding of the sites, appreciate lost features, reveal the likely location of caves presently covered by debris, understand how caves were restored in antiquity, and suggest better ways to preserve and use rock monastery sites. Though this article focuses on Kucha, the proposed method can be used at other archaeological sites.

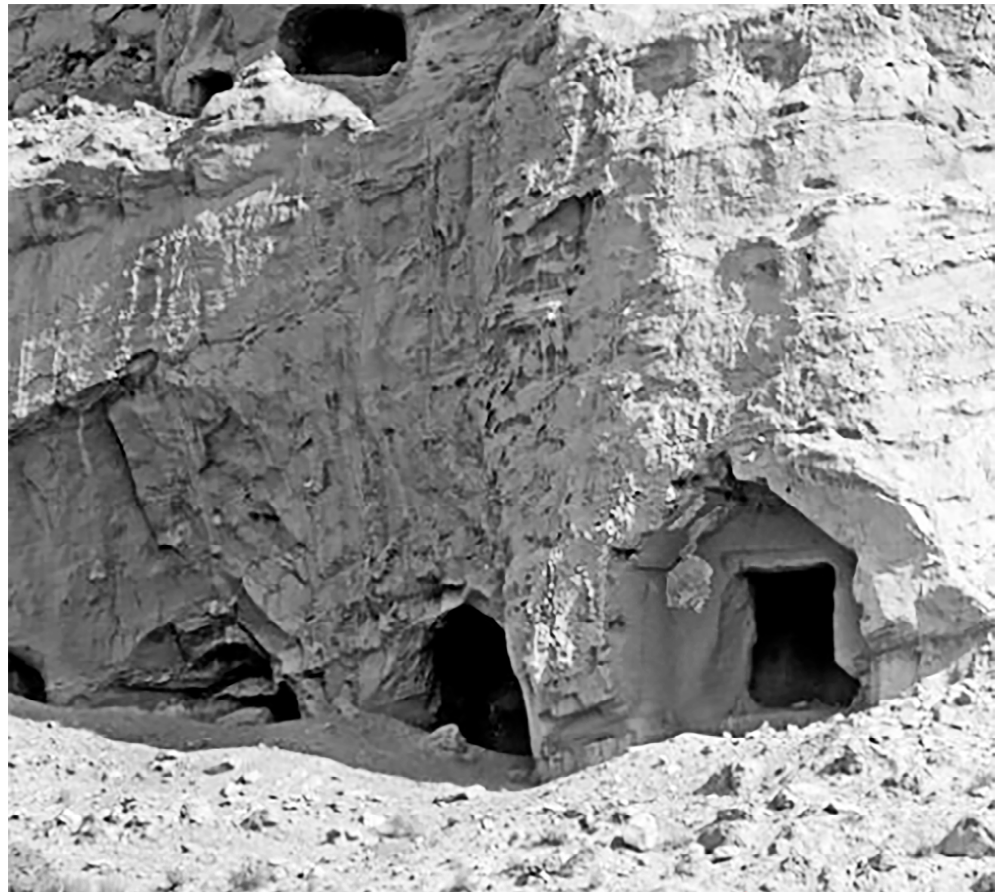
Figure 26. Kizil, Caves 130A, 130, 131, and 132. On the rear wall of the antechamber of Cave 132, part of the painting is preserved and shows the head of a standing Buddha. The painting is presently covered by the cement wall constructed as a reinforcement of the cliff and could be easily overlooked. Photograph adapted from B 1796 © SMB, Museum für Asiatische Kunst.

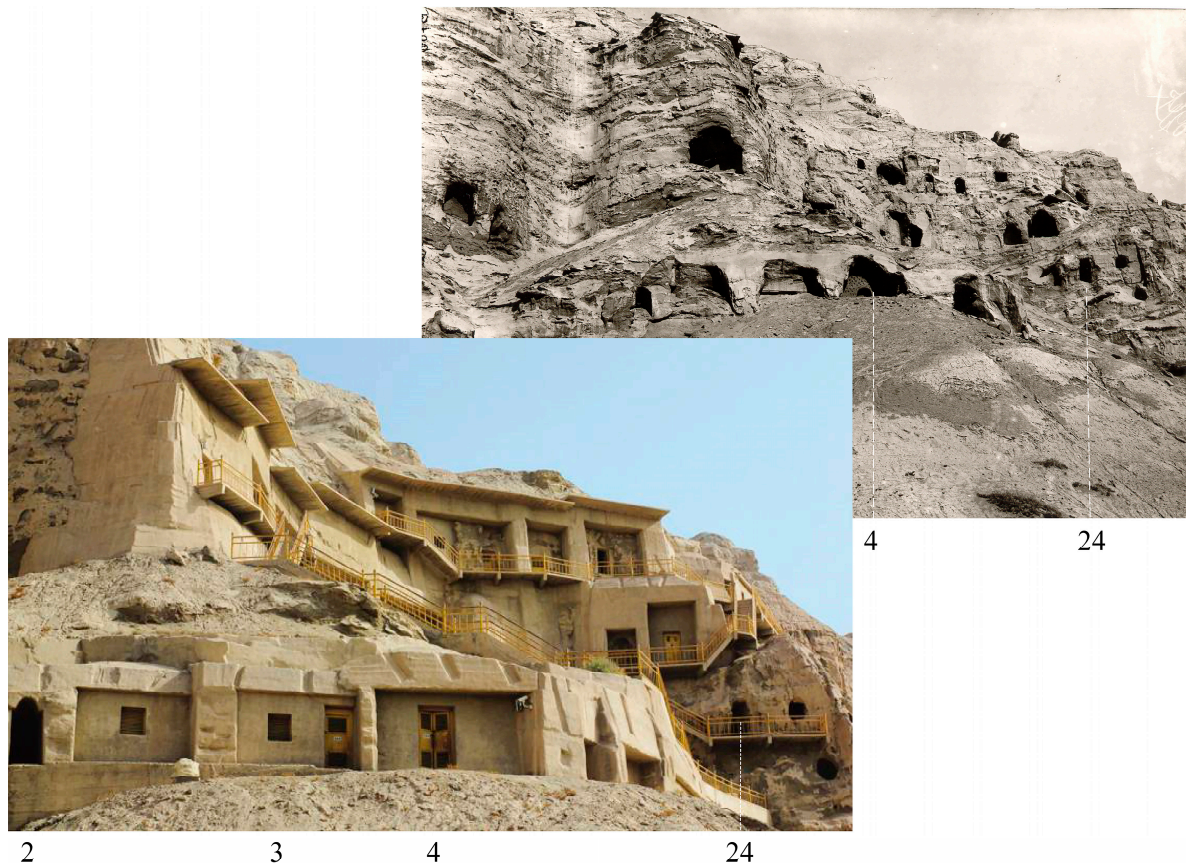
work to consolidate the cliffs and the reparations of caves has modified the outer facade of the cliff and covered many features (Figure 27). Historical photographs have been a crucial material for the accurate study of these features. The lack of attention given to these documents has led to the “invention” of new ways to connect the caves, disregarding the original ones. Understanding how the rock monastery was in the past will help carry out a more accurate restoration. In addition, one also has the opportunity to reassess the original landscape and the visual impact of and from the caves.

Figure 27. Kizil, western end as it appeared in 1906 and as it appears today. Photograph adapted from B 0786 © SMB, Museum für Asiatische Kunst above); photograph courtesy of the Kizil Cave Institute, 2022 (below).

- 44 [Beijing Da Xue Kaoguxue Xi, Kezi'er Qianfuodong Wenwu Baoguansuo \(1997, p. 13, fig. 10\)](#). See photo B 0786, Figure 27.
- 45 The recent large-scale excavation of the Thousand Buddha Caves in the Tuyuq Valley (Turfan) might have benefitted from a careful study of the historical photographs and the ensuing damage that occurred to the site. It would be wiser in the future to carry out small-scale clearing followed by prompt stabilization of the cliff, before proceeding to clear another small section.
