# Strengthening of Corroded Reinforced SCC-RAP Members with CFRP

**Keywords:** reinforced concrete; corrosion; repair; strengthening; FRP

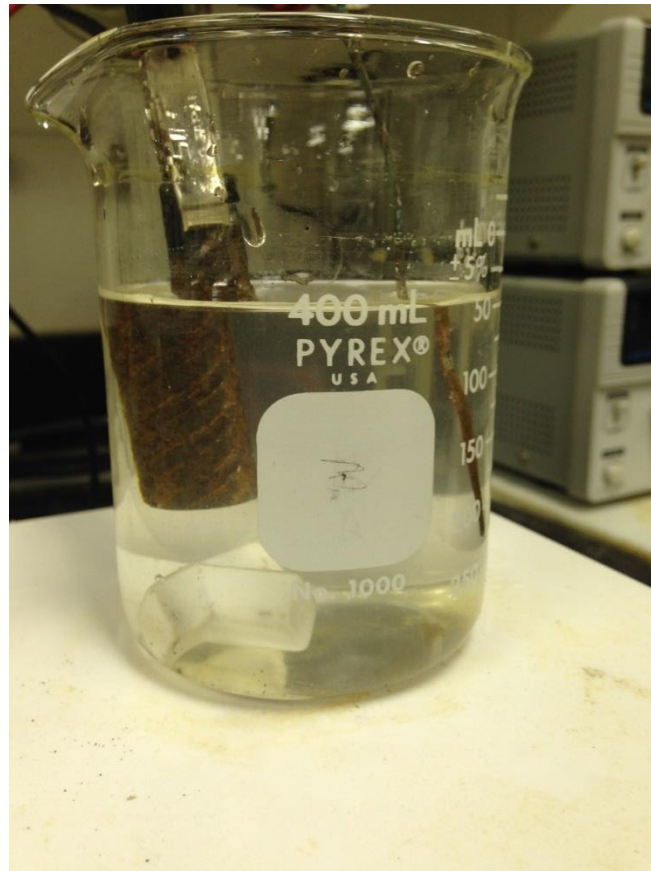
Figure 1. Small corrosion test setup.

To experimentally determine the relationship between the mass loss due to corrosion and electric current or test temperature, small-scale tests were performed first. The test setup is shown in Figure 1. The steel bars and copper sticks were connected to power terminals and immersed in salt solution. The salt solution is 25 wt%. The salt, which is usually used during winter time to melt snow and available in stores was dissolved in tap water. A macroscopic galvanic cell with steel and copper electrodes and molten salt electrolyte were therefore formed. After a number of trials, finally, tests were narrowed down to four small-scale tests on 63.5 mm long 12.7 mm diameter Grade 60 steel bars (Table 2). Both of constant current of 0.1 and 0.2 Amp electric current were considered in this study and applied by means of external power supplies having capacity of 3 Amp. Room temperature,  $24^\circ\text{C}$ , was used for Tests 1, 3 and 4 and  $84^\circ\text{C}$  for Test 2 to observe the effect of temperature. As shown in Table 2, the steel rebar was connected to the positive terminal of power supply (anode) for the first three tests (Tests 1–3), whereas the copper was connected to the negative terminal of the power supply (cathode). In Test 4, the terminals are switched for the steel and the copper to confirm that connecting steel to the cathode would protect steel from corrosion, which means that there would be no mass loss. The container was placed on a stirring and heating station. A stirring bar was placed in the bottom of the beaker to stir the solution during the test. After approximately four days (95.5 h), the steel bars

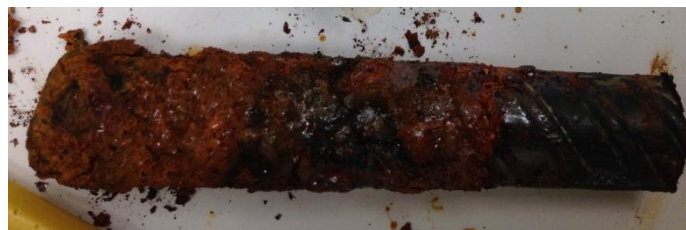
Figure 2. Rebar sample after corrosion.

were retrieved, cleaned and dried to measure the mass to calculate the mass loss. The corroded sample of test 1 is shown in Figure 2.

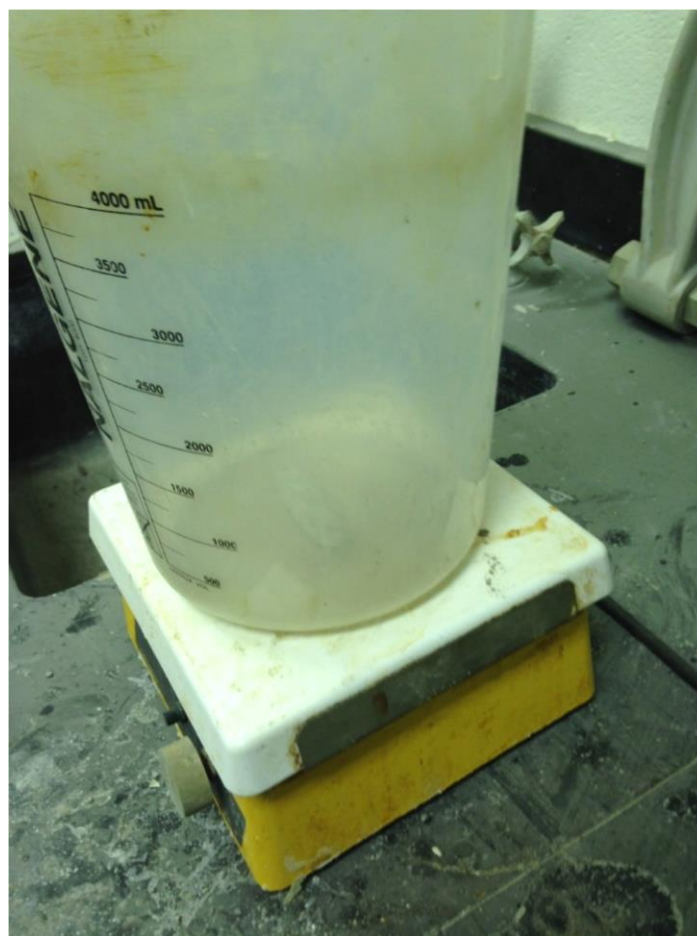
Figure 3. Station to prepare salt solution.

The corrosion test was designed to induce corrosion in a total of twenty Grade 60 deformed steel rebars to achieve different levels of corrosion. The rebars used in this tests are 1.828 m long and (# 5) 15.875 mm in diameter. The level of corrosion was measured by means of measuring the amount of mass loss after the test was completed. Five levels of corrosion were targeted including 10%, 20%, 32%, 40%, and 50%. 32% is very close to 30% so the results of this level of corrosion will provide insight about the 30% of corrosion as well. Based on the amount of mass loss per day that was determined from the small test (Table 2), it was possible to estimate the number of days needed to reach the designated corrosion level. Due to the length of the rebars, gutters with polymer liners were used as testbeds. A total of six testbeds were placed in the laboratory and were filled with salt solution of 25 wt%. The amounts of water and salt were measured in the laboratory to make the salt solution using a stir station (Figure 3).

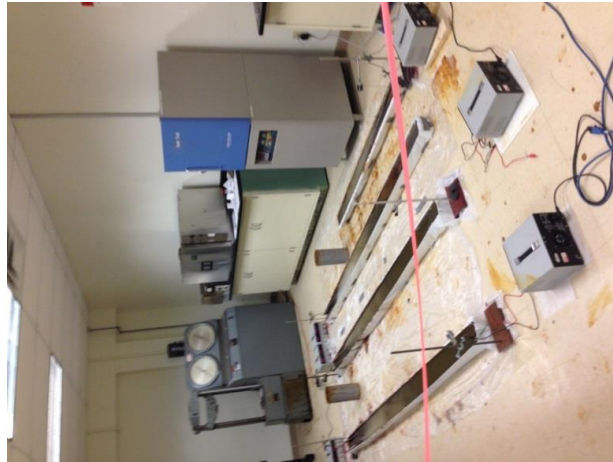
**Figure 4.** Actual corrosion test setup.

Six power supplies were also placed close to the testbeds, with one power supply on one end of each testbed (Figure 4). Each power supply, with a 3 Amp capacity, has three ports while each port has two terminals; therefore, by connecting two adjacent ports in parallel, it was possible to increase the capacity of the power supply to 6 Amp, which was used in the test. Having six test setups made it possible to induce corrosion in six rebars at one time. In each testbed, a steel rebar was placed next to a copper tube (Figure 5). Both of the steel rebar and the copper tube were clamped to the power supply from only one end using a special clamp, which was designed specifically for this test. The steel rebar was connected to the positive terminal of power supply to act as an anode, whereas, the copper was

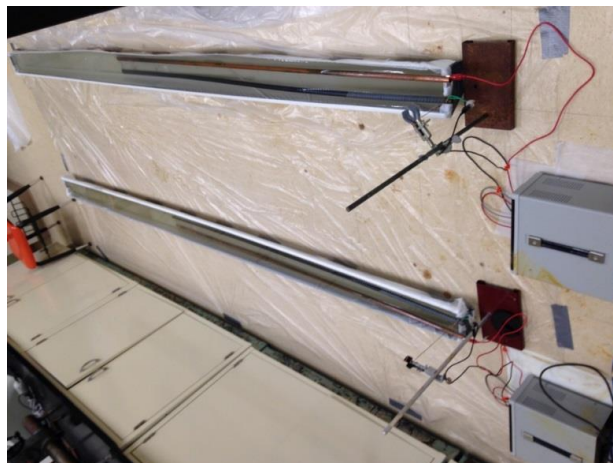
**Figure 5.** Placing copper and steel rebars side-by-side at the beginning of the test.

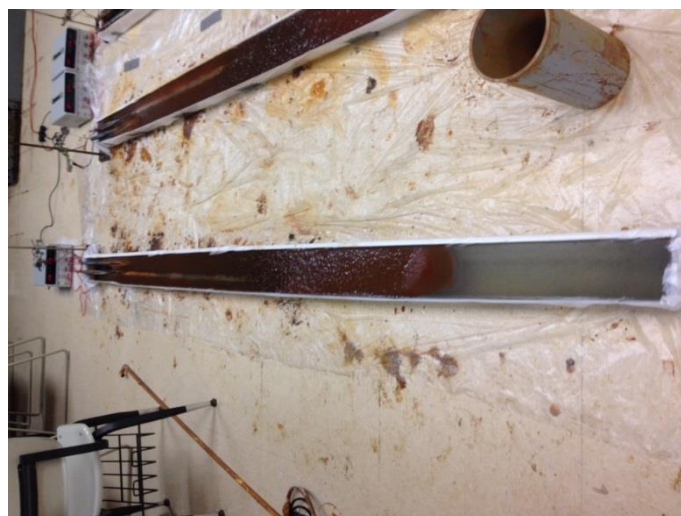
**Figure 6.** Steel rebars are corroding during the test.

connected to the negative terminal of the power supply to act as a cathode. A constant current of 5.76 Amp was applied to all of the testbeds through the installed power supplies (Figure 6).

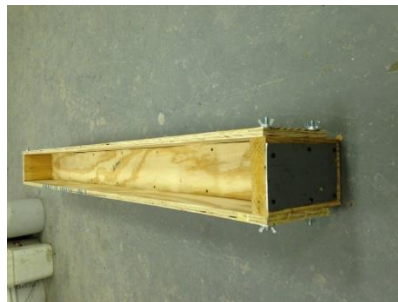
Figure 7. Formwork.

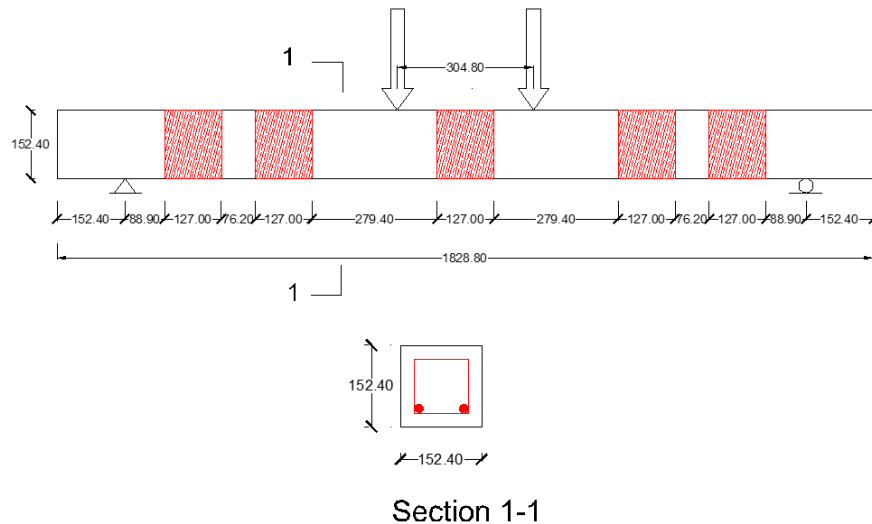
**Figure 8.** A Typical test setup for a repaired reinforced concrete (RC) member (dimensions are in mm).

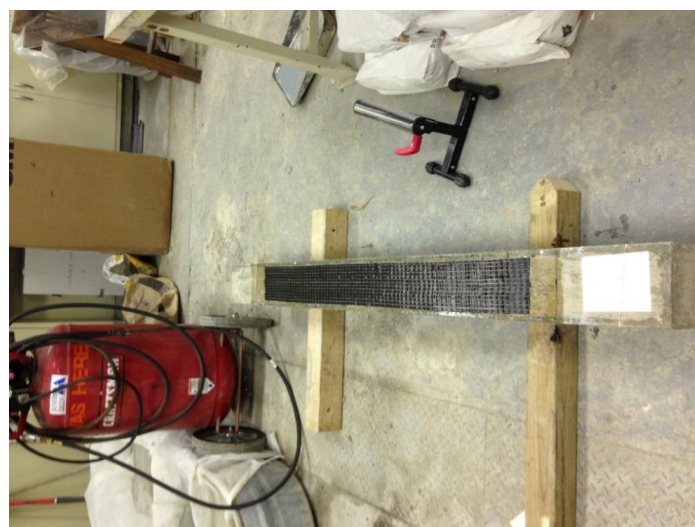
**Figure 9.** Installation of CFRP sheets.

A number of steps were undertaken to prepare the beam before CFRP was applied as recommended by the manufacturer. The beams were flipped so the bottom is facing up. The CFRP sheets and U-wrap were cut and becoming ready. The beams were sanded and air blasted. A primer layer of epoxy was applied to the beam, where CFRP will be applied. The CFRP that had epoxy already applied were applied to the designated locations in the beam (Figure 9). Pressure was applied against the fabric to work out any air pockets between the fabric and beam's surface. Another layer of epoxy was applied to the CFRP using a painting roller. A weight was placed on the top of the beam and also a lateral system was placed to hold the U-wrap in place (Figure 10). After epoxy cured, repaired beams were tested.

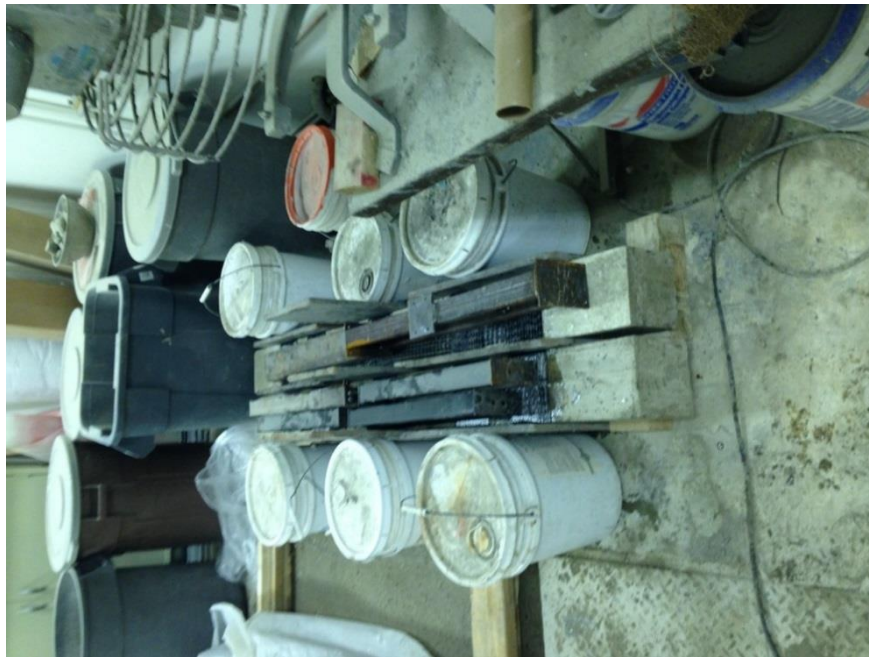
**Figure 10.** RC members after repair.

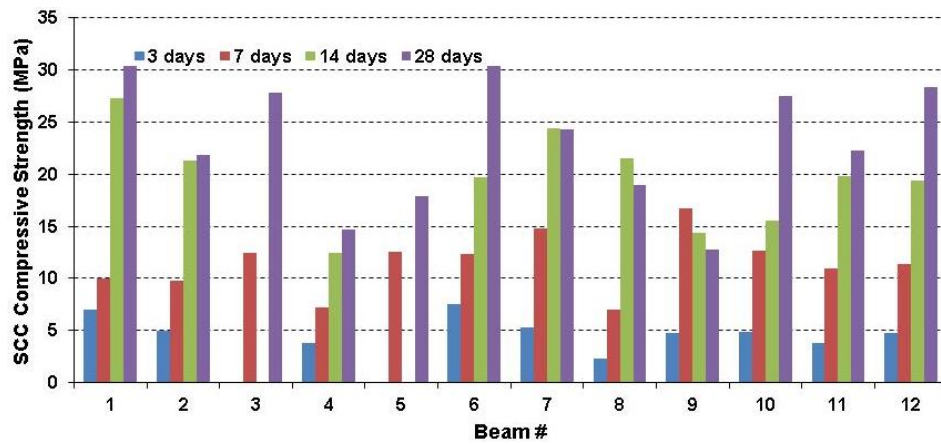
Figure 11. Compressive strength of concrete used in beams.

Figures 11 and 12 show the results of compressive and tensile strength at 3, 7, 14, and 28 days for all of the concrete samples taken from SCC mixtures for all of the twelve beams (Figure 13), respectively. Results analyzed statically using Weibull distribution are also presented in Figures 14 and 15. Table 5 presents a comparison between the average concrete strength and mean concrete strength calculated using Weibull distribution.

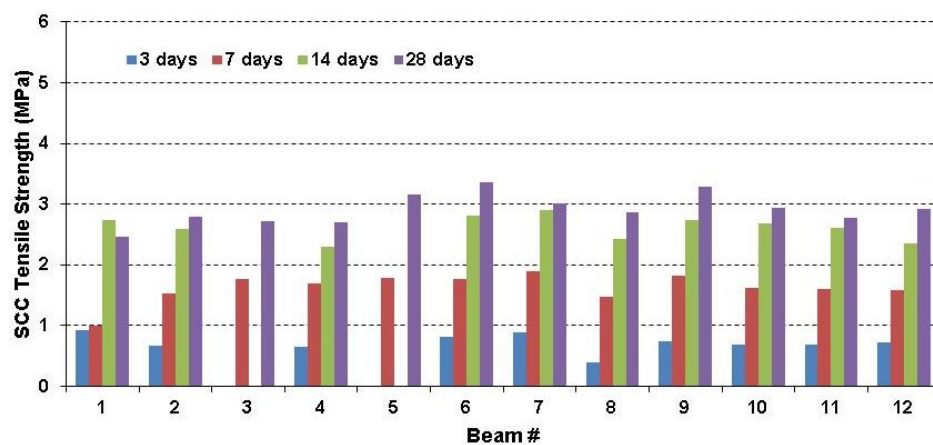
Figure 12. Tensile strength of concrete used in beams.

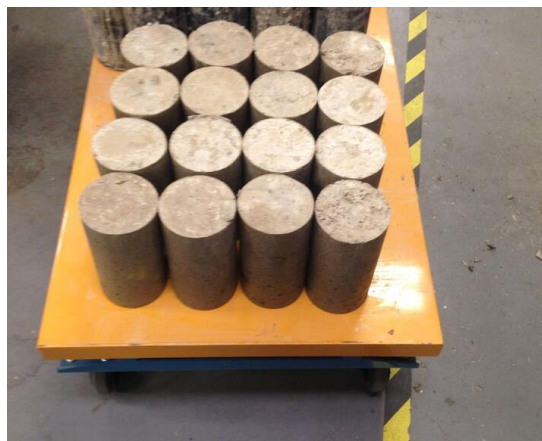
Figure 13. A sample of concrete samples taken for concrete mixtures.

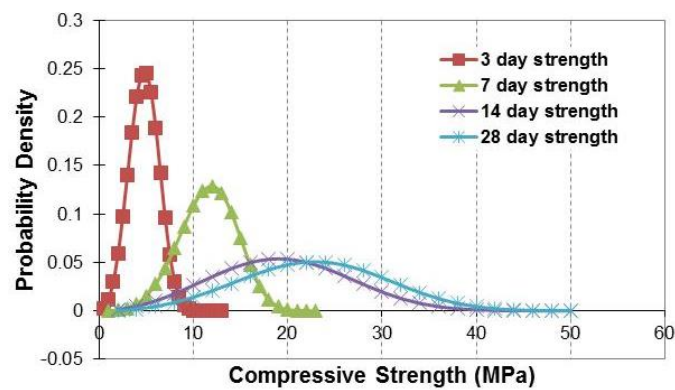
Figure 14. Weibull distribution of compressive strength of concrete used in all beams.

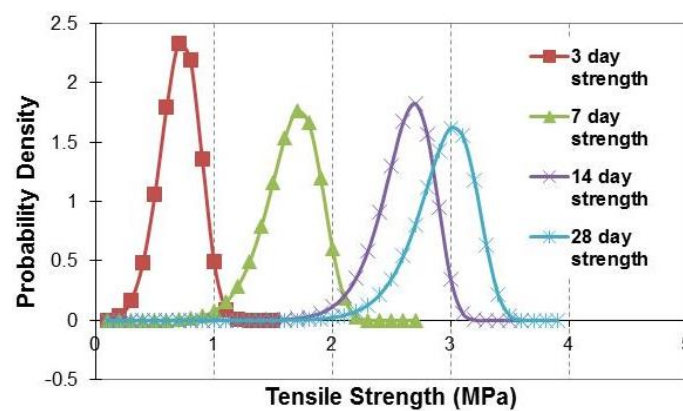
Figure 15. Weibull distribution of tensile strength of concrete used in all beams.

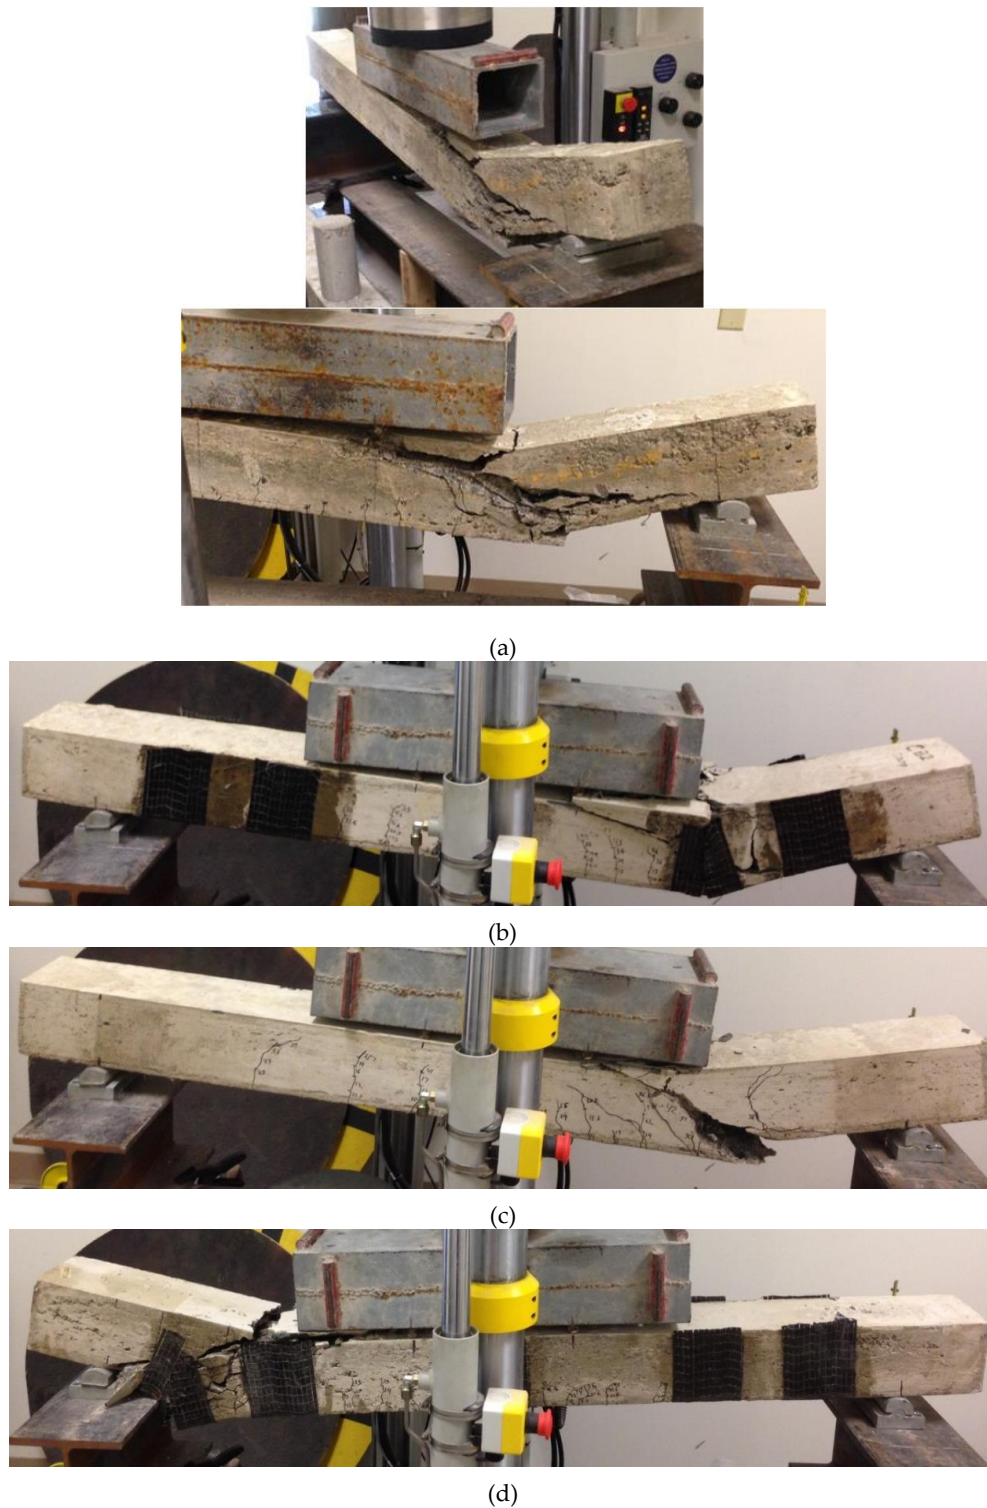
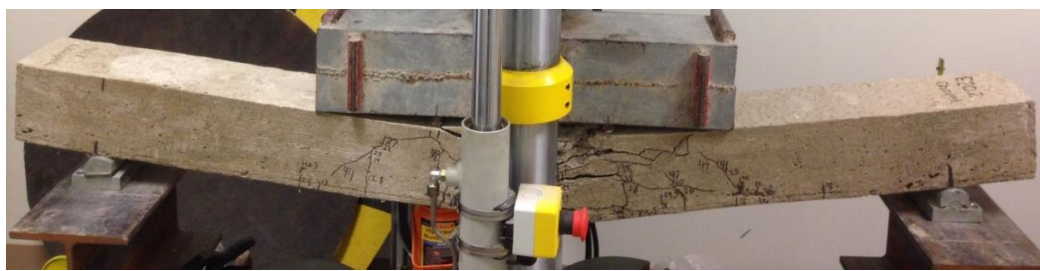
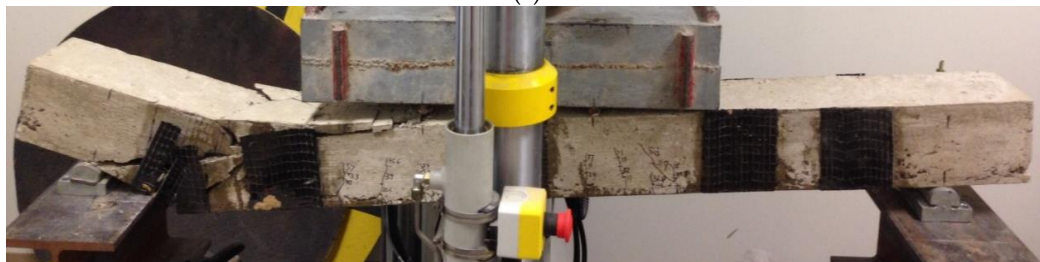
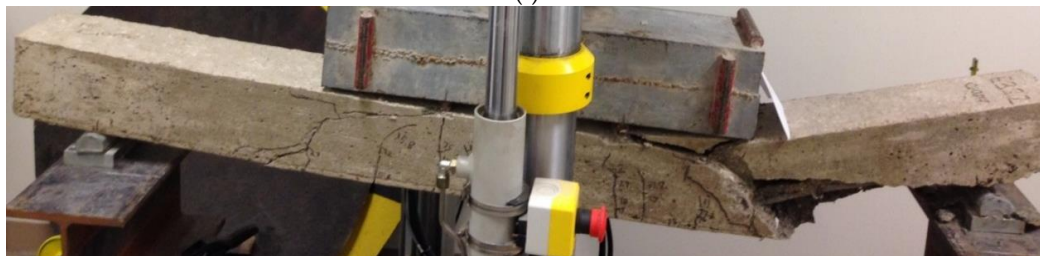
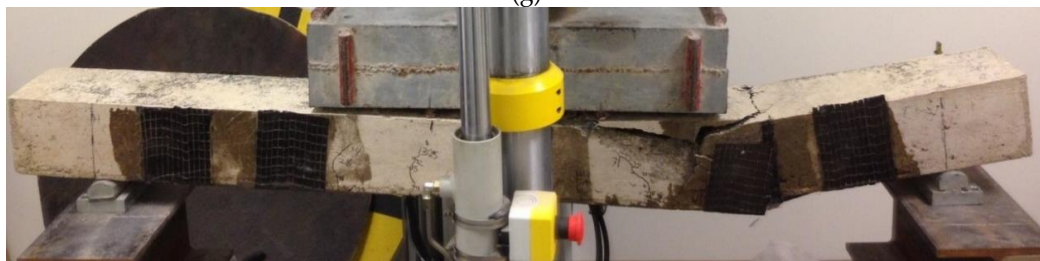
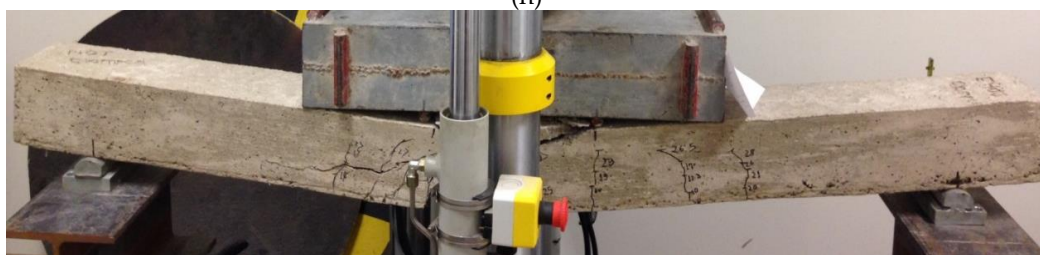
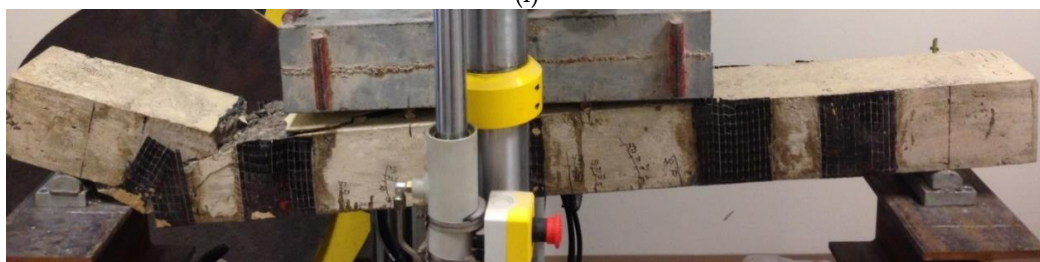
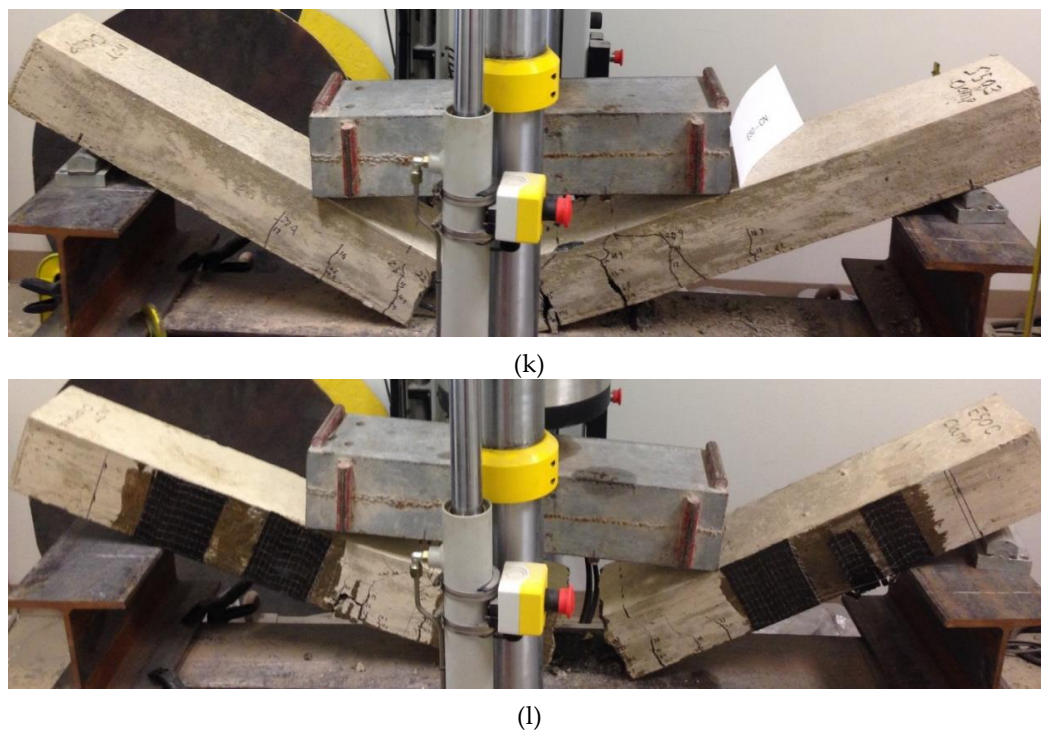
**Figure 17.** Failure of all tested beams. (a) CB–CN; (b) CB–CR; (c) E 10–CN; (d) E 10–CR; (e) E 20–CN; (f) E 20–CR; (g) E 32–CN; (h) E 32–CR; (i) E 40–CN; (j) E 40–CR; (k) E 50–CN; (l) E 50–CR.

As mentioned before, all of the twelve beams were tested under four-point test until failure using the same test setup (Figure 17). The load-deflection relationships for all of the tested beams were generated.

All of the tested beams experienced extensive flexural cracks close to mid-span before failure. Failure of each beam is described as follows:

For **CB–CN** (Control Beam), the first crack appeared at 9.9 kN in the middle of the beam. The next crack appeared to the right of the first crack at 28 kN. The third crack appeared to the left of the original crack at 32 kN. A splitting crack occurred at the very end of the test at approximately 55 kN close to the clamped side, where rebars were clamped during the corrosion process. Note that beam CB–CN did not have any corrosion problem. Failure was initiated by flexural cracks.

For **CB–CR**, which is only reinforced with U-wraps (U). It had its first crack appear at 8.6 kN. At 28 kN a little bit of a popping sound, indicating debonding of CFRP, was heard in the middle U. At 48 kN some popping was heard in the second U from the clamped side. There were a number of flexural cracks close to the mid-span and propagated towards the top. At 54 kN more snapping noise was heard in the middle U and at 58 kN the beginning of a hairline splitting crack started from the loading point on the clamped side and propagated downward. Subsequently, the second U on the clamped side debonded. Then the splitting crack propagated from that loading point down to the support and both of the first U on the clamped side and the second U on the unclamped side debonded. There was also crushing of the concrete in the top. Failure was initiated by flexural cracks.

For **E 10–CN**, The beam showed its first crack at 7 kN. Extensive flexural cracking took place close to the mid-span. At 42 kN, a splitting crack started to propagate on the clamped side between the second and third stirrups. At 44 kN the beam failed due to the splitting crack and crushing of the top concrete. Failure was initiated by flexural cracks.

For **E 10–CR**, the beam first cracked at 4.9 kN. It showed extensive flexural cracking close to the mid-span. At 24.7 kN, a little popping noise was heard from the second U on the unclamped side, indicating debonding of CFRP. At 30 kN a puff of dirt came from the bottom sheet from under the middle U. At 43 kN, a little popping noise was heard from the second U on the clamped side. At 50.5 kN, a splitting crack appeared, originating from near the support on the unclamped side.

Subsequently, there was crushing of the concrete on the top of the beam, debonding of both of the first U and the second U on the unclamped side, which partially debonded. There were also signs of debonding of the second U on the clamped side after the splitting crack took place. Failure was in shear.

For **E 20-CN**, the beam had its first crack at 2.5 kN in the concrete cover. More cracks were developed in the cover. There was extensive cracking close to the midspan of the beam. At 44 kN, a splitting crack started close to the left loading point on the unclamped side of the beam. There was another splitting crack on the other side. Both of the splitting cracks propagated close to the mid-span. The beam later failed due to a flexural crack that propagated at the mid-span and crushing of the top concrete, which is a different mode of failure from the other tested beams. Failure was in flexure.

For **E 20-CR**, The beam first cracked at 7 kN. Extensive flexural cracking took place close to the mid-span. At 28 kN, popping noise was heard from the bottom close to the second U on the unclamped side, indicating debonding of CFRP. Some dust escaped the bottom sheet at 33 kN from close to the midspan. Popping noise was heard from the middle U at 40 kN. The bottom sheet debonded near the mid-span at 44 kN. A stronger popping noise was heard at 47 kN. At 61 kN, a snapping noise was heard. At 62 kN, a splitting crack appeared close to the support on the unclamped side. The first and second U on the unclamped side debonded and there was crushing of the concrete in the top of the beam. Failure was in shear.

For **E 32-CN**, the beam had its first crack at 9 kN. Extensive flexural cracking occurred close to the mid-span. Some of the cracks extended all of the way to the top of the concrete. At 36 kN, a splitting crack started from the loading point on the unclamped side and propagated down near the support on the unclamped side. Later, as that crack propagated, a similar crack propagated on the clamped side. There was also crushing of the top concrete. Failure was initiated by flexural cracks.

For **E 32-CR**, the beam showed its first crack at 10.2 kN. It had a number of flexural cracks close to the mid-span. At 14 kN, popping noise was heard from bottom close to the middle U, indicating debonding of CFRP. At 16 kN, popping noise was heard from the second U on the unclamped side and at 19 kN dust was seen escaping from under the second U on the clamped side. At 27 kN, a snapping noise was heard from the bottom of the unclamped side and at 30 kN, the middle U debonded. At 36 kN a hairline splitting crack was propagating close to the clamped side. At 38 kN, the second U on the clamped side debonded. Later, the splitting crack became more pronounced while the first U on the clamped side debonded and the top concrete crushed. Failure was initiated by flexural cracks.

For **E 40-CN**, the beam showed its first crack at 9 kN. There were extensive flexural cracks close to the mid-span of the beam. Some of the cracks extended to the top of the beam. At 28 kN, a hairline splitting crack developed from under the loading point close to the clamped side and propagated downward. At 30 kN, another hairline splitting crack developed on the other side. At 33 kN, failure took place due to the splitting crack on the unclamped side. There was also crushing of concrete in the top. Failure was in flexure.

For **E 40-CR**, the beam showed its first crack at 2.5 kN. There were extensive flexural cracks close to the mid-span of the beam. Noise indicating debonding in the FRP was first heard at 42 kN in the middle of the beam. A splitting crack occurred close to the unclamped side of the beam at 47 kN. Slight crushing of top concrete also took place. There were signs of debonding in the bottom sheet; however, there were no signs of fracture. Failure was initiated by flexural cracks.

For **E 50-CN**, the beam showed its first crack at 5.9 kN. There were extensive flexural cracks close to the mid-span of the beam. Most of the cracks extended to the top of the beam. At 23 kN, a loud noise was heard close to the mid-span, then the beam splitted into two halves at 25 kN. It was found that both of the two rebars have fractured. Failure took place due to the fracture of the two rebars and crushing of concrete. Failure was in flexure.

For **E 50-CR**, the beam first cracked at 8.5 kN. Popping sound was first noted at 10 kN. Extensive flexural cracking occurred close to the mid-span of the beam. The popping sound occurred more frequently at 27 kN and at 31 kN. Subsequently, the bottom sheet and the U sheets located at the

mid-span and the support on the clamped end ruptured at 31 kN and the load dropped to 25 kN. Flexural failure occurred resulting in the beam to split into two halves. The rebars also ruptured and top concrete crushed. Failure was in flexure.

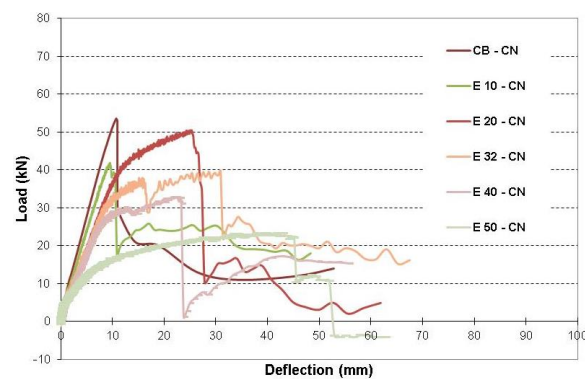
Figure 18. Load-Deflection relationships for all beams without repair.

From comparing load-deflection relationships of beams CB-CN, E 10-CN, E 20-CN, E 32-CN, E 40-CN, and E 50-CN (Figure 18), it can be determined that as the level of corrosion increased, the beam became less stiff. As the corrosion level increased, beams became more ductile except for beam with 40% corrosion as it showed similar stiffness to that with 32% corrosion, but it showed less ductility. Overall, it can be concluded that the cracking load did not change significantly due to corrosion. It can also be concluded that load capacity decreased as the level of corrosion became higher (Table 7). For example, the beam with 40% corrosion level lost about 39% of its carrying capacity while the one with 50% corrosion level lost about 56% of its carrying capacity when they were compared to CB-CN. Thus, the relationship between the corrosion level and the loss in load carrying capacity of RC members seem not linear.

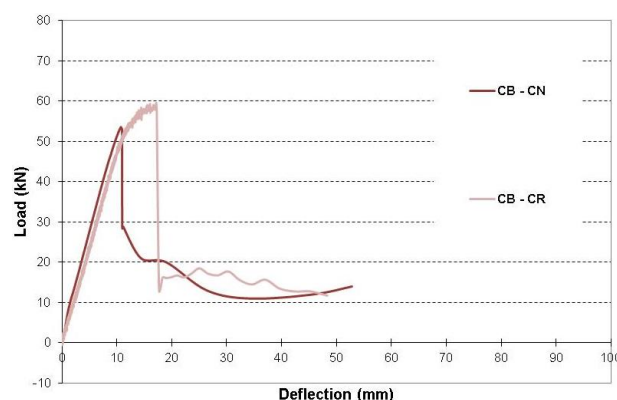
Figure 19. Load-Deflection relationships of control beams without and with repair.

Figure 19 presents a comparison between load-deflection relationships of non-repaired and repaired beams, CB-CN and CB-CR. It is clear that adding only U-Wraps to the CB-CN (control beam) improved its load capacity and ductility. Progressive debonding and then rupture of some of the U-wraps led to the yielding point on the load-deflection curve. As load increased, the beam completely failed. It can also be observed that both CB-CN and CB-CR had similar reserve load capacity after failure.

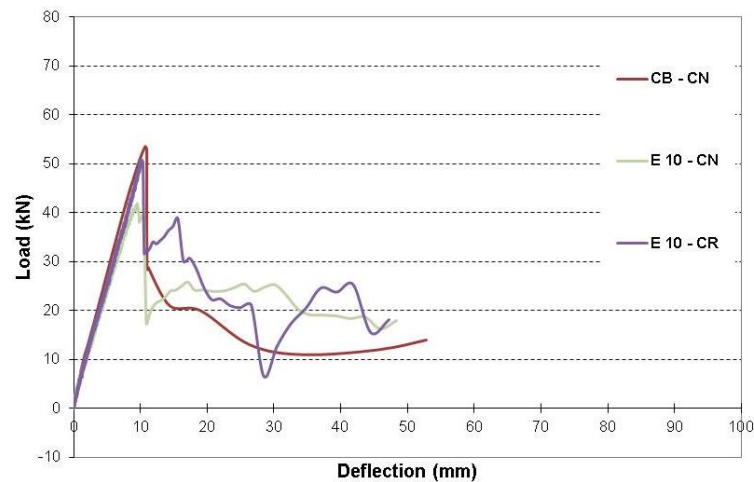
Figure 20. Effect of 10% corrosion level on load-deflection relationship.

Figure 20 presents a comparison between load-deflection relationships of the control beam (CB-CN), E 10-CN, and E 10-CR. Due to 10% corrosion level in rebars, the beam lost about 22% of its load carrying capacity, but when repaired with both CFRP sheet and U-wraps, it recovered about 17% of its load carrying capacity.

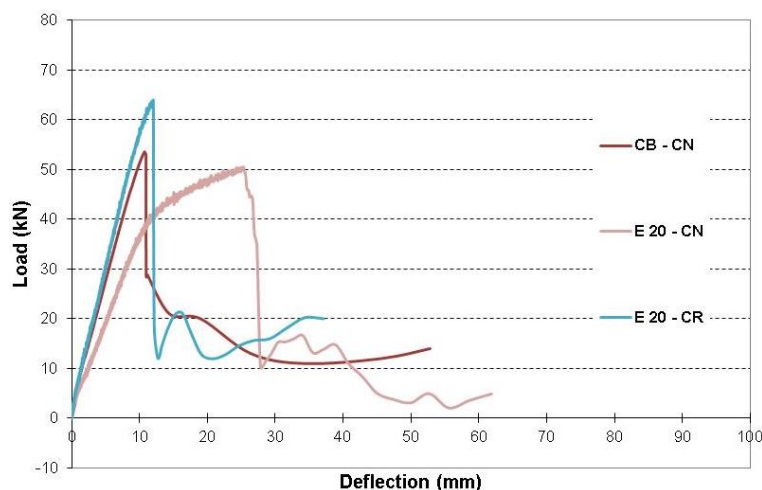
Figure 21. Effect of 20% corrosion level on load-deflection relationship.

Figure 21 presents a comparison between load-deflection relationships of the control beam (CB-CN), E 20-CN, and E 20-CR. Due to 20% corrosion level in rebars, the beam lost about 6% of its load carrying capacity, but when repaired with both CFRP sheet and U-wraps, it had about 19% higher load capacity than the control beam. This can be attributed to the fact that E 20-CN experienced different mode of failure than E 10-CN. It should be also noted that E 20-CN had smaller stiffness than the control beam and was more ductile, but when repaired it had a similar stiffness to the control beam and became less ductile.

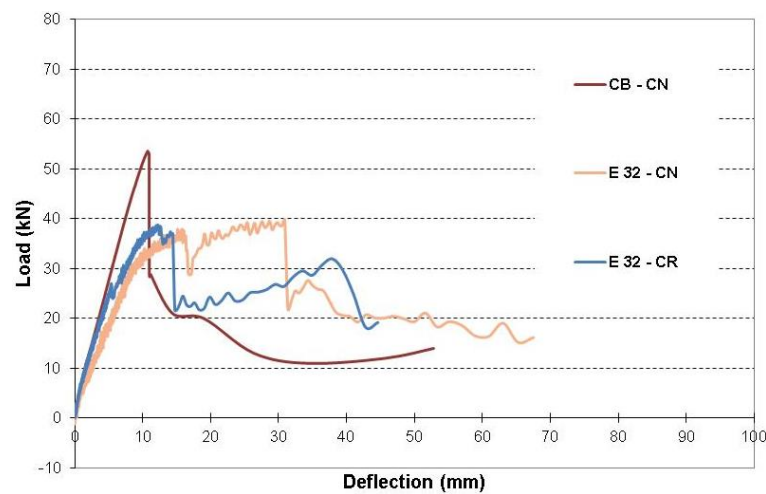
Figure 22. Effect of 32% corrosion level on load-deflection relationship.

Figure 22 presents a comparison between load-deflection relationships of the control beam (CB-CN), E 32-CN, and E 32-CR. Due to 32% corrosion level in rebars, the beam lost about 32% of its load carrying capacity, but when repaired with both CFRP sheet and U-wraps, it only recovered about 4% of its load carrying capacity. This little improvement can be owing to the early signs of debonding in CFRP, which adversely affected the capacity of the repaired beam. Both beams with

32% corrosion level had smaller stiffness than their counterpart control beam and were more ductile. However, E 32–CR became stiffer and less ductile than E 32–CN.

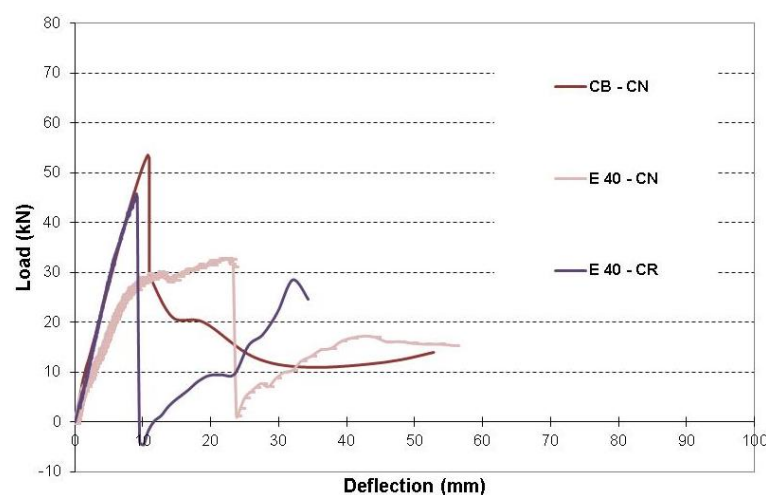
Figure 23. Effect of 40% corrosion level on load-deflection relationship.

Figure 23 presents a comparison between load-deflection relationships of the control beam (CB–CN), E 40–CN, and E 40–CR. Due to 40% corrosion level in rebars, the beam lost about 39% of its load carrying capacity, but when repaired with both CFRP sheet and U-wraps, it recovered about 24% of its load carrying capacity. Beams with 40% corrosion level had smaller stiffness and experienced more ductility than their counterpart control beam, but when repaired, it had stiffness close to the control beam and became even less ductile than the control beam.

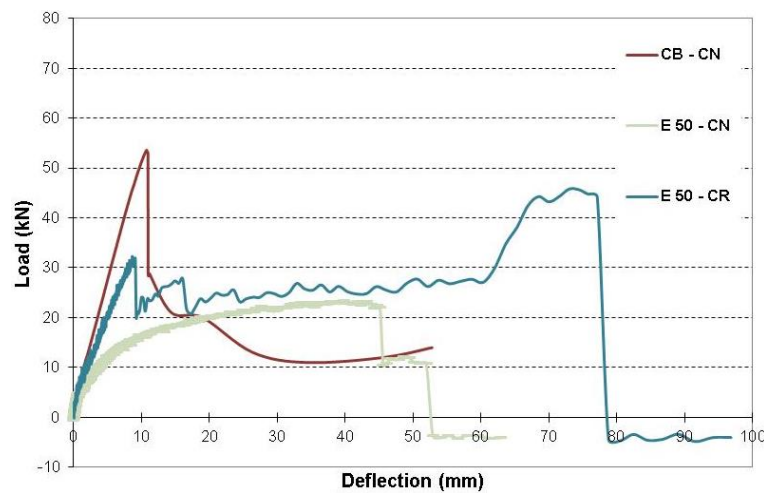
**Figure 24.** Effect of 50% corrosion level on load-deflection relationship.

Figure 24 presents a comparison between load-deflection relationships of the control beam (CB–CN), E 50–CN, and E 50–CR. Due to 50% corrosion level in rebars, there was a drastic loss in capacity. The beam lost about 56% of its load carrying capacity, but when repaired with both CFRP sheet and U-wraps, it recovered about 42% of its load carrying capacity. Both beams with 50% corrosion level exhibited ductile performance as rebars fully yielded, formed nicking, and then ruptured. Furthermore, E 50–CR had load-deflection curve similar to the stress-strain diagram of the steel. E 50–CR experienced drop in capacity before the load levels out due to debonding and rupture of some of CFRP. E 50–CN had smaller stiffness and experienced more ductility than their counterpart

control beam, but when repaired, it had larger stiffness yet smaller than that of the control beam and became more ductile than the control beam.
