Performance of Strengthened Non-Uniformly Corroded Reinforced SCC-RAP Members

Ahmed Abdel-Mohti ^{1,*} and Hui Shen ²¹ Civil Engineering Department, Ohio Northern University, Ada, OH 45810, USA² Mechanical Engineering Department, Ohio Northern University, Ada, OH 45810, USA; h-shen@onu.edu

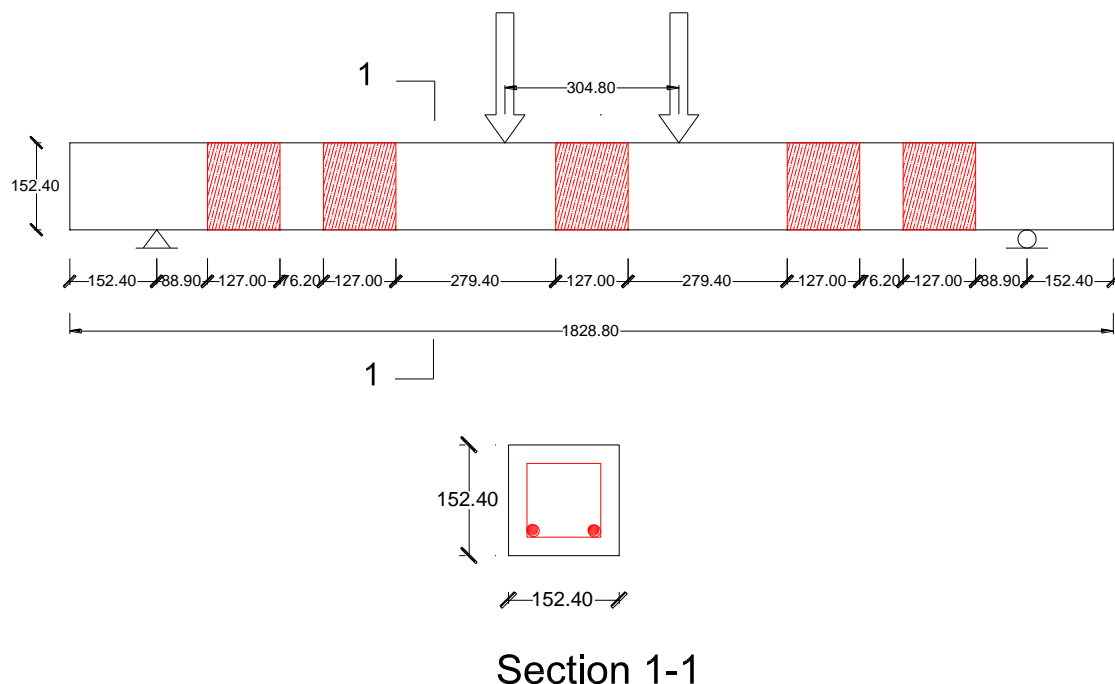
Figure 2. A typical test setup for a repaired reinforced concrete (RC) member (dimensions are in mm).

As mentioned before, all of the 26 beams were tested under two line loads until failure using the same test setup (Figure 2). For all beams under study, the load-deflection relationships were plotted. All of the tested beams experienced extensive flexural cracks close to mid-span before failure. Table 6 presents primary test results of all of the RC members.

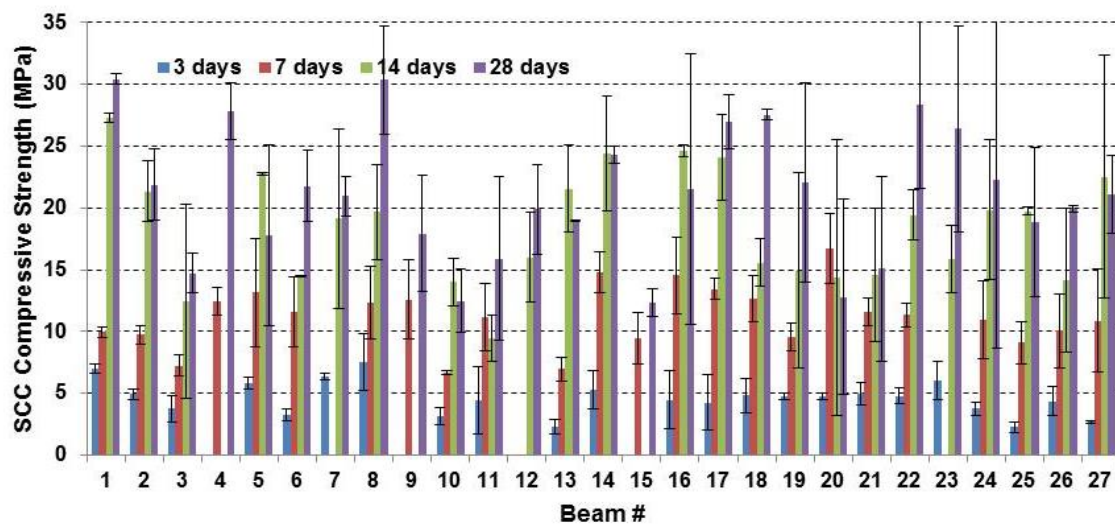
Figure 3. Concrete compressive strength results.

Figures 3 and 4 show the results of compressive and tensile strength at 3, 7, 14, and 28 days for all of the concrete samples taken from the SCC mixtures for all the 26 beams. Results are analyzed using Weibull distribution as presented in Figures 5 and 6. Table 5 presents a comparison between the average concrete strength and mean concrete strength calculated using Weibull distribution.

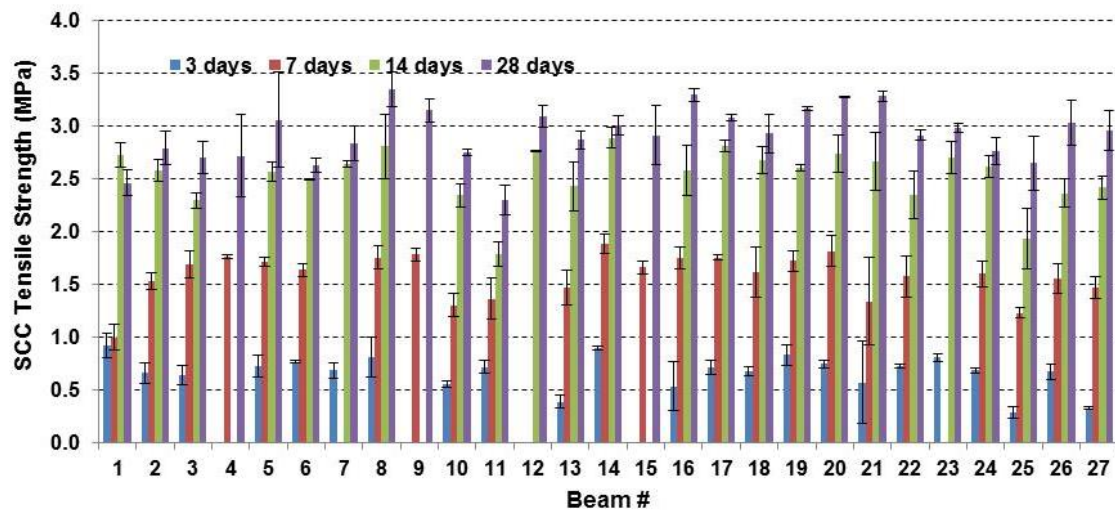
Figure 4. Concrete tensile strength results.

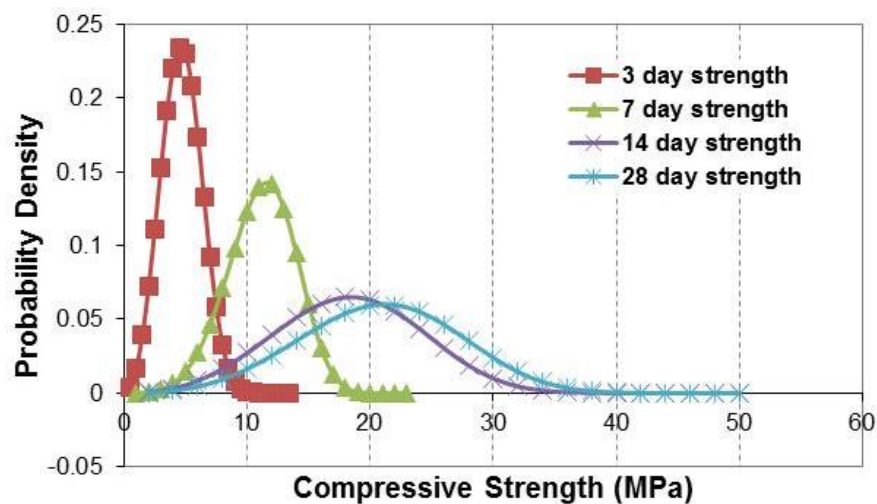
Figure 5. Weibull distribution of concrete compressive strength.

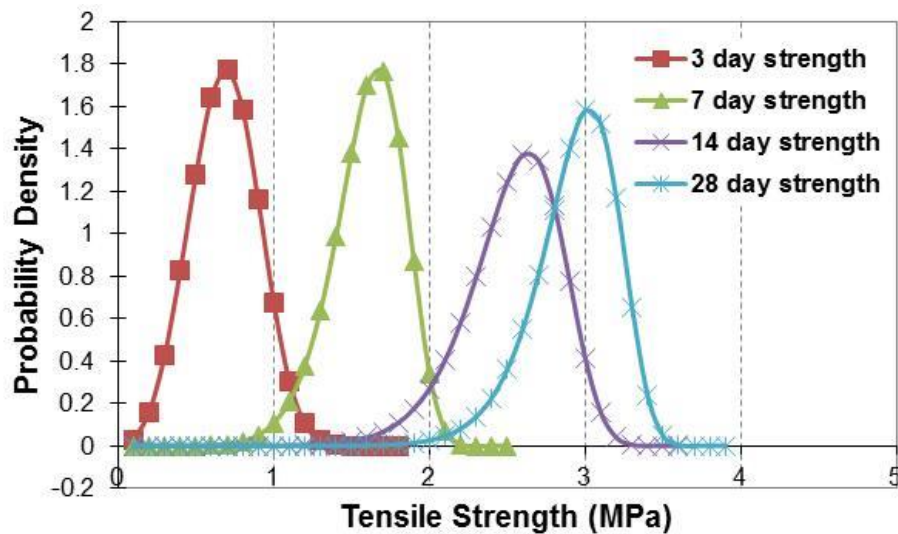
Figure 6. Weibull distribution of concrete tensile strength.

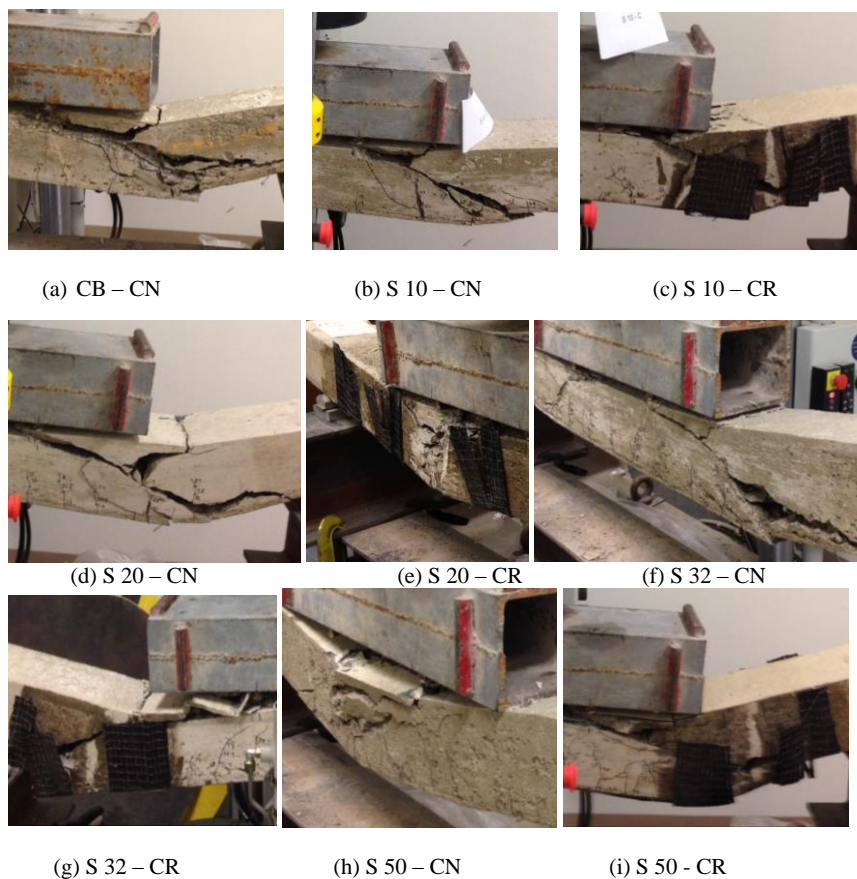
**Figure 7.** Failure of control beam and beams with simulated corrosion.

Table 7 presents a description of failure of the control beam and all beams with simulated corrosion. Also, Figure 7 shows the failure of the beams. By comparing the load-deflection relationships of beams with simulated corrosion to that of the control beam (Figure 8), it can be observed that as the level of simulated corrosion increased, the load capacity became smaller, stiffness became lower, and beam became more ductile. Beam S 10–CN did not follow this trend as it showed the lowest carrying capacity. This may be due to the quality of concrete of beam S 10–CN. It was difficult to simulate 10% corrosion level and the only option was to use 5 # 3 rebar. It seems that there was not enough spacing between rebars due to the large number of rebars used, so, concrete was blocked, which affected the quality of concrete.

Beam	Mode of Failure
CB-CN	Splitting cracking in the clamped side, crushing in top concrete, and debonding cracking in the concrete cover in the clamped side.
S 10-CN	Splitting crack on the clamped side at 30.5 kN and crushing of the top concrete.
S 10-CR	Deboning of CFRP, rupture of first U in the clamped side, splitting crack on the clamped side, and crushing of concrete.
S 20-CN	Splitting crack on the clamped side, debonding crack in the concrete cover, and crushing of the top concrete.
S 20-CR	Debonding of CFRP, splitting cracks close to the unclamped side, and crushing of top concrete.
S 32-CN	Two splitting cracks; one on each side, crushing of concrete, and debonding cracking in the concrete cover on the clamped side.
S 32-CR	Rupture of bottom CFRP sheet on the clamped side, debonding of CFRP, splitting cracking in the unclamped side, and crushing of top concrete.
S 50-CN	Two splitting cracks; one on each side and crushing of top concrete.

S 50-CR	Debonding of CFRP, splitting cracking in the clamped side, rupture in the first U on the clamped side, and crushing of top concrete.

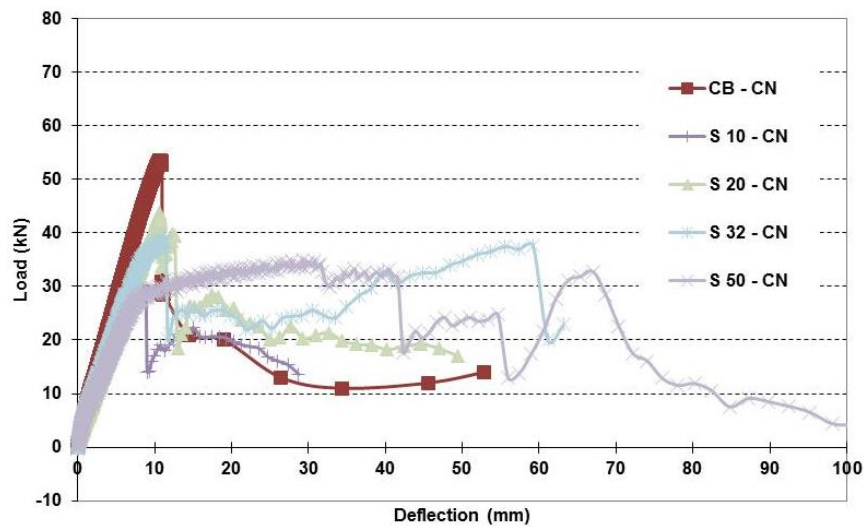
Figure 8. Load-deflection relationships of control beam and beams with simulated corrosion.

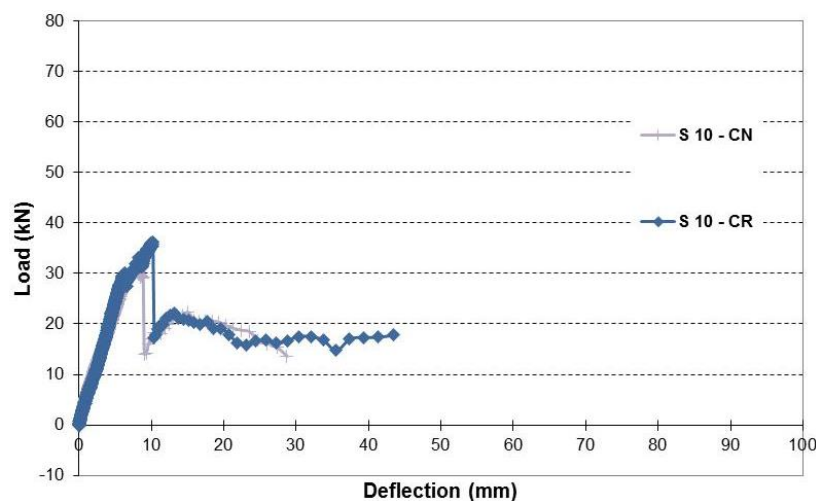
Figure 9. Load-deflection relationship of beams with simulated 10% corrosion level.

When S 10–CN was repaired, its load capacity and stiffness increased (Figure 9). Load capacity of S 10–CR was greater than that of S 10–CN by about 16%. Strengthening S 20–CN resulted in larger stiffness and higher load capacity (Figure 10). Load capacity of S 20–CR was larger than that of S 20–CN by about 7%. S 20–CR was also more ductile due to yielding and debonding of CFRP. Beam S 32–CR was stiffer and showed a larger capacity than S 32–CN by about 30% (Figure 11). Also, S 32–CR showed better ductility due to yielding and CFRP debonding and rupture. For 50% corrosion level, repair resulted in a stiffer beam and about 18% higher load capacity of S 50–CR than S 50–CN (Figure 12). However, S 50–CN showed more ductility than S 50–CR.

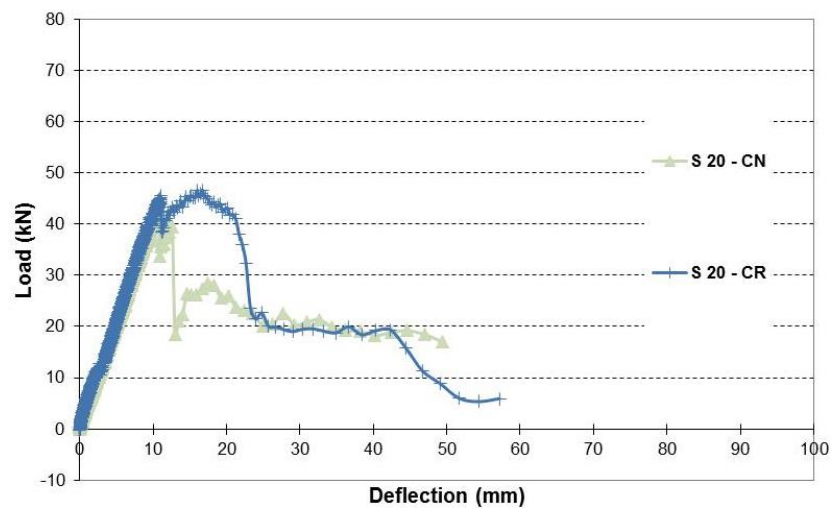
Figure 10. Load-deflection relationship of beams with simulated 20% corrosion level.

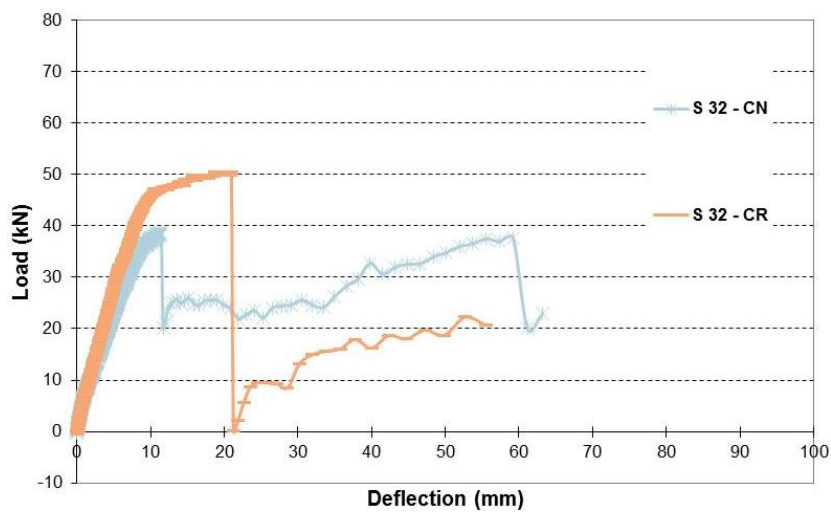
Figure 11. Load-deflection relationship of beams with simulated 32% corrosion level.

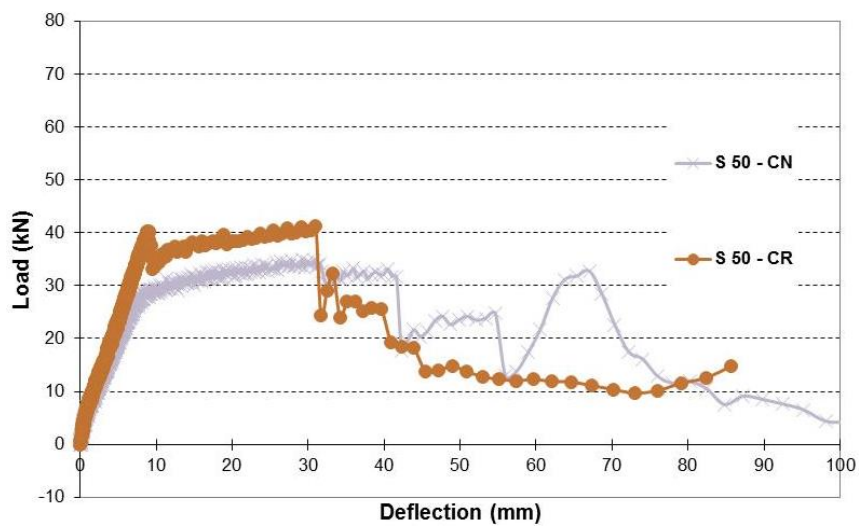
Figure 12. Load-deflection relationship of beams with simulated 50% corrosion level.

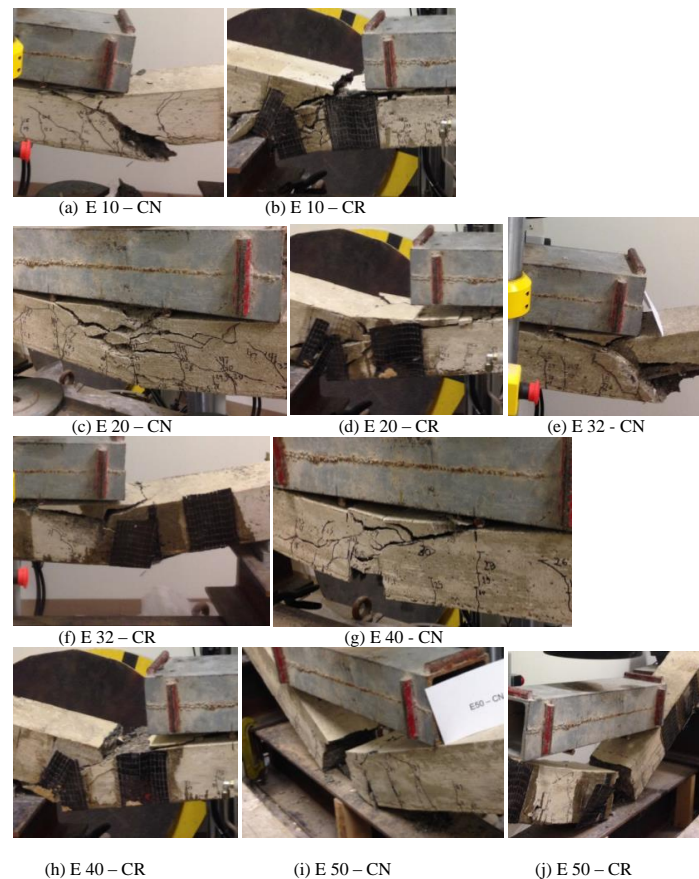
Figure 13. Failure of beams with experimental corrosion.

Figure 13 shows the failure of beams with concrete cover, which is still intact, and with different levels of experimentally induced corrosion. Table 8 describes the mode of failure of these beams.

Beam	Mode of Failure
E 10–CN	Splitting cracking in the clamped side and crushing of top concrete.
E 10–CR	Debonding of CFRP, splitting cracking in the unclamped side, crushing in top concrete, and rupture in the first U in the unclamped side.
E 20–CN	Two splitting cracks; one on each side, crack at mid-span, and crushing of top concrete.
E 20–CR	Debonding of CFRP, splitting cracking in the unclamped side, and crushing in top concrete.
E 32–CN	Two splitting cracks; one on each side, crushing in top concrete, and peeling failure in concrete cover in the clamped side.
E 32–CR	Debonding of CFRP, splitting cracking in the clamped side, crushing in top concrete, and rupture of second U on the clamped side.
E 40–CN	Two splitting cracks; one on each side, and crushing in top concrete.
E 40–CR	Debonding of CFRP, splitting crack in the unclamped side, rupture of the first and second U in the unclamped side.

E 50–CN	Rupture of rebars and crushing in top concrete.
E 50–CR	Debonding of CFRP; rupture of bottom CFRP sheet, middle U, and first U on the clamped side; crushing in top concrete; and rupture of rebars.

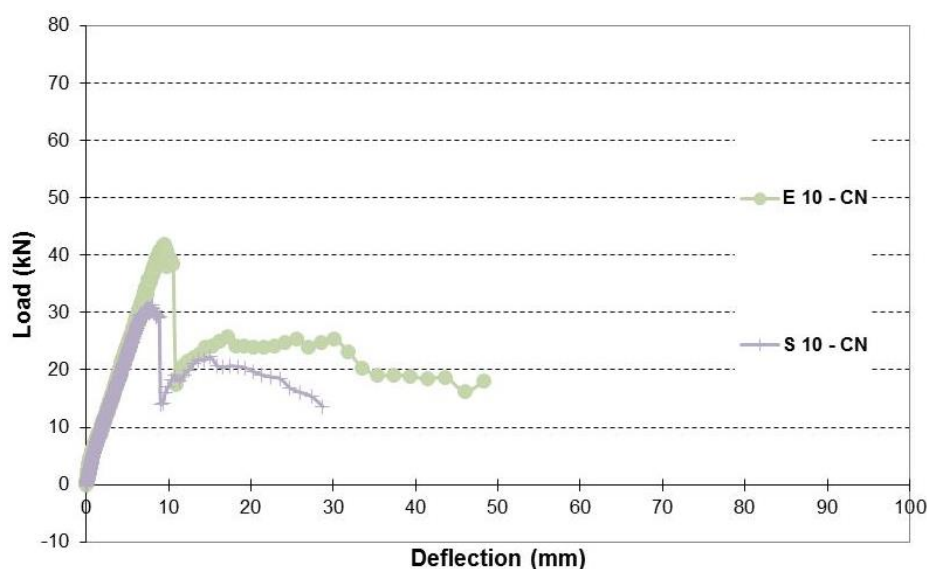
Figure 14. Load-deflection of beams with 10% corrosion levels (No repair).

The beams with either experimental or simulated 10% corrosion level showed a different performance from each other (Figure 14). This difference in performance can be attributed to the non-uniform change in the cross-section of rebars due to the actual corrosion, whereas, in the simulated corrosion case, the reduction in cross-section of rebars was uniform over the entire length of rebars. S 10–CN showed about 25% smaller load capacity than that of E 10–CN (Figure 14). This is also due to the diameter schedule of corroded rebars as shown in Table 2. Both beams had a comparable stiffness. For beams with 20% corrosion level, they showed different performance. S 20–CN showed about 14% smaller load capacity than that of E 20–CN, but beam E 20–CN was less stiff and showed more ductility (Figure 15). For beams with 32% corrosion level, they showed different performance. Also, the trend that was observed in 10% and 20% corrosion level cases has changed. E 32–CN and S 32–CN had a very similar load carrying capacity; however, S 32–CN had a slightly higher load capacity and was stiffer than E 32–CN (Figure 16). Also, E 32–CN showed more ductility than S 32–CN. A similar trend as in the 32% corrosion level case was observed in the 50% corrosion level case. S 50–CN showed more ductility than E 50–CN (Figure 17). S 50–CN showed about 50% higher capacity than E 50–CN and was stiffer than E 50–CN. E 50–CN showed more ductility than S 50–CN. It seems that it is conservative to model the corrosion by using the equivalent area of steel (simulated) for up to 20% corrosion level. Beyond 20% corrosion level, it is not conservative to use the equivalent area of steel to model the corrosion. However, the simulated cases over-predict the load capacity and stiffness of the actual corroded RC at relatively high levels of corrosion.

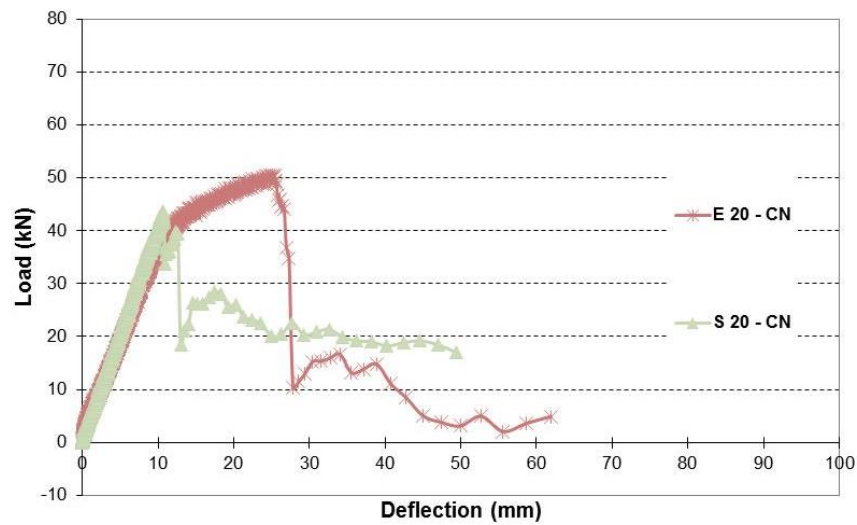
Figure 15. Load-deflection of beams with 20% corrosion levels (No repair).

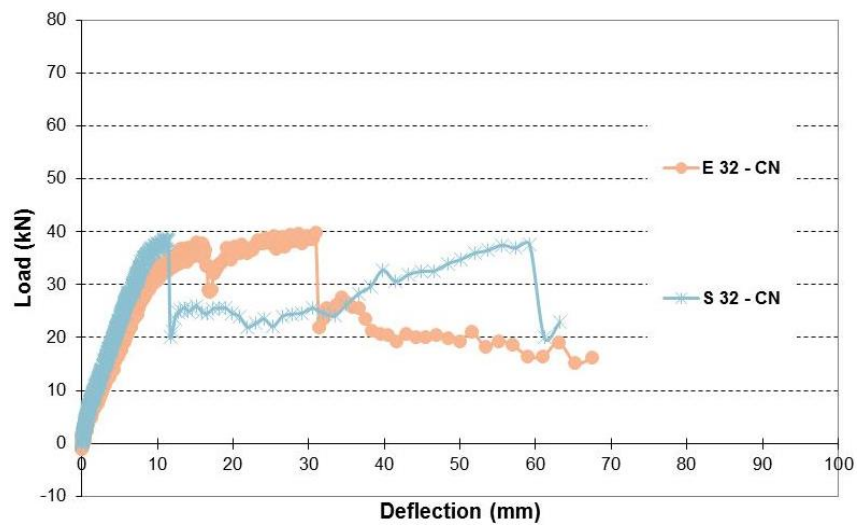
Figure 16. Load-deflection of beams with 32% corrosion levels (No repair).

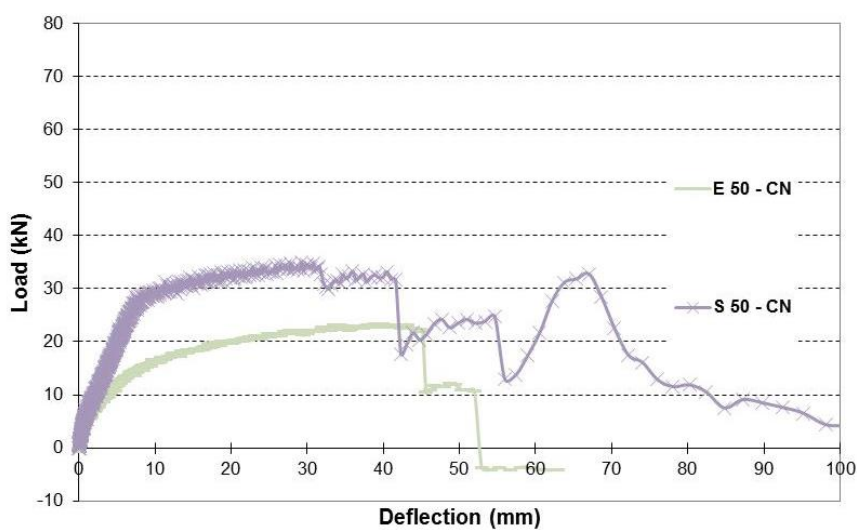
Figure 17. Load-deflection of beams with 50% corrosion levels (No repair).

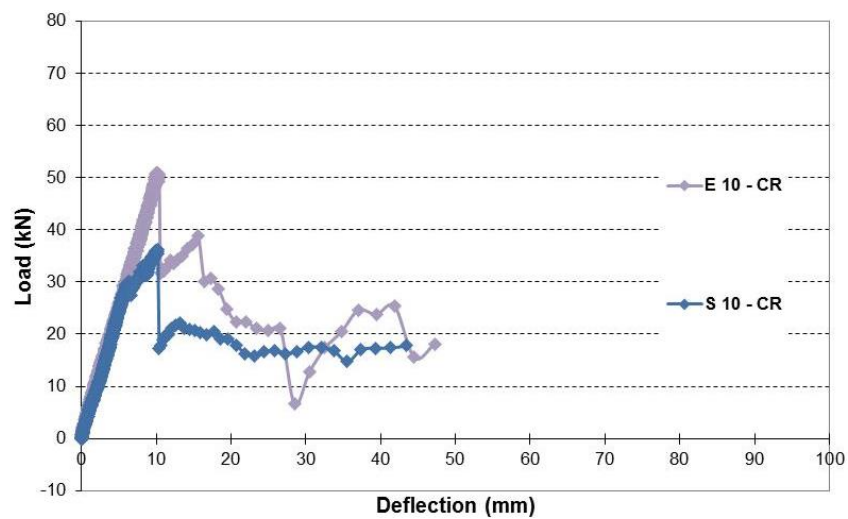
Figure 18. Load-deflection of beams with 10% corrosion levels (Repaired).

After the beams with different levels of actual or simulated corrosion were repaired, they were tested and their performance was monitored. For 10% corrosion level, beam E 10–CR and S 10–CR had a very similar stiffness, but S 10–CR had about 29% smaller load capacity than E 10–CR (Figure 18). S 10–CR showed more ductility than E 10–CR. For 20% corrosion level, beam E 20–CR was stiffer than S 20–CR (Figure 19). S 20–CR had about 27% smaller load capacity than E 20–CR. S 20–CR also showed more ductility than E 20–CR. For 32% corrosion level, a different trend was observed. S 32–CR was stiffer and showed about 30% larger load capacity than E 32–CR (Figure 20). Also, S 32–CR showed more ductility than E 32–CR. The same trend continued, when 50% corrosion level was considered. S 50–CR was stiffer and had about 28% higher load capacity than S 50–CN (Figure 21).

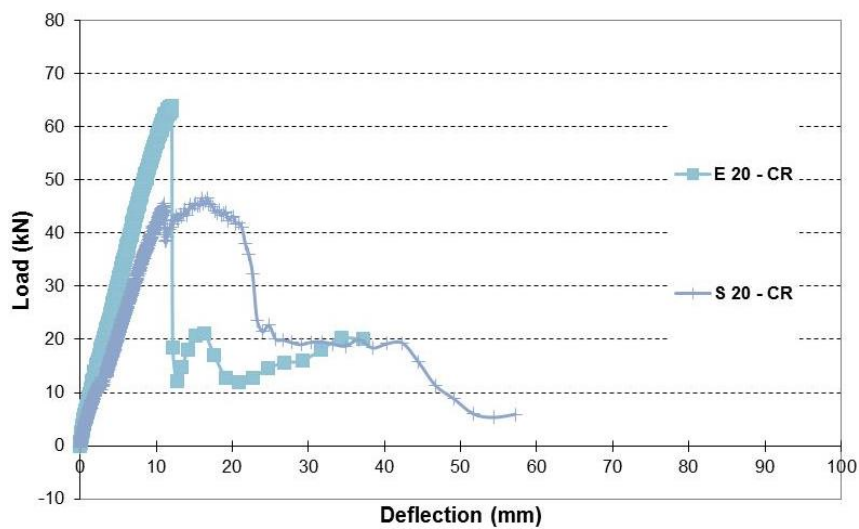
Figure 19. Load-deflection of beams with 20% corrosion levels (Repaired).

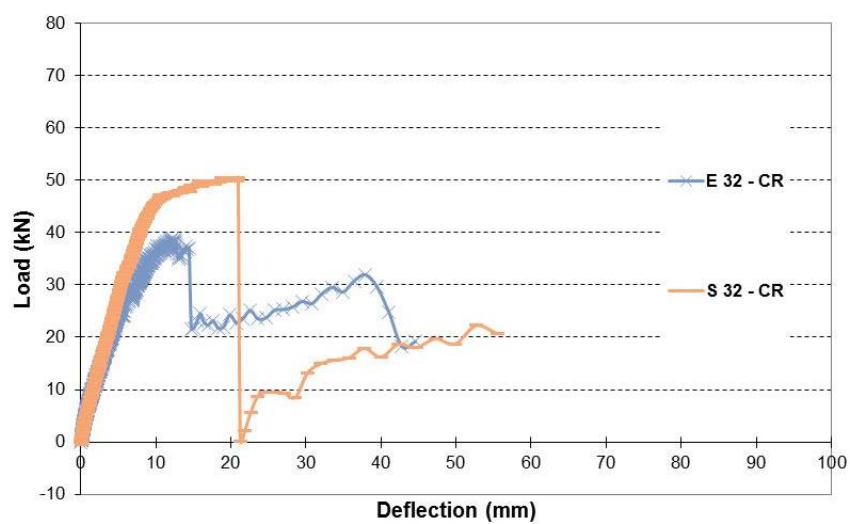
Figure 20. Load-deflection of beams with 32% corrosion levels (Repaired).

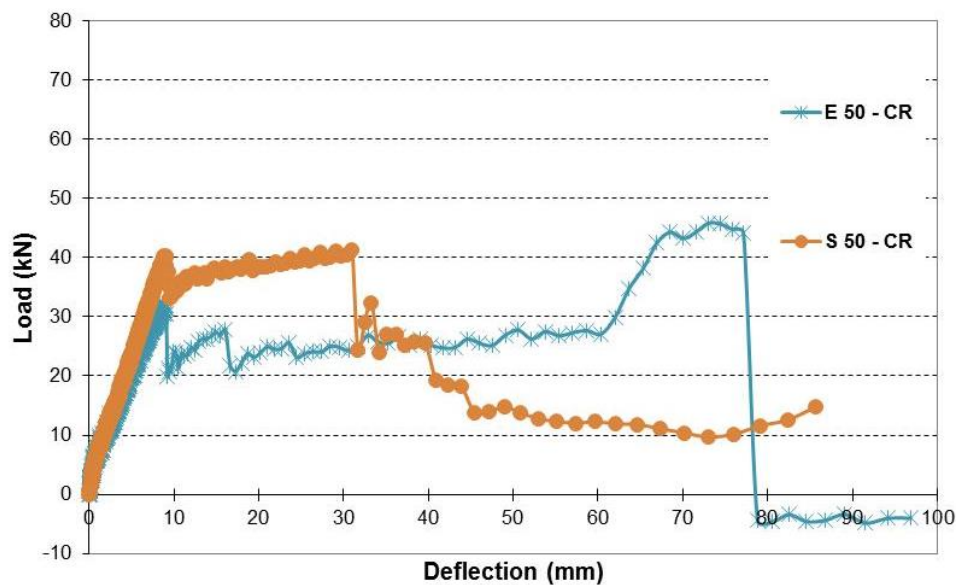
Figure 21. Load-deflection of beams with 50% corrosion levels (Repaired).

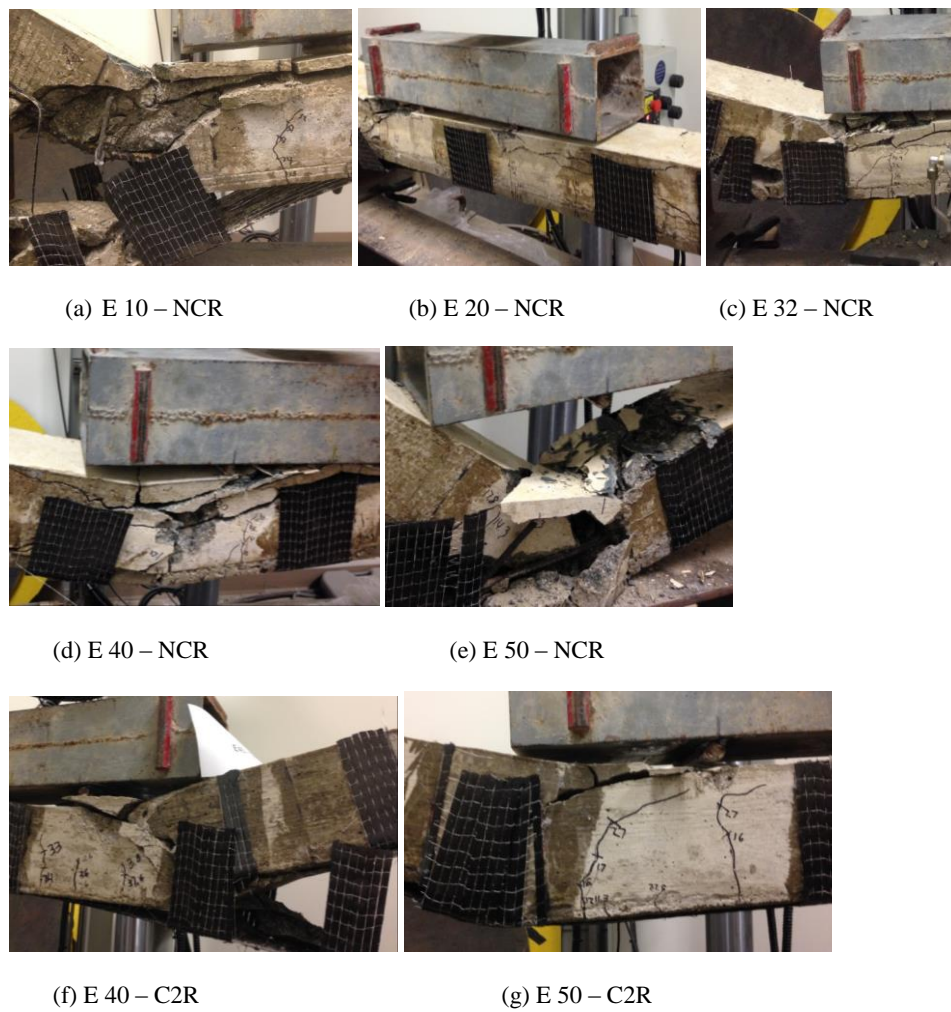
Figure 22. Failure of beams without cover and repaired with double sheets.

Beam	Mode of Failure
E 10–NCR	Peeling failure of concrete cover, splitting crack in the unclamped side, rupture of the first and second U on the unclamped side, and crushing in top concrete.
E 20–NCR	Two splitting cracks; one on each side, debonding of CFRP, peeling failure of concrete cover, and crushing of top concrete.
E 32–NCR	Debonding of CFRP, splitting cracking in the unclamped side, rupture of the first U in the unclamped side, and crushing of the top concrete.
E 40–NCR	Debonding of CFRP, splitting crack on the unclamped side, crushing of top concrete, and a slight peeling failure of concrete cover.
E 50–NCR	Debonding of CFRP, rupture of first U on the unclamped side, splitting crack on the unclamped side, rupture of rebars, and crushing of top concrete.
E 40–C2R	Debonding of CFRP, rupture of the first and second U on the clamped side, splitting cracking in the clamped side, and crushing of top concrete.

E 50–C2R	Debonding of CFRP, rupture of the first U on the clamped side and second U on the unclamped side, splitting cracking in the unclamped side, and crushing of top concrete.

The effect of applying two layers of sheet to repair beams with 40% and 50% corrosion levels was investigated. Figure 22 shows the failure of the beams repaired with two layers of CFRP sheets. Table 9 presents failure of the beams. Figures 28 and 29 show a comparison between the control beam, corroded beam–without repair, repaired beam with one layer of sheet, and repaired beam with two layers of sheet. For 40% corrosion level, it seems that strengthening improved the load carrying capacity. E 40–CR had higher load capacity than E 40–CN, but it was less ductile. When two layers of sheet were applied, E 40–CR and E 40–C2R had similar stiffness to that of CB–CN. E 40–C2R had higher capacity than that of E 40–CN, yet smaller than that of E 40–CR. However, E 40–C2R showed more ductility than E 40–CR as its ductility was similar to E 40–CN. In general, applying double CFRP sheets did not help to restore the full capacity of the corroded beam. A similar trend was observed for 50% corrosion level, but both E 50–CR and E 50–C2R had similar stiffness, which was smaller than that of CB–CN. Also, E 50–C2R showed a ductile behavior, but it had a smaller capacity than E 50–CR. Similarly, applying double sheets did not restore the full capacity of the corroded beam.

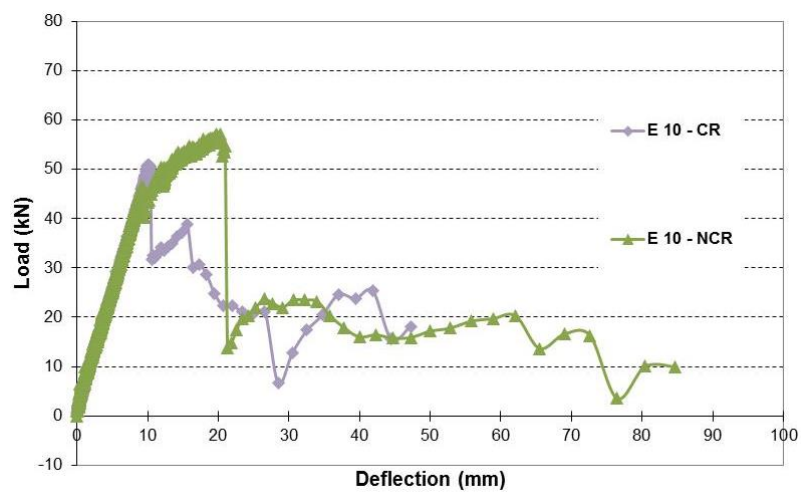
Figure 23. Load-deflection relationship of repaired beams with 10% corrosion level with and without cover.

It was assumed that the RC members would lose the concrete cover due to corrosion. Therefore, beams were constructed without concrete cover. After 28 days, they were recovered by applying a new concrete cover with lower concrete compressive strength than that of the beam. Figure 22 shows the failure of repaired beams without cover. Table 9 presents a description of failures of beams. Figures 23–27 compare the performance of repaired beams with and without cover for different corrosion levels. It seems that for 10% corrosion levels, after the cover was recovered and beam was repaired with CFRP, the repaired beam showed better performance than that of the repaired beam with cover and the same corrosion level. Beam E 10–NCR had similar stiffness to E 10–CR and showed more ductility than E 10–CR (Figure 23). For 20% corrosion level, E 20–NCR had about 45% less load capacity and showed more ductility than E 20–CR (Figure 24). E 20–CR was stiffer than E 20–NCR. For 32% corrosion level, both beams had similar load capacity; however, E 32–NCR was more ductile (Figure 25). For 40% corrosion level, E 40–NCR had smaller stiffness and about 32% less load capacity than that of E 40–CR (Figure 26). E 40–NCR showed more ductility than E 40–CR. For 50% corrosion level, E 50–CR was stiffer and had almost 31% higher load capacity than that of E 50–NCR (Figure 27). In general, it can be concluded that if an RC member experienced loss of cover and 10% corrosion level and was repaired by adding a new cover and applying CFRP, it performed better than a repaired beam that had the same corrosion level and a concrete cover. However, if corrosion level exceeded 10%, the repaired beam that lost its concrete cover had a load carrying capacity that was lower than that of a repaired beam with cover by about 32%. This can be explained that as the rebar gets more corrosive, the strength of the rebar decreases and then the cover plays a more dominant role in strengthening the beam. A weak cover for the recovered beam would offer lower strength than the beam with an intact cover.

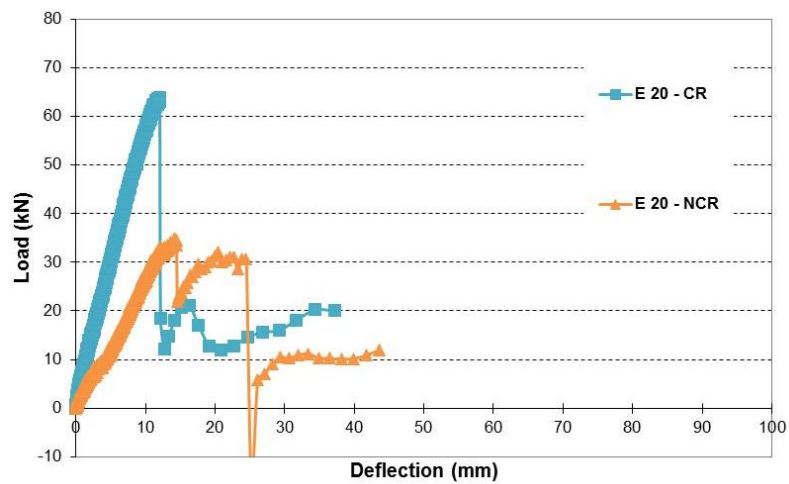
Figure 24. Load-deflection relationship of repaired beams with 20% corrosion level with and without cover.

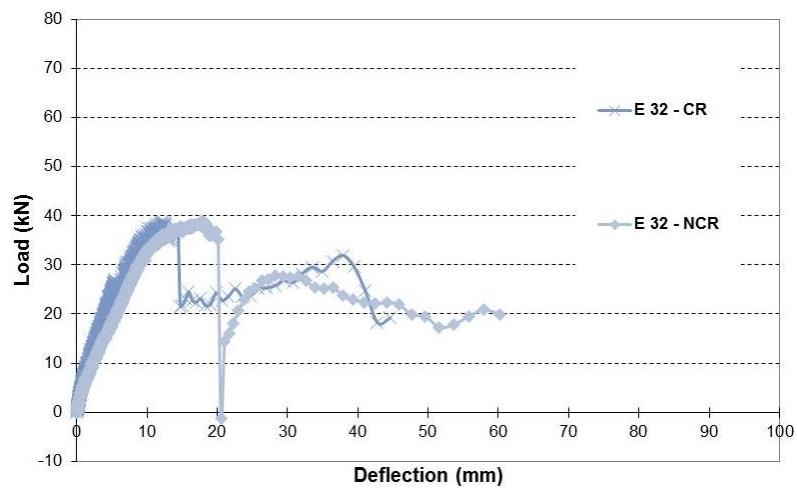
Figure 25. Load-deflection relationship of repaired beams with 32% corrosion level with and without cover.

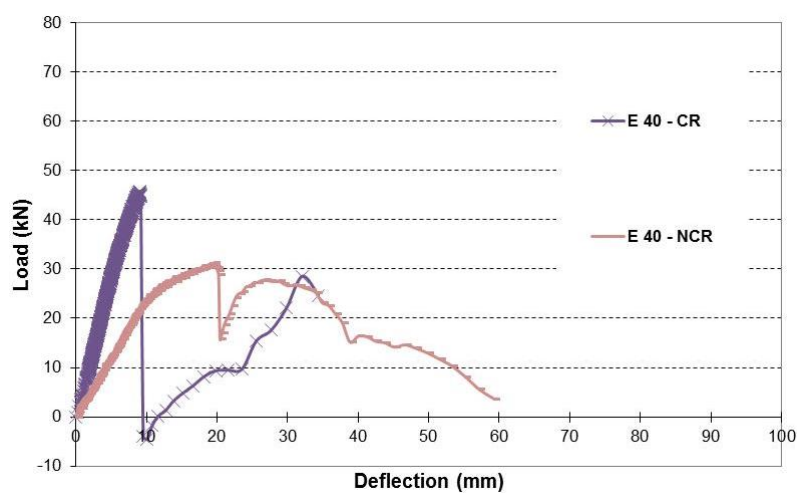
Figure 26. Load-deflection relationship of repaired beams with 40% corrosion level with and without cover.

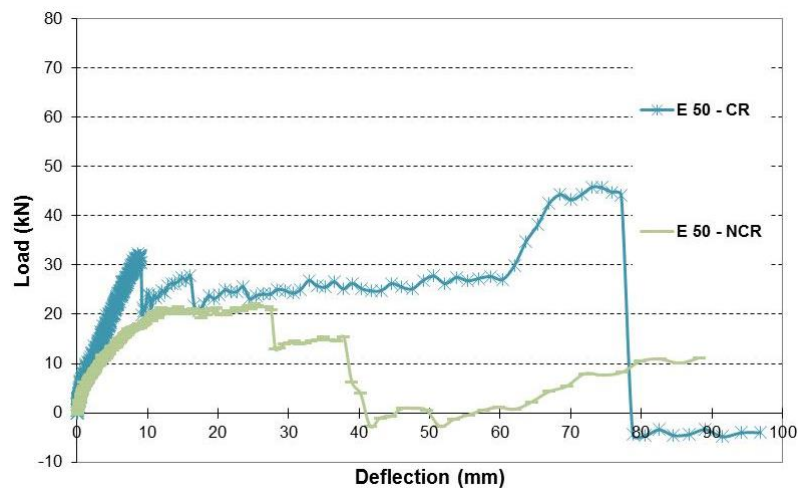
Figure 27. Load-deflection relationship of repaired beams with 50% corrosion level with and without cover.

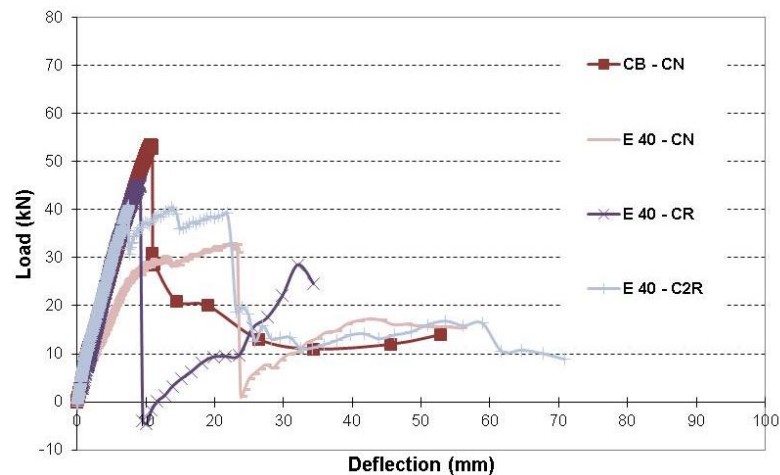
Figure 28. Load-deflection of control beam and beams with 40% corrosion level.

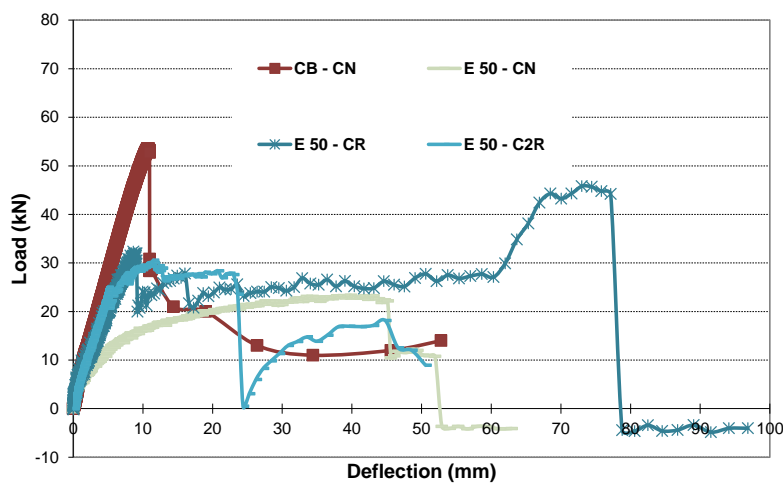
Figure 29. Load-deflection of control beam and beams with 50% corrosion level.
