# A Geotechnical Perspective on a Complex Geological Environment in a High-Speed Railway Tunnel Excavation (A Case Study from Türkiye)

**Abstract:** The T26 tunnel was designed within the scope of the Ankara-Istanbul high-speed railway in accordance with the speed of 250 km/h. Some serious problems and excessive deformations were encountered during the excavation works. The deformations in the tunnel caused subsidence on the surface and the Tunnel Boring Machine (TBM) became stuck; therefore, tunnel excavation works were suspended. Design works for re-excavation in the T26 tunnel and extracting of the TBM were carried out and the tunnel was re-designed by the New Austrian Tunneling Method (NATM) system. The main purposes of the present study are to describe the problems encountered during the T26 tunnel and to discuss the sources of the problems. The advantages and disadvantages of TBM and NATM methods for the tunnel having difficult ground conditions were discussed. Critical points needing to be considered for the tunnels excavated with TBM through weak ground conditions and the effect of the TBM selection process were discussed. Considering the complex geological and geotechnica

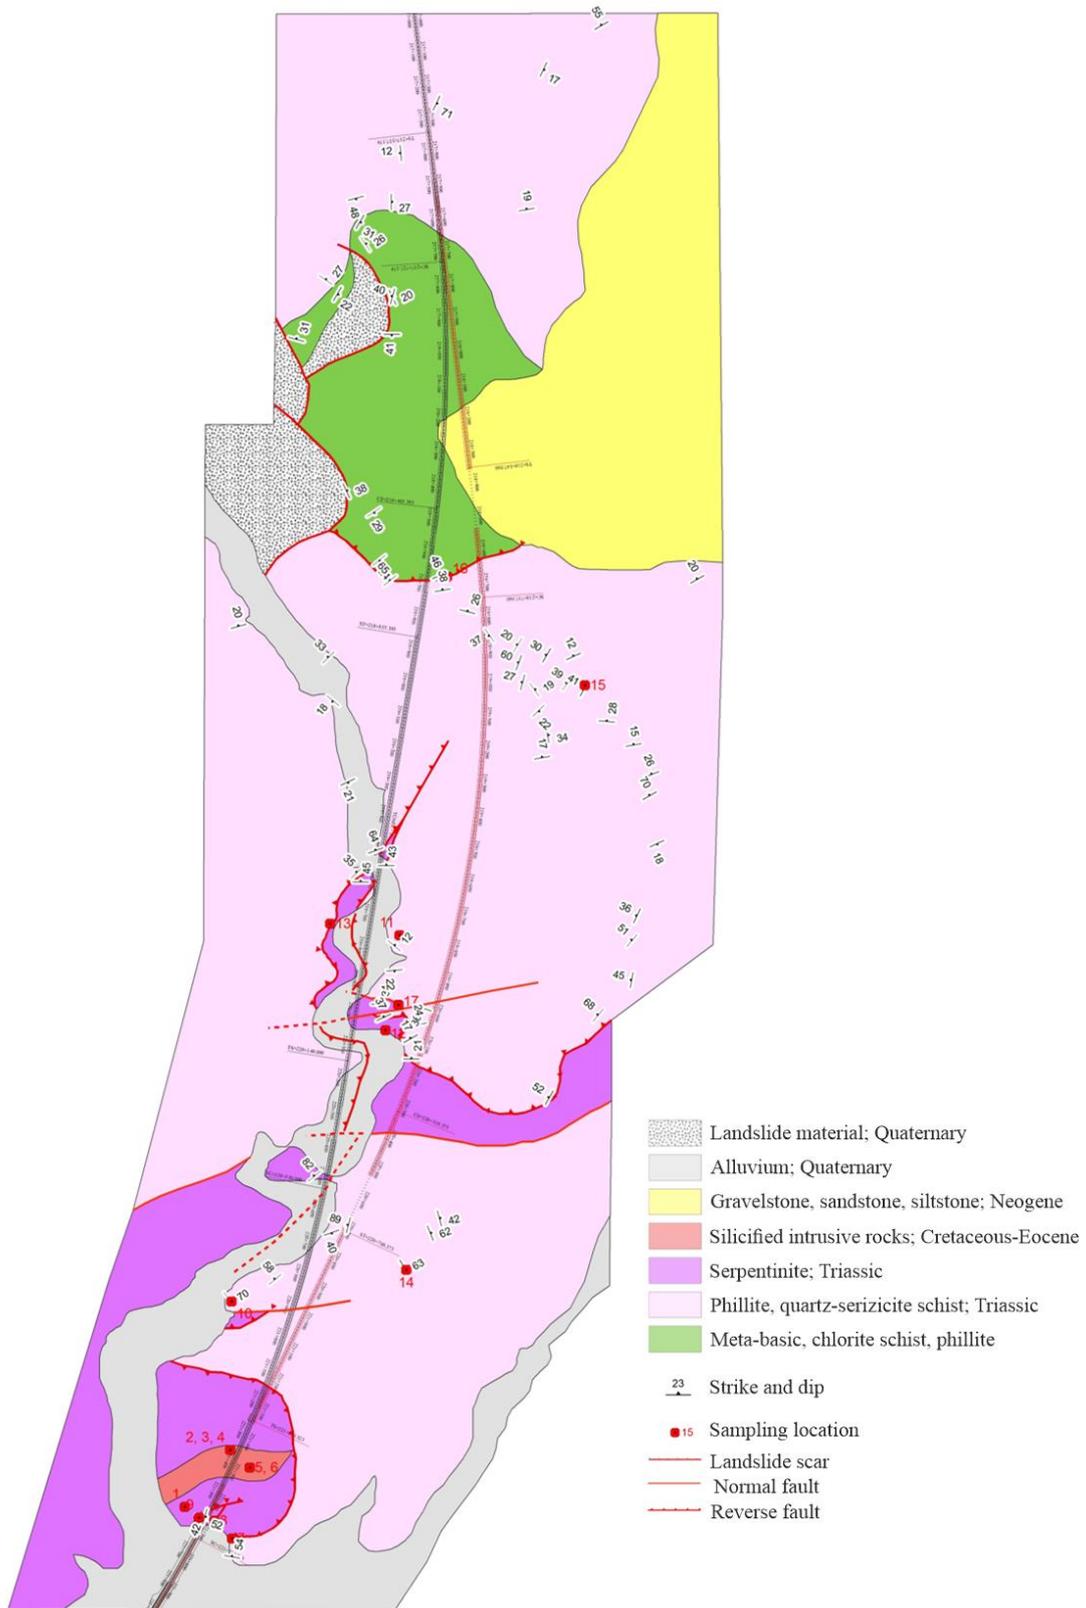
**Figure 3.** Geological map of the site vicinity; the primary design route is indicated using the purple line [22].

intrusive cut them with intrusive interaction; Miocene aged sediments, and alluvium is found in the region in which the T26 tunnel route is located (Figures 3 and 4) [22,36].

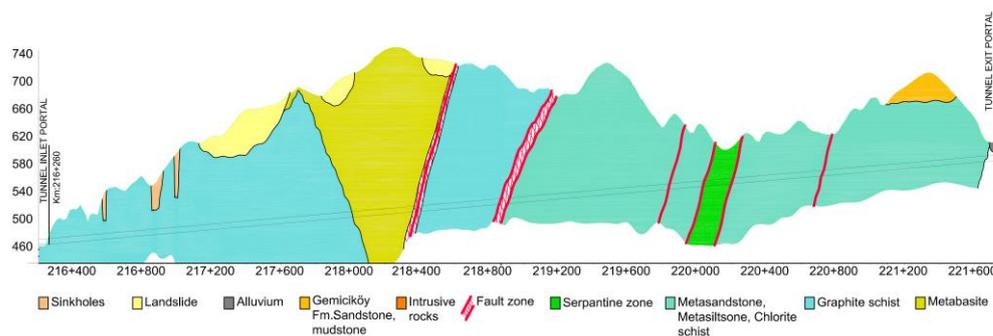
Figure 4. Longitudinal cross-section of the T26 tunnel [36].

As can be seen from Figure 4, T26 excavations were started from the inlet portal and consisted of approximately 1000 m graphite schists from here. Later, after the 200 m metabasite zone, there are again approximately 500 m graphite schists. From here on, T26 was excavated mainly in chlorite schists, and in places fault zones, serpentine and weathering zones exist (Figure 4). Among these, the graphite schists are extremely poor rock masses showing heavy squeezing characteristics.

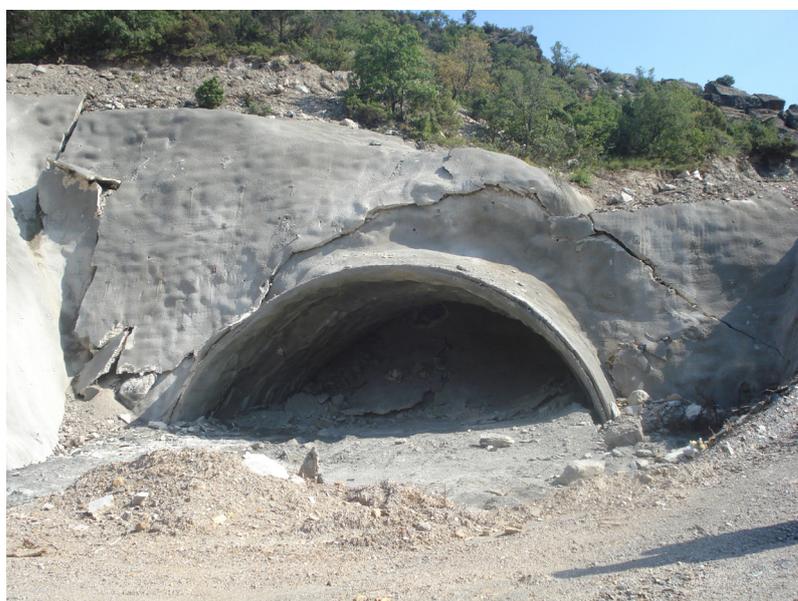
Figure 5. The entrance portal of the T26 tunnel abandoned in 2009 [36].

The first investigations were initiated in 2004 and the excavation works were started in 2009 and a portal excavation advancing through 30 m was completed. As the tunnel excavation passed through an active landslide, a landslide affecting a 100 m section of the tunnel route occurred and this section was blocked. Eventually, the tunnel excavation was stopped, and this section was abandoned (Figure 5). After the occurrence of this landslide, five boreholes with inclinometer installation were drilled near the portal. The inclinometer measurements revealed that there was a clear movement and the existence of a landslide. Therefore, the tunnel route was relocated 200 m away towards the mountainside to avoid the landslide. During these design works, in 2010, the excavation and tunnel support implementations were proposed depending on the NATM method, and site applications were initiated, accordingly. After an advance of 260 m inside the tunnel via the NATM method, to proceed faster, it was decided to progress with the application of the TBM method for the rest of the tunnel.

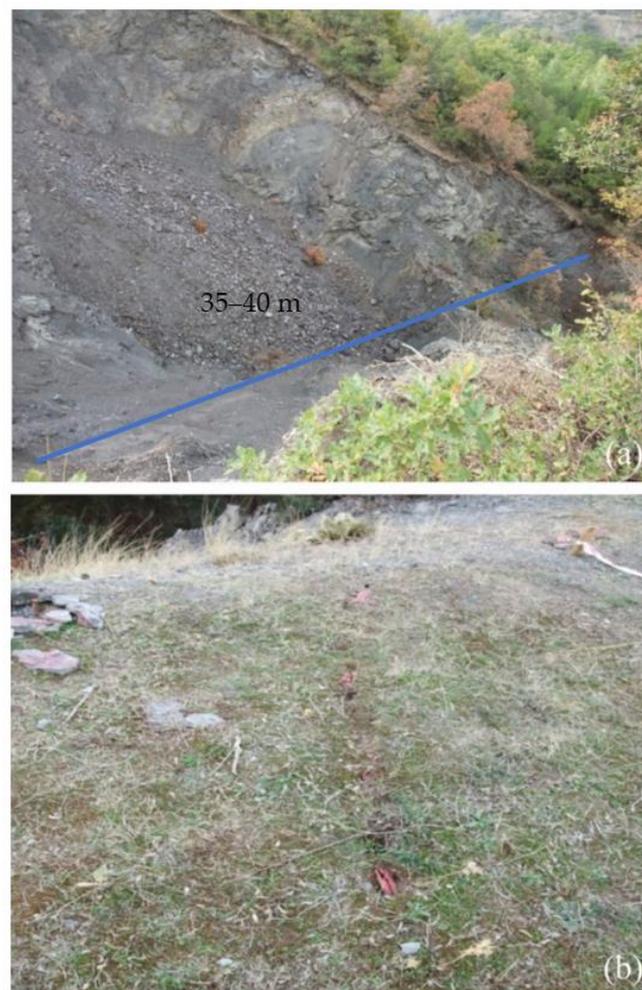
**Figure 6.** View of subsidence developed throughout the TBM excavations (a); tunneling induced surface cracks adjacent to the tunnel alignment (b).

Throughout the TBM excavation, which used a hard rock TBM with an open mode between Km: 217 + 720 to 217 + 770 (see Figure 4), three subsidence developed with a depth of 25–30 m and a diameter of 35–40 m. (Figure 6a). These settlements were observed inside the tunnel during the excavations. In other words, a protective zone around the tunnel could not be established so a plastic zone reaching the surface and dead load was situated. Overburden thickness was reported as around 105 m at these sections [37]. After these problems, necessary modifications were ensured on the TBM; thereafter, the tunnel excavation proceeded. By converting the TBM type from hard rock to Earth Pressure Balanced Machine (EPBM), excavation was advanced for approximately 250 m. Afterward, no more subsidence was observed except for some fractures on the surface and slopes (Figure 6b).

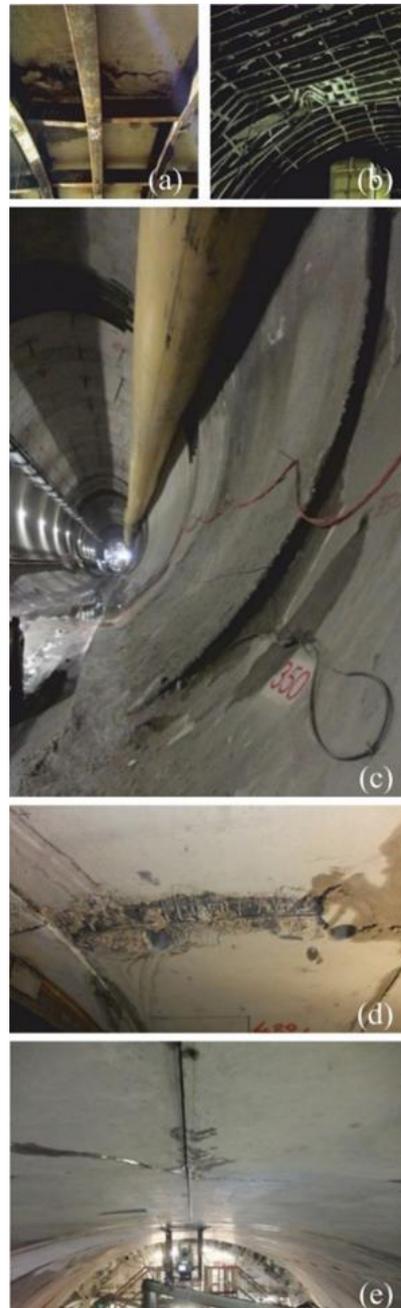
**Figure 7.** Damages on the segments and the reinforcement with NPI profiles (a,b); additional supports; steel-beam, wire mesh, and fiber-concrete shotcrete (c); an example photograph representing excessive plastic deformation in the tunnel (d); an example view of a longitudinal joint in the tunnel (e).

During the excavation works, severe deformations (Figure 7) were observed at the segments. To prevent these deformations, “I” profile supports were installed at the damaged segments. These profiles were selected as NPI 200 steel rib type and installed with a round length of 50–100 cm. They were also reinforced with shotcrete application that was strengthened with fiber-concrete and wire mesh (Figure 7a,b).

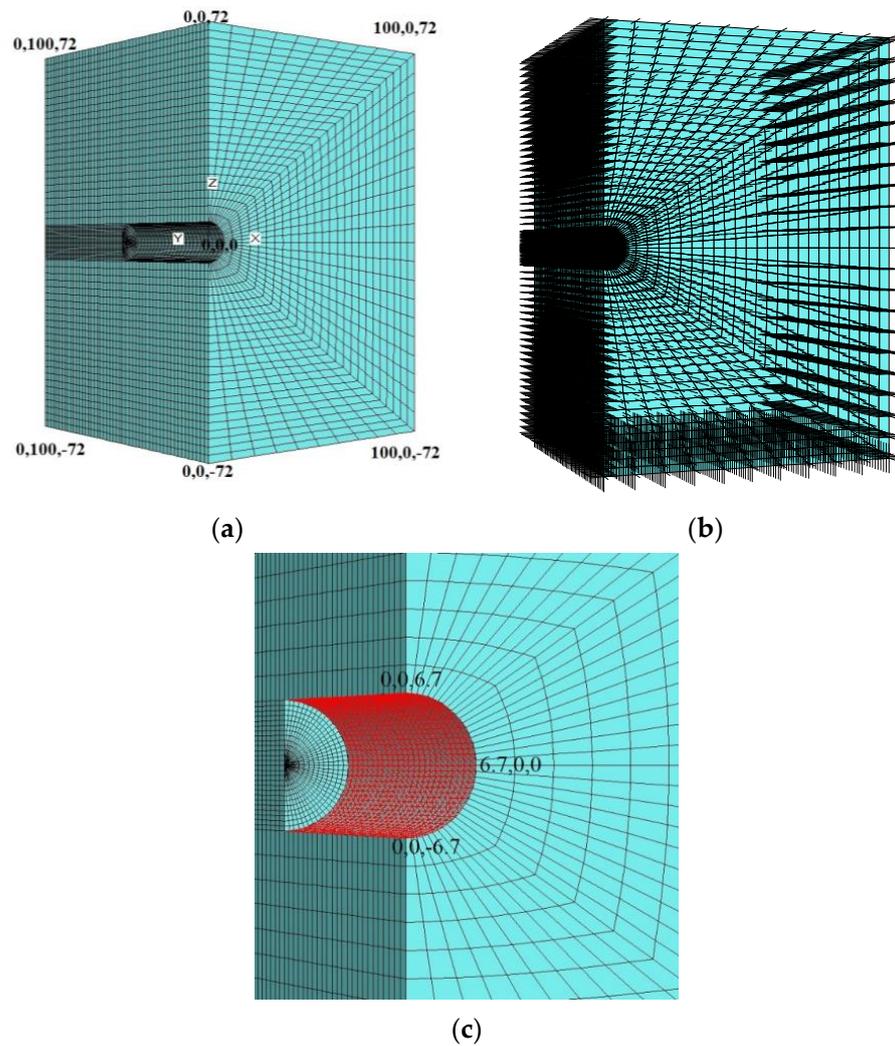
**Figure 8.** (a) FLAC3D model; (b) FLAC3D model boundary conditions; (c) FLAC3D model tunnel section and shell element.

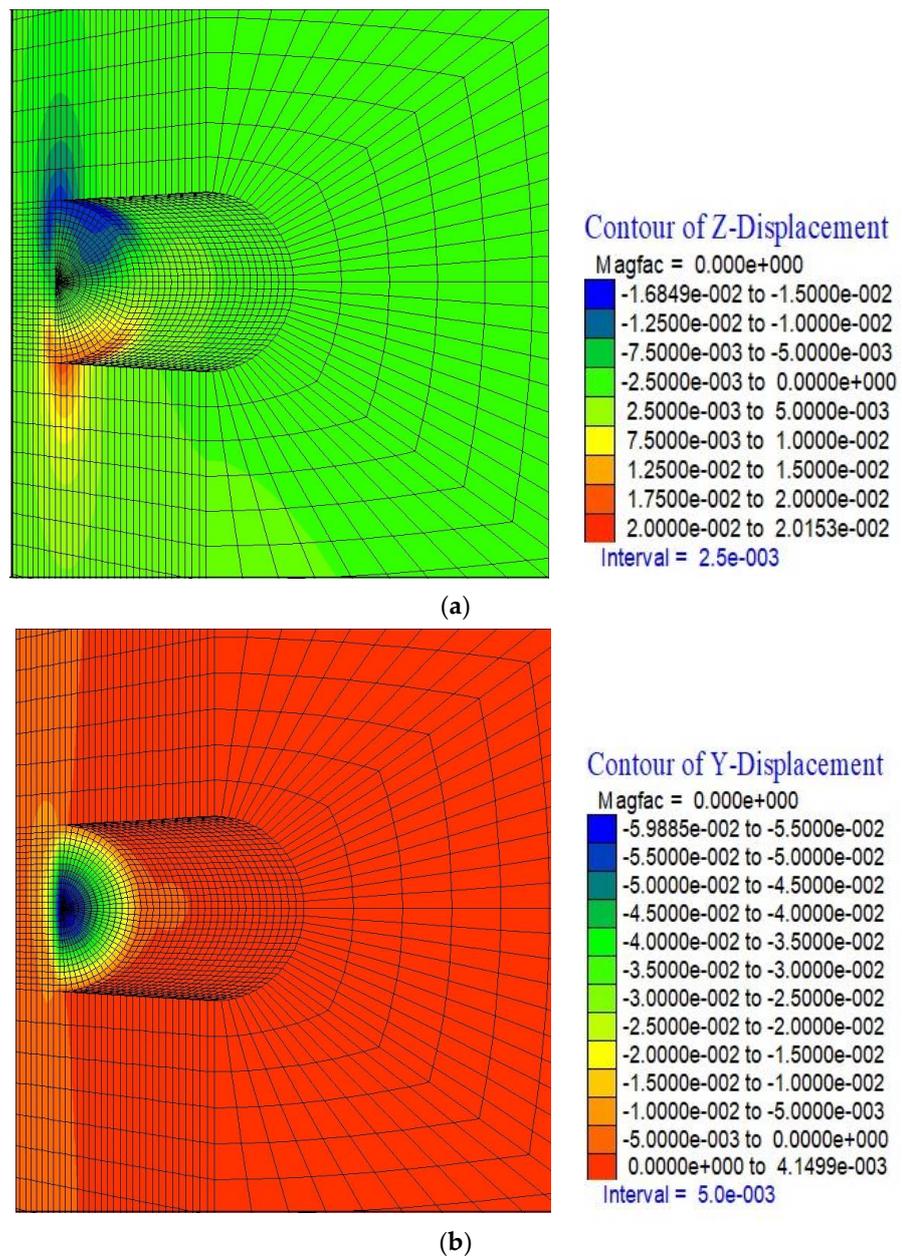
Figure 9. Deformations in Z-direction (a) and Y-direction (b). (units in m).

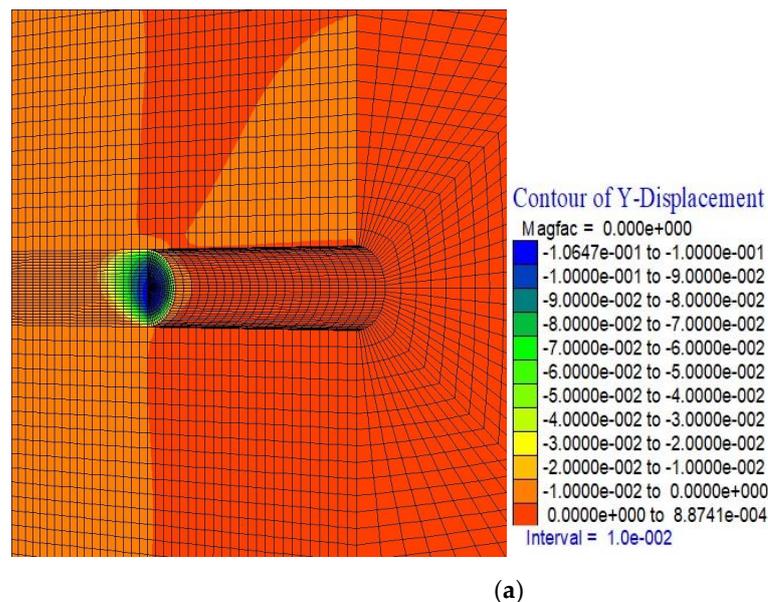
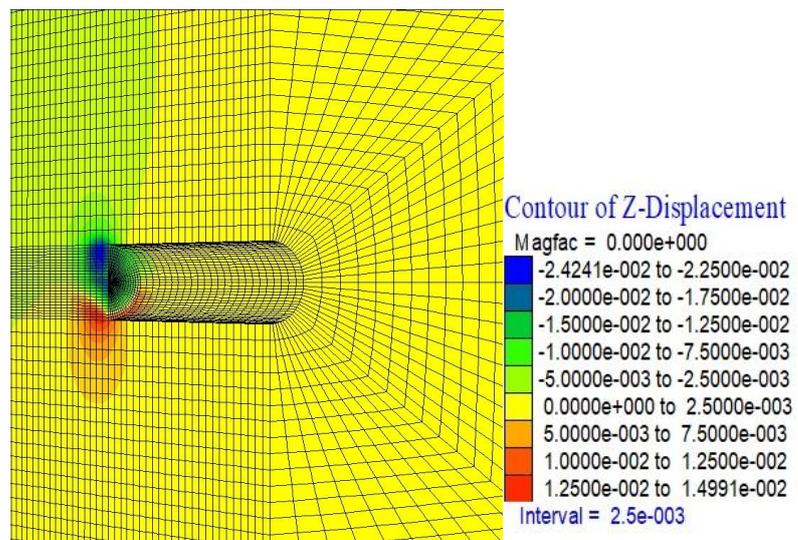
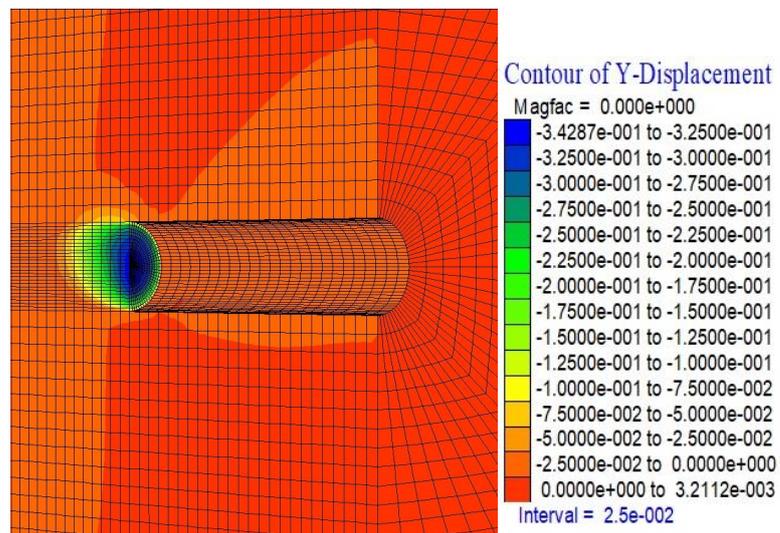
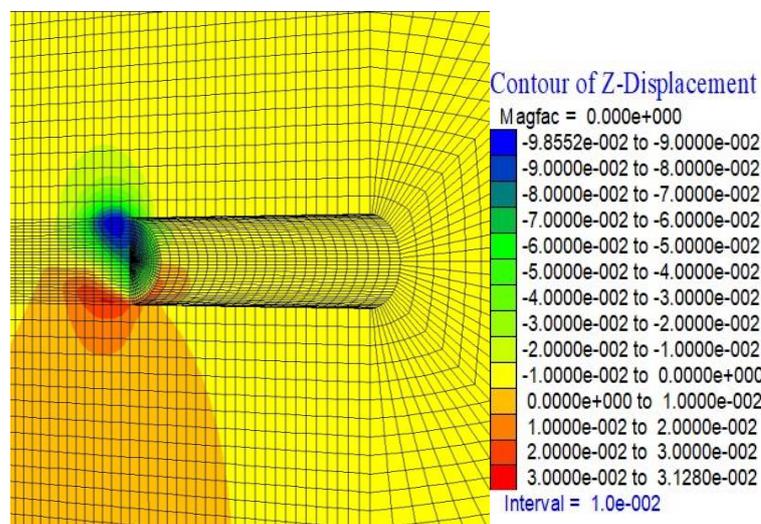
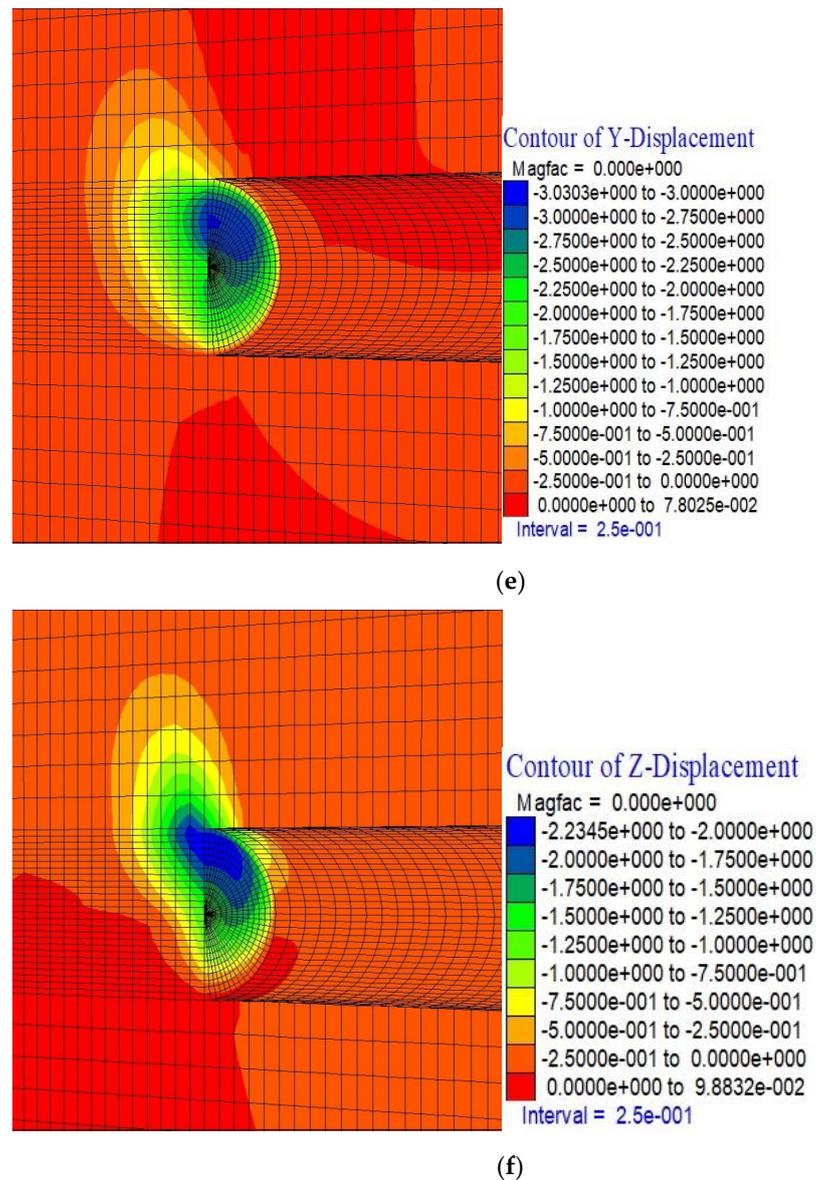
**Figure 10.** Displacements in Y-direction for the Analysis-1 (a); displacements in Z-direction for the Analysis-1 (b); displacements in Y-direction for the Analysis-2 (c); displacements in Z-direction for the Analysis-2 (d); displacements in Y-direction for the Analysis-3 (e); displacements in Z-direction for the Analysis-3 (f) (units in m).

The deformation values obtained from the analyzes for three different parameter sets are given in Table 3 and Figure 10a–f. As can be seen from the results, the displacements increase as the deformation modulus and cohesion value decrease. The displacements in the Y-direction of up to 3 m in the tunnel face were determined in Analysis 3.

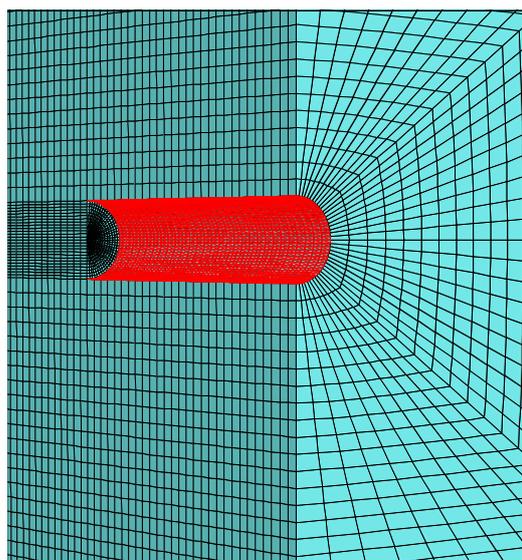
Figure 11. Tunnel segment lining defined as shell elements.

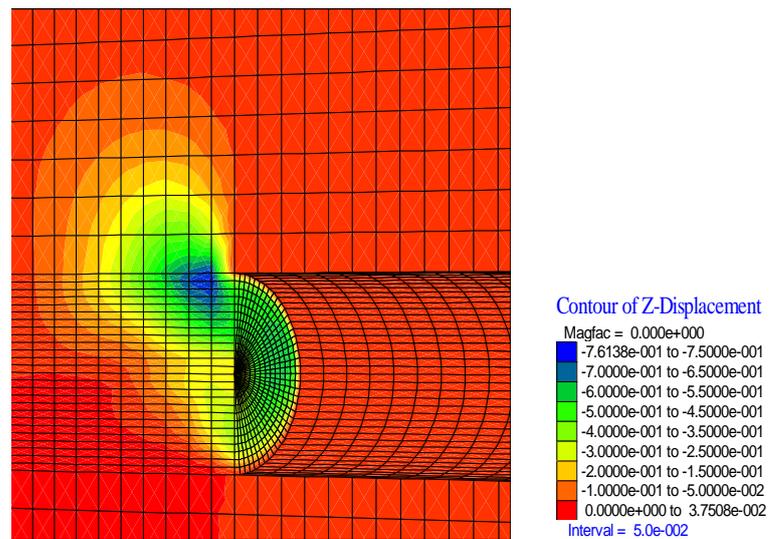
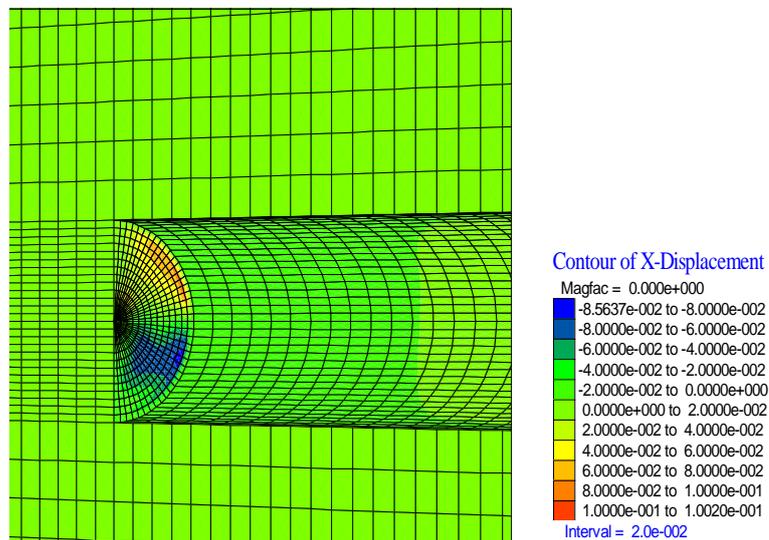
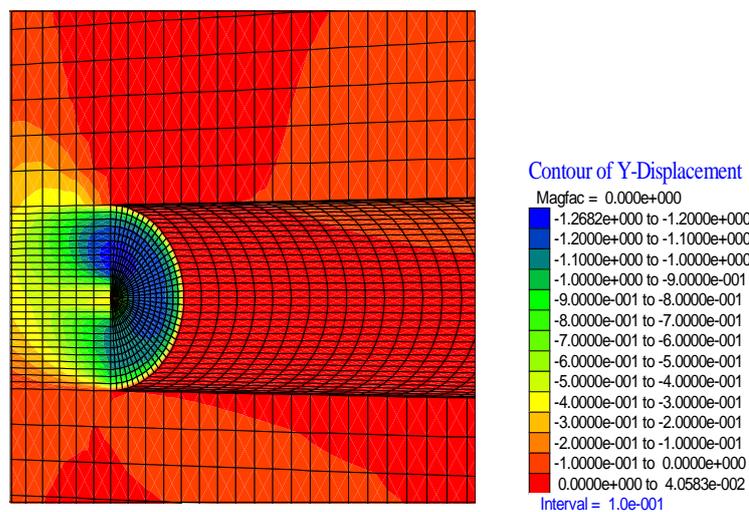
**Figure 12.** Deformation results in third stage (a) Vertical displacement, (b) Horizontal displacement, (c) Face displacement. (units in m).

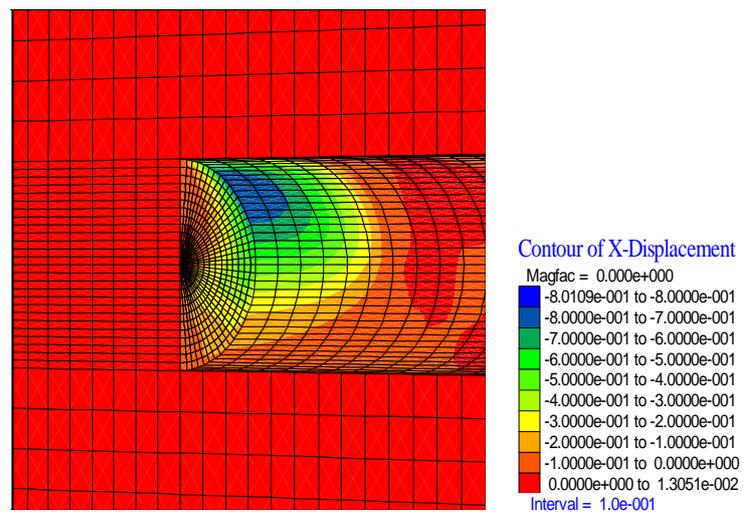
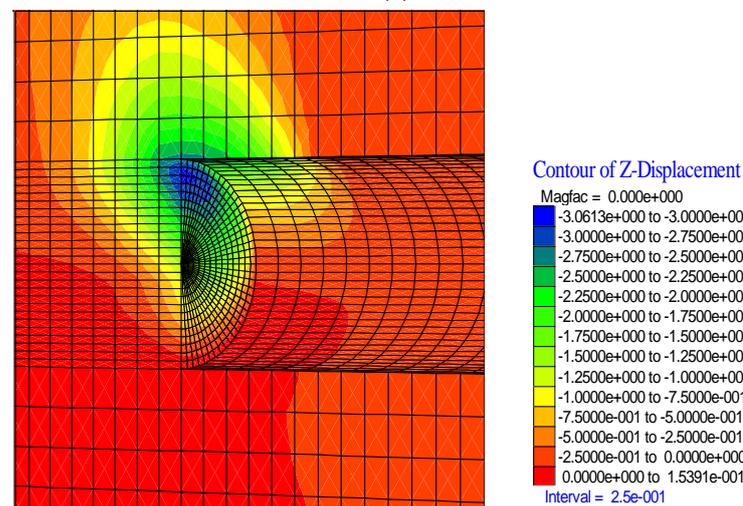
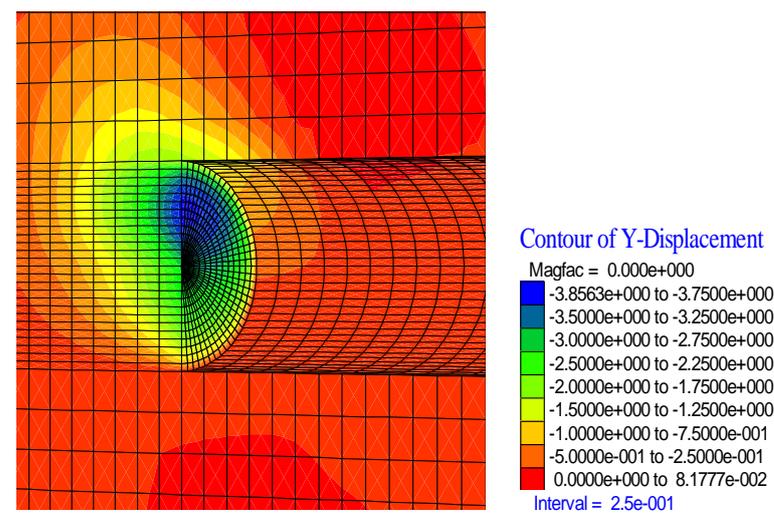
**Figure 13.** Deformation results in eighth stage (a) Vertical displacement, (b) Horizontal displacement, (c) Face displacement (units in m).

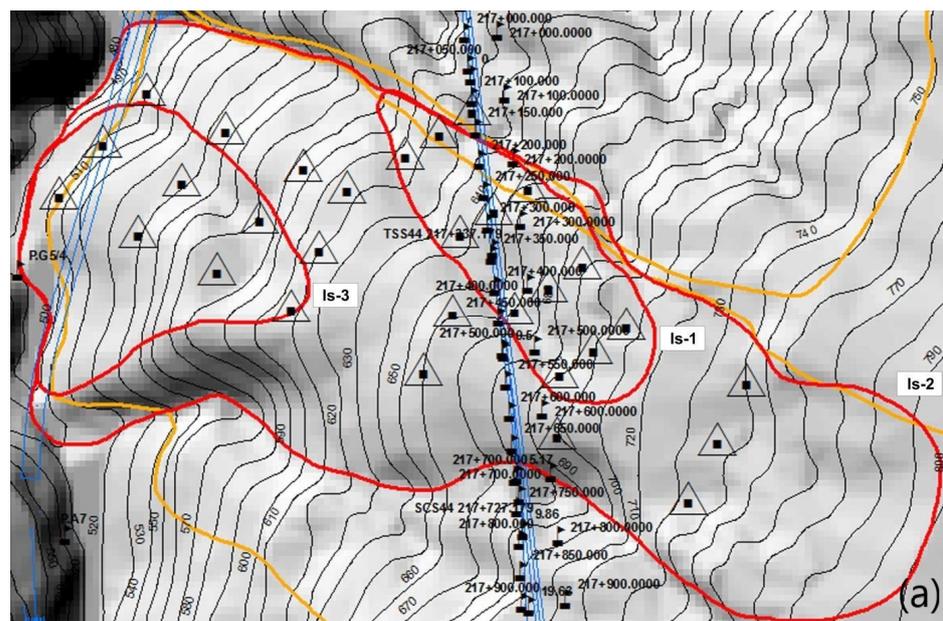
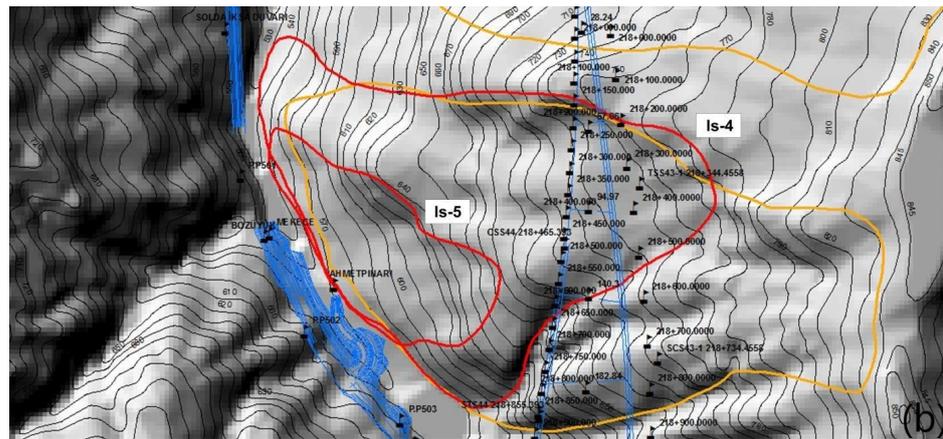
**Figure 14.** Areal distributions of the landslides Ls-1, Ls-2, and Ls-3 interpreted on the 1/25,000 scale digital elevation model; the spatial distribution and the positions of the monitoring stations; 30 monitoring stations are indicated by points in triangle symbols (a); areal distributions of the landslides Ls-4 and Ls-5 interpreted on the 1/25,000 scale digital elevation model (b).

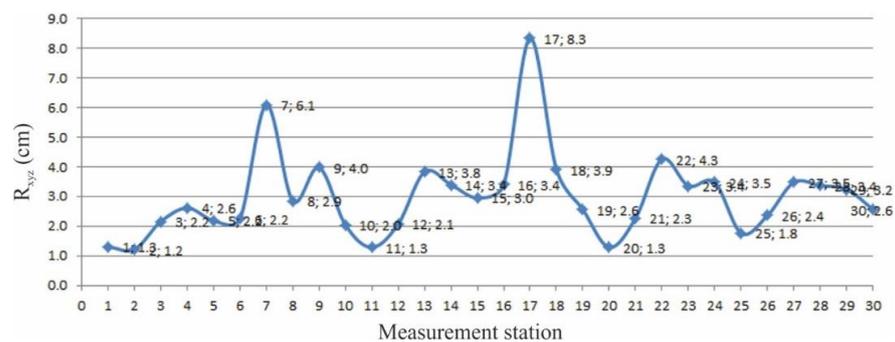
**Figure 15.** Resultant movement vector magnitudes (cm) calculated according to the measurements taken from the monitoring stations in the period of 24 February 2013 and 29 May 2013.

A total of 30 surface measurement stations were established to monitor the surface deformations that occurred due to the landslides observed through the T-26 tunnel route (Figure 14a). Measurements were taken by using differential GPS from the stations in the period of 24 February 2013 and 29 May 2013. The first measurements were more frequent. The precisions of the measurements in the x, y, and z directions were assigned to be 1 mm. Total deformations determined in the x, y, and z directions depending on the measurements taken from the stations are given in Figure 15. Accordingly, the highest resultant deformation in the period of measurement was calculated as 8.3 cm at station No. 17. The areal distribution of the resultant movements detected at the stations is presented in Figure 16a. As can be seen in Figure 16a, the maximum resultant movement vectors were detected at stations No. 7 and 17, which were close to these locations.

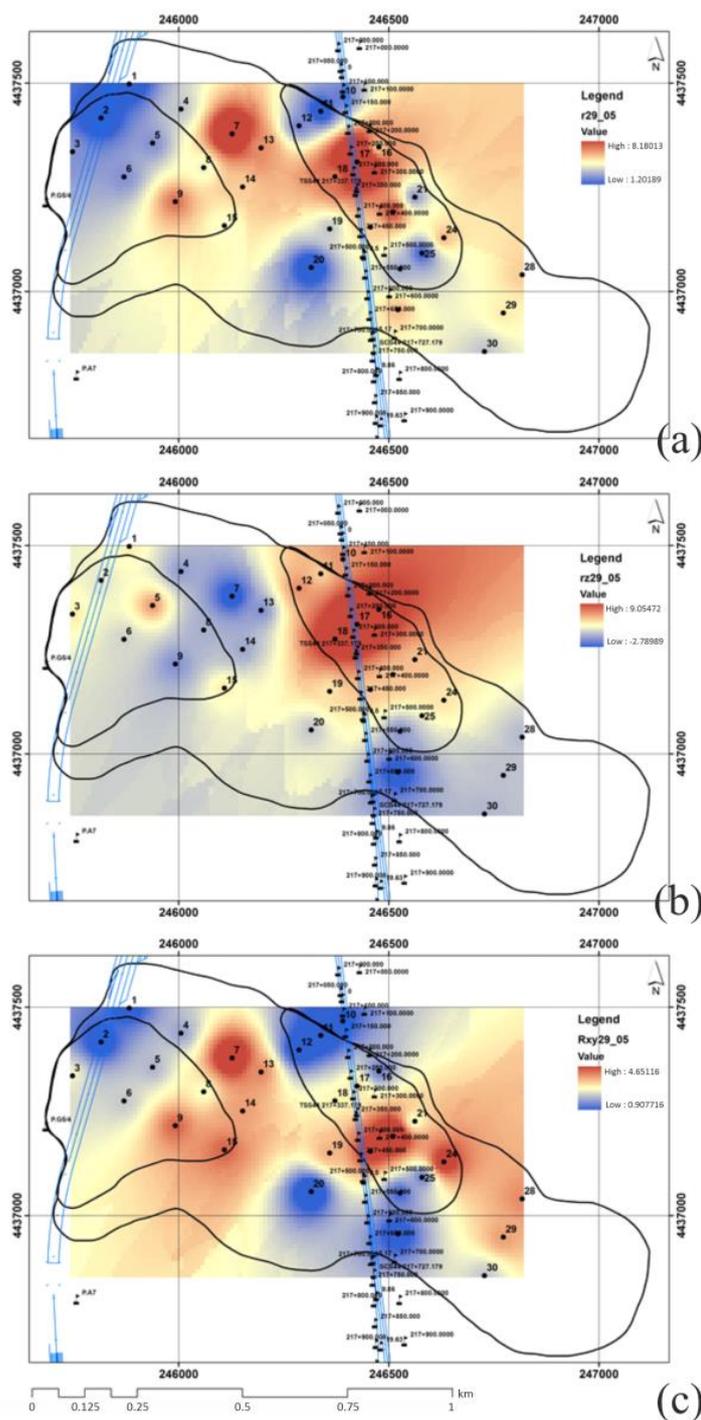
**Figure 16.** Areal distribution of the resultant movement vector magnitudes (cm); the measurements were taken from the monitoring stations in the period of 24 February 2013 and 29 May 2013 (a); areal distribution of the vertical movement vector magnitudes (cm) calculated according to the measurements taken from the monitoring stations in the period of 24 February 2013 and 29 May 2013 (b); areal distribution of the horizontal movement vector magnitudes (cm) calculated according to the measurements taken from the monitoring stations in the period of 24 February 2013 and 29 May 2013 (c).

To better understand the mechanisms of the landslides and their relationship with TBM, the areal distributions of the movements both in the horizontal and vertical directions were determined separately. The distribution of the movement in the vertical direction is shown in Figure 16b. Accordingly, downward vertical deformations reaching up to 9 cm were detected along the tunnel route and particularly in the section where the TBM operates. However, upward vertical movements were detected in measuring locations No. 4, 7, 8, and 9. The main reason for the occurrence of the upward movements can be explained by the landslide Ls-2, particularly by tilting and heaving in the toe section of the failure. The areal extension of the vectors in the vertical direction (Figure 16b), stigmatic surfaces, and pit formations in the landslide are closely related to topographic hills and depressions which can be evaluated as typical hummocky style topography observed in landslides. As a consequence, the results obtained are reliable and reflect the typical landslide topography. The areal distribution of the vertical movement vector magnitudes (cm) calculated according to the measurements taken from the monitoring stations in the period between 24 February 2013 and 29 May 2013 are given in Figure 16c. Accordingly, a horizontal movement that can be described as almost linear in the northern part of the field and on stations No. 7 and 24 is observed. Within the period in which the movements were detected during the measurements, TBM had been operating under this section. Therefore, there should be a relationship between the operation of TBM and the slope movements. This situation was considered as the re-activation of the slope by additional effects created in the landslide region. The directions of the vectors determined for the stations having an amount of total horizontal movement greater than 3 cm are given in Figure 17a. The measurements for the resultant vectors given in Figure 17a were taken between the same dates 24 February 2013 and 29 May 2013. Accordingly, the direction of the movements is downward. The maximum horizontal movement was calculated as 4.7 cm. This value was obtained from the measurements performed on station No. 22. Station No. 22 is located on the surface of the section where the TBM was operated for the last time. Even though the maximum horizontal movement was determined in this section, no deformation was encountered in the tunnel. This is one of the important findings indicating that the tunnel is at a deeper level than the failure surface of the landslide. The locations of the movement vectors obtained from the monitoring stations on the cross-section are shown in Figure 17b. It is expected that the angle of the surface deformations with the horizontal should be compatible; accordingly, the obtained angles are in accordance with the surface of the failure of the surface deformation vectors. However, as can be seen from Figure 17b, the surface deformation measurements showed parallelism mainly with the predominantly shallow surface of failure Ls-1. This is a physically normal situation. The total amount of movement obtained from the surface vectors indicates the maximum movement of both landslides.

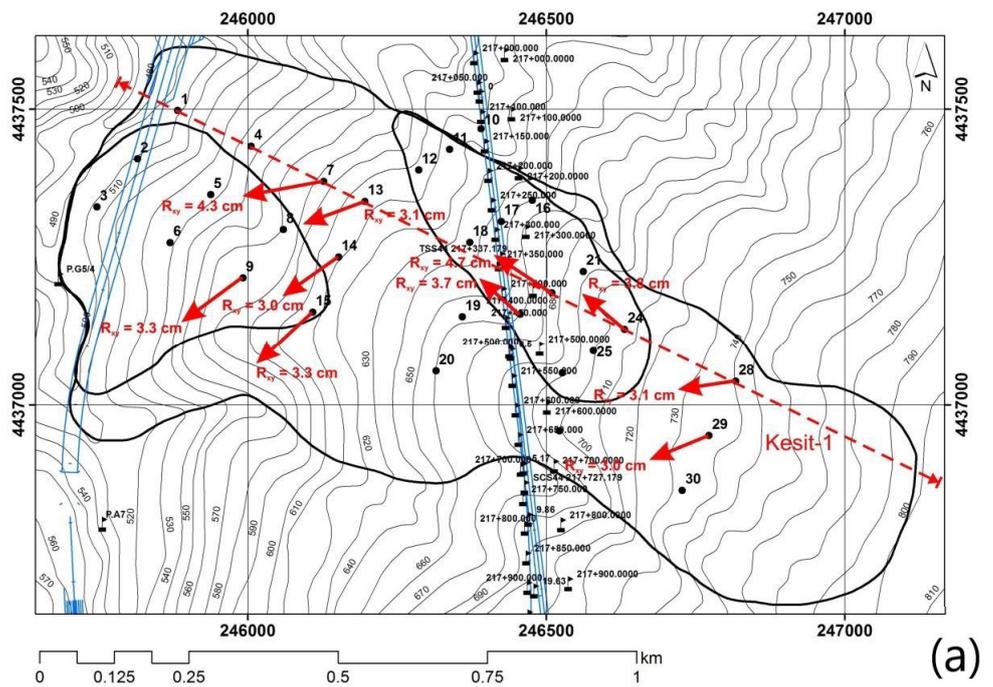
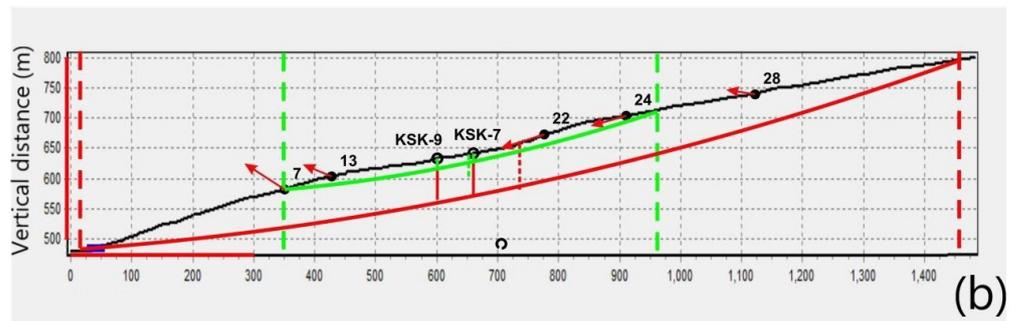
Figure 17. Directions of the vectors determined for the stations having the amount of total horizontal movement greater than 3 cm; the measurements were taken between the dates 24 February 2013 and 29 May 2013 (a); locations of the movement vectors obtained from the monitoring stations on the cross-section; the colors green and red represent Ls-1 and Ls-2, respectively; the tunnel is also represented (b).

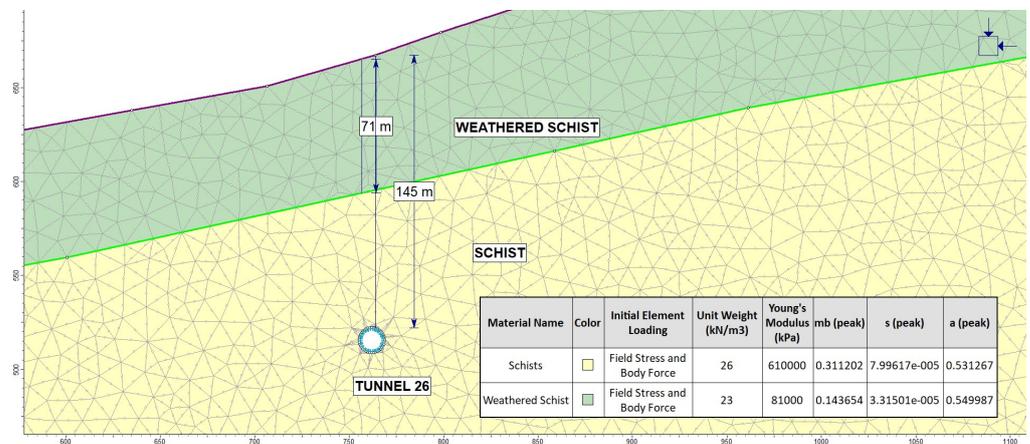
Figure 18. The geological cross-section used in 2D numerical analysis and the material properties.

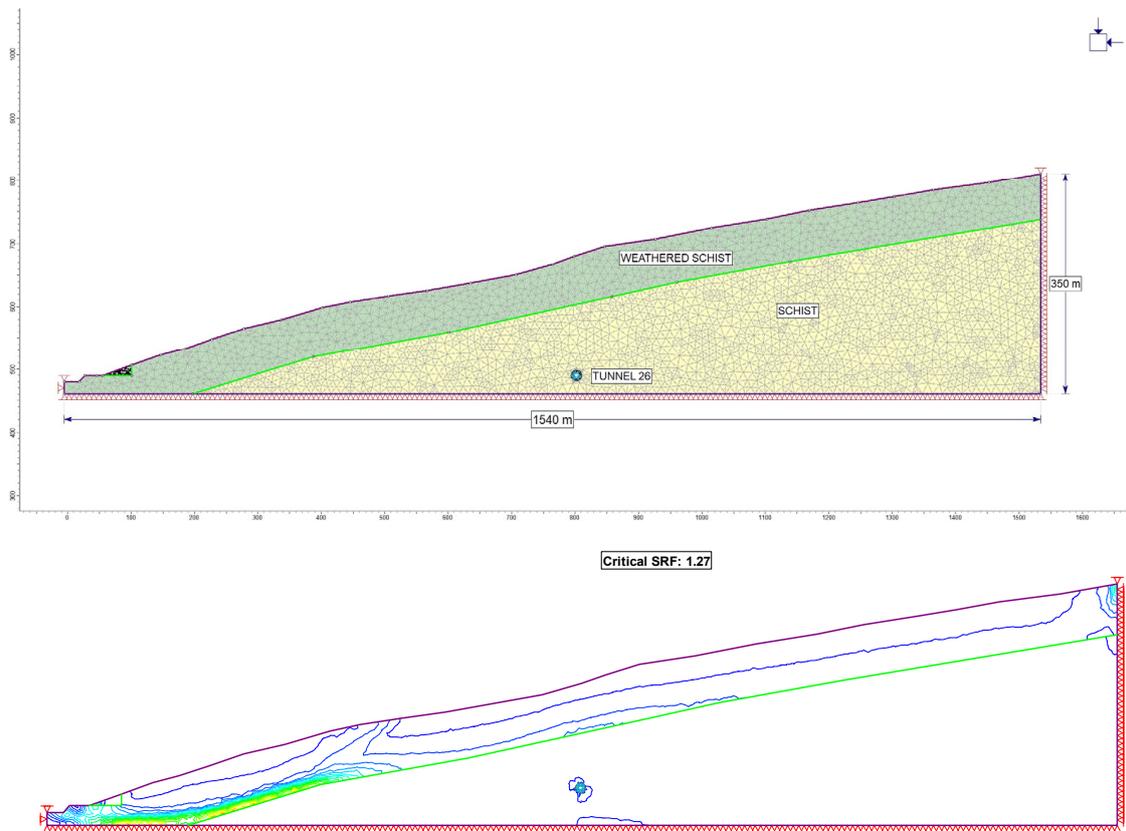
**Figure 19.** Phase2D model for the slope stability analysis (SRF analysis) and the result of slope stability analysis.

To investigate the landslide-tunnel relationship, in addition to empirical approaches and in-situ measurements, two- and three-dimensional (2D and 3D) numerical analyses were also performed. The section at Km: 214 + 400 was chosen for analysis (see Figure 4); because, as seen in Figure 16a, there is a landslide on the surface and its depth and geometry were determined. The cross-section and the parameters used in the analyses are given in Figure 18. In the first stage, to assess the stability of the landslide detected on top of the T26 tunnel, 2D numerical analyses were performed via Phase 2D v8.0 software with a shear strength reduction (SSR) approach that systematically reduced the shear strength envelope of material by a factor of safety [57]. Phase2D v8.0 is used to determine the safety factor of a simple homogeneous slope using the shear strength reduction (SSR) method (Figure 19a). As can be seen from the slope stability analysis (Figure 19b), the critical SRF was obtained as 1.27 and the slope movement does not affect the tunnel.

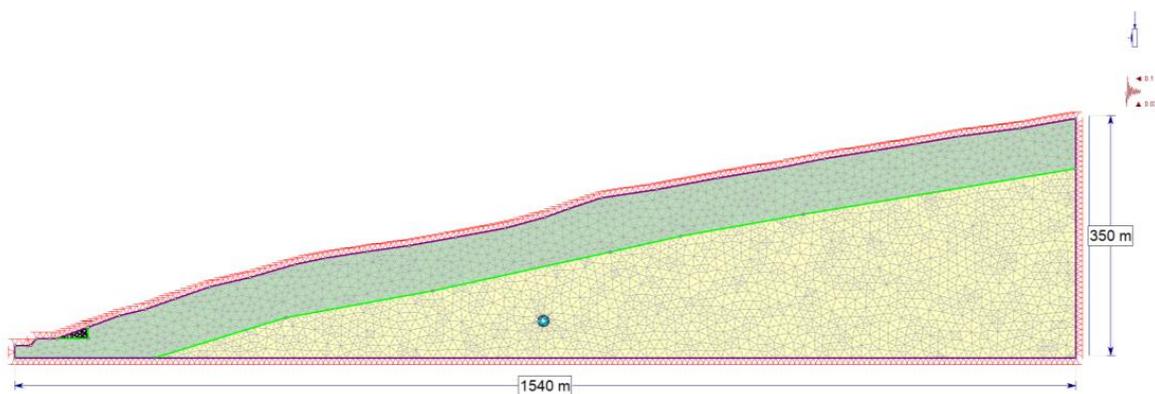
**Figure 20.** Boundary conditions of 2D model for determining the tunnel excavation and support systems.

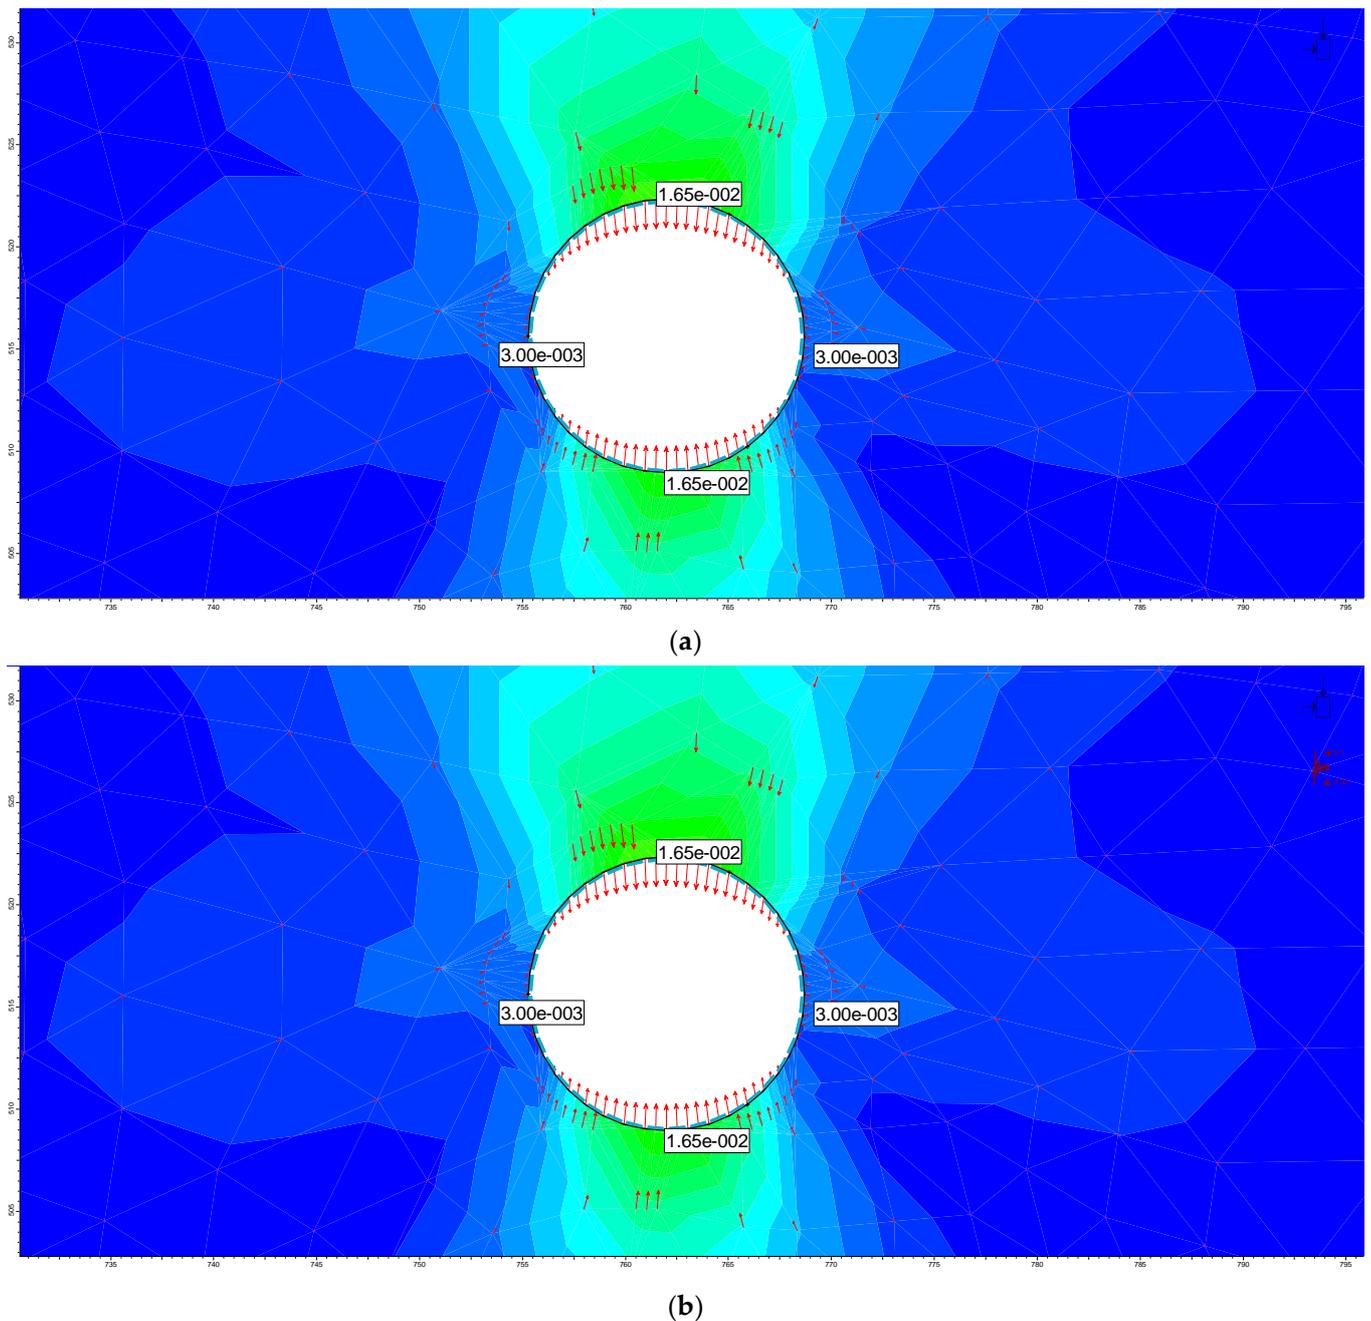
**Figure 21.** Total displacements obtained from the 2D numerical analysis (a) and total displacements obtained from the 2D numerical analysis (seismic conditions) (b). (units in m).

In addition, for the tunnel excavation and support system, 2D numerical analyses were performed with the Phase2D v8.0 program and 3D analyses with the FLAC3D program. The model created for 2D analysis with the Phase2D program is given in Figure 20. Analyses were performed in three stages. In the first stage, the field stresses were described, the tunnel excavation was in the second stage, and immediately the segments were placed, and in the third stage, the seismic parameters were described in the model. The total deformation in the tunnel was calculated as 1.65 cm in the analysis. Likewise, the same deformations under seismic conditions were obtained. The main reason for this is that the overburden thickness is more than 100 m (Figure 21a,b).
