# A Geotechnical Perspective on a Complex Geological Environment in a High-Speed Railway Tunnel Excavation (A Case Study from Türkiye)

**Abstract:** The T26 tunnel was designed within the scope of the Ankara-Istanbul high-speed railway in accordance with the speed of 250 km/h. Some serious problems and excessive deformations were encountered during the excavation works. The deformations in the tunnel caused subsidence on the surface and the Tunnel Boring Machine (TBM) became stuck; therefore, tunnel excavation works were suspended. Design works for re-excavation in the T26 tunnel and extracting of the TBM were carried out and the tunnel was re-designed by the New Austrian Tunneling Method (NATM) system. The main purposes of the present study are to describe the problems encountered during the T26 tunnel and to discuss the sources of the problems. The advantages and disadvantages of TBM and NATM methods for the tunnel having difficult ground conditions were discussed. Critical points needing to be considered for the tunnels excavated with TBM through weak ground conditions and the effect of the TBM selection process were discussed. Considering the complex geological and geotechnica

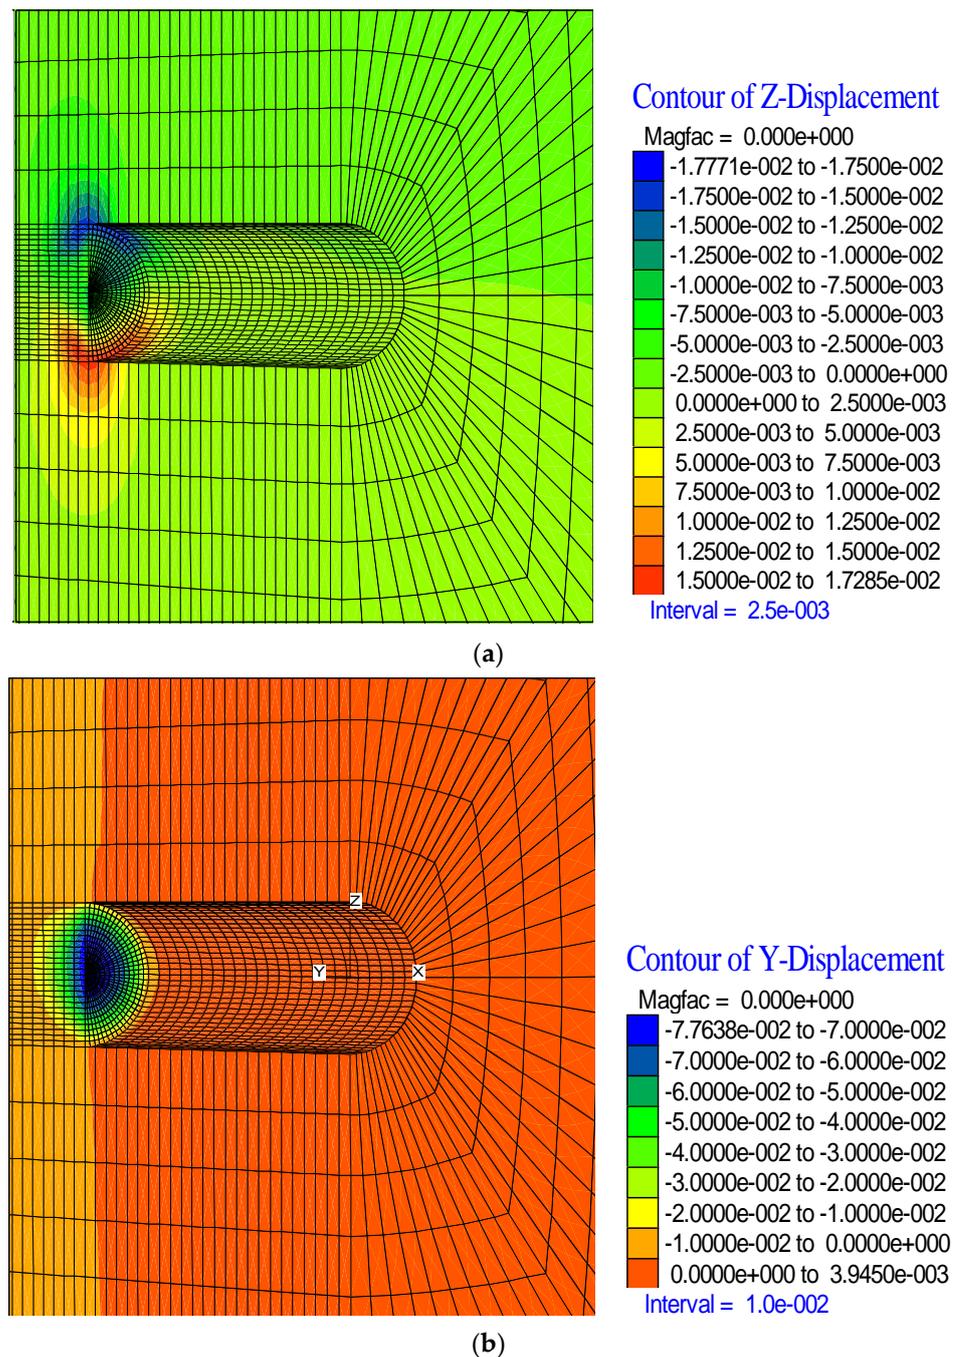
**Figure 22.** Vertical deformations (a) and horizontal deformations (b) obtained from the 3D numerical analyses (units in m).

Three-dimensional numerical analyzes were performed with the FLAC3D program, and the same result was found with 2D numerical analyzes, in other words, 1.7 cm total deformation was obtained (Figure 22a). In addition, deformations occurring in the tunnel face were also investigated, and 7 cm deformation was calculated (Figure 22b). This situation reveals that the face stability of the tunnel must be maintained, continuously.
