Unmanned Aerial Vehicles (UAV) Photogrammetry in the Conservation of Historic Places: Carleton Immersive Media Studio Case Studies

Keywords: UAVs; UAV photogrammetry; built heritage documentation; Prince of Wales Fort; Nepalese heritage; visual assessment

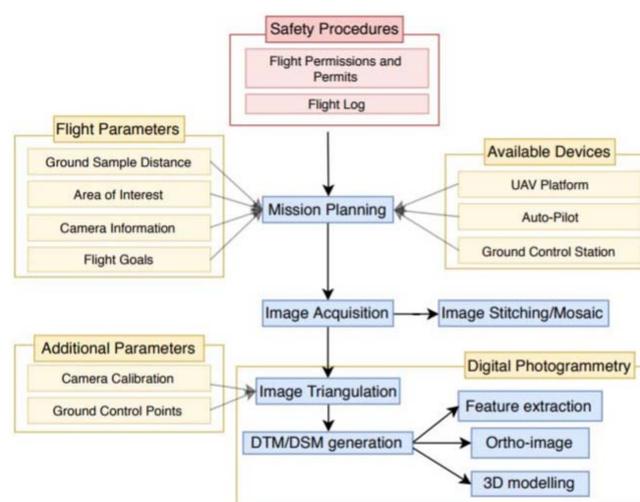
Figure 1. Unmanned aerial vehicles (UAV) Acquisition Workflow—adapted from [3].

Figure 1 is an adapted workflow from [3] that serves as a basis for UAV image acquisition and processing. It is important to note that a separate category, “Safety Procedures”, was added to mission planning in the adapted figure. This is because safety should always be at the forefront of any UAV mission. By understanding the safety procedures and protocols, it helps to minimize the possibility that the UAV will cause damage to both humans on the ground (i.e., the drone becomes out of control and

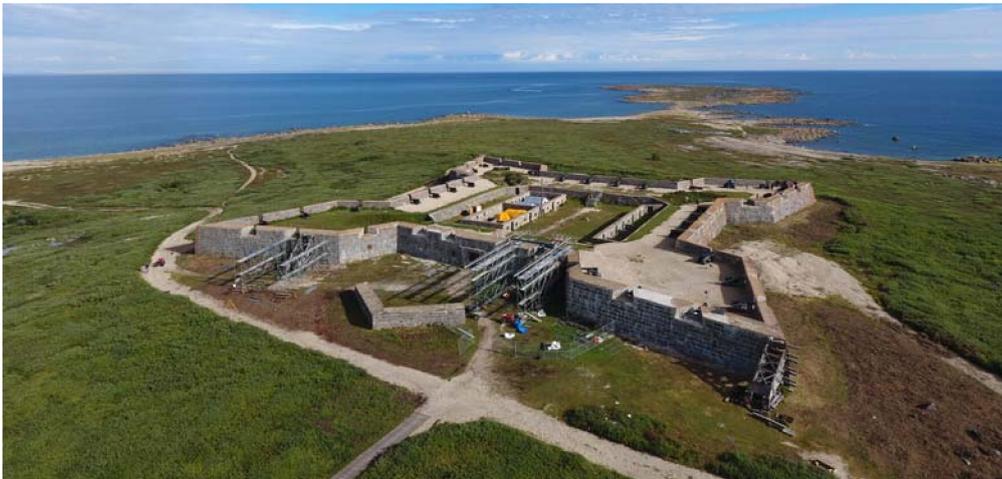
Figure 2. Prince of Wales Fort (taken by Alex Federman).

The site itself was constructed over a forty year period from 1731–1771 by the Hudson's Bay Company in order to protect their northern trade routes [19]. It was damaged by the French in 1782, and it was left dormant and neglected for 150 years until conservation initiatives were put forth by the Historic Sites and Monuments Board of Canada. The conservation efforts of the 1930's and 50's focused on the stabilization of the exterior rampart walls, as some sections were in danger of collapse. As the site was open to the public, the safety of the site was an imminent priority as to not put any visitors at risk of injury. Though the initial interventions did indeed help to ensure the continued longevity of the site, the repair techniques used negatively impacted aspects of the site's authenticity. Specifically, cement was poured behind the walls as a consolidation technique, which erased any signs of 18th century craftsmanship in the specific areas that were commissioned for repair [19]. The site has been greatly affected in recent years due to climate change. Visible cracks and masonry deterioration are visible on site, and monitoring programs have been put in place in order to keep a detailed record of any changes. An overview image of the Fort is shown in Figure 2.

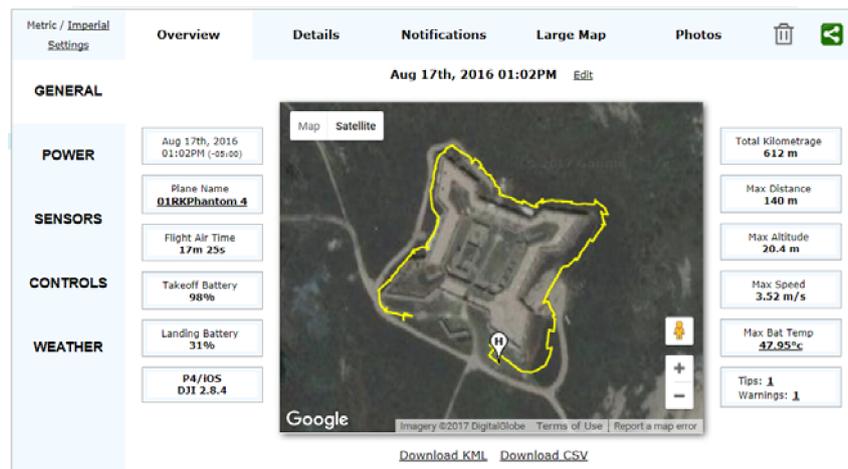
Figure 4. Example of flight path pattern for Prince of Wales Fort—Screenshot from airdata.com [23].

The photos and video footage was manually inspected and named in Adobe Bridge based on the date and flight number for posterity record keeping purposes. Additionally, the metadata from the UAV was imported to the online inventory airdata.com [23]. [Airdata.com](http://airdata.com) provides a way of quantifying the metadata by displaying attributes from the conducted flights, such as the route that the UAV took to capture the images, the altitude that each of the images was taken at, and notifications about the battery life. Figure 4 illustrates an example flight path pattern in airdata.com, while Figure 5 displays the photograph locations from the UAV. This information can be exported as a kml file to be used in a Google Maps application for the easy sharing of flight data.

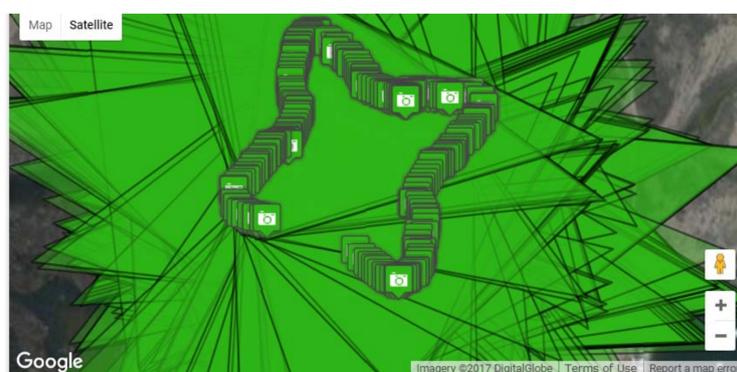
Flight time	Altitude	Home Distance	Gimbal Pitch	Heading	Type
A	01m 03s	8.2 m	13 m	24.5° down	47°	Photo
B	01m 13s	8.7 m	7 m	24.5° down	45°	Photo
C	01m 18s	8.7 m	5 m	24.5° down	46°	Photo
D	01m 21s	8.6 m	5 m	24.5° down	46°	Photo
E	01m 25s	8.5 m	6 m	24.5° down	46°	Photo

Figure 5. UAV Photograph locations at Prince of Wales Fort—Screenshot from airdata.com [23].

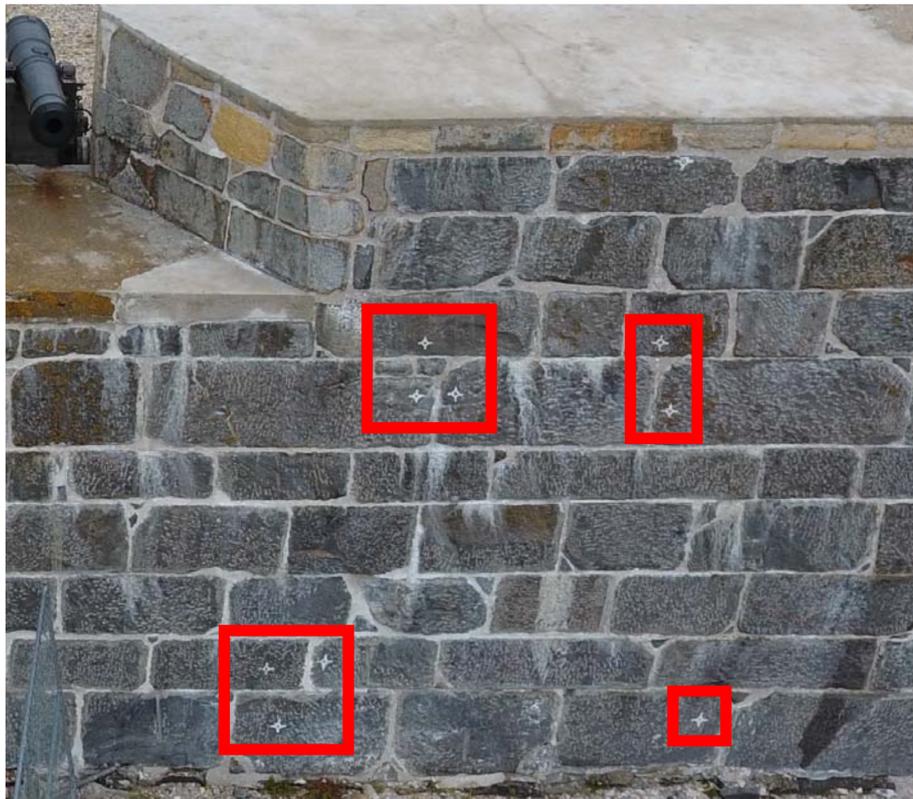
161 Ground Control Points (GCPs) were added to the PhotoScan model before image alignment in order to help with the orienting images of the interior courtyard and the exterior walls, as well as providing scale to the model. These GCPs were surveyed by John Gregg and Shawn Kretz for their own terrestrial photogrammetric survey of the Fort. These GCPs are permanent targets on the walls of the Fort, as seen in Figure 6.

Figure 6. Ground Control Points (GCP) Target Location Example (GCP Targets highlighted in red).

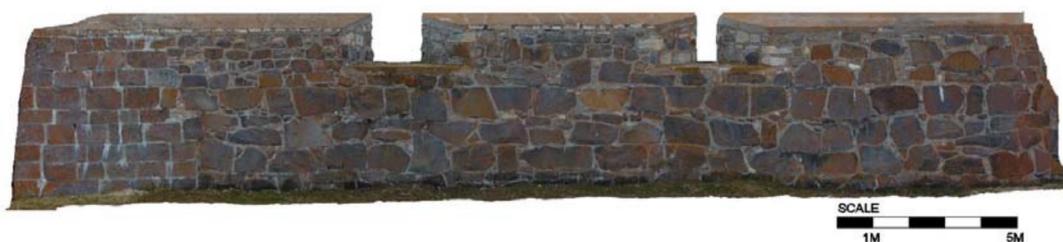
A series of orthophotos were created for individual wall sections of interest. The importance of adding the mesh back into the PhotoScan file was because of the usability of PhotoScan for orthophoto generation. The orthophotos that were created had an approximate GSD of 5 mm per pixel. This value is comparable to the theoretical GSD of the raw images that were used, because when calculations were made using an average flight distance of 12 metres away from the Fort walls, the resulting GSD was 5 mm or less. Though that result is higher than the 3 mm value for a 1:50 scale, as noted by Historic England's *Metric Survey Specifications for Cultural Heritage*, from visual inspection of the image, the mortar joints and the individual stones were all clearly visible to be traced for an elevation drawing [24]. Figure 7 shows the generated orthophoto.

Figure 7. Orthophoto of Wall Section.

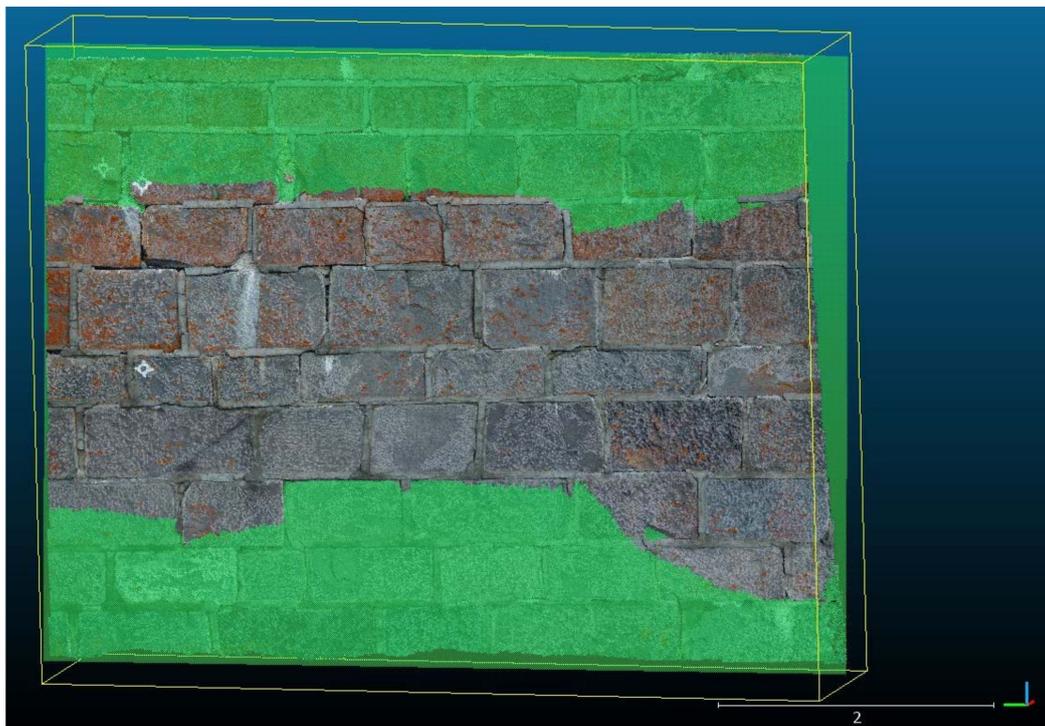
The information that is used for this analysis comes from point clouds generated in PhotoScan by using images from Flight 10, which were photographs that were taken at an angle perpendicular to the wall surface. This type of UAV photography methodology was done in four separate locations around the site. The datum used for the analysis is a best-fit plane, as the wall is rectangular in shape. A screenshot of the plane is shown in green in Figure 8.

Figure 8. Screenshot of best-fit plane applied to point cloud in CloudCompare.

This same plane can be used to compare the point clouds from future interventions because it was generated in the same reference system as the point cloud. The plane can be imported into a new CloudCompare project along with the current epoch's point cloud. After the plane is imported, a cloud to mesh algorithm is run in order to determine the relative distance between the point cloud and the reference primitive. Figure 9 shows the resulting relative distances for the wall surface based on the first epoch. The values measurement unit for the C2M distances is meters. The areas in red and orange in Figure 9 are indicative of the outward bulging of the wall by 0.1 to 0.16 m, as that direction was deemed to be the positive axis. Areas in yellow and light green represent a planar surface, while dark green and blue represent areas where the wall turns back in on itself. This type of analysis can be

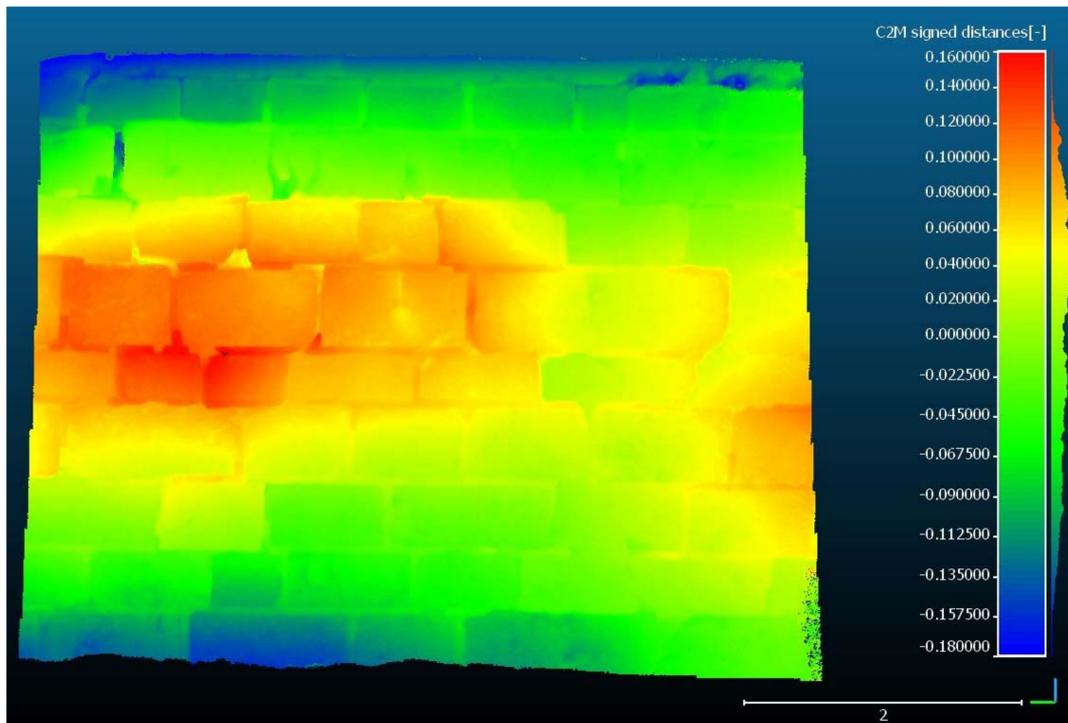
Figure 9. Scalar field wall deformation distances (units in meters).

beneficial in developing wall threshold limits in regards to intervention strategies, i.e., if the wall bulge reaches a certain value, then conservation work is required immediately. After a second data set is compiled, then it can be compared to the first one using the above methodology because it would be in the same reference coordinate system.

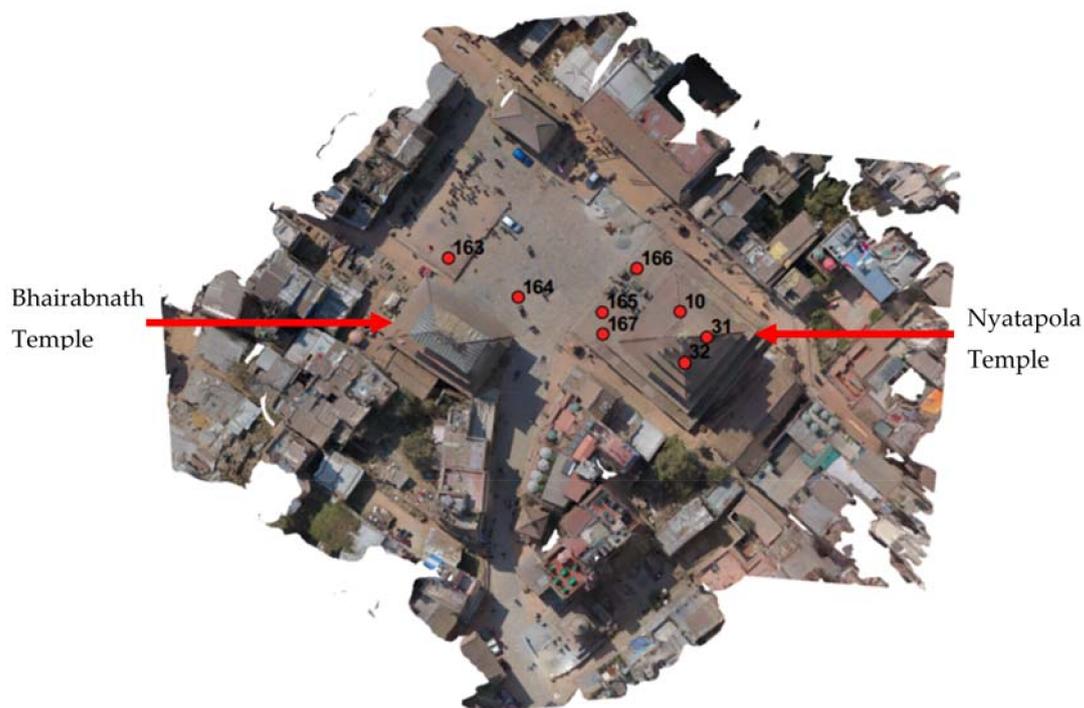
Figure 10. Orthophoto showing GCP locations of Taumadhi Square obtained from UAV Photogrammetry.

The Kathmandu Valley World Heritage property is inscribed as seven monument zones, with Bhaktapur Durbar Square being one of them. Taumadhi Square, which is known as Ta:Maari in local language, is one of the most important squares among the four that compose the Bhaktapur Durbar Square monument zone. Taumadhi Square consists of two important monuments: Nyatapola Temple and Bhairabnath Temple. An aerial orthophoto of Taumadhi Square is shown in Figure 10.

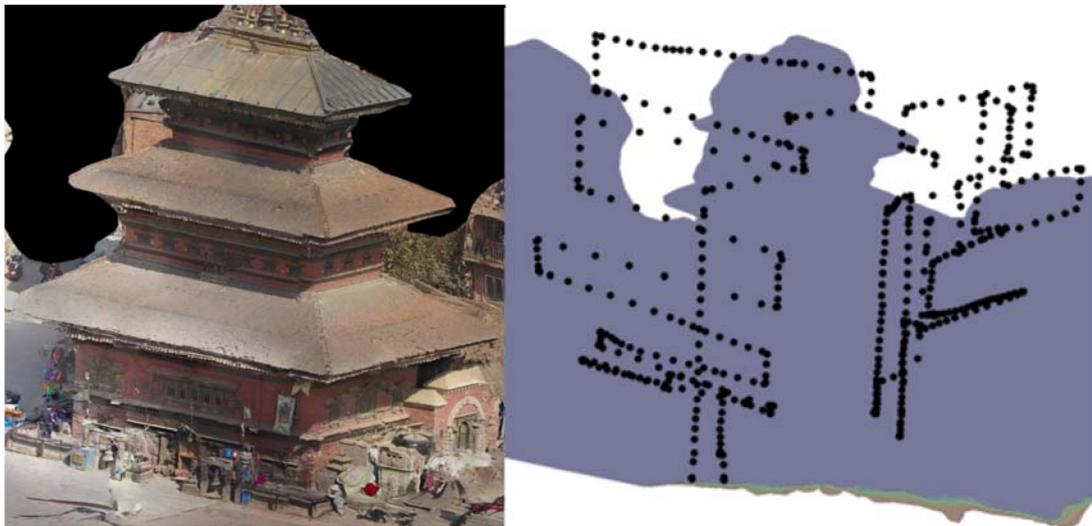
the photos that were obtained were very useful to assess the condition of exterior surface of the structure. Figure 11 shows where images were taken when documenting the Bhairabnath Temple.

Figure 11. Photograph locations used in the processing of Bhairabnath Temple—Right image shows camera locations, while left image shows the Bhairabnath Temple.

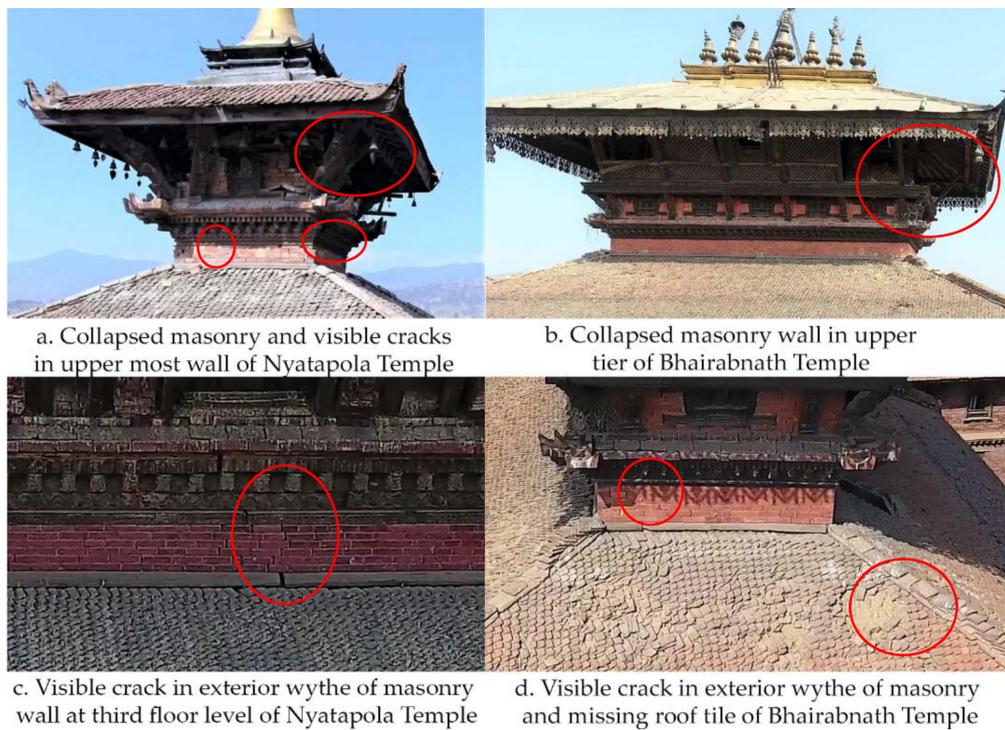
Cracks in the exterior surface of the structural wall were recorded and the extent of damage in the upper level was recorded using the visual assessment of the pictures taken from UAV. The analysis

was more qualitative than quantitative to come to conclusions about the damages. The result that was obtained from the condition assessment is presented in Figure 12.

Figure 12. Damage recording from the UAV photographs.

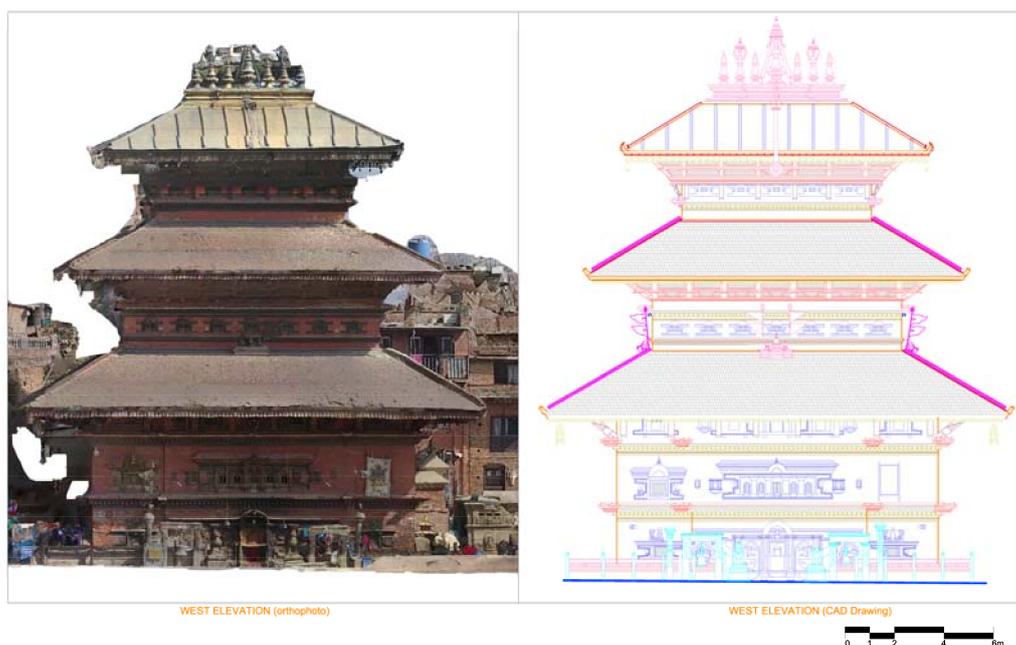
The georeferenced point clouds were used to generate the high quality orthophotos, with a GSD of 5 mm per pixel. These orthophotos were then used to generate the measured drawings of the structure, with an example being shown in Figure 13.

Figure 13. Scaled Orthophoto from Aerial Photogrammetry (Left) and CAD drawing (Right).
