Unraveling the Characteristics of ESS Fires in South Korea: An In-Depth Analysis of ESS Fire Investigation Outcomes

Yong-Un Na ^{1,2} and Jae-Wook Jeon ^{2,*}¹ National Fire Research Institute of Korea (NFRI), Asan 31555, Republic of Korea² Department of Electronic and Computer Engineering, Sungkyunkwan University, Suwon 16419, Republic of Korea

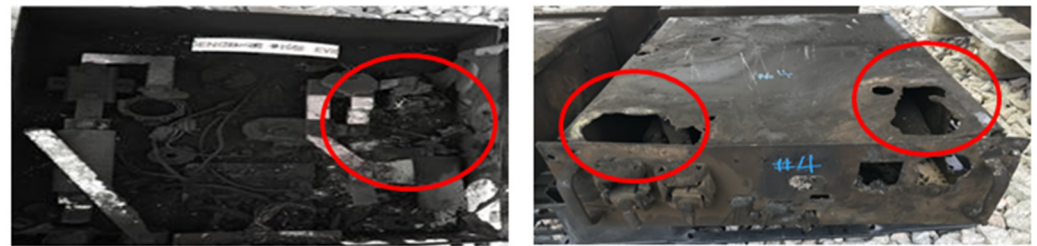
The committee conducted an experiment to verify the hypothesis of the danger of external electric surge as presented in Figure 4. To analyze the entire ESS, the experiment was conducted separately on the DC and AC parts of the system, using a method of short-circuiting the terminal or ground. The results of the experiment on the DC part of the ESS indicated that the external electric surge, such as a short circuit, may cause ESS fires. Moreover, the AC part of the ESS was found to be particularly vulnerable to external electric surges. It is possible for fires to occur in ESS when an external surge at the terminal is generated during experiments. However, since there were no concrete pieces of evidence

indicating an external surge at the fire site due to heavy fires, it is impossible to establish a direct relationship between an external surge and the fires.

Figure 4. Fires in energy storage system module [25].

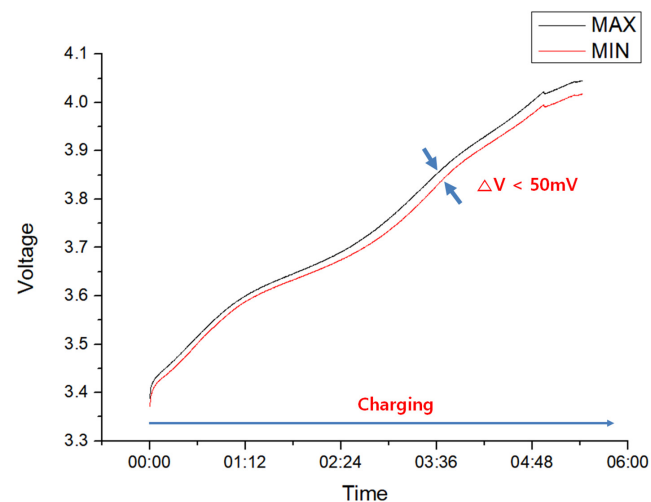
To differentiate the causes of ESS fires, we conducted an investigation at similar ESS sites that utilized batteries manufactured at the same time. Our findings revealed that some batteries exhibited low voltage in the BMS data: specifically, a deviation in voltage between the MAX and MIN cells of approximately 50 mV, as depicted in Figure 7. Although this deviation value falls within acceptable levels, it exceeded the typical deviation of 30 mV observed in normal ESSs. We hypothesized that the MIN cell may have been a contributing factor to ESS fires. To test this hypothesis, two charge and discharge cycles per day were conducted on the selected MIN cell from similar sites for a one-month period, but no fires were observed, nor were there any indications of voltage drops or insulation issues in the MIN cell.

Figure 7. The battery voltage graph for ESS-like site.

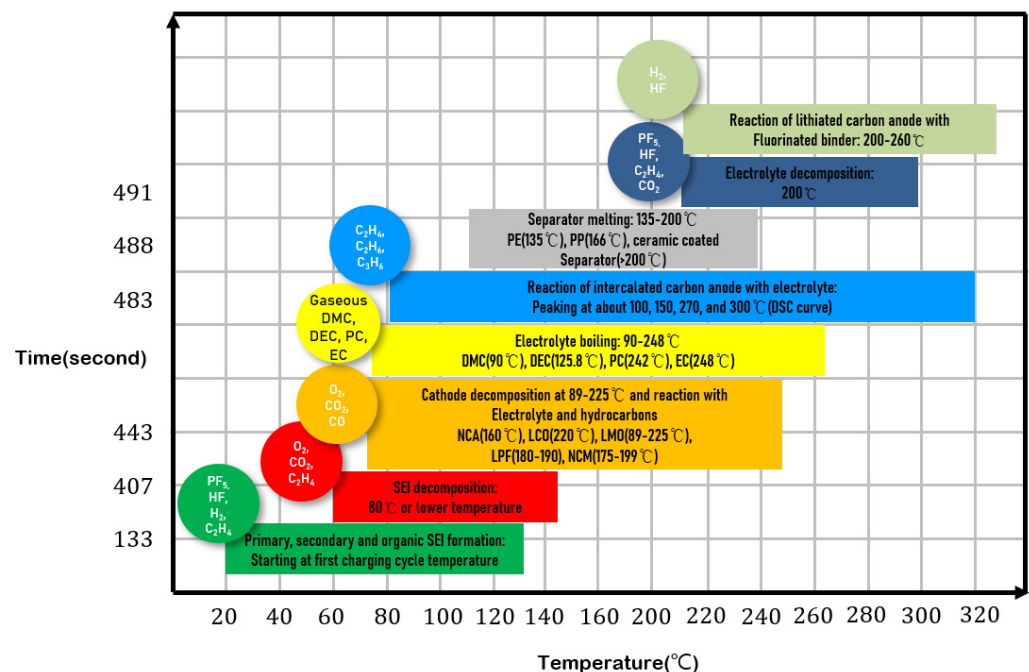
In the event of a thermal runaway within a lithium-ion battery, various gases are generated. As the temperature rises, combustible gases and oxygen are produced, as illustrated in Figure 13. Additionally, the formation of hydrofluoric acid, which poses a risk to human health and safety, particularly for firefighters, is observed. The increase in the volume of generated gases leads to a corresponding increase in the internal pressure of the ESS battery room. Moreover, the deflagration of combustible gases in the battery room may easily occur. Nevertheless, to mitigate the risk of fire, a gas fire extinguisher is installed in the battery room. However, the deflagration and activation of the extinguisher can result in a rapid increase in the internal pressure, potentially leading to structural collapse. This is exemplified in Figures 14 and 15, which depict a site where the battery room collapsed due to deflagration and internal pressure buildup during a fire. On 19 April 2019, this phenomenon (deflagration) resulted in injury to a firefighter at an ESS fire site in Arizona, highlighting the importance of considering the potential consequences of thermal runaway and the importance of adequate protective measures [26,27].

Figure 13. Li-ion battery thermal runaway generated gas [28].

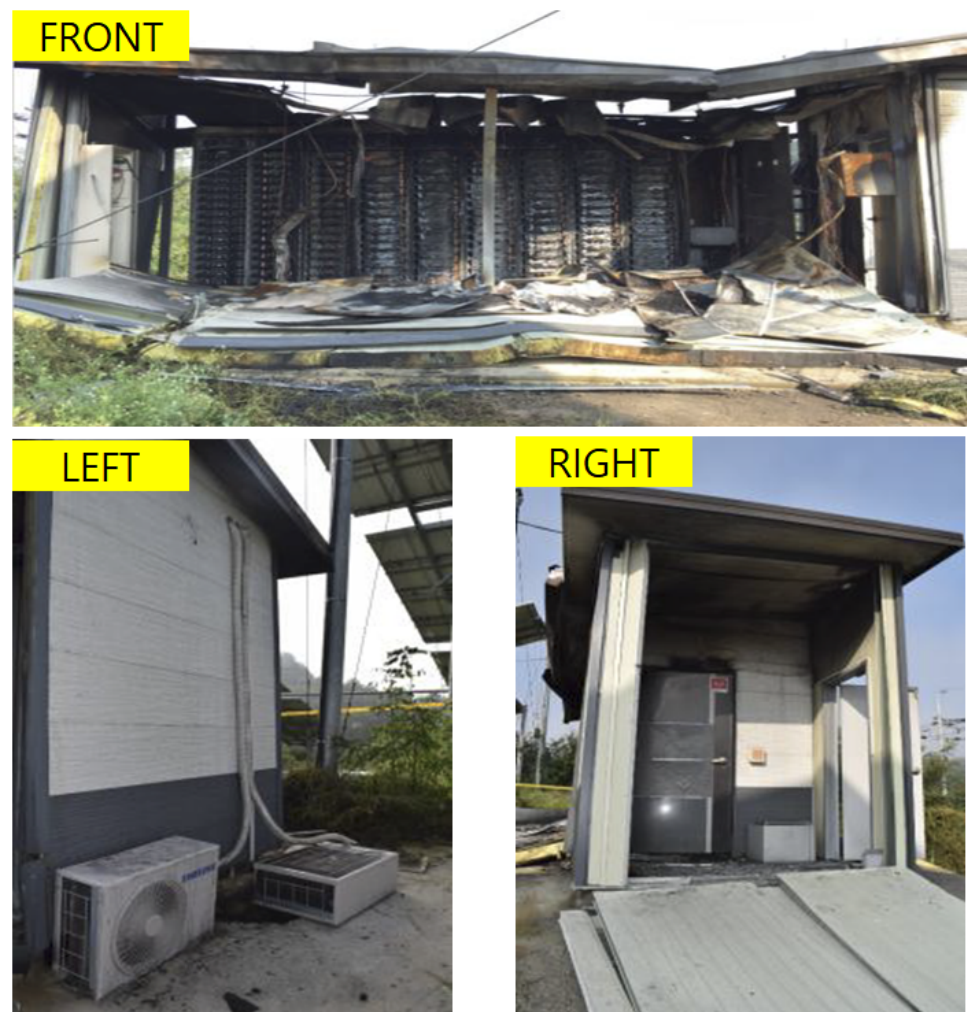
Figure 14. Gunwi energy storage system fire site.

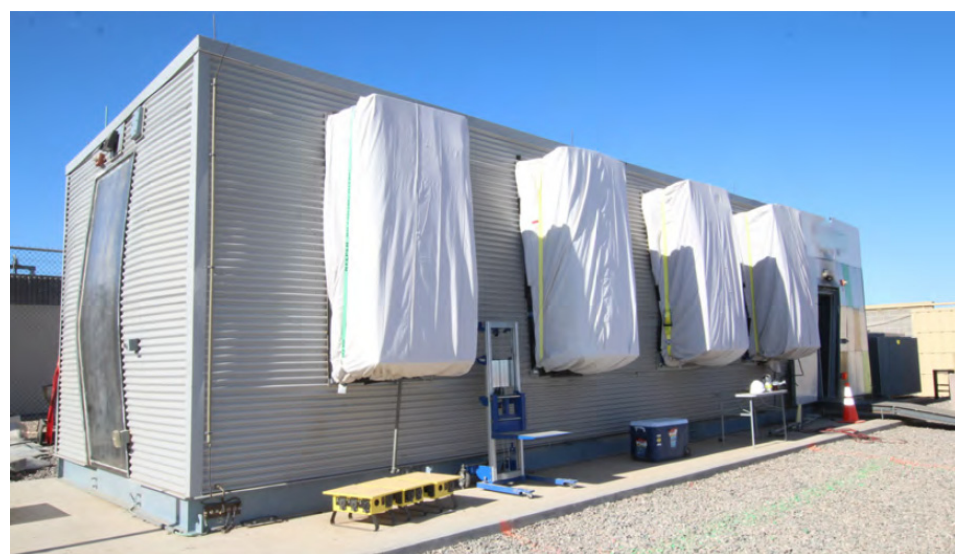
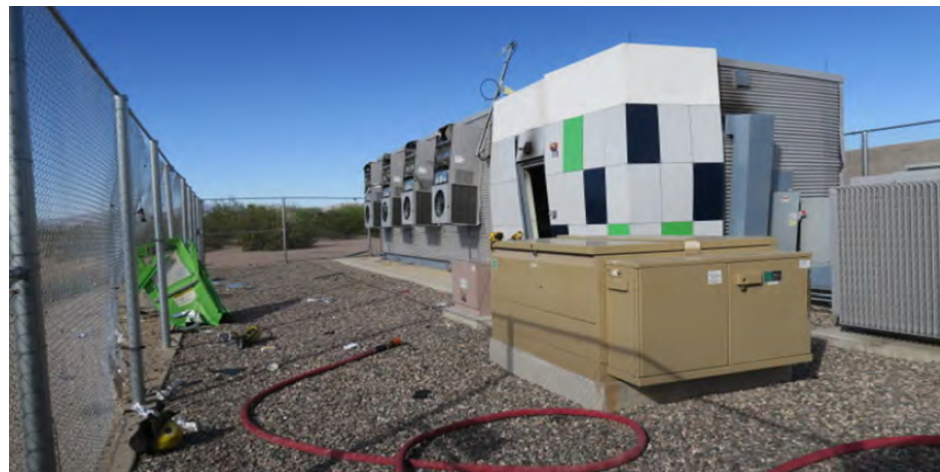
Figure 15. Arizona energy storage system fire site [26].
