# A “Smartly Functional” Urban 3D Model: A New Way to Preserve the State of Health and Quality of a Complex Masonry Structure

Antonietta Varasano \*, Maria Lepore, Marina Zonno and Salvatore Capotorto

**Abstract:** The 3D model is the primary information of an integrated support system for the assessment of structural safety under vertical loads and seismic vulnerability of a masonry building. The available approaches for evaluating seismic demand and capacity still appear inadequate and today aims to improve the process of knowledge of the seismic behavior of masonry structures and of the reliability of the numerical analysis of evaluation methods. Discrete modeling approaches (macro-elements) can lead to more reliable results if accurate surveys of the geometry and construction details of the masonry structure are used, especially in contexts where advise against the execution of invasive on-site tests for assessments both under vertical and seismic loads, limiting the investigation campaigns. In order to improve digital processes, oriented to the knowledge of the state of health and quality of a masonry structure, this study illustrates a new overture to virtual modeling and a

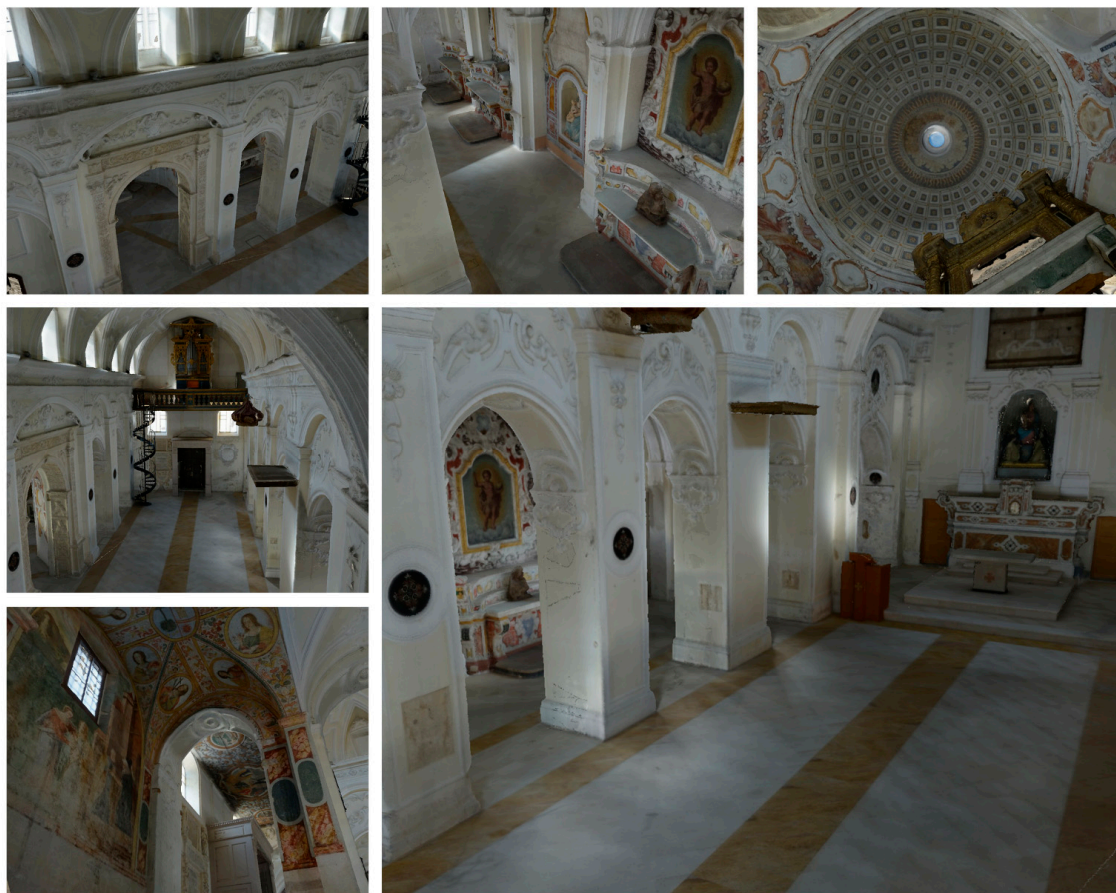
**Figure 5.** Internal views of the textured 3D model.

This is a particularly advantageous aspect if we consider the high number of images used during the texturing phase of modeling which, in a reasonable time, are processed and amalgamated with each other, recreating a particularly realistic chromatic information of the surfaces (Figure 5).
