Article

Seismic Vulnerability Assessment of a Medieval Urban Cluster Identified as a Complex Historical Palace: Palagio di Parte Guelfa in Florence

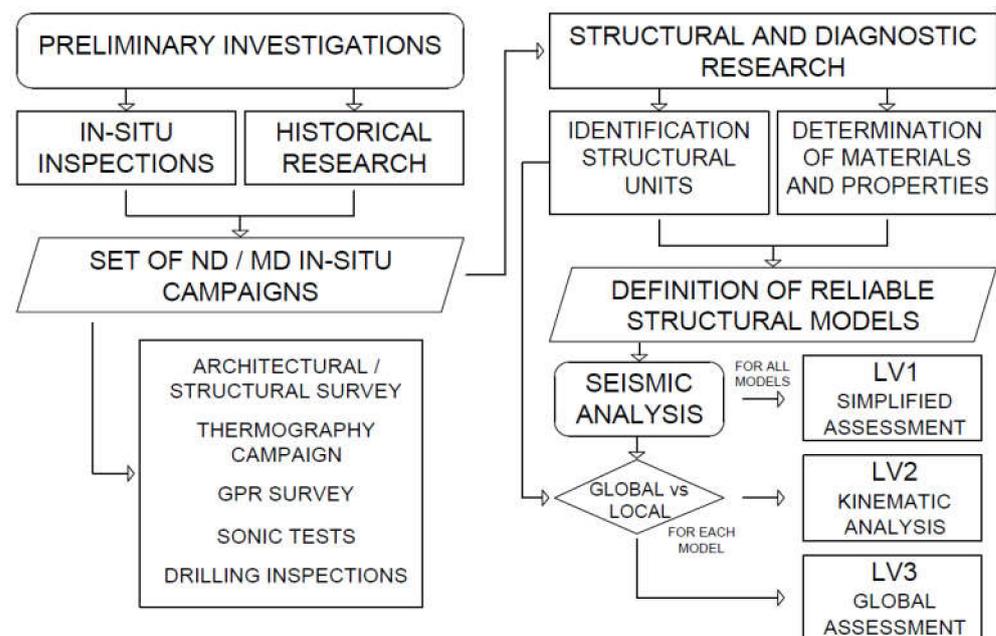
Figure 2. Methodological flow-chart of the research.

The seismic vulnerability assessment of the complex followed the methodological flowchart shown in Figure 2. The procedure can be divided into several substeps. Preliminary investigations were conducted, comprising in situ inspections of the dimensions of the palace in order to determine its relationship within the adjacent units. This phase anticipated the execution of geometrical surveys or the application of diagnostic techniques. During such preparatory evaluations, preliminary structural models can be realized on the basis of the available information. These can be useful to execute sensitivity analyses, highlighting uncertain parameters that are worthy of further investigation [48]. In this work, before our investigation of the building, historical research was undertaken, based on chronicles published by different authors. The combination of the outcomes of historical studies and preliminary in situ observations allowed us to devise a diagnostic campaign. In this research, all the investigations shown in Figure 2 were carried out. Namely, architectural and structural surveys of the building were executed. Then, several ND and MD techniques were performed, such as thermography tests, GPR surveys, sonic tests on the masonry walls, and drilling inspections. All of the proposed tests were ranked according to their priority: (i) ND tests were extensively used to investigate the different parts of the Palace; and (ii) MD tests were undertaken in order check the reliability of the ND tests

and qualitatively characterize specific parts of the structure. On these bases, an architectural survey of the Palagio was performed. The geometrical parameters derived from the architectural digital survey, i.e., combining the outcomes of the executed diagnostic campaigns, were later characterized. Finally, the acquired knowledge allowed us to identify the structural units of the palace and to characterize its materials and their properties for our subsequent seismic analyses. The procedure followed the assessment approach for CHBs provided in [14]. First, a simplified LV1 method was used for all models according to the most reliable approach based on the structural features of the units. Then, the different structures were investigated based on the expected behavior under seismic motion in order to determine whether the units could exhibit a global behaviour or they were suitable to be investigated by kinematic analyses.

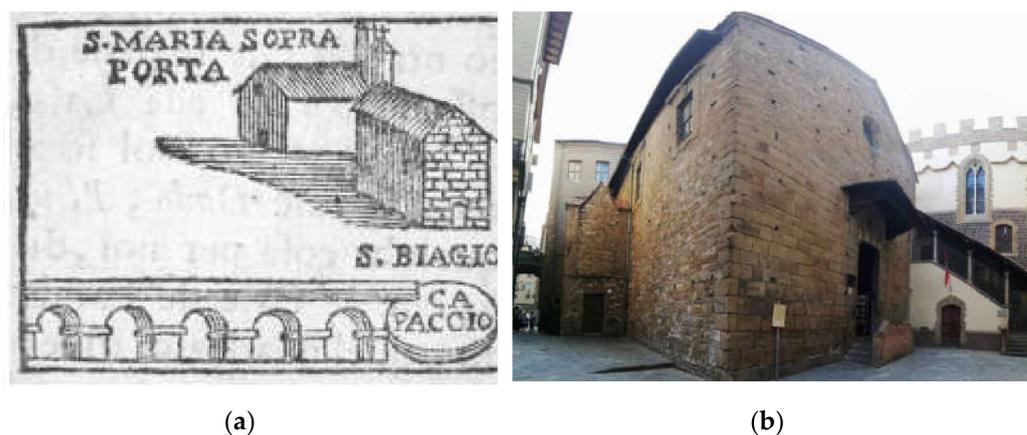
Figure 3. The Santa Maria Sopra Porta Church: (a) historical documentation from [52]; (b) photo of the main entrance.

Historical research was conducted to evaluate the available bibliographical sources with relevant information about the Palace. Specifically, in this section, we take advantage of research carried out by [49–56]. Palagio di Parte Guelfa is located in an area which has been urbanized since the Roman period; therefore, the historical evolution of the building is connected with the presence of other activities and buildings. Specifically, the Parte Guelfa, the Santa Maria Sopra Porta Church and the Arte della Seta represented the three institutions involved in the medieval transformations of the area. The original layout of the Palagio dates from the XII century, when the Guelfs, powerful in the city during the medieval period, were looking for new headquarters. They bought a portion of the complex close to the Santa Maria Sopra Porta Church. Historical information concerning the church is scarce; the available documentation refers to the enlargement of the structure for the realization of a new chapel in 1345 (Figure 3).

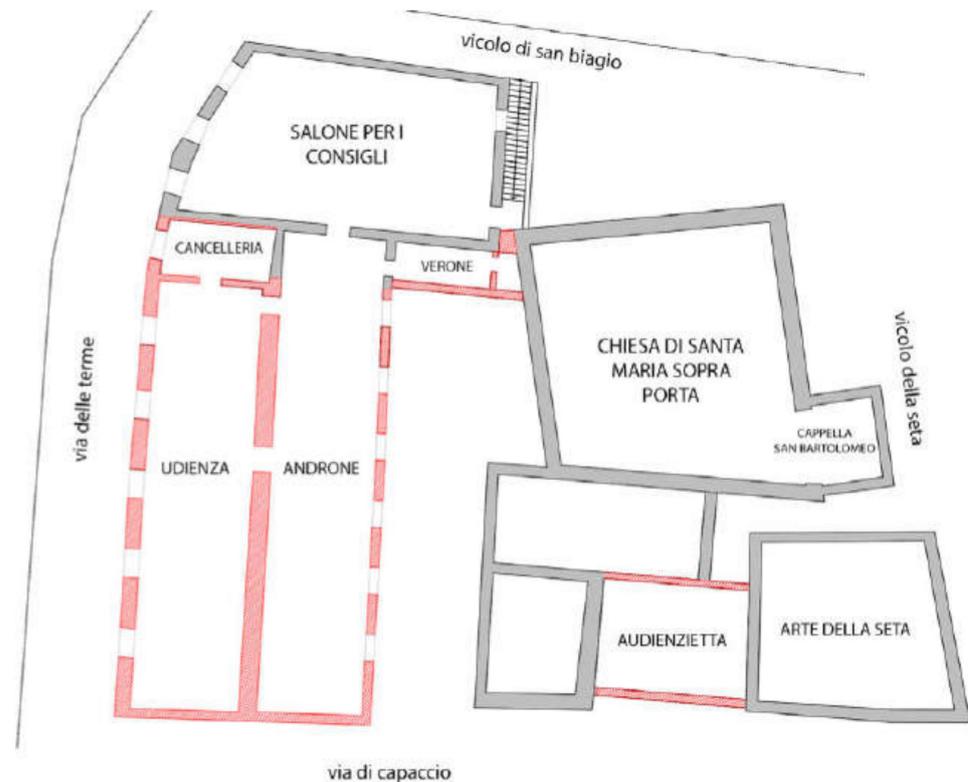
Figure 4. Plan of the first floor: hypothesis of the transformations in the years 1415–1426. In grey, the existing structures at the time are reported. In red, possible new additions are highlighted.

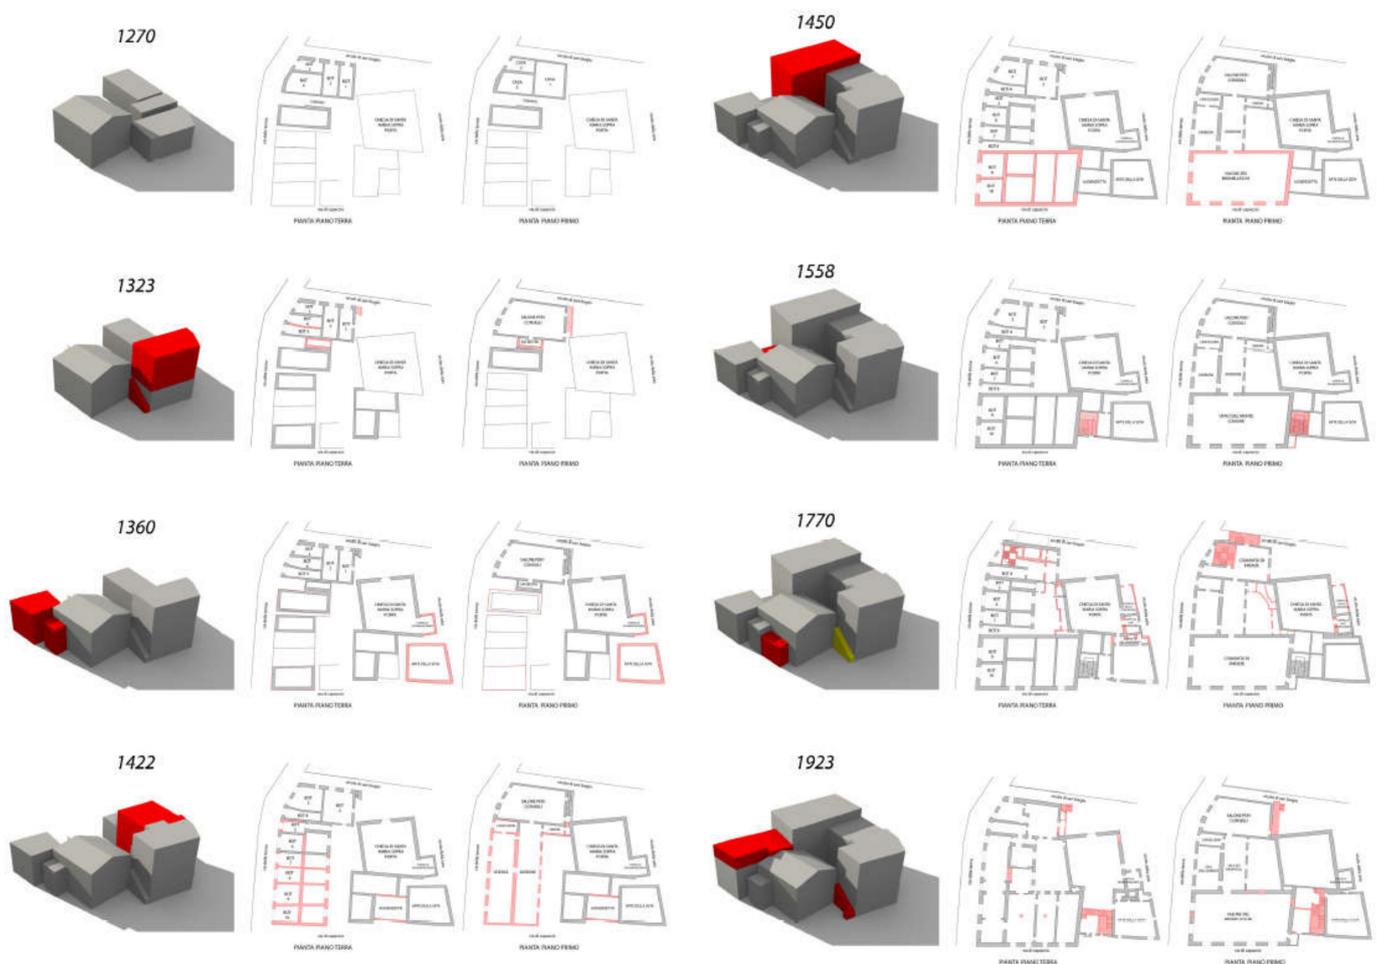
Figure 5. Summary of the transformations which occurred from 1270 to 1923. For each phase, the red parts indicate the spaces constructed during those years.

different institutions and public offices. In Figure 5, a representation of the evolution of the building, showing the major interventions since its origin, is shown.

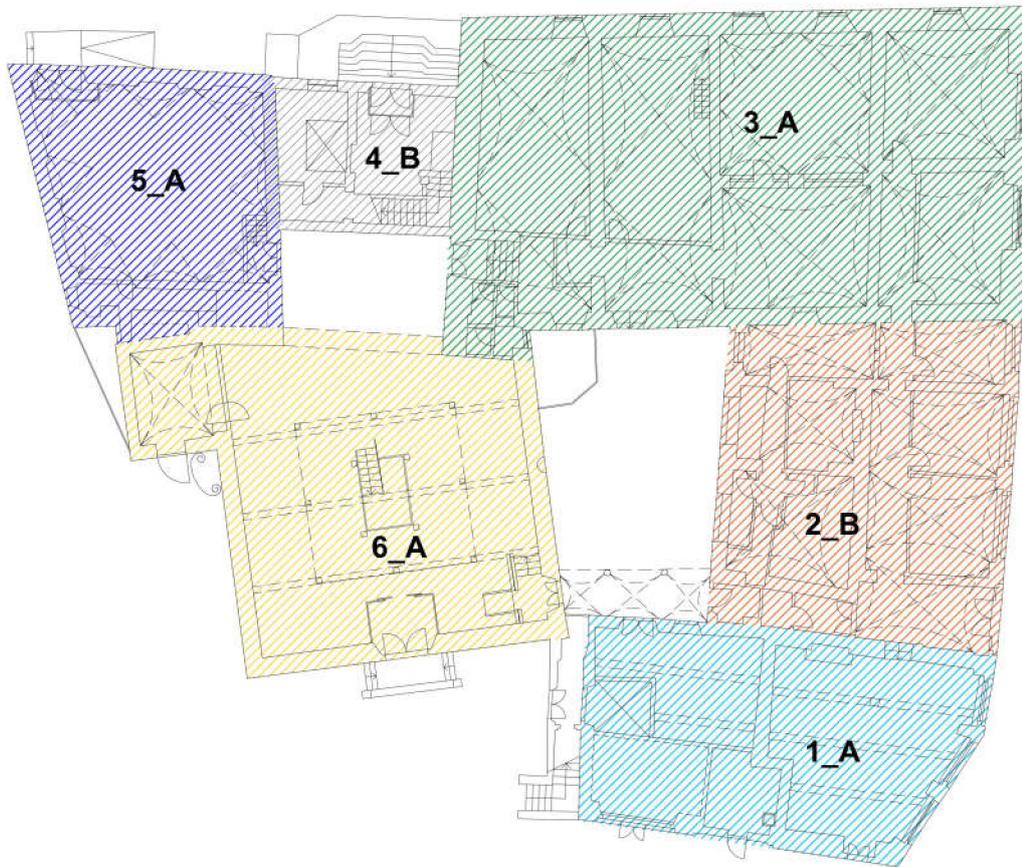
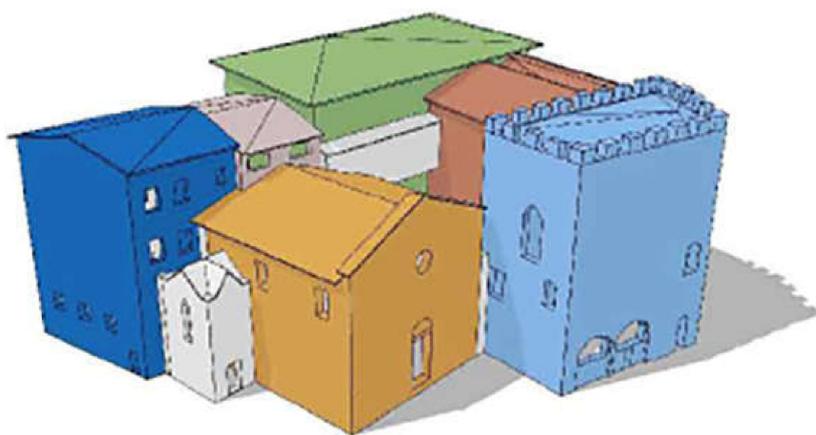
Palagio di Parte Guelfa—structural units

A - homogenous structural unit
B - structural unit saturating the aggregate

- 1_A - Sala dei Capitani
- 2_B - First interventions XV century
- 3_A - Sala del Brunelleschi unit
- 4_B - Arte della Seta unit
- 5_A - Arte della Seta unit
- 6_A - Ex San Biagio Church / library

Figure 6. Identification of the structural units. The letter A indicates homogenous units, while B denotes units made to saturate the spaces. 1_A—Sala dei Capitani (XIV century); 1_B—First intervention in the XV century; 3_A—Sala di Brunelleschi; 4_B—Arte della Seta annex; 5_A—Arte della Seta main unit; 6_A—Ex San Biagio Church.

Table 3. Safety indexes for the different structural units SU comprising the Palagio di Parte Guelfa (the numbers of the different units are consistent with those used in Figure 6).

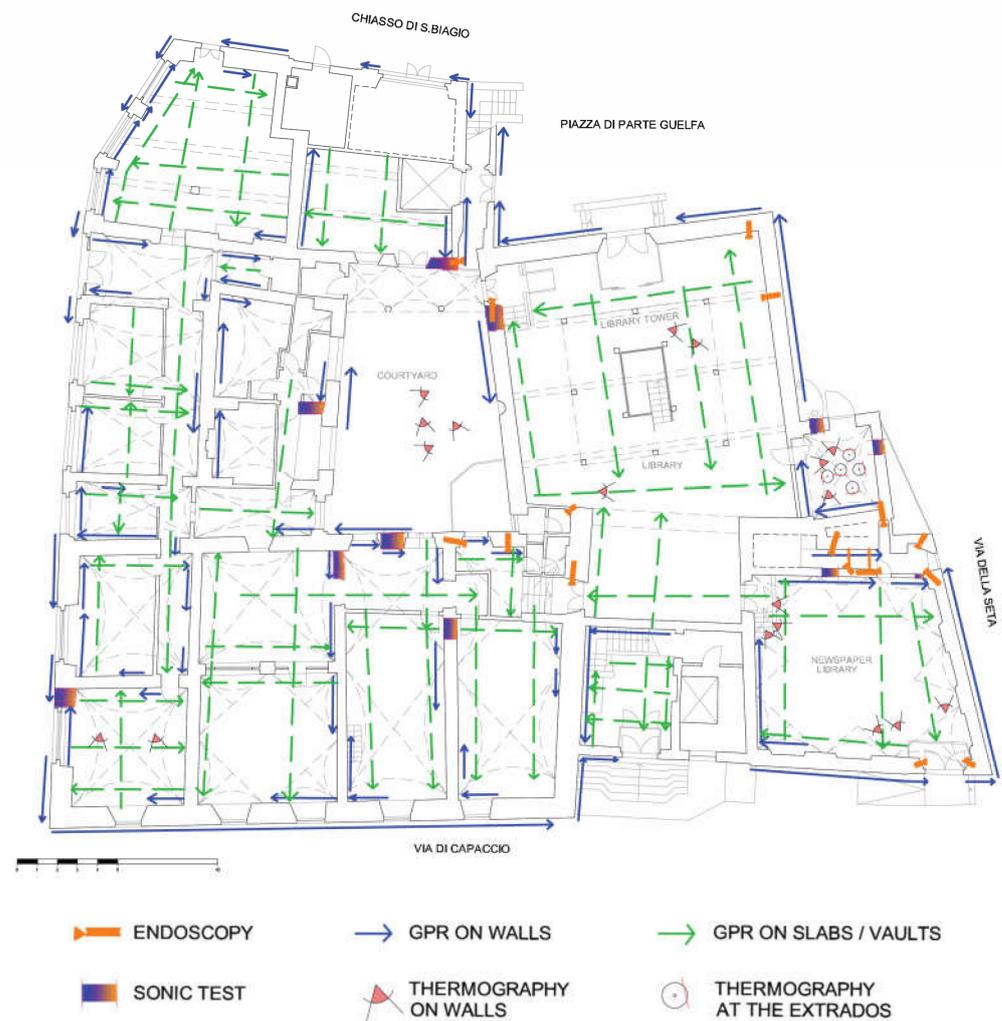
Figure 7. The ground floor plan of the building with the investigations carried out. Other layout diagrams are included in Appendix A.

The structural units of the palace were investigated through four different ND techniques that, combined with the evidence of the architectural survey and the historical research, allowed us to determine the structural features of the building. From a vulnerability perspective, the masonry typologies defined initially after the GPR survey are associated with two current classifications described in the literature, i.e., one provided by the Tuscany Region [71] and the other from the Italian technical code [29] for the whole Italian territory. In Table 1, the two distinct nomenclatures are shown. It is worth noting that the classifications provided in the regional list do not entirely align with those outlined in [29]. In other cases, e.g., in modern masonry typologies, the Italian code lacks a specific classification for typologies characterized by resistant elements with block dimensions. In Table 2, the masonry typologies of the Palagio di Parte Guelfa are listed using both classification systems. In the case of masonry types B and C, the same MIT type, i.e., rubble stone masonry, applies. Further classifications of the different chaotic stone masonries used in medieval buildings in the Tuscany area can be found in [72]. In Figure 8, the layout of the building is presented. The different identified masonry typologies are attributed to the different walls; the dashed walls indicate the suppositions made according to the NT campaigns, while solid lines indicate panels verified with the endoscopy visualization.

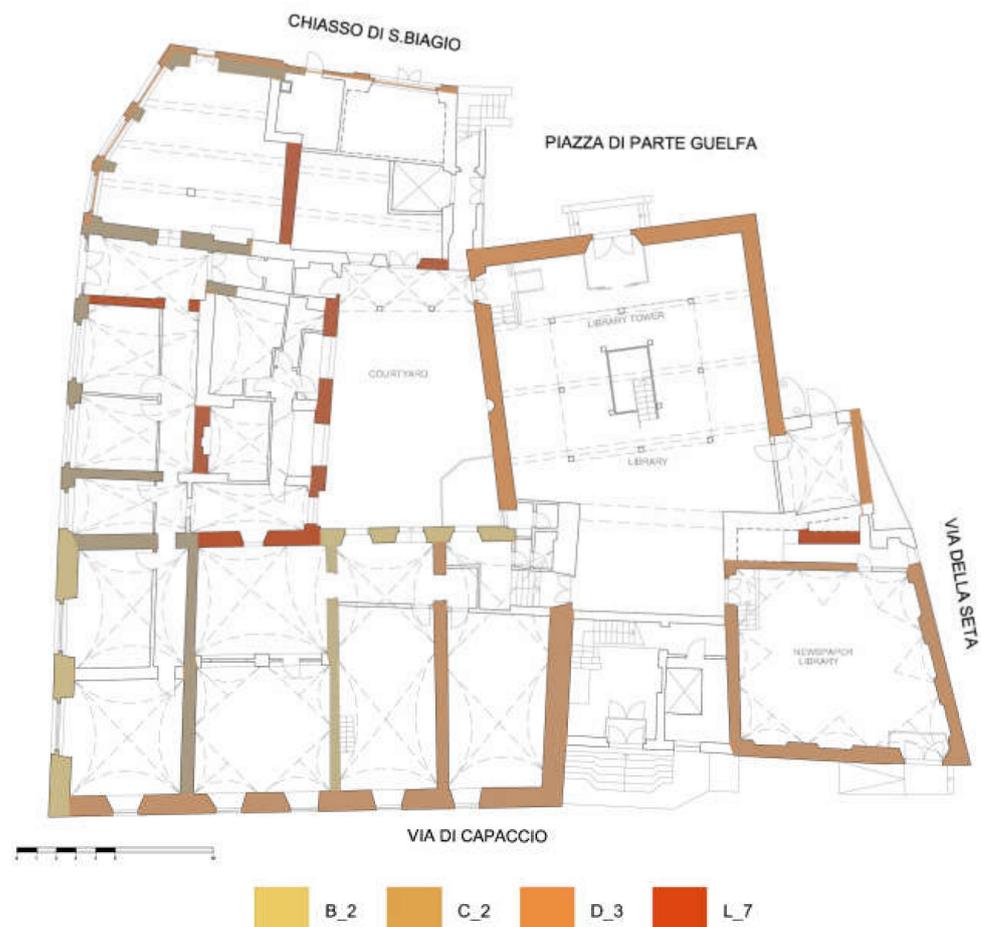
Figure 8. Layout of the building showing the identified typologies.

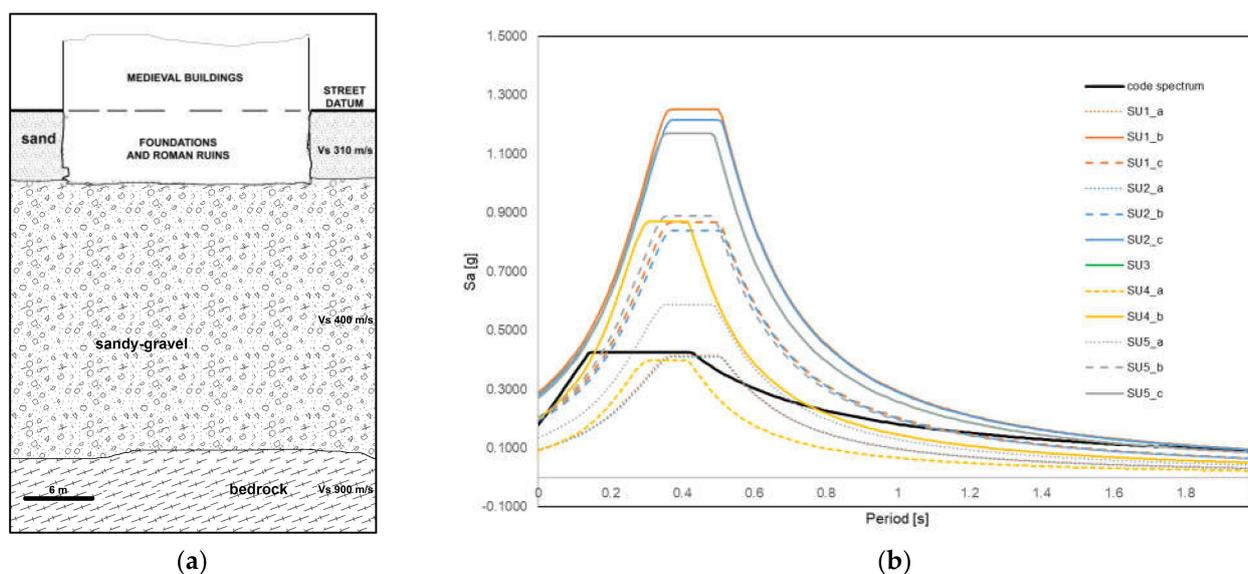
Figure 9. (a) Information about the soil velocity for the different layers according to soil class; (b) considered floor spectra for the different structural units of the palace.

The area around Florence is characterized by moderate seismic activity. The two main seismic sources are located along the vertical axis: one to the north in the Mugello area, and the other in the southern part at the beginning of the Chianti territory. The most significant historical earthquakes occurred in 1453 (MCS level around grade VII–VIII) and 1895 (grade VIII of the MCS scale) [73,74]. Considering the study site, the Italian code considers a peak ground acceleration PGA for a return period of 475 years equal to 0.131 g for a rigid soil or bedrock. In the new seismic micro-zoning of the city of Florence (in the public domain at https://emidius.mi.ingv.it/CPTI15-DBMI15/place/IT_45020 accessed on 5 November 2022), the site of the Palagio di Parte Guelfa has an amplification factor of between 1.97 and 2.39. In addition, the local seismic response of the area can be defined; this considers the geometric and seismic-stratigraphic information of the soils in order to define the in situ seismic design spectrum. The area of the Palagio is characterized by bedrock 15 m under the current level of the street. Over it, the soil stratigraphy consists of 5 m of archaeological layer and 10 m of sandy gravel. In an analysis of the soil stratigraphy in terms of shear-wave velocity, soil class B was identified, according to the prevision of the Italian Rule [75] (Figure 9a). The code spectrum for the reference area and an important class factor equal to III was adopted for the seismic analyses; for kinematic evaluations of the mechanisms located at different heights of the structure, the floor spectra formulation presented in [75] was used. The spectra vary from floor to floor according to the fundamental period of each structure, T_0 , and the considered level of the analysis (z/H ratio). In Figure 9b, a set of spectra for the different structural units of Palagio di Parte Guelfa are reported. Considering the fundamental period, the simplified formulation provided by [76] for masonry structures was used ($T_0 = 0.05 \times H^{0.75}$). Hence, for each unit, different spectra were considered based on the position of the hinges.

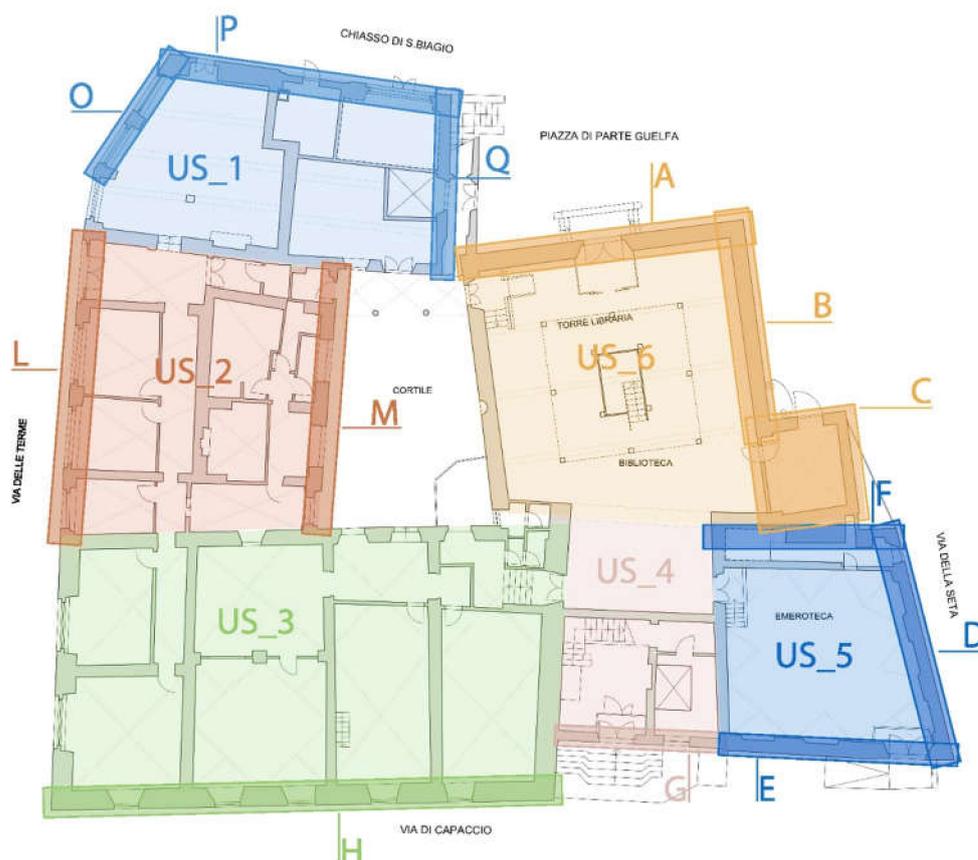
Figure 10. Identification of the considered macro-elements for the different structural units.

For each structural unit, several out-of-plane mechanisms were identified considering several macroelements (capital letters, Figure 10). Based on the obtained data, the most likely kinetic action is the one activated by lower acceleration (leading to the low safety index). In Table 4, the results of the kinematic assessment are shown. Different mechanisms were identified, such as simple overturning (OT), composed overturning (COT), the vertical flexural qualities of the panels (VF), and overturning involving the top part (TOP) of the structure or the relative merlons. Plausible mechanisms were identified on the basis of the building's historical evolution and the accumulation of the urban aggregate. In case of masonry walls closing the inner space between pre-existing structural units, as the new facades are not orthogonally connected to the other bearing walls, these will be more vulnerable to overturning actions. The results for the first column $I_{s,SLV}$ excluded the contributions of the existing tie rods (worst condition). In column T of Table 4, the tension forces needed to prevent the activation of the mechanisms are shown. The blue boxes refer to the cases where tie rods were found, the other boxes indicate design forces for strengthening interventions. The tension loads were compatible with the dimensions and

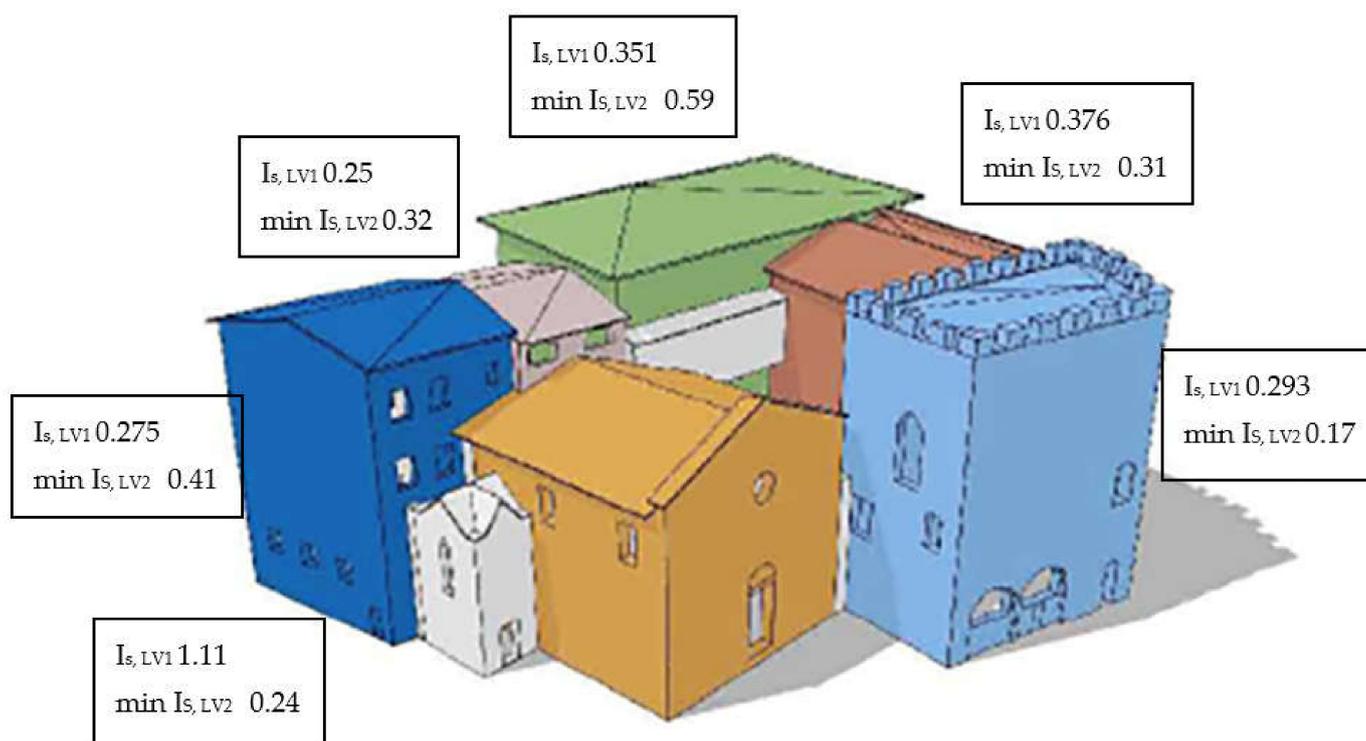
Figure 11. Summary of the safety indexes obtained for each structural unit of the palace.

The values less than 0.6 are colored dark red, those between 0.60 and 0.99 in orange, and those greater than 1 in green. In general, the lowest indexes result from the existence of vulnerable and secondary elements at the highest level of the structure (e.g., medieval merlons) which are subjected to higher acceleration because of their positions and slender proportions with no stabilizing action. Mechanisms involving bigger portions of the structures are less likely to occur and have bigger I_s values. As expected, simple overturning yields safety indexes below those resulting from the vertical flexural mechanism. Regarding some macroelements (for instance, macroelement M for US2), our kinematic analysis identified critical values, assuming the absence of a contribution of the tension of the existing tie rods (which is unknown); nonetheless, compatible tension values inside the steel bars would prevent out-of-plane effects due to ground motions. The lowest values were observed in structural unit n. 1 in both evaluations, i.e., LV1 and LV2; however, all the structural units presented critical values.

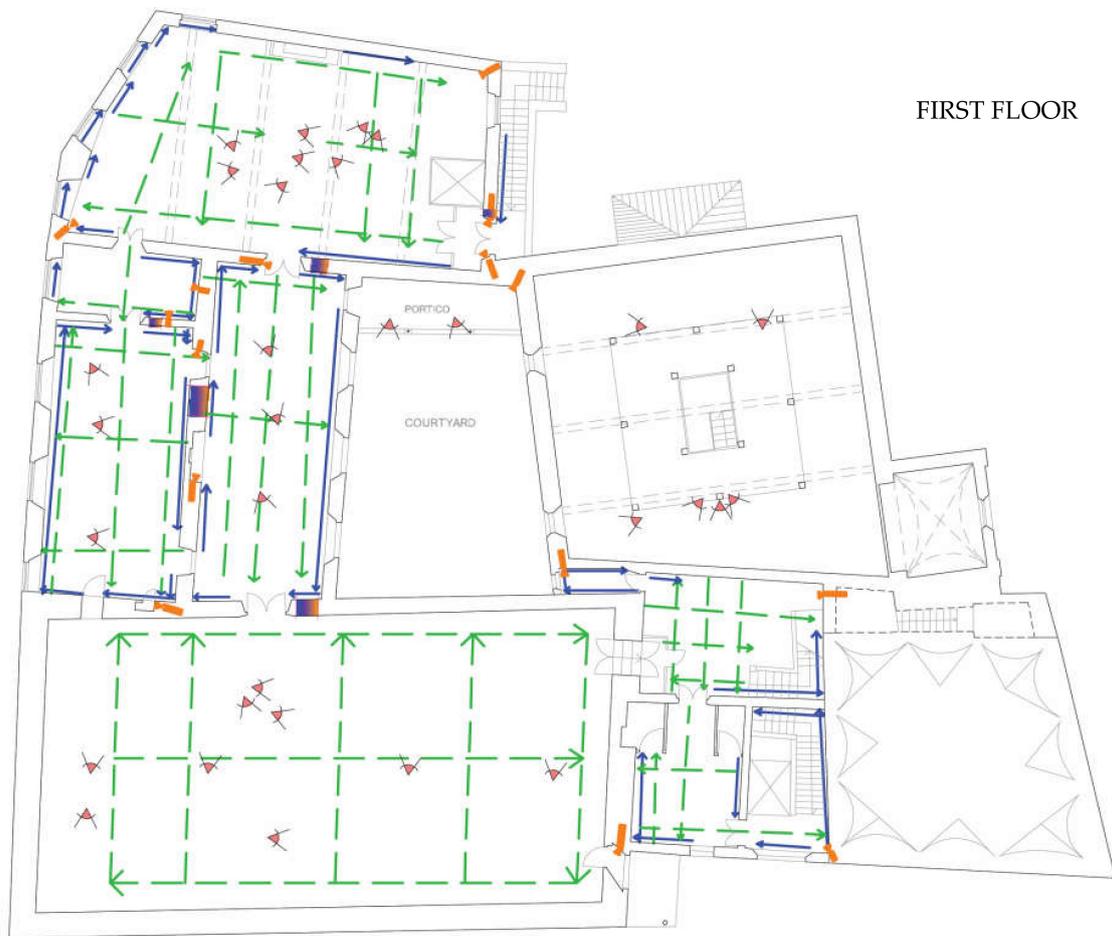
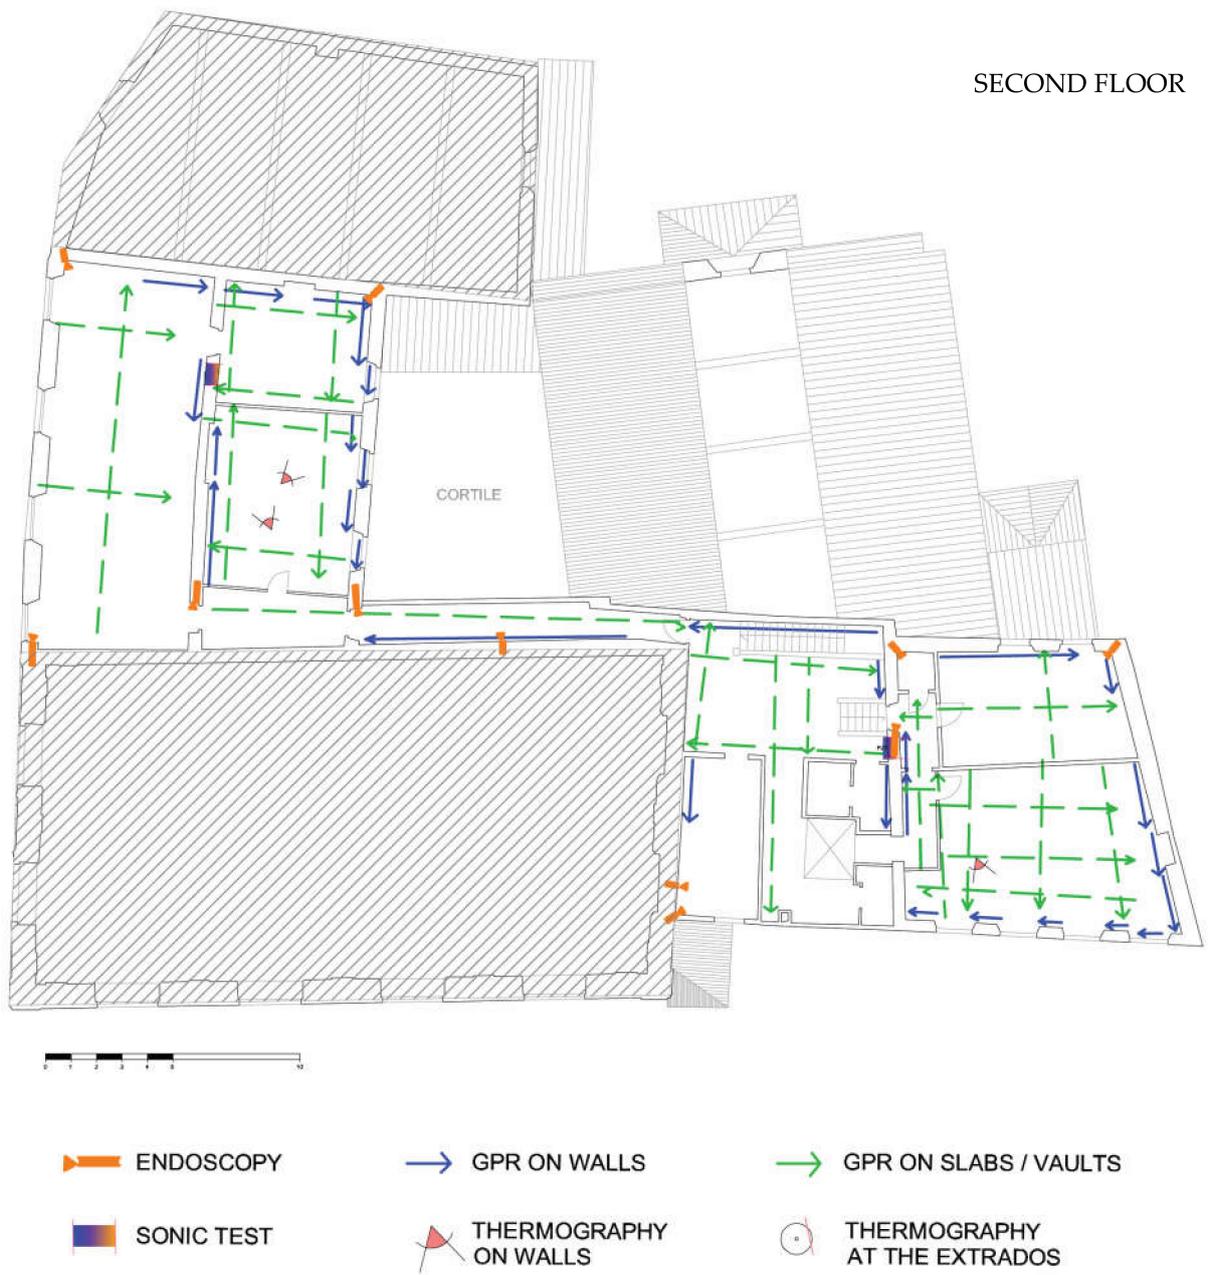
FIRST FLOOR

Figure A1. Investigations carried out on the different parts of the building.

Figure A1 refers to the investigations carried out during the experimental campaigns. Figure A2 shows the masonry typologies identified as the result of the different studies.

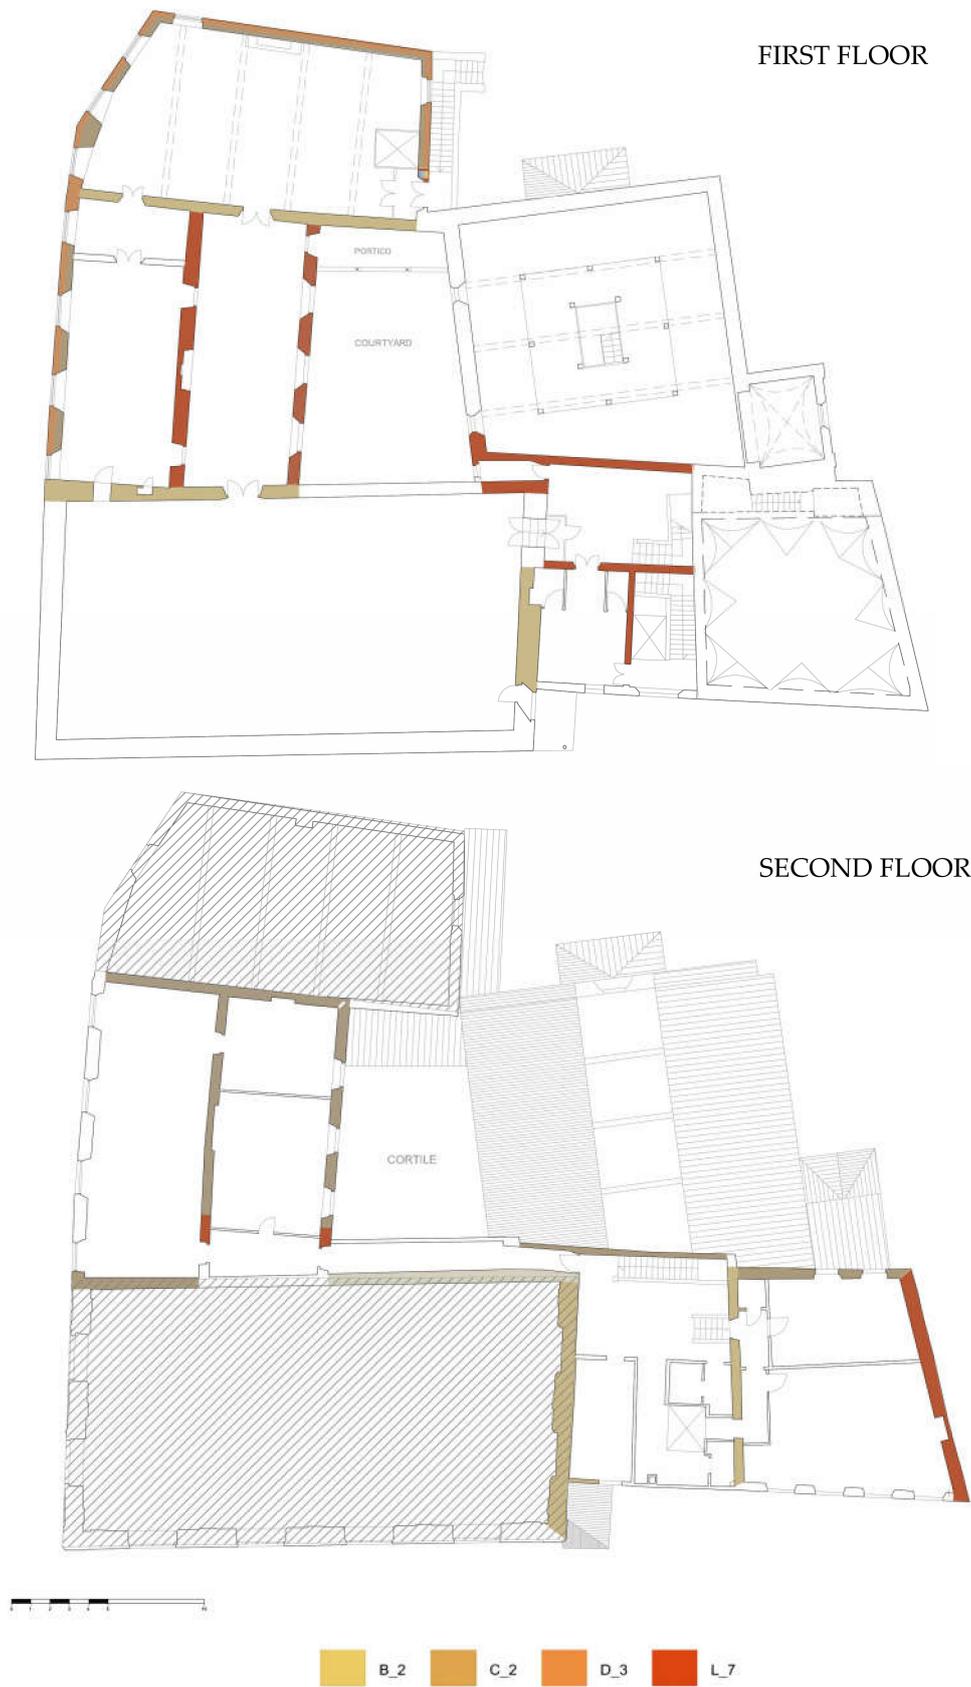
Figure A2. Identification of the masonry walls on the different levels.
