# Stone Endurance: A Comparative Analysis of Natural and Artificial Weathering on Stone Longevity

**Citation:** Lisci, C.; Sitzia, F.; Pires, V.; Aniceto, M.; Mirão, J. Stone Endurance: A Comparative Analysis of Natural and Artificial Weathering on Stone Longevity. *Heritage* **2023**, *6*, 4593–4617. <https://doi.org/10.3390/heritage6060244>

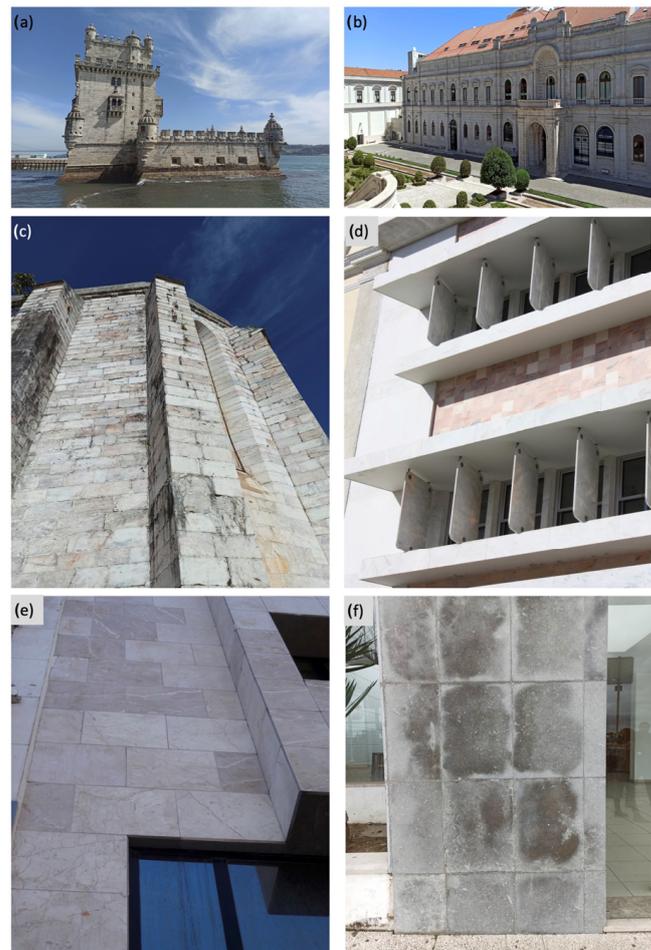
**Figure 1.** Ancient and contemporary buildings built with Portuguese stones. Lioz limestones were used for constructing the (a) Belem Tower and (b) Palace of Parliament in Lisbon (Portugal). Rosa and BW marble were used in ancient architecture, as well as in (c) Estremoz Castle (Portugal) and (d) residential buildings in Lisbon; (e) Alpinina is used in civil modern architecture; (f) is an example of Azul limestone used as cladding with weathered polished finishing.

Selected lithotypes are: Lioz A (limestone), Lioz B (limestone), Lioz C (limestone), Alpinina (limestone), black and white marble (labelled BW marble), Rosa marble, and blue limestone (Figure 1).

The selection of suitable materials for architectural projects is crucial in achieving both aesthetic appeal and functional excellence. In historic and recent times, Portuguese stones have gained significant recognition, owing to their demand for cladding applications (Figure 1).

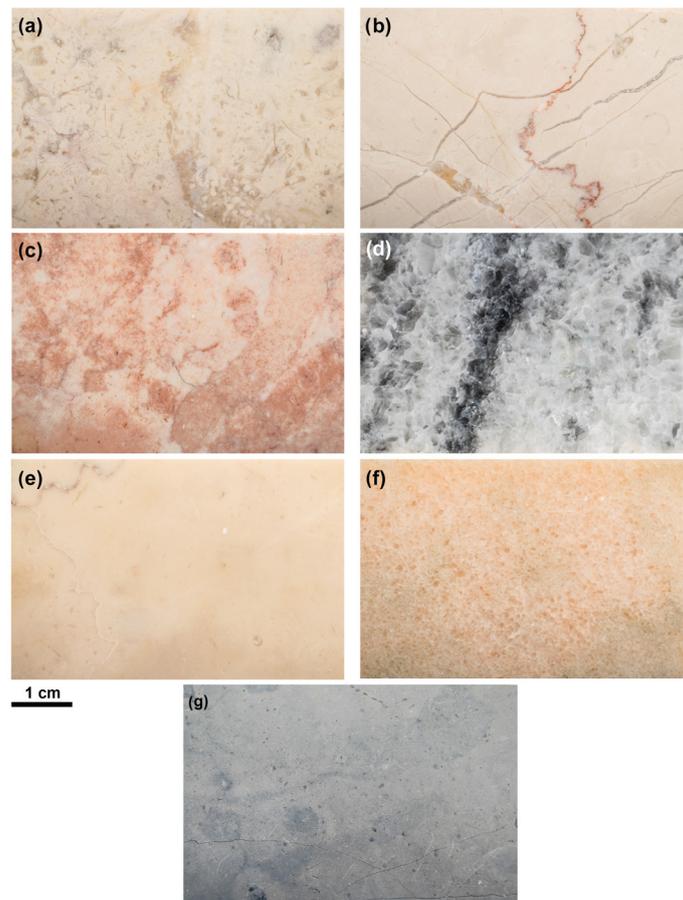
**Figure 2.** Macroscopic appearance of the lithotypes selected for this study. (a) Lioz A, (b) Alpinina, (c) Lioz B, (d) black and white marble, (e) Lioz C, (f) Rosa marble, (g) blue limestone.

Lioz limestone samples range from compact–very compact, and are coarse, bioclastic, pure limestones. Their commercial nomenclature depends on their colour, on the quantity of fossils, and on the presence of stylolithic joints with variable openings and frequencies, depending on their *facies* (Figure 2a,c,e).

Alpinina is a fine-grained limestone with a compact, beige colour. It contains closed stylolites, iron-rich veins, and bioclasts. This limestone has undergone intense tectonic activity and recrystallisation (Figure 2b).

Rosa is a pink marble with a medium-fine grain size. It shows grey veins, caused by the presence of oxides (Figure 2f).

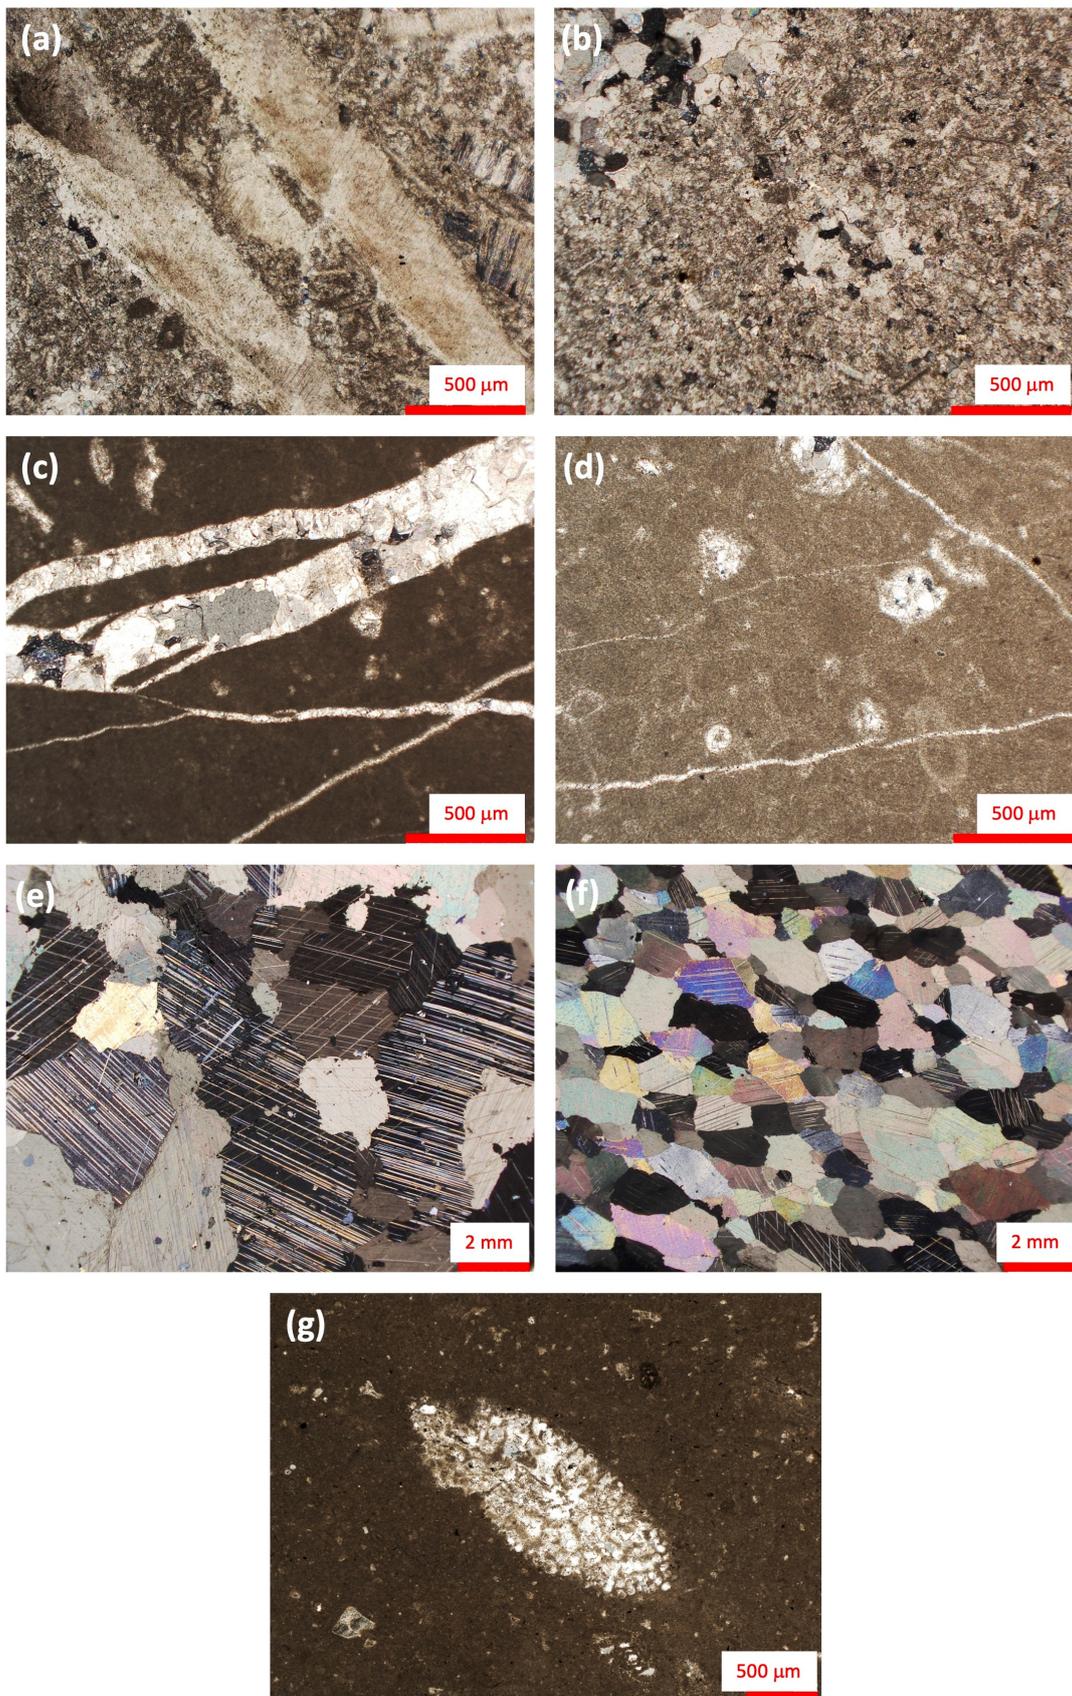
**Figure 3.** Characterisation through optical observations: (a) Lioz A (biosparite), (b) Lioz B (biosparite), (c) Lioz C (biomicrite), (d) Alpinina (pel-biomicrite-sparite), (e) BW marble, (f) Rosa marble, (g) blue limestone (biomicrite).

Alpinina (Figure 3d) is a slightly metamorphosed limestone. It is characterised by a micritic mud-supported matrix that accounts for 80% of its makeup. The remaining 20% of the thin section shows subparallel recrystallised sparitic veins with variable spacing and openings in the range of 0.1 mm–5 mm. Bioclasts of foraminifera, gastropods, bivalves, echinoids, and ostracods are recognisable. Diffuse peloids smaller than 0.5 mm are also observed. According to Folk classification, Alpinina is an intermediate form of pel-biomicrite-sparite.

BW (Figure 3e) is a calcitic marble with a homeoblastic, isotropic, and granoblastic interlobate texture. The maximum grain size (MGS) of calcite crystals is 8 mm, with an average size of 5 mm. The grain boundary shape (GBS) is mainly curved, toothed, and partly straight. Sub-millimetric inclusions of well-rounded quartz, pyroxene, iron oxides, and opaque phases are detected ( $\approx 2\%$ ).

Rosa (Figure 3f) has a homeoblastic, semi-polygonal granoblastic-oriented and isotropic texture. The MGS is 2 mm and the average grain size is 1.2 mm. The GBS is mainly straight and secondarily curved. 98% of the rock crystals are calcitic, with 2% sub-millimetric inclusions of opaque minerals (10  $\mu m$ ) and quartz (200  $\mu m$ ).

Blue limestone (Figure 3g) is characterised by a micritic matrix (>90% vol.) with a clay mineral content of <2%. Allochem crystals of quartz in a range from 0.4 to 1.8% vol. have been recognised. The organic matter is up to 6% vol. The bioclastic component is also relevant. According to Folk, the stone is classified as biomicrite.

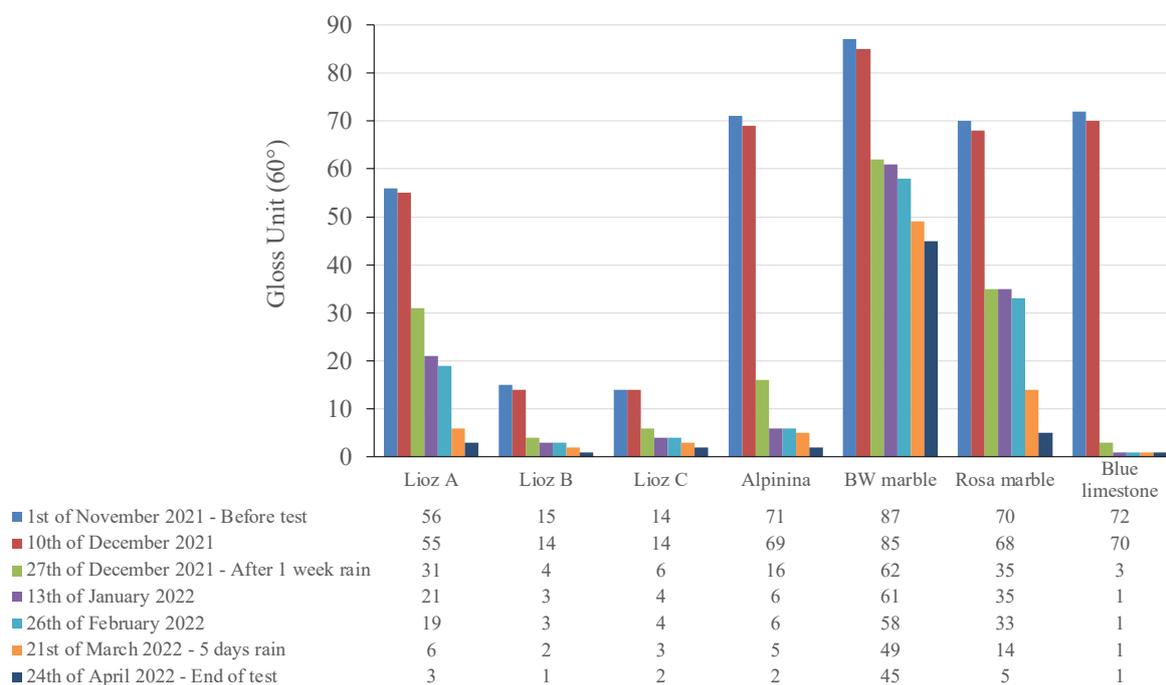
**Figure 4.** Gloss unit variation (60° reflected light) for each stone before and during the outdoor ageing, correlated with the date of collection of the rainwater. Histograms show the gloss reduction mainly after rain events (27 December 2021 and 21 March 2022).

Gloss measurements with 60° of reflected light (Figure 4) showed a decrease in gloss after 1 week of rain, passing from 56 to 31 in Lioz A, from 15 to 4 in Lioz B, from 14 to 6 in Lioz C, and from 72 to 16 in Alpinina. In marbles, gloss decreased from 87 to 62 in BW and from 70 to 35 in Rosa. Blue limestone almost completely lost its gloss (3 gloss units on 27 December 2021, 1 gloss unit on 3 January 2022).

Regarding the marbles, the gloss of BW decreased after 1 week of rain registered in December (from 67 to 62 gloss units). Gloss of Rosa marble reduced from 70 to 35. This was an unexpected result, because gloss is normally conferred by the natural reflectance of the calcite crystals in marble. This superficial alteration confirms that the physical parameters of the rainwater also opacified the polished finishing of marbles. After that, another important variation occurred after 5 days of rain in March, where a pH of 6.5 and a TDS of 5 ppm drove another dissolution period of the stone.

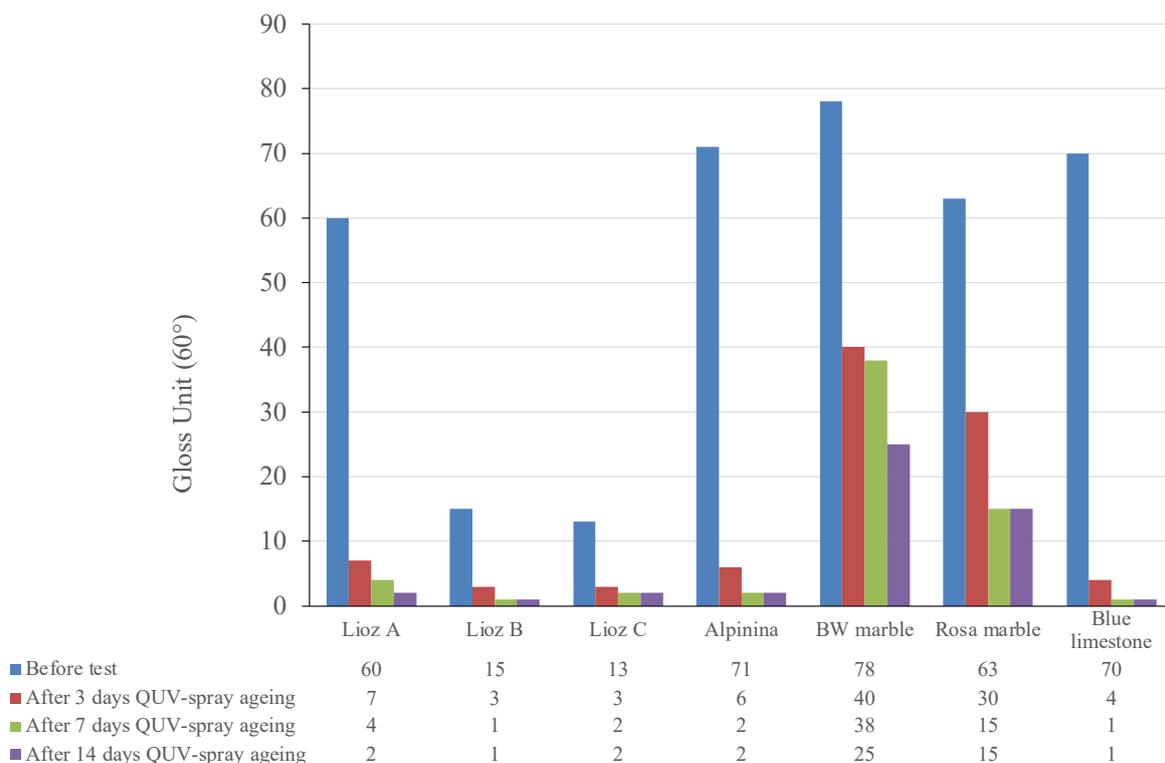
**Figure 5.** Gloss variation (60° reflected light) for each stone before the QUV-spray ageing and after 3, 7, and 14 days.

Interpreting the gloss variation monitored after the QUV-spray ageing (Figure 5), a radical decrease in the gloss unit occurred only after three days of ageing in most samples, except in BW and Rosa marbles. Compared with the results obtained after natural ageing, it can be stated that, in this case, three days of QUV-spray chamber ageing correspond to five months of natural ageing. In blue limestone, the correlation is just two months. Considering that, from 1 November to 27 December, just a few mm of rain fell and a minimal reduction in gloss emerged, three days of natural ageing correspond to four months, highlighting that the most important variation took place after 1 week rain in December.

The gloss of BW marble was stable at 45 until 24 April, after 6 months of natural ageing, whereas it decreased to 40 after 3 days of QUV-spray ageing, stabilizing at 25 after 14 days of ageing. This means that BW, being a marble with coarse texture, takes more than several months of winter to lose its polished finishing.

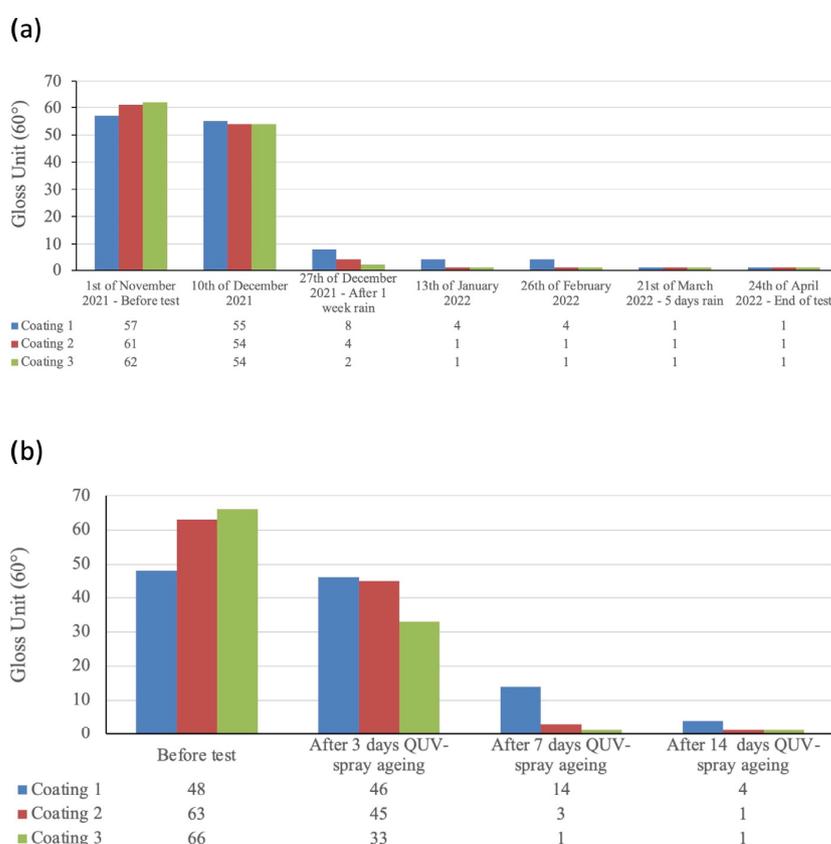
**Figure 6.** (a) Gloss variation in blue limestone treated with protective coatings before and during the outdoor ageing. Additionally, in this case the graph points out the gloss reduction mainly after rain events (27 December 2021 and 21 March 2022). (b) Gloss unit variation ( $60^\circ$  reflected light) for blue limestone treated with protective coatings. Coating 1 (aminopropyltriethoxysilane), coating 2 (aminopropyltriethoxysilane in 1:2 dilution), coating 3 (tripotassium propylsilanetriolate).

The same considerations can be made regarding the blue limestone treated with hydrophobics. After one week of rain, the gloss of the samples was drastically reduced (Figure 6a). This was an unexpected result. Concerning coating 1, it presented 8 gloss units instead of the 3 observed during the natural ageing of the untreated blue limestone on the same date and maintained a value of 4 until 26 February 2022. The stone completely lost the gloss after five days of rain ending on 21 March 2022, while the uncoated blue limestone lost the gloss on 13 January after twenty-five days of rain since the beginning of the experiment. Additionally, blue limestone treated with coatings 2 and 3 lost its gloss on 13th of January.

Different results were acquired for coated samples subjected to QUV-spray ageing (Figure 6b). They preserved a certain level of gloss after three days of artificial ageing, as observed from coating 1, which retained some gloss after seven days and a residual value after 14 days. The gloss differences are very relevant when compared to the uncoated blue limestone after one week of rain in December 2021, and also when compared to the blue limestone that was artificially aged for three days. It can be stated that all hydrophobic materials are more efficient in the climatic chamber than in outdoor exposure, as was observed by other authors [18]. During natural ageing, the rainfall accumulation registered in December 2021 was 96.91 mm, concentrated mostly during one week (from the 20th

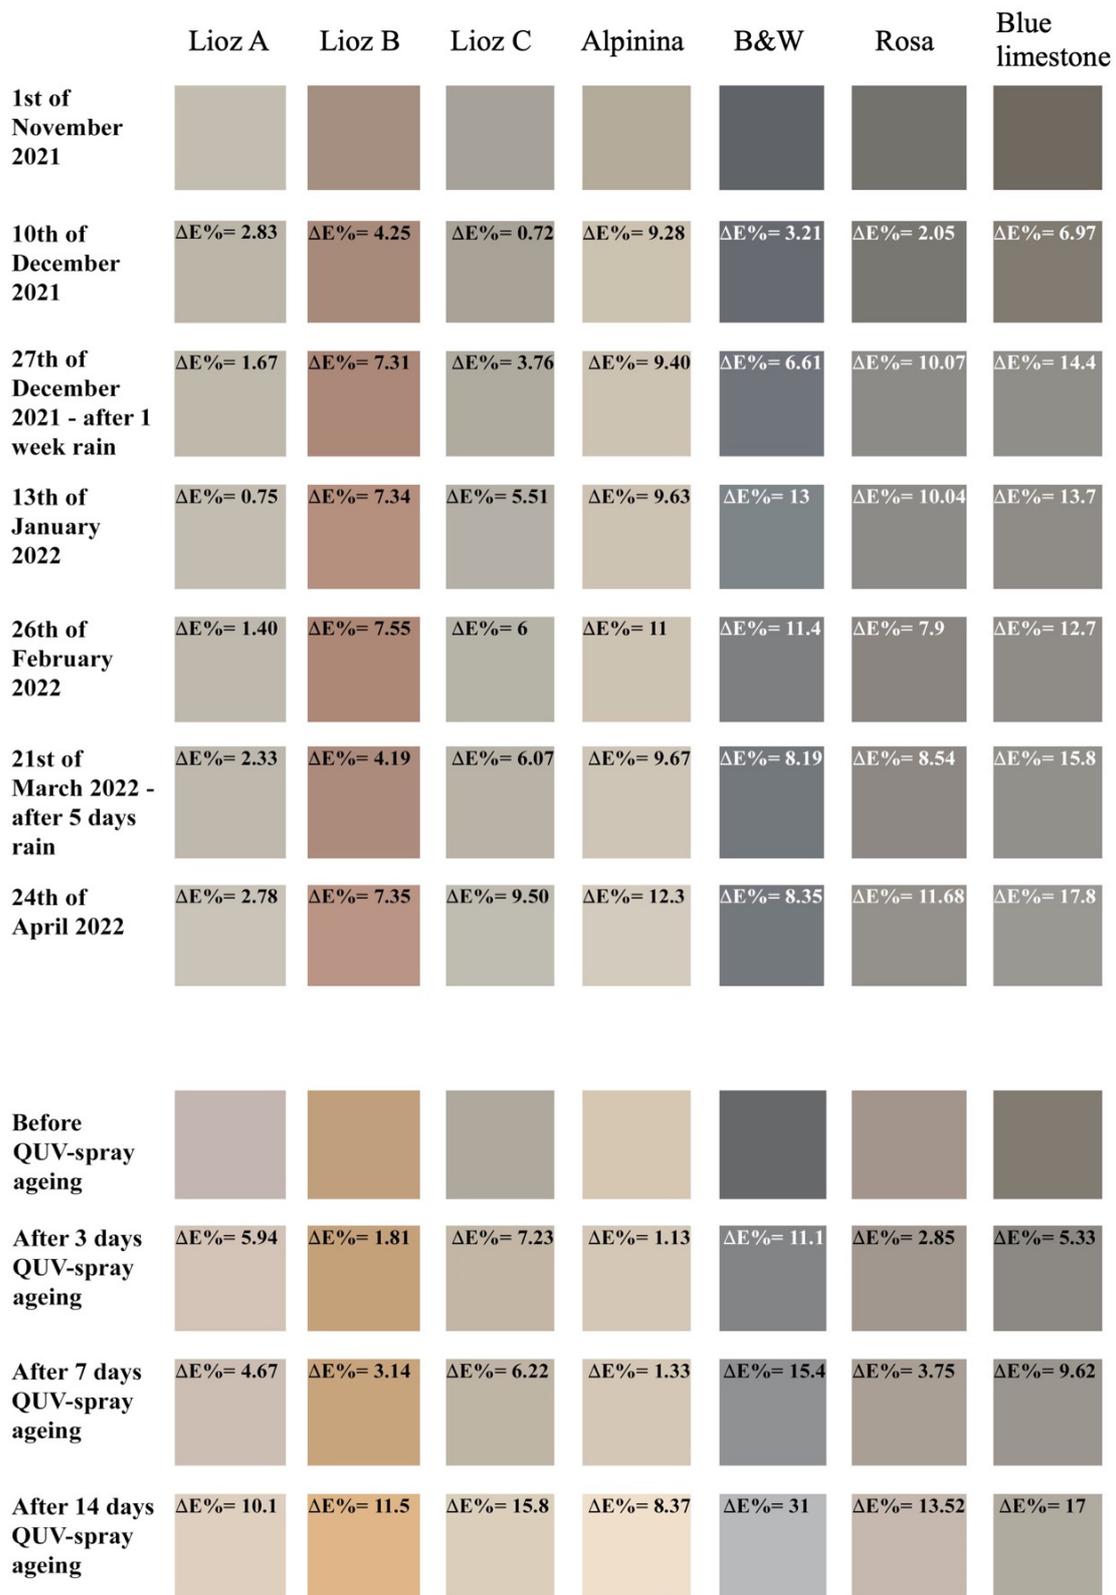
**Figure 7.** Colour variation and colour difference,  $\Delta E\%$ . An overall whitening of all stones can be seen.  $\Delta E\%$  of stones before, during, and after natural and QUV-spray ageing. Irregular trends characterised almost all samples during natural ageing. In the QUV-chamber,  $\Delta E\%$  increased regularly, probably due to the limited and fixed parameters of the ASTM G154-cycle7.

The effect of the QUV-spray chamber had a more aggressive effect on the colour distance increment after up to fourteen days of ageing, except for Lioz A and Lioz C, which had different degrees of gloss ( $60^\circ$  and  $13^\circ$ , respectively). A regular increase in  $\Delta E\%$  can be noticed, probably due to the limited controlled and fixed parameters of the ASTM G154-cycle7. Photochemical reactions occur in light-sensitive minerals such as calcite that can undergo discolouration. Stones were exposed to  $1.55 \text{ W/m}^2$  UVA radiation, moisture, and high temperatures, resulting in a change in their colour. Stone surfaces suffered physical damage as well when moisture at high temperatures interacted with their matrices, resulting in thermal shock, as declared by the producer. This can result in a modification of the macroscopic appearance and colour of the minerals, also affecting the marbles, which are supposed to be more resilient.

In general,  $\Delta E\%$  does not permit a temporal correlation between natural and artificial ageing in each case due to the wavering trend emerging during the outdoor exposure, as pointed out by [21,38]. Conversely, QUV-spray showed a correlation between temperature, humidity, UVA radiation, and spray.

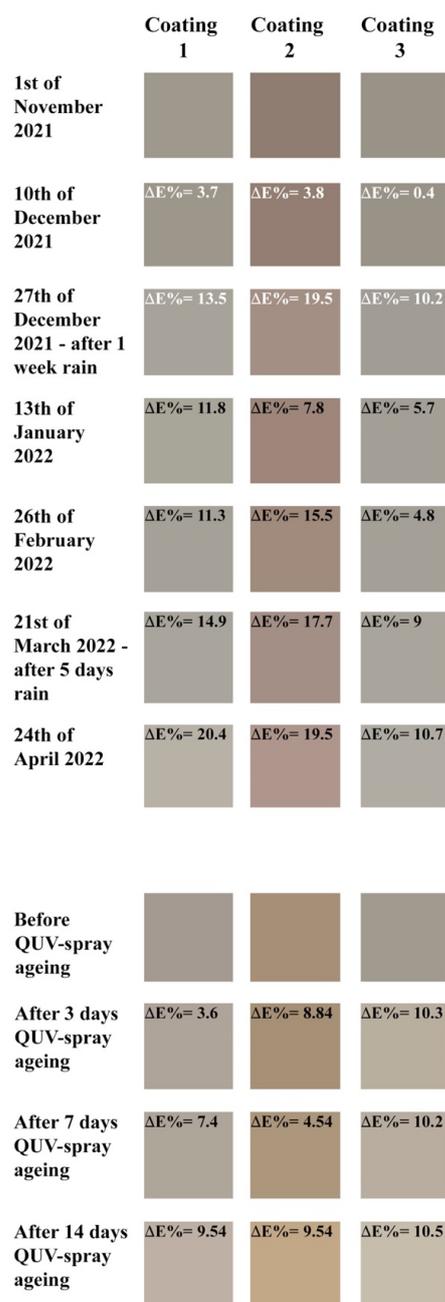
**Figure 8.** Colour variation and colour distance ( $\Delta E\%$ ) of blue limestone coated with hydrophobic coating 1 (aminopropyltriethoxysilane), coating 2 (aminopropyltriethoxysilane in 1:2 dilution), and coating 3 (tripotassium propylsilanetriolate). An overall whitening of all stones was discerned.  $\Delta E\%$  of stones before, during, and after natural and QUV-spray ageing. An irregular trend characterised almost all samples during natural ageing. In the chamber,  $\Delta E\%$  increased regularly, probably due to the limited and fixed parameters of the ASTM G154-cycle7.

Additionally, in the blue limestone protected with hydrophobics (Figure 8),  $\Delta E\%$  does not permit a reliable temporal correlation between natural and artificial ageing. The irregular trend is more pronounced in the natural ageing of coated samples than in those without hydrophobic treatments, which can be attributed to the degradation of the coatings. In contrast, in QUV-spray accelerated weathering,  $\Delta E\%$  regularly increased, as shown by the samples without any treatment. Furthermore,  $\Delta E\%$  values measured during artificial degradation were lower than those obtained in natural ageing, confirming that natural ageing is more severe.

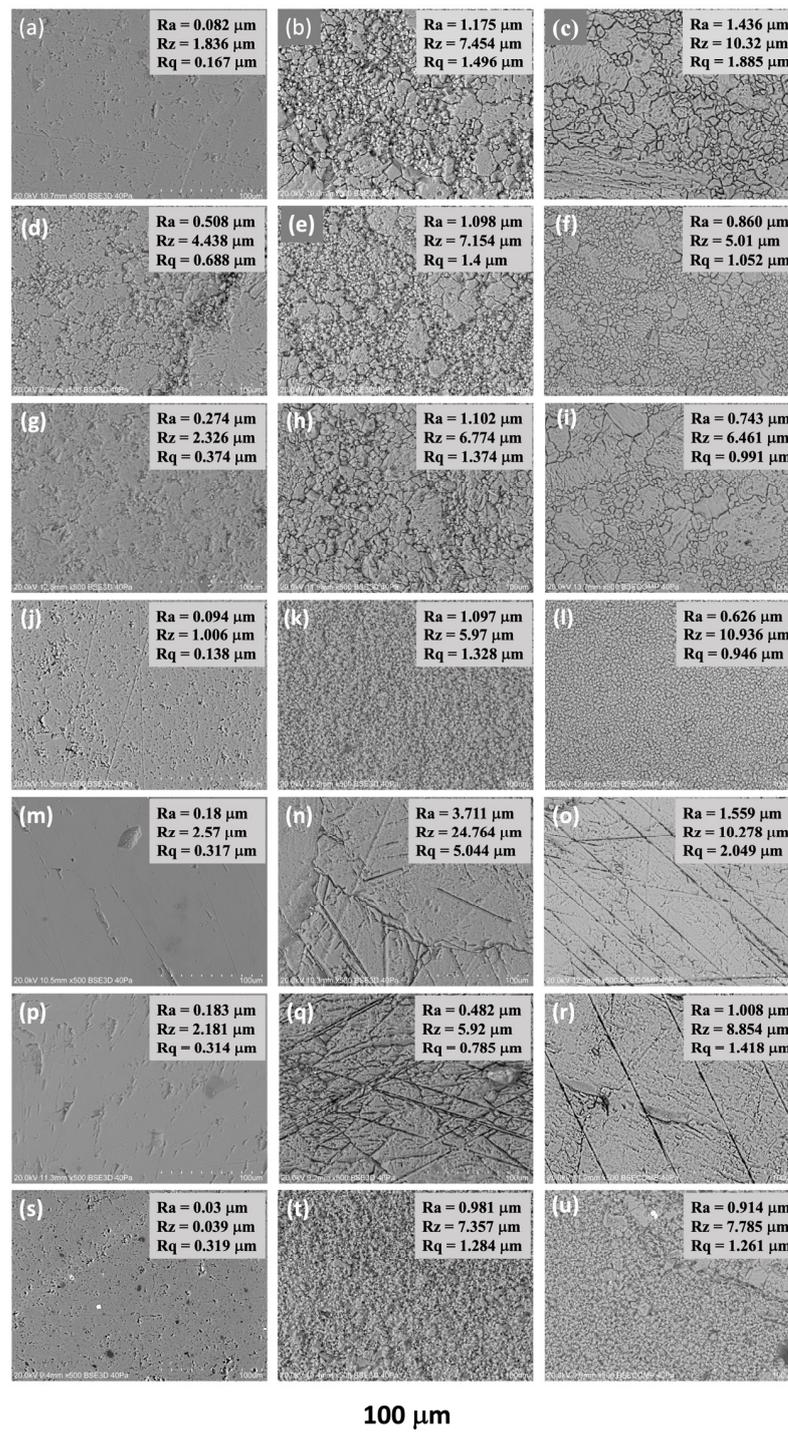
**Figure 9.** Micro-texture analyses through SEM and according to the roughness parameters, Ra, Rz, and Rq, measured with the digital rugosimeter. (a–c) Lioz A before and after natural ageing and after QUV-spray ageing, (d–f) Lioz B before and after natural ageing and after QUV-spray ageing, (g–i) Lioz C before and after natural ageing and after QUV-spray ageing, (j–l) Alpinina before and after natural ageing and after QUV ageing, (m–o) BW marble before and after natural ageing and after QUV ageing, (p–r) Rosa before and after natural ageing and after QUV ageing, (s–u) Blue limestone before and after natural ageing and after QUV ageing. The data support the argument that weathering significantly affects superficial texture, resulting in increased roughness and irregularity in both limestones and marbles, as evidenced by the changes in Ra values before and after natural and artificial weathering.

The microtexture images obtained through scanning electron microscopy (SEM) and the calculation of digital superficial roughness using parameters such as Ra, Rz, and Rq (as shown in Figures 9 and 10) provide compelling evidence of the significant changes induced in the superficial texture by natural and artificial weathering. The results clearly demonstrate that the weathering process leads to a general trend of increased roughness and irregularity in the surface texture, regardless of whether the samples are limestones or marbles. These changes in superficial texture were observed after both natural and artificial weathering, and a comprehensive analysis of microtexture and superficial roughness was conducted before and after these weathering events. One of the most representative parameters for comparing the changes in texture before and after weathering is Ra, which generally shows higher values after natural weathering, except in the cases of Rosa and Lioz A. For instance, in Rosa, Ra increased from 0.183  $\mu\text{m}$  before ageing to 0.482  $\mu\text{m}$  after natural ageing, and further to 1.008  $\mu\text{m}$  after QUV-spray ageing. Similarly, in Lioz A, Ra showed a similar trend, with values of 0.082  $\mu\text{m}$  before ageing, 1.175  $\mu\text{m}$  after natural ageing, and 1.436  $\mu\text{m}$  after QUV-spray ageing. In the case of blue limestone, Ra remained consistently high at 0.981  $\mu\text{m}$  after 6 months of natural ageing, and reached 0.914  $\mu\text{m}$  after QUV-spray ageing, indicating that this stone is highly susceptible to rapid alteration under any weathering conditions.

Indeed, the textural analyses and data of rugosity confirm that changes in surface roughness due to water-carbonate interactions cause the loss of the stone's glossy aspect and discolouration, affecting the aesthetic and the economic value imparted by polishing. This shows that polished stones are more suitable as decorative elements in indoor environments, where they are protected from weathering agents, while rougher surfaces (hammered, brushed, flame-treated, etc.) are proper for outdoor environments, where safety and footfall-resistance requirements must be guaranteed.

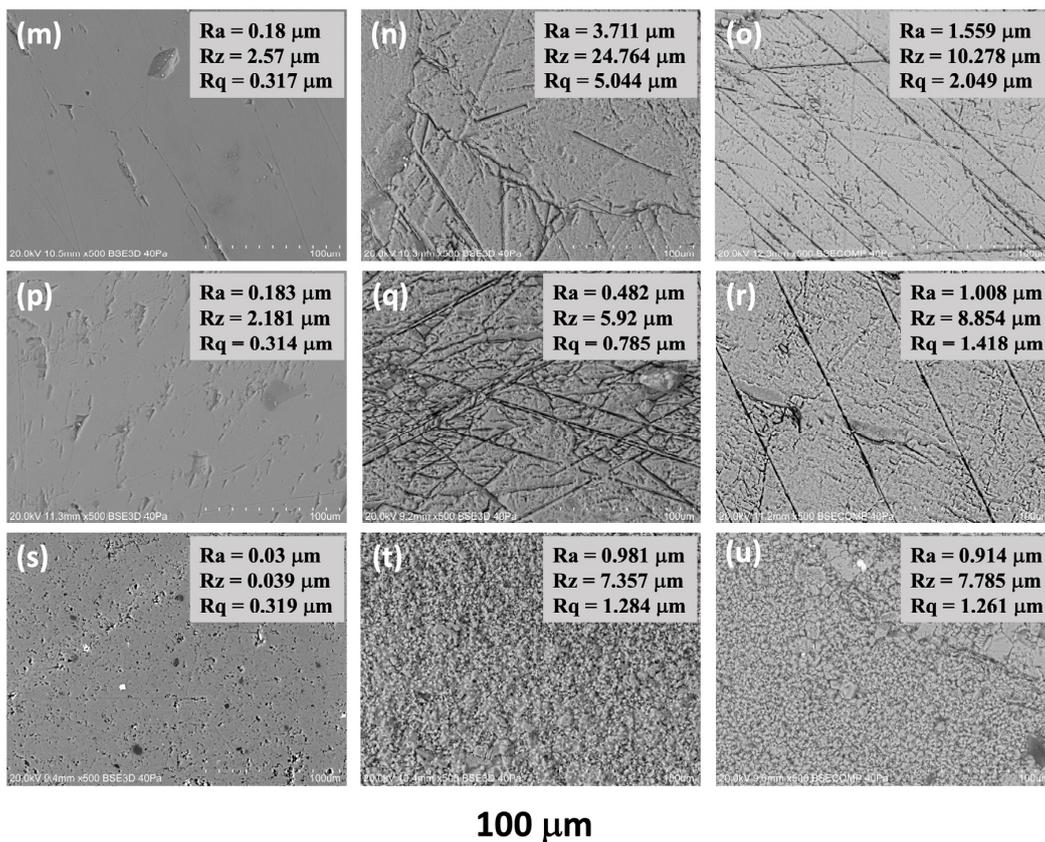
**Figure 10.** Micro-texture of blue limestone coated with hydrophobics. (m) coating 1 before the tests, (n) after natural ageing, and (o) after QUV-spray ageing; (p) coating 2 before the tests, (q) after natural ageing, and (r) after QUV-spray ageing; (s) coating 3 before the test, (t) after natural ageing, and (u) after QUV-spray ageing. The white minerals and spots are pyrite inclusions.

The rugosity of blue limestone treated with hydrophobic coatings (Figure 10) underlines the degradation susceptibility of the coatings during natural exposure to slightly acidic rainwater and, in the QUV-spray chamber, to the other measured parameters.

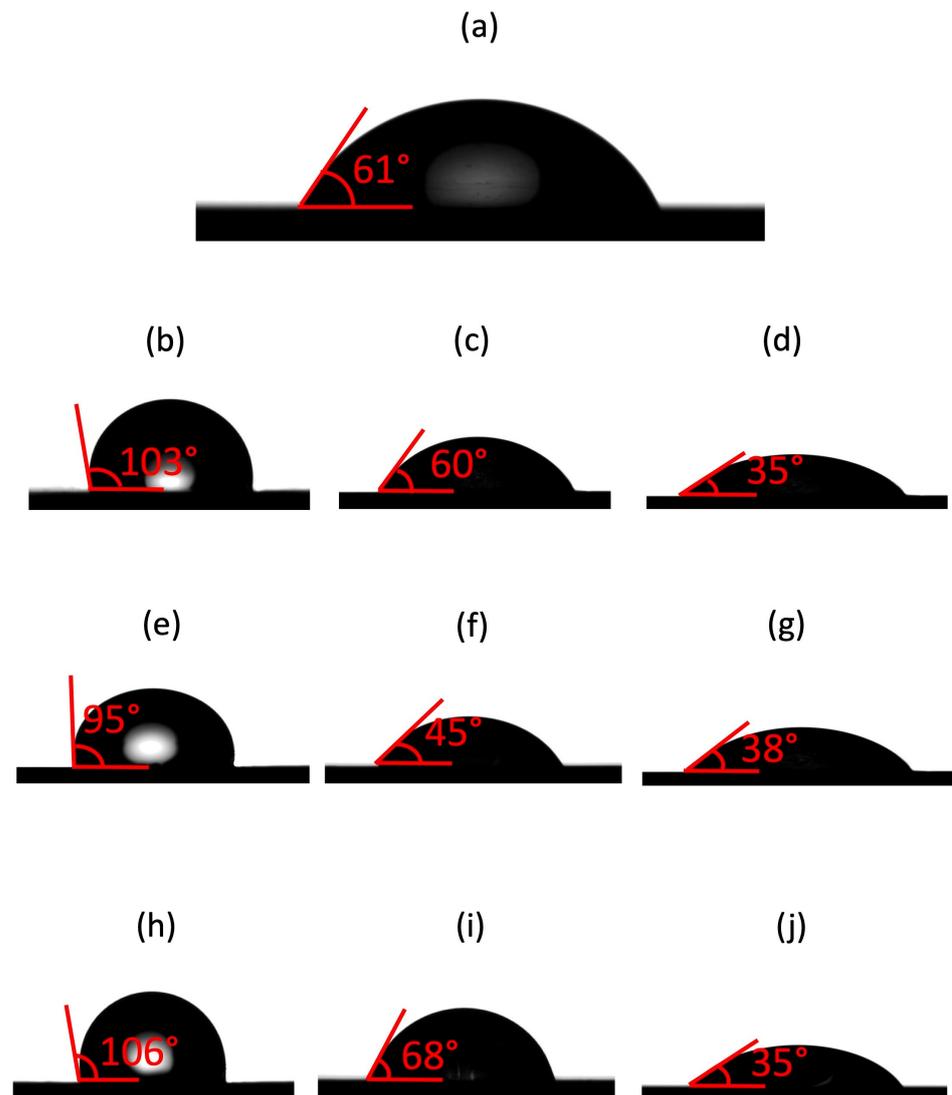
**Figure 11.** Contact angles of blue limestone. (a) Untreated blue limestone; (b–d) coating 1 before the tests, after natural ageing, and after QUV-spray ageing; (e–g) coating 2 before the tests, after natural ageing, and after QUV-spray ageing; (h–j) coating 3 before the test, after natural ageing, and after QUV-spray ageing, respectively.

Both natural and artificial weathering reduce the contact angle value. Lower values (from 35° to 38°) appeared in samples subjected to UVA radiation and spray and moisture accelerated ageing. Natural ageing affected the decrease in the contact angles of coating 1 and coating 3 (68–60°) less, while the reasonable value of 45° after natural ageing for coating 2 is attributable to the dilution of coating 1.
