Article

Feasibility of Using Green Laser for Underwater Infrastructure Monitoring: Case Studies in South Florida

Abstract: Scour around bridges present a severe threat to the stability of railroad and highway bridges. Scour needs to be monitored to prevent the bridges from becoming damaged. This research studies the feasibility of using green laser for monitoring the scour around candidate railroad and highway bridges. The laboratory experiments that provided the basis for using green laser for underwater mapping are also discussed. The results of the laboratory and field experiments demonstrate the feasibility of using green laser for underwater infrastructure monitoring with limitations on the turbidity of water that affects the penetrability of the laser. This method can be used for scour monitoring around offshore structures in shallow water as well as corrosion monitoring of bridges.

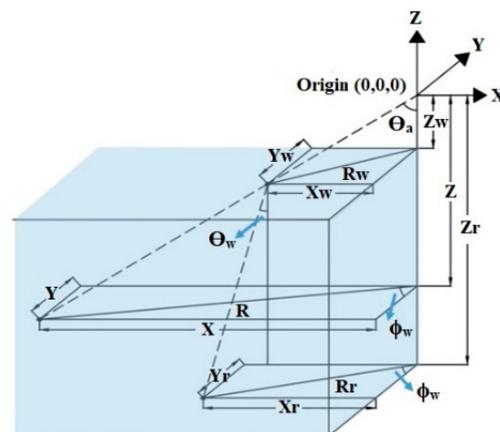
Figure 1. Schematic diagram of refraction correction applied for underwater scanning [adapted from Smith et al., 2012] [2,24,31].

The research methodology involves data collection using green wavelength Leica laser scanner and performing refraction correction using an in-house developed MATLAB routine. The laser scanner computes 3D geometric information namely X, Y, Z coordinates and reflectance of the scene using known azimuth and zenith angles and the computed range. The relationship can be expressed using a simple cartesian coordinates to polar coordinates transformation. The visualization and extraction of the laser point cloud were performed using Leica Cyclone (version 6.0.4) and Cloud Compare (version 2.12) software packages. Figure 1 shows the schematic diagram of the converted polar coordinates.

Refraction correction is applied to the X, Y, Z coordinates. “The X, Y, Z coordinates after refraction correction are shown in Equations (1)–(3) below [2]:

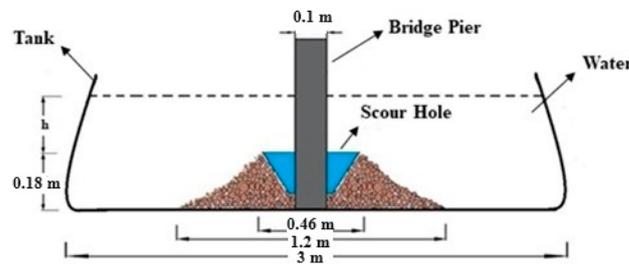
Figure 2. Schematic diagram of experimental set-up [29,30] (used with permission).

Initially, the feasibility of using the green laser in scour monitoring was carried out in the laboratory using a prefabricated scour hole in a pool with diameter 3.048 m (Figures 2 and 3) [2]. The turbidity inside the pool is changed from 1.2 to 20.8 NTU by adding Kaolinite powder. The turbidity of the clear water was 1.2 NTU. The turbidities considered for the study were 1.2 NTU, 3.9 NTU, 5.5 NTU, 6.4 NTU, 12.1 NTU, and 20.8 NTU. The fabricated scour model used in Nagarajan et al., 2018 and Banhany 2018 was used for laboratory experiments [2,24,28]. Six trials were conducted by varying the water depth of the pool. The scanning was carried out using the Leica Scan Station II. The water depth inside the pool was varied from 0.38 to 0.6 m.

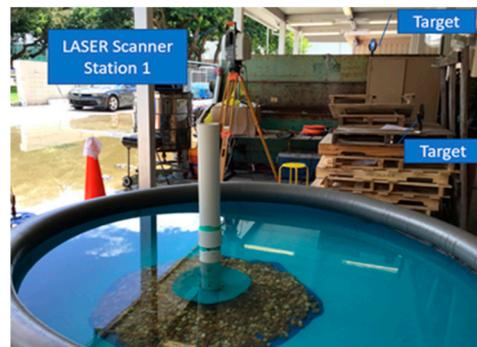
Figure 3. Experimental set-up in the pool [29,30] (used with permission).

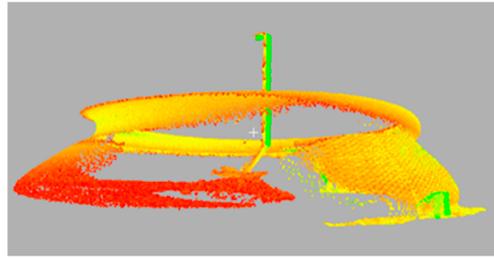
Figure 4. Three-dimensional laser scan prior to refraction correction for turbidity 5.5 NTU [29] (used with permission).

Initially, the prefabricated scour hole was dry scanned to obtain a reference model for calibration. The dry scan of the prefabricated scour model was used as a reference model to compare the scan data for different turbidity levels and water depths. The scour mapping was carried out by mixing kaolinite powder with pool water to increase the turbidity [2]. Based on the underwater scan, the depth of water was decreased when the underwater scan of the prefabricated scour hole was not completely visible. The underwater scan was carried out for turbidity levels up to 20.8 NTU. For turbidity 20.8 NTU, the depth near the prefabricated scour hole was 0.2 m, and 0.3 m elsewhere in the pool. The green laser undergoes refraction underwater and refraction correction was applied to the scan data. Figures 4 and 5 show the sample scan for a turbidity level of 5.5 NTU before and after applying refraction correction.

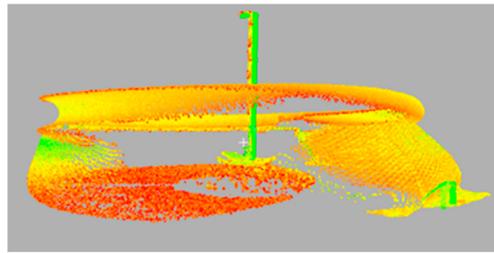
Figure 5. Three-dimensional laser scan following the refraction correction for turbidity 5.5 NTU [29] (used with permission).

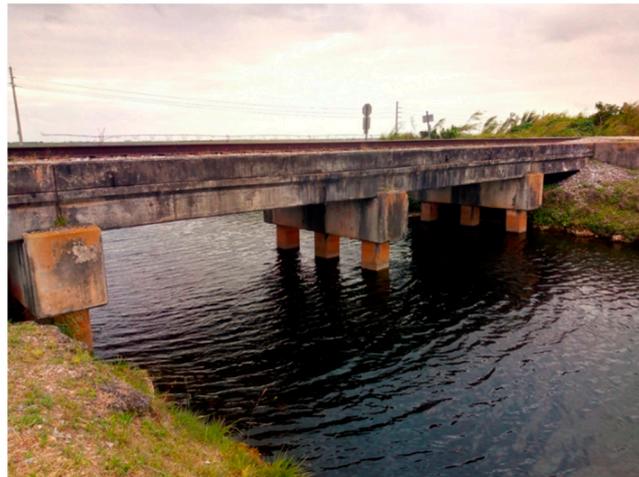
Figure 7. Pictorial view of the railroad bridge—Miami, Florida.

Based on the laboratory testing, the green laser was used for a feasibility study of scour mapping around one railroad bridge and two highway bridges in South Florida, United States. Figure 6 shows the location of all the bridges considered here in this study for the underwater scan using green laser. The railroad bridge selected for the study is the SXG59.70 railroad bridge near SW 112th St, Miami, Florida, United States. The average turbidity of the water samples collected from the canal’s surface is 0.45 NTU. The pictorial view and the approximate dimensions of the SXG59.70 railroad bridge are shown in Figures 7 and 8. Figures 9 and 10 show the scan station on the right and left banks of the canal near the railroad bridge.

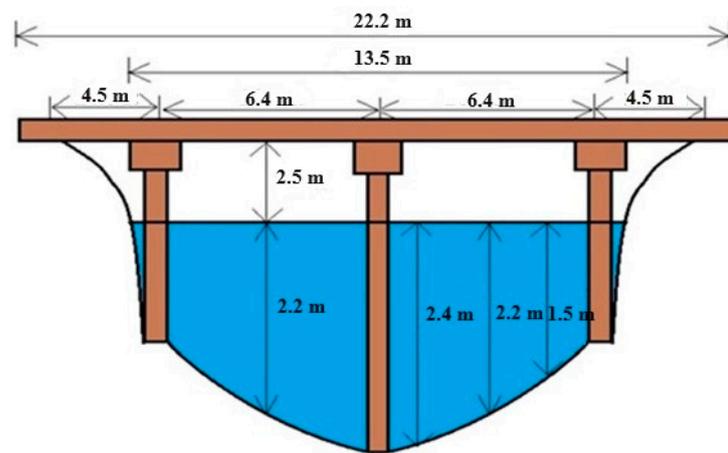
Figure 8. Dimensions of the railroad bridge—Miami, Florida (approximate) [29,30] (used with permission).

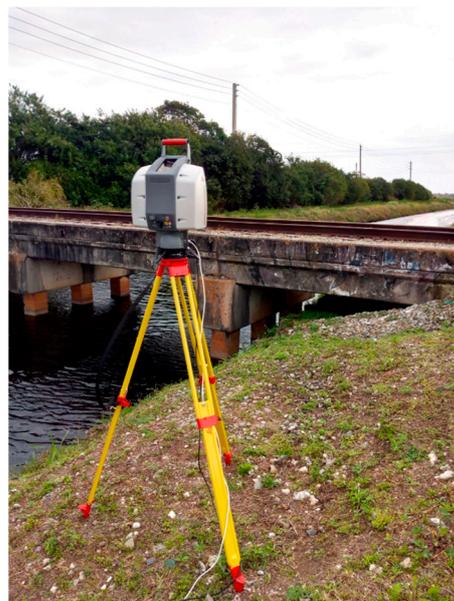
Figure 9. Scan station 1 set up on the right bank of the canal near the railroad bridge.

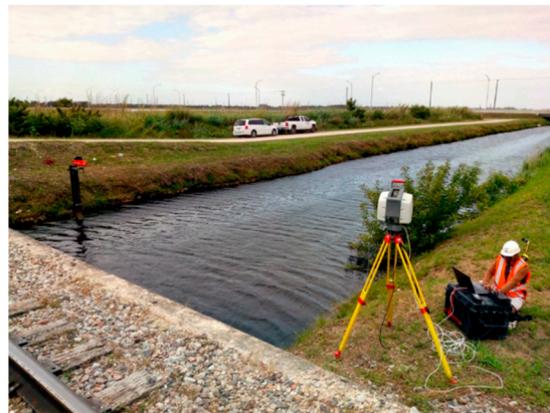
Figure 10. Scan station 2 set up on the left bank of the canal near the railroad bridge.

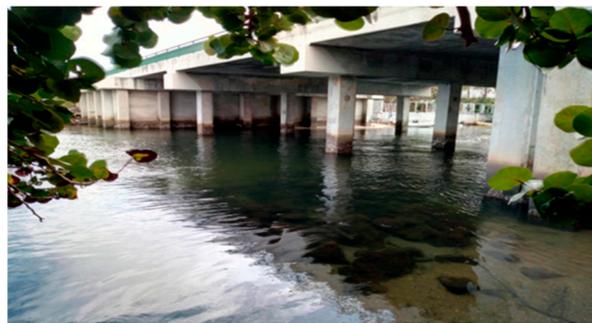
Figure 11. Pictorial view of the highway bridge—Little Lake Worth bridge, Florida [29,30] (used with permission).

The first highway bridge selected for the study was the Little Lake Worth bridge near 11072–11078 Florida A1A, Palm Beach Gardens, FL, USA (Figure 11). The Florida Department of Transportation (FDOT) owns and maintains the bridge. The bridge’s approximate dimensions are shown in Figure 12.

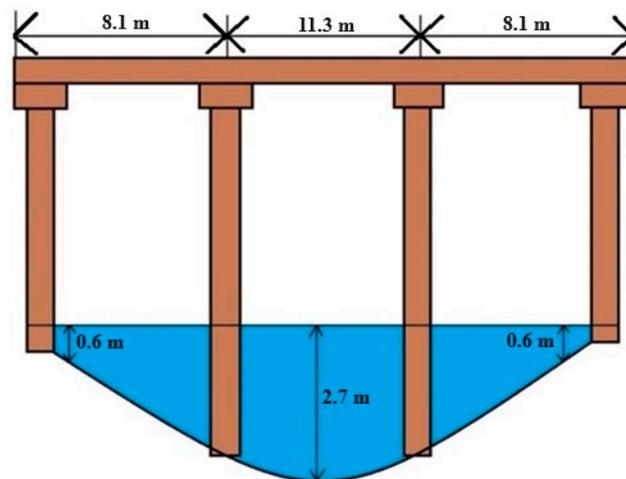
Figure 12. Dimensions of the highway bridge (approximate)—Little Lake Worth Bridge, Florida [29,30] (used with permission).

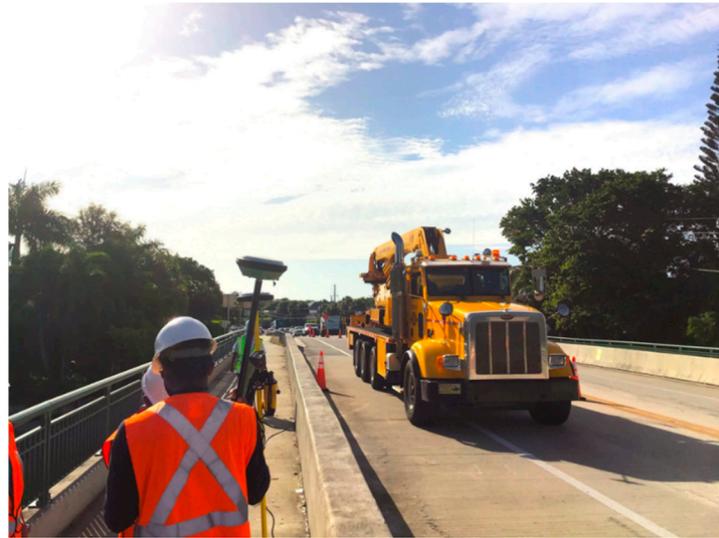
Figure 13. Snooper truck used for underwater scanning of highway bridge—Little Lake Worth Bridge, Florida.

Water samples were collected during the scanning process from different locations around the highway bridge piers. The average turbidity of the water samples collected from the surface was 1.74 NTU. For underwater scanning, an ASPEN A-62 Bridge Inspection snooper truck was used (Figure 13). The snooper truck is owned by the Florida Department

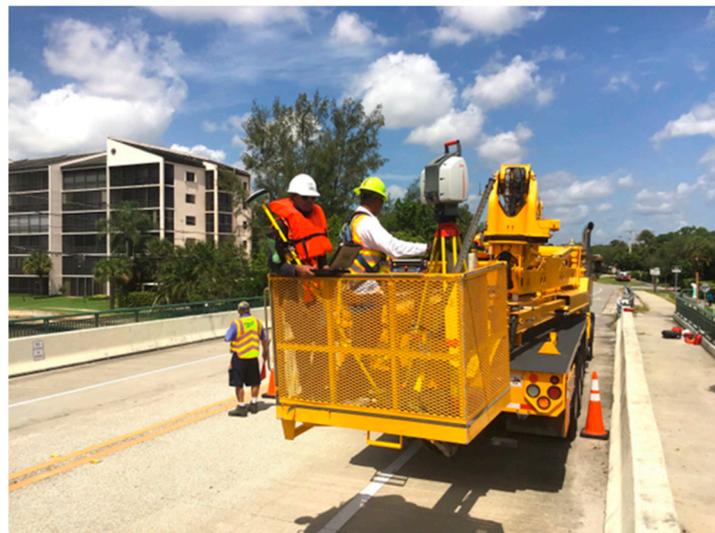
Figure 14. Leica scan station II set up in man basket of snooper truck used for underwater scanning of highway bridge—Little Lake Worth Bridge, Florida.

of Transportation District 4 office located in Fort Lauderdale, Florida, United States. The Leica Scan Station II with the tripod was set up in the man basket of the snooper truck (Figure 14).

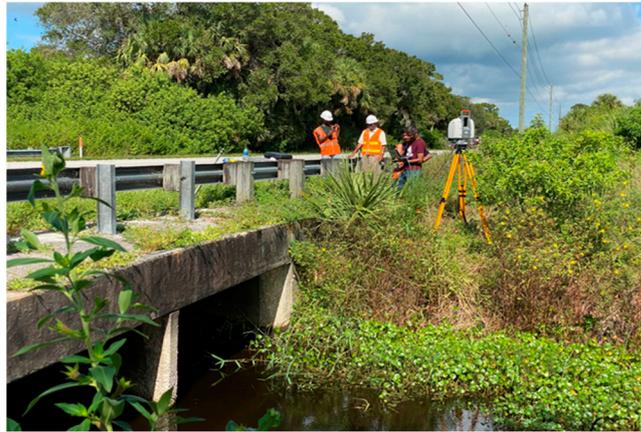
Figure 15. Leica scan station II set up for underwater scanning of SX.928 highway bridge.

The second highway bridge selected for the study was the SX.928 located in the SW Warfield Blvd Road (FL-710), Indiantown, FL, USA. The bridge is owned and maintained by the Florida Department of Transportation. The water under the bridge was highly turbid and the water depth under the bridge was 0.28 m. Water samples were collected to measure the average turbidity of the water and the turbidity was 5.25 NTU. Figure 15 shows the Leica scan station II set up for underwater scanning of SX.928 highway bridge. The approximate dimensions of the bridge are shown in Figure 16.

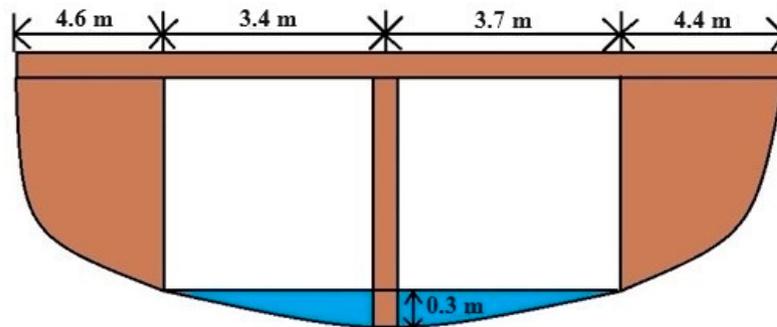
Figure 16. Dimensions of the SX.928 highway bridge (approximate).

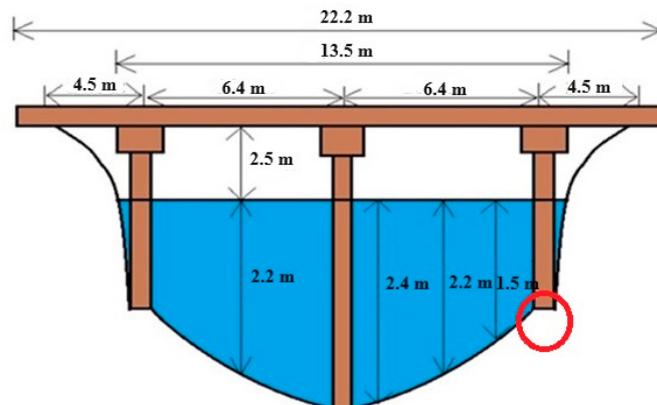
Figure 17. Dimensions of the railroad bridge with targeted end pier in red circle—Miami, Florida [29,30] (used with permission).

The first underwater scan was performed for the SXG59.70 railroad bridge. The scan stations were set up on both banks of the canal. The scan was carried out for the right end (in red circle) of the pier using two scan stations on the two banks of the canal (Figure 17). Figure 18 shows the point cloud data collected from the right bank of the canal (station 1), and Figure 19 shows the point cloud data collected from the left bank of the canal (station 2). Figures 20–22 show the point cloud data before and after the refraction correction.

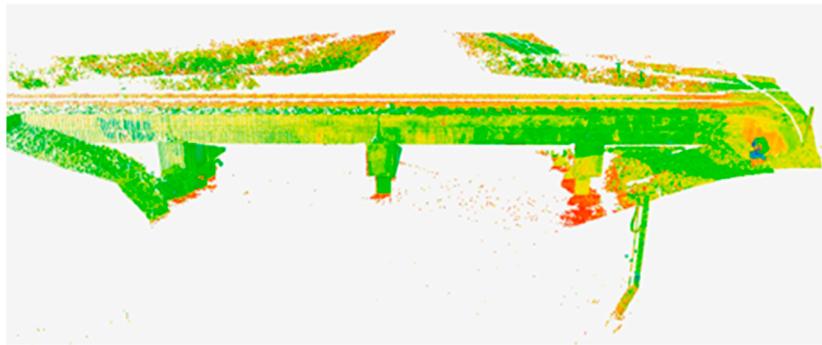
Figure 18. Green laser point cloud data collected from station 1 [29,30] (used with permission).

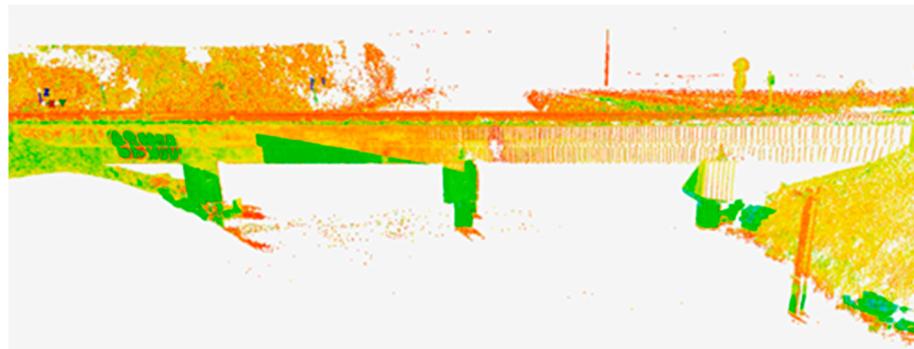
Figure 19. Green laser point cloud data collected from station 2 [29,30] (used with permission).

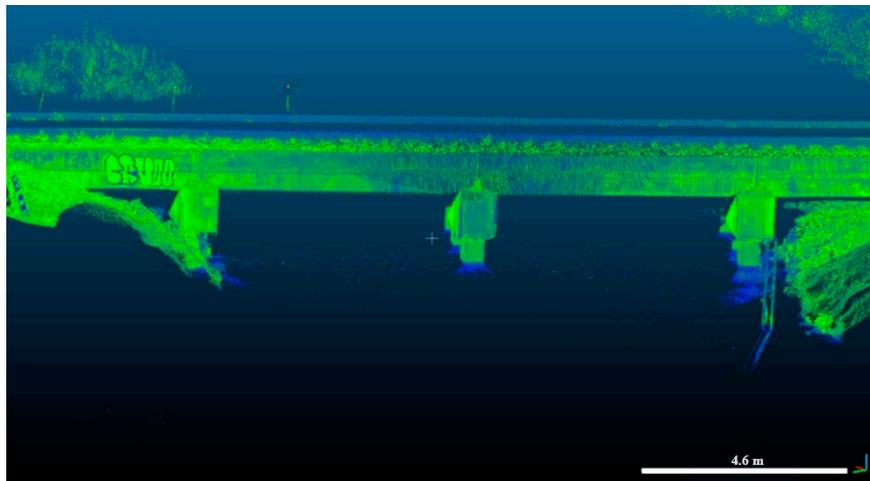
Figure 20. Railroad bridge green laser point cloud data before refraction correction [29,30] (used with permission).

From Figures 20–22, the green laser was unable to reach the bottom of the bridge pier due to high water turbidity in the canal. The bottom of the canal was highly turbid, and the green laser could not reach the bottom of the canal.

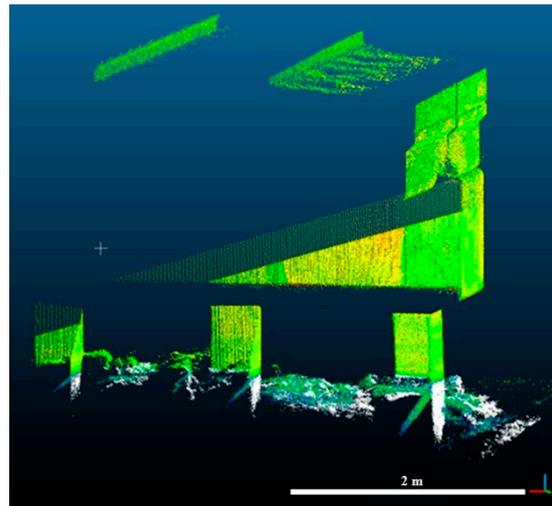
Figure 21. Railroad bridge green laser point cloud data from station 1 before (green) and after (white) refraction correction [29,30] (used with permission).

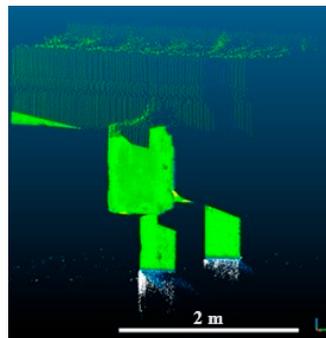
Figure 22. Railroad bridge green laser point cloud data from station 2 before and after (white) refraction correction [29,30] (used with permission).

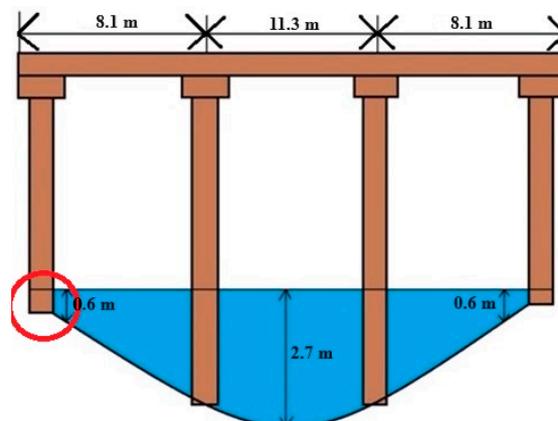
Figure 23. Dimensions of the highway bridge with targeted end pier in red circle—Little Lake Worth, Florida [29,30] (used with permission).

The scan was carried out for the left end pier (in red circle) using the Leica Scan Station in the man basket (Figure 23). With the help of the snooper truck, the man basket could be moved around various locations. The man basket was able to be moved around different locations, and scan data was collected when the man basket was stationary. Figures 24 and 25 show the scan data of the left end pier.

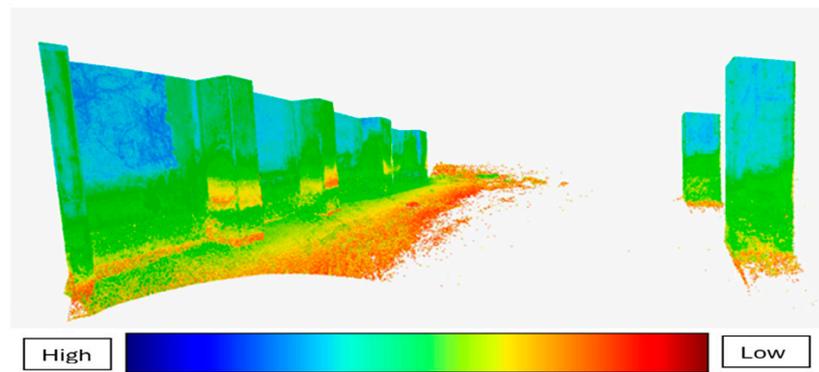
Figure 24. Scan data of the end pier of the highway bridge, Little Lake Worth, Florida (display by hue intensity) [29,30] (used with permission).

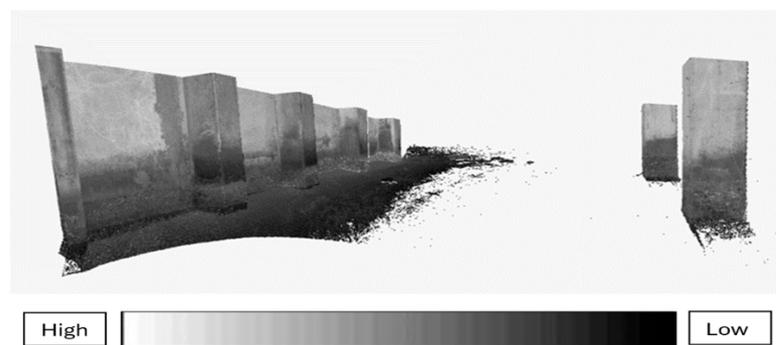
Figure 25. Scan data of the end pier of the highway bridge, Little Lake Worth, Florida (display by intensity) [29] (used with permission).

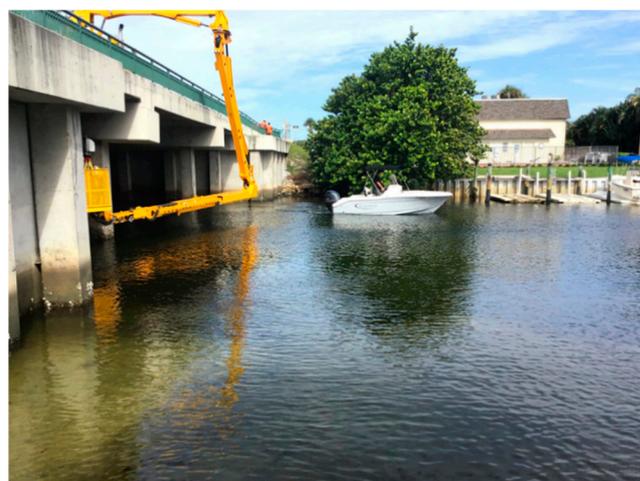
Figure 26. Boat traffic under the highway bridge, Little Lake Worth, Florida.

Since there was constant boat traffic under the bridge, the water on the top surface was disturbed continuously (Figure 26). The underwater scan data of the left end pier was collected effectively. The laser was undergoing refraction while traveling through the water, and refraction correction was carried out for the data points collected. Figure 27 shows the point cloud data before and after refraction correction.

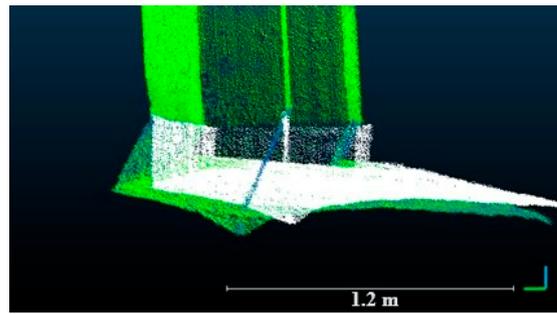
Figure 27. Point cloud data before (green) and after (white) refraction correction of the left end pier—Little Lake Worth, Florida [29,30] (used with permission).

From the point cloud data, it is visible that there is no visible scour around the left end pier. The green laser is effective in underwater scanning around the bridge pier. The scan data around other piers were not able to be obtained as there was continuous boat traffic.

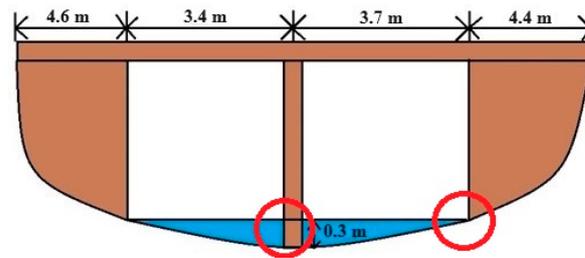
Figure 28. Dimensions of the SX.928 highway bridge with targeted scan areas in red circle.

The final scan was carried out for the center pier and right end (shown in red circle) of the SX.928 highway bridge using the Leica Scan Station II (Figure 28). Figure 29 shows the point cloud data from the scan. The green laser was unable to reach the bottom of the highway bridge due to highly turbid water. The scattering of the laser was also high for this case.

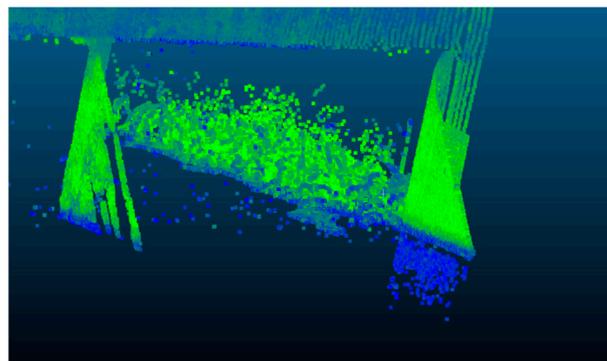
Figure 29. Point cloud data from the laser scan for SX.928 highway bridge.
