# Soiling Comparison of Mirror Film and Glass Concentrating Solar Power Reflectors in Southwest Louisiana

Kenneth Ritter III \*, Albert McBride and Terrence Chambers

Department of Mechanical Engineering, University of Louisiana at Lafayette, Lafayette, LA 70504, USA; albert.mcbride1@louisiana.edu (A.M.); terrence.chambers@louisiana.edu (T.C.)

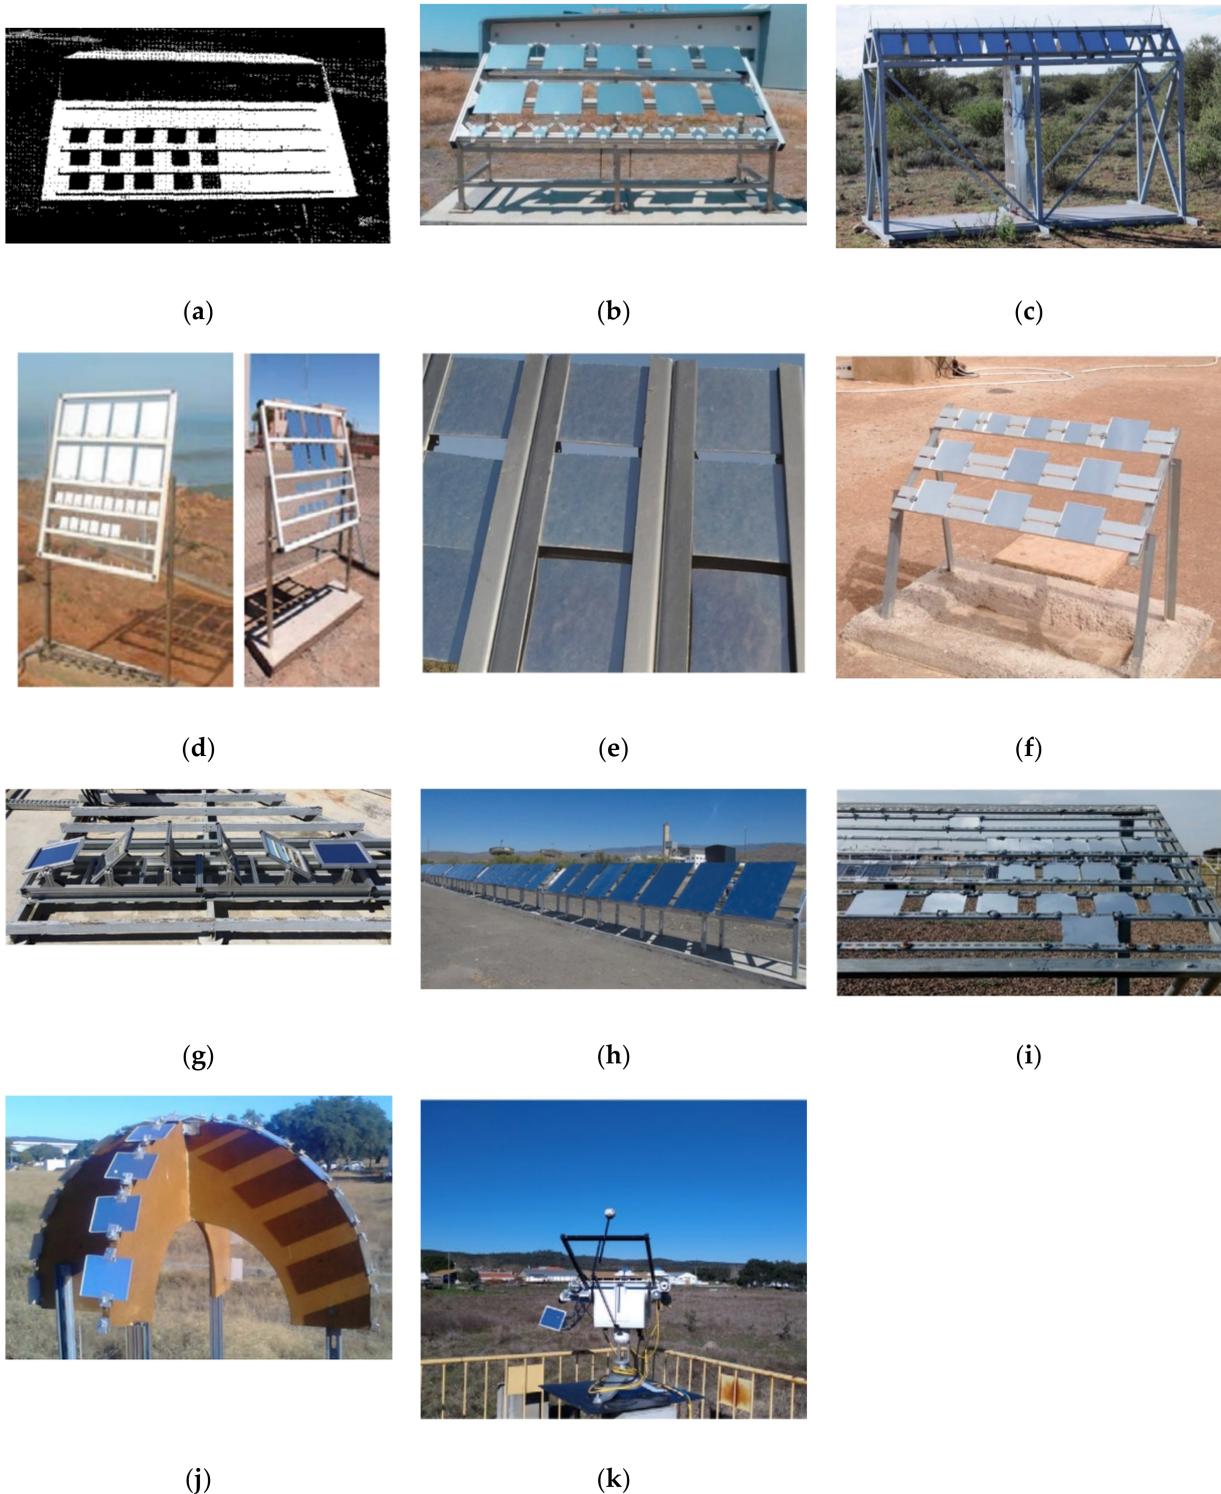
**Figure 1.** Concentrating solar power reflector testbeds: (a) Sandia national laboratories, Albuquerque, NM [1]; (b) Plataforma Solar de Almería (PSA) Tabernas, Almería, Spain [6]; (c) the semi-arid southern Kalahari region in Northern Cape, South Africa [27]; (d) left is Temara Oceanside site and right is the Skoura desert site in Morocco [28]; (e) Southwest Morocco [29]; (f) University of Oujda in Eastern Morocco [10]; (g) Gardens Point campus, Brisbane, Australia [30]; (h) PSA in Tabernas, Almería, Spain [23]; (i) Benguerir, Morocco [14]; (j) Portugal on an experimental site (Valverde) of the University of Évora [26]; (k) in a rural region of Évora, Alentejo, Portugal [31].

effects of soiling on reflectors in different climate regions. In Figure 1 below, testbeds from Australia, Morocco, Portugal, Spain, South Africa, and the United States are shown.

The most common testbed design was found to be fixed tilt, with the tilt similar to the latitude where this study was conducted. This design allows for multiple rows of reflector panels to be easily cleaned and tested for multiple types of outdoor studies. Table 1 presents the location, studied technology, and main findings of studies of the reflector testbeds shown in Figure 1.

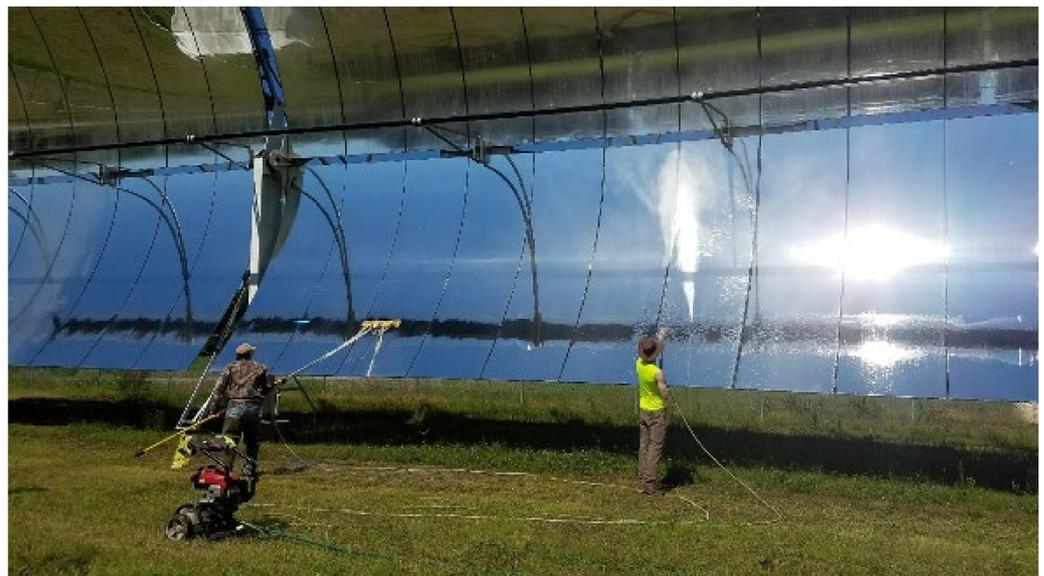
Figure 2. Solar reflector cleaning in Crowley, LA.

In a previous study in southern Louisiana, measurements taken of the specular reflectance showed that after having been reduced to less than 80%, washing the reflectors returned them to original performance specifications for reflectivity >95% [16]. The washing procedure currently employed at the Louisiana CSP plant involves using a pressure washer with deionized water and a microfiber cloth attached to a pole brush designed by 3M (Figure 2). This brush consists of a long pole attached to a brush head that clamps the microfiber cloth down on a sponge that has running water flowing to it to reduce surface friction. The reflector-washing procedure consists of an initial spray of water with a pressure washer, followed by wiping with the brush before the reflectors are sprayed again.

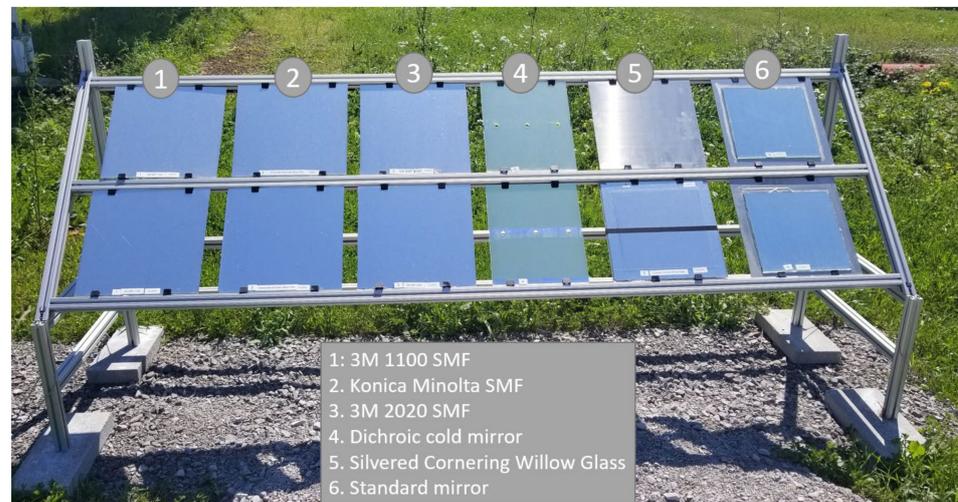
**Figure 3.** Concentrating solar panel reflector testbed installed at the Solar Applied Research and Testing (START) Lab in Crowley, Louisiana. Bottom row is cleaned for testing and the top is left dirty.

In a rural region of Crowley, Louisiana, a fixed-tilt CSP soiling testbed (Figure 3) was designed and built to analyze soiling of various reflective materials. The soiling testbed consisted of six sets of reflective surfaces mounted at a fixed tilt at 30 degrees. The reflective surfaces included three sets of thin-film surfaces and three sets of glass types. The samples are all secured on a 15 inch by 15 inch aluminum backplate. All the samples were developed for concentrating solar applications except the standard glass sample that is a 12 inch by 12 inch mirror purchased from Home Depot. Each set had one reflective surface that was cleaned weekly and one that was left dirty. Two generations of 3M thin-film, 3M 1100 SMF and 3M 2020 SMF, were tested along with Konica Minolta SMF. For the glass-type reflectors, silvered Corning Willow Glass is tested along with a standard mirror and a dichroic cold mirror used for beam splitting in concentrating solar photovoltaic applications [41]. The dichroic cold mirror is a spectrally selective mirror with dichroic film by the Evaporated Metal Films Corporation (EMF).

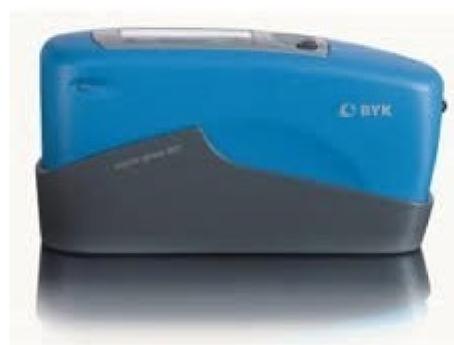
**Figure 4.** Byk-Gardner micro-TRI-gloss glossmeter.

Mirror reflectivity analysis is driven by experimental data of the specular reflection of concentrating mirror surfaces. Specular reflection consists of the spectrum of light that is reflected at an angle equal and opposite to that of the incident light beam. A micro-TRI-gloss glossmeter by Byk-Gardner (Figure 4) has been used to measure specular reflectance of the solar reflectors. The device offers an easy one-time calibration versus a reference that allows for efficient measurement of multiple panels. This device produces a derived reflectivity value rather than a direct measurement [37]. This glossmeter measures the reflectance at an angle of  $20^\circ$  to the mirror surface and is repeatable to within  $\pm 0.2\%$  for highly reflective surfaces [42]. It consists of a camera-shaped device and a standard comprising a true black sample, which can be measured by the glossmeter for calibration. The gloss measurements can be correlated to the specularity of the reflectors, a major factor in optical efficiency [43]. The gloss measurement, expressed in specular gloss units (SGU), as described in ASTM D523, states that a glass of refractive index  $n = 1.567$  at  $589.3 \text{ nm}$  has a specular gloss value of 100 SGU for any angle of incidence [44]. Along with specular gloss measurements, an onsite weather station recorded temperature, humidity, wind speed and direction, and precipitation throughout this study. The National Renewable Energy Laboratory (NREL)'s Measurement and Instrumentation Data Center (MIDC) collects irradiance and meteorological data from various stations in the United States. All weather and solar resource data for the Crowley, Louisiana, testing location used in this study is available online on the MIDC website [45].

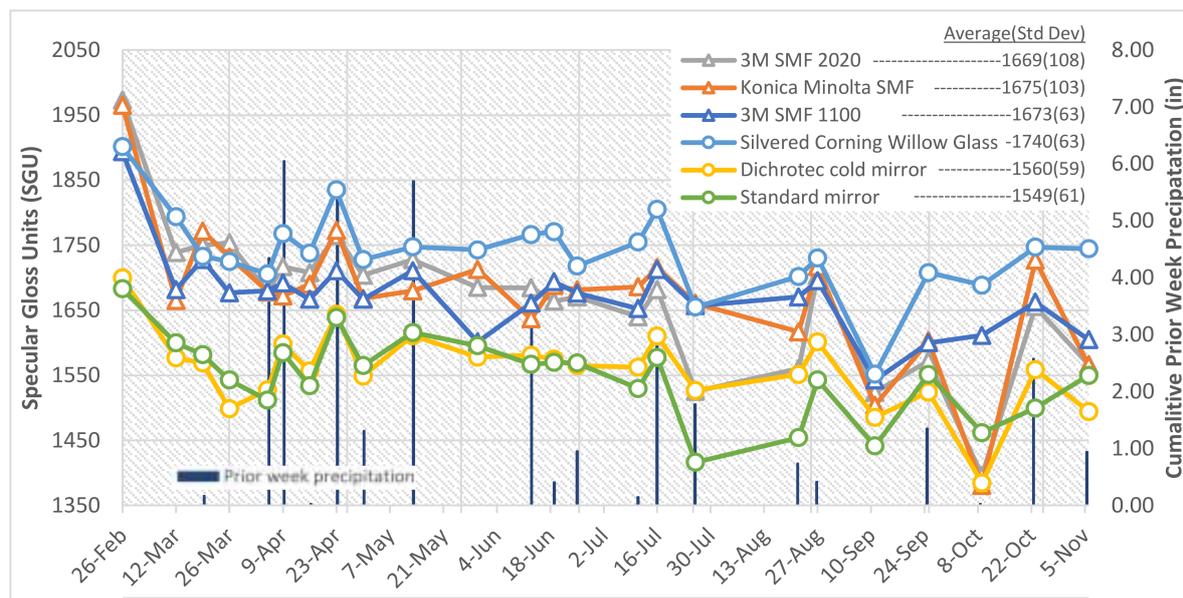
Figure 5. Gloss of natural event-cleaned reflector panels.

The measured SGU ranged from approximately 1350 to 2150 throughout this study. The raw SGU measurements for the panels that were not cleaned throughout this study, referred to as dirty, are shown in Figure 5. These panels were only cleaned by natural precipitation events. The prior week precipitation total is shown and correlates with dips in the SGU after little to no precipitation events, such as 11 September and 9 October. After precipitation events, SGU increases are shown in several tests, such as on 9 April, 23 April, 16 July, 25 September, and 23 October. In an analysis of 20 soiling stations in the US, it was found that no cleaning effect occurred following rain events of 0.012 inches or less; therefore, anything below 0.012 inches is considered negligible and is not counted in the cumulative prior week's precipitation [39].

As shown in Figure 5, the silvered Corning Willow Glass had an average of 4% higher SGU readings throughout this study. Following precipitation events, the silvered Corning Willow Glass had significantly higher SGU readings, with up to 7.3% higher than the average thin-film tested. As stated in the Methods section, the reflector panels that were regularly cleaned were tested before and after cleaning, allowing the soiling rate to be calculated between precipitation events. The 3M SMF 2020 and Konica Minolta SMF gave an average of 1.6% higher SGU readings than the silvered Corning Willow Glass when cleaned at regular intervals, as shown in Figure 6.

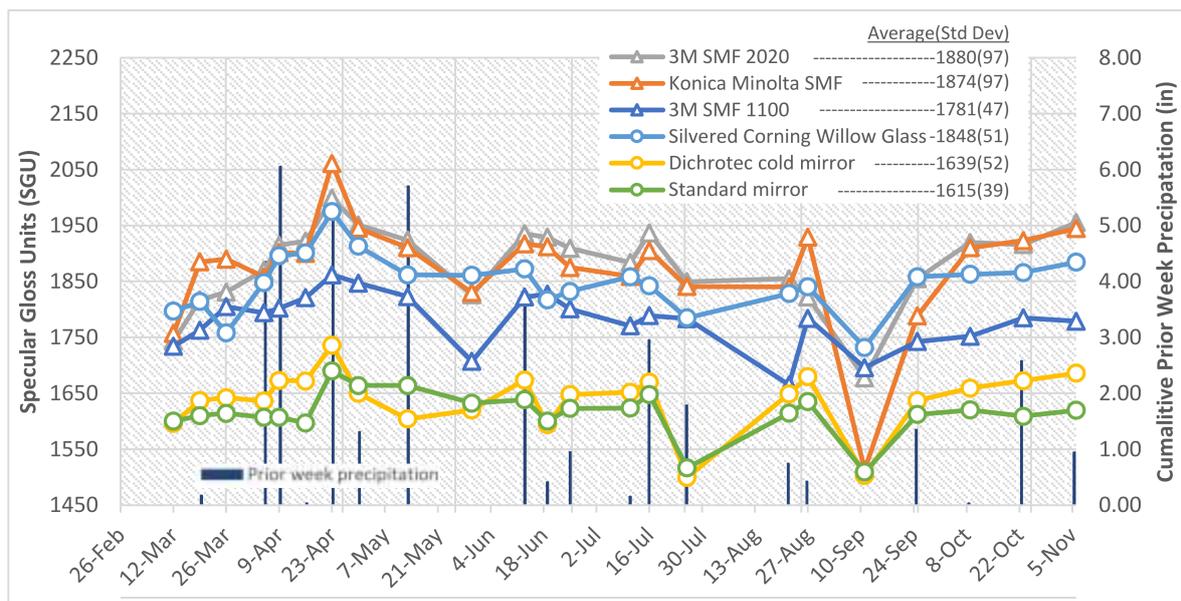
Figure 6. Gloss of prewash (cleaned at regular intervals) reflector panels.

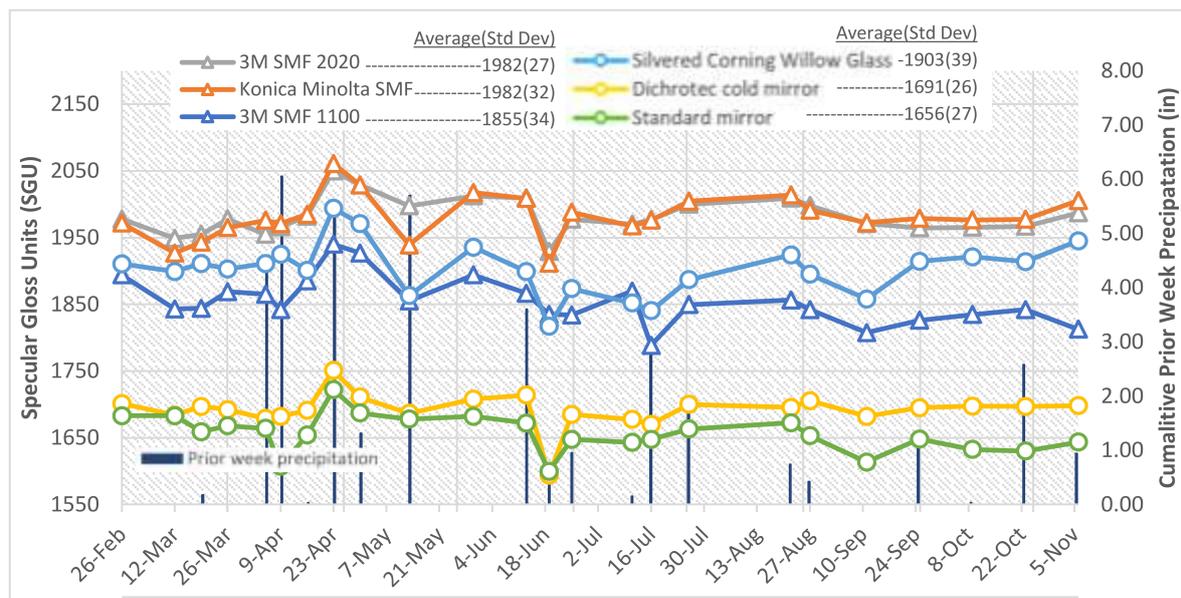
Figure 7. Gloss of cleaned reflector panels.

The SGU of the cleaned reflector panels remained consistent with the least amount of standard deviation throughout this study compared with the dirty and prewash measurements. As shown in Figure 7, the Konica Minolta and 3M 2020 had an identical average gloss of 1982, trailed by the silvered Corning Willow Glass at 1903, and 3M 1100 at 1855.

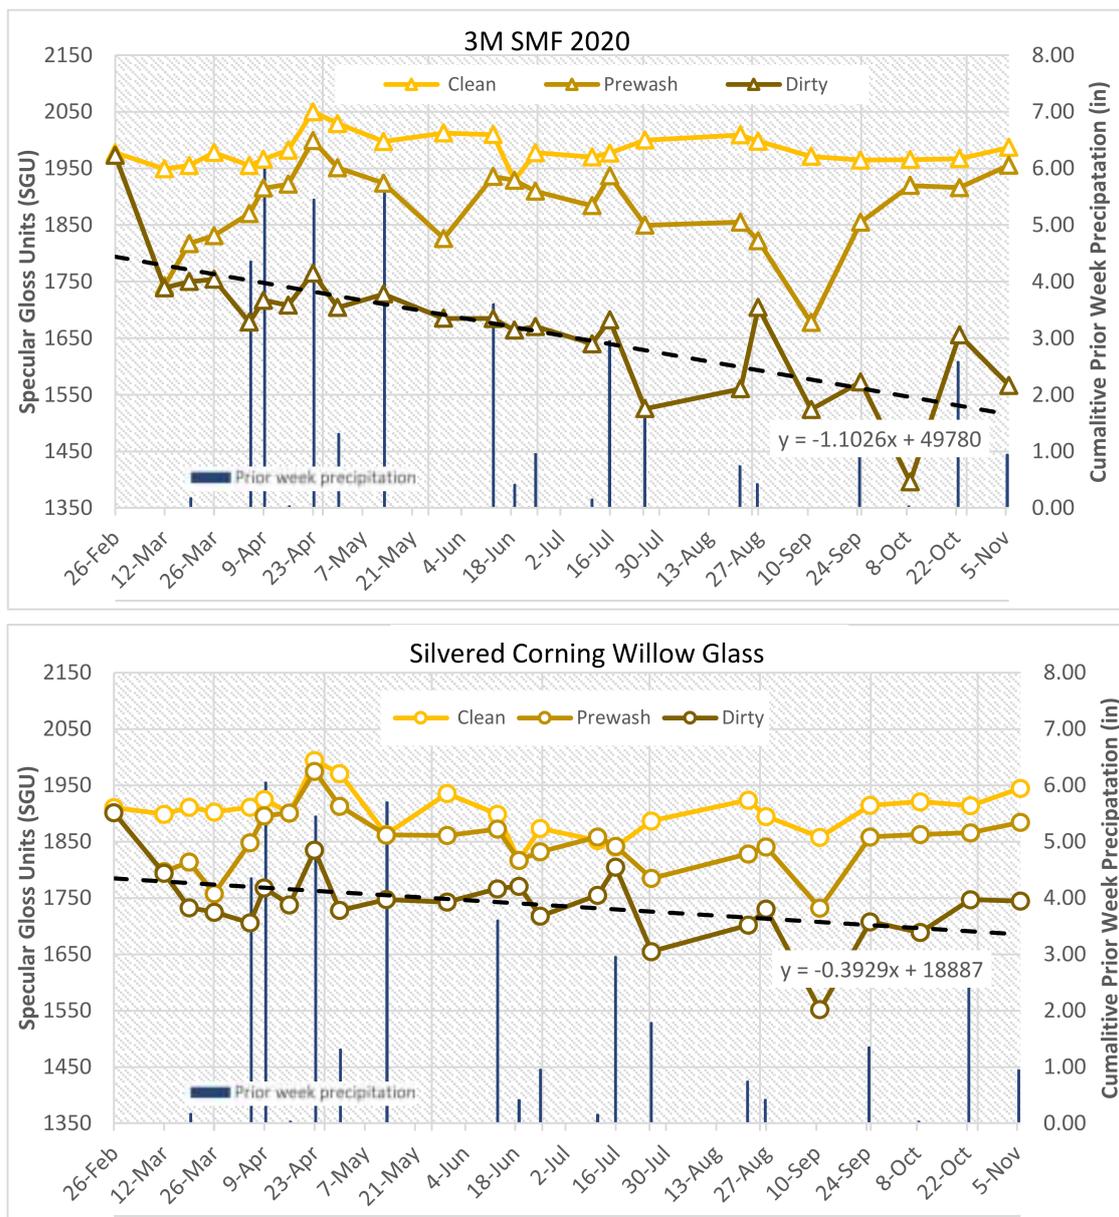
**Figure 8.** All three tests on 3M SMF 2020, top, and silvered Corning Willow Glass, bottom.

The natural event cleaned (dirty), the prewash, and cleaned tests are combined together to show the contrast between a thin-film and glass-type reflector. Figure 8 shows the 3M SMF 2020 and silvered Corning Willow Glass results for all three types of tests. Although the 3M SMF 2020 has the higher average for the cleaned and prewash tests the silvered Corning Willow Glass is dominant in the dirty test. A trend line is graphed for the dirty test and the slope is indicative of the long-term soiling rate. As shown in Figure 8 the silvered Corning Willow Glass has approximately one-third the slope, at  $-0.39$ , then the 3M SMF 2020 at  $-1.10$ .

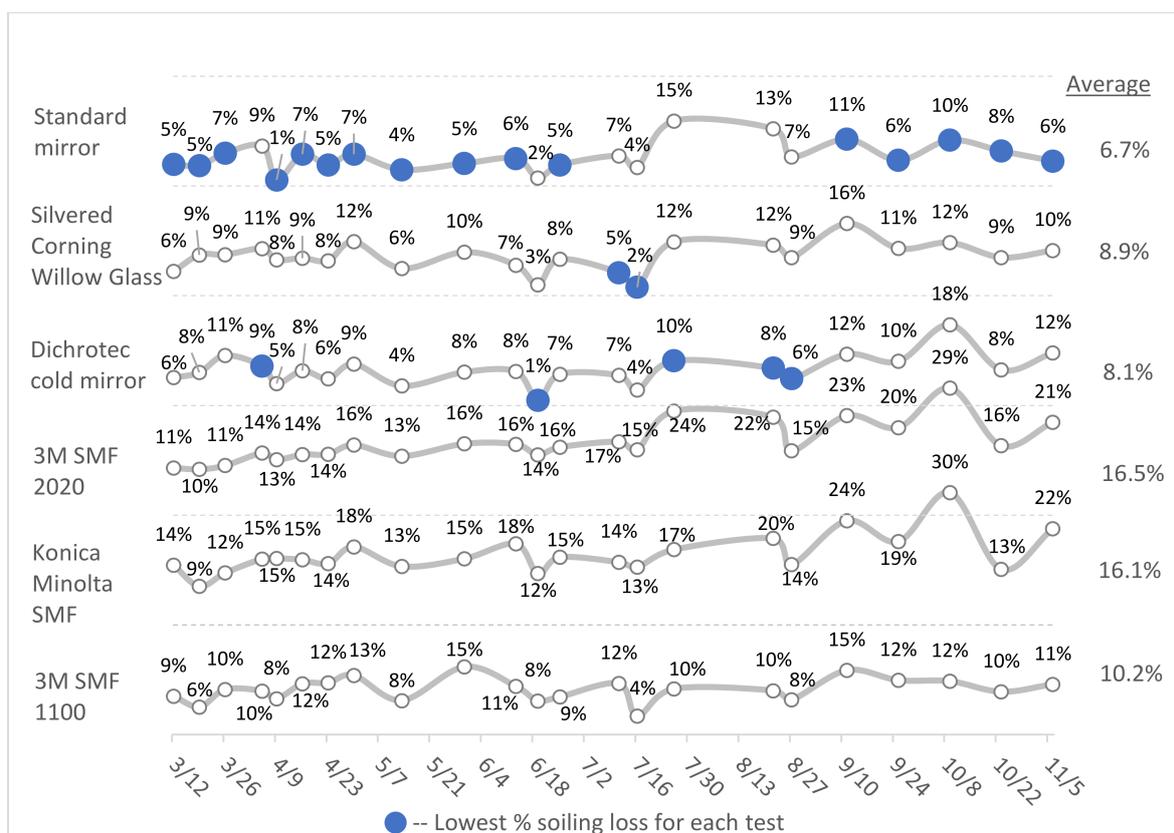
Figure 9. Cumulative percentage of soiling loss in the dirty (natural cleaning only) reflectors.

The cumulative SL percentage of the dirty compared with the clean panels is shown in Figure 9 below. The Konica Minolta and 3M 2020 demonstrated the highest losses from soiling. Although the dichrotec and standard mirrors showed consistently fewer SGU readings than other reflectors (Figure 5 above), they were less affected by soiling throughout the year. Furthermore, during high precipitation events, such as April 9 and June 18 as seen in Figure 9, the mirrors were cleaned more efficiently than other reflectors with less than 5% SLs following the precipitation events. As shown with the blue dots, the standard mirror demonstrated the lowest percent SL for 70% of the tests with an average of 6.7% throughout this study. This equates to 2.5-fold less SL than the 3M SMF 2020, which showed the highest average SL at 16.5%. The silvered Corning Willow Glass gave an average SL of 8.9% throughout this study, which is considerably less than the thin-films tested. The most significant average SL of all reflectors occurred on 9 October when there had been virtually no precipitation events for 18 days.

The SL of the prewash or regularly cleaned reflectors is shown in Figure 10. When comparing to the naturally cleaned reflector group in Figure 9, the silvered Corning Willow Glass outperformed the thin-film reflectors again and even showed slightly better performance than the dichroic cold mirror. The 3M SMF 2020 showed better average performance than the Konica Minolta SMF in the prewash but not the natural cleaning. This is partly due to the 11 September test when there were no precipitation events for the prior 10 days and the Konica Minolta SMF showed significant SL compared with the other reflectors tested.

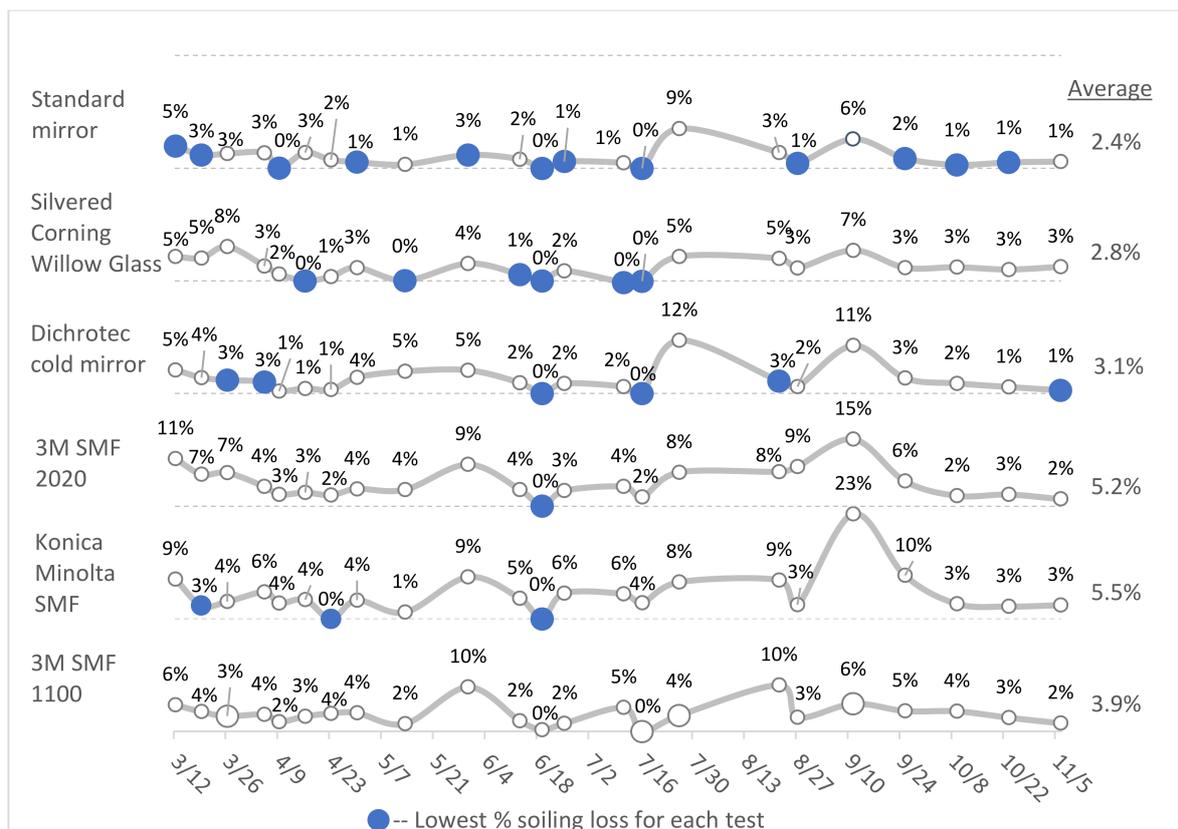
Figure 10. Soiling loss in prewash (cleaned at regular intervals) reflector panels.

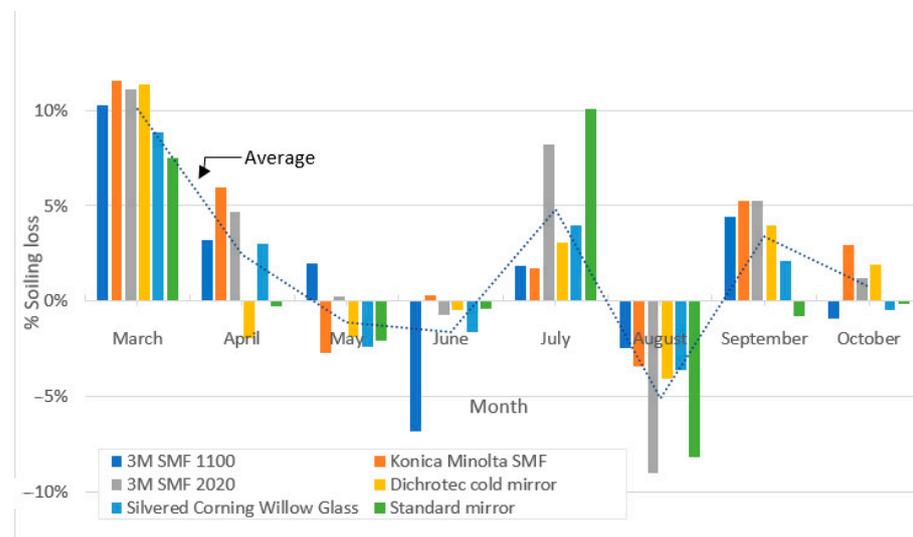
Figure 11. Reflector soiling loss for each month.

In the initial testing in February, the cleanliness, calculated using Equation 1, was found to be 99.8% averaging the value of all reflectors. In March, it was 89.7%, in April, it was 87.2%, and the lowest was the 9 October test with 81.3%. The monthly SL (Figure 11) shows the difference between the end of one month's cleanliness and compared to the end of month following. In the beginning of the testing period and before any soiling occurred, there was a large contrast between the soiling at the beginning and end of the month. A trend is observed from the start of this study, where the SL percentage generally decreases each month (except for July and September), as shown with the dotted line in Figure 11. Initially, there is a large difference in the amount of soiling, but the rate decreases after reflectors are soiled. The July and September anomalies are possibly due to large precipitation events in the previous month. The average month across the entire testing period incurred a 2% SL however, in the beginning of this study a 10% SL average was shown. May, June, and August all showed an increase in cleanliness at the end of the month due to natural precipitation events.

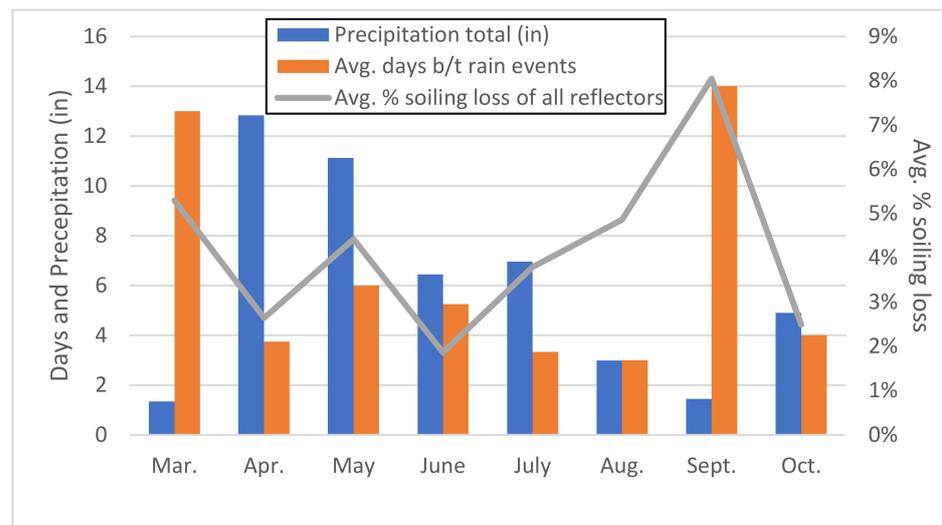
**Figure 12.** Monthly average % soiling loss of all reflectors compared with precipitation and days between rain events.

In a previous study, it was found that SLs had the strongest correlation with the average number of days between rain events [39]. As shown in Figure 12, the monthly average SL for all reflectors correlates with the average days between rain events. September had the least amount of precipitation and the highest average number of days between rain events. This combination resulted in the highest average SL of 8% across all the reflectors.

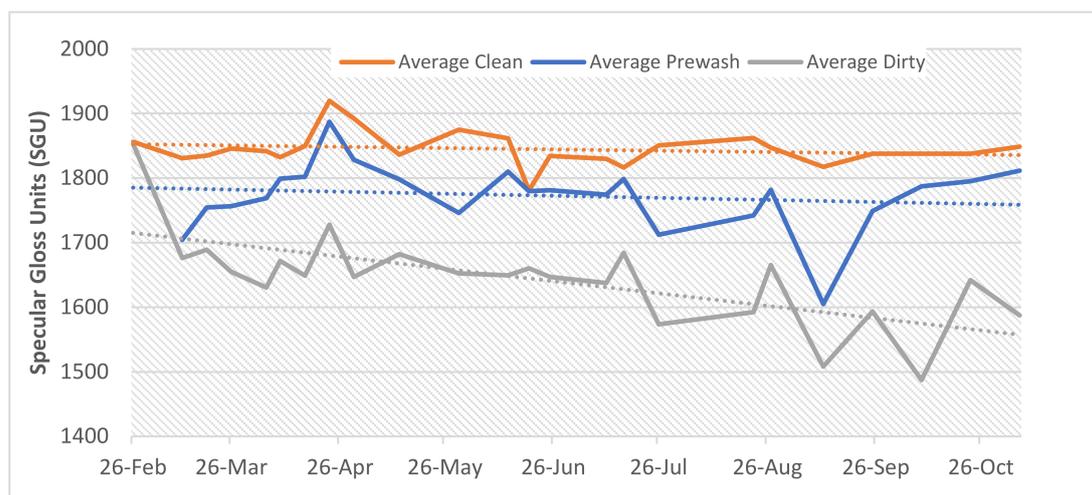
**Figure 13.** Trends of the average clean, prewash, and dirty SGU measurements.

An average of all panels was taken to see the overall trend of the SGU measurements throughout this study as shown in Figure 13. The average clean reflectors stayed consistent with a linear slope of  $-0.0356$ . The average prewash reflectors showed more of a decline throughout the testing period with a linear slope of  $-0.31$ . Despite heavy precipitation events, the dirty reflectors have a gradually lower linear trend with a slope of  $-0.79$ .
